GROVE GARDEN ELECTRICAL SUPPLY

Merton College, Oxford

Watching Brief Report

Document No: TJC2013.17

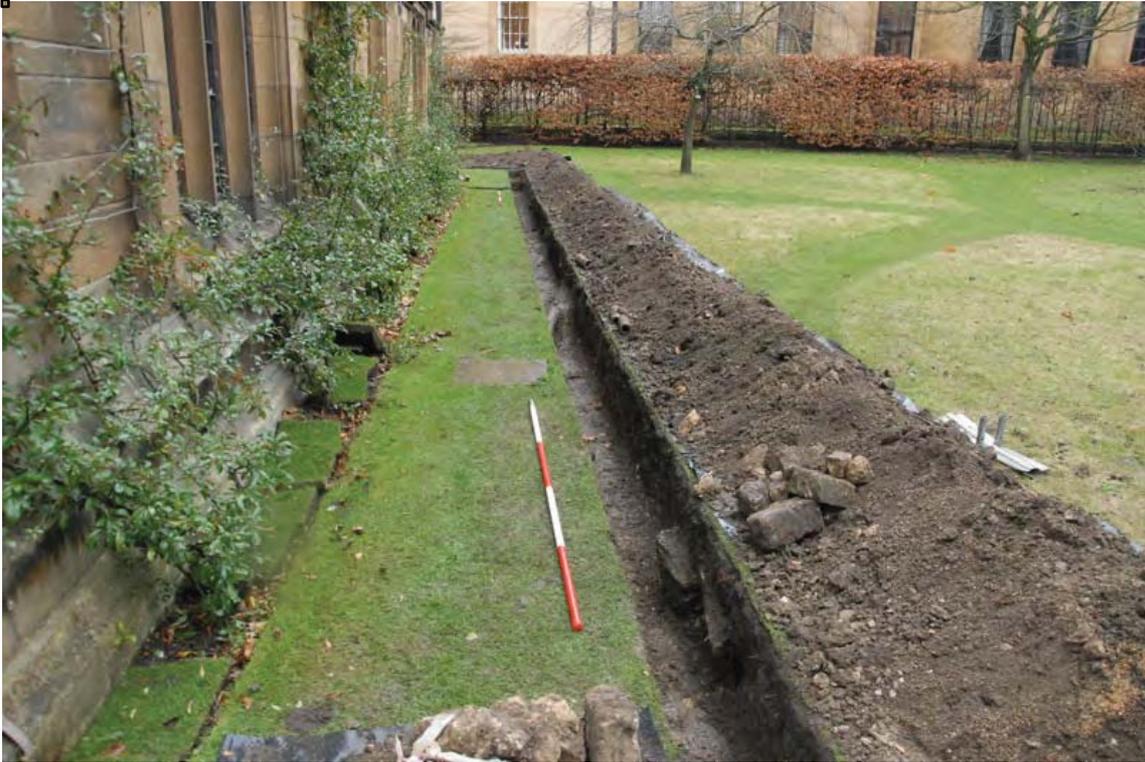
Appendix 3.5: General view of Trench 3, looking west; note stone chamber (032) in foreground.

In the east part of the trench, c.4m from the north-east corner of the Grove Building, a stone-lined chamber, or drain (**032**), was observed in the north side of the trench (**Appendix 3.5**). This was beneath (**001**) and cut into (**028**) and a mottled clay layer (**029**) to the east. The east wall of this feature was damaged and appeared to be of a dry-stone construction. There was a substantial stone slab on the top that covered a shallow void, 0.4m wide and over 0.6m in length. The base of this feature extended beneath the depth of the trench and its full extent, or function could not be established, however it was notably different from all of the other drainage features identified during the archaeological watching brief.

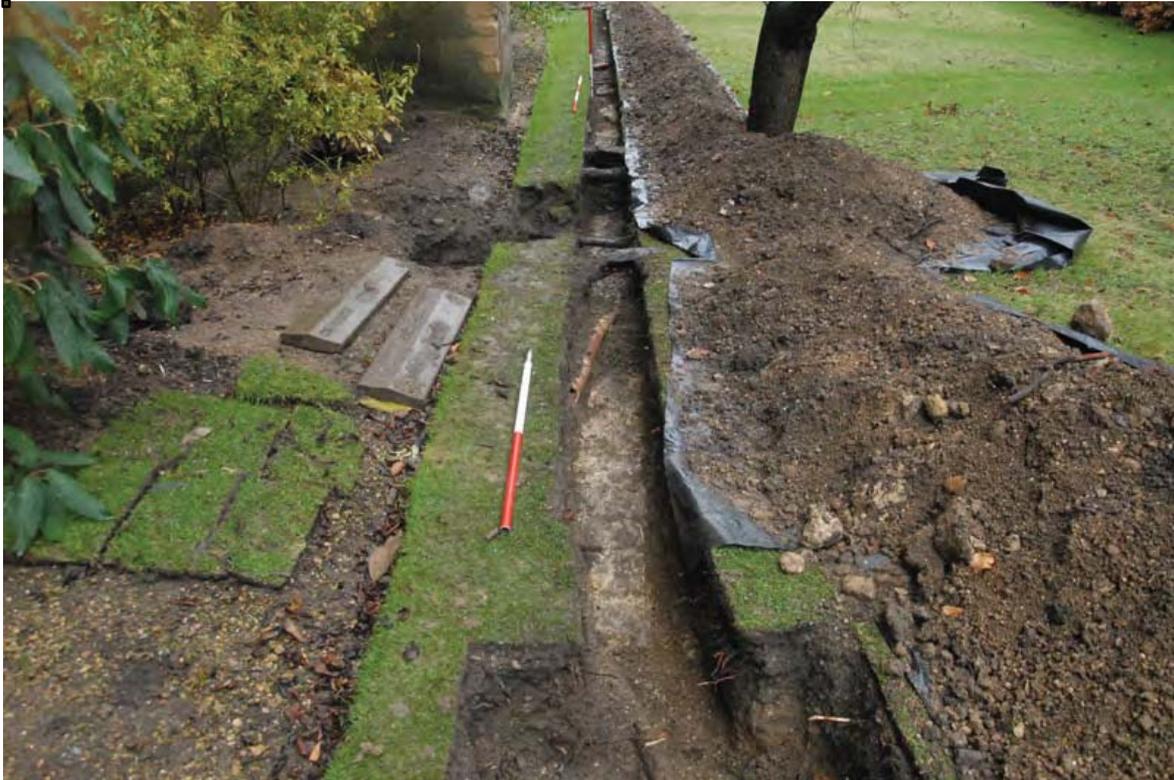
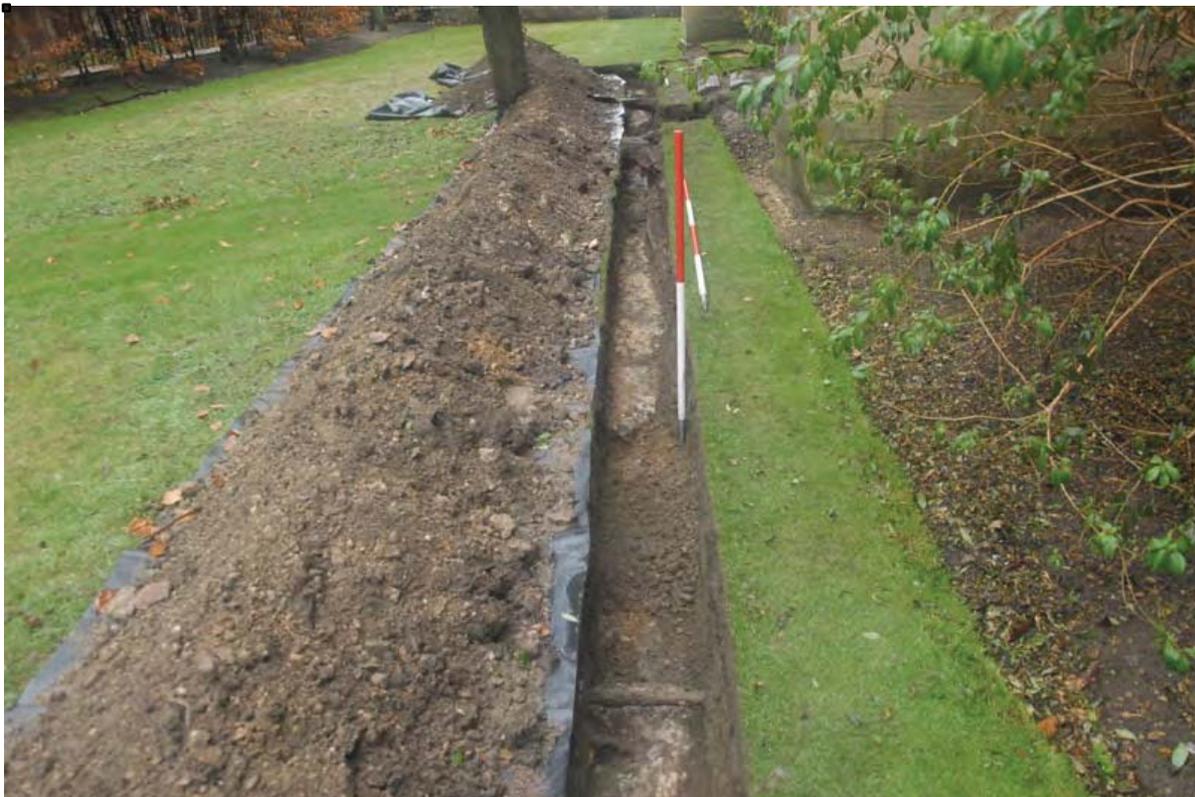
Alongside the west window of the tower of the chapel a solid stone footing (**011**), 6.6m in length, was exposed along the base of the trench at a depth of 0.44m (**Appendices 3.9, 3.10**). This feature extended beyond the trench and appeared to have straight edges at either end, set at

right angles to the chapel, one possibly aligning with a blocking in the west wall of the south transept. The upper surface of (011) was relatively level and it is suggested that it represents a possible foundation for a former surface, or floor, or alternatively represents a lower course of a former wall that has been reduced in height to this level. The date of (011) is unclear, but its proximity to the chapel (only 2.6m away), may indicate that it was associated with one of the various stages of construction of the building.

Against the north edge of (011) was a row of stones (017), one containing a cut off section of metal bar set in lead (**Appendix 3.9**). It is unclear, however, whether they represent the secondary re-use of earlier material to form a wall foundation, or an earlier ground level, with a wall that incorporated a metal fence.

Appendix 3.9: Detail of exposed stone foundation (011) in Trench 1, looking south (1m scale).

Appendix 3.10: Detail of exposed stone foundation (011) in Trench 1, looking north (1m/2m scale).

The purpose of the stone foundation, or footing, that was exposed in the northern section of Trench 1 is still unclear. It is possible that it is associated with the various stages of construction of the tower and transepts of the chapel and is within the plot of land originally intended for the nave, but was never realized.
