# THE STABLE COURTYARD, GUNBY HALL, LINCOLNSHIRE

## Historic Building Survey on behalf of the National Trust

August 2017

Document No: TJC2017.09

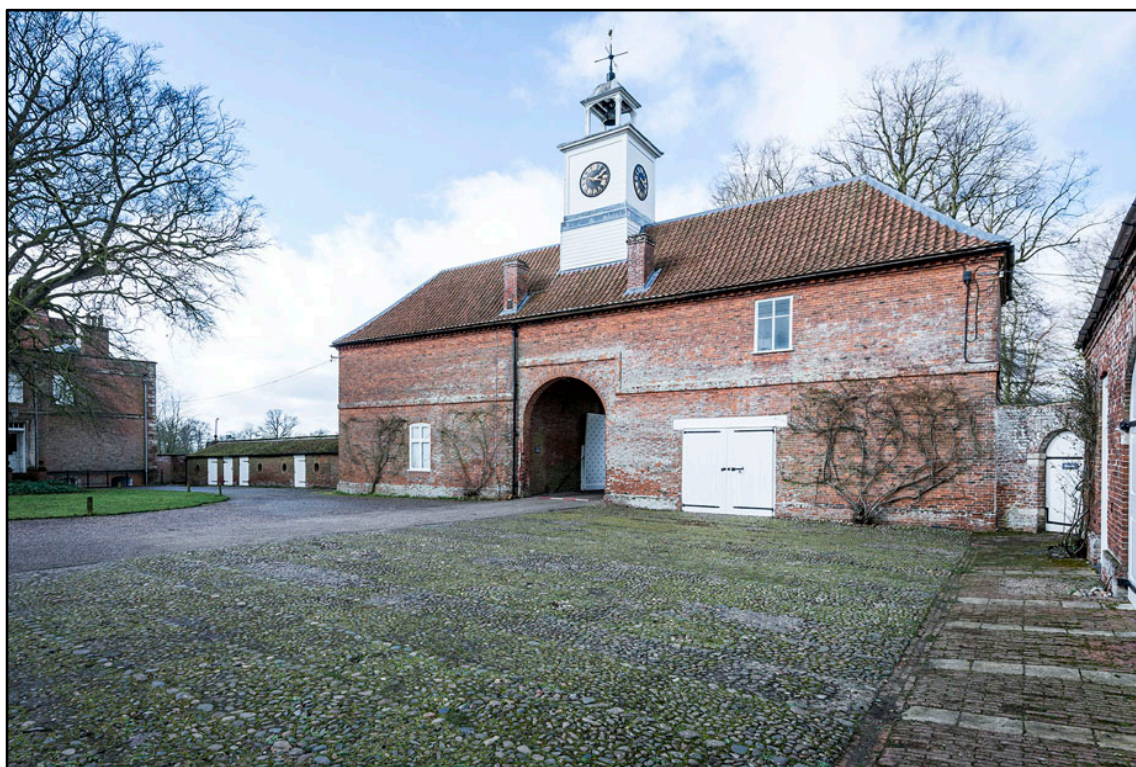
**Appendix 2.18:** General view of Clock House, looking southwest; note decorative banded cobbles (2m scale). **Photo No.15**

The south wall contains an angled chimney flue (**Appendix 2.51**) linked to one of the small external stacks on east pitch of the roof (**Appendix 2.18**) and is interpreted as a secondary alteration following the addition of the Clock Tower. At the base of the flue is a stone hearth indicating that there would have been a grate to provide heating within the room. It was not possible to examine all of the south wall due to stored materials, but a straight joint was noted, which helps confirm that the chimney stack has been adapted.

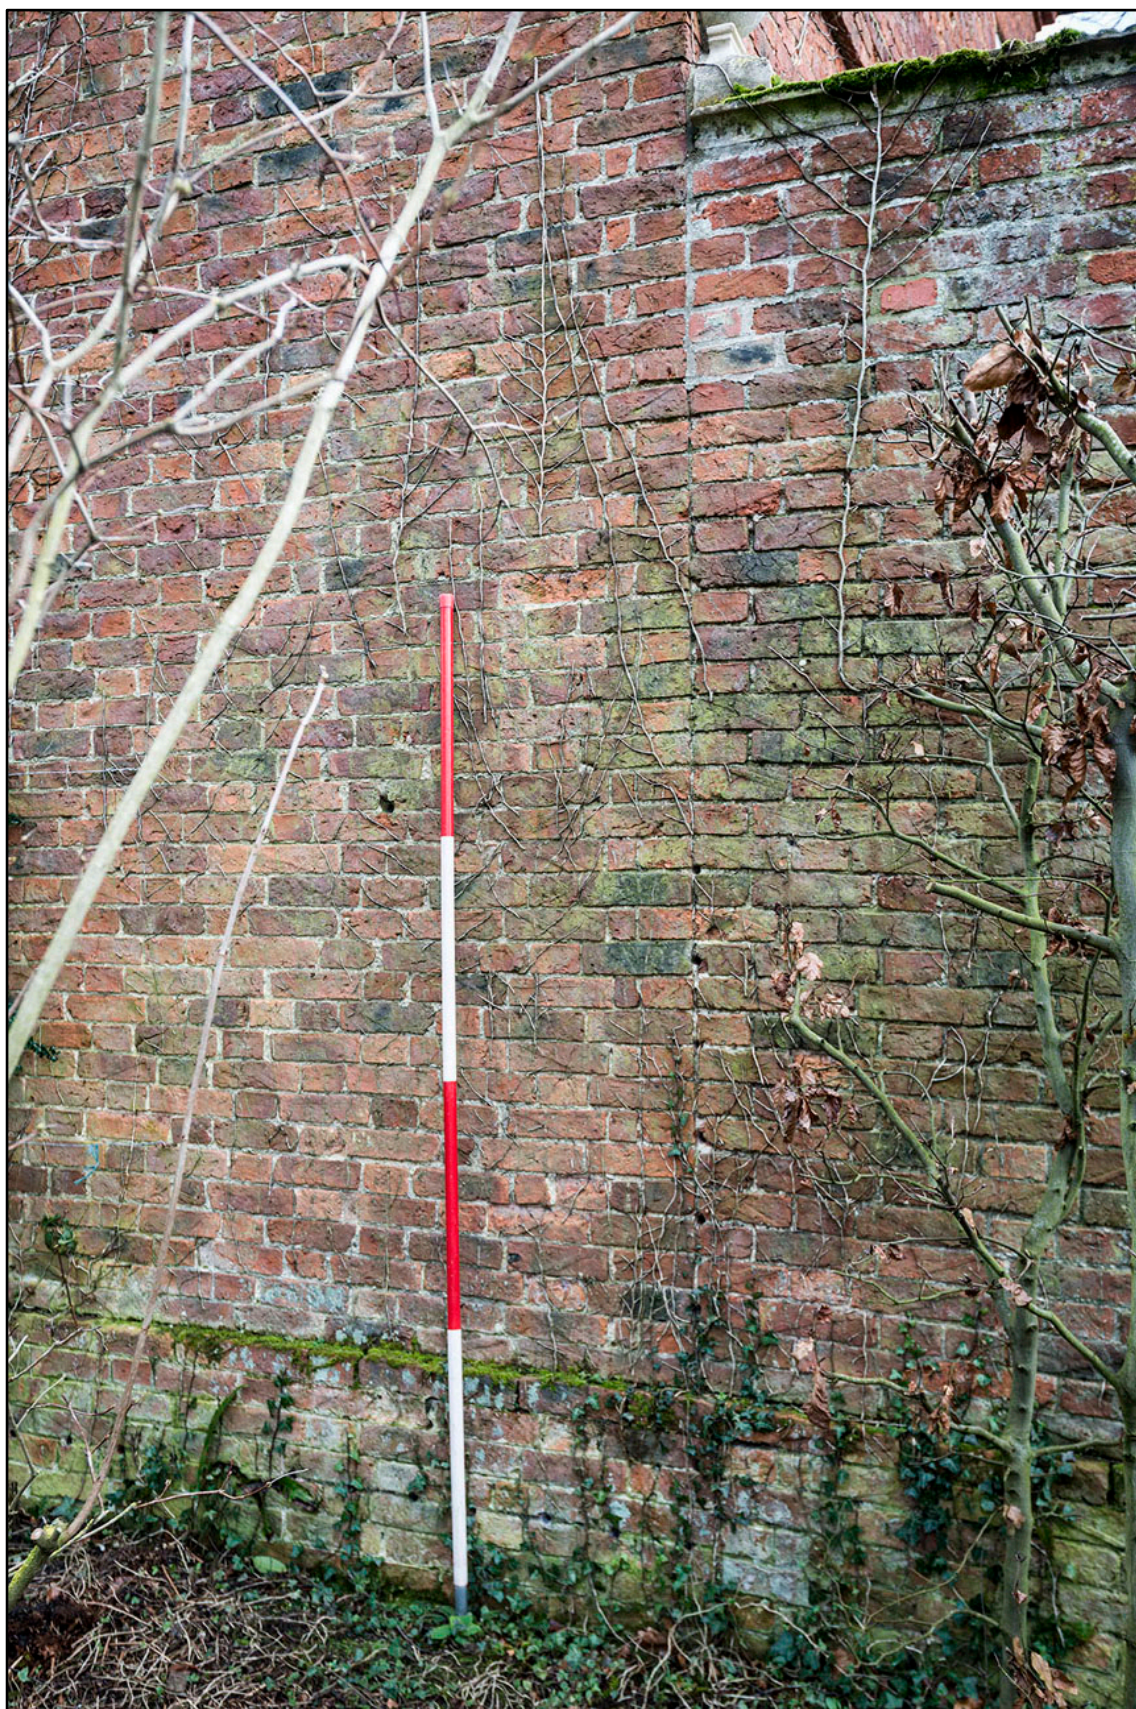
**Appendix 2.21:** Detail of vertical joint between garden wall and SW corner of Clock House (2m scale). **Photo No.23**

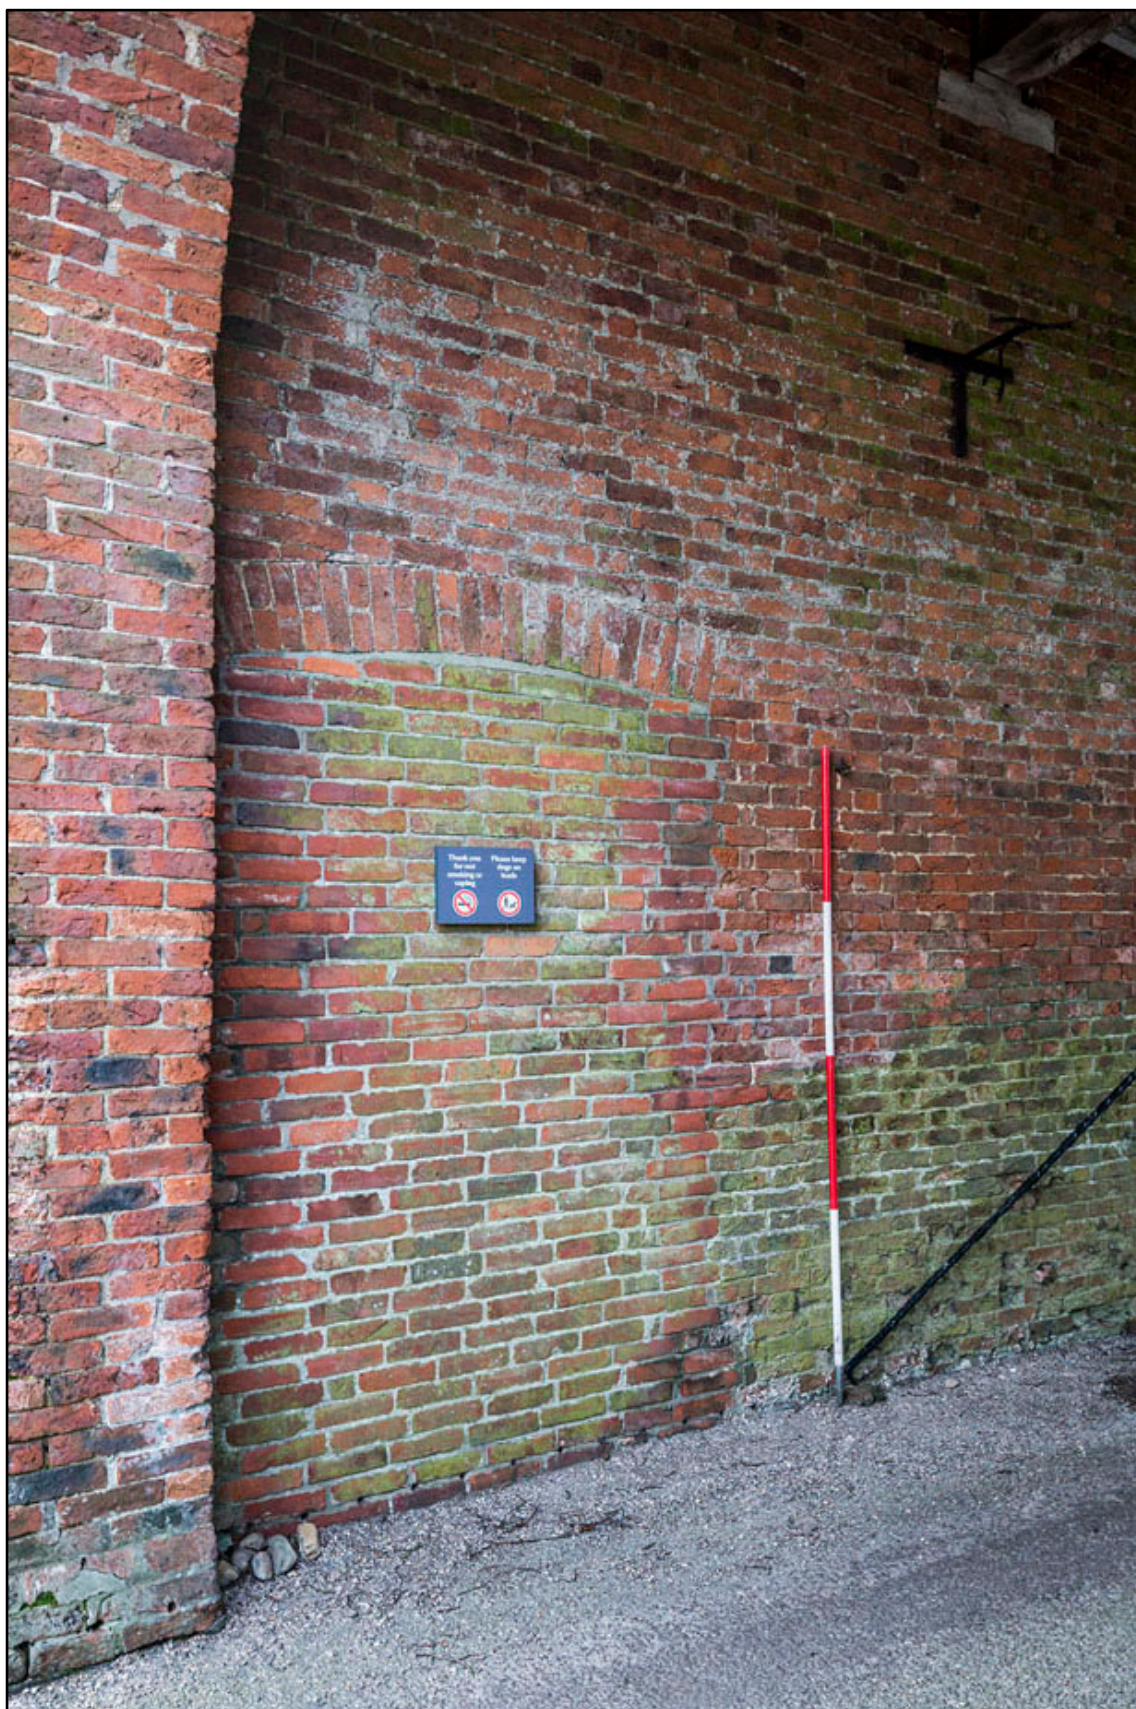
**Appendix 2.23:** Detail of blocked doorway in south wall of Clock House entrance passage 2G3 (2m scale). **Photo No.36**

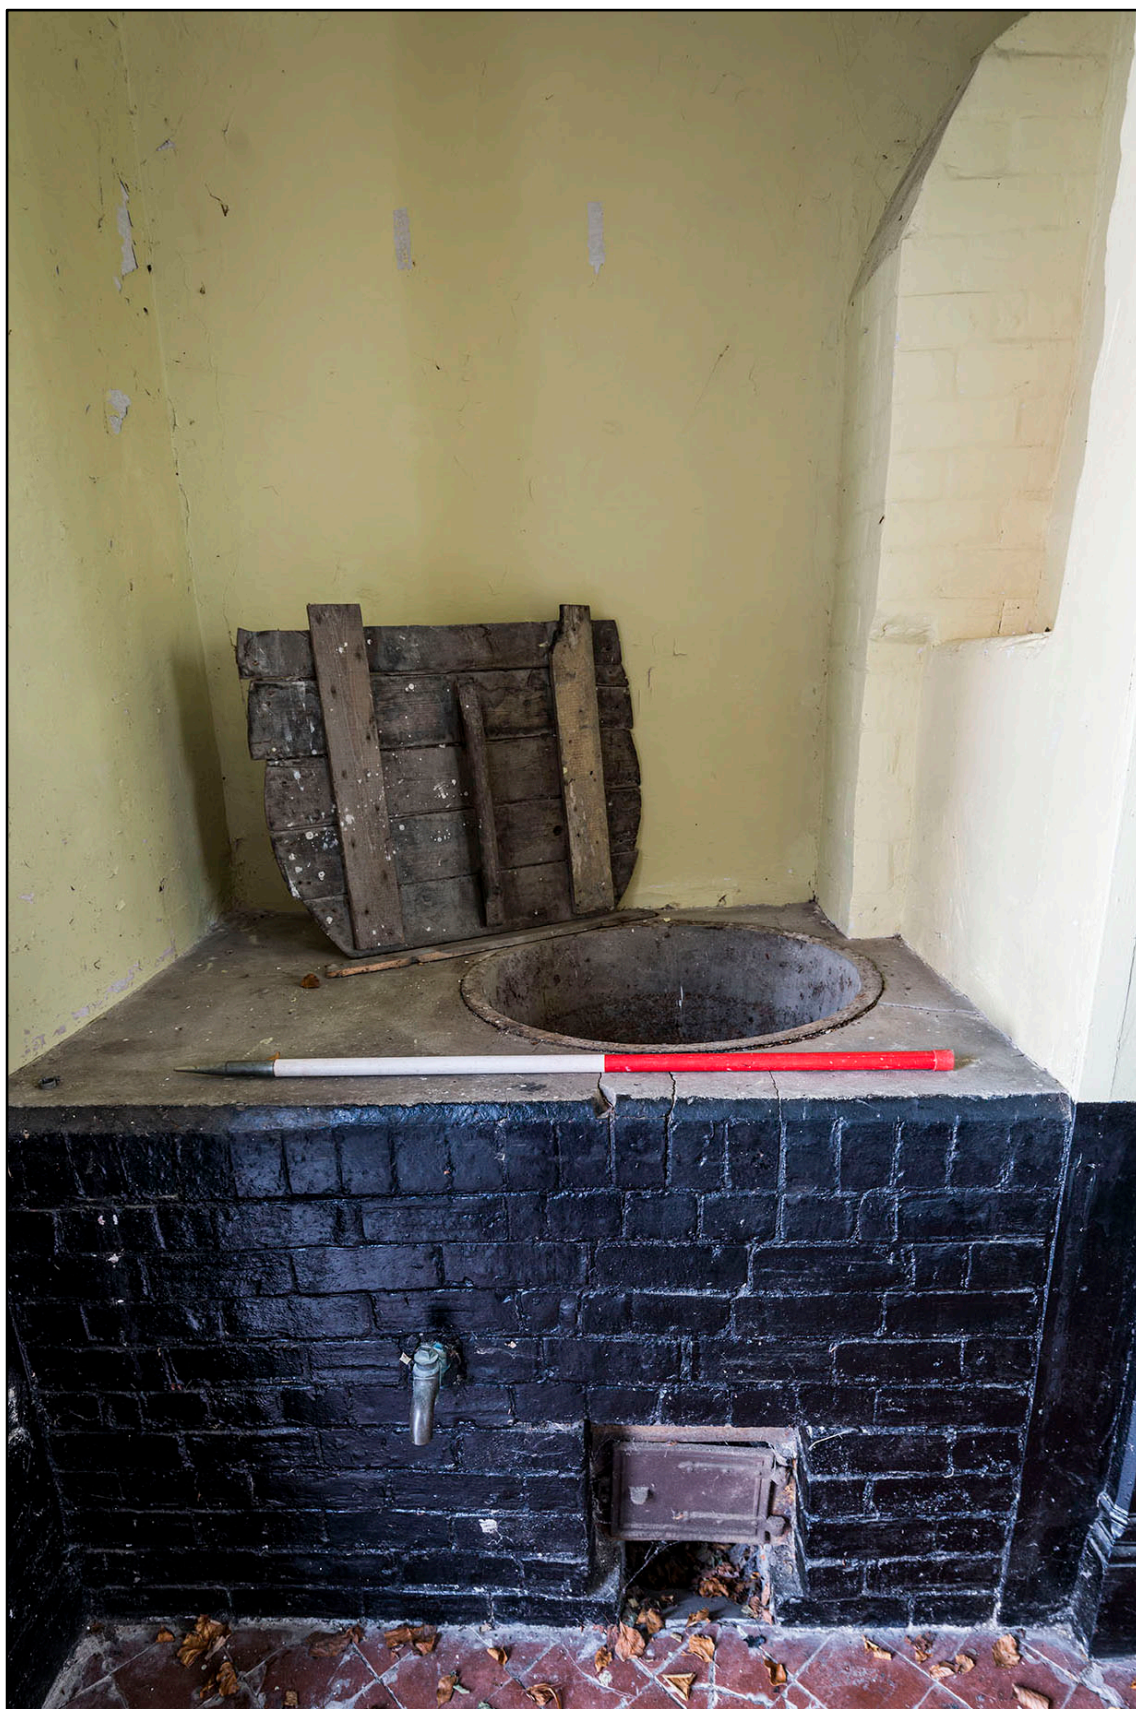
**Appendix 2.43:** Detail of (east) cast-iron laundry boiler and lid in room 2G4 (Clock House) (1m scale).Photo No.76

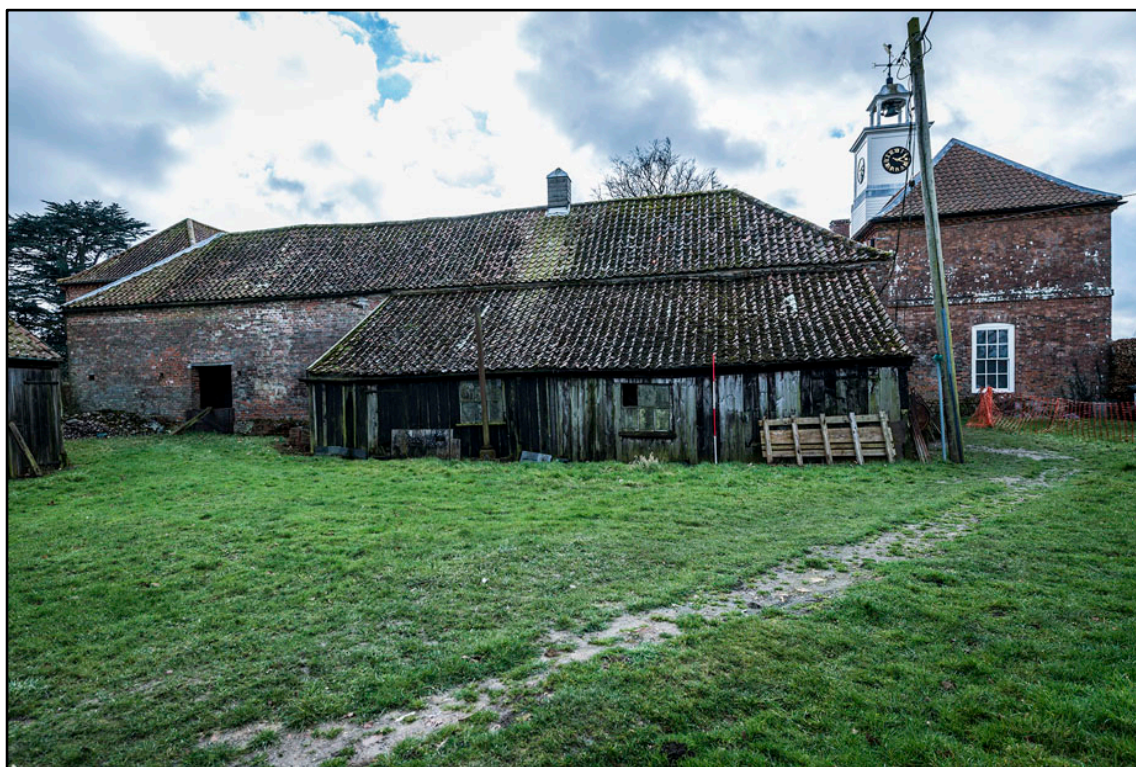
**Appendix 2.66:** General view of north elevation of Coach House with attached sawmill shed (2m scale). **Photo No.41**

Built against the northwestern part of the Coach House is the sawmill **3G5** and engine house **3G6** (**Appendix 2.66**). This structure dates to the first part of the 20th century and has a timber frame clad with vertical timber planks and a mono-pitch roof covered with pantiles. There are two six pane windows in the north wall and a metal vent pipe from the engine in **3G6**.

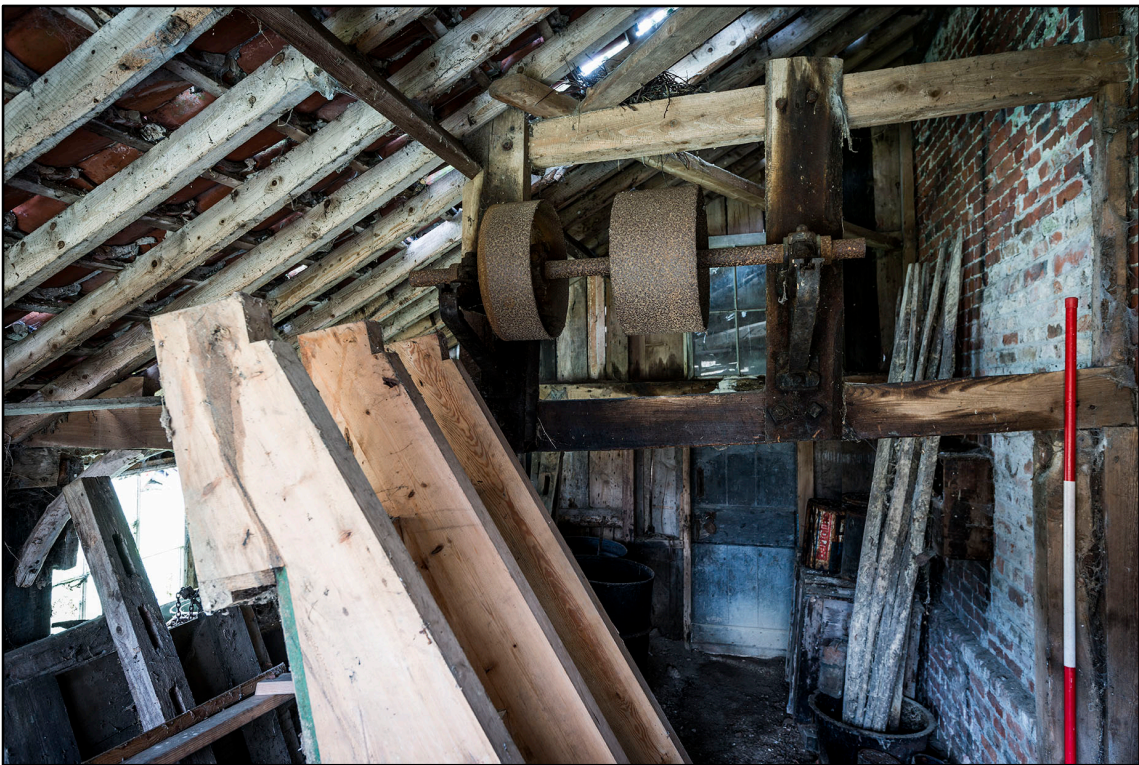
**Appendix 2.70:** Detail of overhead belt wheels for power drive to former saw bench in room **3G5** (2m scale). **Photo No.44**

Although access was restricted at the time of survey due to stored materials (**Appendix 2.70**), the sawmill measures 4.2m x 6.7m. Remains of a saw bench survive along the north wall and there are overhead metal belting wheels that formed a power drive from the engine in the adjacent room (**Appendix 2.69**). Evidence for a secondary power drive was noted in the form of a high level metal wall box in southeast corner of the room, set into the brick walling of the Coach House. This features appears to relate to grease staining and fixing bolts on the west wall of the adjacent room **3G1** and it is likely that they are contemporary with one another.

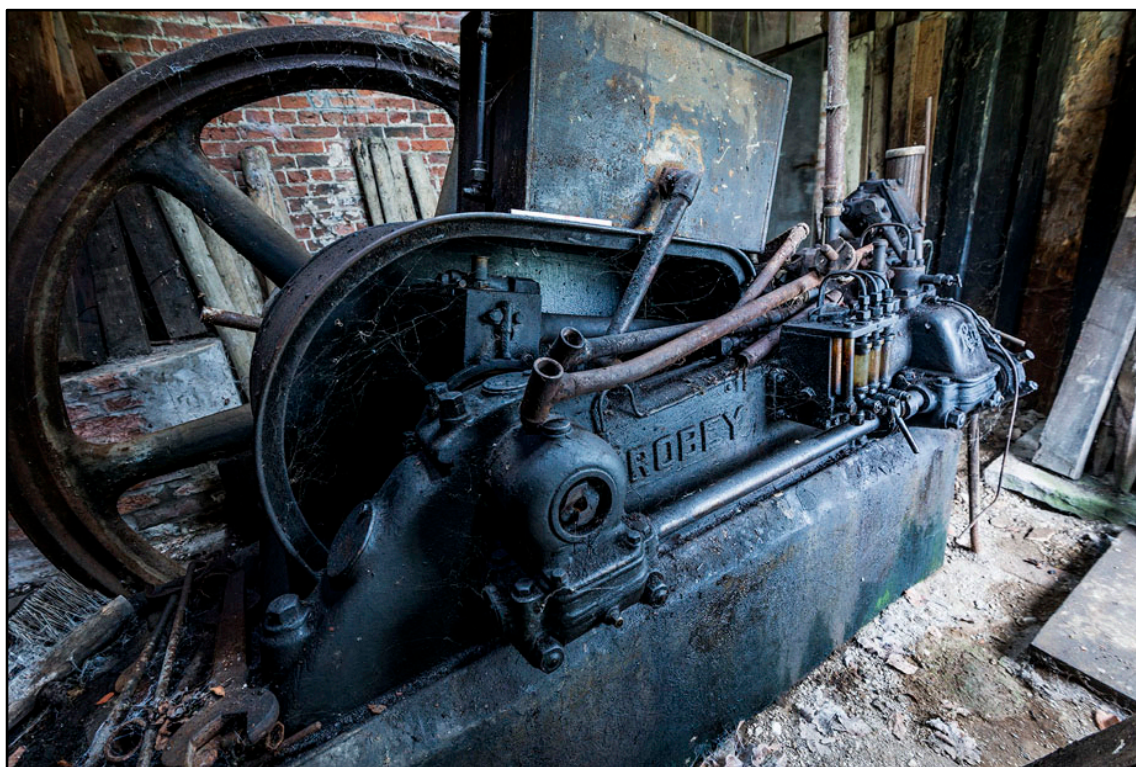
**Appendix 2.73:** Detail of ROBEY engine in room 3G6, looking southwest (20cm scale). **Photo No.48**

There is a restored engine of an almost identical design at the Amberley chalk pit museum in Sussex and another being restored at the former Anglo Brewery in Darshill and Bowlish in Devon. Each engine was tailor made dependent upon the specific requirements of the Client and contained a register plate to ensure that the exact spare parts could be quickly supplied. The factory number of the Gunby engine is stamped on a grease stained brass plate – **No.44559**.

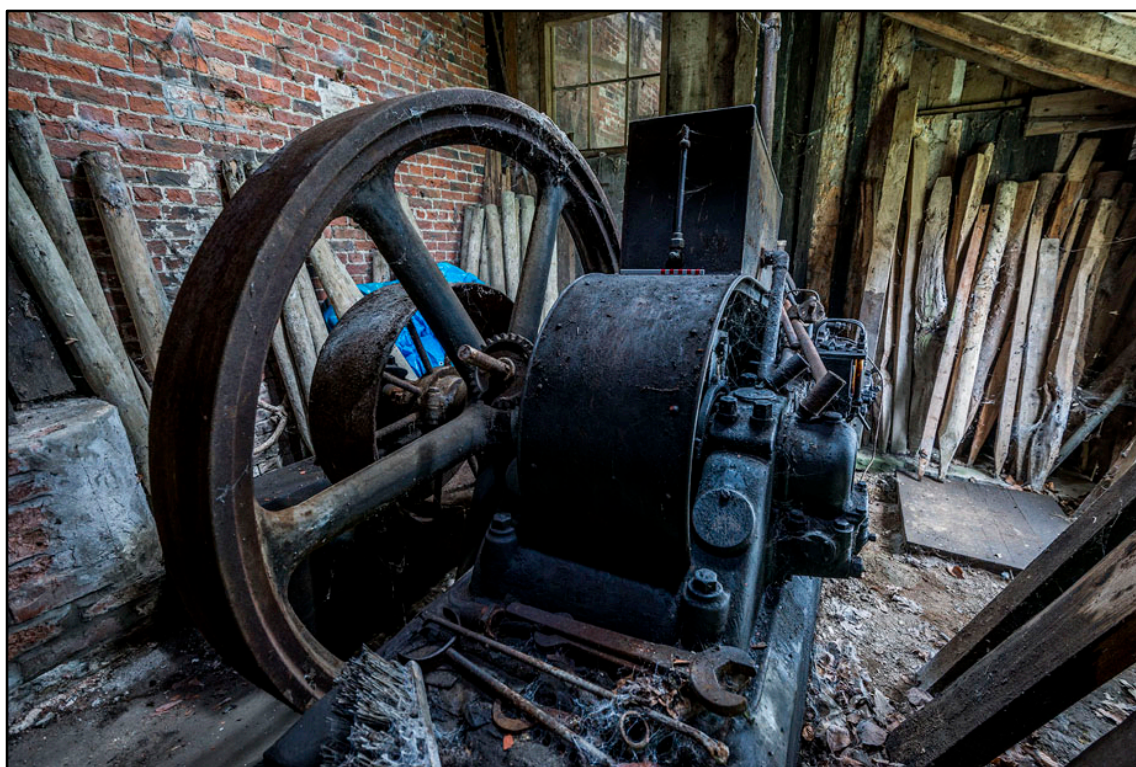
**Appendix 2.74:** Detail of ROBEY engine in room 3G6, looking west (20cm scale). **Photo No.47**

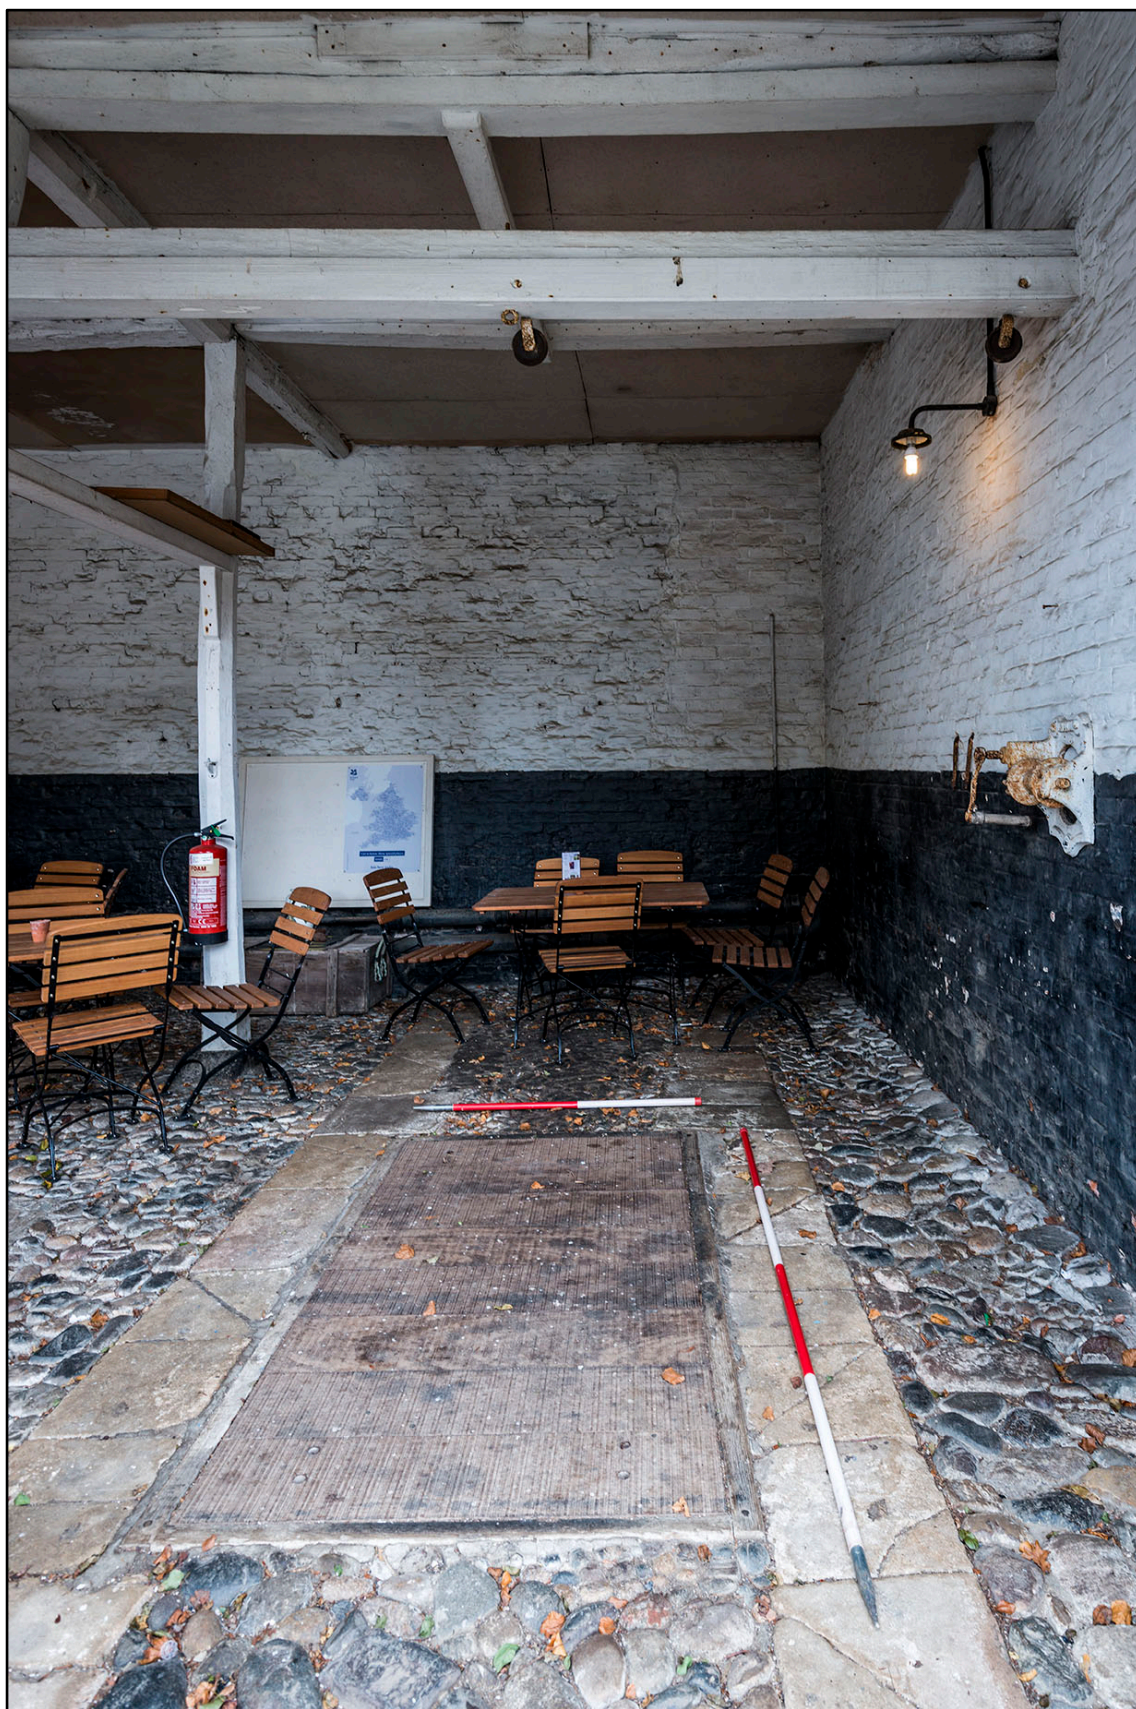
**Appendix 2.83:** Detail of inspection pit in room 3G3, looking east; note wall lamp and winch (2m scale). **Photo No.103**

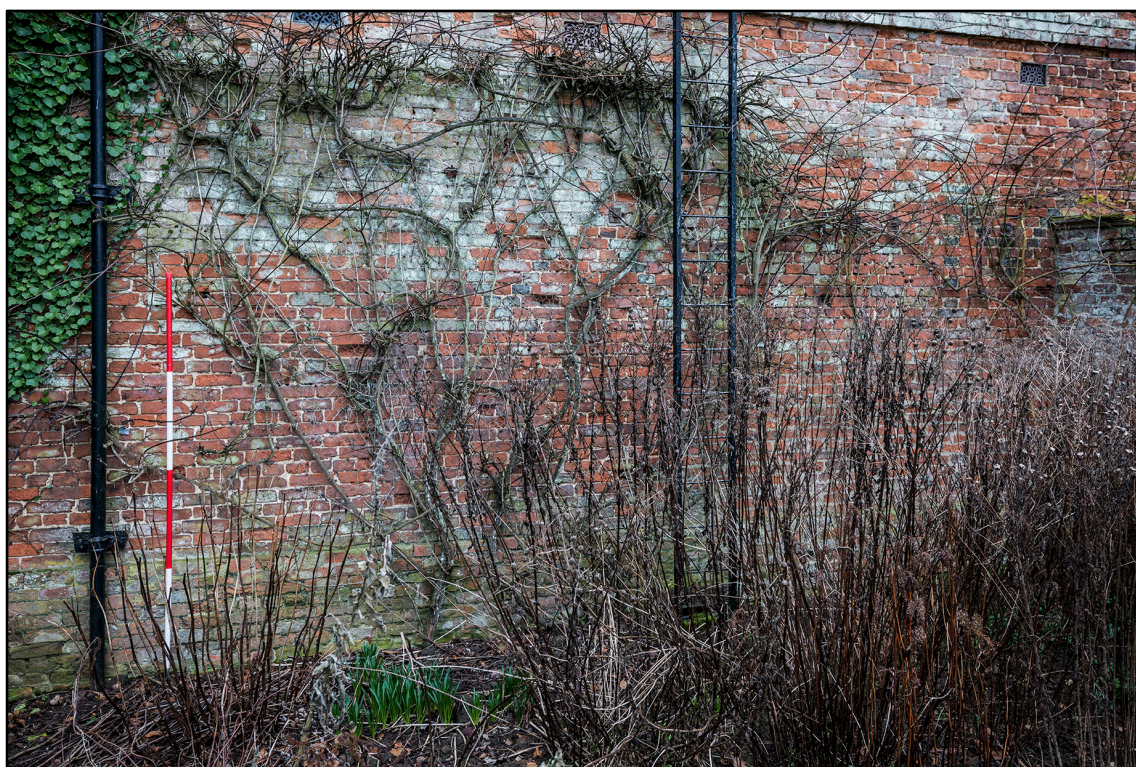
**Appendix 2.96:** Detail of brick initials WM (black bricks) in east elevation of Stables (2m scale). **Photo No.56**

Whilst this eastern elevation faces away from the Stable Courtyard, two unexpected features have been noted within the ground floor brickwork. Unlike the other buildings forming the Stable Courtyard there are no keystones above any of the openings with incised dates or initial, however these details have been built within the actual walling fabric in a contrasting dark/black brick. Beneath the two inserted high level windows is the date 1735 (**Appendix 2.95**) c.1m in height and 4.8m wide, and below the first floor windows in the south part of the elevation are the letters WM (**Appendix 2.96**) c.1m in height and c.2.5m wide. The form of the typography is rather crude, but was clearly an attempt to immortalise the association of the building with the then owner William Meux Massingberd in 1735.

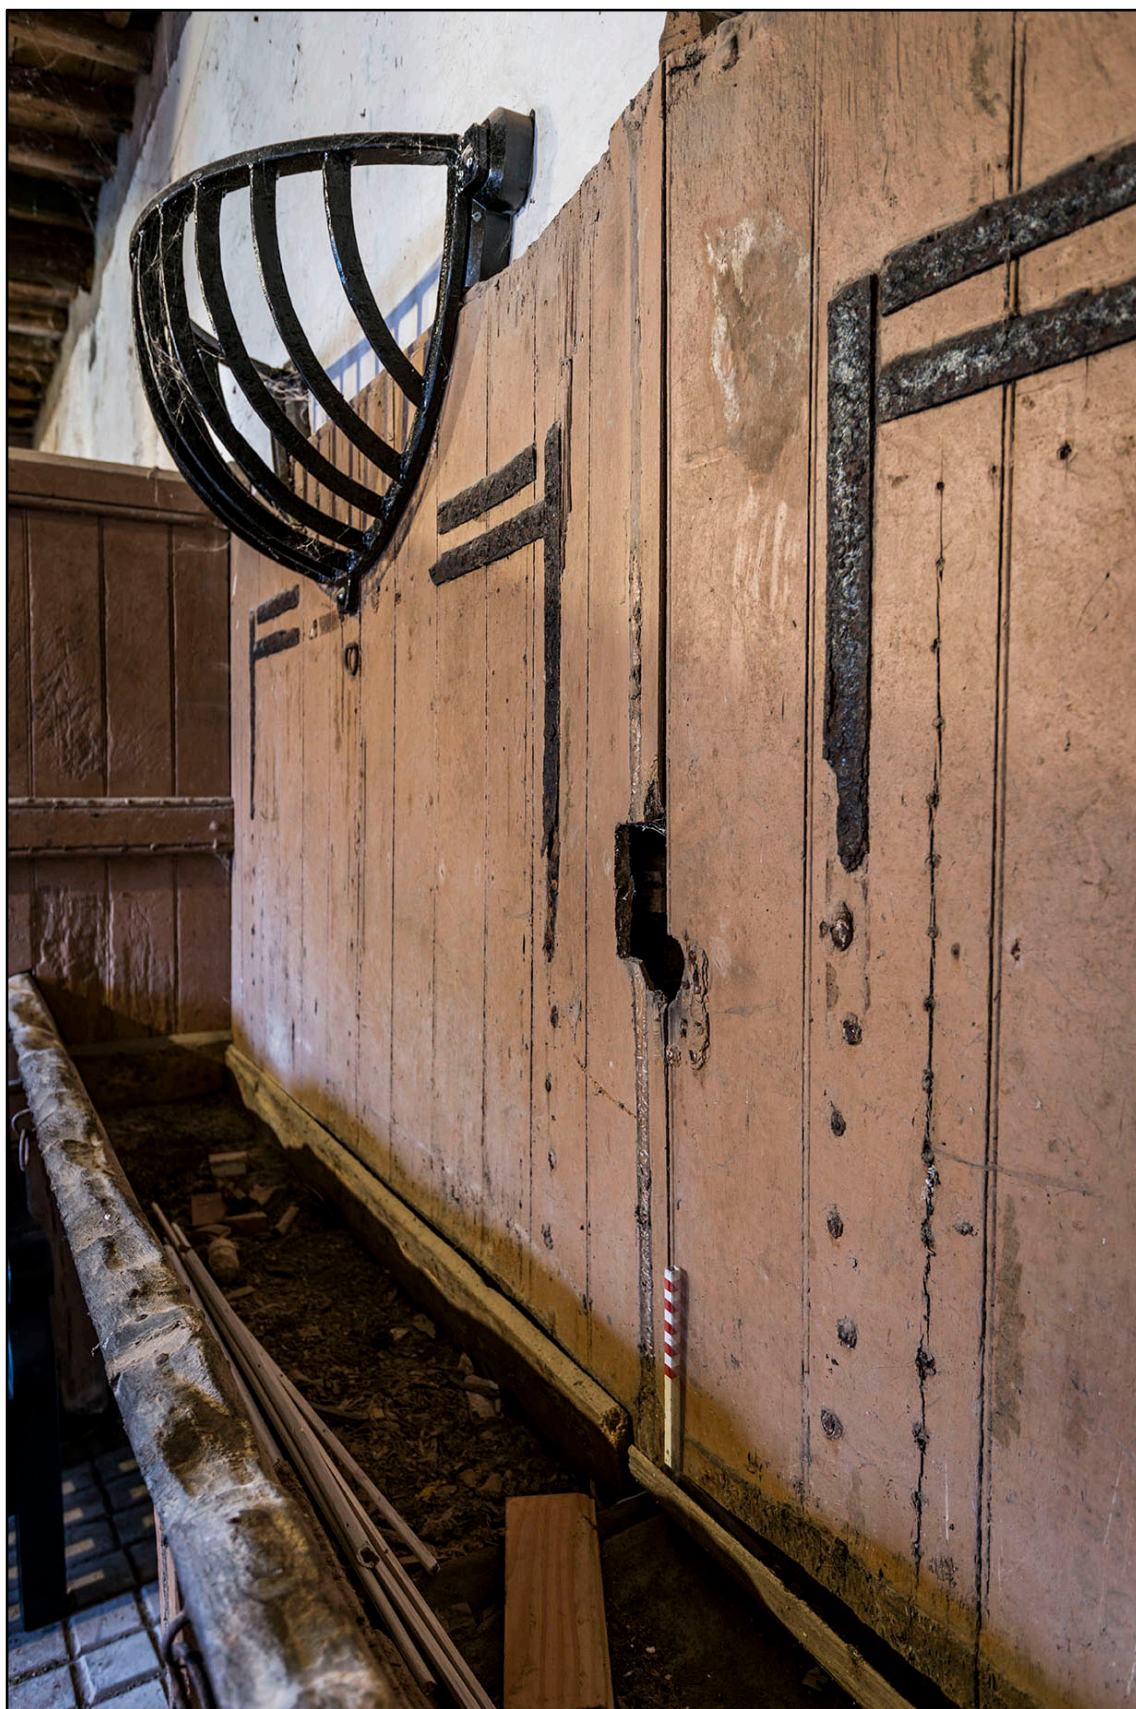
Appendix 2.101: Detail of cast-iron manger and iron strap-work in end stall in room 4G2 (Stables) (20cm scale). Photo No.110

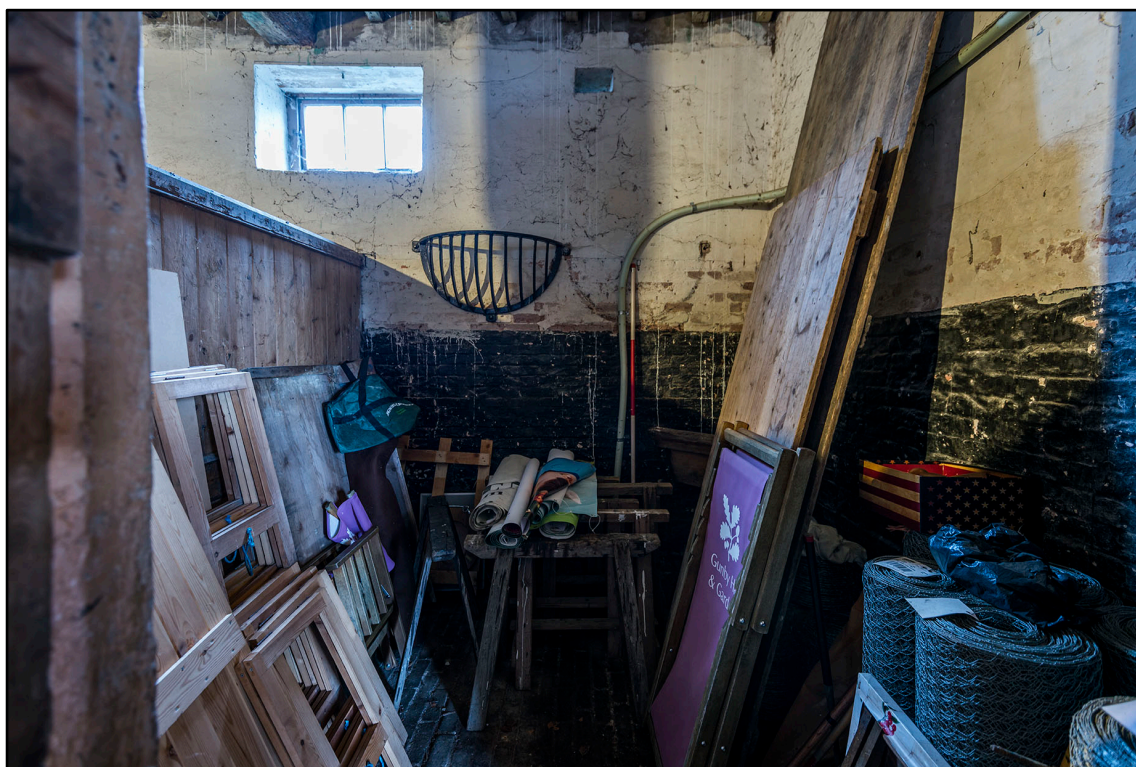
Appendix 2.107: General view into loose box **4G3.4**, looking east (2m scale). Photo No.121

The loose boxes that have been created can be divided into two separate sizes: 2.65m x 2.9m, **4G3.3-4G3.4** (**Appendices 2.107, 2.108**); and 2.9m x 3.6m, **4G3.1, 4G3.2** (**Appendices 2.106, 2.109**). The loose boxes have timber plank walls 2.25m high, many of which are worn and kicked. The entrance doors are 1m in width, with wide strap hinges (**Appendix 2.105**). Each room contains a metal hay basket and a corner manger of differing sizes.

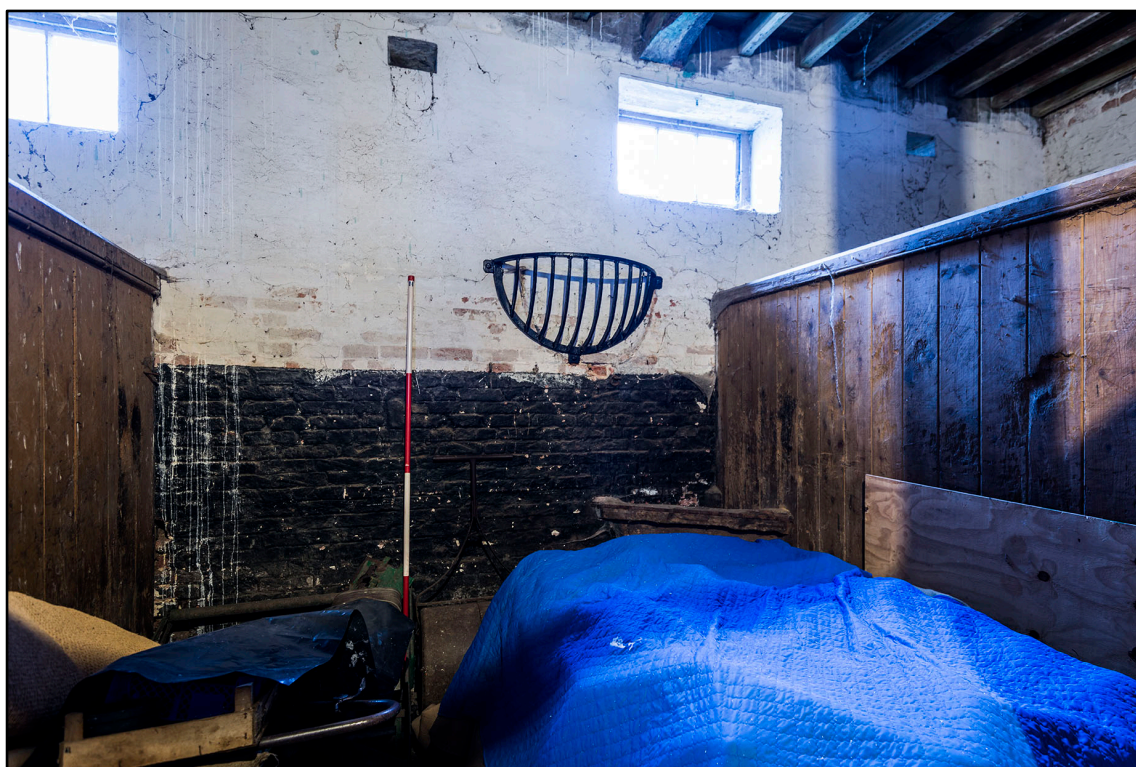
Appendix 2.108: General view into loose box **4G3.3**, looking east (2m scale). Photo No.122

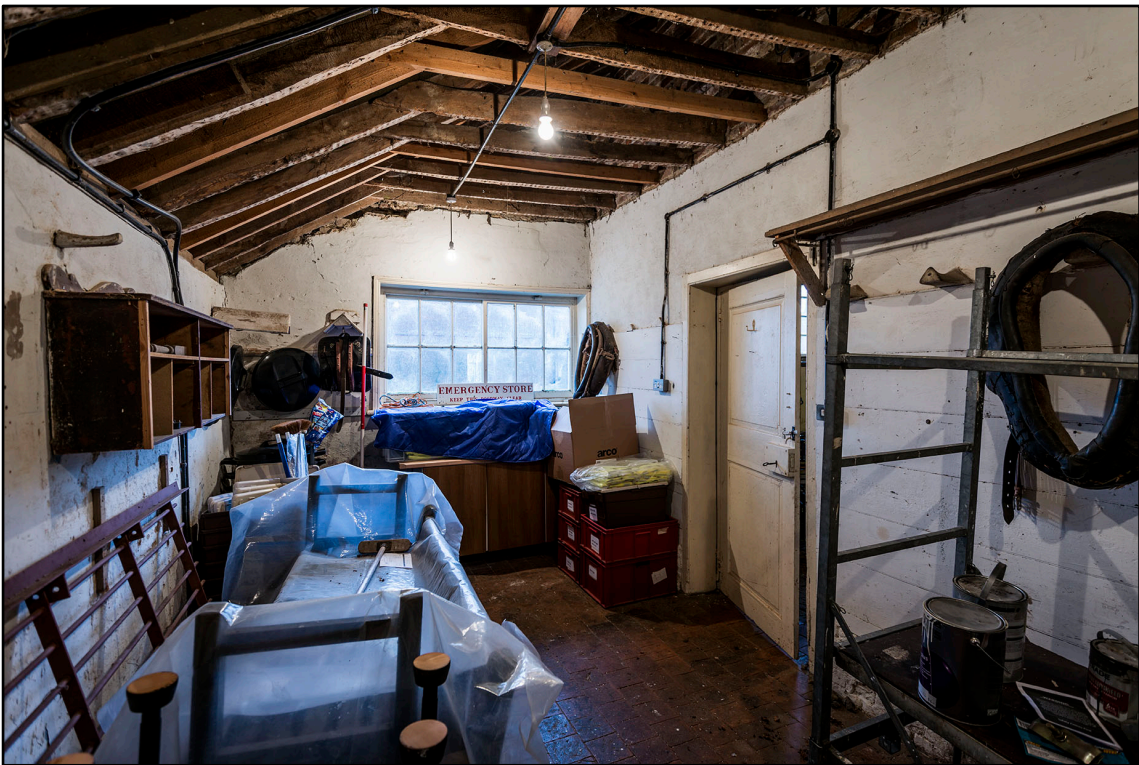
Appendix 2.II1: General view of tack store **4G4**, looking west; note hooks for harnesses (2m scale). Photo No.II5
