Porthcurno Telegraph Museum

Maintenance Block Archaeological Watching Brief

Negative Result

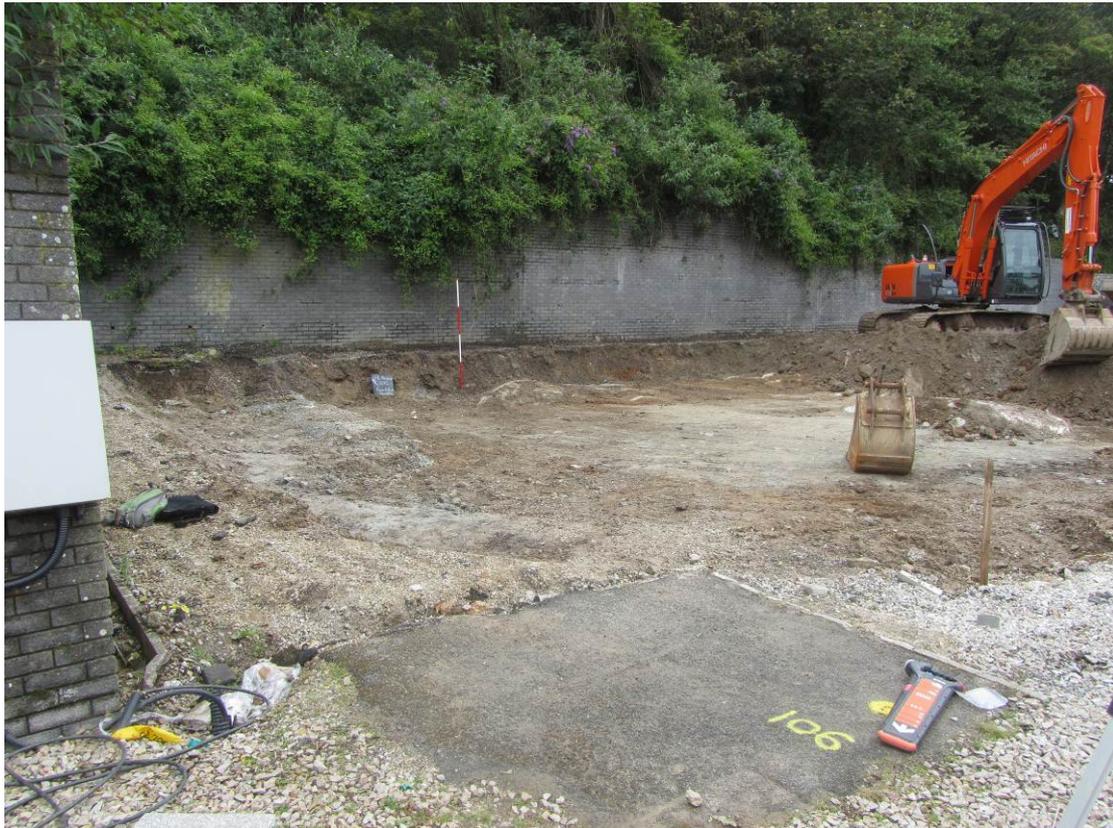
Front cover illustration: Ground work excavations taking place on Maintenance Block site, July 2012

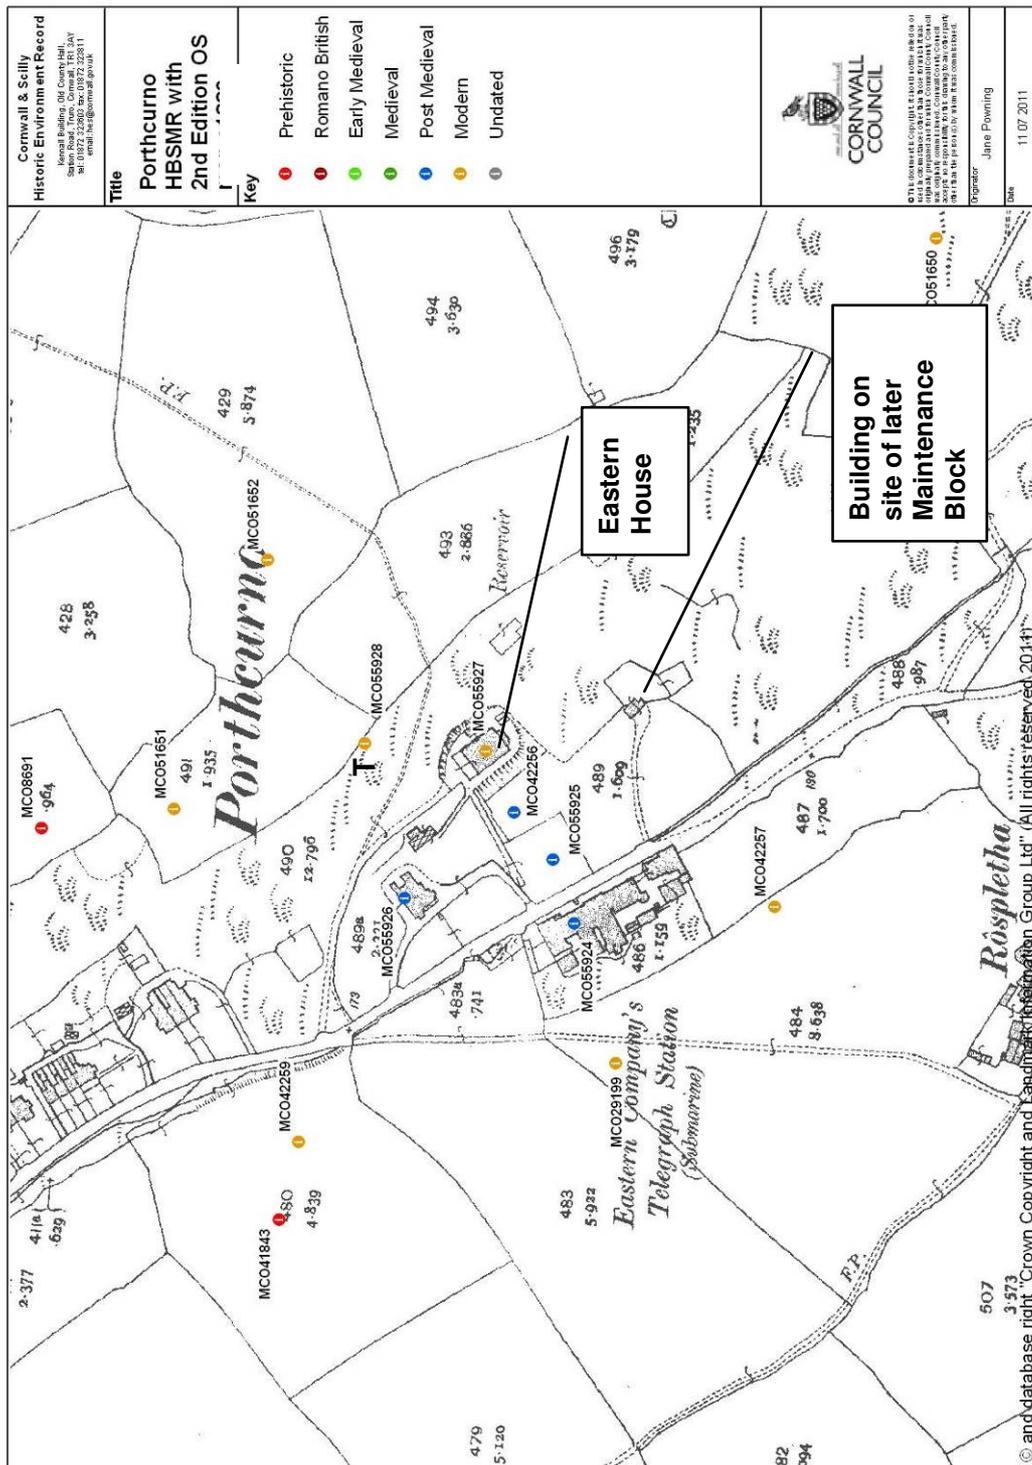
Figure 2: 1907 2nd Edition 1:2500 OS Map (Historic Environment Record, Cornwall Council), showing location of Eastern House and later Tunnels (T) and the building which predated the 1970s/80s Maintenance Block

The Appraisal also assessed the potential for buried archaeological remains being revealed by the development. On the 1880 OS map, two small enclosures occupy the general site of the later Maintenance Block. By the time of the 1907 OS map (Figure 2) the larger of the two enclosures had a small structure in its eastern corner, with a track way leading from there to Zodiac House (the first Eastern Telegraph Company station building). The structure also appears in early 20th century photographs, as a low, insubstantial looking (wooden?) building with a pitched roof and some sort of construction against its southern gable end (Figures 3-4).

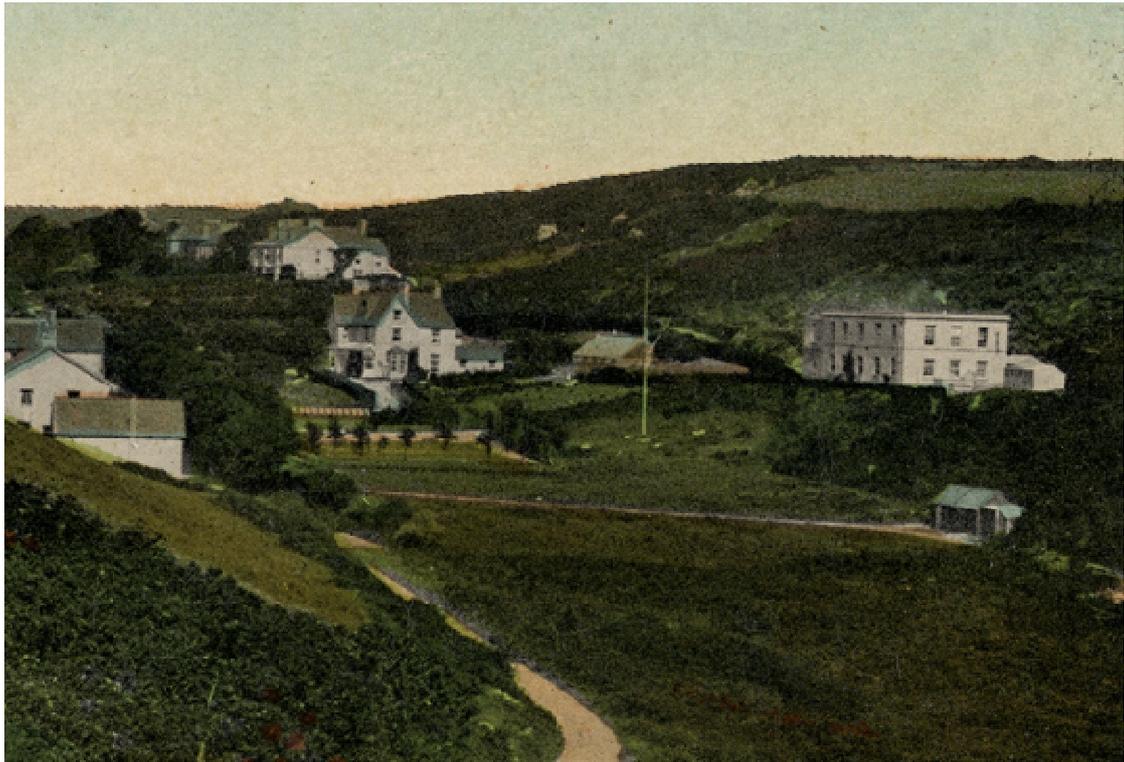
Figure 3: Tinted postcard photograph taken just prior to WW1, with the precursor to the Maintenance Block centre ground right (on the valley floor below Eastern House), looking NE

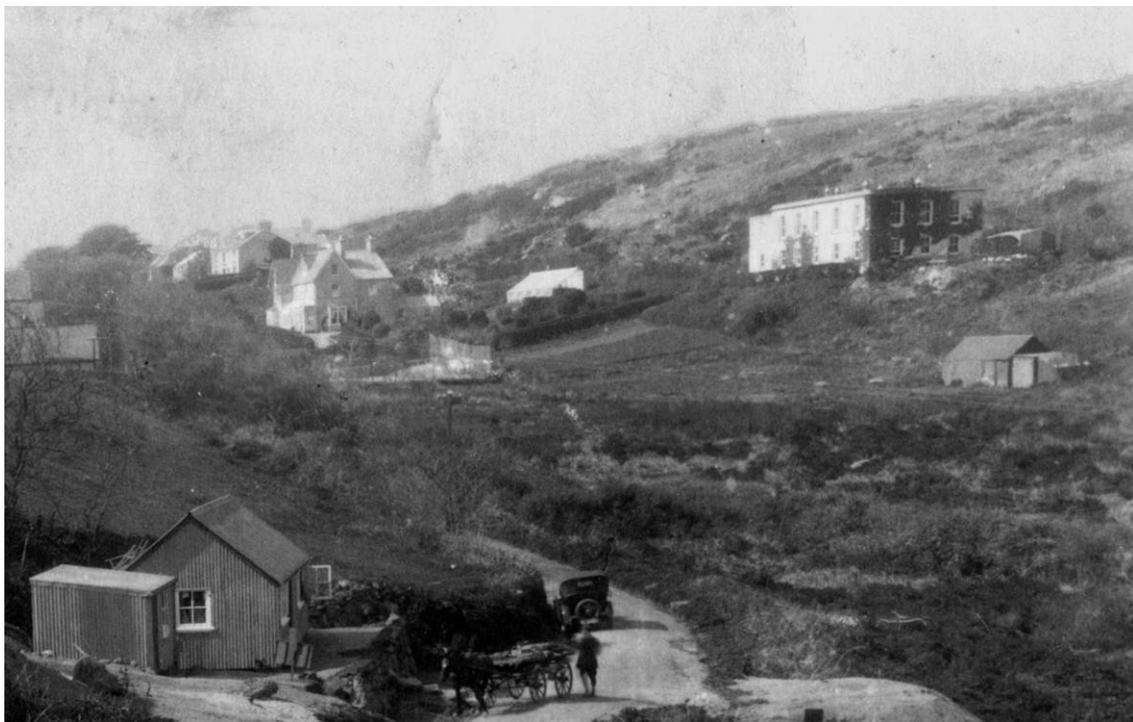
Figure 4: Postcard photograph taken c1920; looking NE towards Eastern House, with the precursor to the Maintenance Block centre ground right

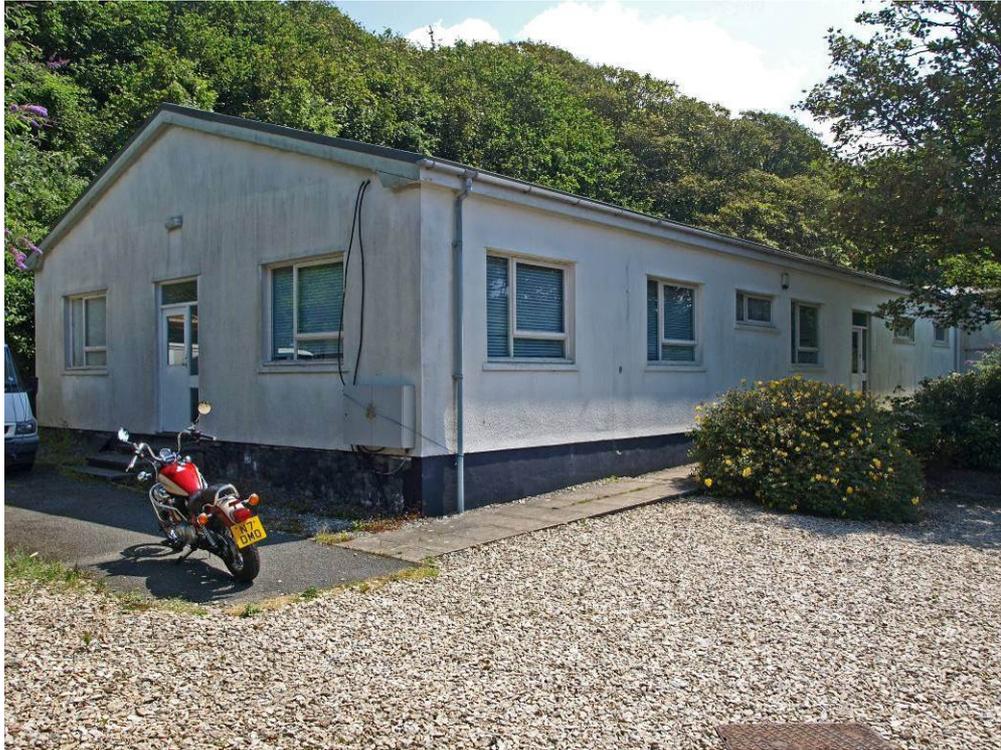
The Appraisal identified that the Maintenance Block (built of rendered concrete blocks on a paved concrete plinth in the 1970s/80s – Figures 5 & 6) did not have any intrinsic architectural value, but had some historic significance in that it represented a surviving element of the final years of Cable and Wireless' operations at Porthcurno.

Figure 5: Maintenance Block, from NW

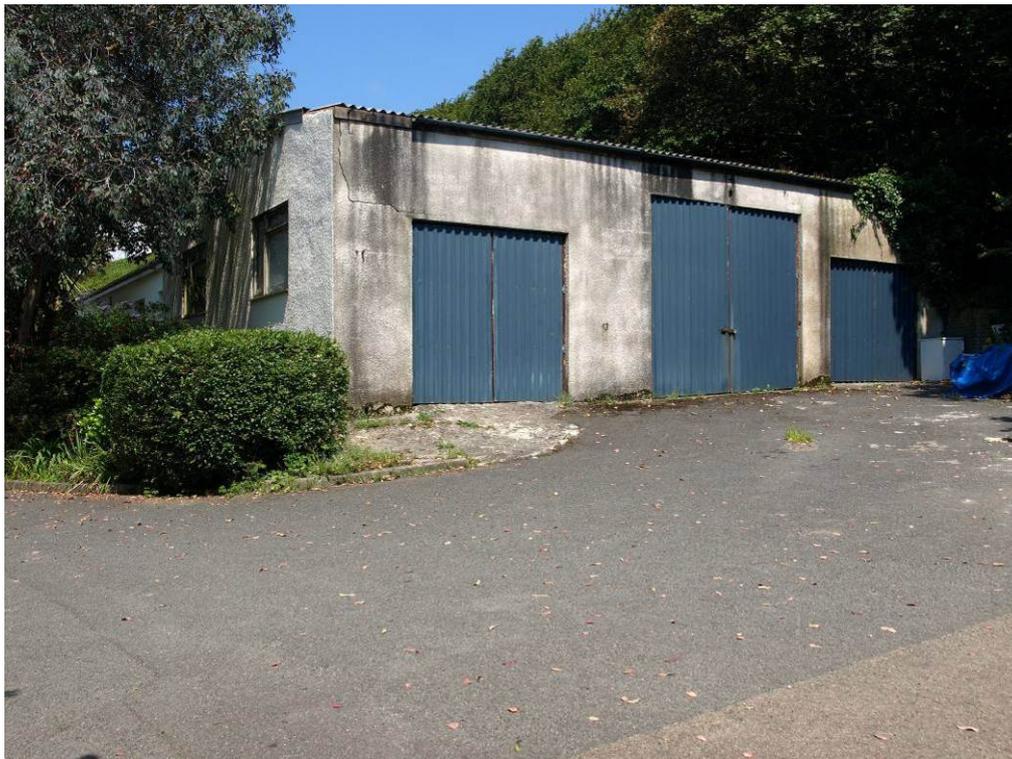
Figure 6: Maintenance Block, from S

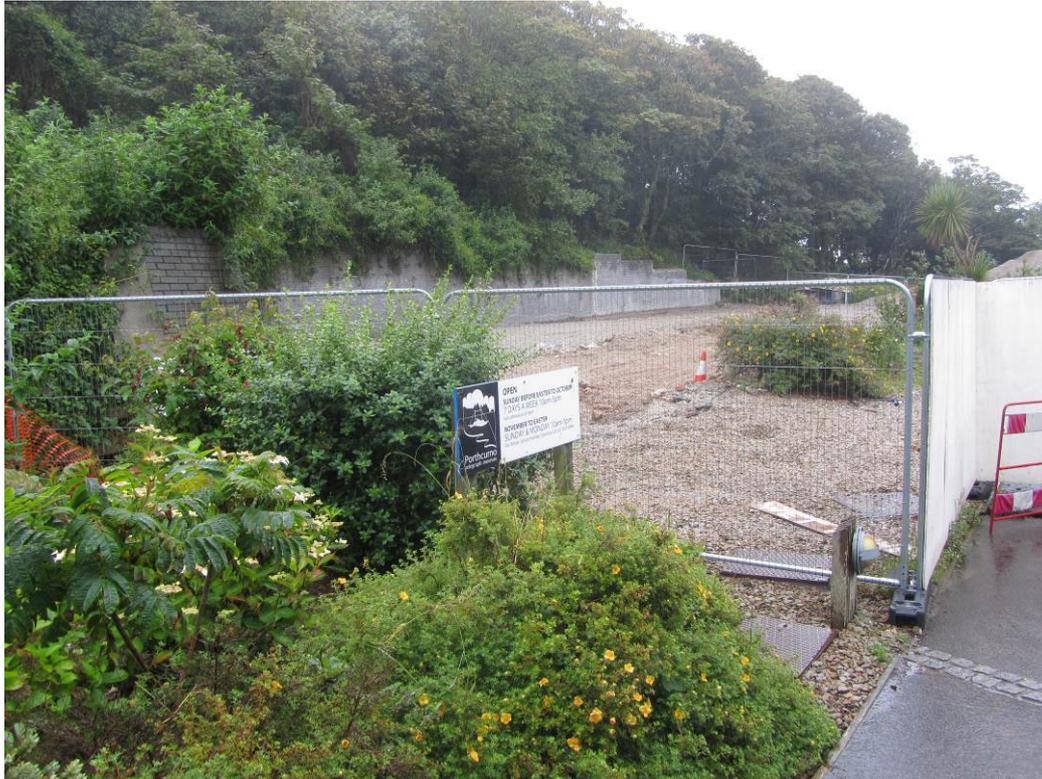
The watching brief revealed that the (now demolished) Maintenance Block had been built onto a platform levelled into the bottom of the valley side. The depth of the cut made is indicated by the brick retaining wall, which still stands, to a height of up to 4 metres (Figure 7-10).

Figure 7: View of the Maintenance Block site from NW, after demolition of the building, before foundation excavations

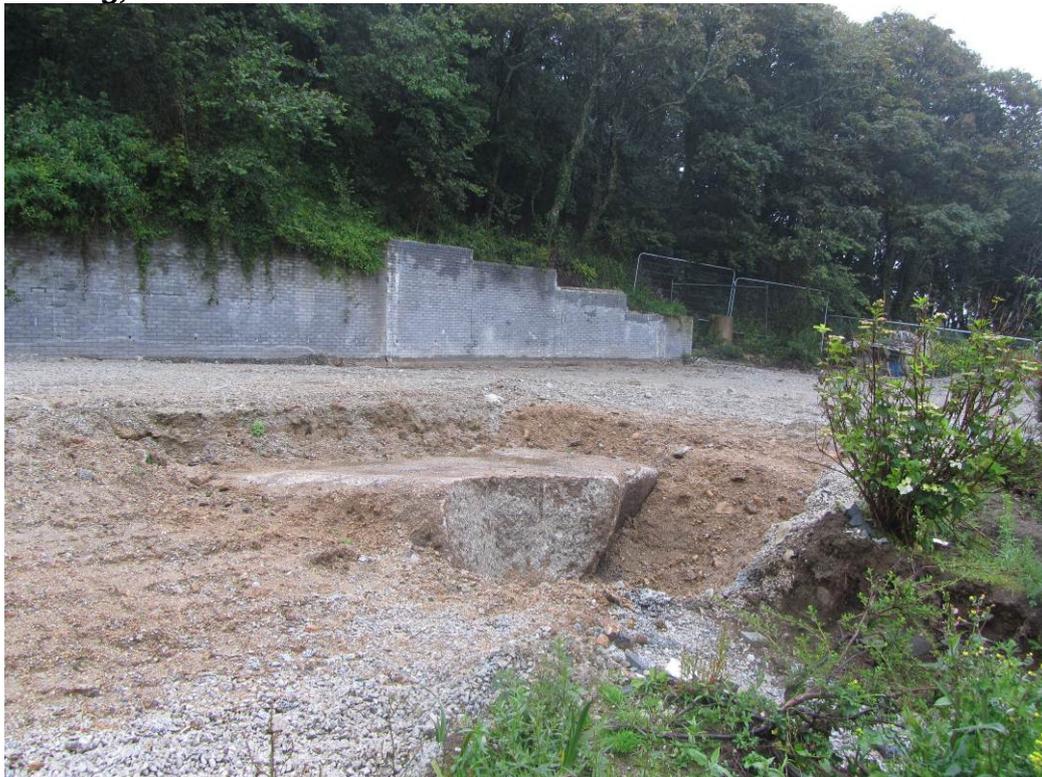
All that was recorded during the watching brief were layers of re-deposited gravel, overlying natural *rab* (orange-grey granitic subsoil), cut though by drains associated with the Maintenance Block (Figure 10). Large pieces of natural granite were also exposed, including one massive block with a squared-off face with drill marks, indicating that part of it had been blasted away during the 1970s levelling process (Figure 8).

Figure 8: Natural granite rock with drill marks from when it was split during the construction of the Maintenance, from NW

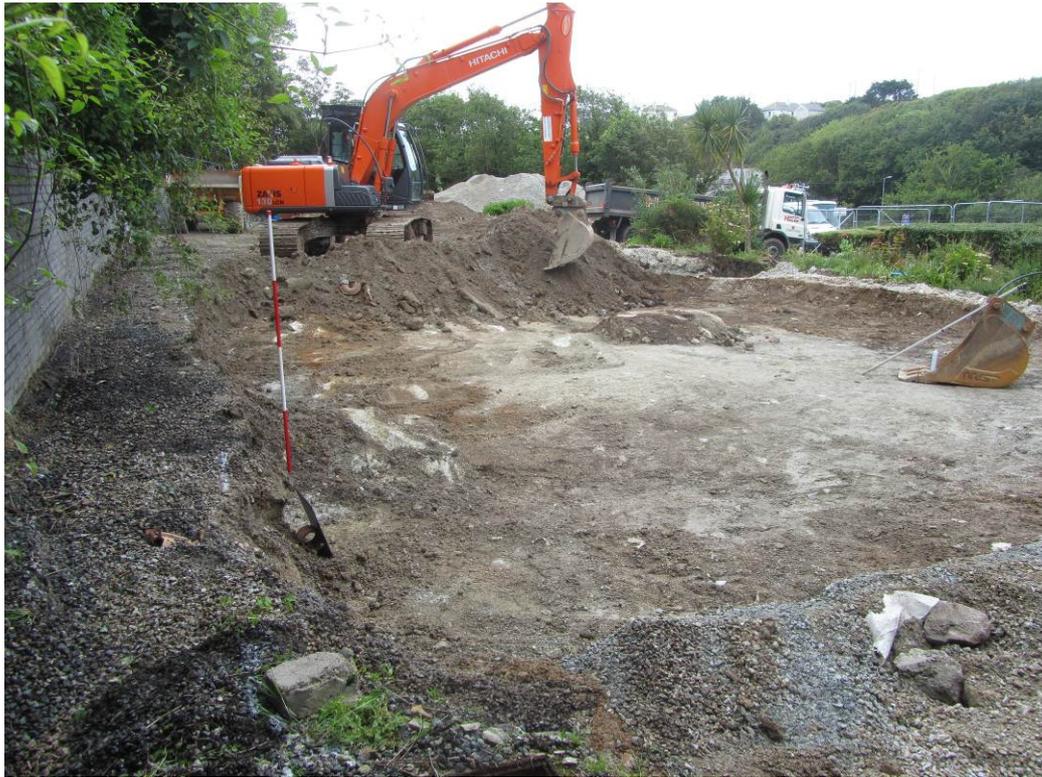
Figure 9: View of the Maintenance Block site from N, during foundation excavations

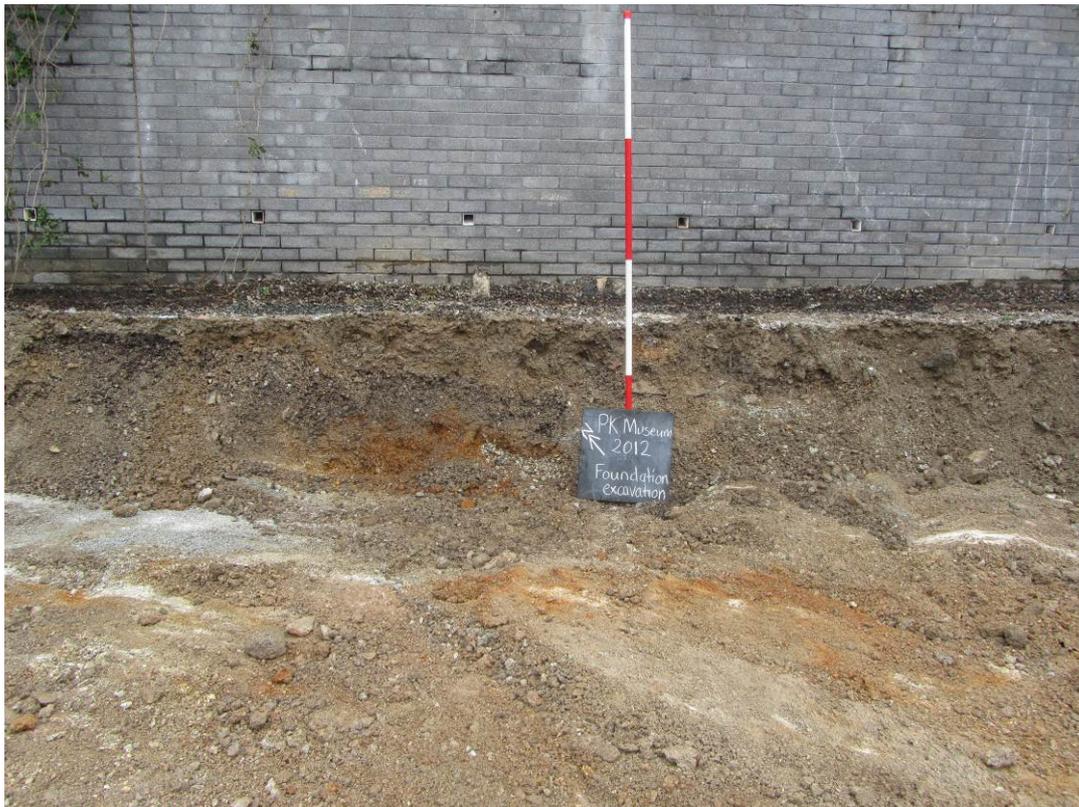
Figure 10: Maintenance Block site – NE section of foundation excavation
