### 14 Teetotal Street, St Ives, Cornwall

# Archaeological Recording of Pilchard Cellar Floor March 2013

Jeanette Ratcliffe
Historic Environment Consultant

August 2013

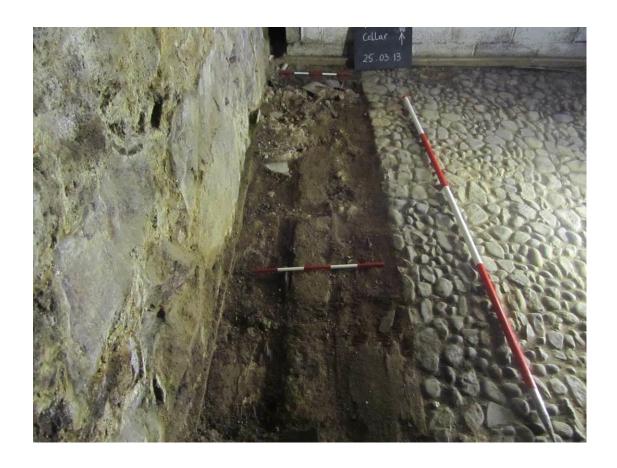
**Front cover illustration**: 14 Teetotal St – N wall of cellar, showing the cobbled floor surface with inset timber-planked base/drain on which barrels of pilchards rested during the pressing process

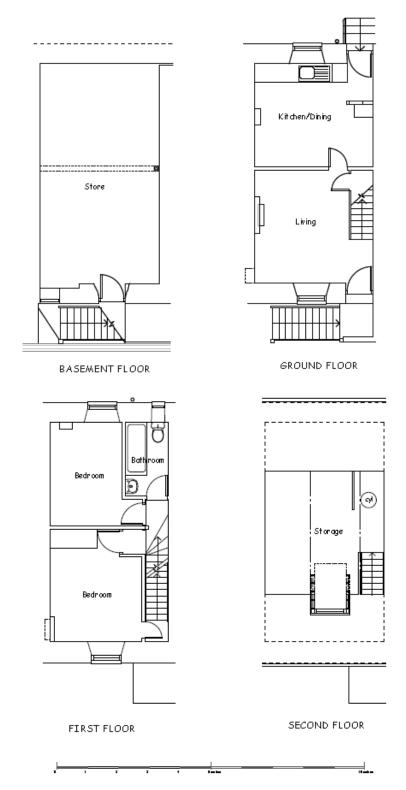
Figure 2. Plans of 14 Teetotal Street, existing (Andrew Williams, Architect, Aug 2011)

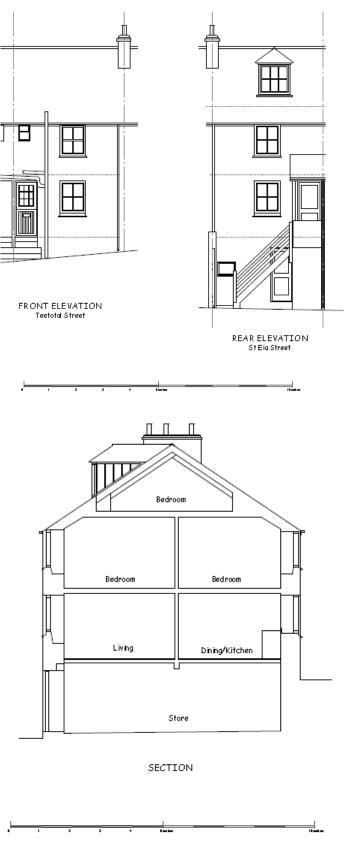
Figure 3. Elevations & section of 14 Teetotal St, existing (Andrew Williams, Architect, August 2011)

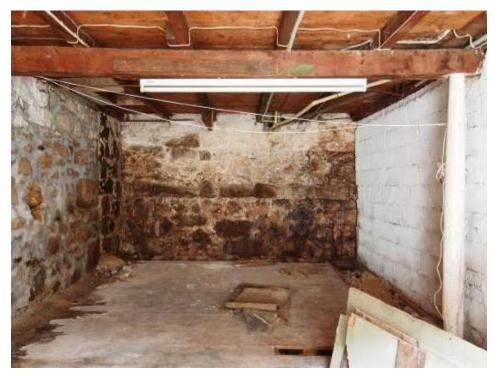
- Back (north) pressing wall; with a ledge under which pressing-poles would have been wedged (it is unusual in the way it projects out from both the upper and lower wall face like a shelf, rather than an overhang)

Figure 4. Cellar before removal of wooden floor; looking N to rear wall with pilchard pressing ledge (Eric Berry, Sept 2012)

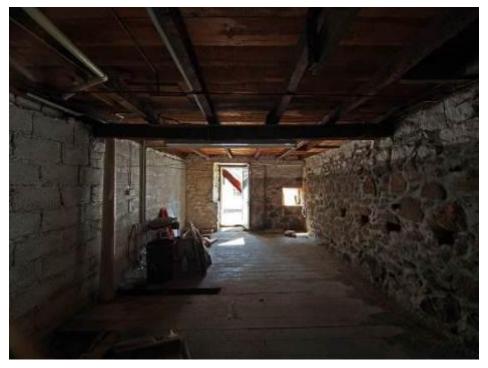
- Side (west) pressing wall; with 5 square/rectangular pressing-pole slots, an average of c0.5 metres apart and measuring 10-20cm wide/high
- The two pressing walls (and the south wall of the cellar) were of similar, largely granite, construction (though the stonework of the W wall face was partly obscured by recent, heavy cement pointing); they appeared to be of contemporary date

Figure 5. Cellar before removal of wooden floor; looking S to St Eia St entrance; note pilchard pressing pole slots in right hand wall, re-used ships spar supporting large cross beam (Eric Berry, Sept 2012)

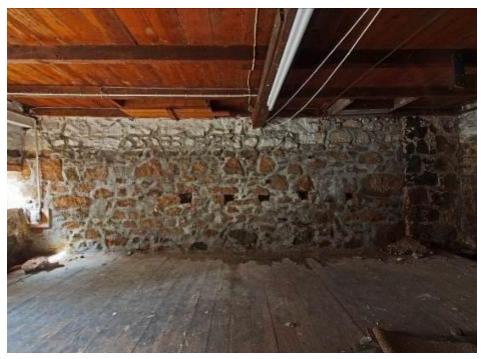
Figure 6. Cellar before removal of wooden floor; pressing pole slots in W cellar wall (Eric Berry, Sept 2012)

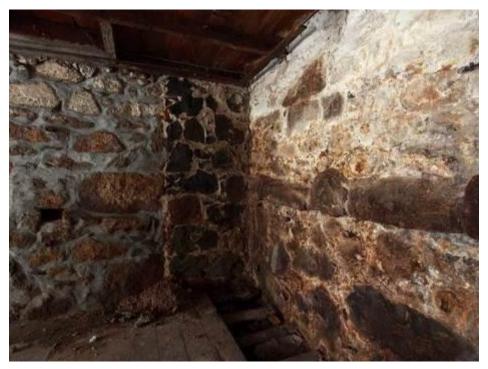
- Blocked doorway in NW corner; in the angle between the two pressing walls; would originally have given access to an adjacent cellar, under No 15 (this interconnectivity was a common aspect of such domestic-scale fish cellars, which were often operated by different members of the same extended family); doorway blocking was mainly large blocks of Elvan stone (with some brick) and was probably related to the changing use of the basement from a fish cellar to a store/workshop

Figure 7. Cellar before removal of wooden floor; NW corner of cellar, with pressing ledge in N wall, pressing pole slot in W wall and blocked doorway in between (Eric Berry, Sept 2012)

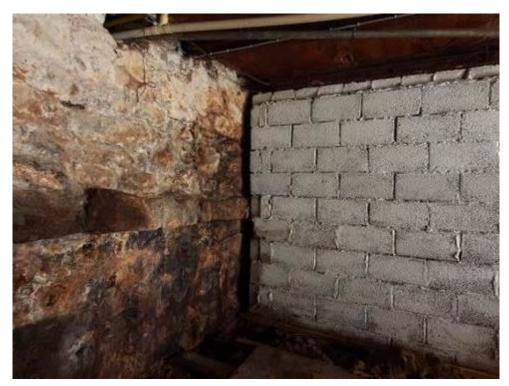
- Concrete-block east wall; a modern subdivision of the cellar, which
  originally extended eastwards under the adjacent, end of terrace, house; the
  north wall pressing ledge continued behind the end of the concrete wall;
  occupants of both properties would probably have been operating the shared
  cellar (there was also a blocked connecting doorway between the ground
  floor of the two houses)

Figure 8. Cellar before removal of wooden floor; pressing ledge of N cellar wall continuing beyond modern concrete block partition wall, indicating that cellar originally extended below No. 16/17 Teetotal St (Eric Berry, Sept 2012)

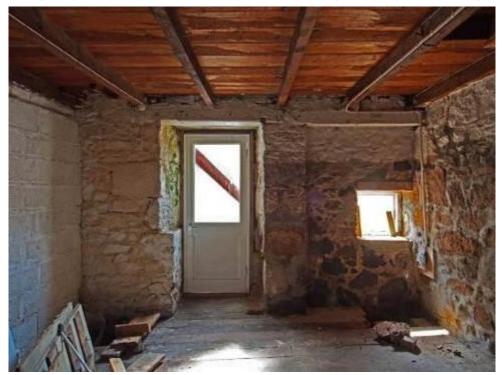
- Door & window openings (south wall); originally a wide doorway with a
  window to the right, the existing arrangement was the result of the doorway
  having been in-filled to create a small window opening and the original
  window having been converted to a doorway; modifications to the openings
  were probably relate to the basement's change of use

Figure 9. Cellar before removal of wooden floor; S wall, showing present doorway (originally a window) and window (originally a wide door opening); both have re-used ships timbers as internal lintels (Eric Berry, Sept 2012)

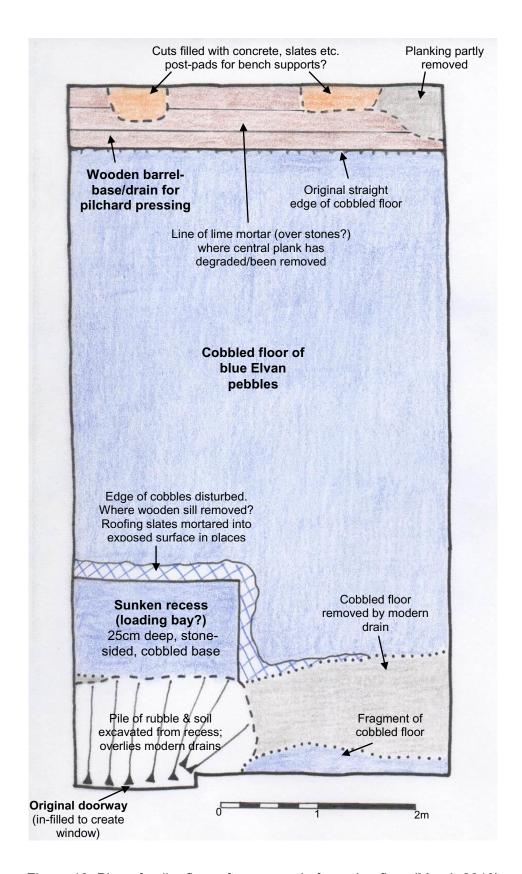
Recording the surviving extent of the cobbled floor, together with the location of service trenches – see Figure 10

Figure 10. Plan of cellar floor after removal of wooden floor (March 2013)

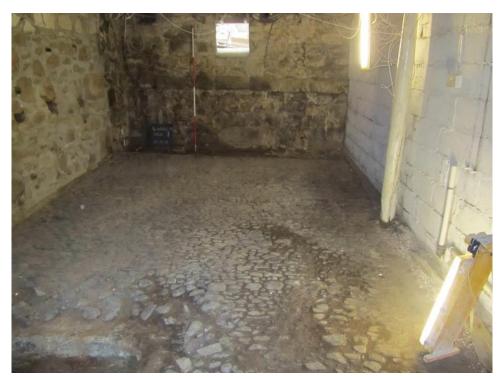
- Cobbled floor of blue Elvan pebbles (Figure 11); this extended over the interior, except where it butted up against contemporary features (located along the north wall and in the south west corner of the cellar), or had been cut through by modern drains; it is similar to floors found in pilchard cellars elsewhere in St Ives and Cornwall (Ratcliffe 1998, 2011, 2012); the cobbled surface continued under the modern concrete-block wall which divided the original cellar in half; the floor sloped down in an easterly and south easterly direction, which appeared to be deliberate and suggested that any sump(s) for run-off was located in the blocked-off half of the cellar

Figure 11. Cellar after removal of wooden floor; looking N across cobbled floor towards pressing ledge & wooden barrel-base/drain along N wall, and new window opening (March 2013)

According to the builder, the intention was to preserve the historic cellar floor by sealing it below a layer of sand (pers. comm. Alan Cox).

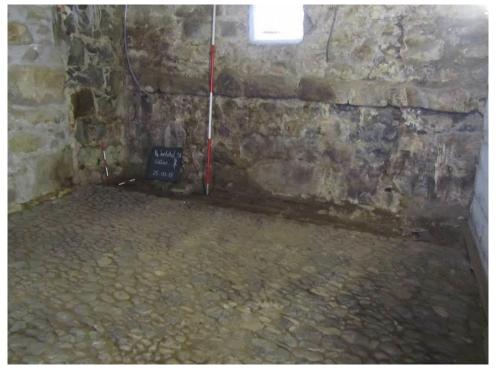
- Wooden barrel-base/drain along north wall (Figure 12-15); a timberplanked base on which the barrels of pilchards would have rested during the
  pressing process, with under-lapping, angled planks either side creating
  runnels for catching the fish (traan) oil which came out of the bottom (and
  channelling it to a barrel or wood-lined pit set into the cellar floor); the
  base/drain was built into (its top flush with) the floor, with the cobbled surface
  butting up against it in a straight line on the south and the bottom of the north
  cellar wall (with pressing ledge above) along its other side; identical (original
  and replica) examples of this feature can be seen in St Ives Museum (Figures
  16-17); half way along its length the barrel base was formed by lime mortar
  (over rectangular stones set end to end?), perhaps inserted to replace a
  rotten plank; although the base/drain had suffered modern disturbance at the

point where the concrete-block east cellar wall met the north wall, it clearly
  extended under the former, into the other half of the cellar
- Sunken recess (loading bay?) in SW corner (Figure 18-20); 25cm deep, rectangular in plan, with its north and east sides edged with stone and its west side formed by the western cellar wall; it's base was formed by identical cobbling to the cellar floor, suggesting that it was contemporary with the latter and therefore connected to the original use of the basement as a fish cellar; this was further supported by the fact that the pressing beam slots in the west cellar wall respect the recess, stopping short of its north edge; the southern extent of the recess was obscured by an overburden of soil and rubble (dug out of its northern half by the builders); the exposed part measured 1.0m x 1.7m; the feature may have extended up to the cellar's south wall (making it 2.0m long x 1.7m wide); it was positioned inside the (now blocked) original doorway to the cellar and may have been a bay for carts off-loading salt and fish and loading up barrels of cured pilchards; the cobbled cellar floor is ragged-edged around the top of the recess, perhaps because the latter was

Figure 12. Cellar after removal of wooden floor; pressing ledge and wooden barrel-base/drain along N wall (March 2013)

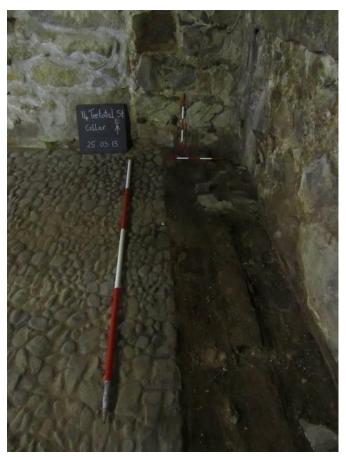
Figure 13. Cellar after removal of wooden floor; wooden barrel-base/drain along bottom of N wall, looking W (not E, as it says on board) (March 2013)

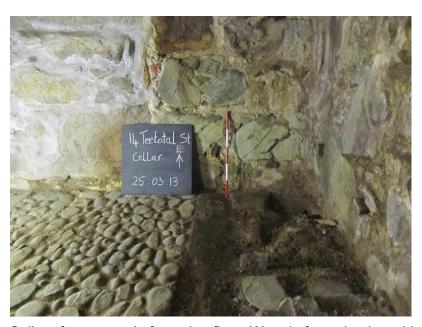
Figure 14. Cellar after removal of wooden floor; W end of wooden barrel-base/drain, looking W (not E, as it says on board) (March 2013)

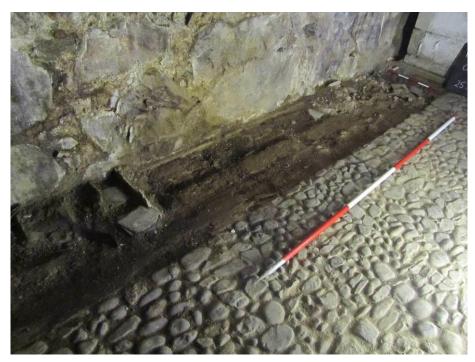
• Post-pads, for work bench? (Figure 15); at two places there were later, sub-rectangular cuts in the wooden barrel-base/drain, which were packed with slates and other material; these appeared to be pads for posts, perhaps supporting a work bench (associated with the re-use of the cellar as a store/workshop)

Figure 15. Cellar after removal of wooden floor; wooden barrel-base/drain along bottom of N wall, looking NE (March 2013)

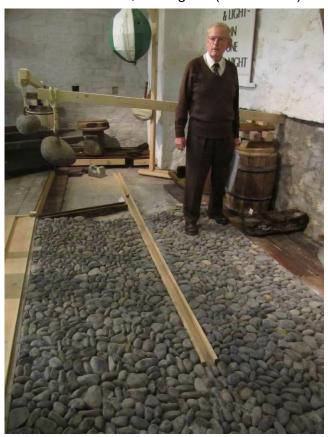
Figure 16. St Ives Museum (originally a pilchard pressing cellar); original pressing ledge and wooden barrel-base/drain along the bottom of the wall (cobbles and other wooden drains are reconstructions); with Curator, Brian Stevens (2012)

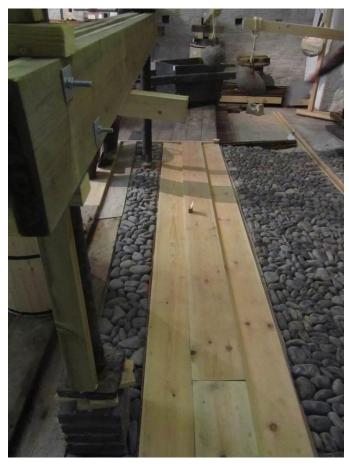
Figure 17. St Ives Museum – replica wooden drain (2012)

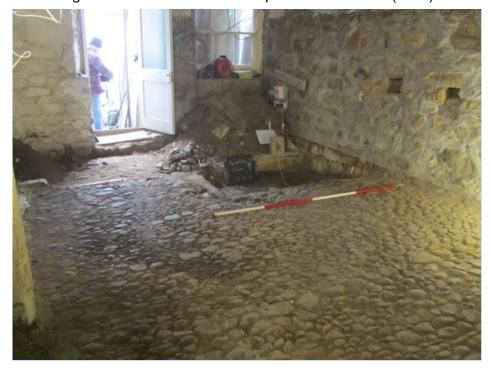
originally formed by wooden sleepers (to soften the impact of carts), which were subsequently removed

Modern drains (Figure 18 & 21); a 0.8m-1.0m wide (back-filled) trench
housing modern drain pipes extended across the south end of the cellar; it
had been cut down through the floor, removing the cobbled surface in this
area; at its west end the drain cut through (and presumably removed) the
southern part of the recess/loading bay

Figure 18. Cellar after removal of wooden floor; sunken recess in SW corner of cellar, looking SW (March 2013)

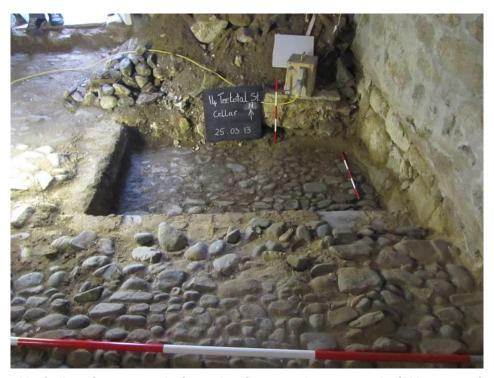
Figure 19. Cellar after removal of wooden floor; sunken recess in SW corner of cellar, looking S (not N, as it says on board) (March 2013)

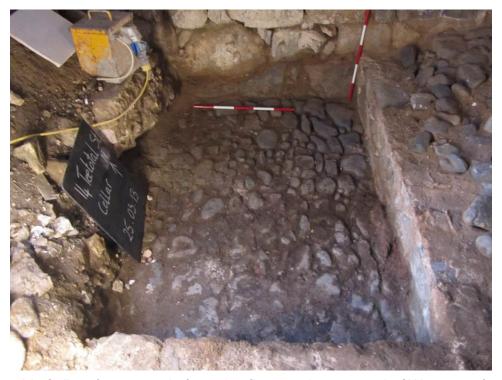
Figure 20. Cellar after removal of wooden floor; sunken recess in SW corner of cellar, looking W (March 2013)

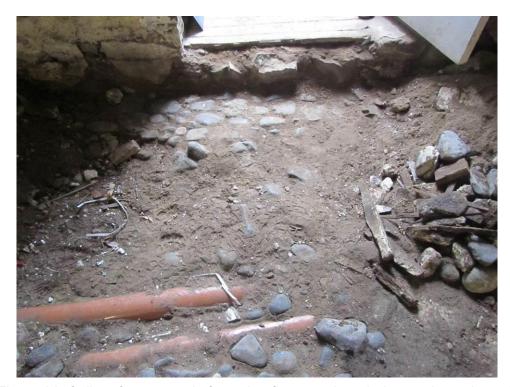
Figure 21. Cellar after removal of wooden floor; modern drain trench cut through cobbled floor across S end of room, looking S; fragment of cobbling surviving in front of doorway (March 2013)
