Former Engraver's Workshop

10a Market Place, Penzance

Historic Building & Archaeological Recording

September 2013

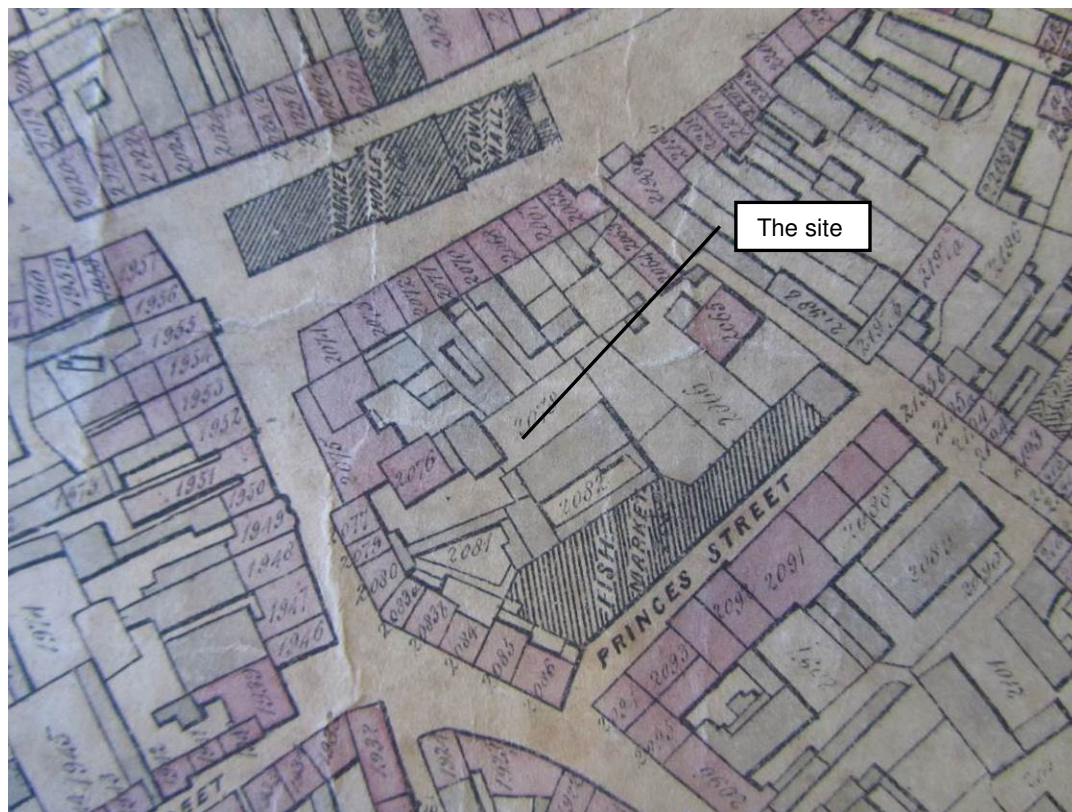
Figure 7. 1845 Borough of Penzance (CRO RH/9/5/21/1)

Although the 1840 Tithe Map (Figure 6) shows no detail, the 1845 Borough of Penzance map clearly depicts the site as being part of a large, rectangular, open yard (Figure 7). On the 1880, 1907 and 1930s OS mapping (Figures 8-10) the yard area is shown as completely built over, yet a larger scale plan forming part of a 1933 conveyance shows the site, itself, as still unroofed (Figures 11). The plan relates to the sale of the warehouse (now a modern block of flats and access way) that previously enclosed the east and south side of the site – the vendor was William Bennetts Michell (the Jeweller at 10 Market Place) and the purchaser Joseph Walter Meek (the Furnisher at 14 Market Place). The site - named as 'Mr Michell's Yard' - was not part of the sale, and continued to be associated with the jewellery shop until 1987, when it was sold to the Engraver, Malcolm Pilcher.

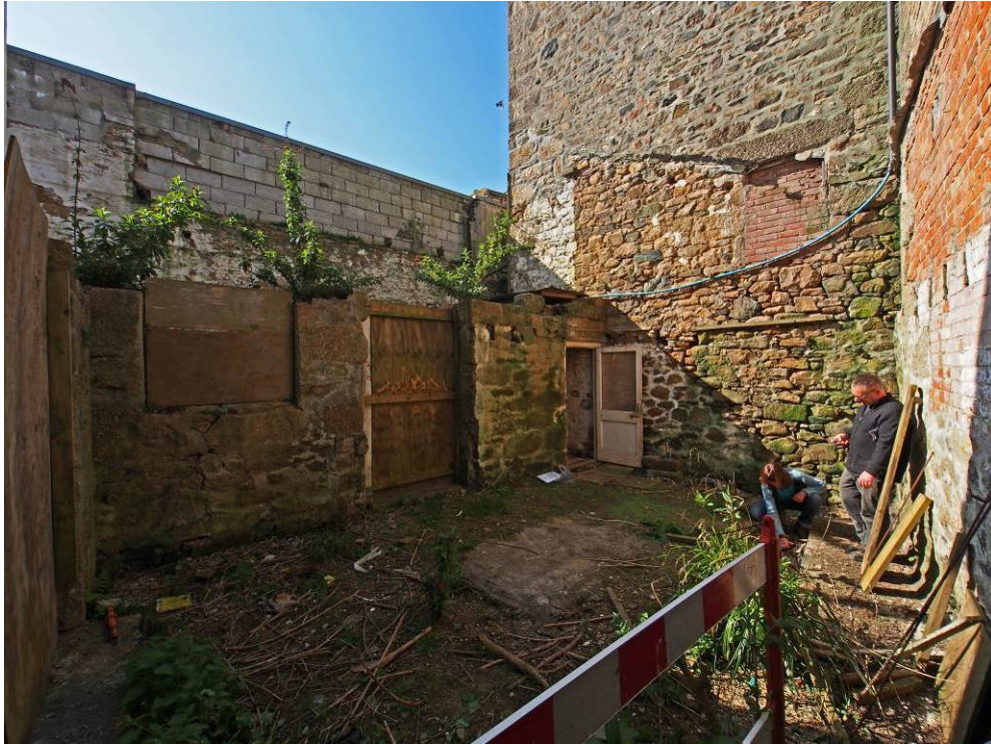
This walling survived only at ground-floor level (to a height of 2.5-3.0m), the roof and upper walling of the workshop having already been removed. First-floor beam slots survived in the north face of the remnant wall and in the site's northern boundary wall, and the scar of the workshop's roof (continuing the line of the north pitch of the warehouse) was visible in the wall face of the historic building (part of No. 11 Market Place) bordering on the west (Figure 17 & 18).

Figure 17. The site viewed from N corner, prior to removal of historic walling

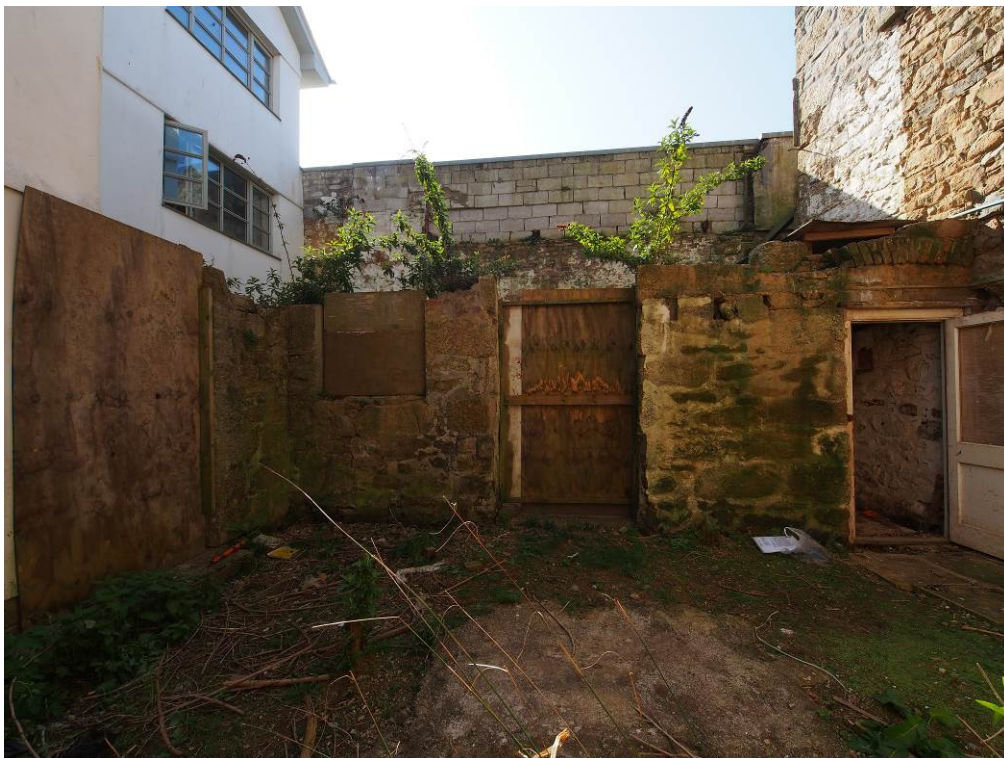
The remnant granite walling was double-faced, 0.5m wide and included a 1.3m wide doorway and 1.0m wide window opening, with cut quoin stones and traces of lime wash and later cement mortar. The doorway is depicted on the 1933 plan (Figure 11) as providing access from the warehouse into the yard and presumably continued in use until the ownership of the two became detached (as a result of the 1933 sale), from which point the only entrance into the yard for its owner would have presumably been via the passageway.

Figure 18. Historic walling from NW

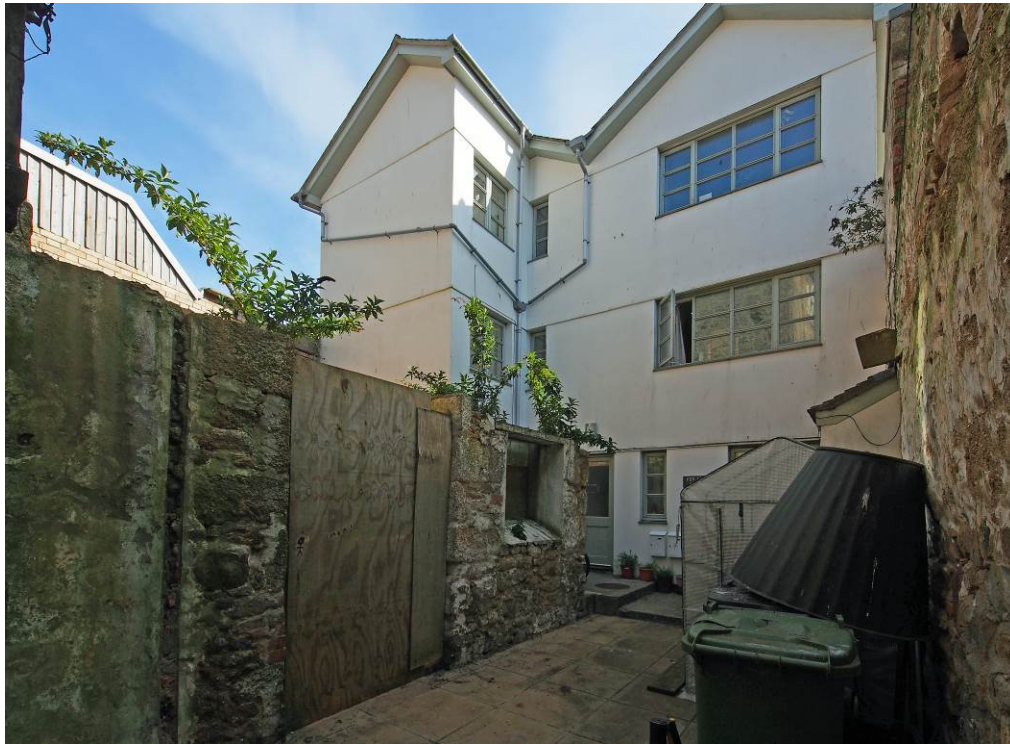
Meek's warehouse had been pulled down some years previously, with the area adjoining the east side of the former engraver's site having been developed into flats and the part to the south left open as an access way (Figure 19 & 20).

Figure 19. Site on left, prior to removal of historic wall, from SW

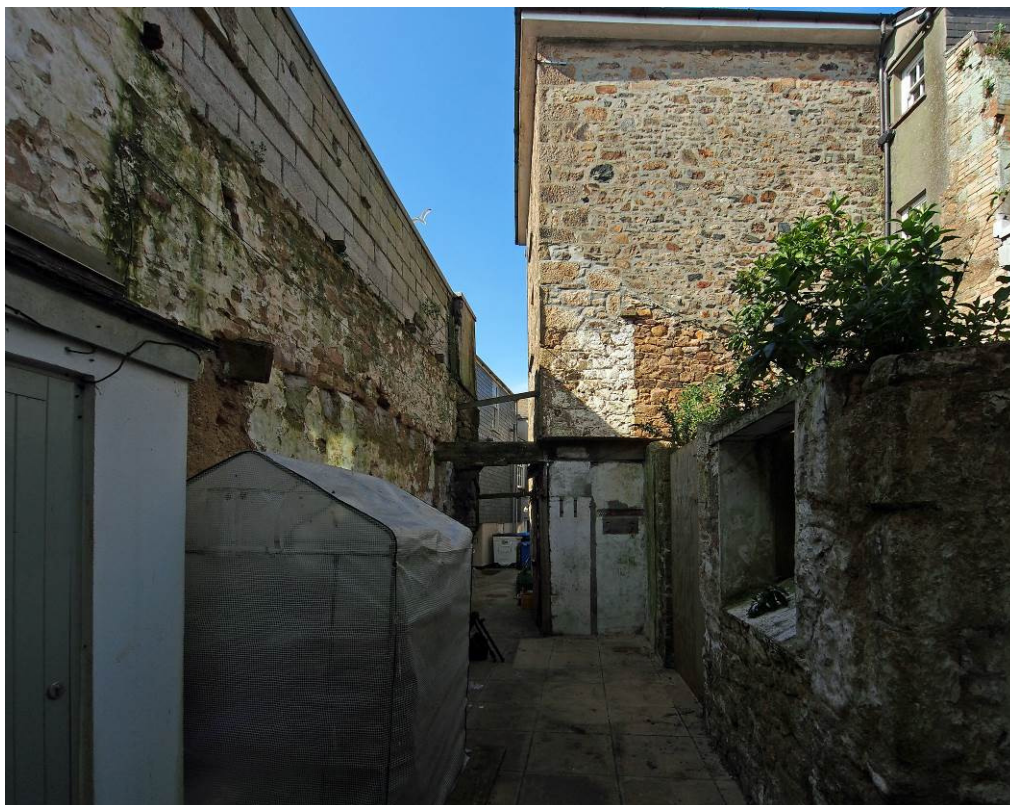
Figure 20. Looking W, with the site/historic wall on the right

The passageway was formed on the west by the back wall of No. 11 Market Place and on the east by a 1.4m length of single-brick-width wall, with a sliding wooden-planked external door at its southern end (Figure 22). At the northern (yard/workshop) end of the passageway, there was a brick arch over wooden lintels (Figure 18). Two large wooden beams (originally supporting part of the floor of the adjacent warehouse) extended along the top of the passage, back into the wall bordering the site to the south (Figure 20 & 22).

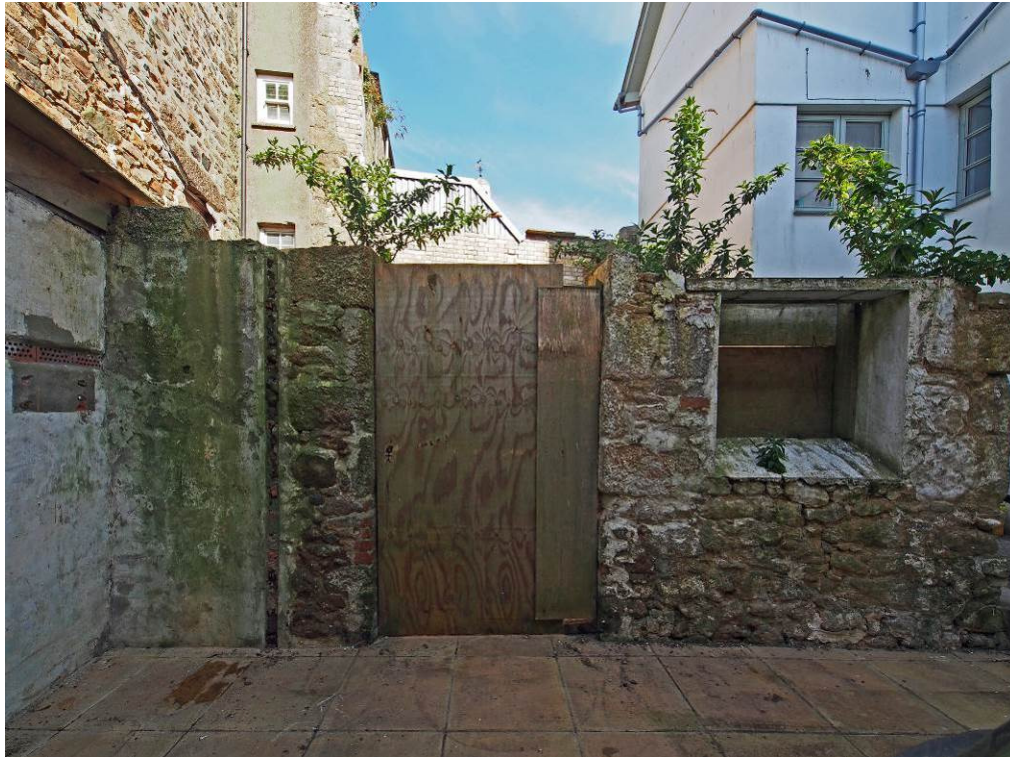
By the time of the historic building photographic recording in May 2013, the only building remains on the site were an L-shaped length of granite wall running 5.5m along the south side and making a short (1.5m) return along the east, with an (1.5m long by 0.9m wide) brick-built entrance passage attached to the west end (Figure 2 & 17-22).

Figure 21. Historic wall, from SE

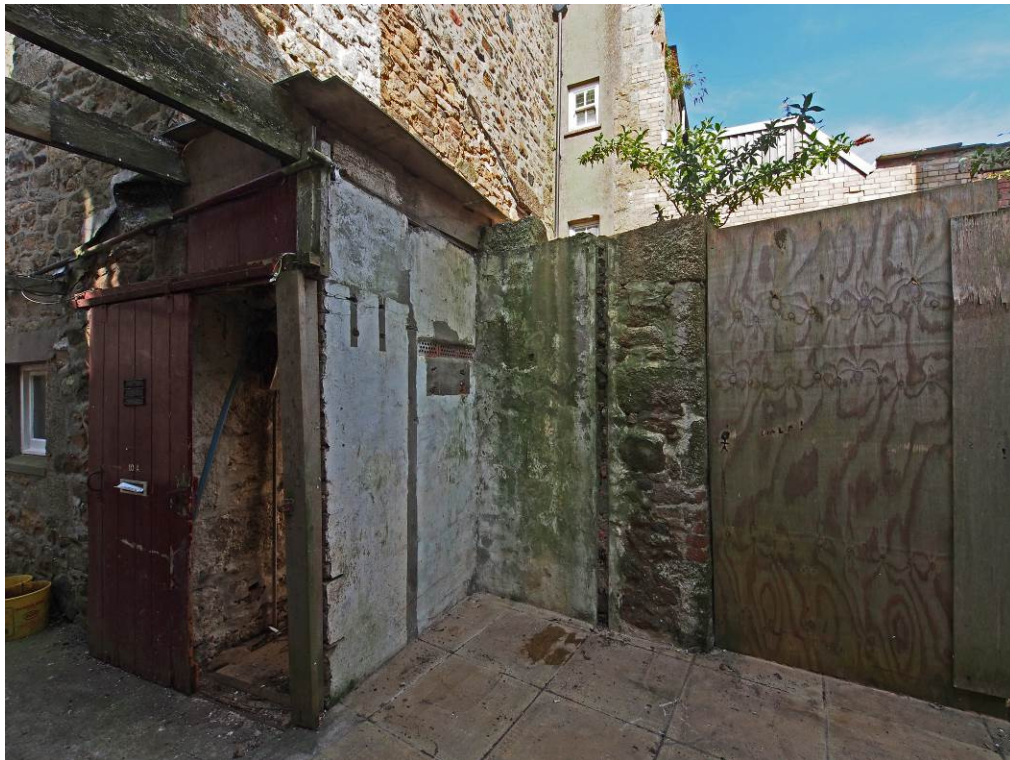
Figure 22. Brick-built passageway into the site, from E

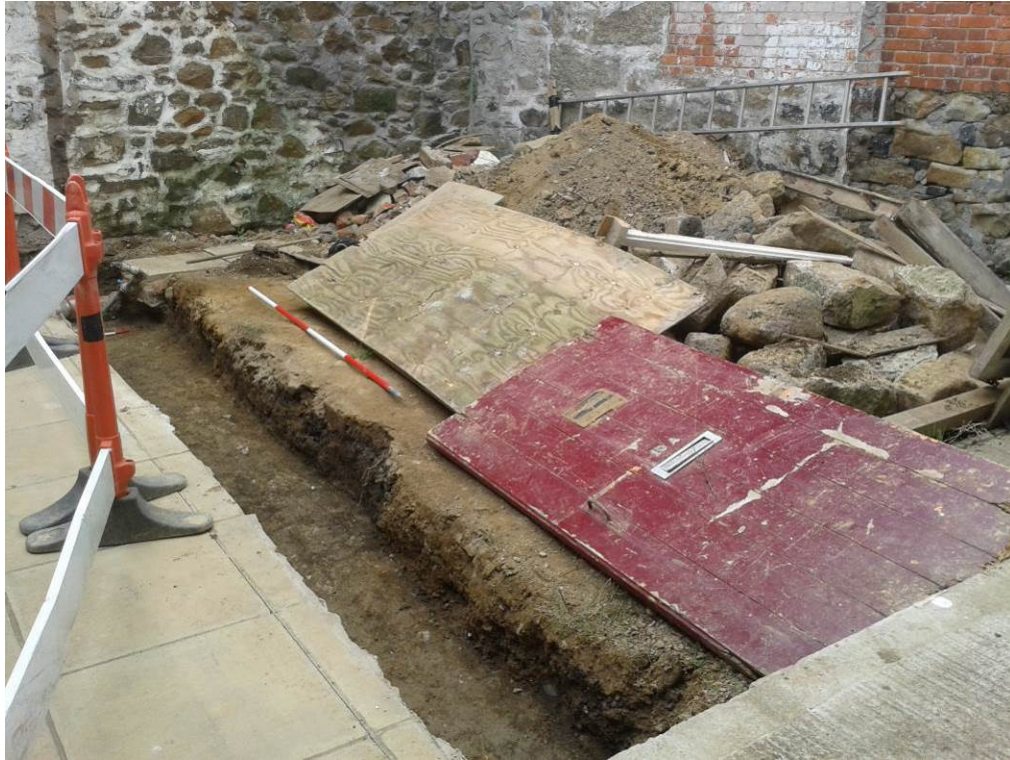
No evidence for earlier (pre-19th century) use of the site was found during the archaeological watching brief. Removal of the remnant walling had left an east-west trench averaging 0.4m deep (Figure 15-16 & 23).

Towards the west end of the trench a ceramic drain pipe ran across it, having originally entered the site beneath the brick-built entrance passage, presumably sometime during the later 20th century, with a more recent alkathene water pipe beside it (Figure 23-24). This end of the trench had already been disturbed by modern ground works.

Figure 23. Trench left by of removal of historic wall, from E

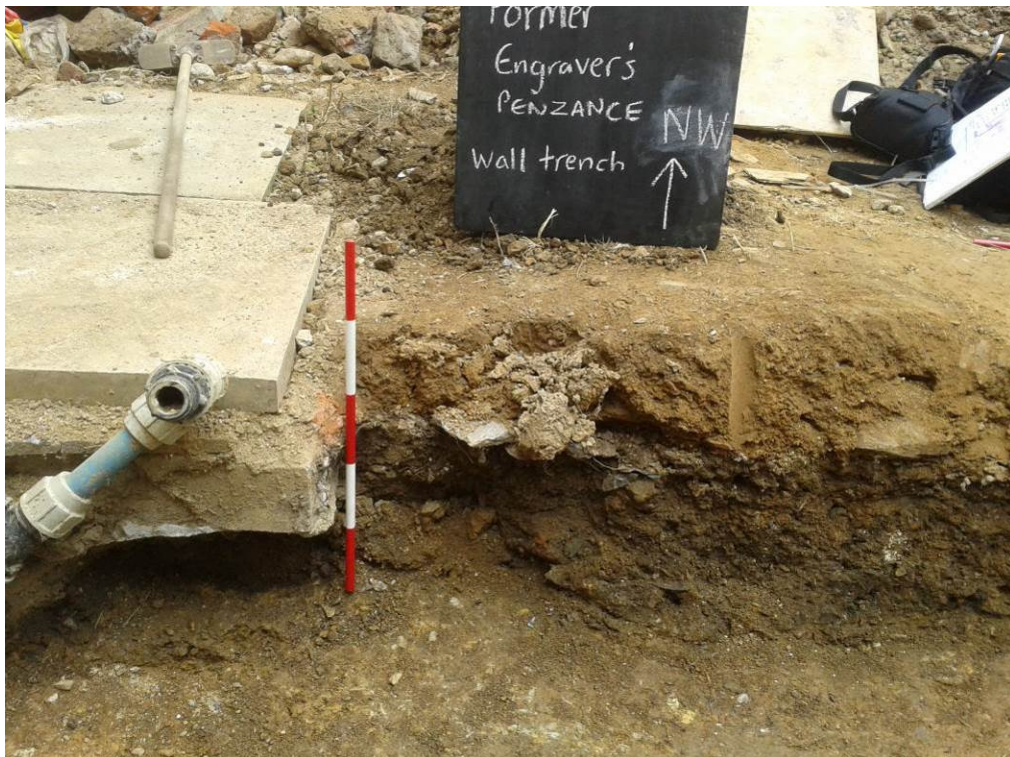
Three main layers were revealed in the main part of the trench section (Figure 24).

1. An upper, 10-20cm deep, layer of orange-brown clayey soil (earth mortar) with fragments of brick and other building material.
2. An underlying, 30cm deep, layer of mixed orange-brown and grey clayey soil, containing pieces of natural slate shillet as well as pieces of brick and roofing slate.
3. Natural yellow/orange-brown clayey shillet (slate-derived) subsoil

Layer 1 is debris from the recent wall demolition. Layer 2 appears to be re-deposited material; the grey staining perhaps representing organic waste. It may represent levelling associated with the laying of the granite paving which previously covered the site. Layer 3 is the natural, undisturbed sub-soil.

Figure 24. North section of wall trench

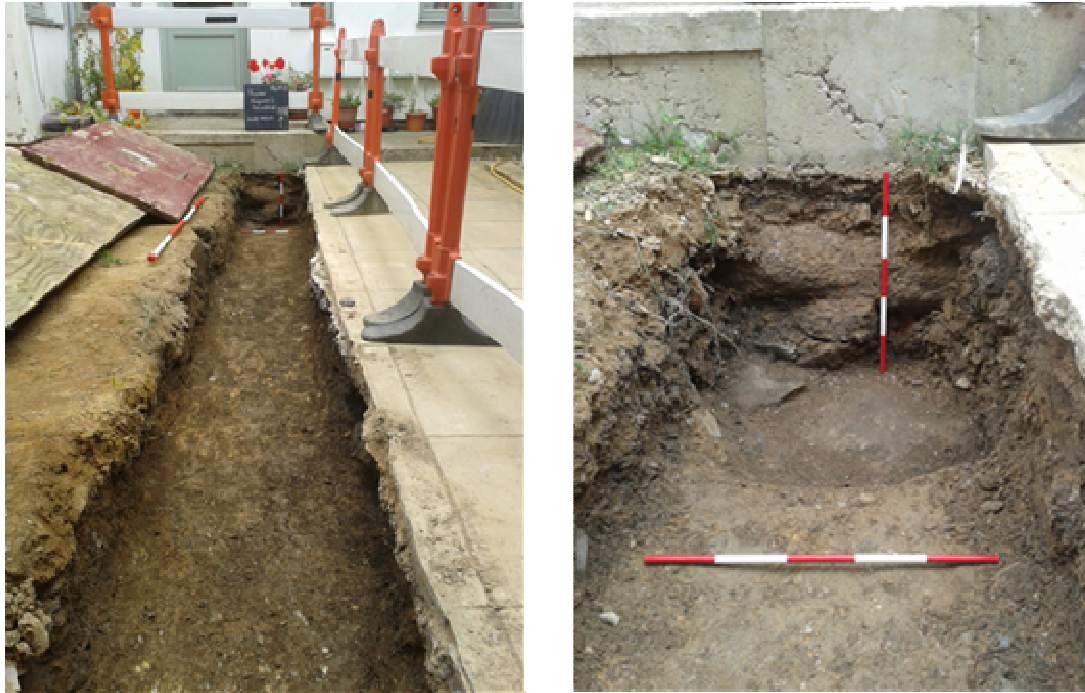
At its east end the trench sloped down a further 0.2m into the north-south cut for the return wall, with remains of the base of that wall still visible on the bottom and in the east section, where it granite stones were overlaid by the modern concrete surface associated with Meek's flats (Figure 16 & 25). The northern extent of the north-south 'robber' trench had already been backfilled.

Figure 25. Wall trench, from NW, with base of return wall

The east-west wall was built on top of the natural sub-soil, while the north-south walling was constructed within a shallow foundation trench dug down into it. This suggests the possibility of phasing, with the north-south wall perhaps being of slightly earlier date. It was unclear whether foundation trenches for both or either walls were dug down through Layer 2 or whether the latter accumulated / was deposited after they had been built. At any rate, it is unlikely to be earlier than 19th century in date, and may be much more recent.
