**Ludlow Touring Park
Overton Road, Richard's Castle, Shropshire**

Archaeological Site Investigations

406.03602.00001

January 2012

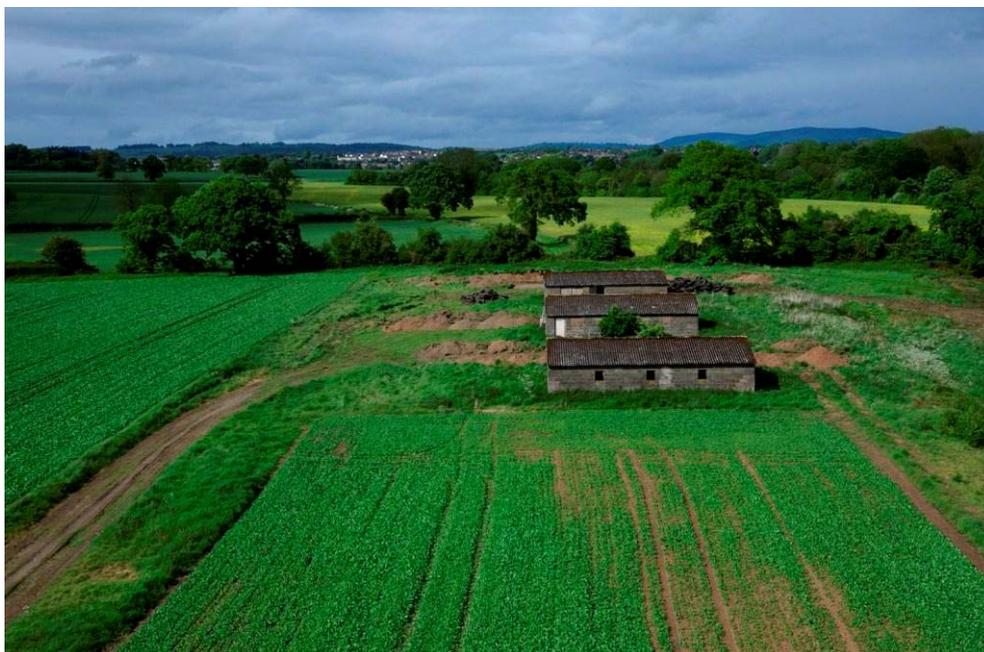
**Figure 5 View looking north
showing three surviving RAF huts with Ludlow in distance**

The three surviving RAF huts (Figures 5 and 6) were recorded on 1st August 2011. All were of concrete block construction (460 x 220 x 225mm) and their dimensions were approximately 13 x 7m, with walls 2.2m in height and 240mm in width, supporting pitched asbestos corrugated-sheet roofs. Modifications from the standard design were evident in each, partly from their discrete original functions, but also from adaption in later years for farming purposes. According to the farmer they had been used for cooking and related activities when the training camp was in operation, most of which had consisted of tented accommodation. Sketch plans and photographs are included within Appendix 2.

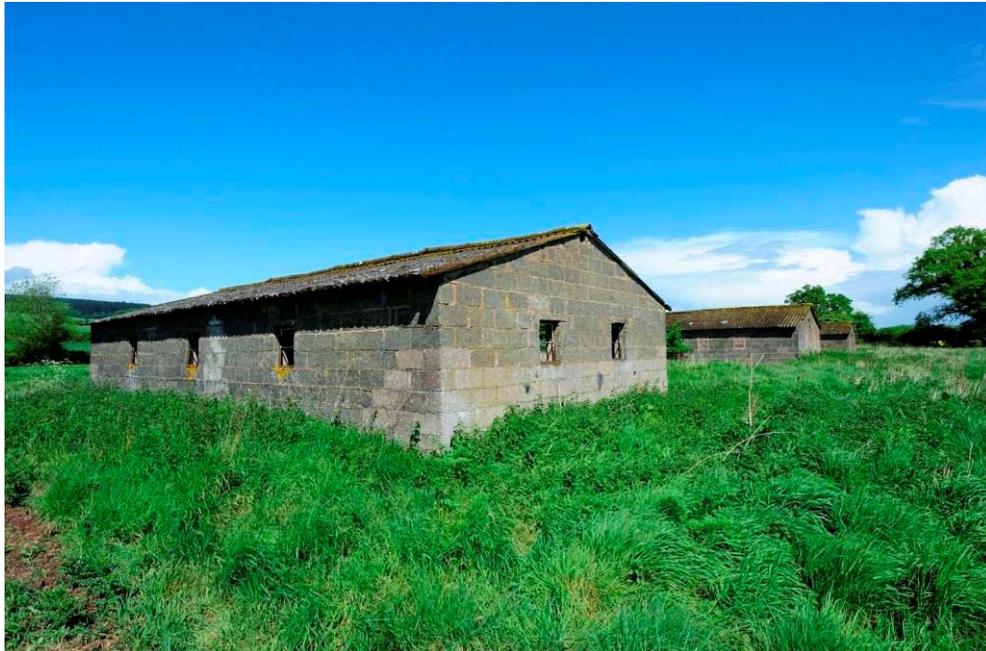
Figure 6
RAF huts 1, 2 and 3 looking northwest

The southern-most hut was 13 x 6.8m, with three iron-framed windows along the southern wall, and spaced along the northern wall two doors with two windows between them. In the east and west walls there were two windows in each. Three pillars were aligned along the centre of the interior to support the roof apex, and two sink units were built into the southeast and northeast corners. An interior division wall was located two-thirds of the length eastwards, and the walls were rendered with lime-based mortar.

The northern-most hut was 13.77 x 6.66m, with two original doorways approximately in the centre of the southern and eastern walls. A wide modern entranceway had been added to the southwestern end. Along the northern wall there were nine windows, three for each of the rooms, and in the western wall there was a single blocked-in window offset from centre to the south. Two internal walls divided the building into three rooms, with the eastern one separate and only accessed externally, the other two being connected by a doorway at the south end of the internal division. The western room had been rendered with lime-based mortar.

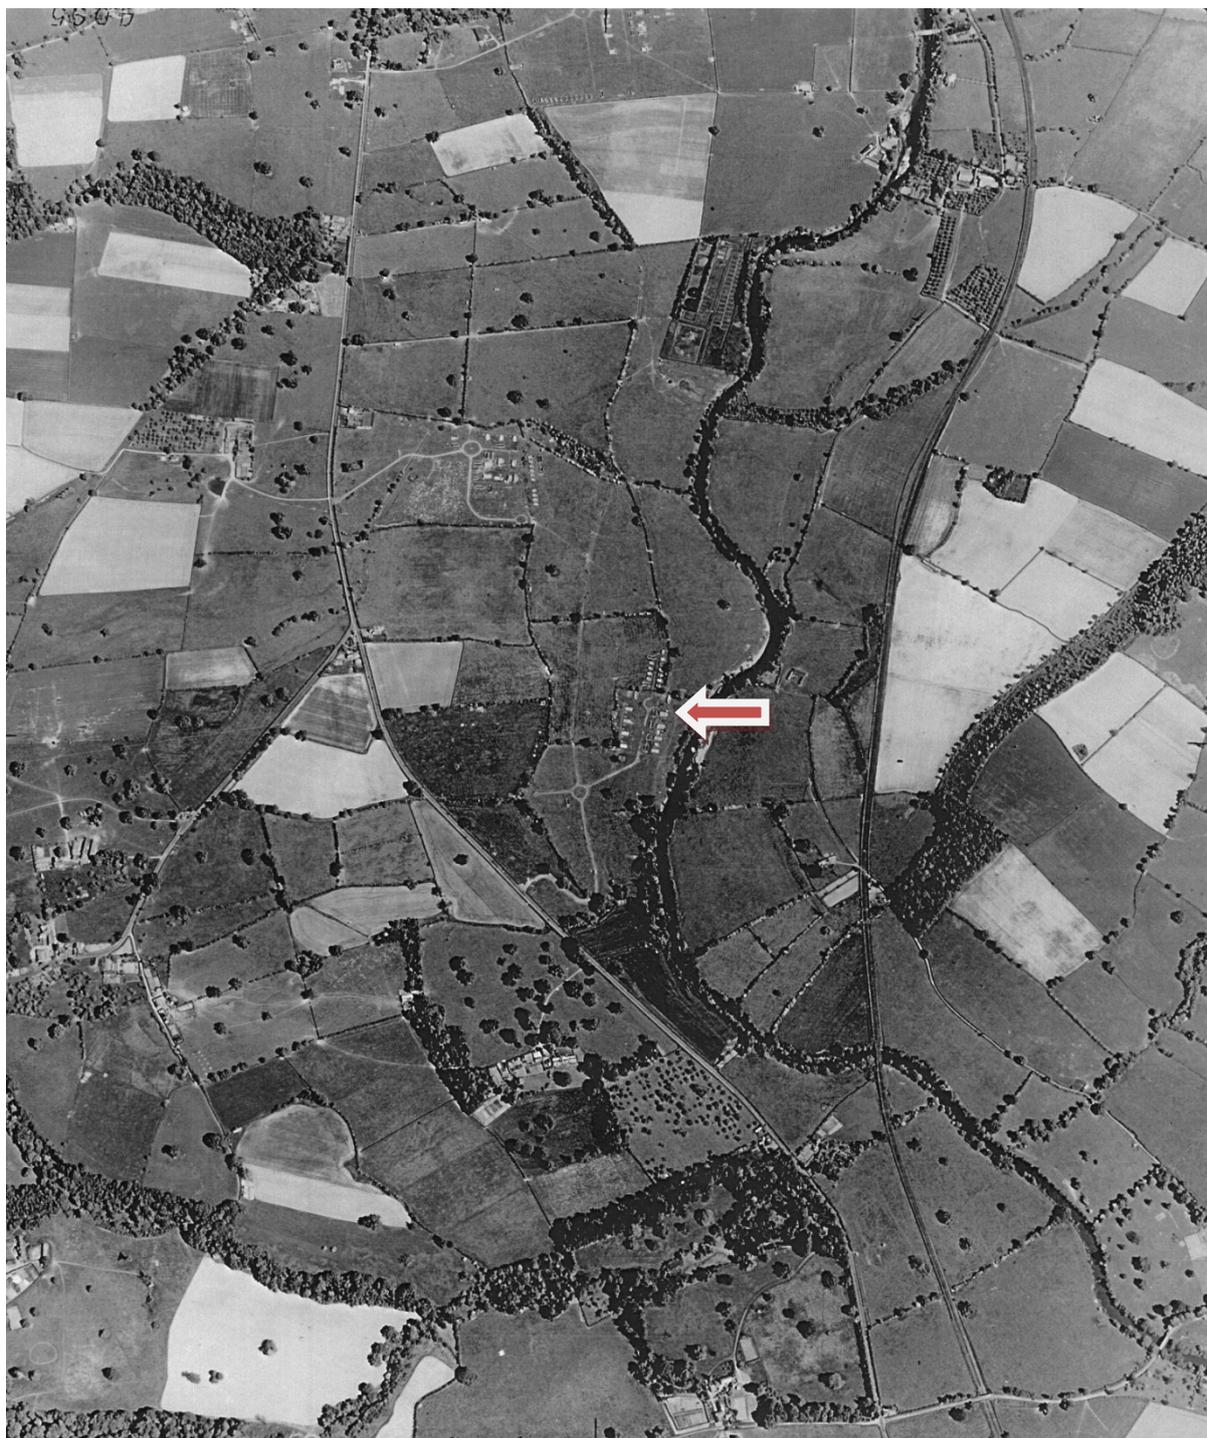
**Figure 7 Air photograph taken in 28th May 1947
showing extent of RAF training camp (RAF/CPE/UK/2095 frame 1135)**

The camp in its heyday during the Second World War extended not only over the consented site, but also through the adjoining fields northwards towards Ludlow. A photograph taken in 1947 (Figure 7) shows the tracks, roundabouts, and arrays of huts which were still in evidence at that time. The nature of most of the camp is believed to have been of a temporary nature, with tents being used to accommodate the occupants, and only some of the essential facilities being provided with concrete huts.

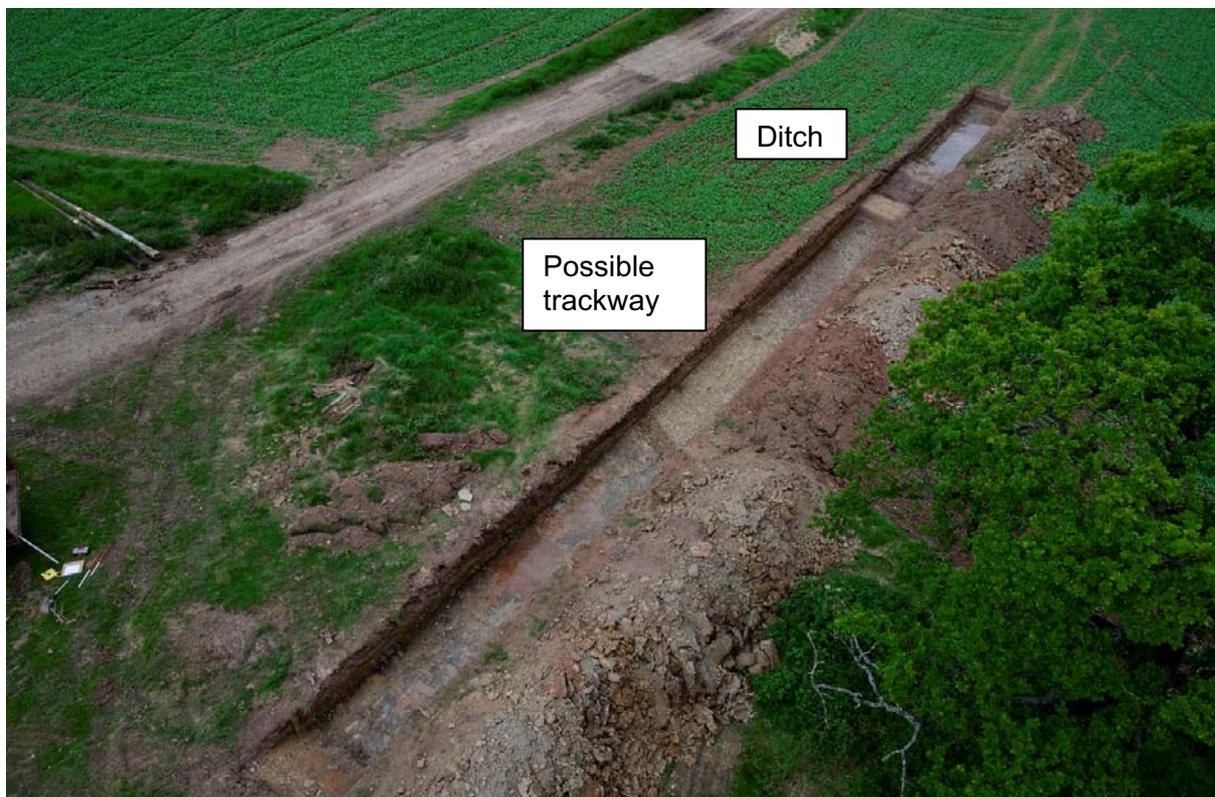
Figure 8
Aerial view of Trench 1 looking northwest

Trench 1 was 43m long, 1.8m wide, aligned north-south, located in the southwestern part of the site within the footprint of a planned building and designed to intercept a possible east-west prehistoric trackway (Figures 4 and 8). The uppermost layers represented ploughsoil over a thin band of made ground, which overlay alluvial/colluvial deposition. A boundary backfilled in 1985³ on an east - west alignment was found to be present in the north of the trench and a concrete drain in the middle. A slight rise and dryer zone in the underlying clays in the centre of the trench, seen in Figure 8 as a light grey colour, might indicate the line of the possible trackway.

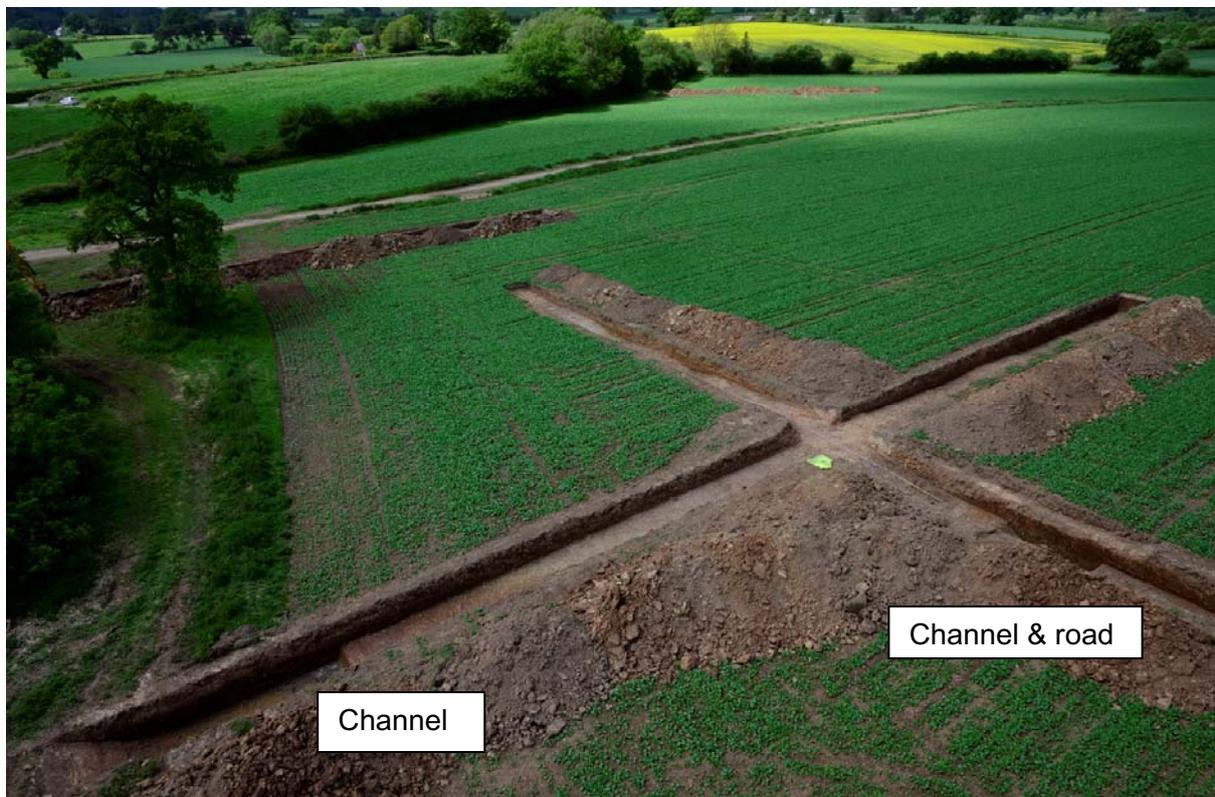
Figure 9
Aerial view of Trenches 2 and 3 looking northwest

Trench 2 was 53m long, 1.8m wide, aligned north-south, located in the southeastern part of the site within the footprint of a flood attenuation pond and designed to cross the line of a possible east-west prehistoric trackway. The ploughsoil was 0.3m deep and overlay a subsoil of loose reddish-brown sandy clay with occasional stones which was seen to be <0.40m in depth. Most of the southern part of the trench contained a large linear feature interpreted as a water channel (208) filled by alluvial deposits comprising stony compacted sandy clay (203-207), with a significant organic content noted in the primary fill (205).

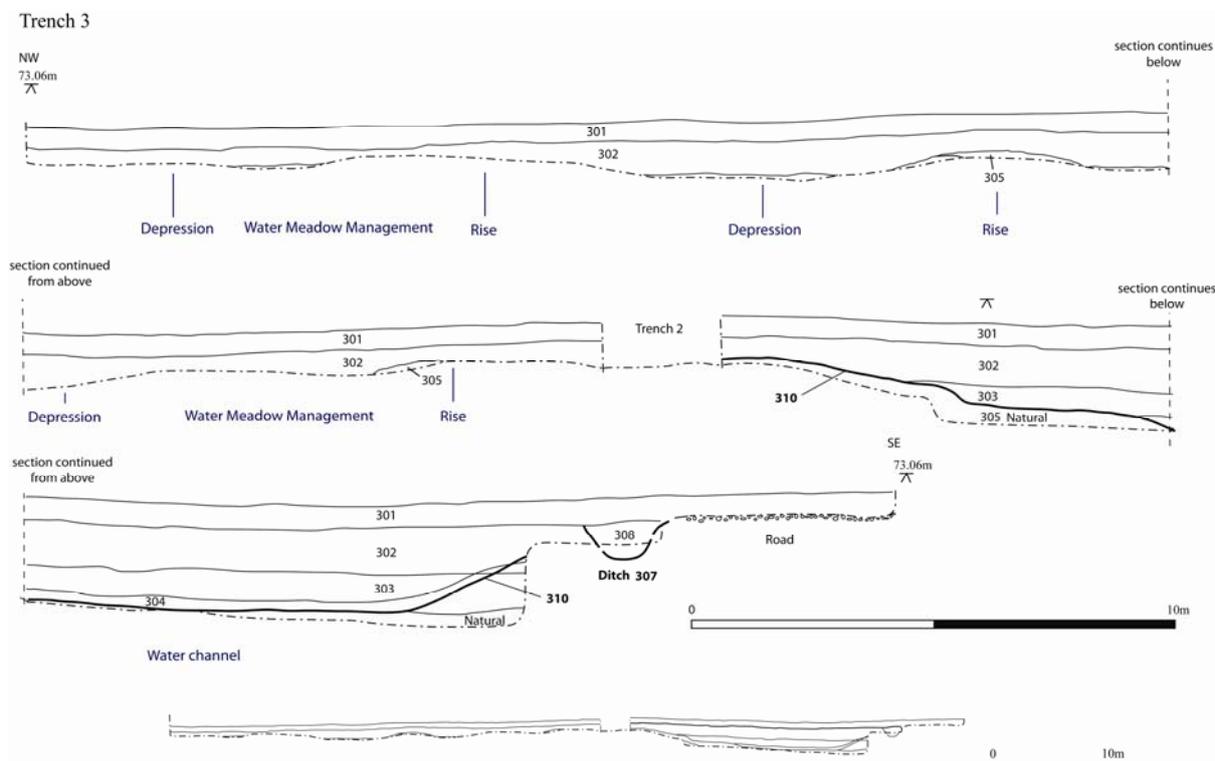
Figure 10
Trench 3 section drawing showing water management features and old road

Trench 3 was 50m long, 1.8m wide, aligned east-west through the attenuation pond zone and designed to cross the line of the old road at the eastern end of the trench. Underlying the 0.3m depth of ploughsoil at the eastern end of Trench 3 the remains of the road were found, orientated approximately north – south, and a northern extension to the trench was opened to record the road, so that a total of 5.6m of its length was exposed. The road (309), 2.3m wide, 0.1m thick, had been damaged by ploughing, and lacked much of the stone metalling seen elsewhere. A 1m wide ditch, 0.7m deep, ran parallel to the road on its western side (307) and was filled by a sandy silt (308). The road appeared to rest on an alluvial deposit (303) which in turn overlay and filled a linear channel orientated northeast – southwest (310). The lowest fill within this channel was initial sedimentation (311) above which lay a grey clay (304), which contained organic material. This material was sampled⁴ but results were uninformative (see Appendix 3).

The orientation of the channel suggested a possible link here between the River Teme and a system of channels or streams within scrub to the south of the site. In the western part of Trench 3 a series of three or four north – south aligned undulations were observed with the length of each undulation (rise and depression) c.8m in total, ranging from 0.1 – 0.6m in depth below the topsoil (filled by the subsoil (302) with the “bank” element comprising natural gravel (305). These may represent the remains of water management features to help with improving meadowland, for which the water channel at the southern and eastern ends of the trenches might also have formed part.

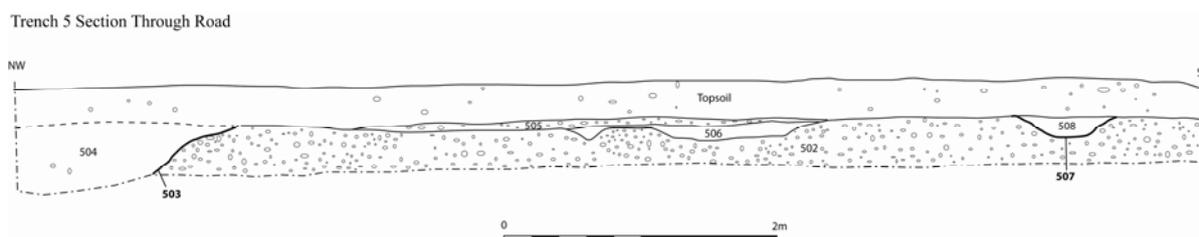
Figure 11
Trench 5 section through old road (505) and ditches (503 & 507)

Trench 5 was 25m long, 1.8m wide, aligned northwest – southeast and located to intercept the line of the old road in the central eastern part of the site. A 9 x 1.8m extension was added to the south side of the east end of the trench to expose an area across the old road (Figures 11 and 12). At the east end of the trench, immediately underlying the 0.3m thick ploughsoil, were the remains of the road, in a similar plough-damaged state to the section found in Trench 3, and visible as a 3.7m wide, 0.06m thick, band of loosely packed stones in a silty-sand (505) and set into a 0.1m thick bedding layer of compacted sandy-clay (506). A linear feature, interpreted as a shallow ditch (507), 0.7m wide, 0.15m deep, filled by a sandy-silt (508) was observed to the east of the road, while to the west a larger ditch (503), 1.6m wide, 0.5m deep, containing a fill of compacted sandy-silt with large stones on top (504), was found, both orientated on the same alignment as the road. The larger stones in the ditch may represent part of an overlying paved surface for the road, which had been otherwise removed or robbed. No other archaeological features of value were observed in the trench. A waste pipe, probably associated with the RAF huts, was the only other feature. Between the road and the ditches part of the underlying natural gravels was found (502) suggesting that the road foundation had been scooped into the gravels or that usage had worn a slight hollow-way into the gravels, and to the west an alluvial deposit (509) at least 0.3m thick was seen which is an eastward continuation of similar deposits in Trench 4. At the eastern end of the trench the ploughsoil came down directly on to river gravels (502).

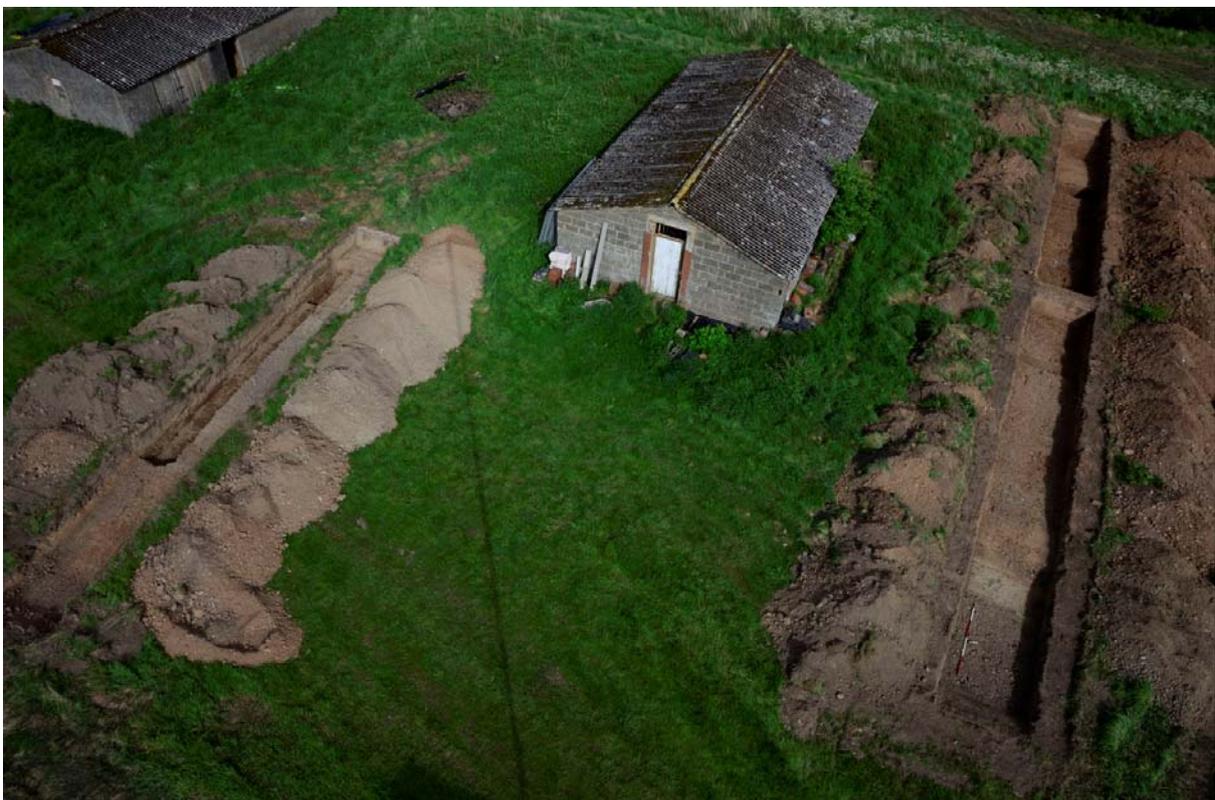
Figure 13
Trenches 7 and 8 and Hut 2 looking southeast (2m scale over old road in Trench 7)

wall a doorway with window above (Figure 13), and decorative concrete frame around it, survived. Internally three pillars supported the roof and the interior walls had been rendered with lime-based mortar, scored to appear as large blocks.

Trench 8 was 15m long, 1.8m wide, aligned northwest – southeast and located to intercept the line of the old road in the northern part of the site (Figure 13). Underlying 0.3m ploughsoil a 0.2m subsoil (813) was found at the northwestern end of the trench and 0.4m thick (807) at the southeastern end. Between these a disturbed deposit of subsoil was found (802 and 803) above the road which was orientated on a northeast - southwest alignment. Parallel ditches were located on either side of the road, of which the western one was the larger and more substantial.

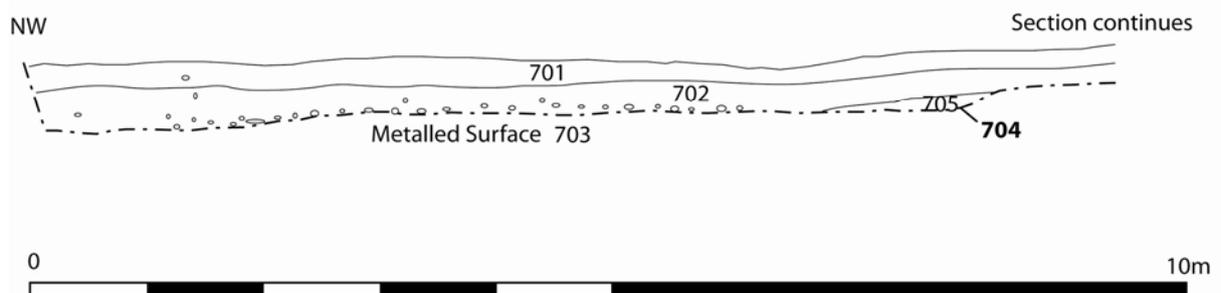
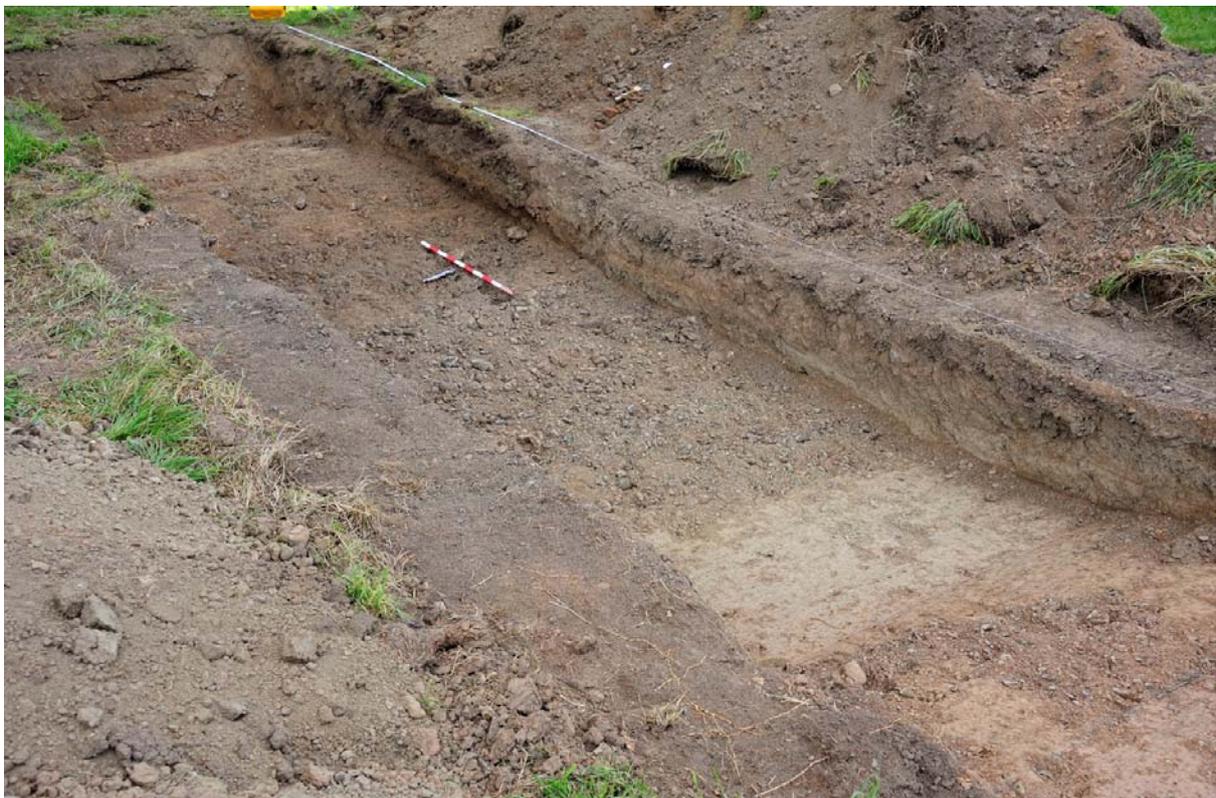
Figure 14
Trench 7 section through old road

Trench 7 was 36m long, 1.8m wide, aligned northwest – southeast and located to intercept the line of the old road in the northern part of the site. The ploughsoil was 0.25m thick overlying a 0.25 - 0.5m subsoil of compacted orange-brown sandy clay with occasional stones (702) (Figures 13 and 14). The road, 5.8m wide, 0.15m thick, was located at the western end of the trench, with a loose stone metalling (703) orientated roughly northeast - southwest lying between two ditches, the western of which (711), was seen as a narrow band of clay. The eastern ditch (704) was 1.10m wide, >0.10m deep, with a silty clay fill (705). A thin band of dark grey-brown silt (712), 0.05m thick, lay above the road and below the subsoil. This contained a large assemblage of ceramic material, including ceramic building material (CBM; probably roof tile) and large fragments of a slipware dish, as well as later yellow ware, salt-glazed ware, stoneware and bone china giving a range of date from early 19th – early 20th centuries.

A notable change in the consistency of the underlying natural deposits from hard gravels to a considerably softer mixture of gravels and clays in the eastern part of the Trench was detected (the subsoil (702) was found to increase in thickness), and this was also noted in those trenches further north (Trenches 8 and 9). This change suggests the road may follow a natural ridge of harder gravels. The trench also seemed to confirm the farmer's memory that the land around the RAF huts had been built-up to make a level area for their construction, and a series of service trenches including metal pipes and drains (706 – 710) were found at the eastern end of the trench cutting the subsoil (702).

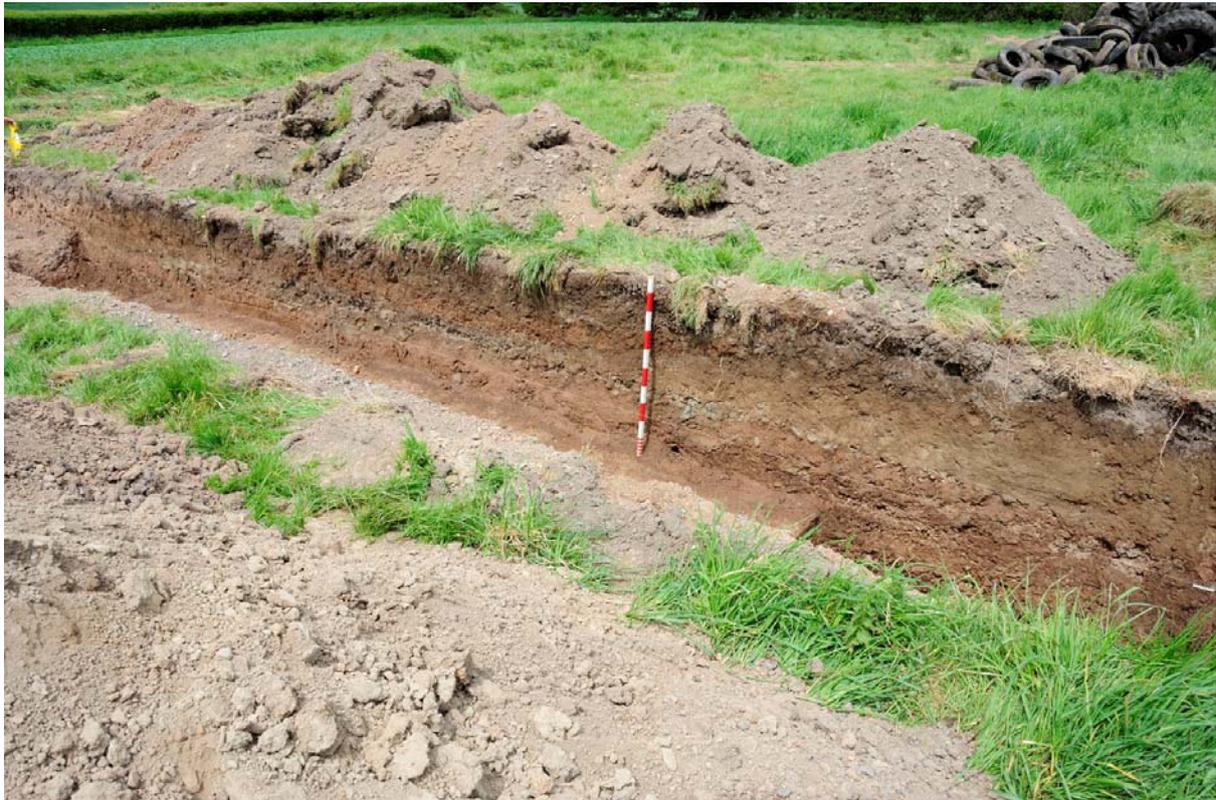
Figure 15
Trench 8 looking northwest

A slot was excavated through the road to get a greater understanding of its composition. The road itself was revealed as a 5.2m wide, 0.1m thick layer of extremely loose stones and gravel, sitting on a 0.04 – 0.1m thick foundation layer of stony orange sandy-clay, similar to alluvium located in other trenches (Figure 15). The western ditch (809) was 1.3m wide, 0.3m deep, with a flat base and infilled by compacted sandy-clay (810). The eastern ditch (811) was 0.9m wide, 0.18m deep, and filled with compacted sandy-clay (812).

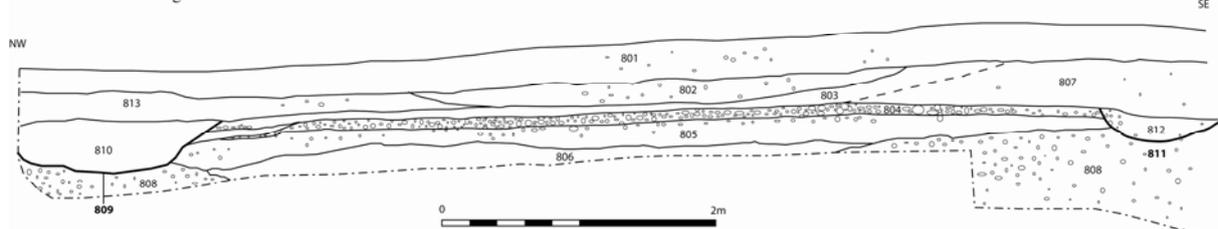
Trench 8 Section Through Road

Consideration of the road's possible course suggested that it might be following a natural ridge of gravels, and that the alluvial material in the ditches and used as a foundation for the road, was mined locally and placed on the gravels to provide a consistent bedding material.

The material overlying the road (807/813) was a compacted sandy-clay. This deposit had been cut into from just under the topsoil resulting in a 3.6m wide shallow scoop. No dating evidence was recovered from this cut or its fill (802) of loose sandy-clay with angular stones. Proximity with the RAF buildings in this area might offer an explanation for this activity.

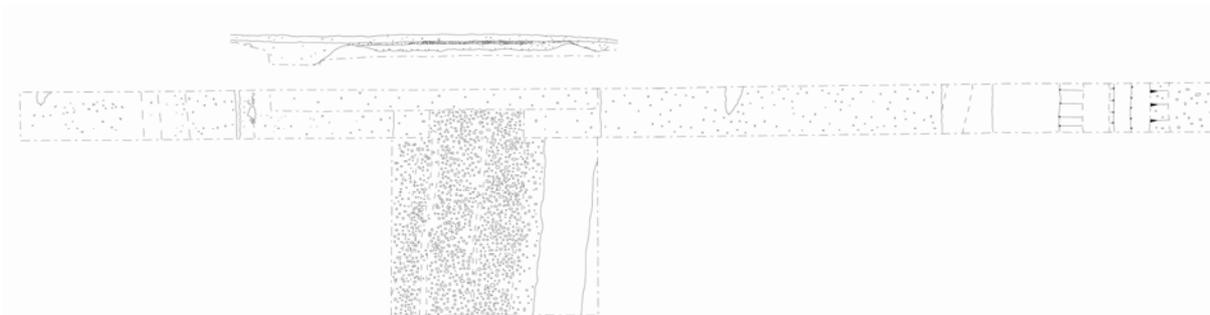
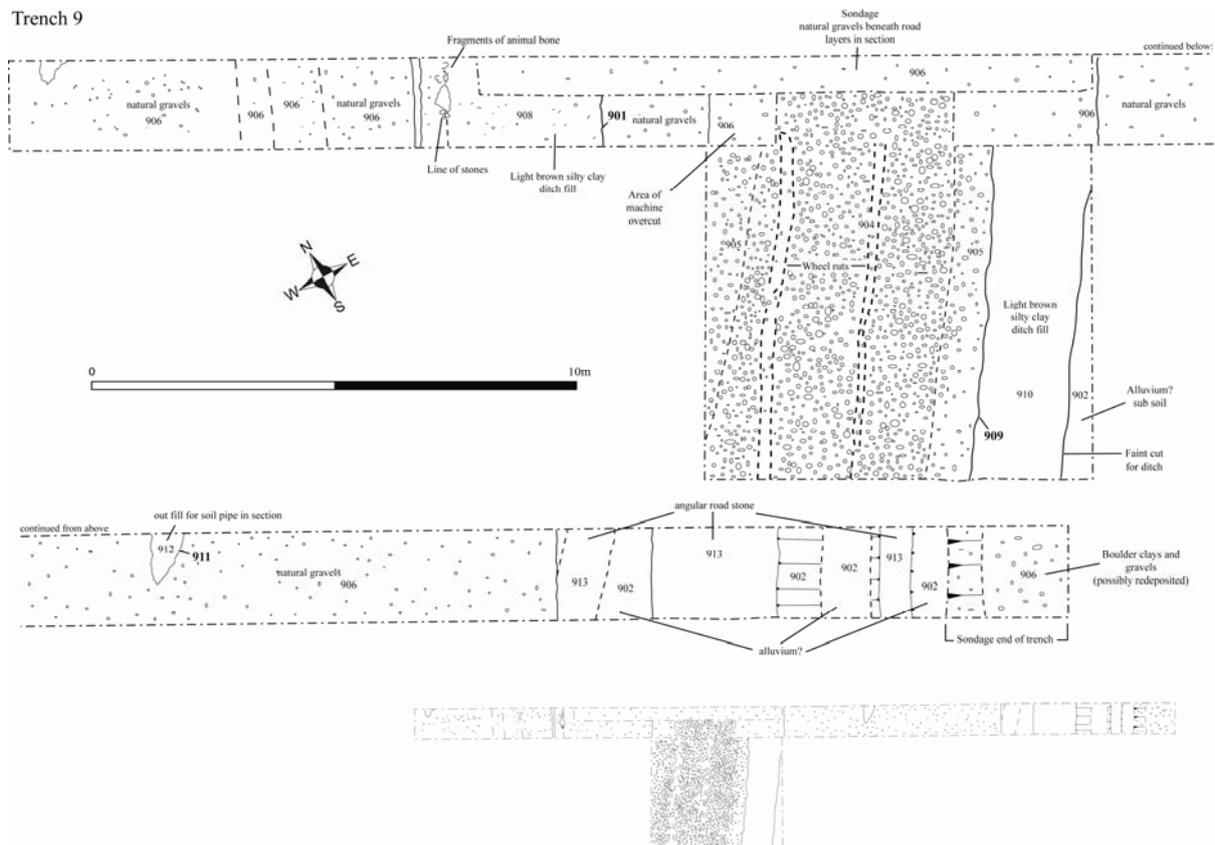
Figure 16
Trench 9 plan of eastern end and section through old road

The old road was located in the central-western part of the trench and was found to be 5.7m wide by 0.1m thick, orientated northeast – southwest. The road metalling comprised loosely compacted stones (904) bedded on a 0.15 – 0.22m thick foundation of sandy-clay (905) (Figure 17). Two possible wheel ruts were identified in the stony metalling (904) which followed the alignment of the old road (Figure 16), but investigation could not confirm whether they were ruts or plough marks. The road was flanked by a large 4.4m wide ditch

(907) to the west and a shallow, 1.6m wide ditch (909) to the east. Within the fill (908) of the western ditch were several larger flat mudstones, lying on top of each other, which were initially considered to be forming the base for a wall or boundary. Further investigation proved these to be loose in the fill of the ditch. Several pieces of bone (sheep/goat and cattle) were also recovered overlying the stones, as well as some 20th century ceramics and a narrow glass flask top.

Although there was no evidence for robbing in this trench, and the road appeared to have a similar composition to that in Trench 8 (i.e. a thin layer of gravel and stones overlying an orange sandy-clay), the flat pieces of mudstone marking the edge of the western ditch fill, however, could represent broken and discarded fragments of the original paved surface of the road (Figures 16 and 18).

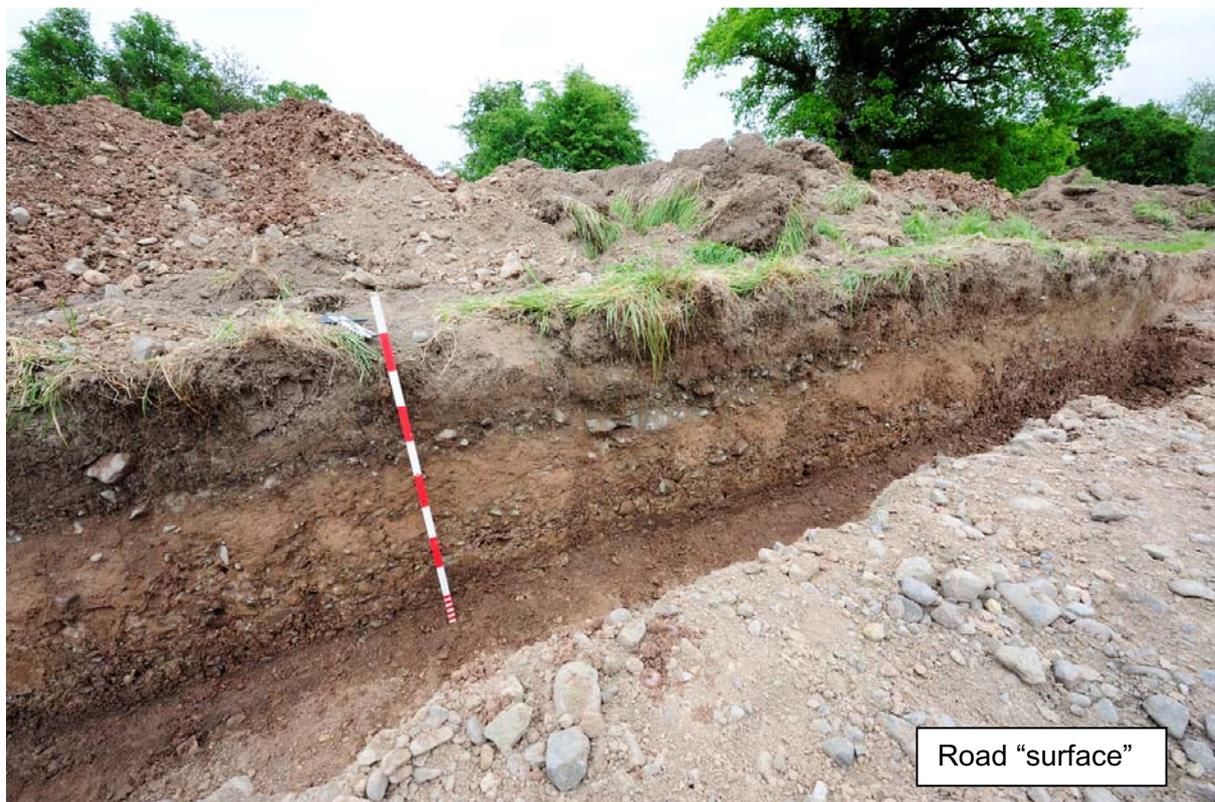
Figure 17
Trench 9 photo of section through road looking northeast

Trench 9 was 47m long, 1.8m wide, aligned northwest – southeast and located to intercept the line of the old road as it entered the site from the north (Figures 16, 17, and 18). The ploughsoil was 0.3m thick at the northwestern end, but only 0.1m thick at the southeastern end, and beneath this the old road was observed. The trench was extended along the line of the road to clarify its orientation, and a deeper slot was also excavated to gain a better understanding of its foundation. An 8m length of the trench over the road was widened by an additional 7m in order to record the road in plan as well as in section, exposing a total area of 8 x 8.8m. A 0.75m wide slot was cut through the road deposits over a length of 12.8m within the original trench in order to record the detail in the south-facing section.

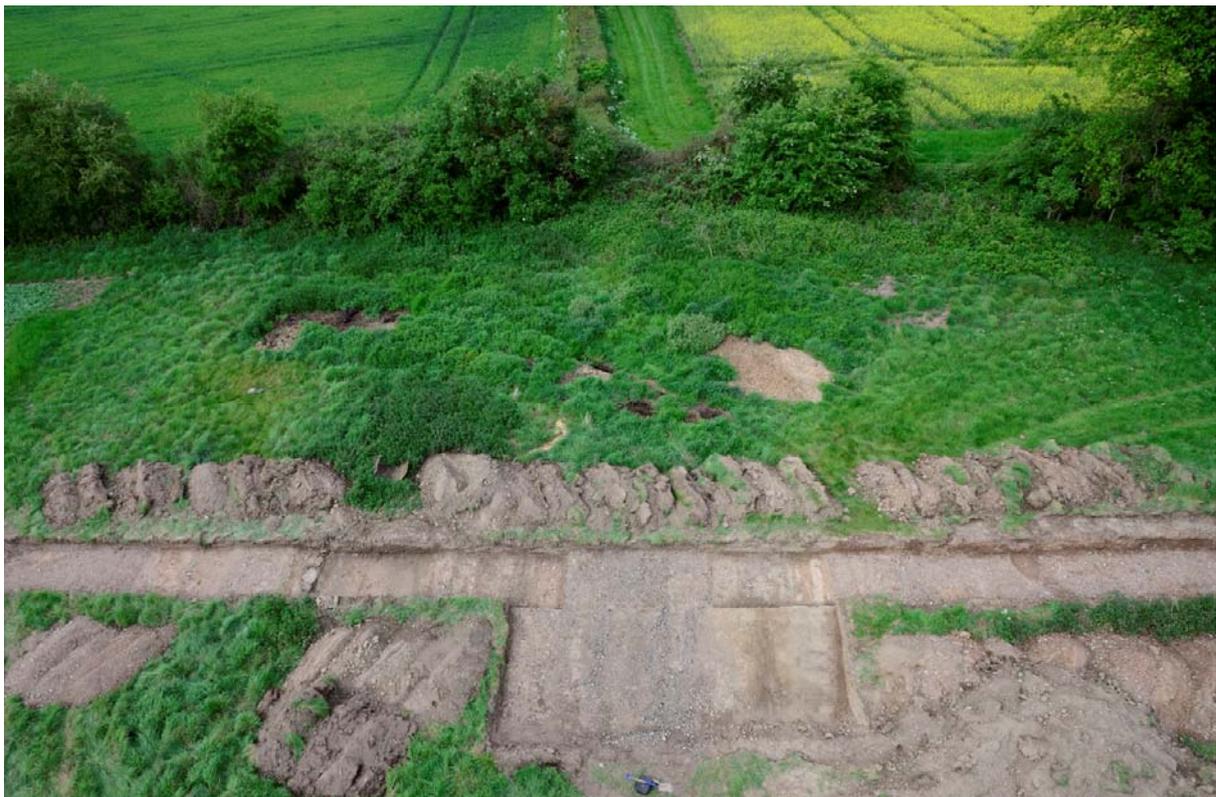
Trench 9 aerial view showing road and ditches with possible discarded paving slabs

(Note: northwards continuation of road as green lane beside hedge in field to north of site)

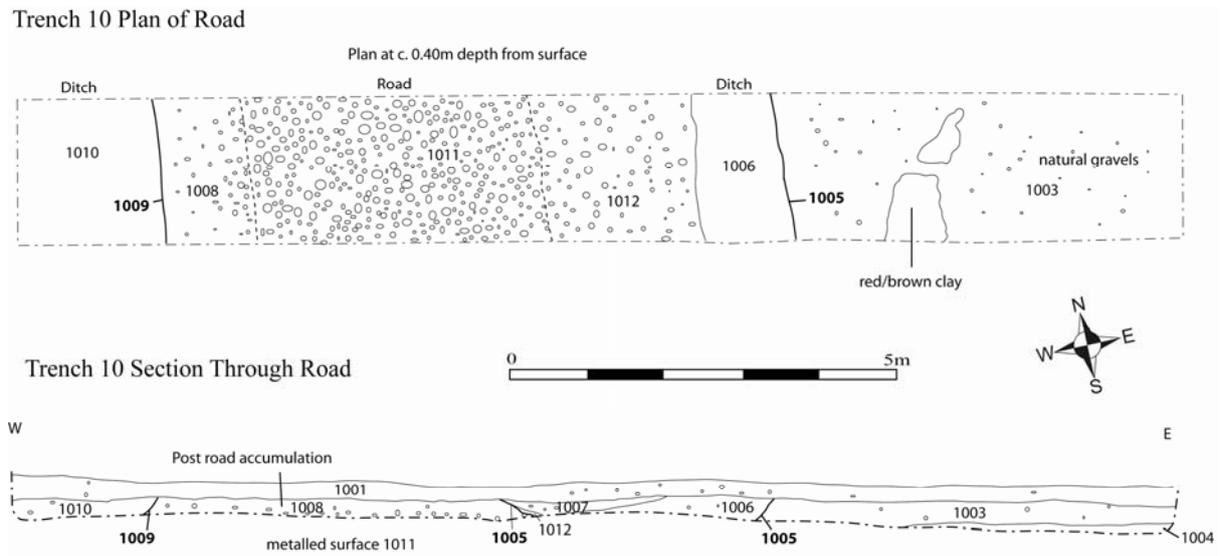
Figure 19
Trench 10 section and plan of old road

The ditches associated with the road were also located in this trench. The metalled part of the road (1011) was revealed as a loosely compacted continuous layer of rounded stones 3.8m wide, preserved beneath a deposit of loose sandy-silt (1008) containing a less dense stone inclusion and interpreted as a post-use layer of accumulation (Figure 19). Although the road was not excavated it possibly extended a further 2m to the east (total width 5.8m) as a deposit (1012) with a less dense concentration of stones was found beneath a later intrusion (1007). It is therefore possible that (1012) was a continuation of (1008) but was not fully excavated to the underlying road.

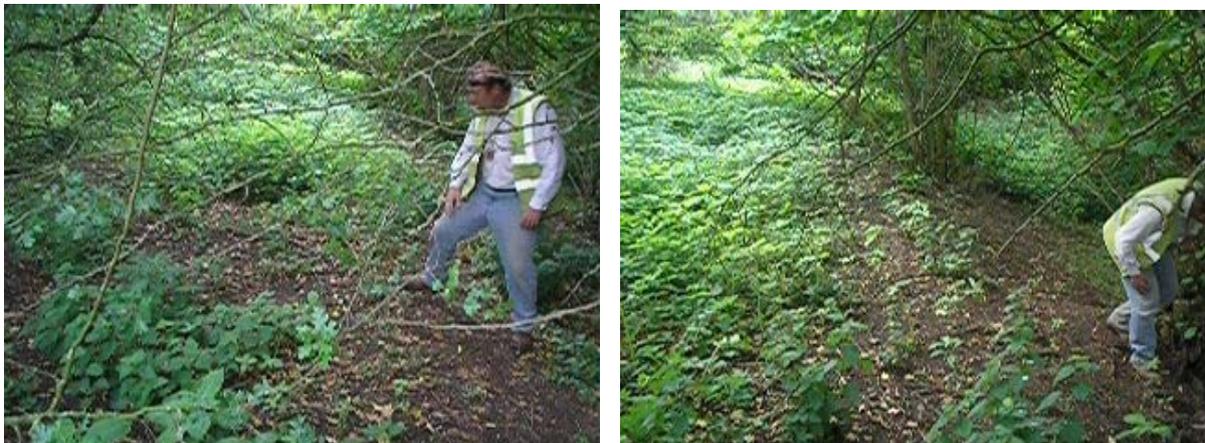
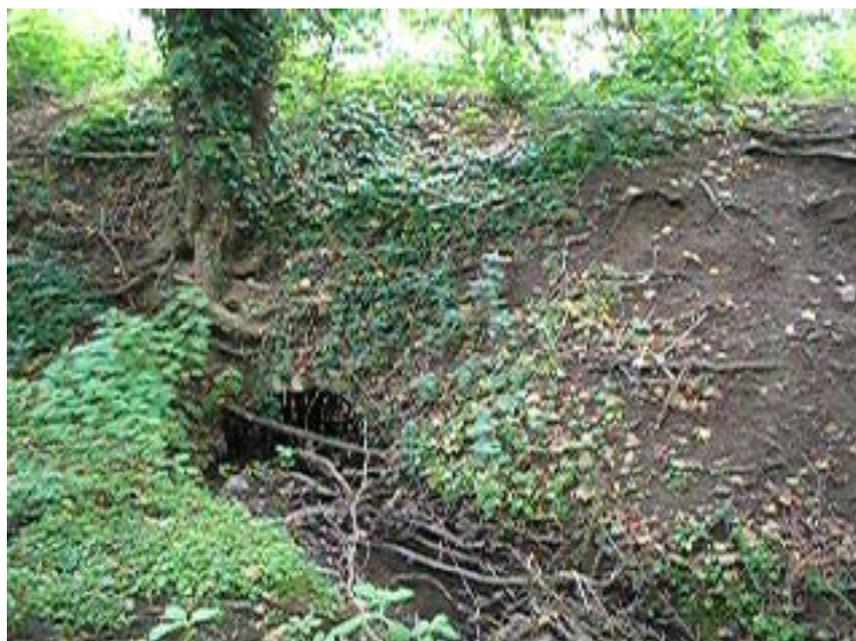
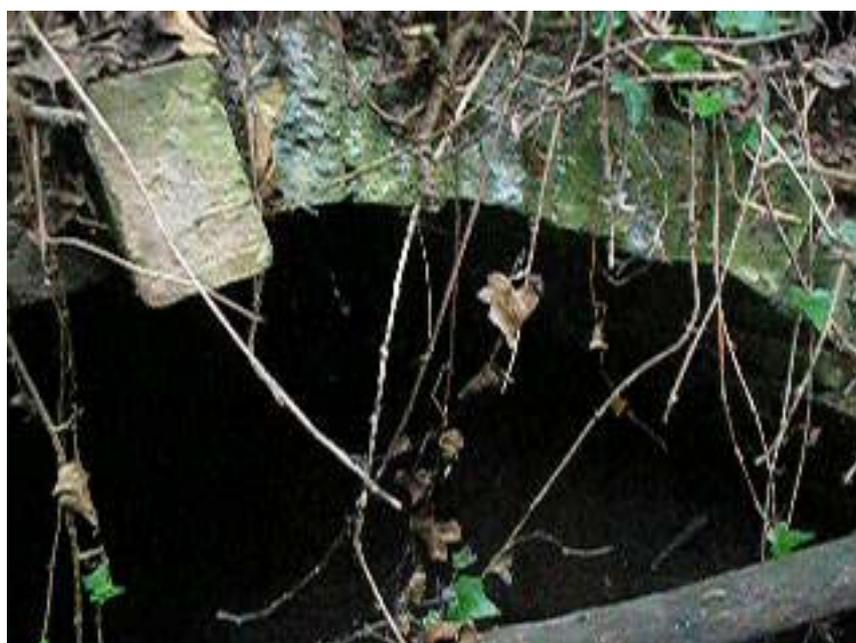
Figure 20
The top of the causeway embankment, and details of brick culvert

The old road continued as a causeway adjacent to the River Teme within the southeastern extremity of the site (shown on Figure 4). Although overgrown with vegetation, the road could be seen as a well-engineered structure which maintained the gradient of the road as it passed over a slight valley, formed by the outflow of a small stream. This stream now forms the sinuous boundary between the site and the garage to the south. The land to the north (the site) was drained by this stream via a tributary and a ditch(es) now in-filled but which originally ran through the site. The construction of the road, cambered and surfaced with pebbles, included a c.2m high earth embankment as the causeway (Figure 20), through which a brick-built culvert allowed the stream to pass on its way to the Teme. This demonstrates that the existing road is post-medieval in date, and probably of 18th century date.

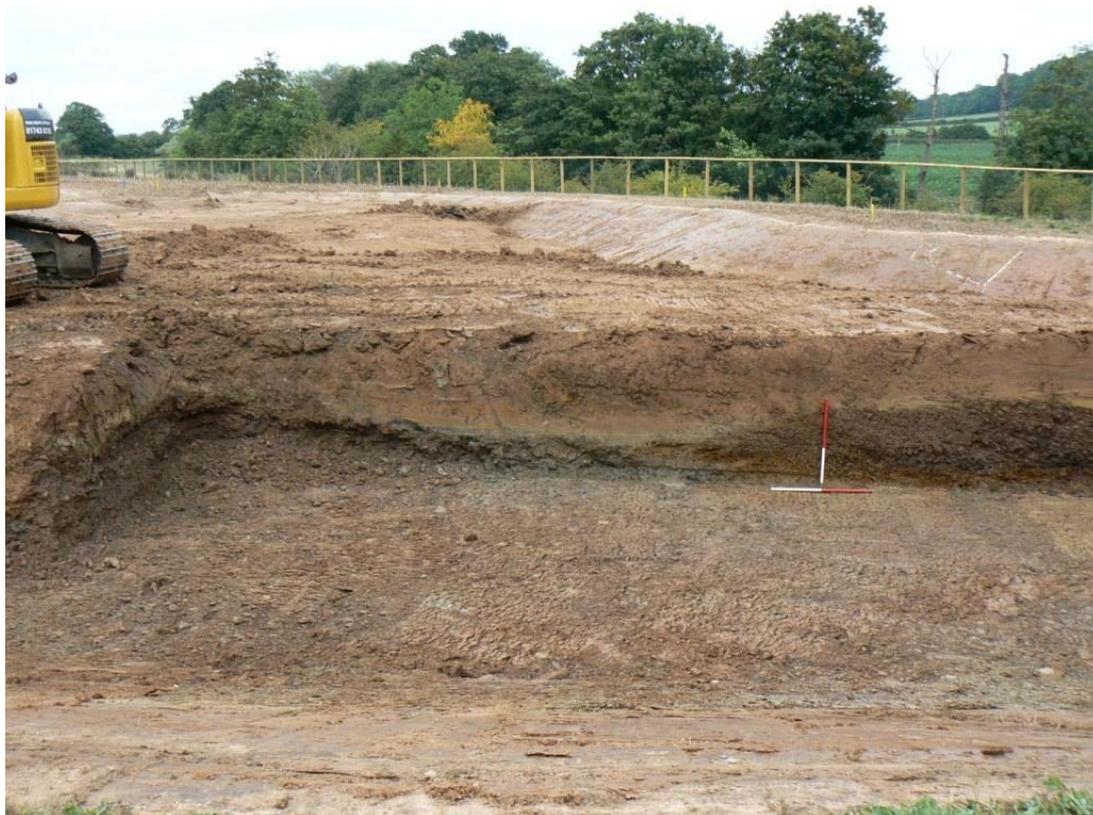
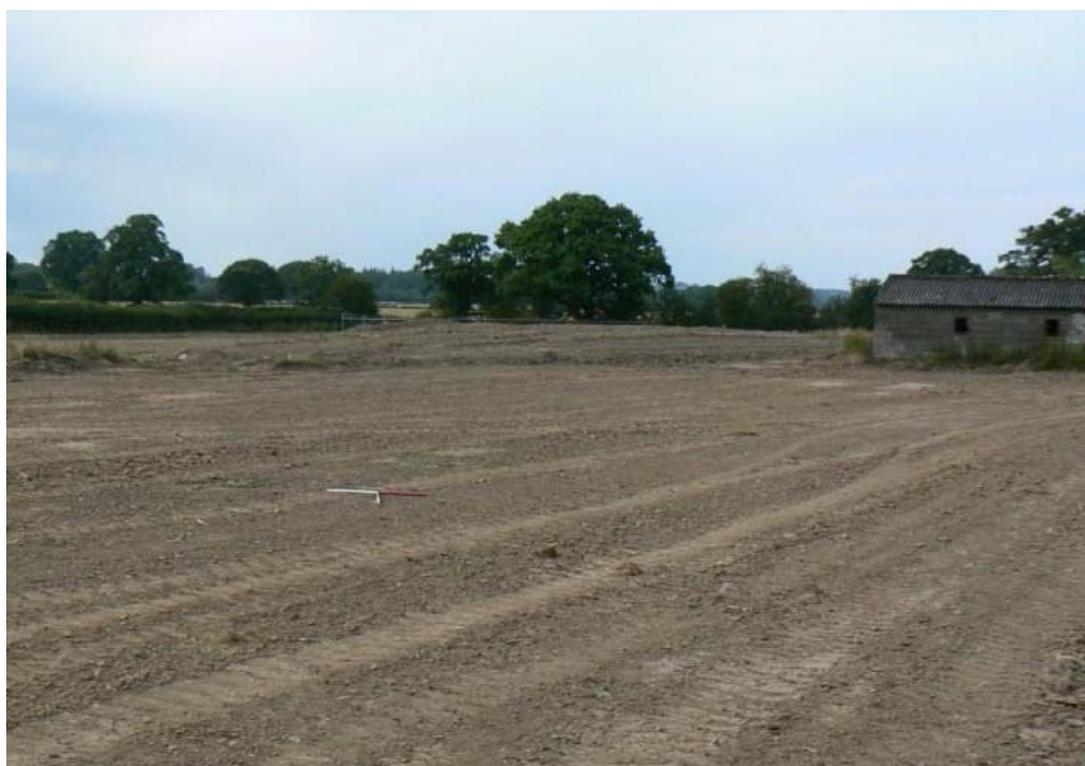
Figure 21
Top: section through water channel looking east;
base: view north showing raised land surface over road

No significant results were obtained from the monitoring of groundworks during construction. The flood attenuation pond excavation revealed more of the water channel seen in Trenches 2 and 3, and made for an easier photograph of this feature in section (Figure 21a). Nothing further was observed during excavation for the foundations of the permanent reception building, and the old road was not disturbed by the construction of the new access road and general surface clearance of the field. The ground was raised slightly within the northern area adjacent to the RAF huts which should help to protect the remains of the old road in this location (Figure 21b).
