**Ludlow Touring Park
Overton Road, Richard's Castle, Shropshire**

Archaeological Site Investigations

406.03602.00001

January 2012

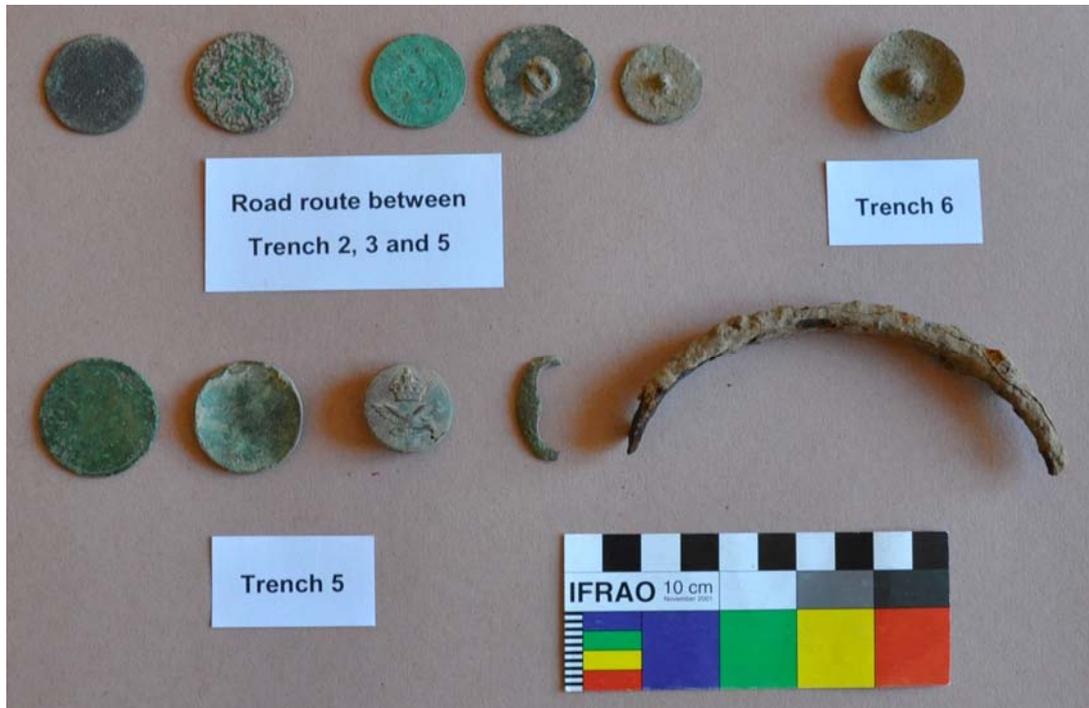
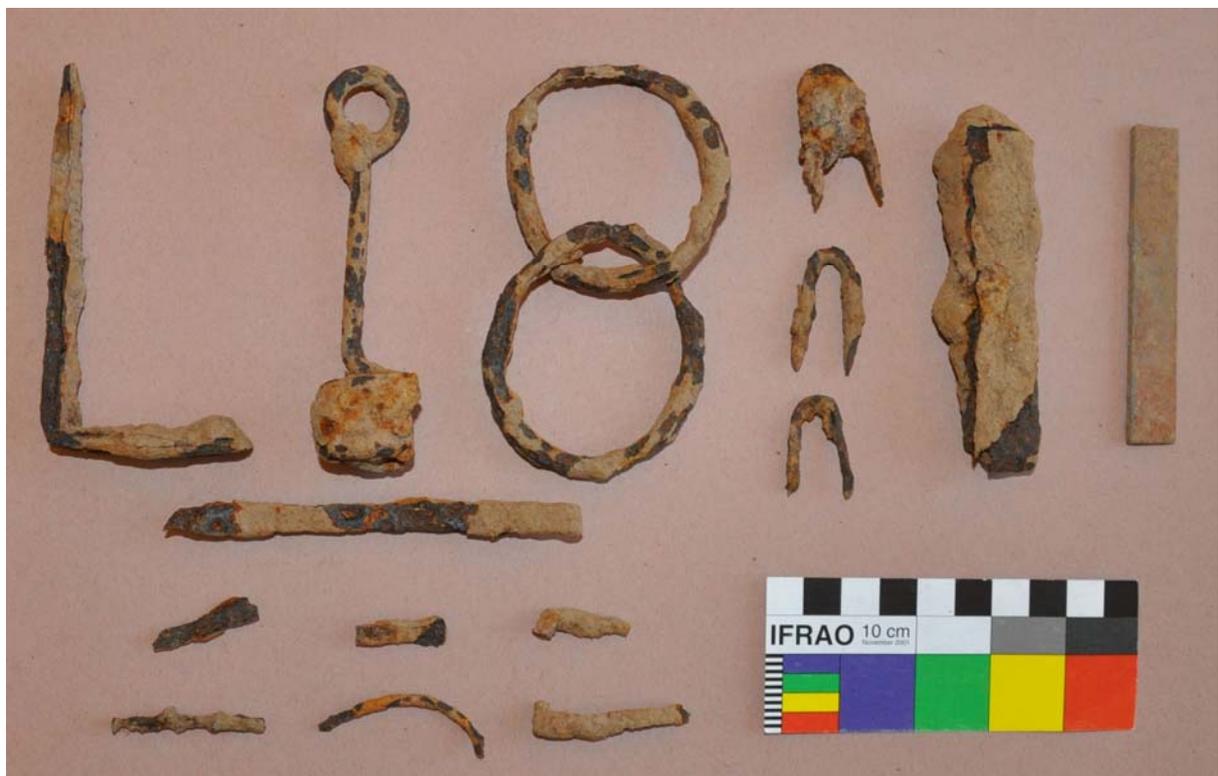
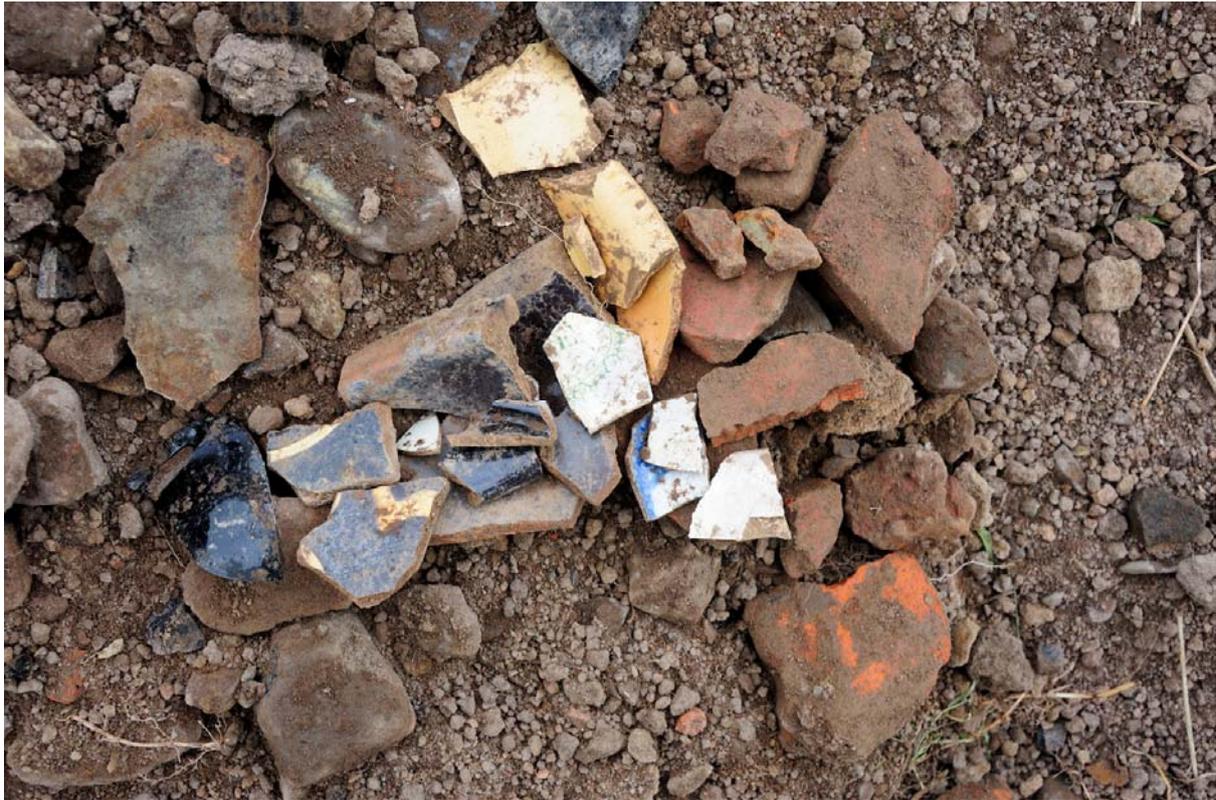
Figure 22:
a) Selected metalwork; b) iron artefacts from Trench 5;
c) pottery and tile from Trench 7 (context 712)

2 x copper-alloy flat disks 27 x 1mm, one with mineral-replaced textile threads adhering to it. Very regularly cut disks, no identification possible, but size and regular edge to circle suggests coins of late 17th or early 18th century⁷; size could suggest possible half-pennies.

Two probable coins, unidentifiable but with some mineral-replaced textile adhering, found along the line of the road, could be of late 17th or early 18th century date, and large sherds from a slipware dish of similar date (712) could perhaps derive from use of the old road in that period.

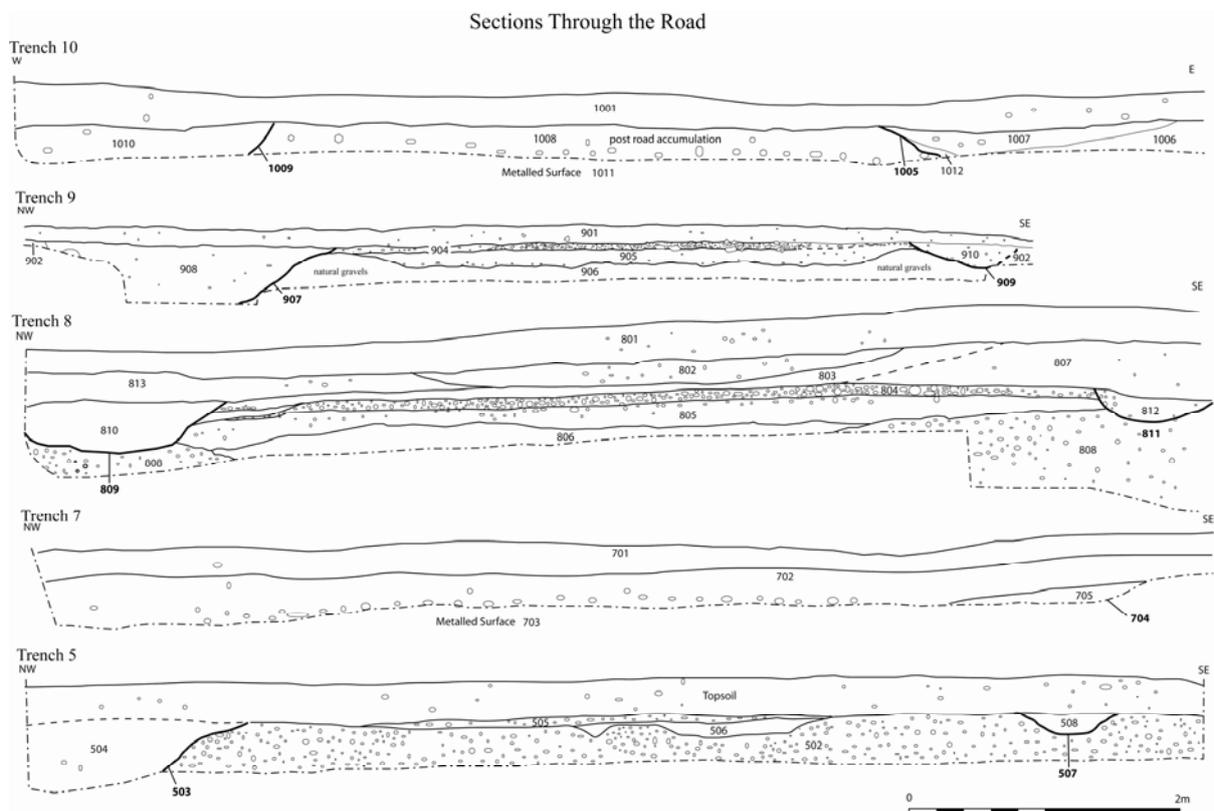
Figure 23
Comparative sections through old road

The comparative exposures of the old road have allowed a description to be produced (see Table 1 and Figure 23). Consistent characteristics are the presence of a c.0.1m thick stony deposit loosely set in a silty matrix, laid on a foundation of compacted sandy-clay (where excavated), with ditches to either side of which the western one was larger than the eastern one. The road's dimensions ranged from 2.3 – 5.8m in width, but four of the six sections were between 5.2 and 5.8m wide; plough damage or other disturbance might account for the reduced width in Trenches 3 and 5.

Trench No	Road dimensions	Western ditch	Eastern Ditch
3	2.3 x 0.10m	1.0 x 0.7m	
5	3.7 x 0.06m	1.6 x 0.5m	0.7 x 0.15m
7	5.8 x 0.15	0.4m	1.0 x >0.10m
8	5.2 x 0.10m	1.3 x 0.3m	0.9 x 0.18m
9	5.7 x 0.10m	4.4 x >0.9m	1.6 x 0.38m
10	5.8m	>2.0 x >0.30m	1.17 x 0.1m

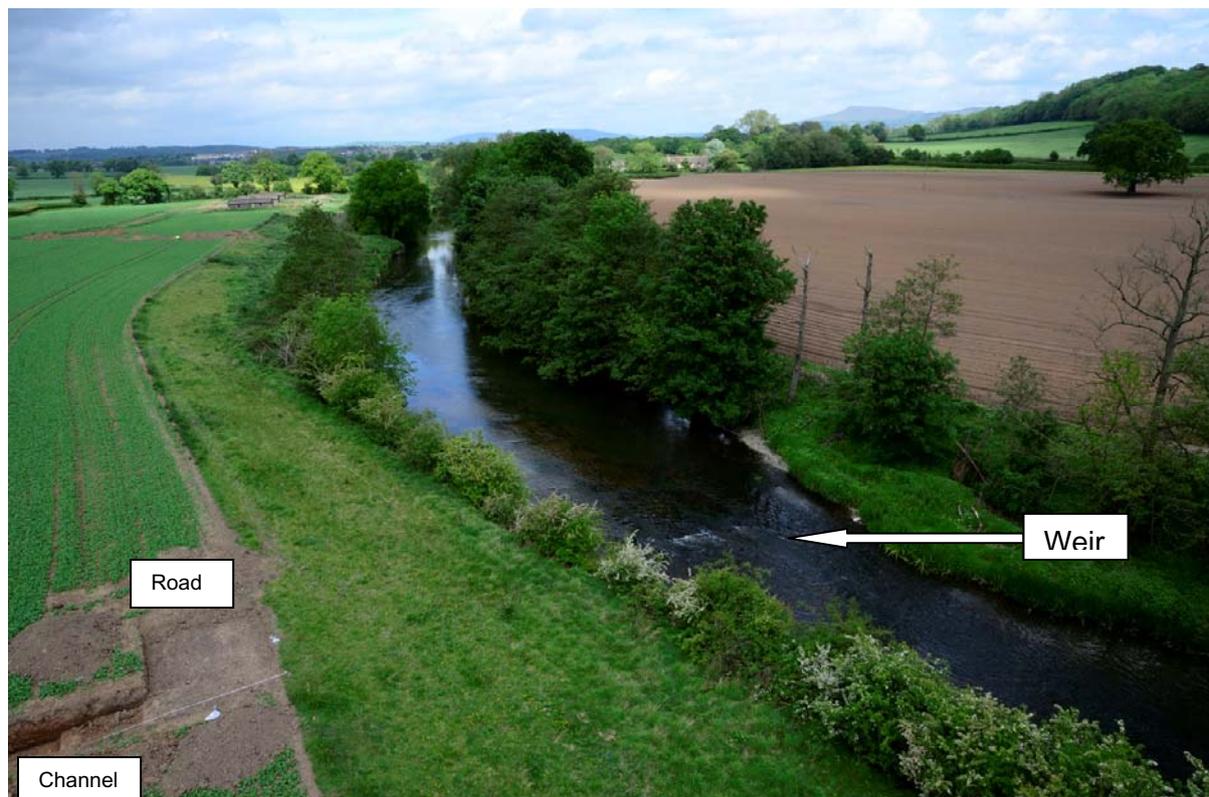
Figure 26
Aerial view showing possible weir in River Teme; old road in Trench 3 in foreground

In Trench 2 and 3 a large water channel and a series of undulations were recorded, and the road was found to have been constructed over the in-filled channel showing that this water feature was from an earlier period. In addition another water feature (a drainage ditch) was discovered in Trench 1 running towards the stream on the southern boundary, and within this trench a zone of slightly higher and dryer natural geology could possibly indicate the line the trackway (Queb Lane) that might have been part of a prehistoric route¹⁰. This putative prehistoric route would have crossed the Teme adjacent to the southeastern extremity of the site, opposite Saltmoor Well. The maps shown in Figures 24 and 25 record the fact that much of the land adjacent to the river was used as meadows, and the interpretation for the undulations seen in Trench 2 is that these were some form of water management feature to enhance the meadow-land; this activity was developed during the 16th – 18th centuries and was an agricultural improvement for sheep and corn farming¹¹. The channel could have been designed to supply the water meadows, but its substantial size could suggest another possibility as a leat supplying a watermill. The name Byletts has been found in connection with mills elsewhere in Shropshire and a feature in the River Teme half-way along the eastern boundary of the site, looked like a possible weir (Figure 26), perhaps for deflecting water into the channel, and effectively creating an “island” in the southeastern part of the site. Whatever its function, the most likely date for the channel is medieval or post-medieval.

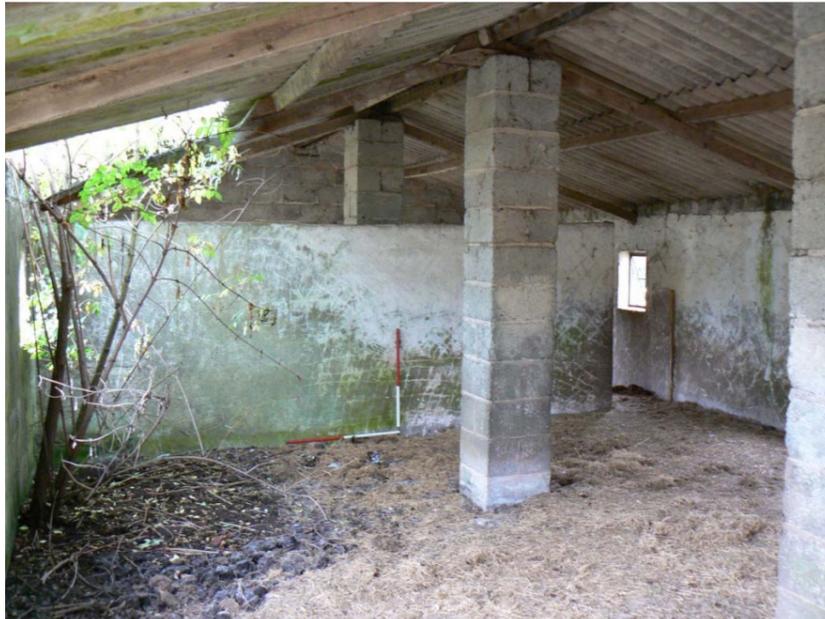
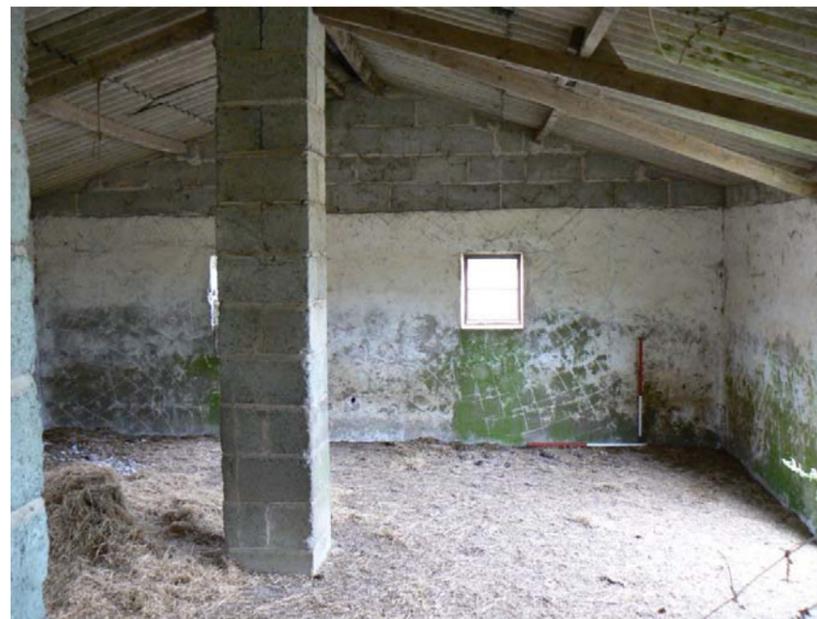
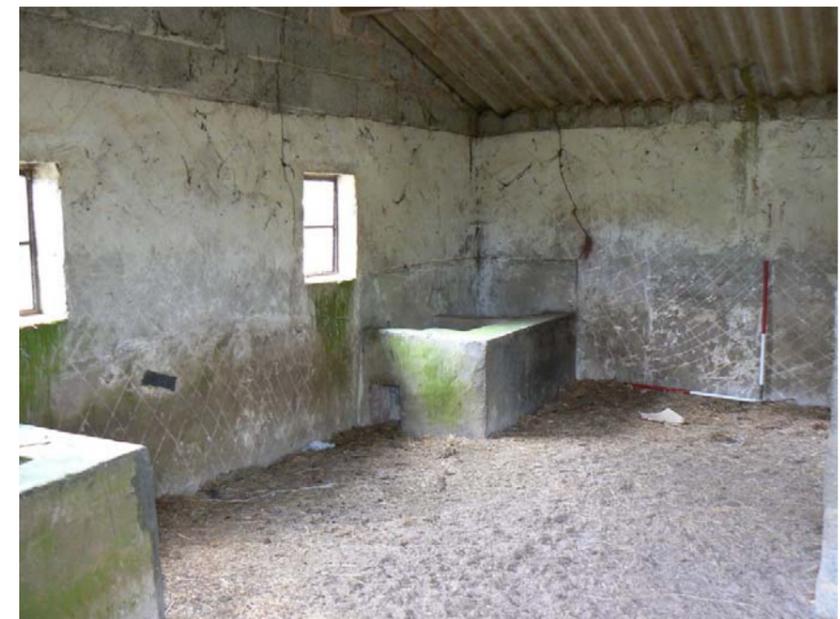
Top: Hut 1 interior shots: a) Northwestern room facing SW; b) northwest end looking NW; c) southeastern room with sinks in situ looking SE

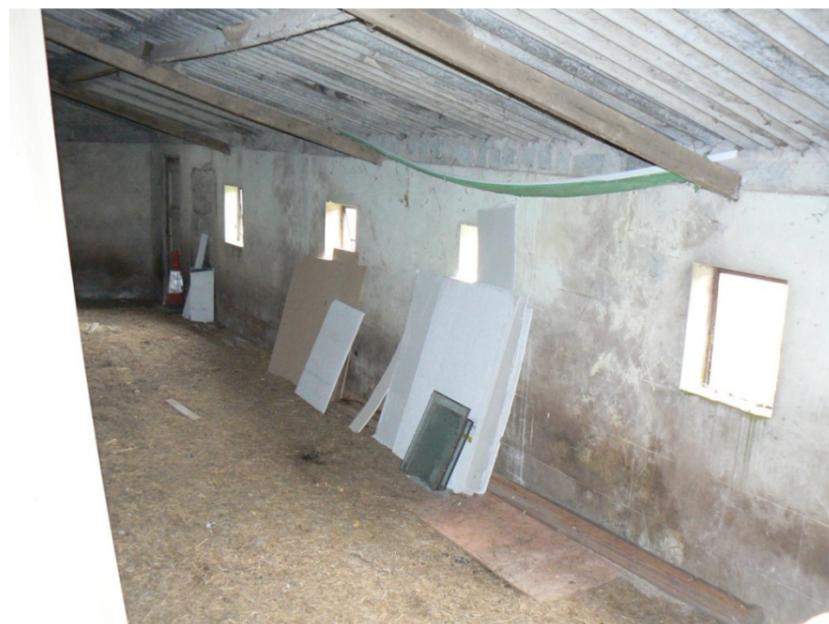
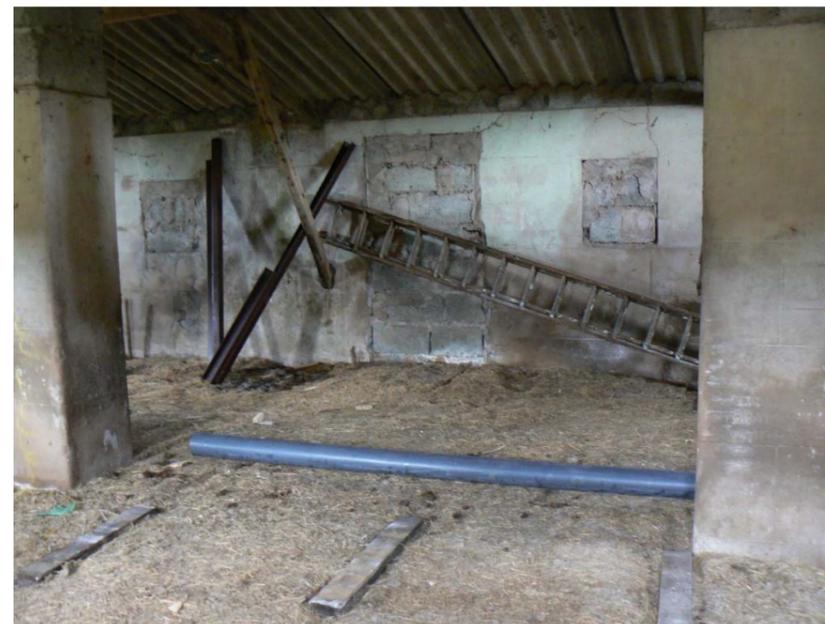
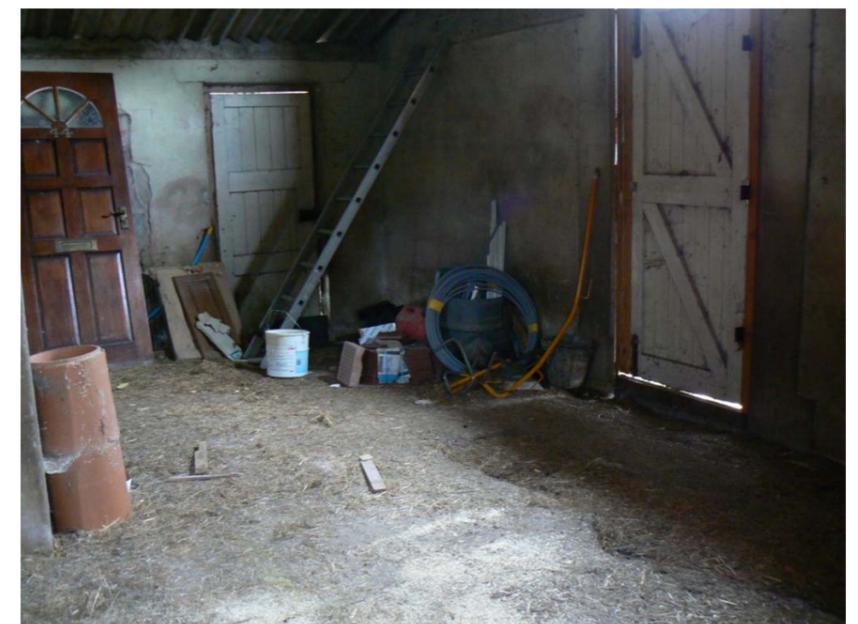
Base: Hut 2 interior shots: a) northwestern wall looking N; b) centre southwestern wall looking S; c) southwest corner and west wall looking S

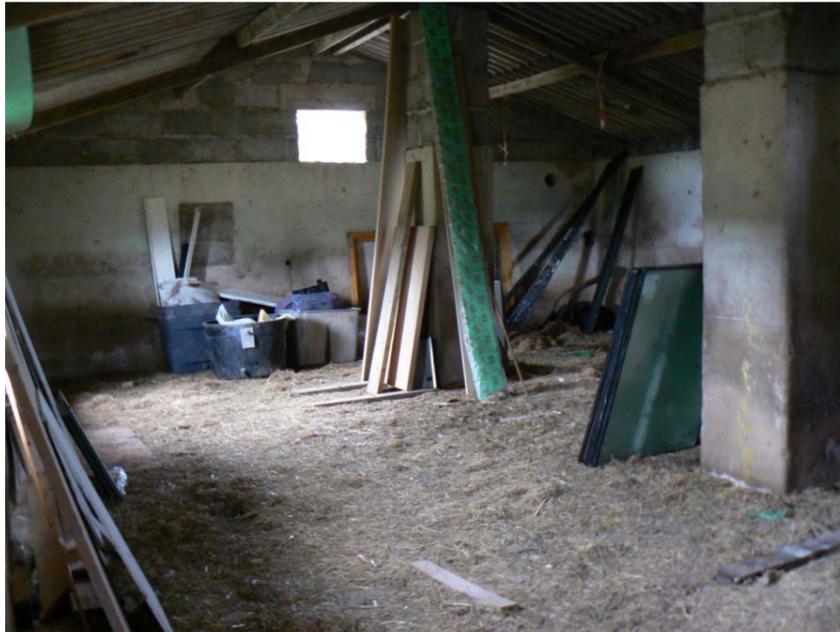
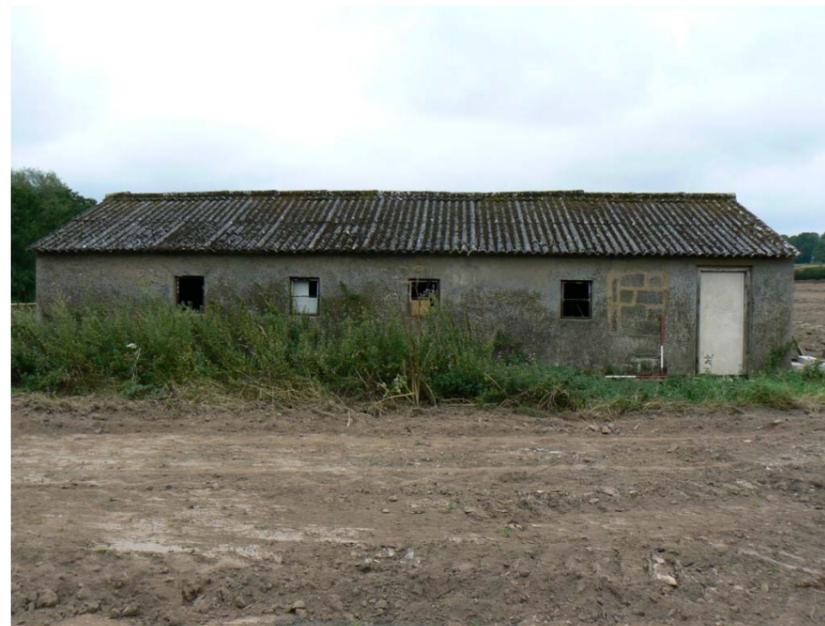
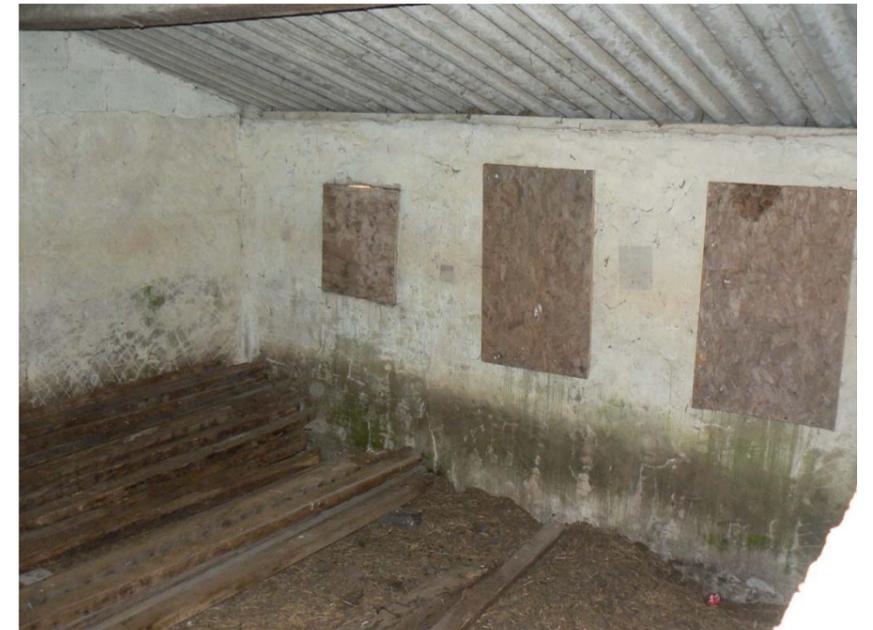
Top: a) Hut 2 southeastern interior facing SE; b) Hut 2 northeastern elevation facing SW; c) Hut 3 interior northwestern room facing N;

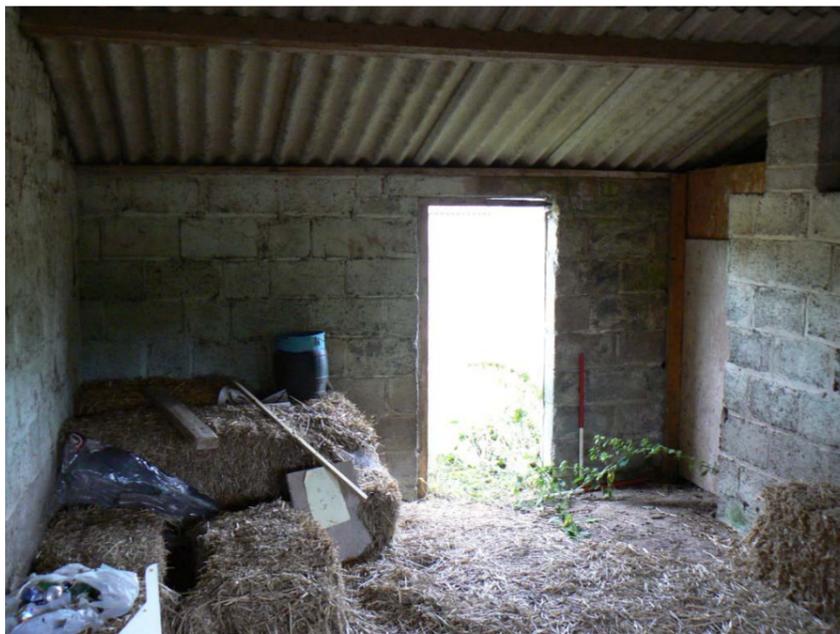
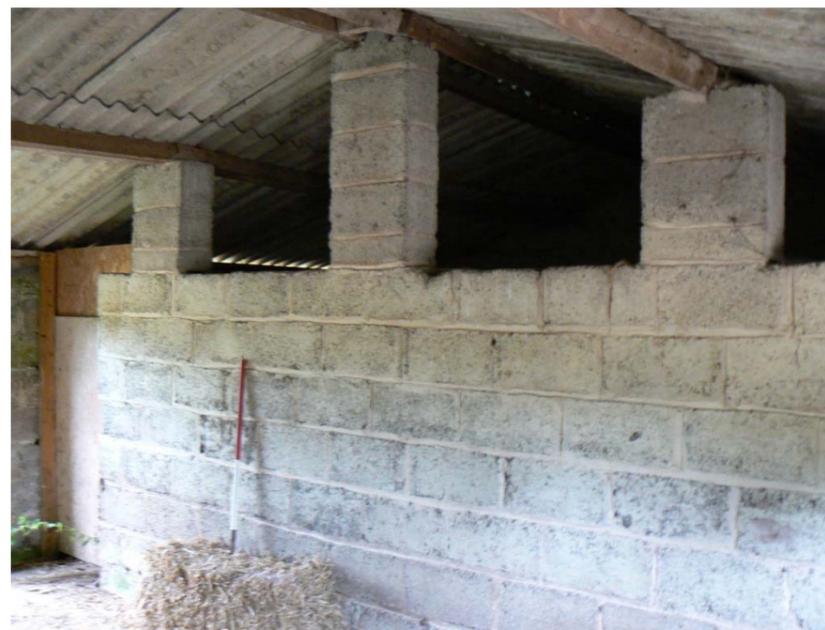
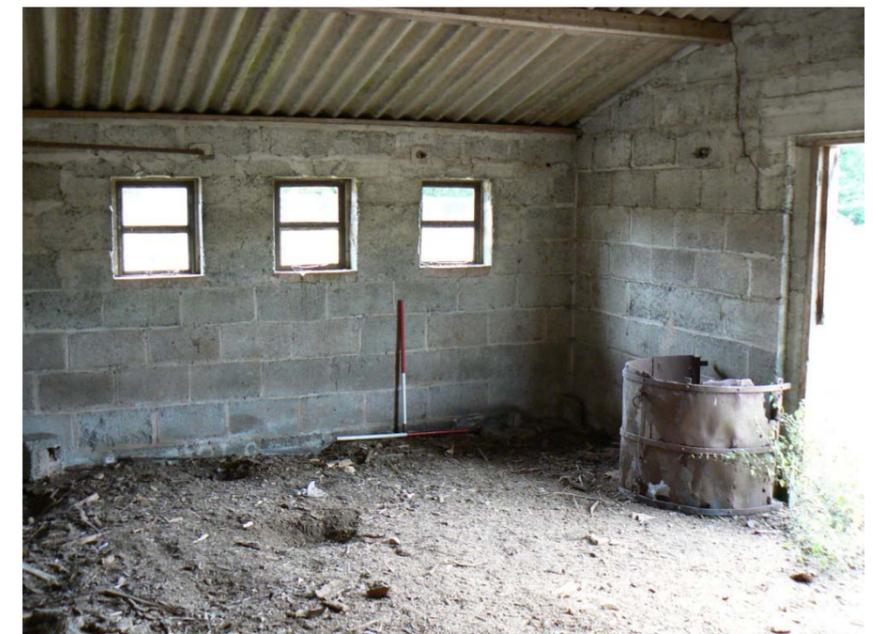
Base Hut 3 interior: a) middle room facing SW; b) southeastern room facing W showing partition wall; c) Hut 3 southeastern room interior facing E;

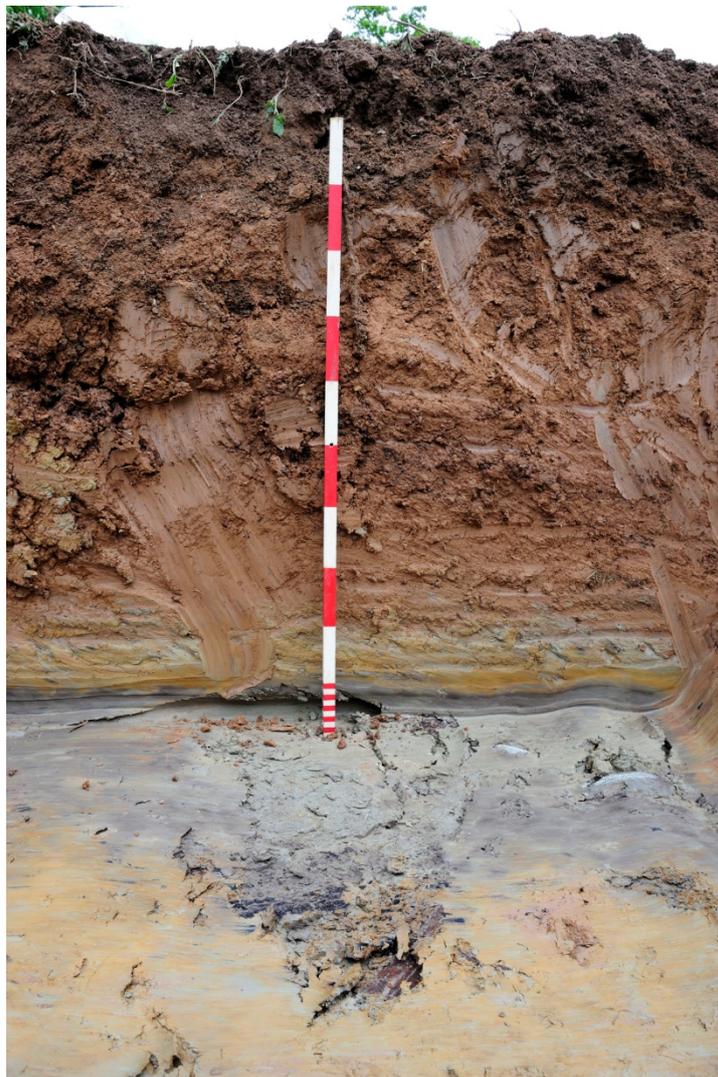
Plate 1: Trench 4 alluvial and colluvial deposits

The trench was more water-logged than the other trenches, which was perhaps surprising, considering its greater distance from the Teme. The organic layer (403) was sampled (samples 1,2, 3) and assessment of these remains has shown that they all derived from ash charcoal, suggesting an activity surface preserved between the alluvium and the colluvium (see Appendix 3).
