**The Titterstone Cleve Hill Radar Station,
Shropshire**

Watching Brief Report

**September 2007
SLR Ref: 406.1805.00001**

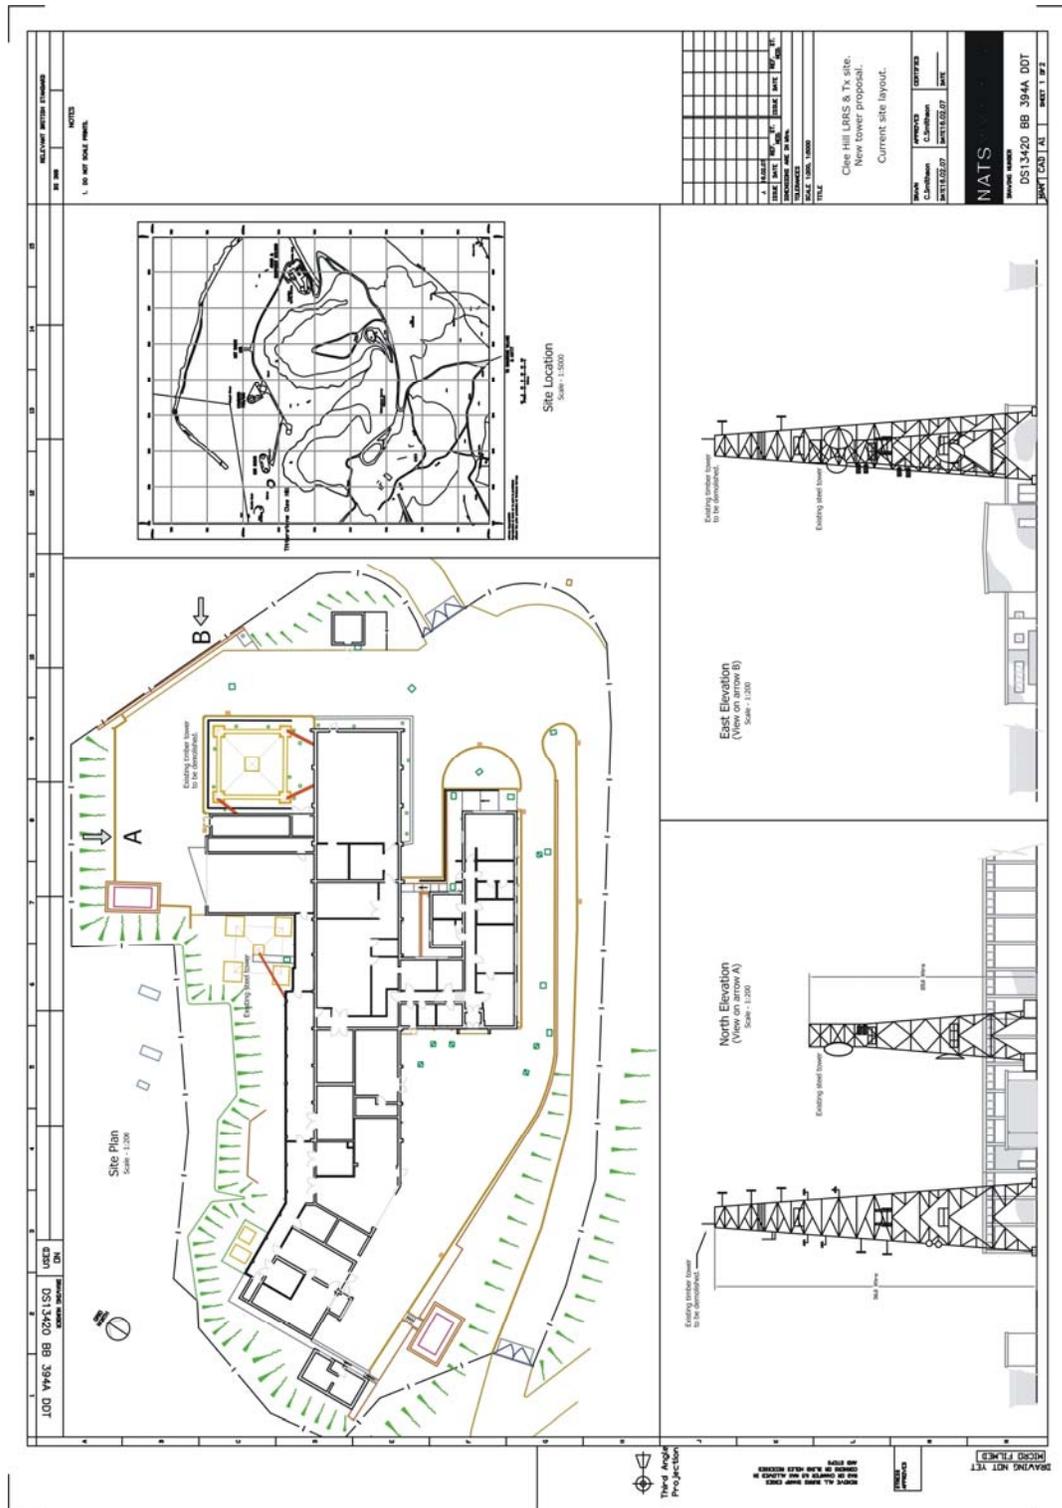
Figure 1

Existing and proposed plans for a replacement mast showing location of the site in relation to Clee Hill (Produce courtesy of NATS).

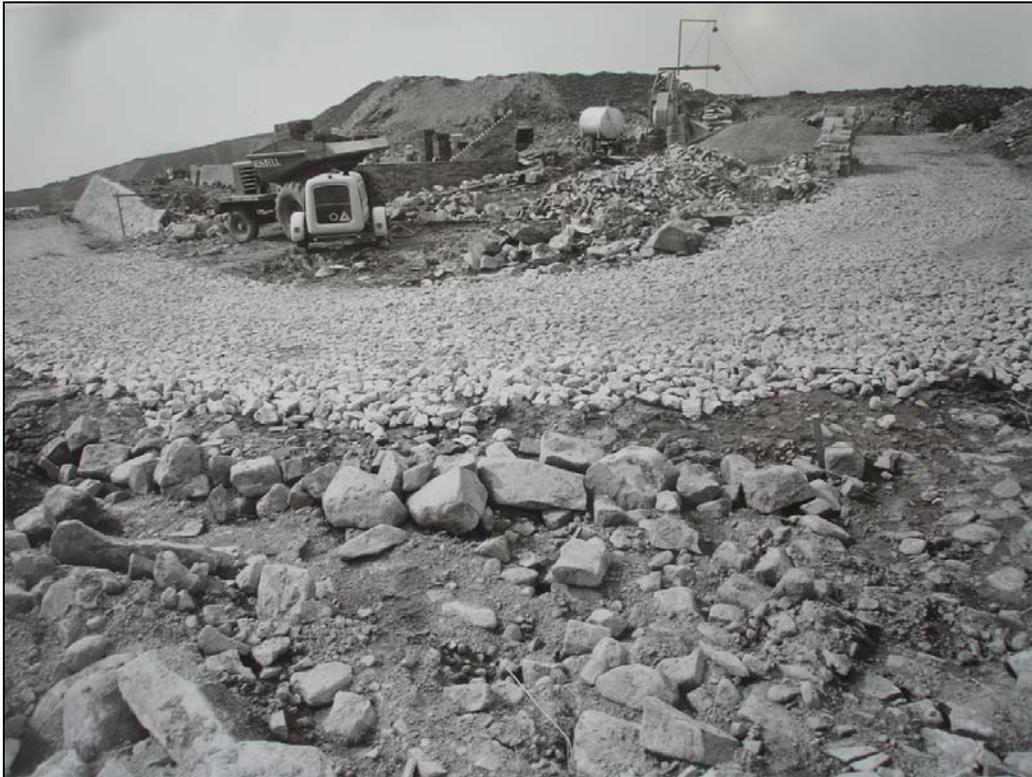
Figure 2

The site prior to the construction of the CAA radar station, looking SE (taken 12 September 1963)

The site for the mast constructed later in 1968 is to the right of the picture. Note probable cairn belonging to the rampart in the foreground (Courtesy of NATS).

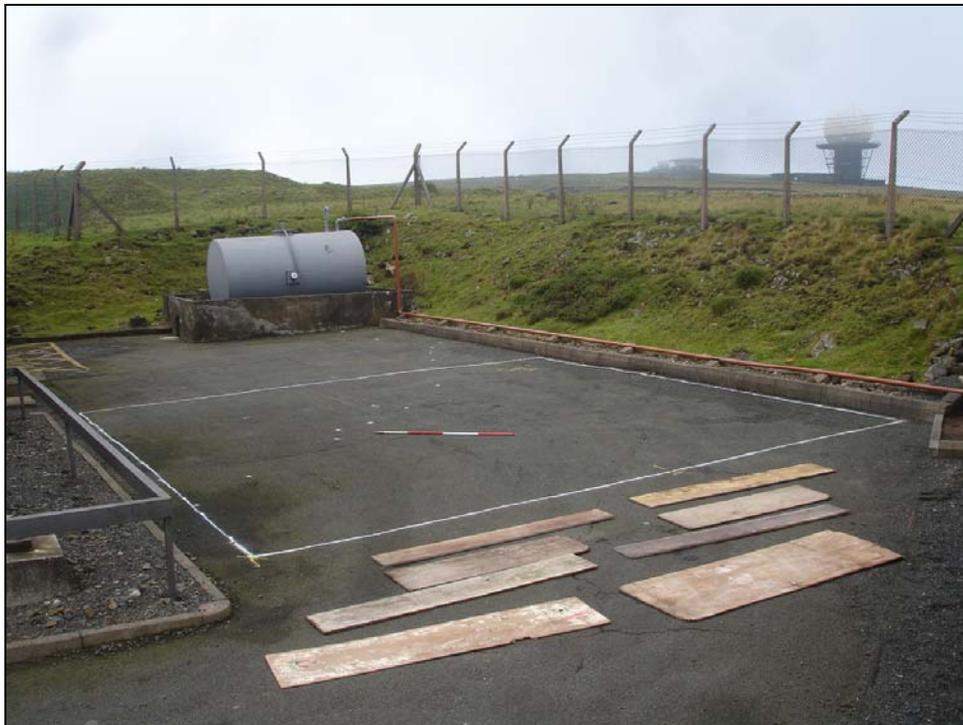
Figure 5

The extent of the trench prior to excavation, looking SW.

The proposed development included the excavation of a large trench located within the NW section of the Radar station site. The ground works phase was undertaken in two stages and comprised the excavation of a trench measuring 9m x 9m, located immediately NW of the present wooden mast (Plate 2). The depth of excavation was 2.5m below the present ground level of the rear parking space.

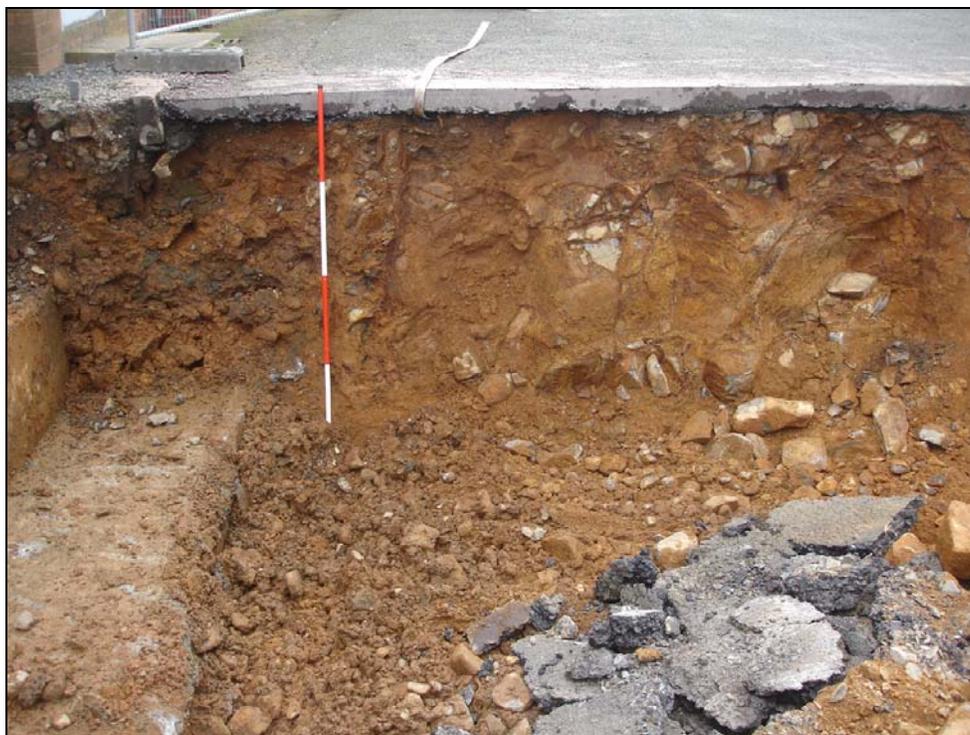
Figure 6
Image showing the stratigraphy of the trench, looking SW.

The watching brief in section recorded three contexts: a tarmac surface measuring approximately 0.05m in thickness (Plate 2). Underlying this was a sub-base material measuring a further 0.05m. Both contexts extended into all sections of the trench. Recorded within the SW and NE trench section and running across the trench was a ceramic drain pipe. This pipe, laid into the sub-base material carried a copper earth strip across this section of the station. Immediately underlying the sub-base material and extending into all sections of the trench was igneous bedrock.

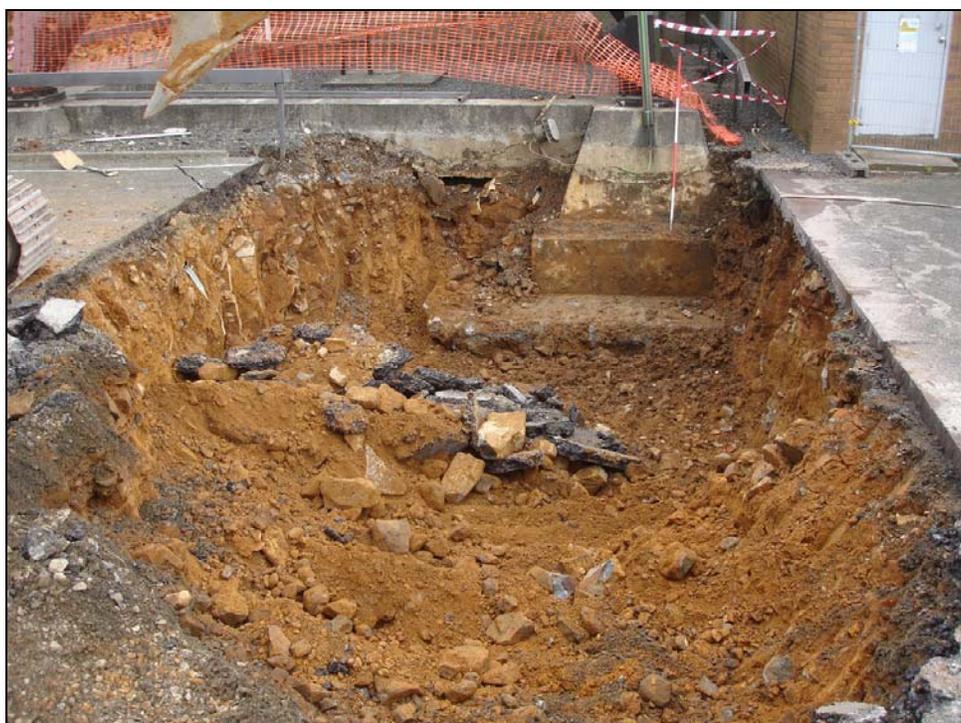
Figure 7
Southern section of the trench revealing the stanchion base of the mast, looking east.

Located within the SE section of trench were two large concrete block stanchions that provided the stability and rigidity of the current mast (Plates 3 & 4). The concrete stanchions, extending to a depth of 2.5m below the present ground level were constructed in 1968. The construction trench for these stanchions was recorded within the SW and NE corners of the trench.

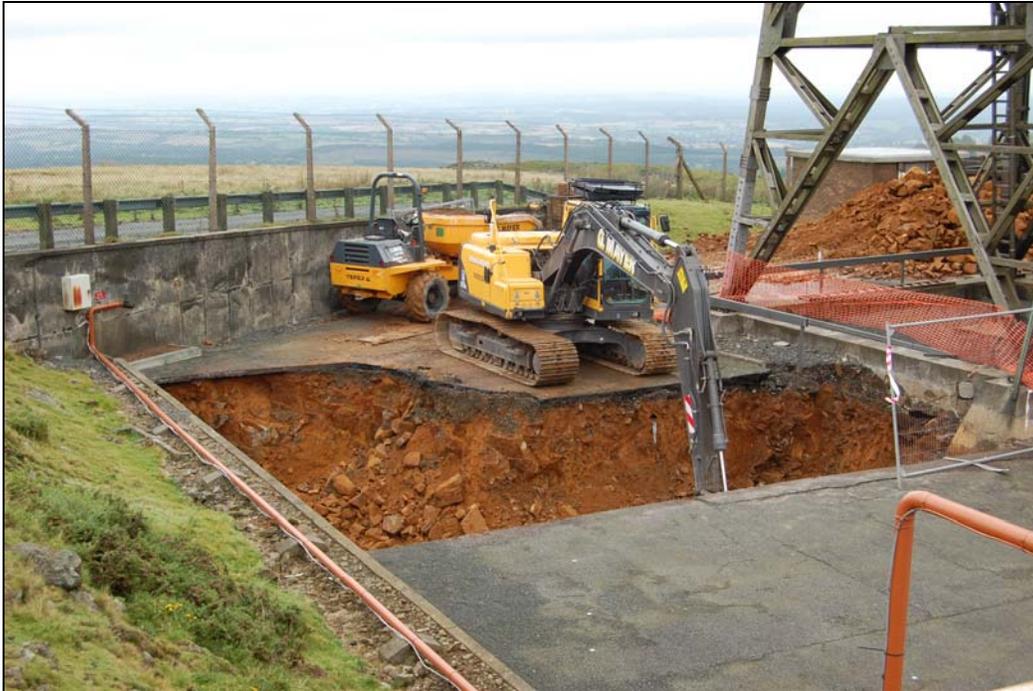
Figure 8

Final excavation phase showing trench proximity to the current mast base, looking NE.
