British Waterways
Archaeological Works
2005/2006

Bowling Canal Basin
Project: BW-6779-05-01

Archaeological Monitoring
Dec 2005 – Jan 2006

Project Description Archaeological Monitoring and Excavation at Bowling Canal Basin during refurbishment works affecting the Scheduled Area

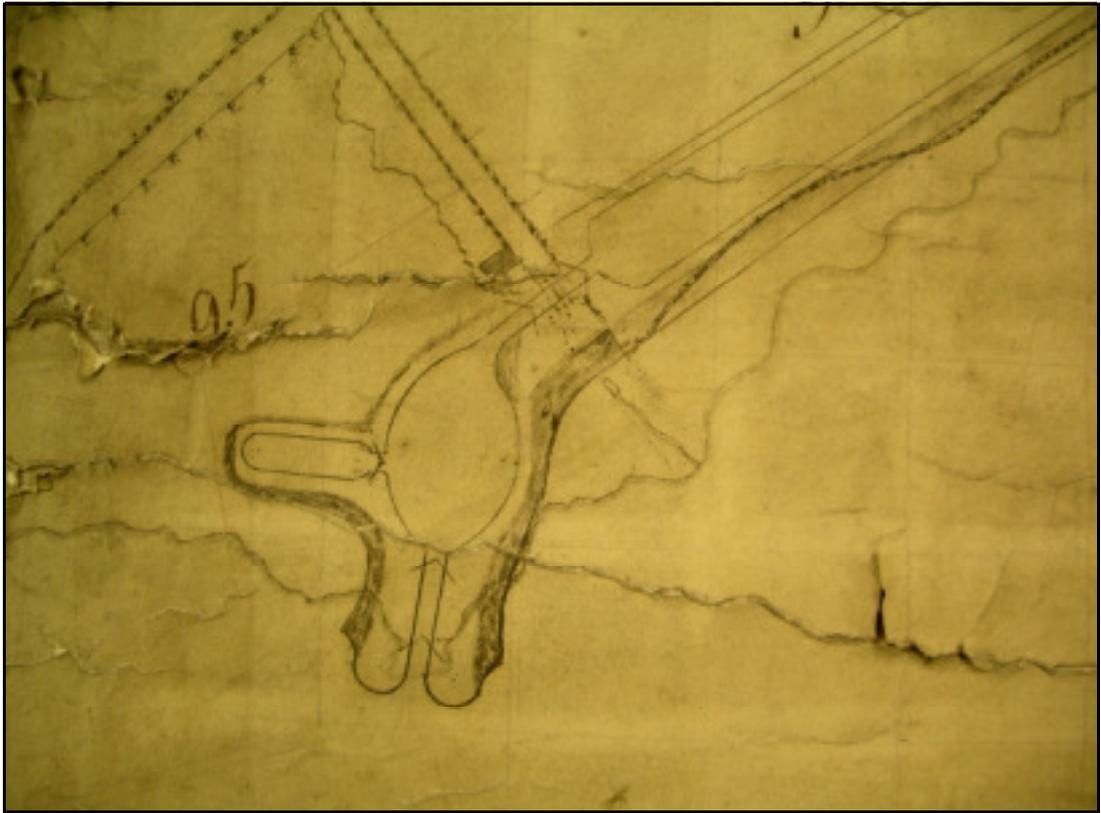
Fig. 3 *Plan of whole canal as finished. 1790 (CHP P9)*

This plan shows the terminus of the canal with the original ovoid basin (NE to top). A dry dock (lock gate depicted) extends to the north-west. The only building shown on this detail is the Collector's House/ Custom House, without its rear wing. The shading alongside the canal may indicate embanking.

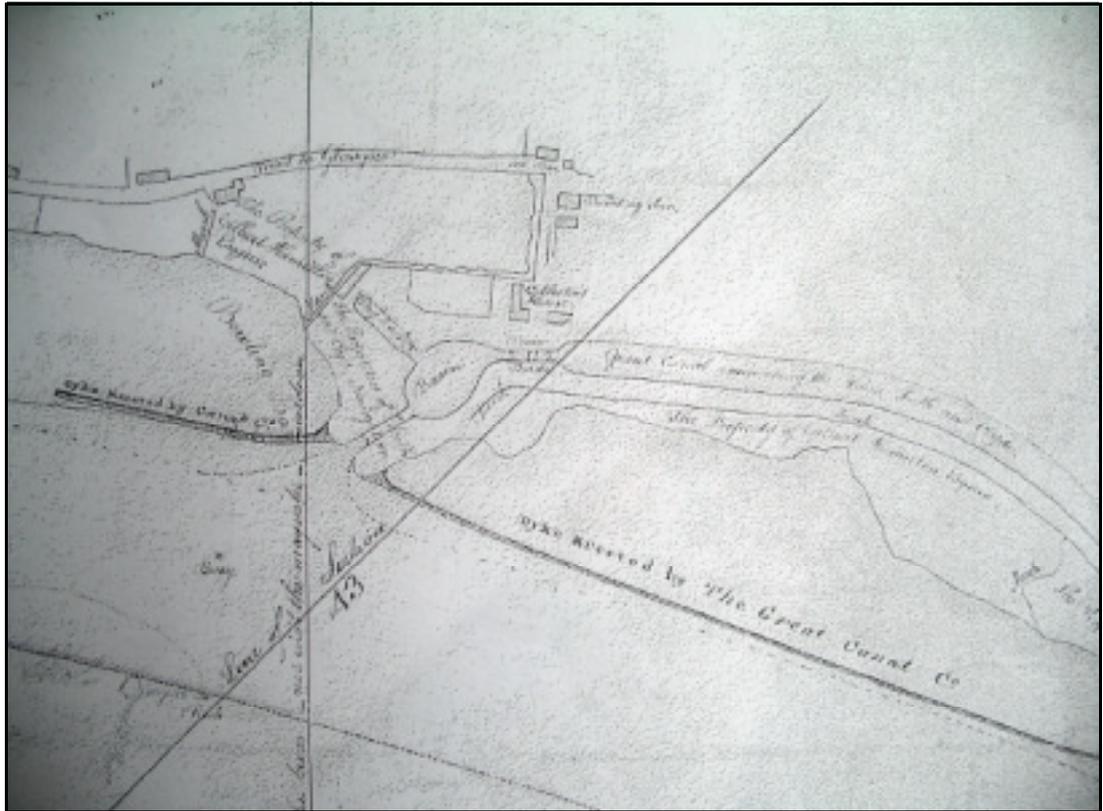
Fig. 4 Plan of the River Clyde illustrating improvements to navigation and giving details of frontages, from the River Cart to Bowling Bay 1808. NAS RHP2859

A plan of 1808 (NAS RHP2860) shows the basin with a lock at its entry from the river and another, with draw bridge, immediately its north. A dry dock, 40 feet wide, is shown projecting 132 feet north-west from the basin at right angles to the line of the first lock. A burn, marked as a 'March' or boundary, is shown flowing southwards towards the 'Collector's House' where it turns at a right towards the west then turning again into Bowling Bay. Two dykes are shown as 'erected by the Canal Co' running parallel with the river from near the mouth of the canal. One dyke to the east cut the whole distance across the small bay which existed to the east of the canal basin, with a small outlet to the river near its eastern end. It defines the approximate line of the present foreshore. A shorter dyke extended westwards from the mouth of the canal following the line of the present pier. Frisky House is shown to the west of Bowling Bay. Another plan of 1808 (NAS RHP 2859) shows the same details. A plan of 1830 (NAS RHP is identical, but omits the dykes.

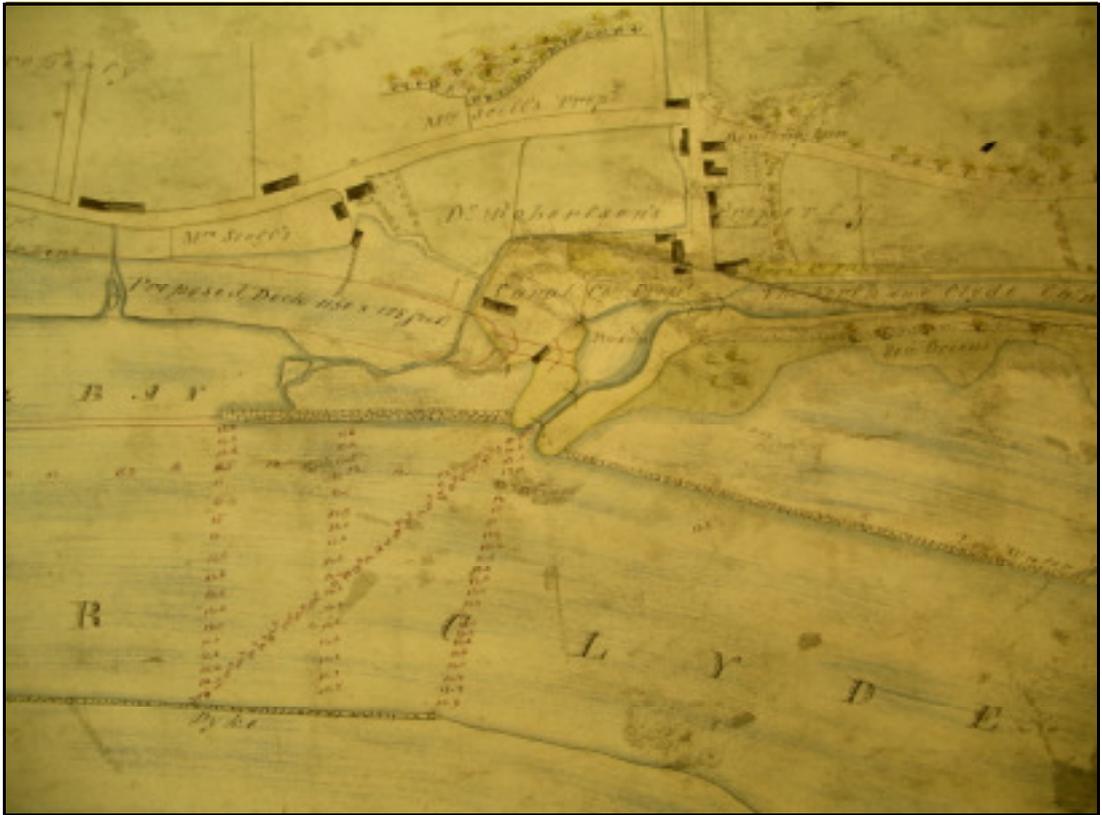
Fig. 5 *Plan for Proposed Docks 1800. (CHP P130)*

Soon after the construction of the canal, there was a demand for more docks. This plan shows a proposed dock, drawn over the existing arrangement. The later shows the extent of the foreshore at that date, reclamation being limited to the area immediately surrounding the canal basin. The burn is shown as draining into the present harbour. The dyke on the site of the present pier can be seen, extending west near the canal lock. The plan shows another dyke to the east, along the line of the present shore, with unclaimed land behind.

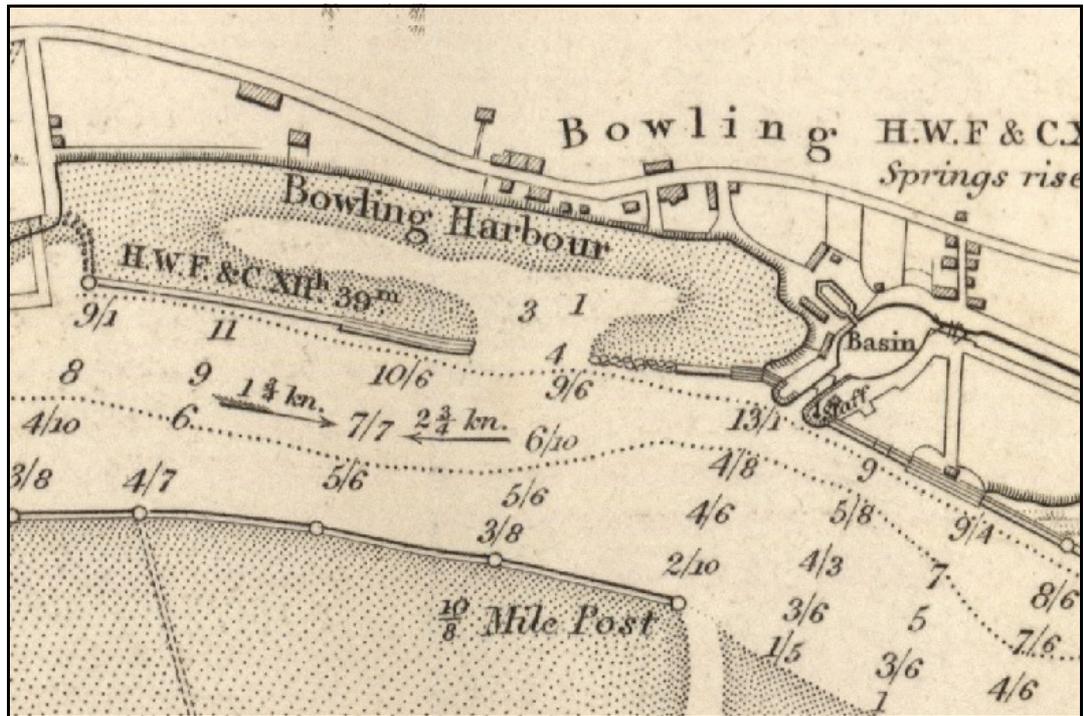
Fig. 6 River Clyde from Dumbarton to Glasgow. Hydrographic Office, London, surveyed 1846, published 1850. NLS Admiralty Chart 2007.

This shows the basin unexpanded and the harbour in its undeveloped state. The depiction of the pier would seem to indicate three different types of construction, the outermost shown as a line of rubble.

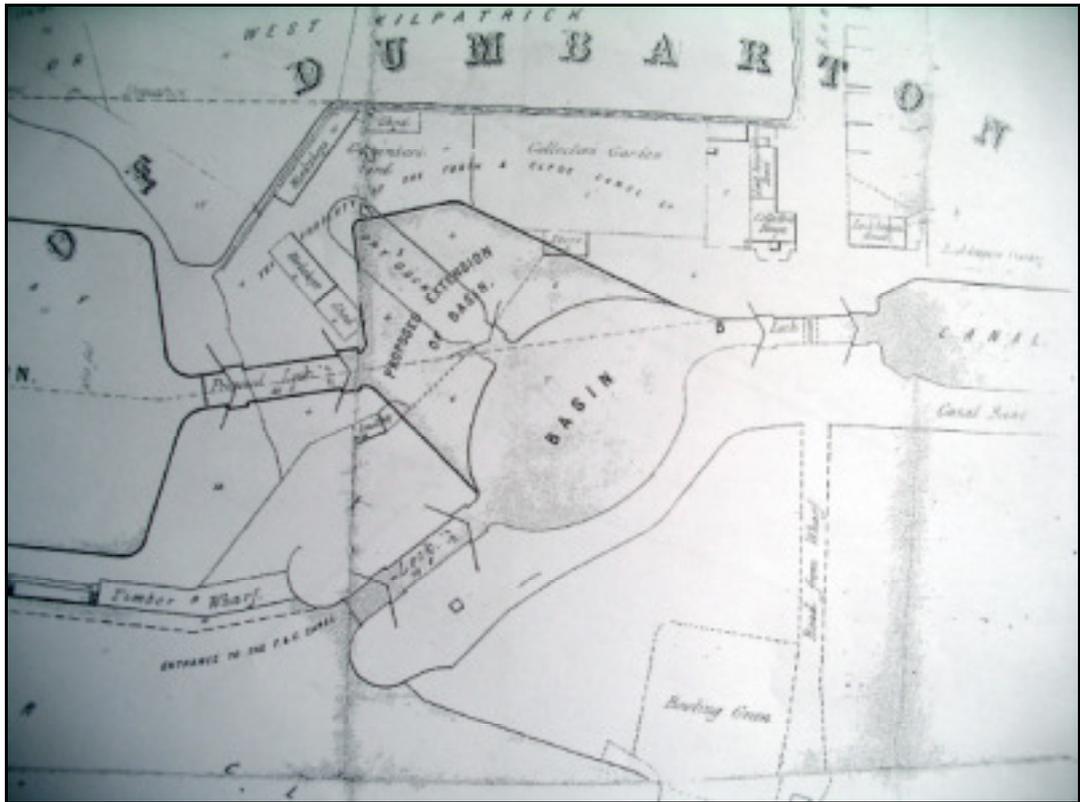
Fig. 7 *Plan of Bowling Bay with proposed improvements for Better Accommodation of the Trade of the Forth and Clyde Canal, 1845. NAS RHP 2637.*

This proposal established the basic form of the present layout. The canal basin was to be extended to the north-west, over most of the length of the dry dock. Another lock leads westwards from this extended basin into a larger basin, approximating to the present harbour. A new quay wall, 500 feet long, was to be created on the north side of this basin, approximately 80 feet to the south of the previous foreshore. Sections show that this quay wall was proposed to be 13 feet in height and rising from just below low water, below which it is shown as supported on three piles, extending down a further 15 feet to below the level of the bottom of the river. It was proposed to enclose the southern, or river, side with a new timber wharf (another timber wharf appears already to have been erected to the west by the Clyde Trustees). This new wharf was to rise 6 feet above high water. It was based on long outer piles, about 28 feet in length and a shorter central pile, 12 feet in length, which extended through the centre of the former dyke to the low water mark. The surface within the basin was to be lowered around 8 feet thus creating a harbour from what had been a tidal mudflat within the confines of the dyke.

This would seem to be a variant on a plan of 1845, illustrated above (NAS RHP 2637).

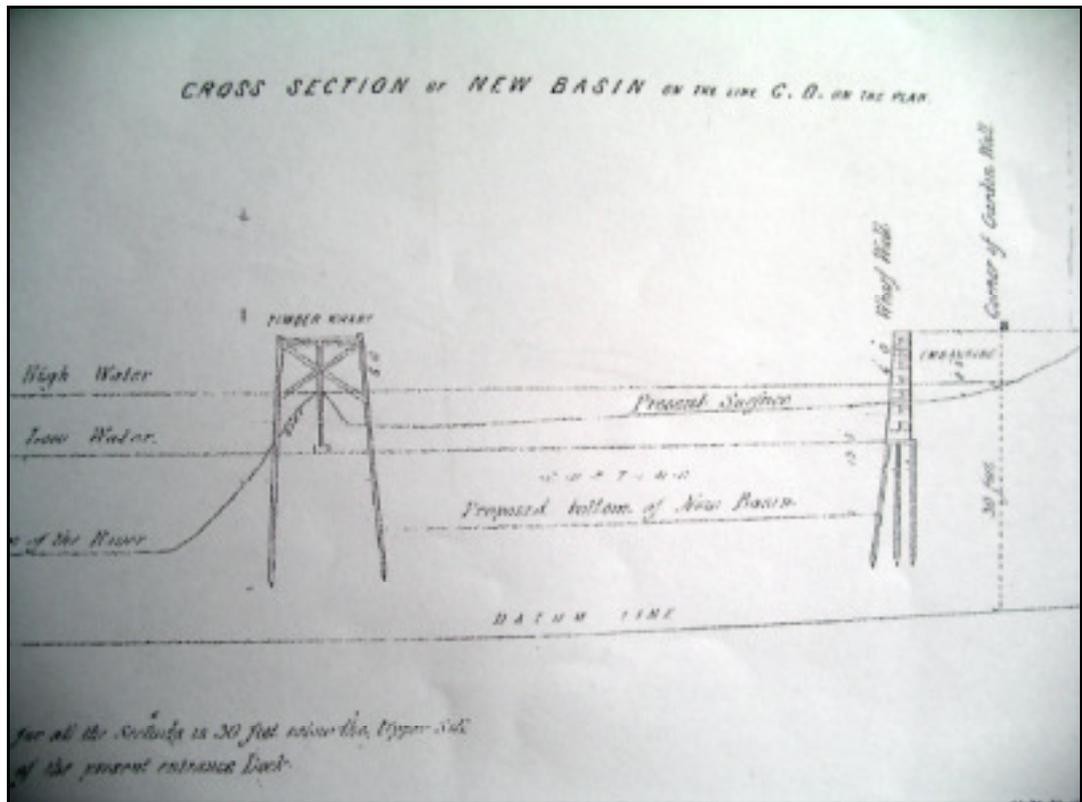
Fig. 8 Detail of *Plan of Bowling Bay with proposed improvements for better accommodation to the trade of the Forth and Clyde Canal 1845*. NAS RHP2637.

Cross section of New Basin.

The pier/warf at the harbour entrance is shown as a timber platform on piles, which are based on a dyke. The proposed construction of the northern edge of the harbour consisted of a masonry wharf wall, resting on piles below low water, and with embanking behind.

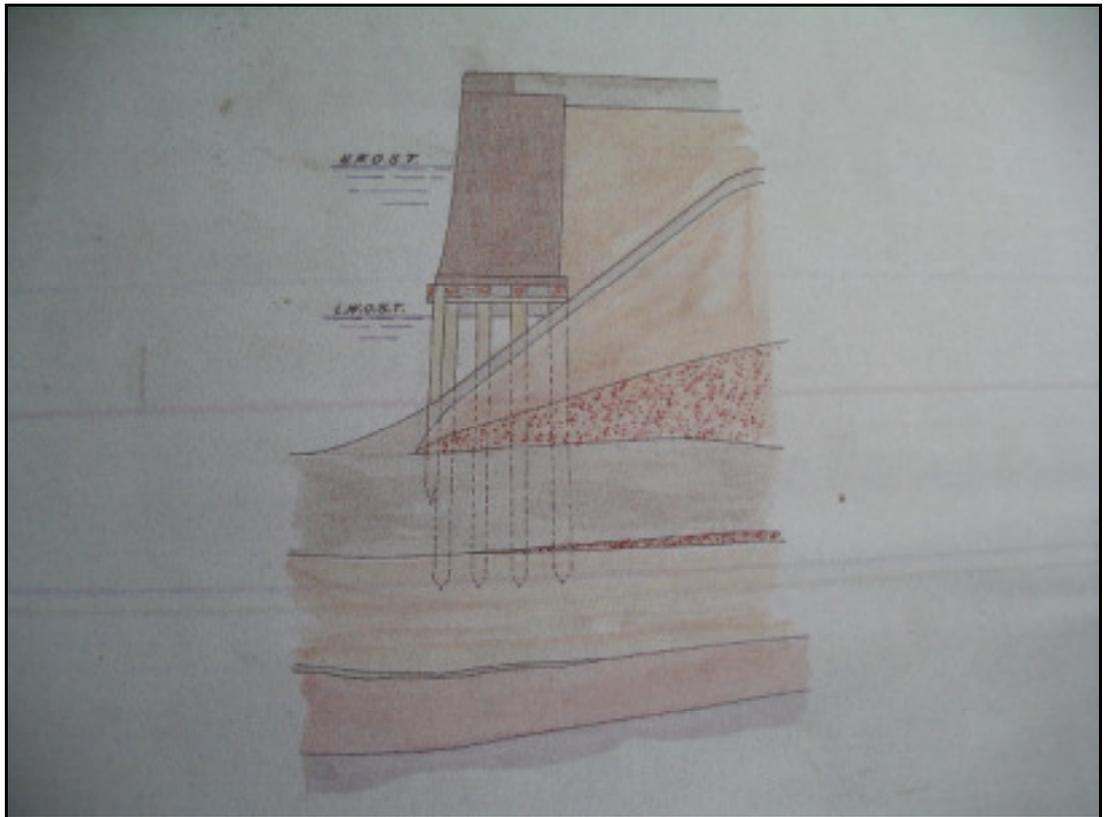
Fig. 9 *Caledonian Railway. Bowling Harbour. Plan and Cross Sections of Quay Wall. February 1901. NAS RHP120695*

Section of existing west end of the wharf prior to proposed improvements with new quay walls and cylinders. This appears to show the quay wall as constructed in the mid nineteenth century.

These show details of the proposed rebuilding of the north wharf of the harbour. Details of bores alongside the wharf show c 6m of sand and gravel over boulder clay at the west. The sand and gravel was deeper at the east end, with 12m over the boulder clay.

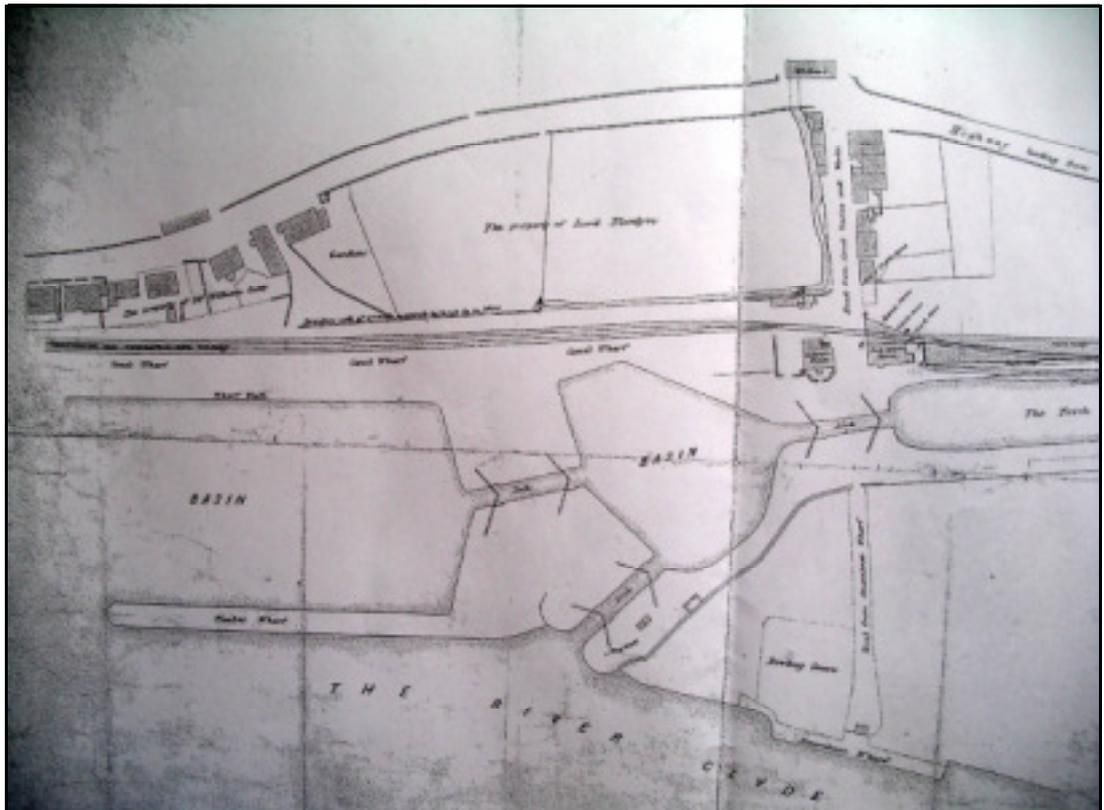
Fig. 11 *Plan of the Basin of Forth and Clyde Canal at Bowling 1850. NAS RHP105.*

This plan of 1850 shows the first impact of the coming of the railways on Bowling. The line of the Caledonian and Dumbartonshire Railway runs north of the harbour basin, immediately north of the 'Collector's House' (Custom House) to the north bank of the canal. In 1850 Caledonian and Dumbartonshire Railway opened from Bowling to Balloch, with steamer connections at each end.

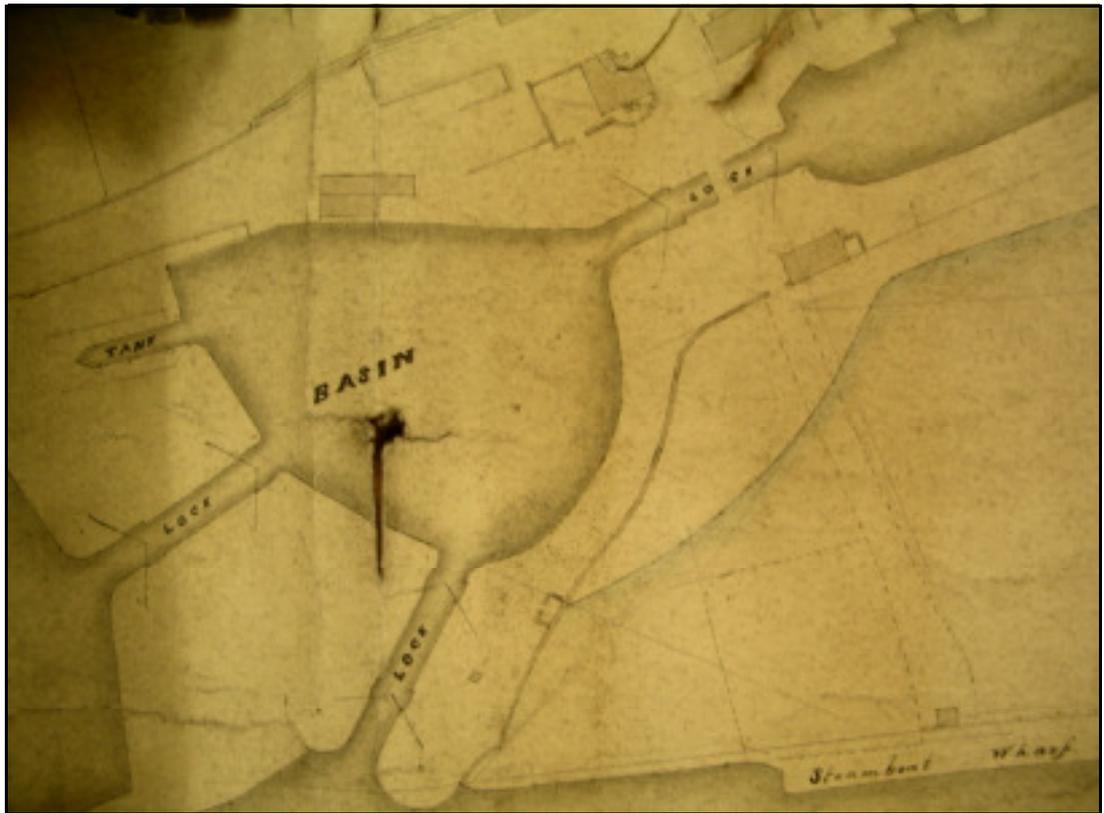
Fig. 12 CHP P504 Plan for Bowling Basin. Undated.

The details are simplified on this plan. Although it shows no railway, it marks the probable engine house on the north side of the basin, as on the OS 1857-61 plan. It shows one a dry dock to the NW of the basin, not two as on the OS plan, so is likely to be earlier than 1857-61. Collector's House with a lock keepers house behind and another across the road to the E- Road leads to a bridge, possibly a bascule that then continues to a wharf to the S. Large garden and various outbuildings- Bowling harbour not constructed.

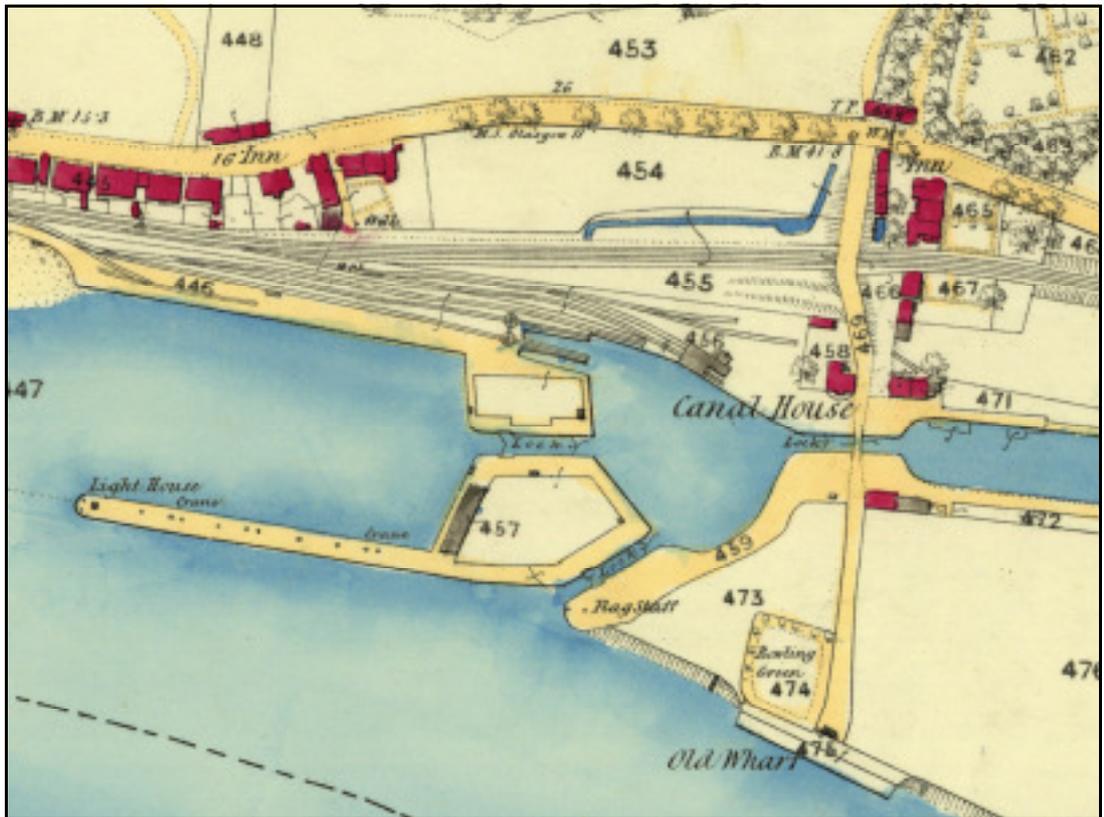
Fig. 13 OS 1:2500 Dumbartonshire XXII.12. Surveyed 1857-61

This shows two docks extending west from the canal basin. This and the north side of the basin are served by a network of railway sidings, some terminating in a possible engine shed. A bowling green is established by the steamer wharf. The road now passes over the main railway on an embankment. The burn is within a culvert before entering the basin.

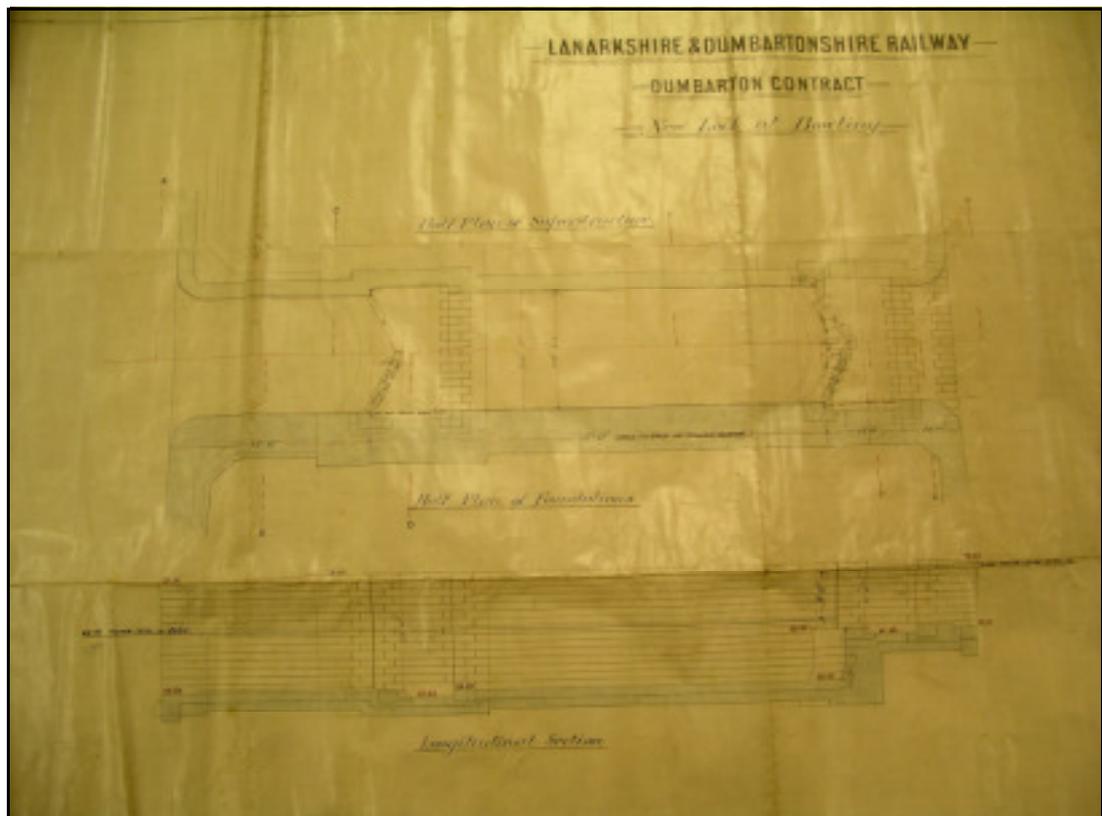
Fig. 14 *Lanarkshire and Dumbartonshire Railway. New Lock at Bowling. CHP116. Half plan and longitudinal section.*

This lock was associated with the building of the line for the Lanarkshire and Dumbartonshire Railway, which travelled on a large swing bridge over the canal. Nine drawings survive showing elevations, plans, sections and details of masonry and steelwork for this swing bridge (NAS RHP1 22184-122192).

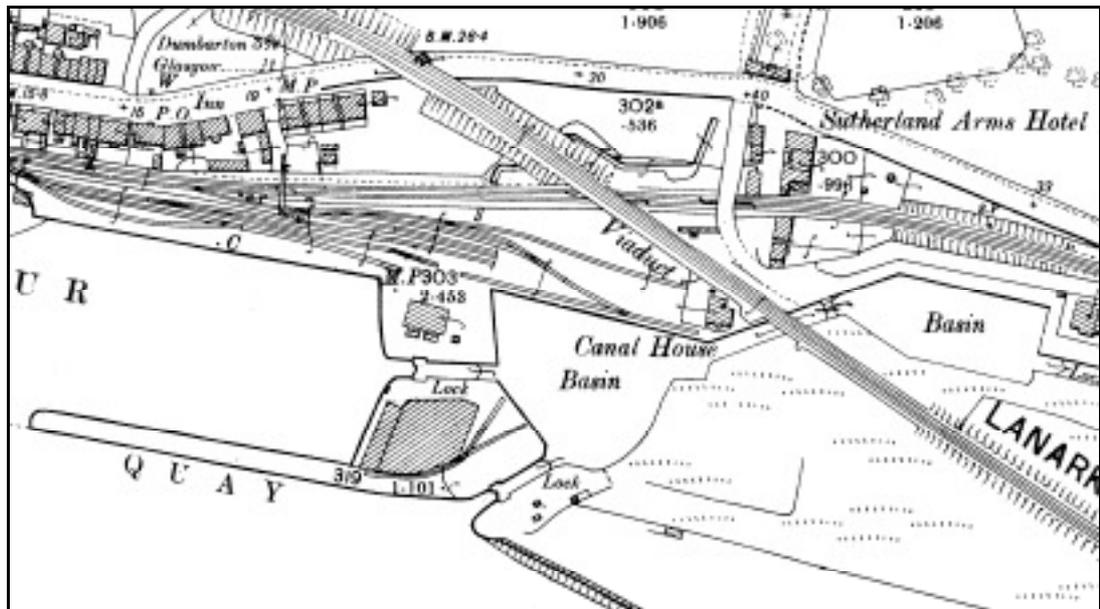
Fig. 15 OS 1:2500 Dunbartonshire XXII.12 1898.

The second canal lock has been removed. The two tanks in the NW corner of the Lower Basin have been filled in and the angle taken out of N Basin edge. New channel dug on NE-SW orientation connecting Upper and Lower basins (now at same water level). Helenslea House and its Lock Built. Land outside Customs House considerably reduced and cut away on SW-NE angle- this removes semicircular feature on S end of Customs House. Customs House no longer entered directly from 1st Floor level- steps built up to it from reduced ground level. Railway Bridge, Swing Bridge and Bascule Bridge added and extension of train tracks on N shore, crossing Swing Bridge to S basin shore. Road N of New Railway Bridge is now diverted to swing E to Helenslea or W under bridge and round to Custom's House – no longer gives access to the Old Wharf and Bowling Green which have become defunct. Replacement of buildings N and S of Lock into Bowling Harbour.

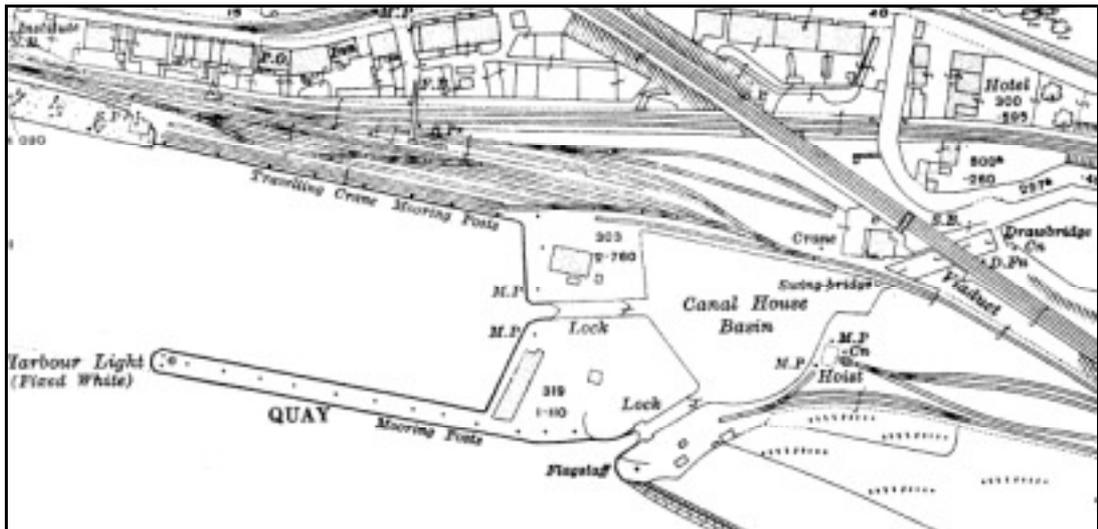
Fig. 16 OS 1:2500 Dumbartonshire XXII.12. 1918.

The railway extends across a swing-bridge to the south of the viaduct. A siding extends to the east side of the basin adjacent to a hoist and crane. There is a travelling crane along the north side of the harbour. Mooring posts line the harbour.

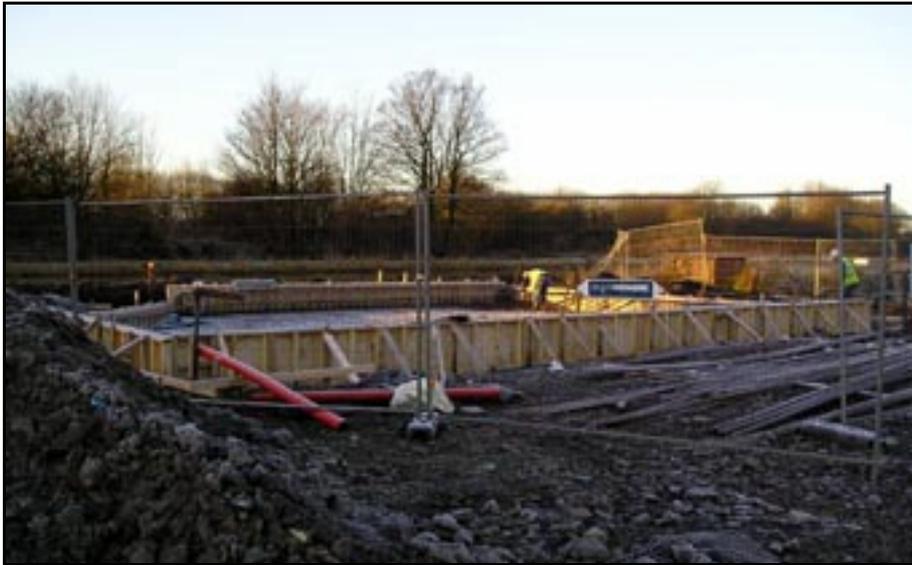
Fig. 17 *Trench 9 Crane Pad*

Trench 9 was a trench for a crane pad 15m long x 12m wide E of Helenslea House. This trench was dug prior to on site archaeological supervision and had been lined with a pvc membrane and had its concrete base poured. It was therefore not possible to make a record of the deposits encountered although the trench looked as if it had been dug, at least partially, through a deposit of material dredged from the canal. A photographic record of these works was taken by British Waterways.

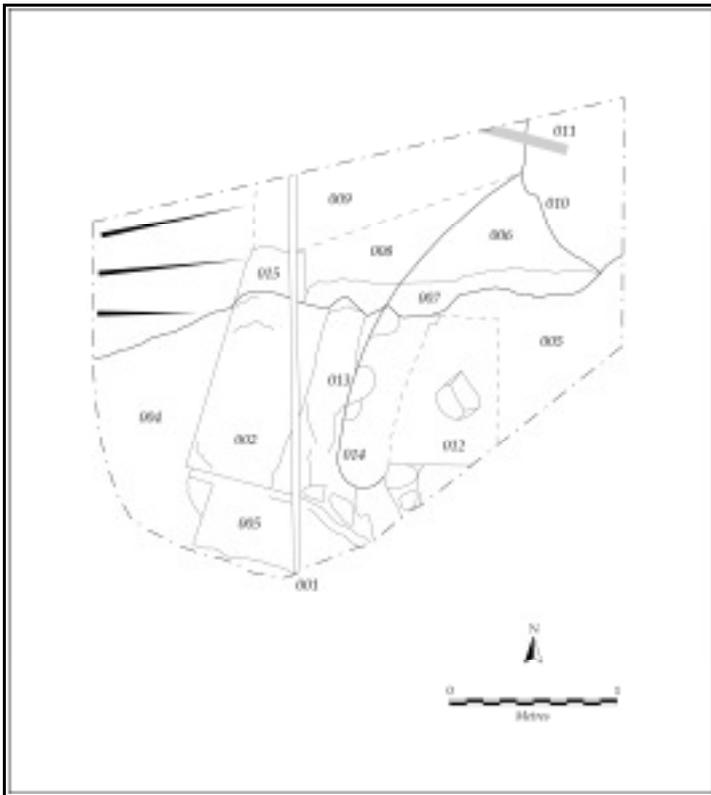
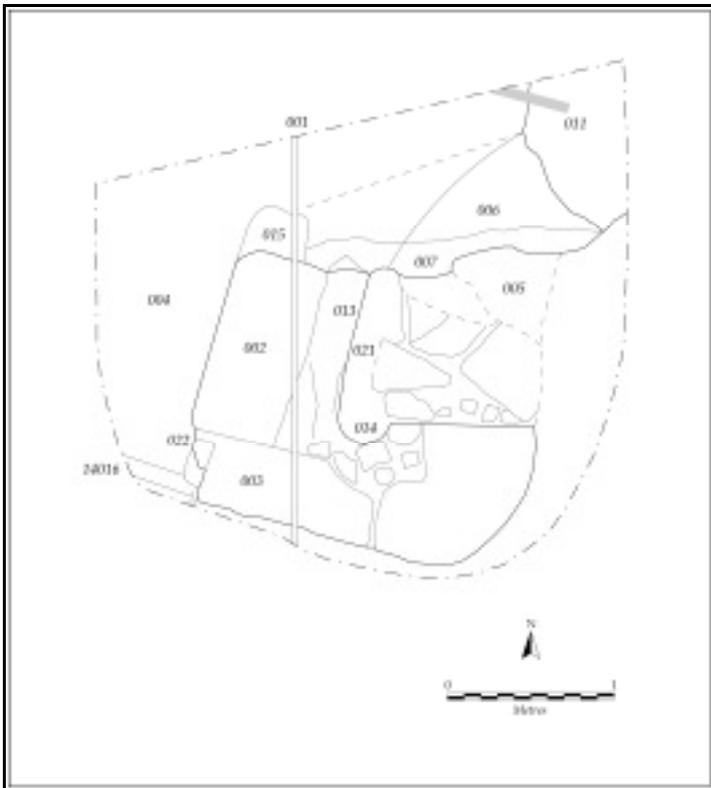
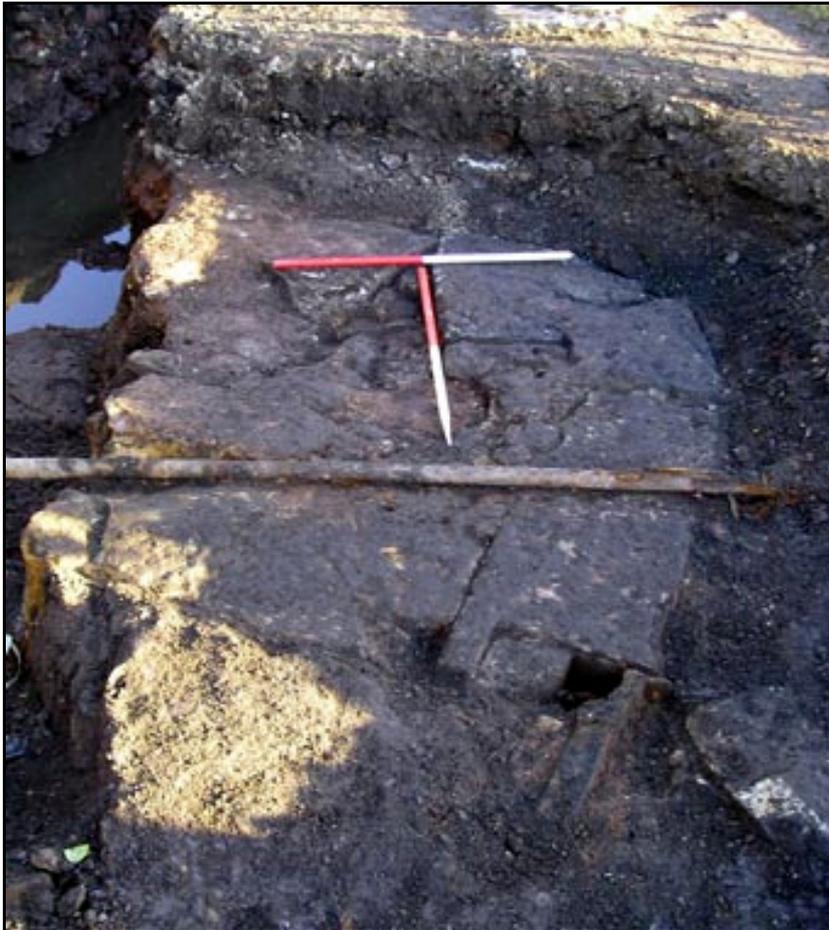
Trench 14 refers to the W extreme of Trench 2 where masonry remains were

encountered and had to be recorded before the sewer pipe trench could proceed. Some masonry was disturbed before it became clear that there was a masonry feature in situ. A 50mm cast iron gas pipe **14001** was also exposed running N-S through the trench and was worked around. Historic Scotland were contacted by British Waterways and permission obtained to expand the trench to try to identify the feature. An area of 3.20m E-W x 2.40m N-S was accordingly exposed. The ground surface consisted of a modern gravelly grit **14019** up to 100mm thick overlying **14018**, a loose dark grey layer up to 250mm thick composed of silt, sandstone rubble and pieces of slate- likely demolition debris from buildings featured on the 1896 plan and now removed. Beneath this was **14020**, a very compact layer of black ash up to 250mm thick overlying a redeposited heavy gritty pink clay **14017** up to 200mm thick. These layers sealed **14002**, a platform composed of mortared blocks of dressed blonde sandstone 2.00m E-W x 1.60m N-S covered to the NE by **14005**, a very compact mottled orange brown layer of gritty sand and sandstone rubble at least 100mm thick- this appeared to be demolition debris and was separated from an almost identical layer **14014** by **14012**, a moderately compact layer of black ash with clay and angular stone inclusions <50mm. This layer was probably the same as **14020** but had been compressed by the blade of the digger. To the W of **14002** was **14004**, a banked up compact layer of dark brown gritty clay at least 360mm deep that appeared to be a post-construction backfill related to the masonry platform. To the SW of Trench 14 was **14003** (part of Masonry Platform **14002**) a blonde sandstone block with a rebated rectangular socket **14022** on its NW corner that appeared to have housed a flattened cast iron leg **14016** 500mm long x 90mm wide x 100mm thick. To the NW of Platform **14002** was a further blonde sandstone block **14015** bonded to **14002** by a greyish-pink cement. This was an in situ part of the masonry that was disturbed by the digger. Platform **14002** sat over a layer of concreted sandstone rubble **14007** at least 300mm thick x 2.20m E-W. This was in turn bedded on **14006**, a curving concrete platform at least 150mm thick with a ragged cut **14010** on its NE edge. This curve was mirrored on Platform **14002** where curved scar **14013** was backfilled by **14005**, **14012** and **14014**. Cut **14010** could not be fully described as it ran into the SE and NW sections however it also cut through the E face of puddle clay **14009**. Banked up against **14007** was a layer of heavy pink clay **14008** with a further layer of grey puddle clay **14009** to the N. These were only observed in plan so dimensions were not established. Overlying clay **14009** was **14011**, a piece of decayed wood 60mm wide x 500mm long E-W with cast iron fixings- it is likely that this was a later backfill.

Fig. 19 *Trench 14 Plan*

Fig. 20 *Trench 14 Plan Overlay*

Fig. 21 *Trench 14 Post-excavation*

It would therefore appear that a substantial feature operated in this location previous to the Lower Basin's realignment in 1896. Puddle clay is used throughout the canal system to seal masonry structures, helping to repel water. The curvature scar and iron fixtures associated with what is a substantial masonry platform infer that it was the basis for some kind of machinery/fitting associated with the 'tanks' noted on both the 1850 and 1863 Basin Plans. Demolition debris associated with the upper layers as well as scar **14010** suggest that machinery and masonry were removed or ripped out and then partially redeposited as part of the 1896 refit.

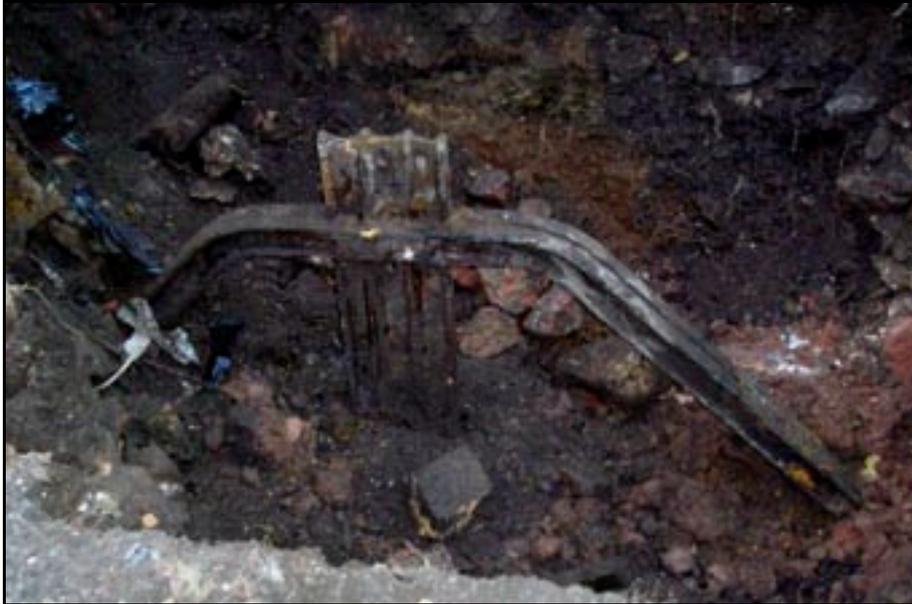
Fig. 17 Trench 15 with exposed buffer

Trench 15 connected the main sewer pipe to the arched bays under the 1896 Railway Bridge. It ran from Trench 2 approximately 4.00m from the SE corner of the garden wall of Customs House where it headed N for 20m before turning WNW for a further 25m. The trench was typically 800mm wide x 800mm deep- This rose to a depth of 2.00m to the N where the land had been built up. This trench was cut out with the strict limits of the Scheduled area but was monitored in case anything of archaeological interest was uncovered. It was only recorded in plan and

photographically. The S portion of the trench contained cobbles bedded on gritty grey ash while the N portion was built up with layers of infill presumably related to the 1896 refit of the N Basin side.

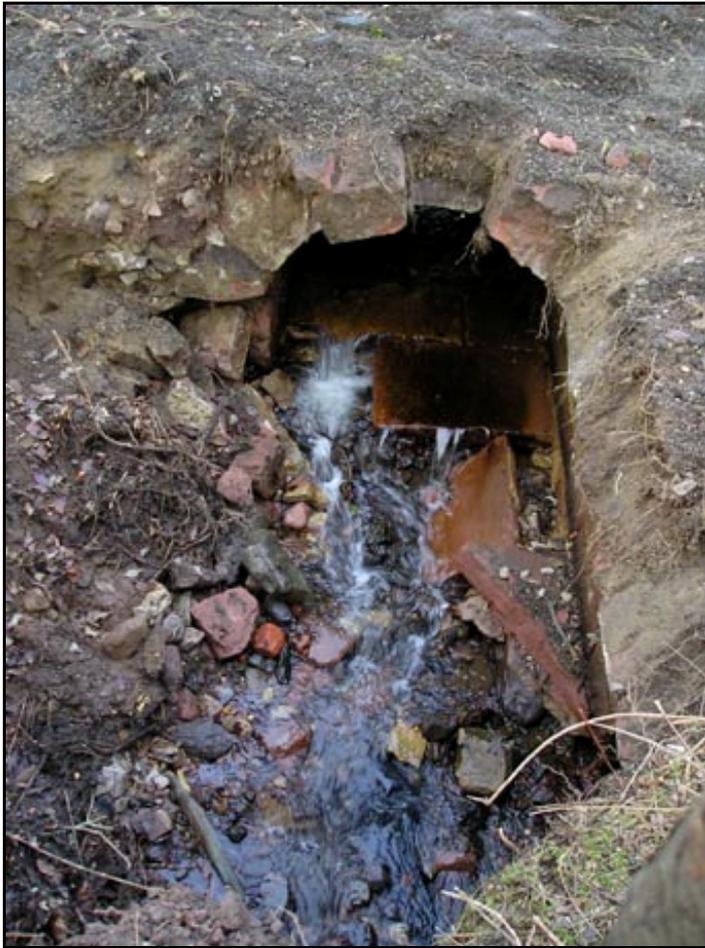
Fig. 24 *Damaged section of culvert*

In addition to these trenches, the culvert that runs into the NE corner of Bowling Harbour was examined. It was in a state of partial collapse and was photographed and recorded as thoroughly as its dilapidated state would allow. A series of observations were made in relation to both the fabric of the structure and the evidence for its development from the historical site plans. The burn running through the culvert followed a natural course prior to 1790 after which it was rationalised to follow the angular course as seen on the 1790 Plan. By 1850 and the construction of Bowling Harbour, the burn had been rerouted. It followed a similar route but had been shifted 50m N. The burn was enclosed in a culvert with a flat sandstone slabbed roof for at least its last 40m before flowing out from the corner of the newly constructed harbour wall. To the N, the roof is arched in red sandstone- this is purposely built into the wall of the adjacent platform. The floor of the culvert was at least partially slabbed in red sandstone- the exact form is unclear due to recent clearance after a collapse. The rest of the burn was possibly un-enclosed and running in a walled channel with chamfered red sandstone copes. The burn was built over by the main line railway of the mid-19th century and became enclosed in an arched culvert with a red brick roof but retained the stone sides of the open culvert. In the late 20th century a manhole was added S of the platform wall which was itself reinforced with a concrete lintel. More recently, a 3m stretch of the sandstone-arched section of the culvert collapsed and was cleaned out by JCB.
