BERWICK-UPON-TWEED

Distribution and Significance of Urban Waterlogged Deposits

Project Report

Title	Distribution and significance of urban waterlogged deposits in Berwick-upon-Tweed (Project 3A5.201)
Author:	Karen Derham, Assistant Archaeologist, karen.derham@northumberland.gov.uk , 01670 622655
Approval:	Sara Rushton

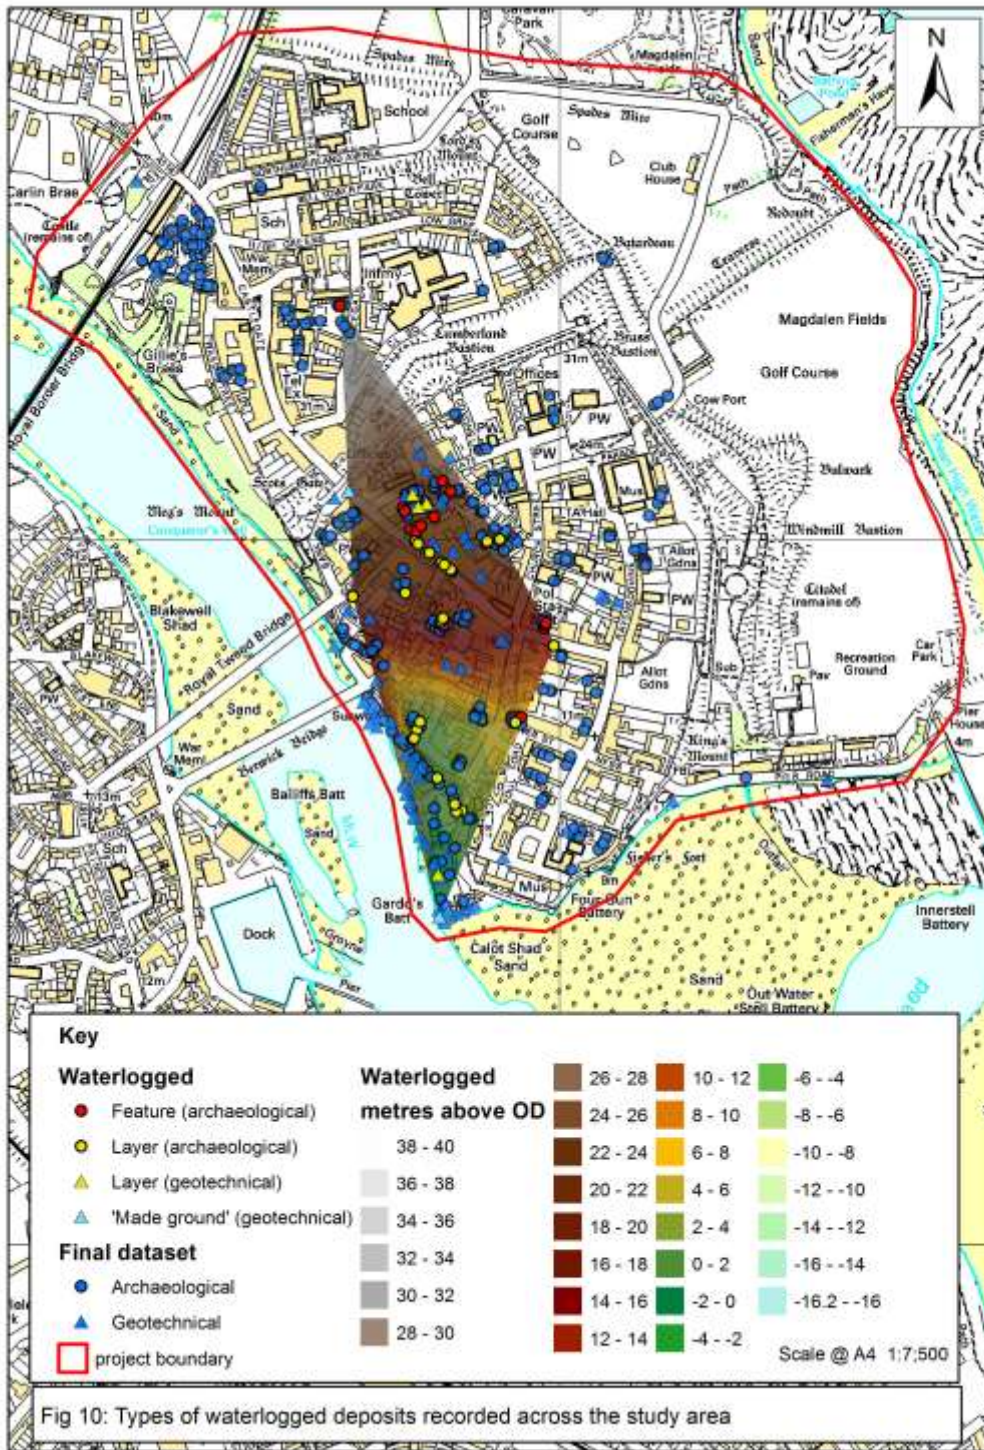
Fig 10: Types of waterlogged deposits recorded across the study area

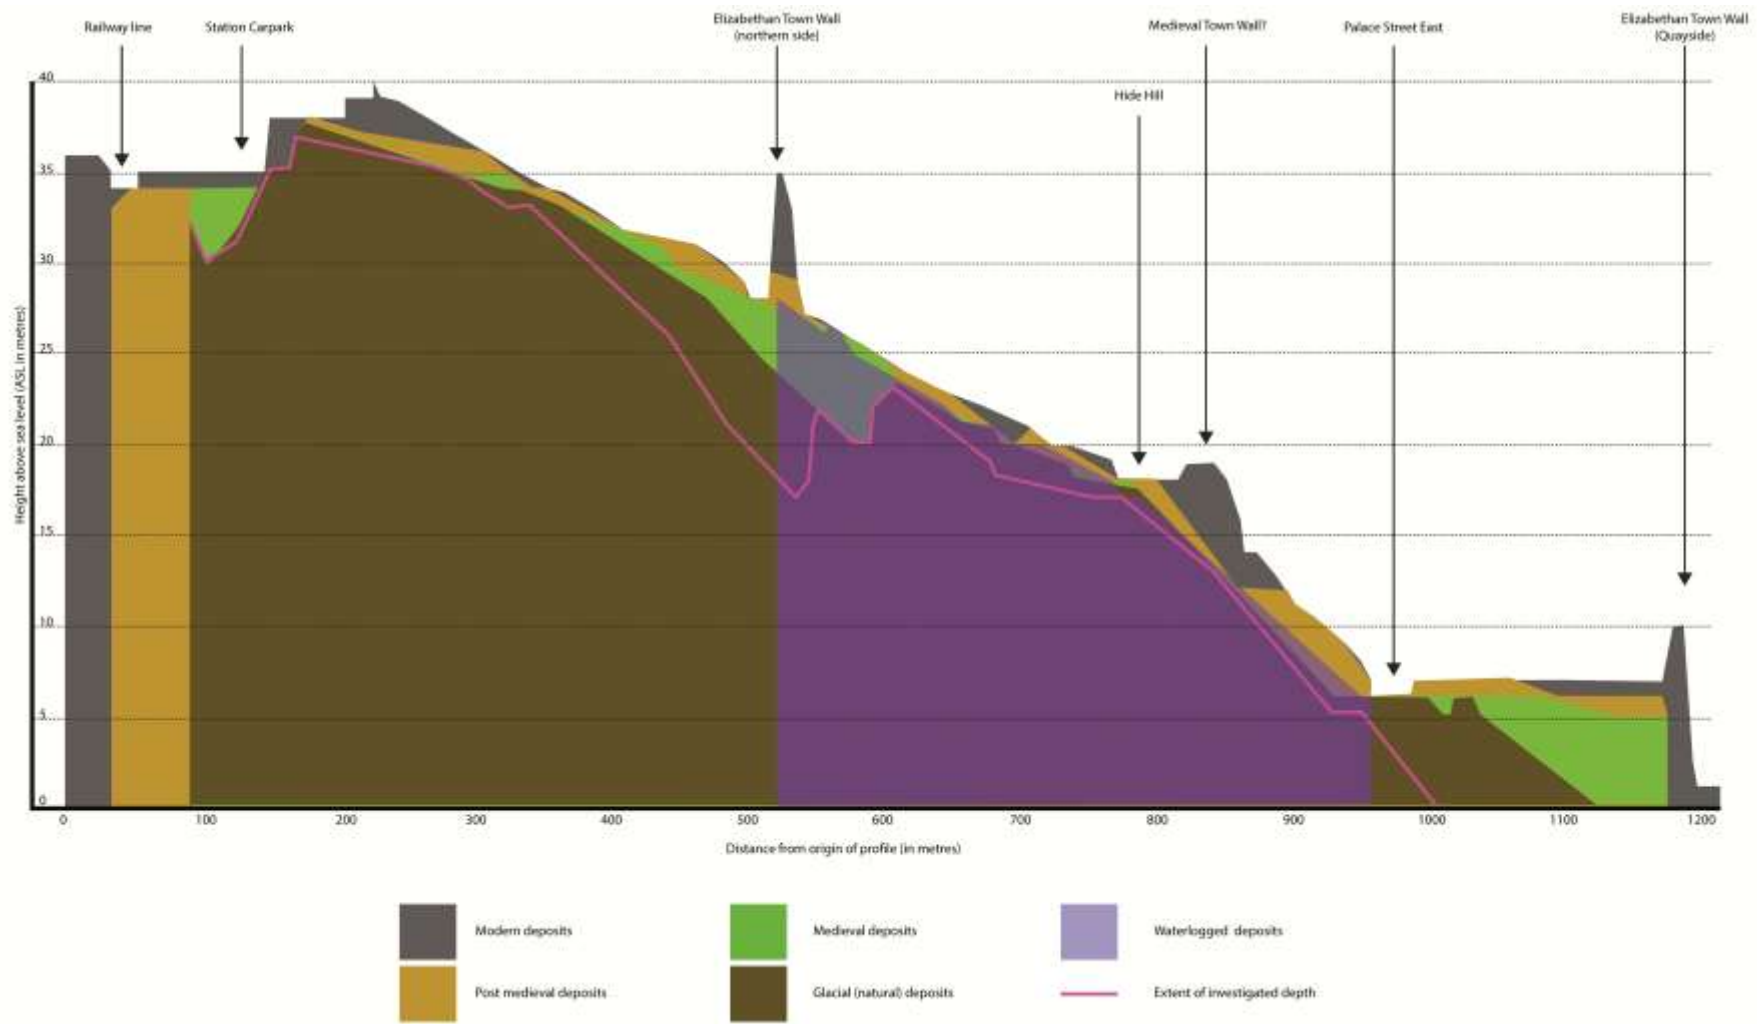
Fig 14: Profile 1 from train station car park (NW) to Palace Green (SE)

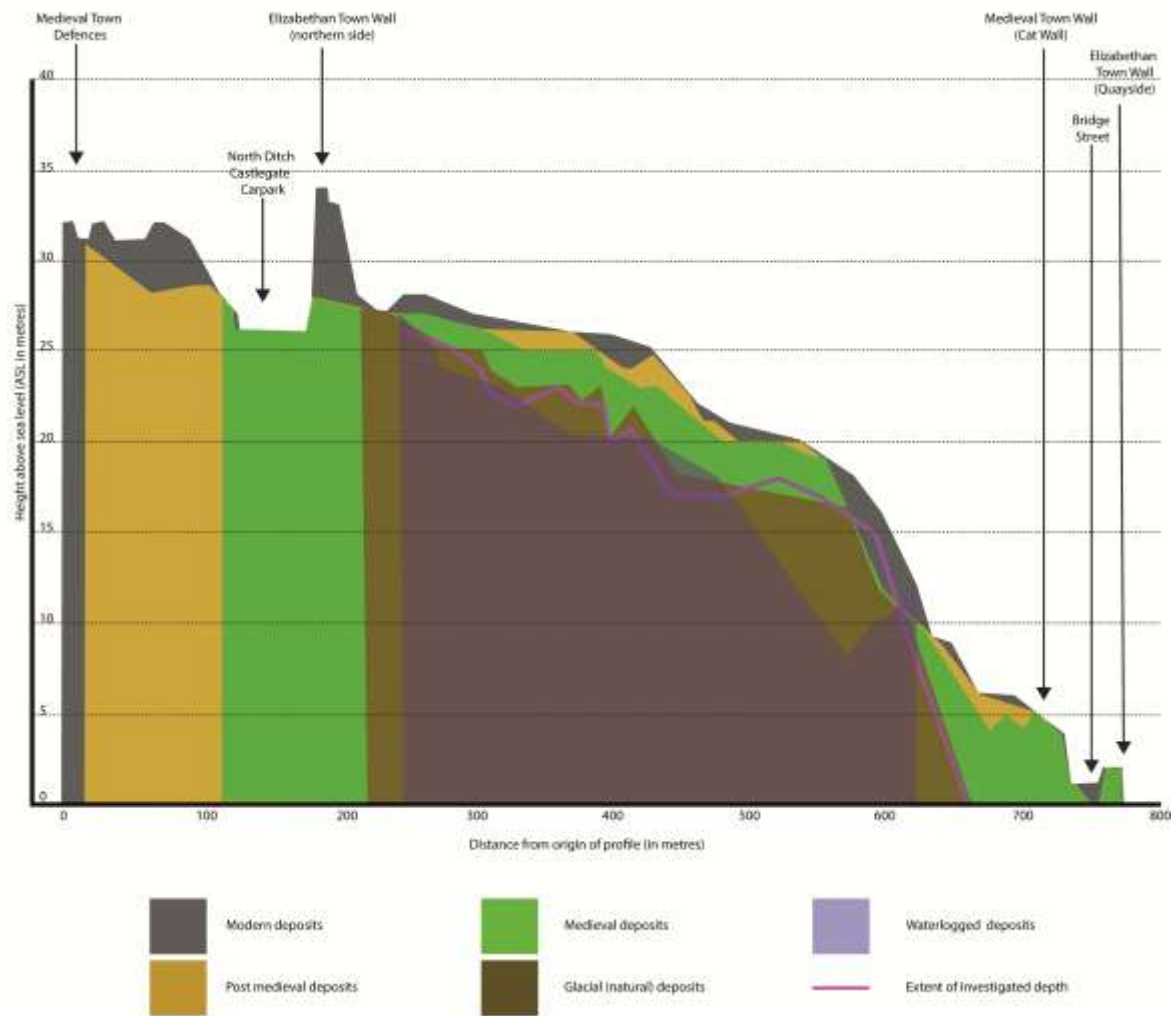
Fig 15: Profile 2 from Low Greens (NE) to south of Berwick Bridge (SW)
