Archaeological Report

Project Name: West Heslerton Primary School Site 13BA

Report by: James Lyall

Date: 30/11/2006

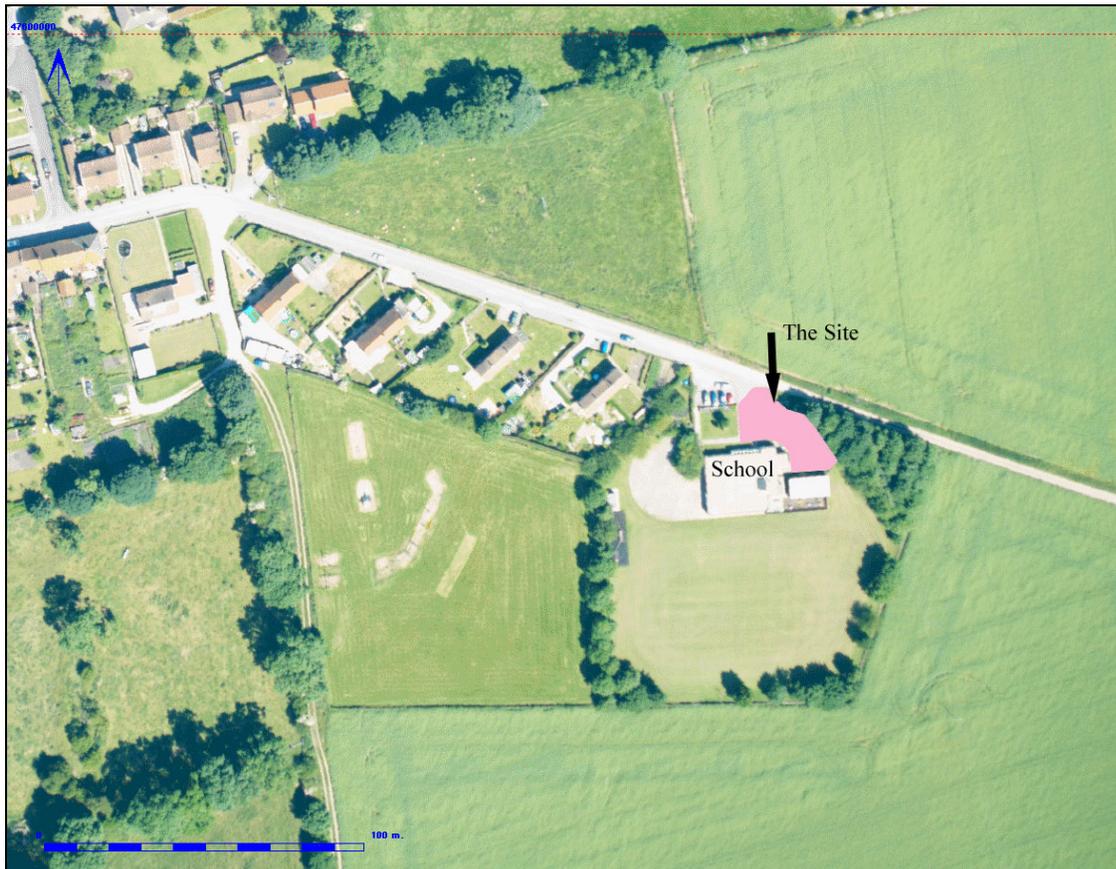
The area concerned is situated to the north of the current school and to the south of the track leading to Rectory Farm, and is centered on NGS grid reference SE 91457/75873.

Figure 1 Aerial photograph taken in 2005 with location of site superimposed (scale bar 100m)

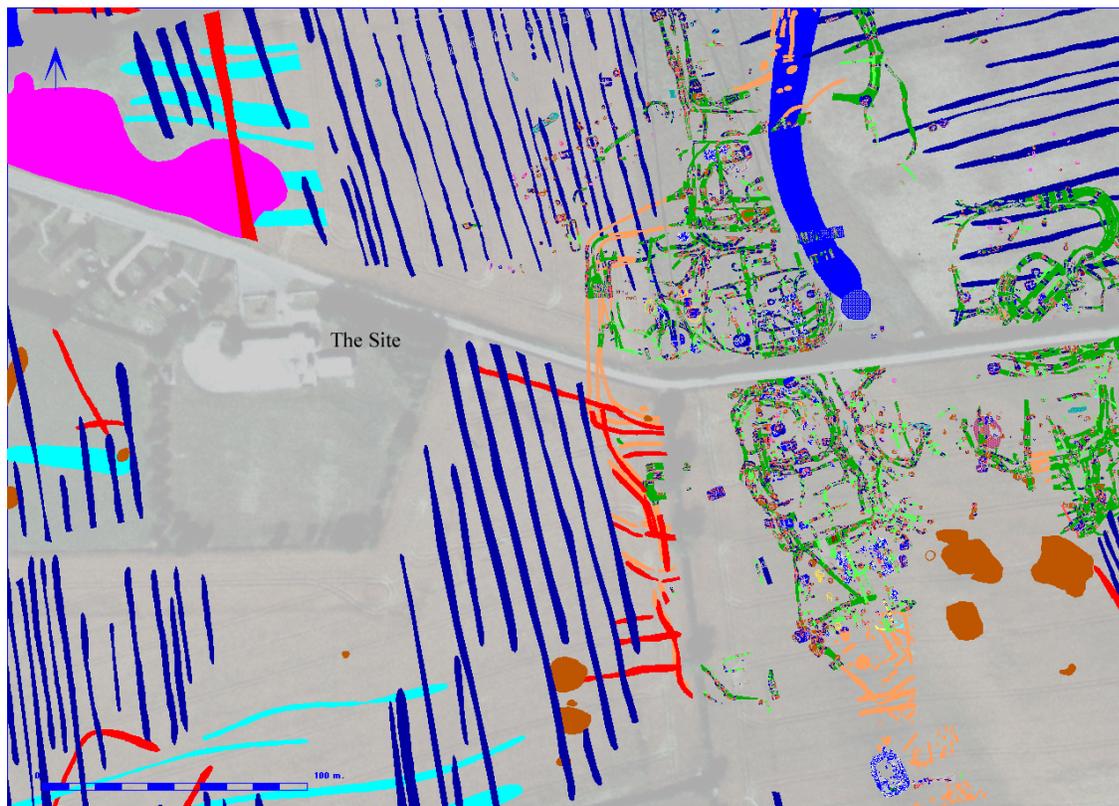
Figure 2 Excavated and geophysical survey plans on an aerial photographic background.

The excavation of the early Anglo-Saxon settlement in the fields to the east and north of the site also found widespread evidence of Roman and Iron Age activity, as well as more dispersed earlier prehistoric features, and thus the potential for finding archaeological features in this area is always present. That being said, the geophysical surveys carried out around the school indicate that the main foci of activity are located to the north and east (Roman and Anglo-Saxon), and the west (the medieval village of West Heslerton). From the geophysical data, it was anticipated that the remains of the furrows of ridge and furrow ploughing would be encountered (see Figure 2).

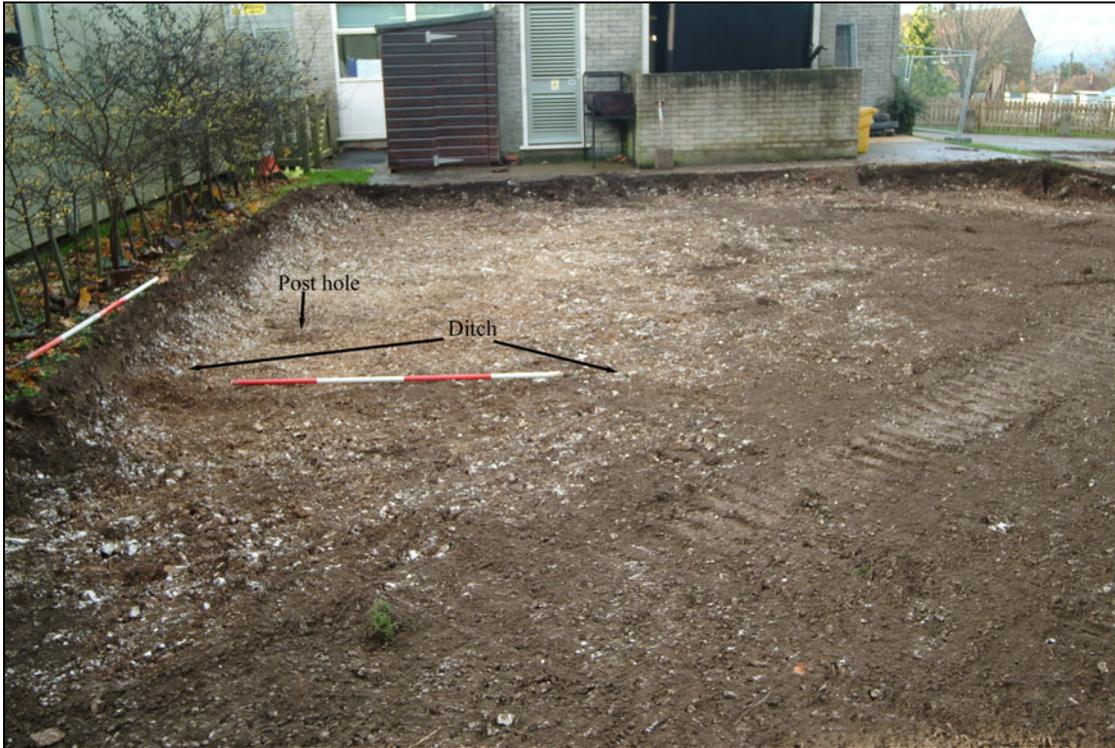
Figure 3 Excavated remains of the truncated ditch and post hole.

Two archaeological features were encountered in the northern part of the area, where the depth of overburden removed was greatest. Both of these features had been plough truncated, so that only the bottom 5-10cm remained. The first feature noted was a small posthole, with only the bottom 5cm of the feature remaining. There were no finds, and the fill was a mixed loamy sand with 50% chalk gravel inclusions. No other post holes were encountered within the stripped area, so interpretation of the possible function is not possible at this stage.

When the second feature was first seen, the excavator initially believed that this was probably the remnants of a Medieval plough furrow, but the orientation of this feature did not match with the known alignment of the ridge and furrow field system. It was thus interpreted as the shallow remains of a ploughed-out ditch. The fill (remaining depth varying from 5-10cm) was a loamy sand with 50-60% chalk gravel inclusions. The only find was a river-worn pebble. The ditch continued to the north under the topsoil, but as it was to be preserved under a membrane and stone capping, no further excavation of the feature was conducted.

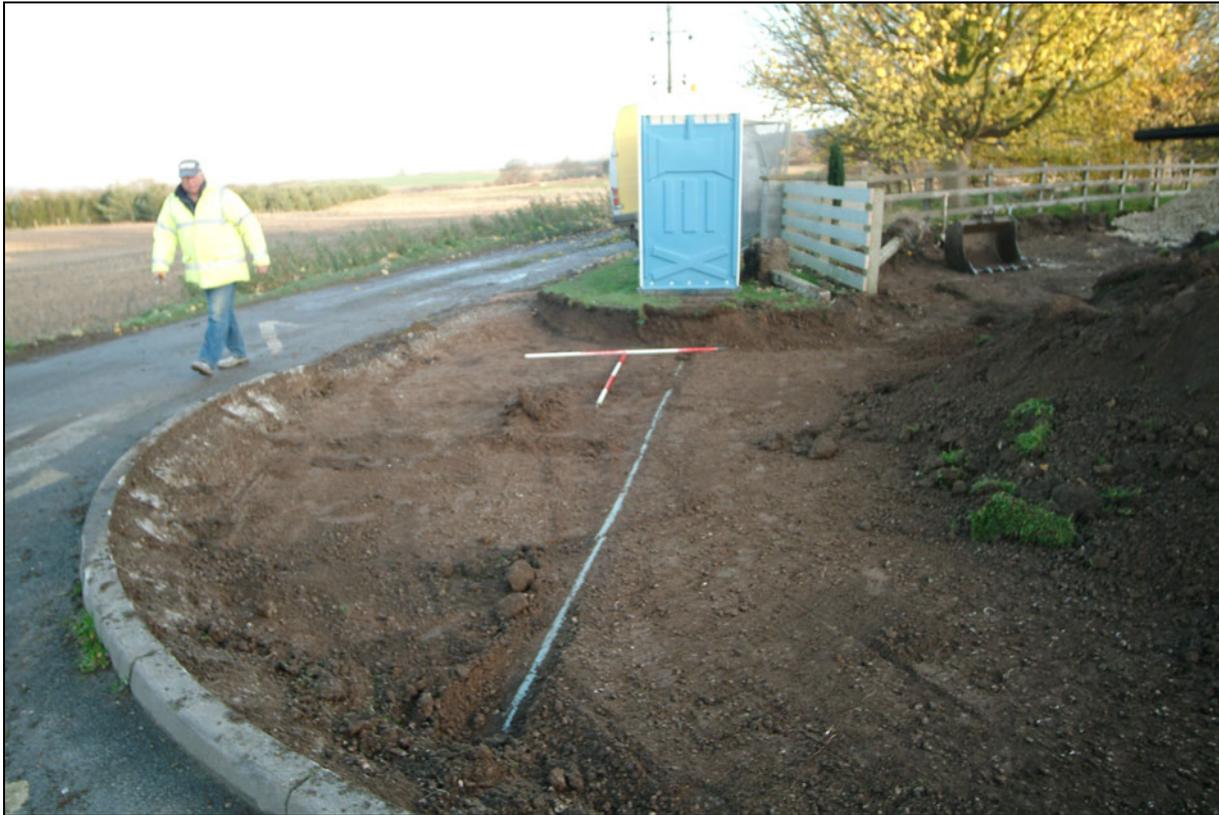
Figure 4 Telecom services pipe cut through the hillwash deposit.

When the north-western area was stripped, the topsoil (only 15cm deep at this point) was immediately above a layer of hillwash. A further 15cm of this colluvial layer was removed. The hillwash had been disturbed by a number of services (water, electricity and telephone service trenches were all present).

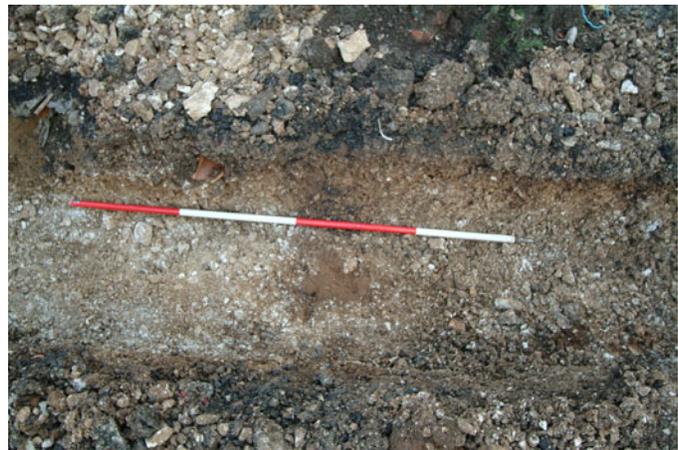
Figure 5 Footing 2 showing the solution hole

The second phase of the watching brief was carried out on the afternoon of the 30th November and the morning of the 4th of December, 2006, and comprised the examination of the wall footings, which were excavated to a depth of approximately 60 cm below the current ground surface. These were excavated by machine through a 50cm thick layer of made up ground consisting of chalk rubble, bricks and other building detritus, and 10cm of the underlying chalk geology. No archaeological features were encountered during the construction of these footings. A single solution hole was noted during this phase of the excavation.

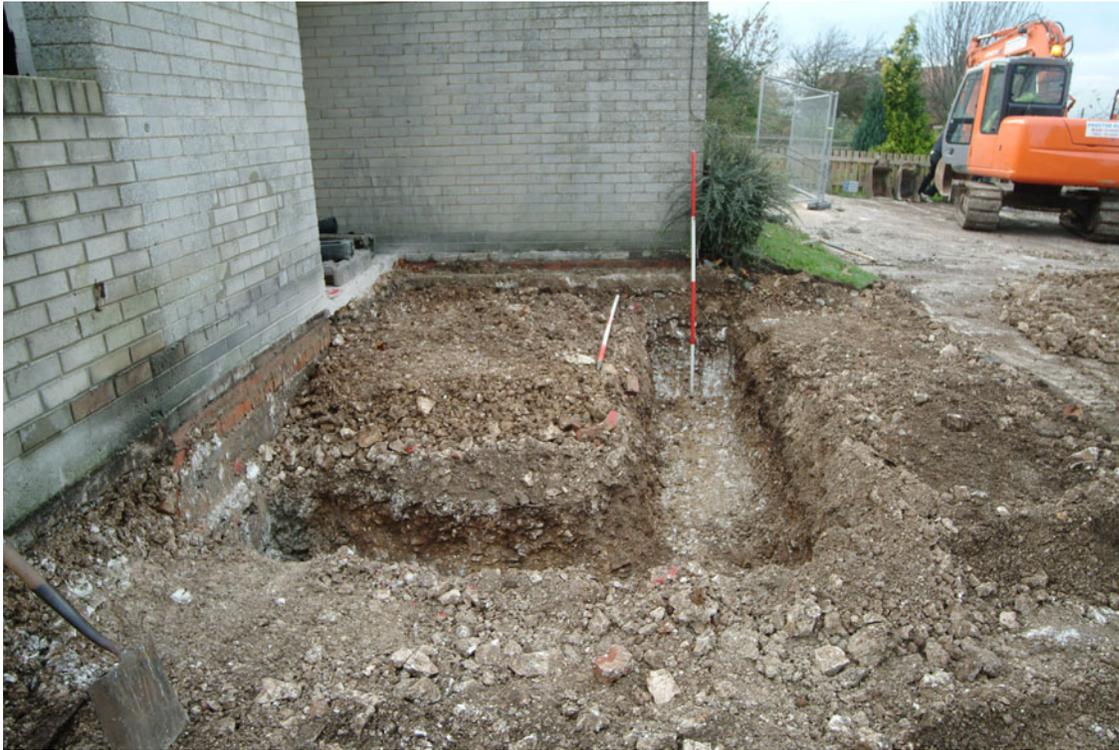
Figure 6 First footing after excavation (looking west)

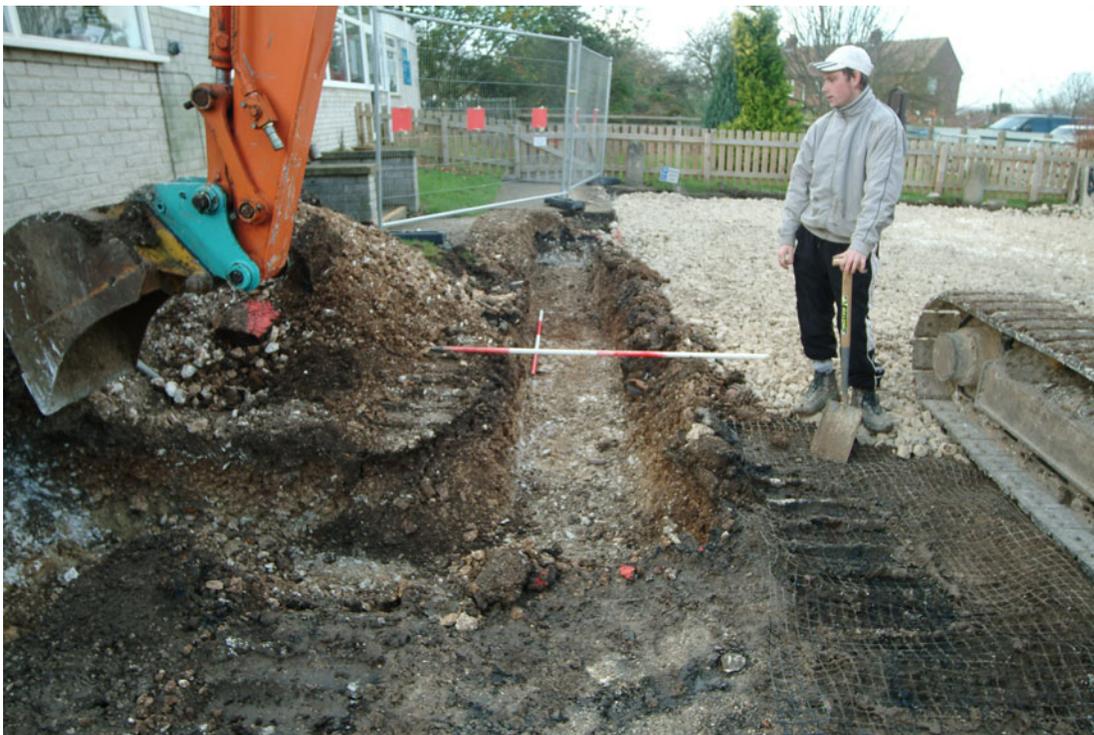
Figure 7 Second footing after excavation (looking west)

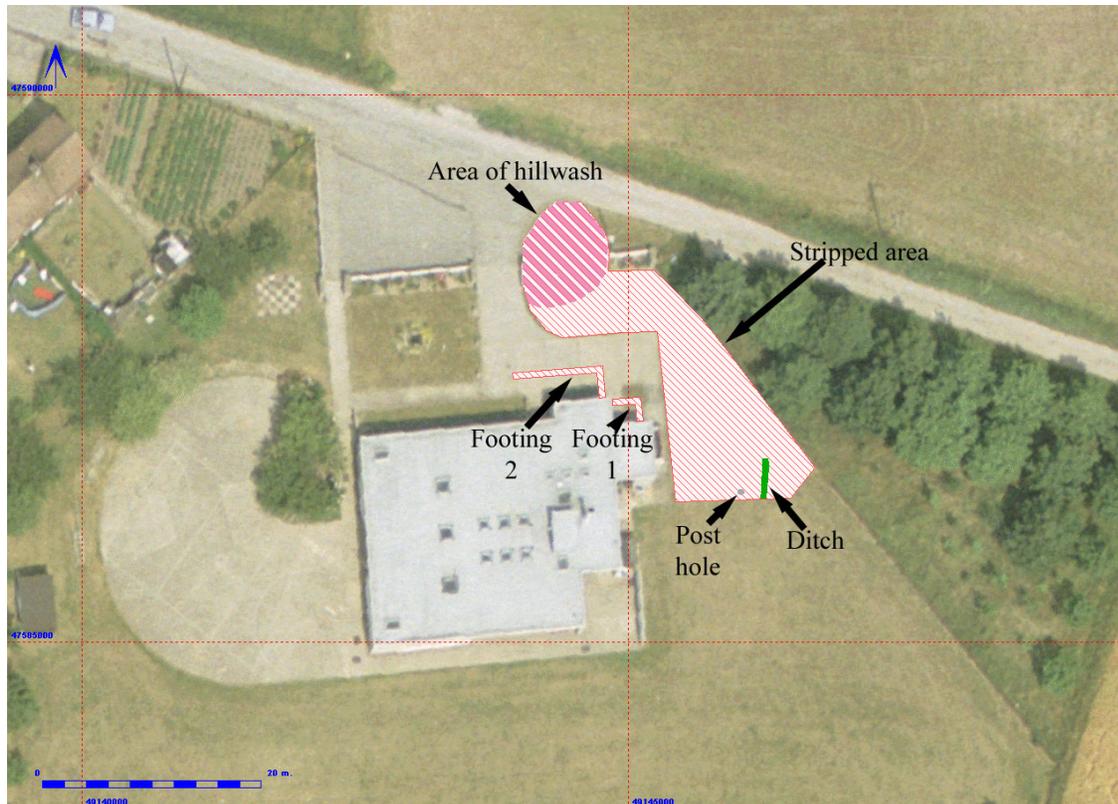
Figure 8 Location of areas observed and archaeological features encountered (scale bar 20m).

In conclusion, it can be stated that only in the southern part of the stripped area was enough topsoil removed to disturb the underlying archaeological features, both of which were severely plough truncated. The rest of the area had been previously disturbed in the 1960's by the construction of the school (on a raft) and the concrete parking area. It is possible that archaeological features remained preserved under the area of hillwash in the northern part of the stripped area.
