### Bay View Scarborough, North Yorkshire; Archaeological Desk-Based Assessment.

November 2007

## Summary

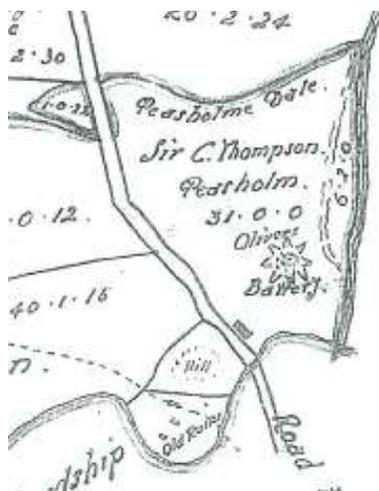
Plate 1. A plan of the site as shown on the Scalby Enclosure Award Map of 1771.

- 5.11 The Scalby Enclosure Award map of 1771 shows a star-shaped fort on the top of the hill, partially extending into the southeastern corner of the proposed development site. It is labelled as 'Olivers Battery', but is now known as Peasholm Fort (4). Knox (1855, 154) theorises that the "star-fort", along with the hill in Peasholm Park to the south formed one military station during the siege of Scarborough Castle by Cromwell's forces in the Civil War. During the war Scarborough was one of only a few coastal strongholds that were held by Parliament (Haward 1971). The fort is not mentioned in any of the contemporary accounts of the Civil War resulting in a wide interpretation of its role during the two sieges of the town. The first siege occurred between January and July 1645 and was led by Sir John Meldrum and Sir Matthew Boynton. The second Siege was the result of the declaration of Colonel Mathew Boynton to the King. This ended in December 1648. There is no evidence to suggest when the fort was built, but it would have played an integral role in defending the North Bay against attempts to supply reinforcements by the Royalist *via* the sea (Pearson 1991).

- 6.2 The first map to show the proposed development area is the Scalby map of 1771. The site forms part of a large area of land owned by Sir C. Thompson. It is bounded by *The Road to Scarborough* on the west, Peasholm Dale to the north and the coast to the east. Peasholm Fort is marked as a star shape entitled *Oliver's Battery*. There are no buildings marked on the map. The surrounding landscape is divided up into areas of land of differing sizes, most of which are owned by different people. They do not form a regular pattern. The 1<sup>st</sup> edition Ordnance Survey map of 1853-54 shows that the site has been divided into four areas. It does not state who the owners/tenants of the land were, but the fort is now marked as *Peasholm Fort*. The surrounding landscape is still divided into a number of fields of differing size and representations of buildings are present to the south of the site in the area now known as Peasholm Gap.

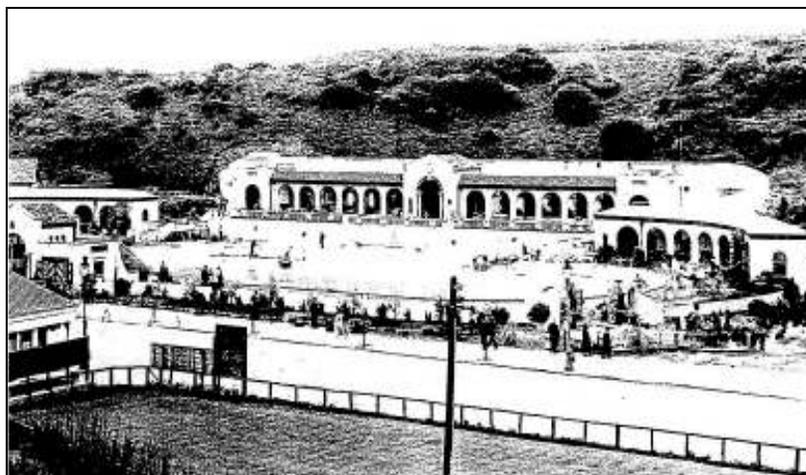
Plate 2: Photograph showing the North Bay Swimming Pool with the proposed development site in the background

- 5.14 During the 18<sup>th</sup> and 19<sup>th</sup> centuries the proposed development area remained undeveloped. It is documented that during “the Easter tide” the townsfolk would “bowl many coloured eggs” on the hills surrounding Peasholm Hill (Baker 1882, 45). This suggests that the activity took place on the site. The establishment of the North Bay as an area for recreation and leisure activities began in the early 20<sup>th</sup> century. In 1909 the North Cliff Golf Course was opened on the proposed development area. The land was bought from the Duchy of Lancaster in 1921 and in 1928 the golf course was relocated to allow work to begin on the North Bay Pleasure Gardens. These were the creation of Harry W. Smith, the borough engineer. A photograph from the early 1930s (Plate 2) shows the North Bay Swimming Pool. The proposed development area is present in the background and can be seen sloping gently from east to west. No buildings are visible on the site.

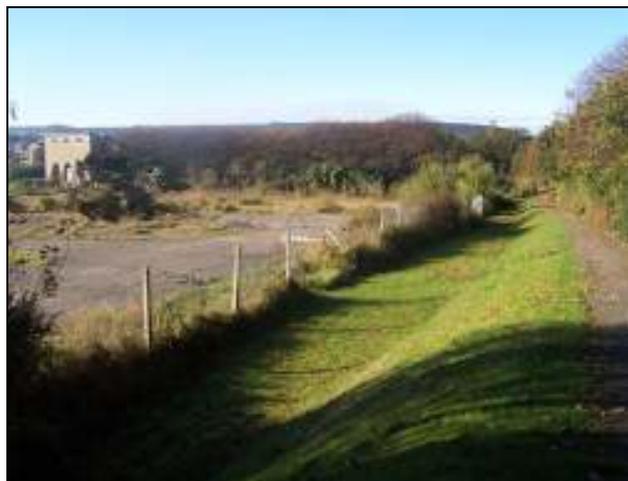
Plate 3. The northern end of the site, looking west. The earthen mound is to the right and the levelling process can be seen by the steep incline from the natural ground level onto the tarmac area.

- 7.2 A topographic survey was undertaken within the site by Alan Wood & Partners in October 2007. It showed that there was a natural incline from east to west and from north to south. The incline in both directions was steep, the ground level varying by approximately 7m from north to south and 7m from east to west. The survey also reinforced the theory that the site had been terraced from east to west and levelled on each terrace. Evident within the northern part of the site was an average 2m drop between each terrace and in the southern part of the site this reached 1.50m. A pool that was located in the northeastern corner of the site had truncated the ground severely, reaching a depth of approximately 3m. The survey, coupled with photographic evidence from the site visit (Plate 3) also served to reinforce the idea that the earthen mound running around the perimeter of the site was compiled from the material removed during levelling.

- 
- 7.3 The incline shown in Plate 3 is not as prominent along the southern boundary. Following the excavation within Peasholm Fort, Pearson (1991) argues that due to the shallow depth of the ditch and its close proximity to the surface it could be “disturbed by a minor change in land use”. It is therefore highly likely that the disturbance in the southeastern corner of the site has truncated the ditch further, if not removed all evidence of it.
