WATCHING BRIEF AT NEW DWELLING AT DEANERY GARDENS, RIPON.

At the request of Mr. Brian Duffield, Rhona Finlayson on behalf of York Archaeological Trust visited the site of a new development in Deanery Gardens, Ripon on 12th May 1995 to carry out an archaeological watching brief. The watching brief was a condition of scheduled Monument Consent granted by the Department of National Heritage.

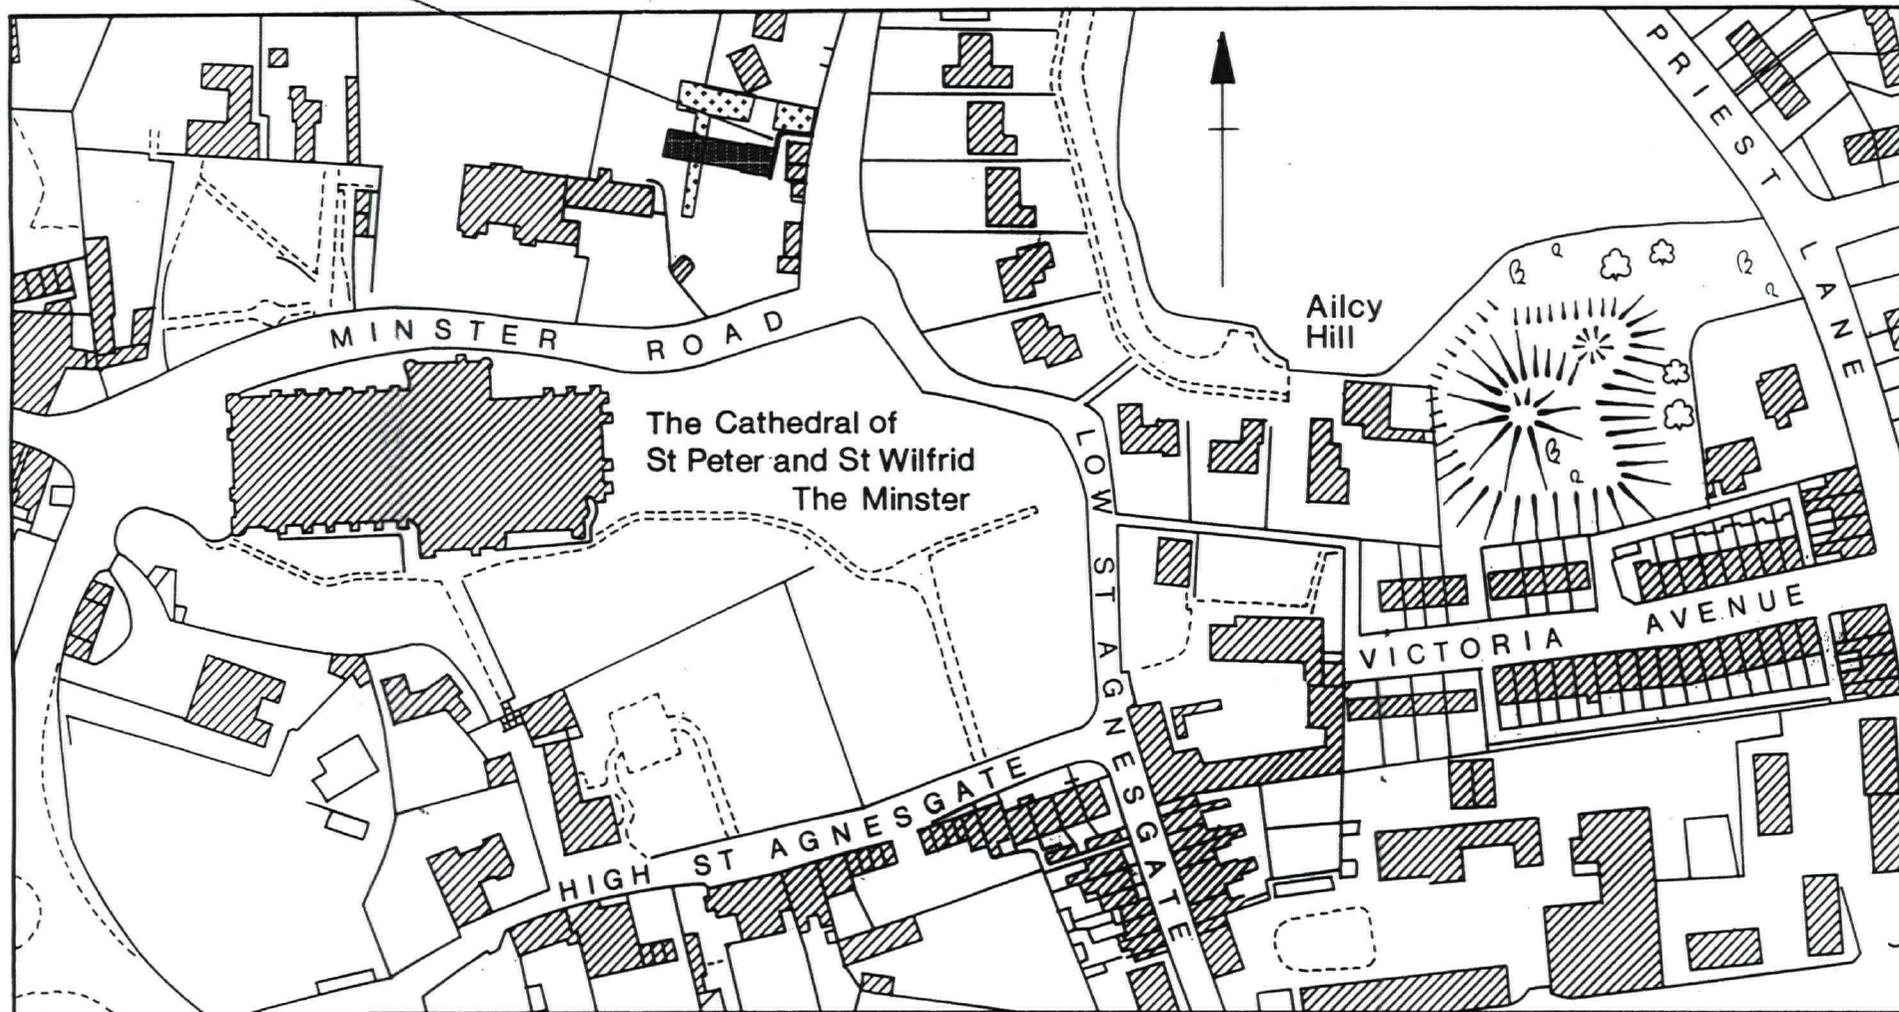
Figure 1

Excavation which took place in 1977  
directed by David Greenhaugh.

Site of new dwelling

Service trench

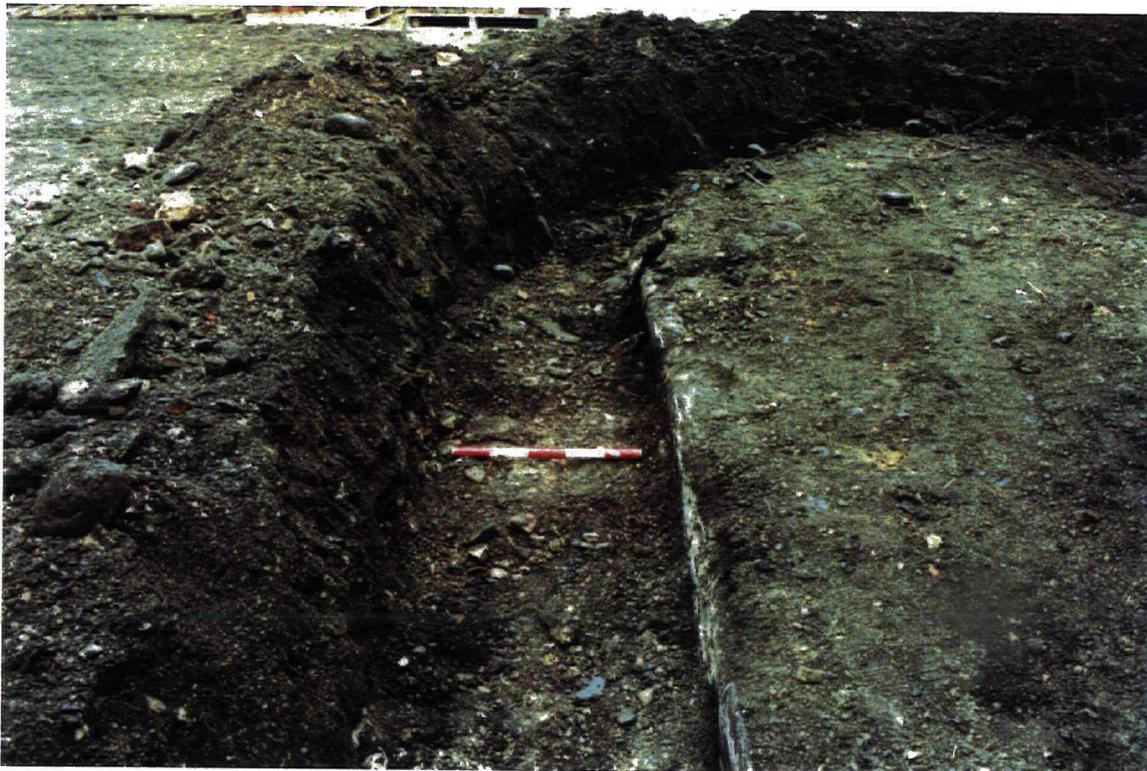
The service trench was cut through a deposit of dark brown loam, with occasional fragments of modern pottery, which had the appearance of cultivated soil. The previous use of the site as an allotment would appear to confirm this. This deposit was approximately 0.35m deep close to the new dwelling and deepened to below the base of the trench to the north of the new dwelling.

In the base of the service trench where the cultivated soil was shallowest, a mixed sandy clay with frequent inclusions of plaster and brick fragments and occasional bone fragments was seen. This may have been demolition debris which could have derived from the demolition of the small brick buildings close to the perimeter wall of the site identified within the excavation in 1977 directed by David Greenhaugh. The brick and plaster fragments within the deposit appeared to be of post-medieval date. A full interpretation of the deposit was not possible since none of this material was disturbed during construction.

1. Facing North, service trench, cut through garden soil, mixed brick and plaster in a matrix of sandy clay seen at base of trench.

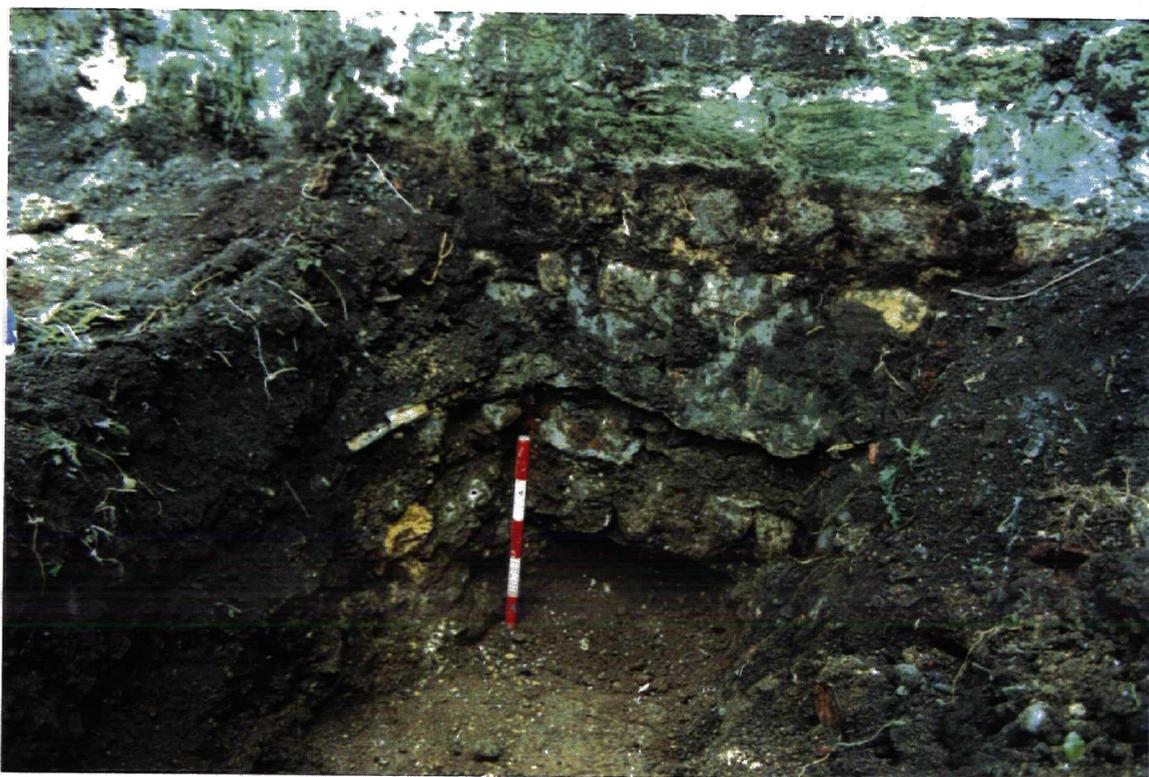
Beneath the flag a light brown sandy clay with frequent cobble and pebbles was seen. The deposit was encountered at approximately 0.35m below the modern ground surface and continued beyond the depth of the service trench. It was seen to extend at least 2m from the face of the wall but its full extent was not observed since the depth of the service trench rose to 0.35m some 2m from the wall. This material appeared to form the foundation upon which the perimeter wall had been built. No edge to a construction trench was observed and the material may have represented a larger deposit associated with the wall construction. No dating material was recovered .

2. Facing north-west, service trench adjacent to perimeter wall, showing top of wall foundation.

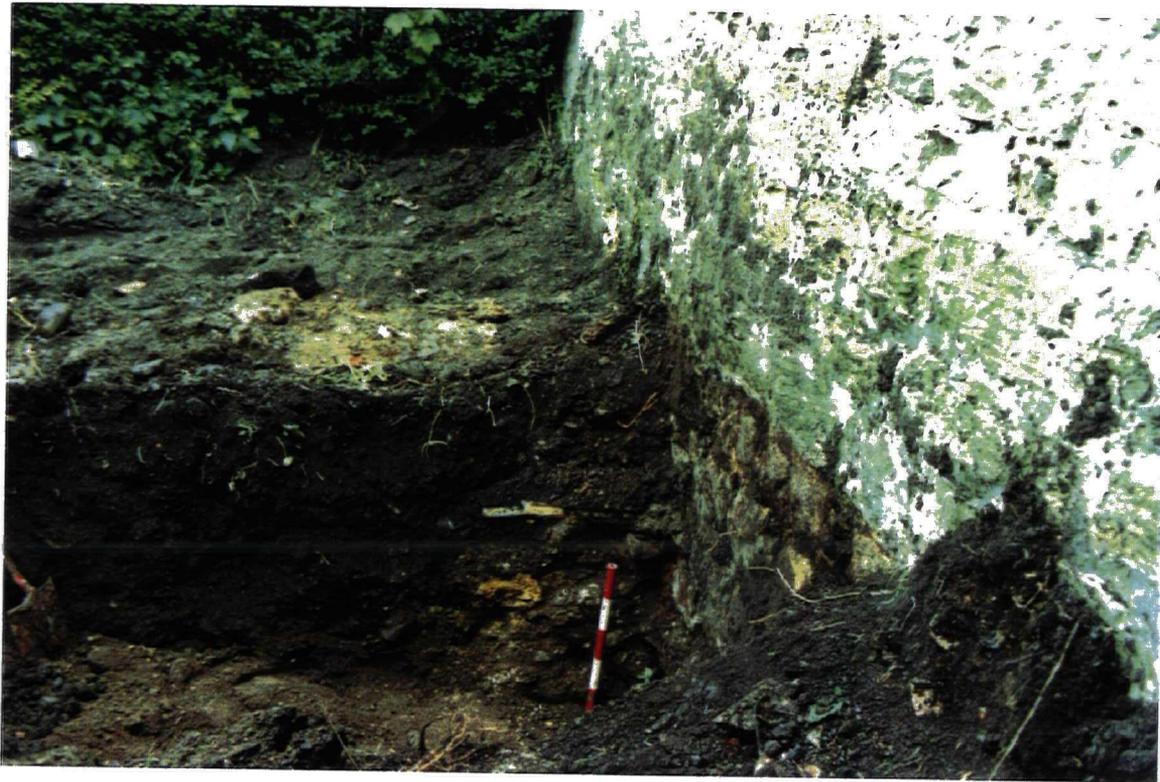
The western profile of the perimeter wall was seen to be vertical . The only variation in the stonework was that the two lowest courses were more roughly faced than those above them. A patch of plaster adhered to the wall face close to the construction trench. This plaster may have been associated with the small brick buildings built close to the wall identified by David Greenhaugh.

3. Facing North, service trench adjacent to west face of perimeter wall, showing almost vertical profile.

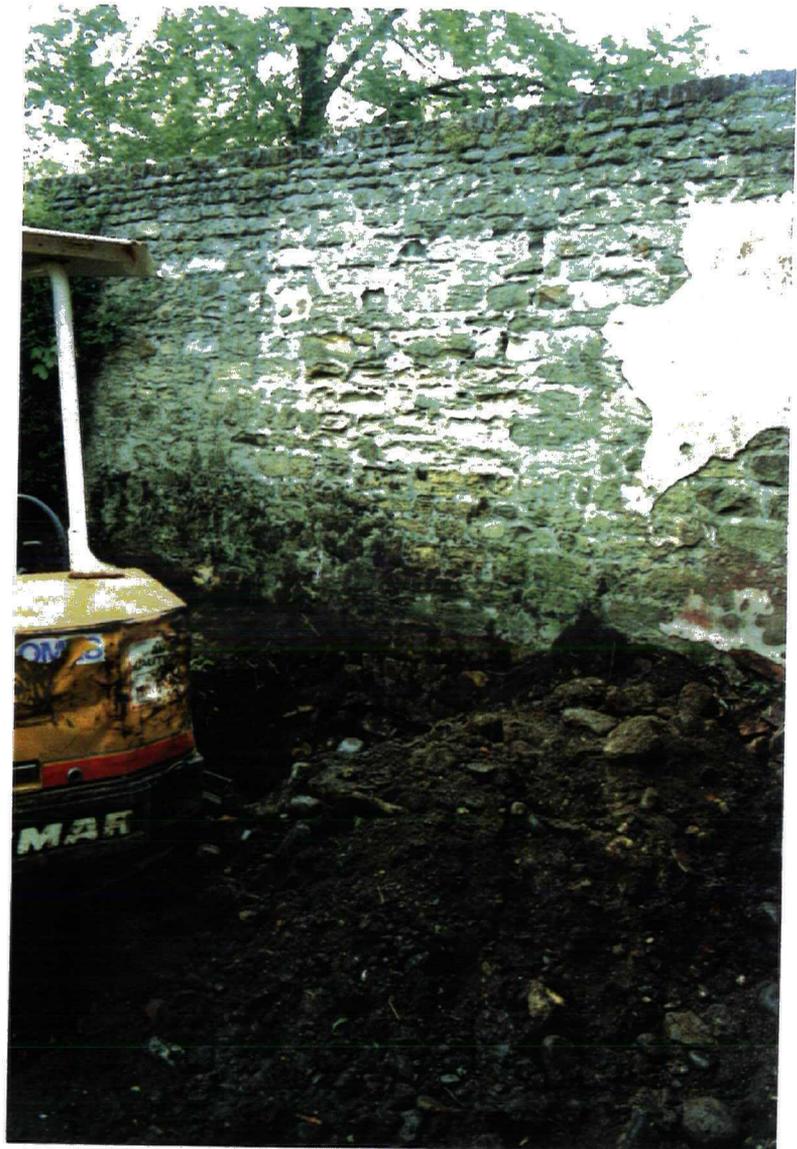
4. Facing north-west, showing full height of wall where service trench was constructed.
