ARCHAEOLOGICAL WATCHING BRIEF
STANLEY MAIN
SKIPWITH

SITE CODE : STM 01
NGR: SE663385

REPORT
October 2001

Client: UK COAL MINING LTD
Harworth Park
Blyth Road
Doncaster
DN11 8DB

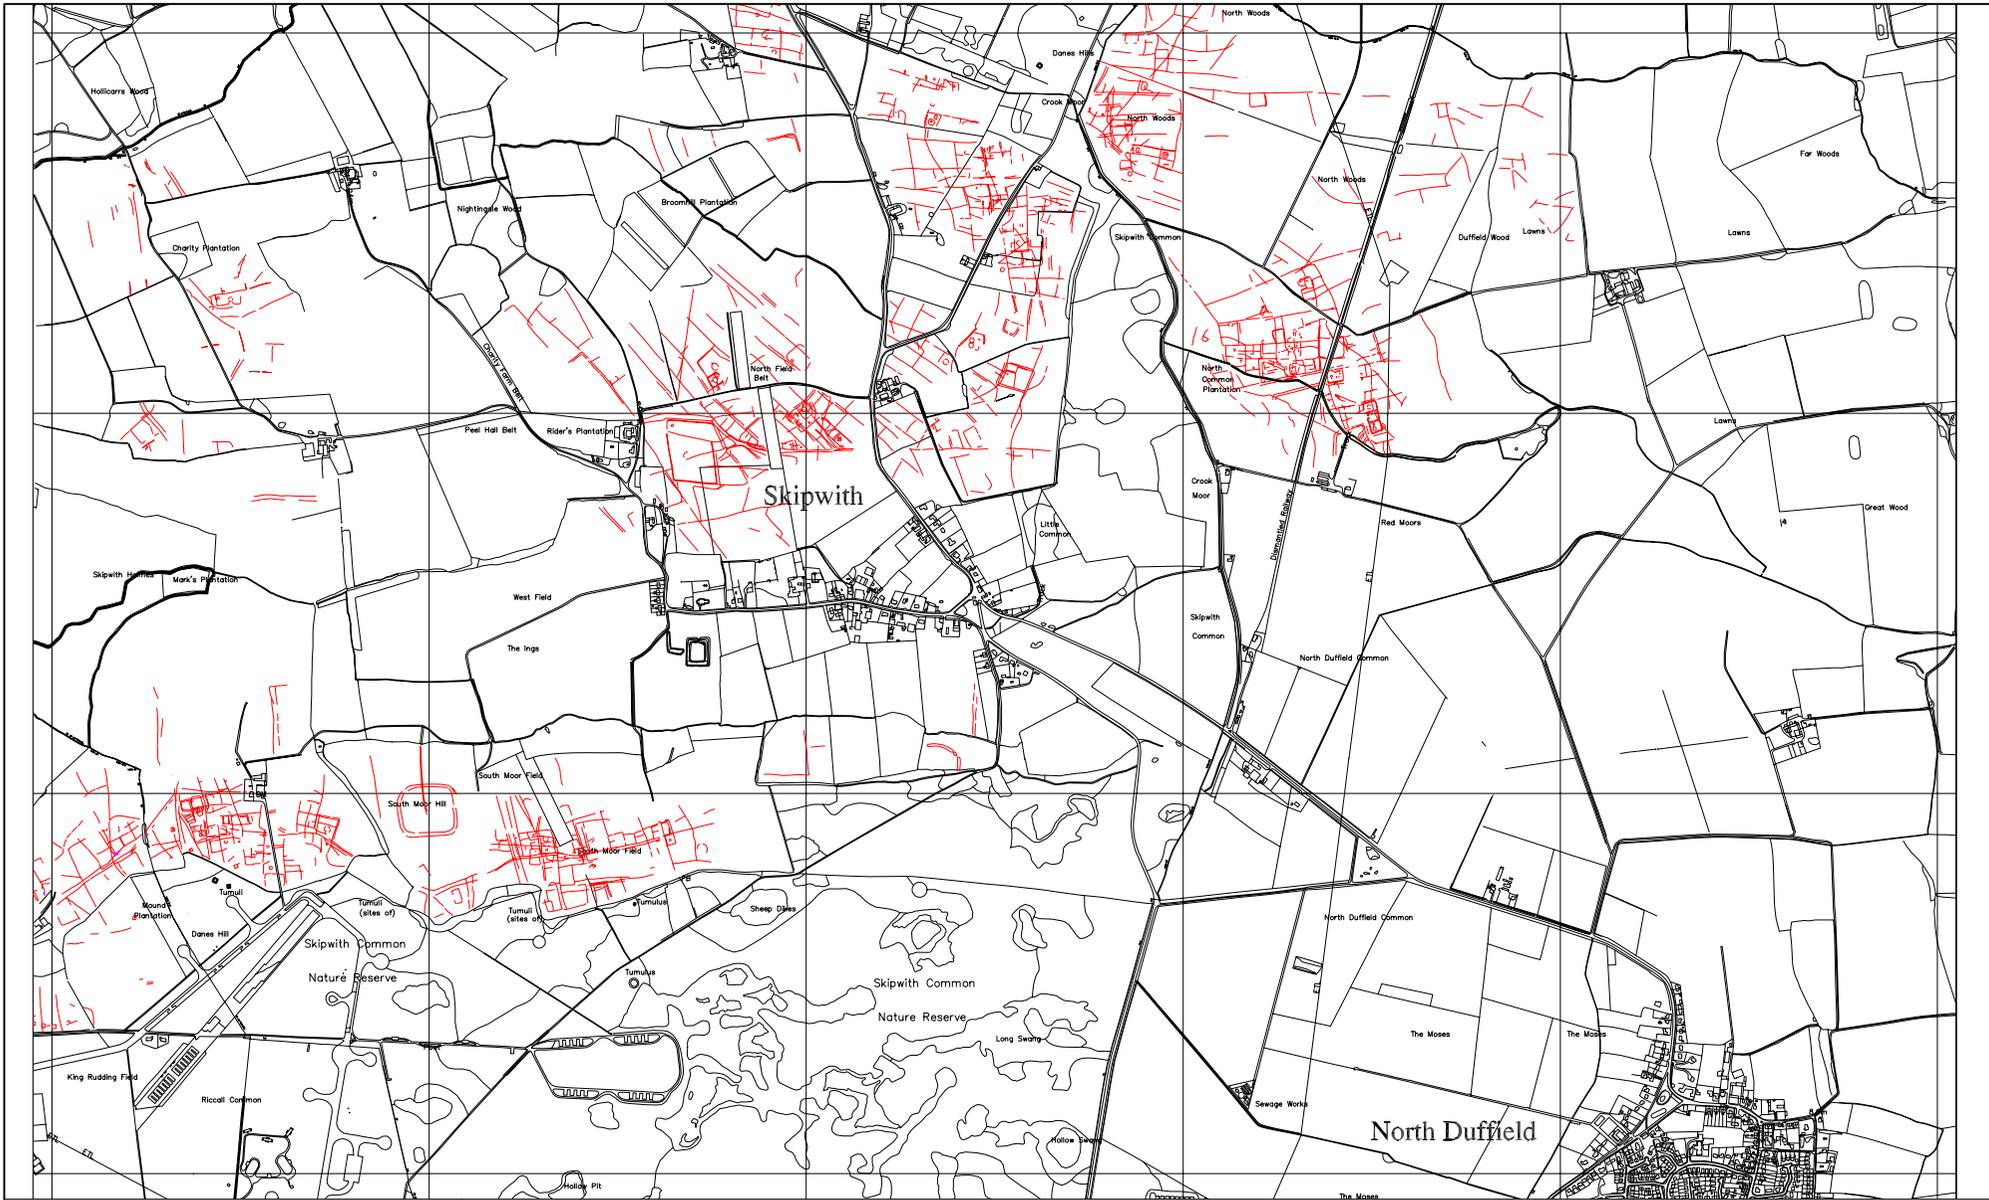
Figure 2

Map showing cropmark distribution

Previous archaeological investigations have provided evidence for a wide spread pattern of land use in the region around Skipwith dating from the Iron Age (Fig.2). These remains, mostly identified by aerial reconnaissance but also from surviving earth works, have been interpreted as field boundaries, settlement patterns and burial mounds.

Fifty-five archaeological features were noted, with clear concentrations between TP 3 and TP 6, which correspond with extensive cropmark evidence for the field (Fig.2). Spade cleaning of drain sections was carried out wherever possible; this demonstrated that the features observed cut the layer of windblown sand.

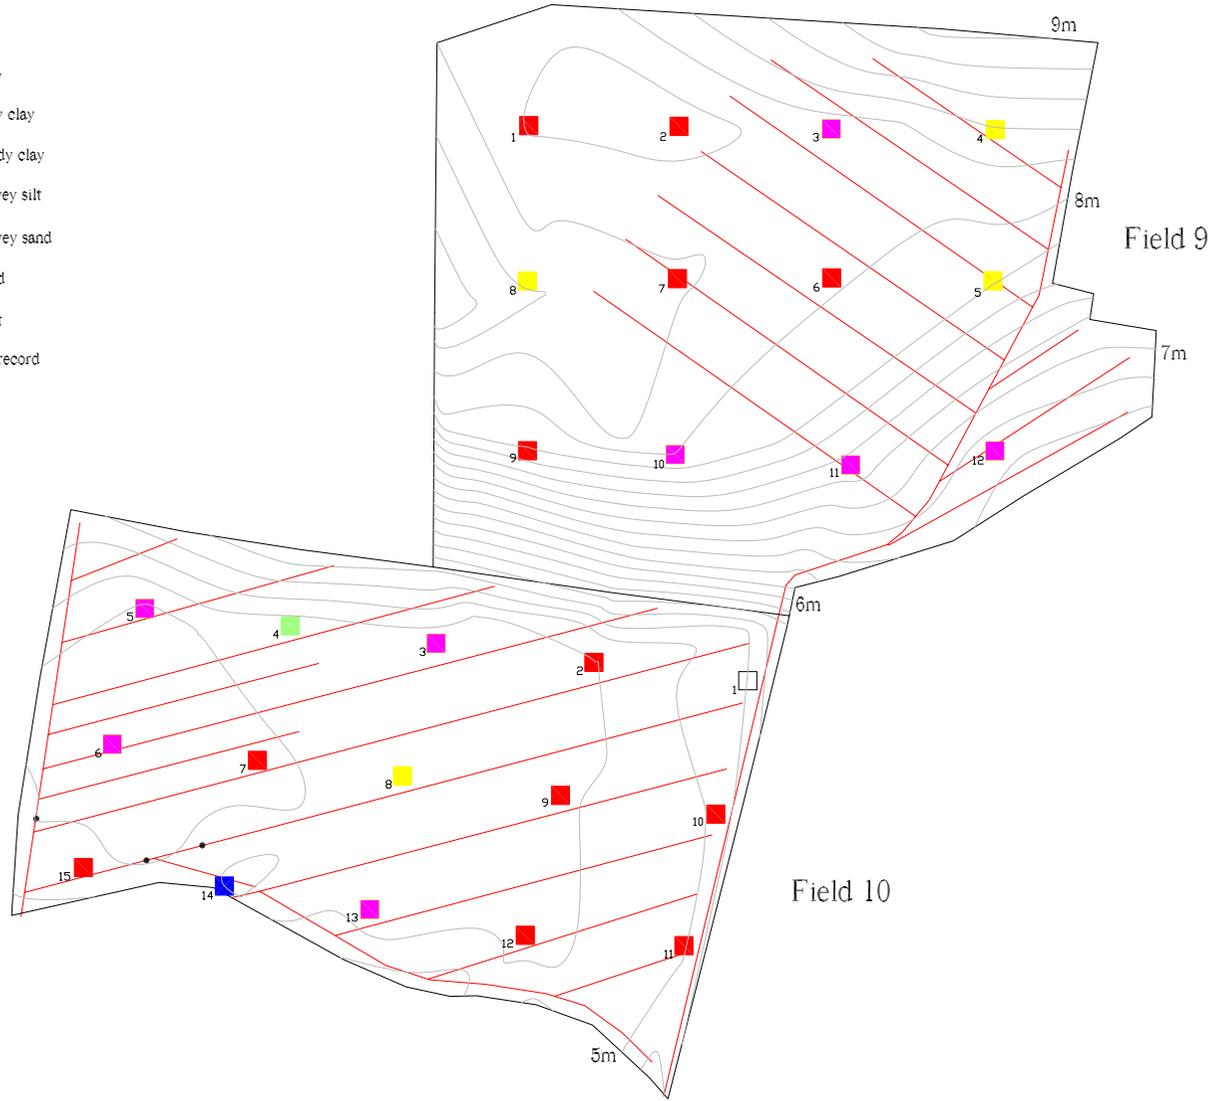
Figure 3

The field is bordered on the east by a row of houses and on the north by a track. It abuts Field 8 on the west and Field 10 on the south (Fig.1). The ground surface drops by 3m towards the southern field boundary (Fig.3).

Plan of Int.18

clayey subsoil was noted on the western side of the field (Fig.3). A windblown sand deposit was observed beneath the topsoil throughout the whole field, ranging in thickness between 0.04m and 0.63m (Appendix A, Table 1). This considerable variation in thickness was investigated and it was determined that the deposit generally became shallower towards the lower ground to the south. No buried soil layers were identified within the deposit of windblown sand.

The field contained a varied geology, with a prevalence of clay in the eastern half of the field, while the western half contained clayey sand, sand and clayey silt (Fig.3). Subsoil was not contacted in TP 1, as an older ceramic drain was found at 0.45m below ground level (BGL). Windblown sand was absent from TP 14 (Appendix A, Table 2). Only three archaeological features were identified and these were all located in the southwestern corner of the field.

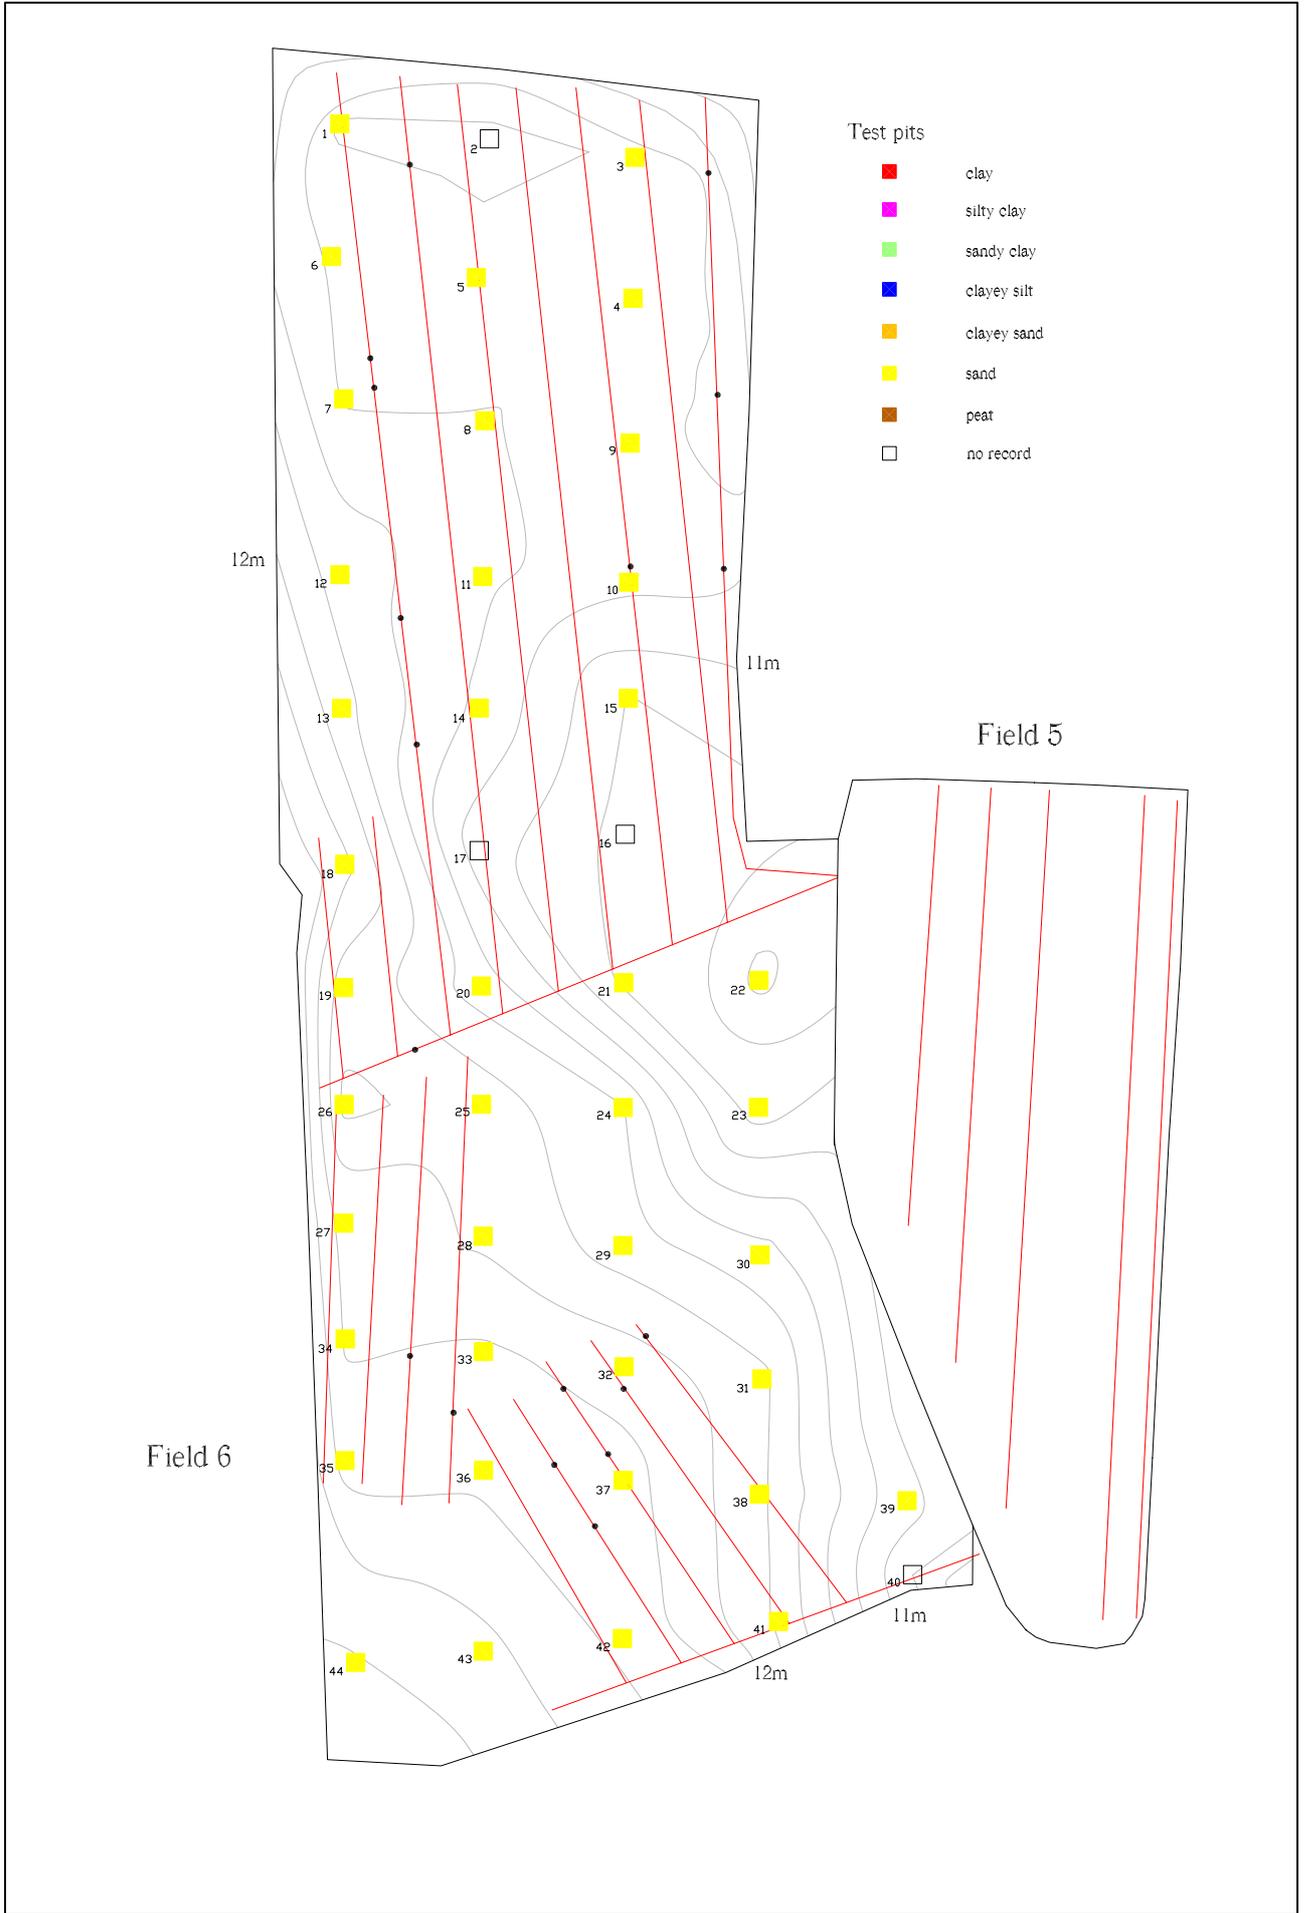
Figure 4

Test pitting revealed a uniform subsoil consisting of sand (Fig.4). However, subsoil was not contacted in Test Pit 40, as a field drain was encountered at 0.60m. Only the test pits in the southern and central parts of the field produced windblown sand deposits between 0.04 to 0.35m thick (Appendix A, Table 3). A concentration of thicker aeolian deposits was identified on higher ground in the southwestern corner of the field. Other, smaller concentrations followed no apparent pattern.

Plan of Int.21

Twenty-three archaeological features were observed during the watching brief. These were infrequent to the north, but were more densely concentrated in the southern half, between TP 32 and TP 37. Two features noted in TP 16 and TP 17 fall within the limits of a disused field boundary and are thought to represent an enclosure.

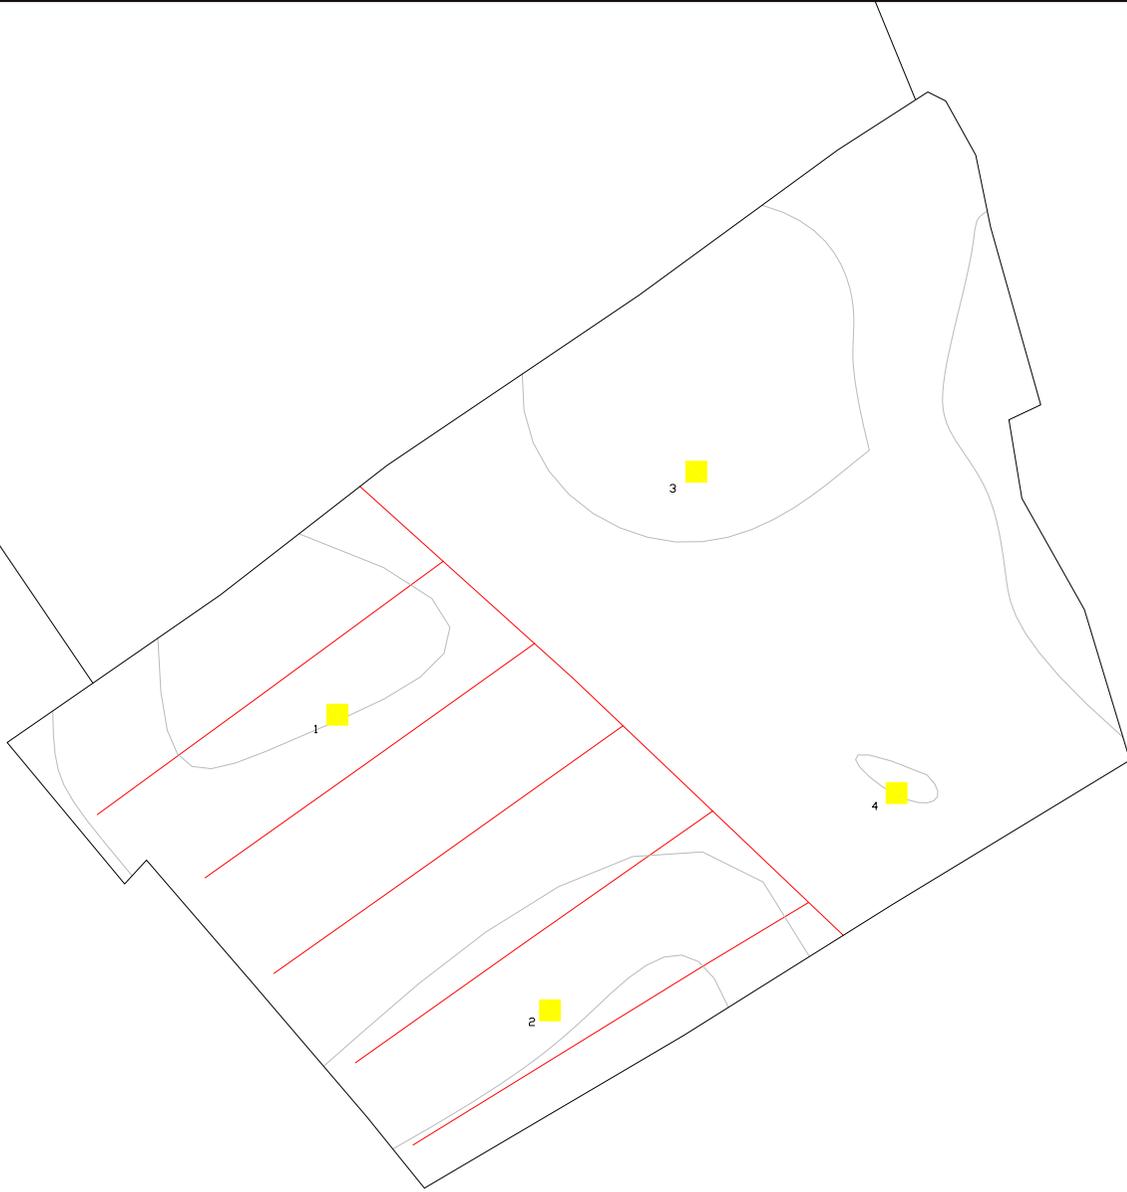
Figure 5

This field is relatively flat and is situated to the east of the Hare and Hounds public house, being defined by Skipwith Little Common to the east, a small paddock to the south and Field 2 to the north (Fig.1). It belongs to North House Farm and was uncultivated. Drainage installation took place in the western half of the field, covering 0.37km (Fig.5).

Plan of Int.23 Field 1

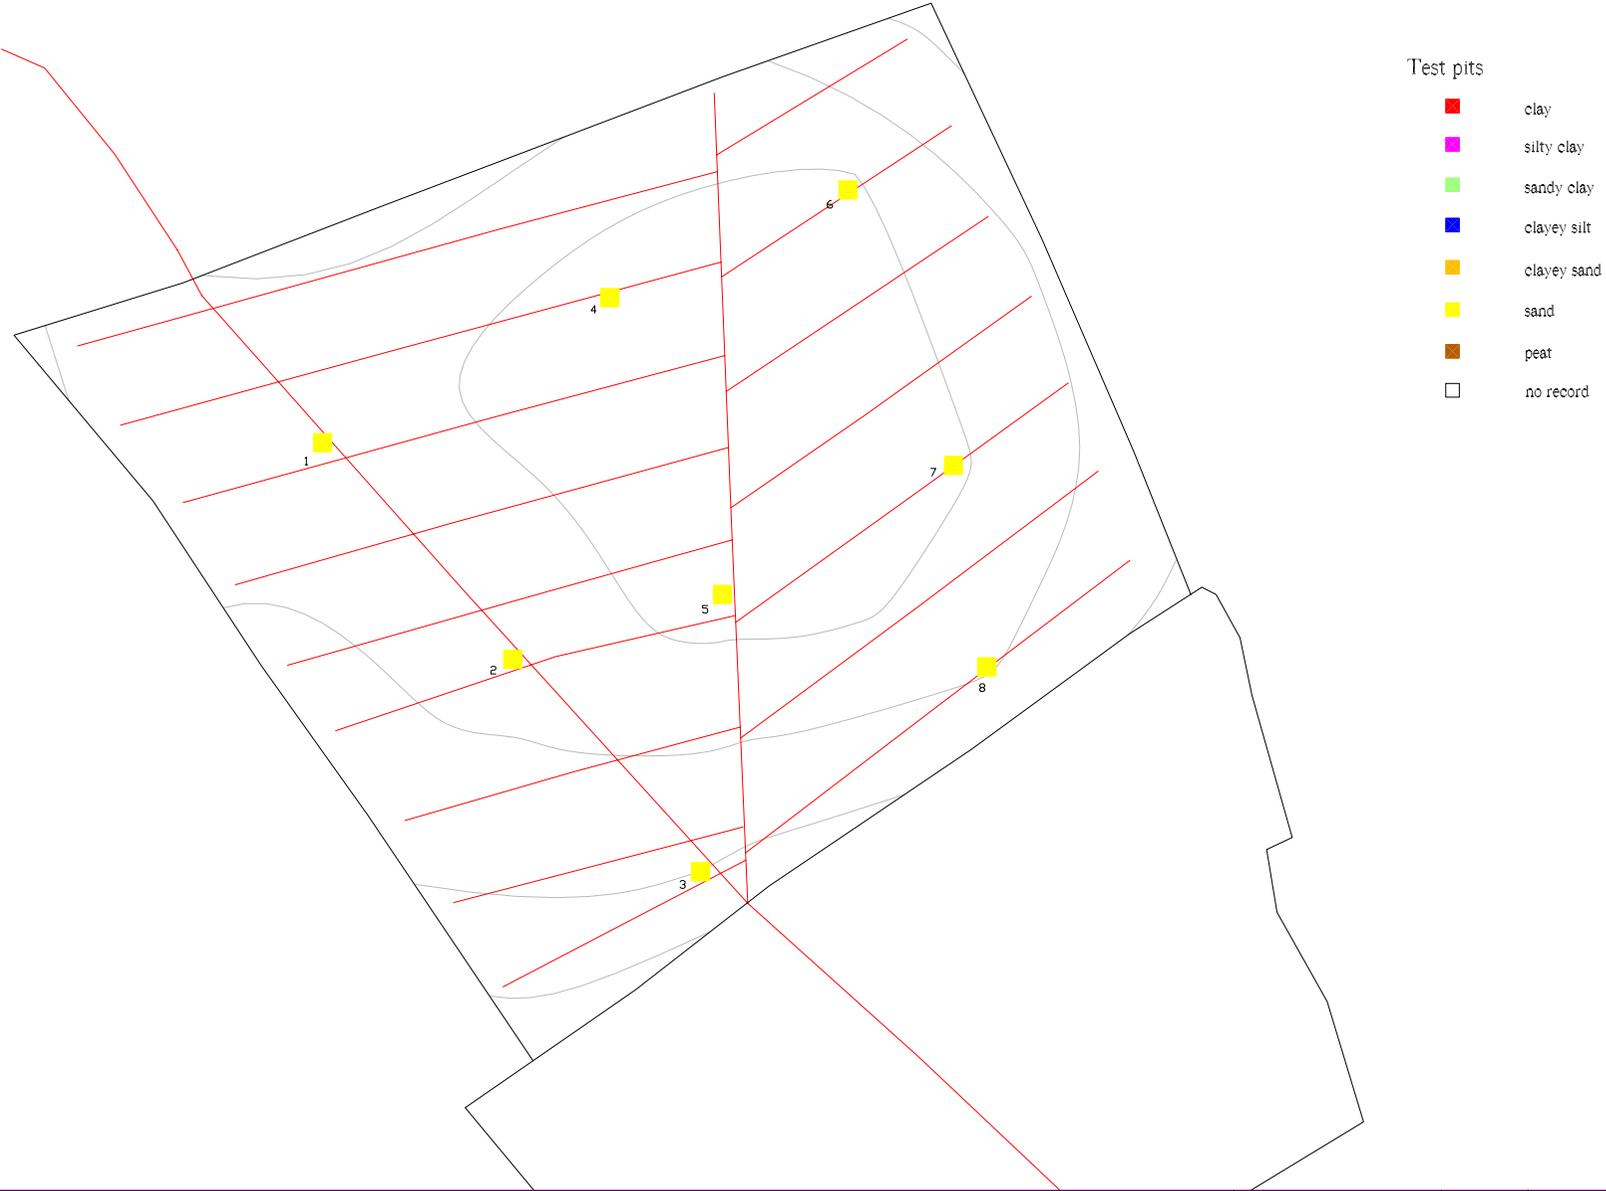
Figure 6

This field is part of Park Farm, and is bordered by Field 1 to the south, by a dyke to the north, Skipwith Little Common to the east and residential housing to the west (Fig.1). The ground surface drops by 0.86m towards its centre. The drainage scheme affected the whole field, covering a length of 1.37km (Fig.6).

Plan of Int.23 Field 2

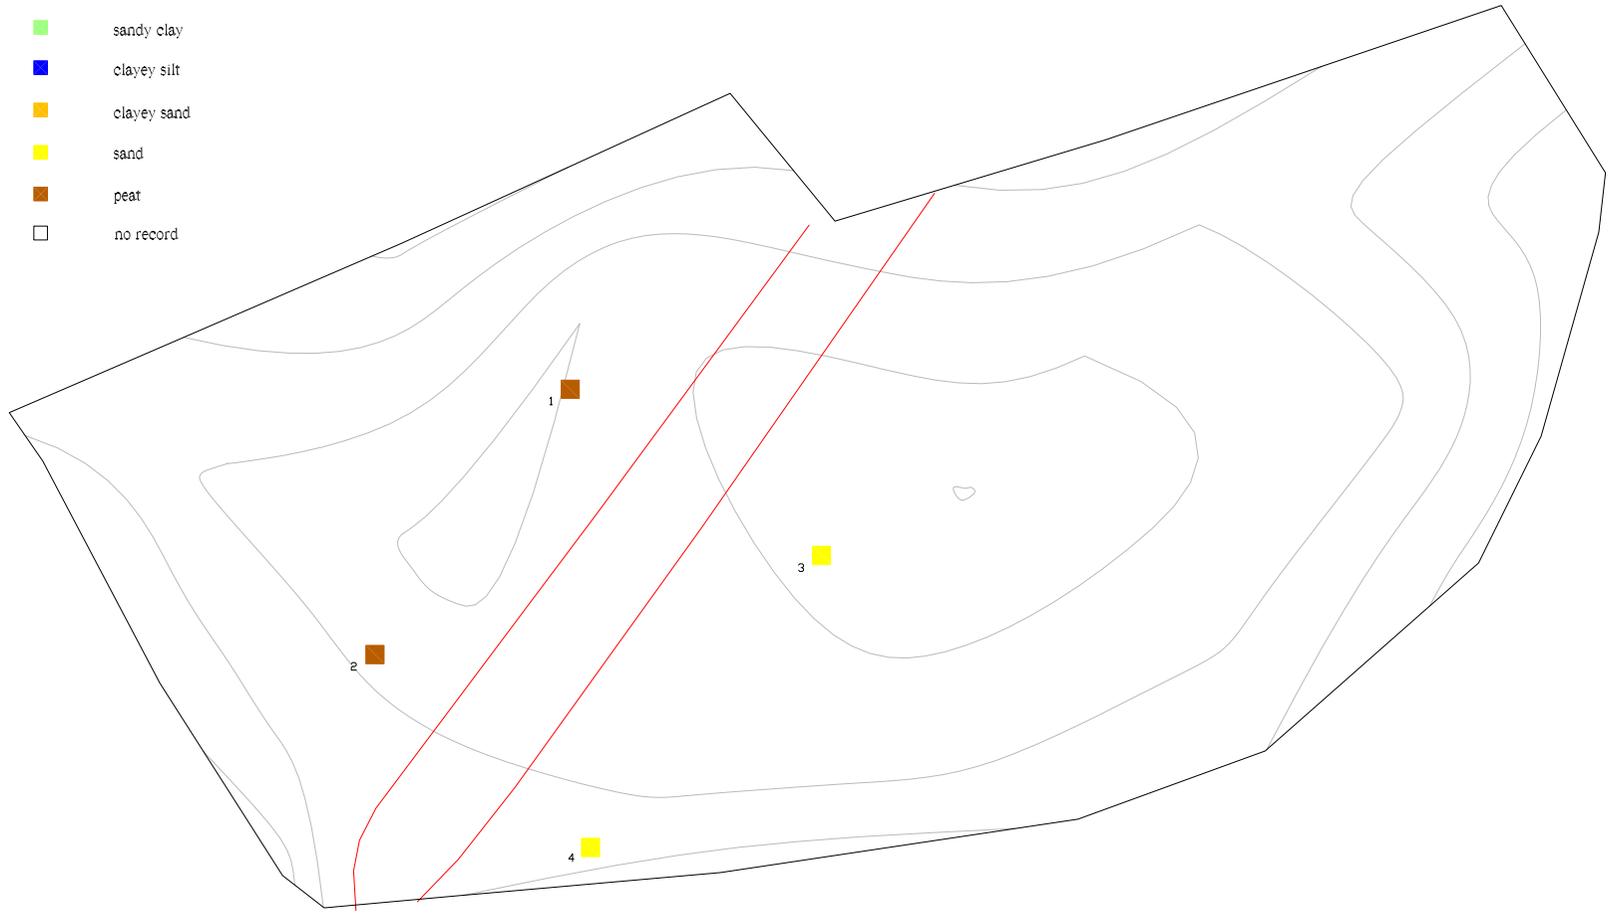
Figure 7

A sandy subsoil was observed in the eastern part of the field (Fig.7). Test pitting revealed a substantial deposit of windblown sand, between 0.35 and 0.73m thick (Appendix A, Table 6). Interestingly, TP 1 and TP 2 in the western part of the field revealed a deposit of peat beneath the

Plan of Int.23 Field 3

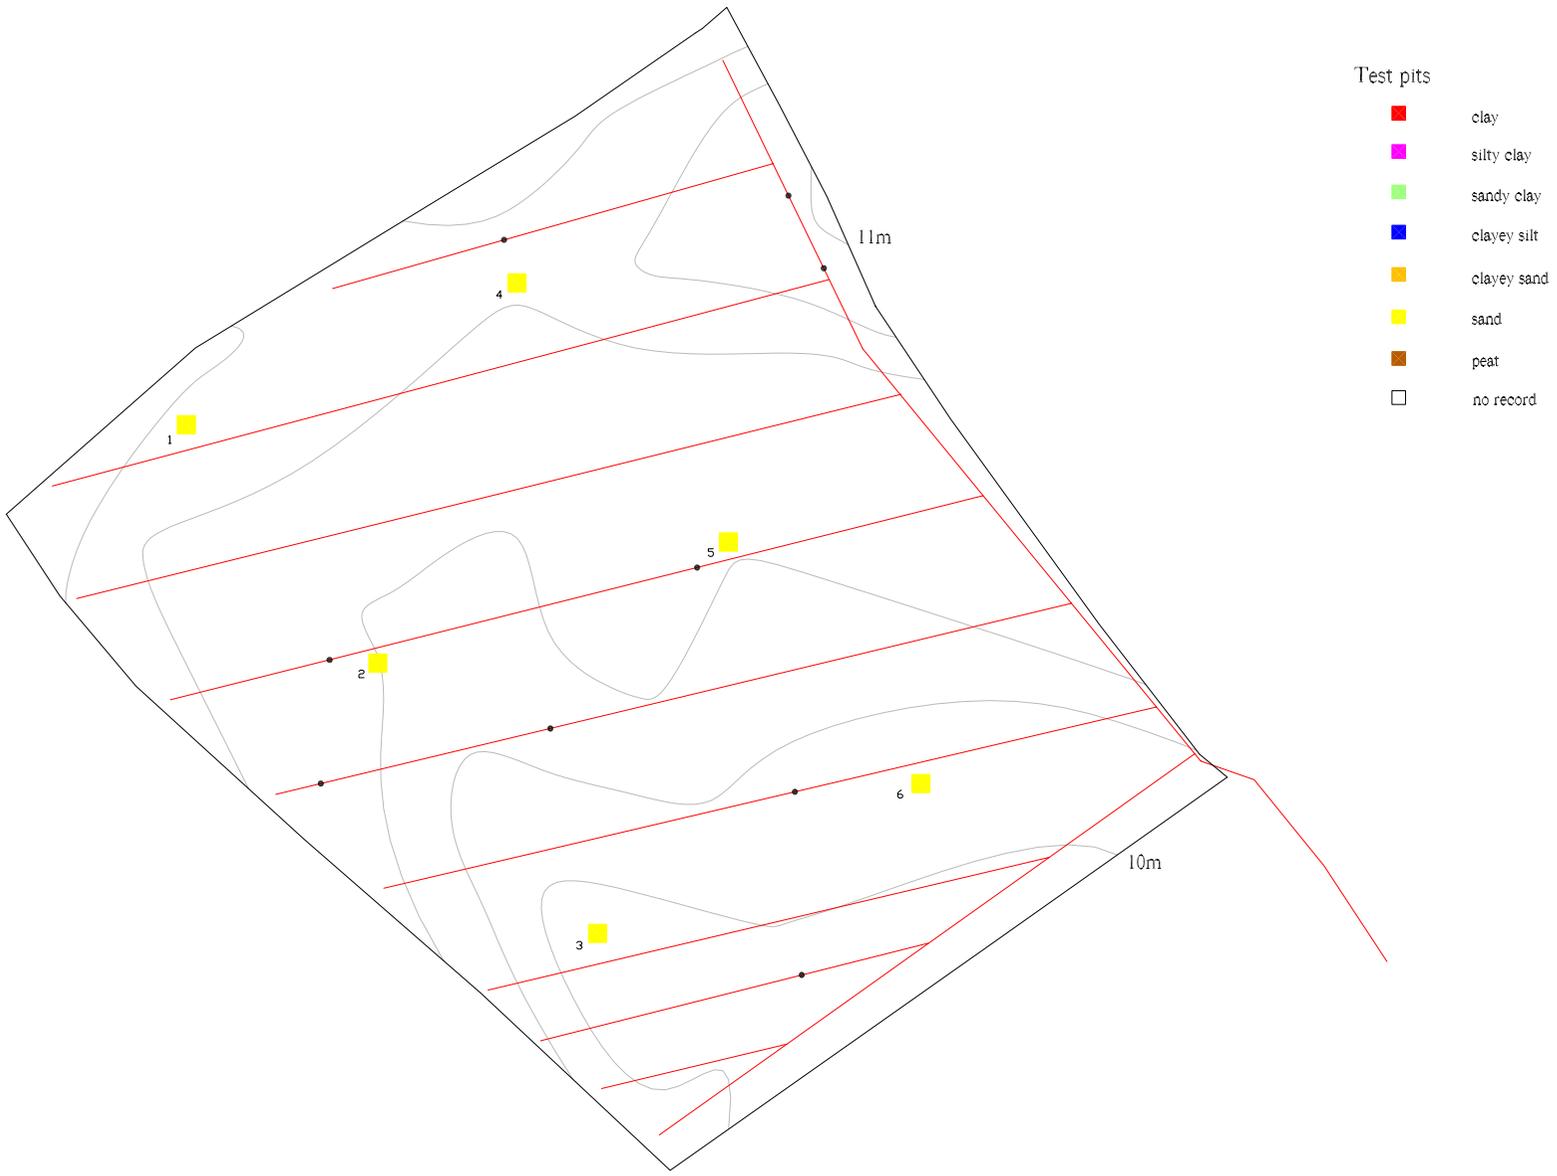
Figure 8

Plan of Int.23 Field 4

This field forms part of School Farm and is bordered by the Oak Mere Farm caravan park to the north, the main Escrick road to the west, and residential housing to the south (Fig.1). Its ground surface drops southwards by 1.14m. A drainage scheme covering the whole field was installed (Fig.8), with a total length of 1.20km.

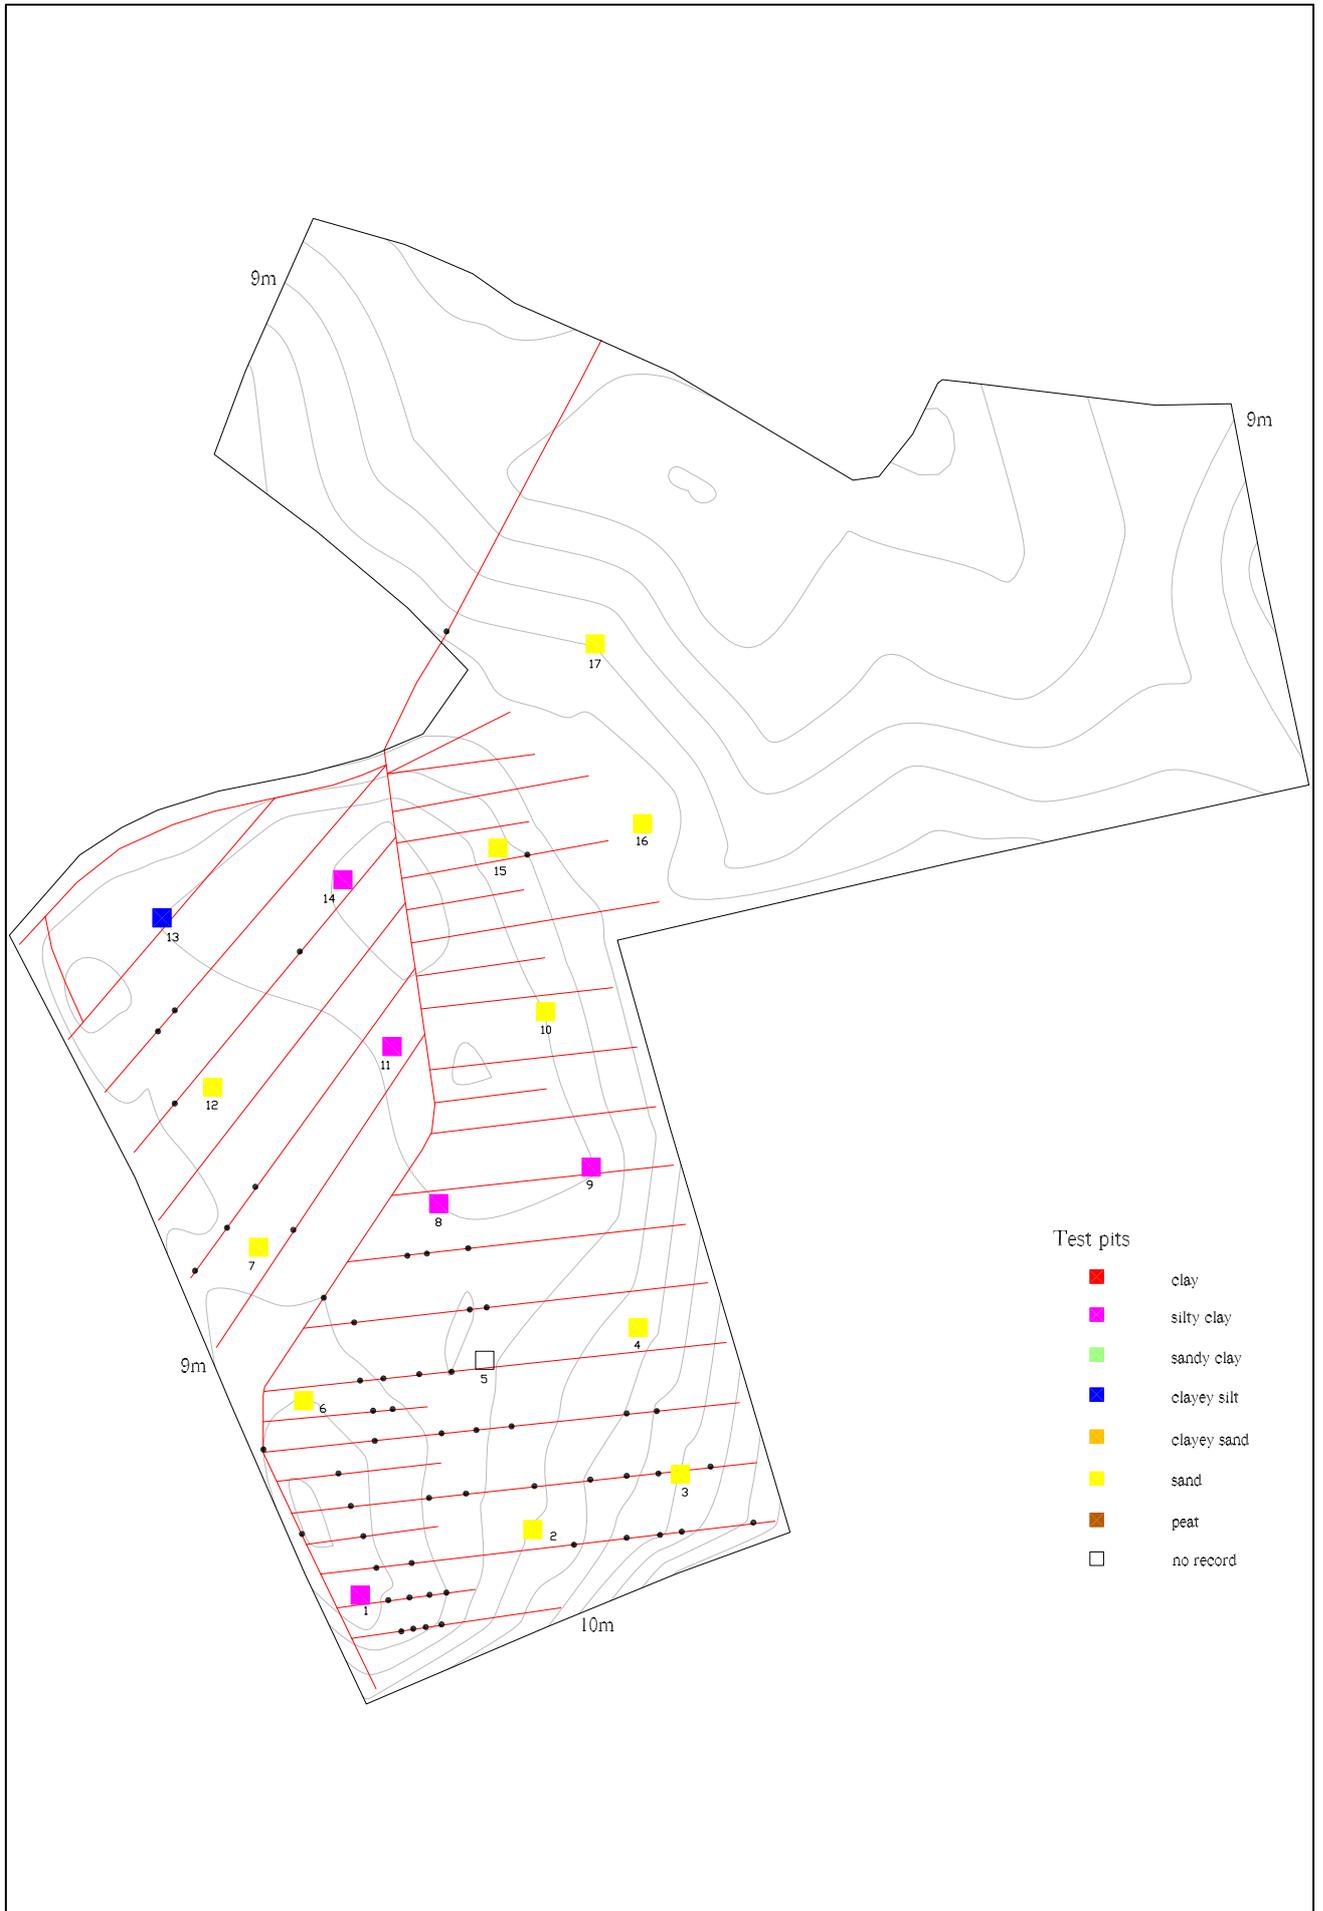
Figure 9

Plan of Int.23 Field 5

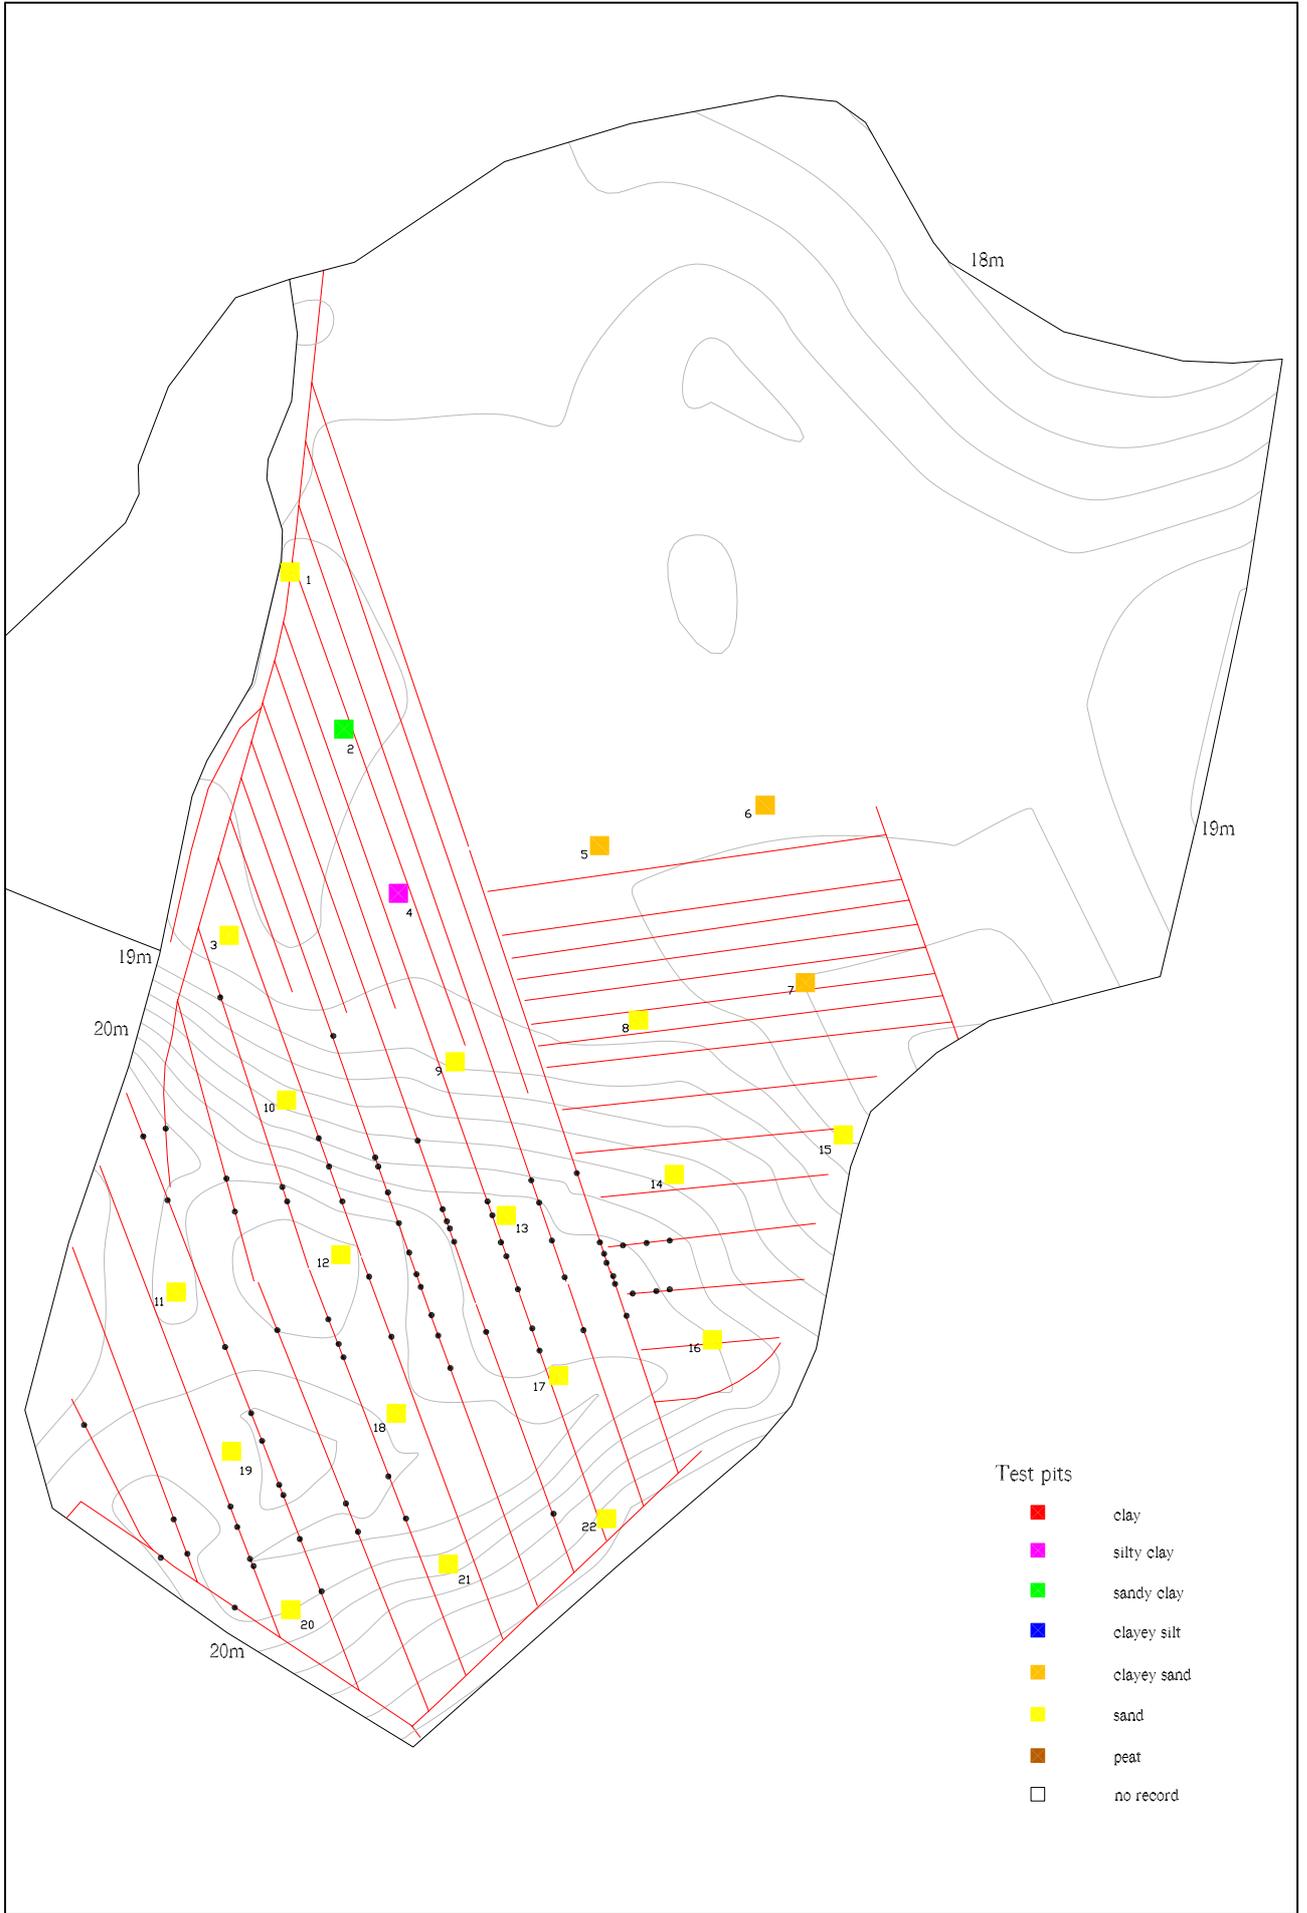
Figure 10

Plan of Int.24

The test pits revealed a sandy subsoil on the higher ground, and silty or sandy clay on the lowest ground, while a clayey sand was noted in TP 5, TP 6 and TP 7 (Fig.10) Subsoil was not contacted in TP 5, where a drain was encountered at 0.40m (BGL). Only four test pits contained aeolian deposits (TP 10, 11, 13 and 22). These were between 0.02m and 0.20m thick (Appendix A, Table 9).

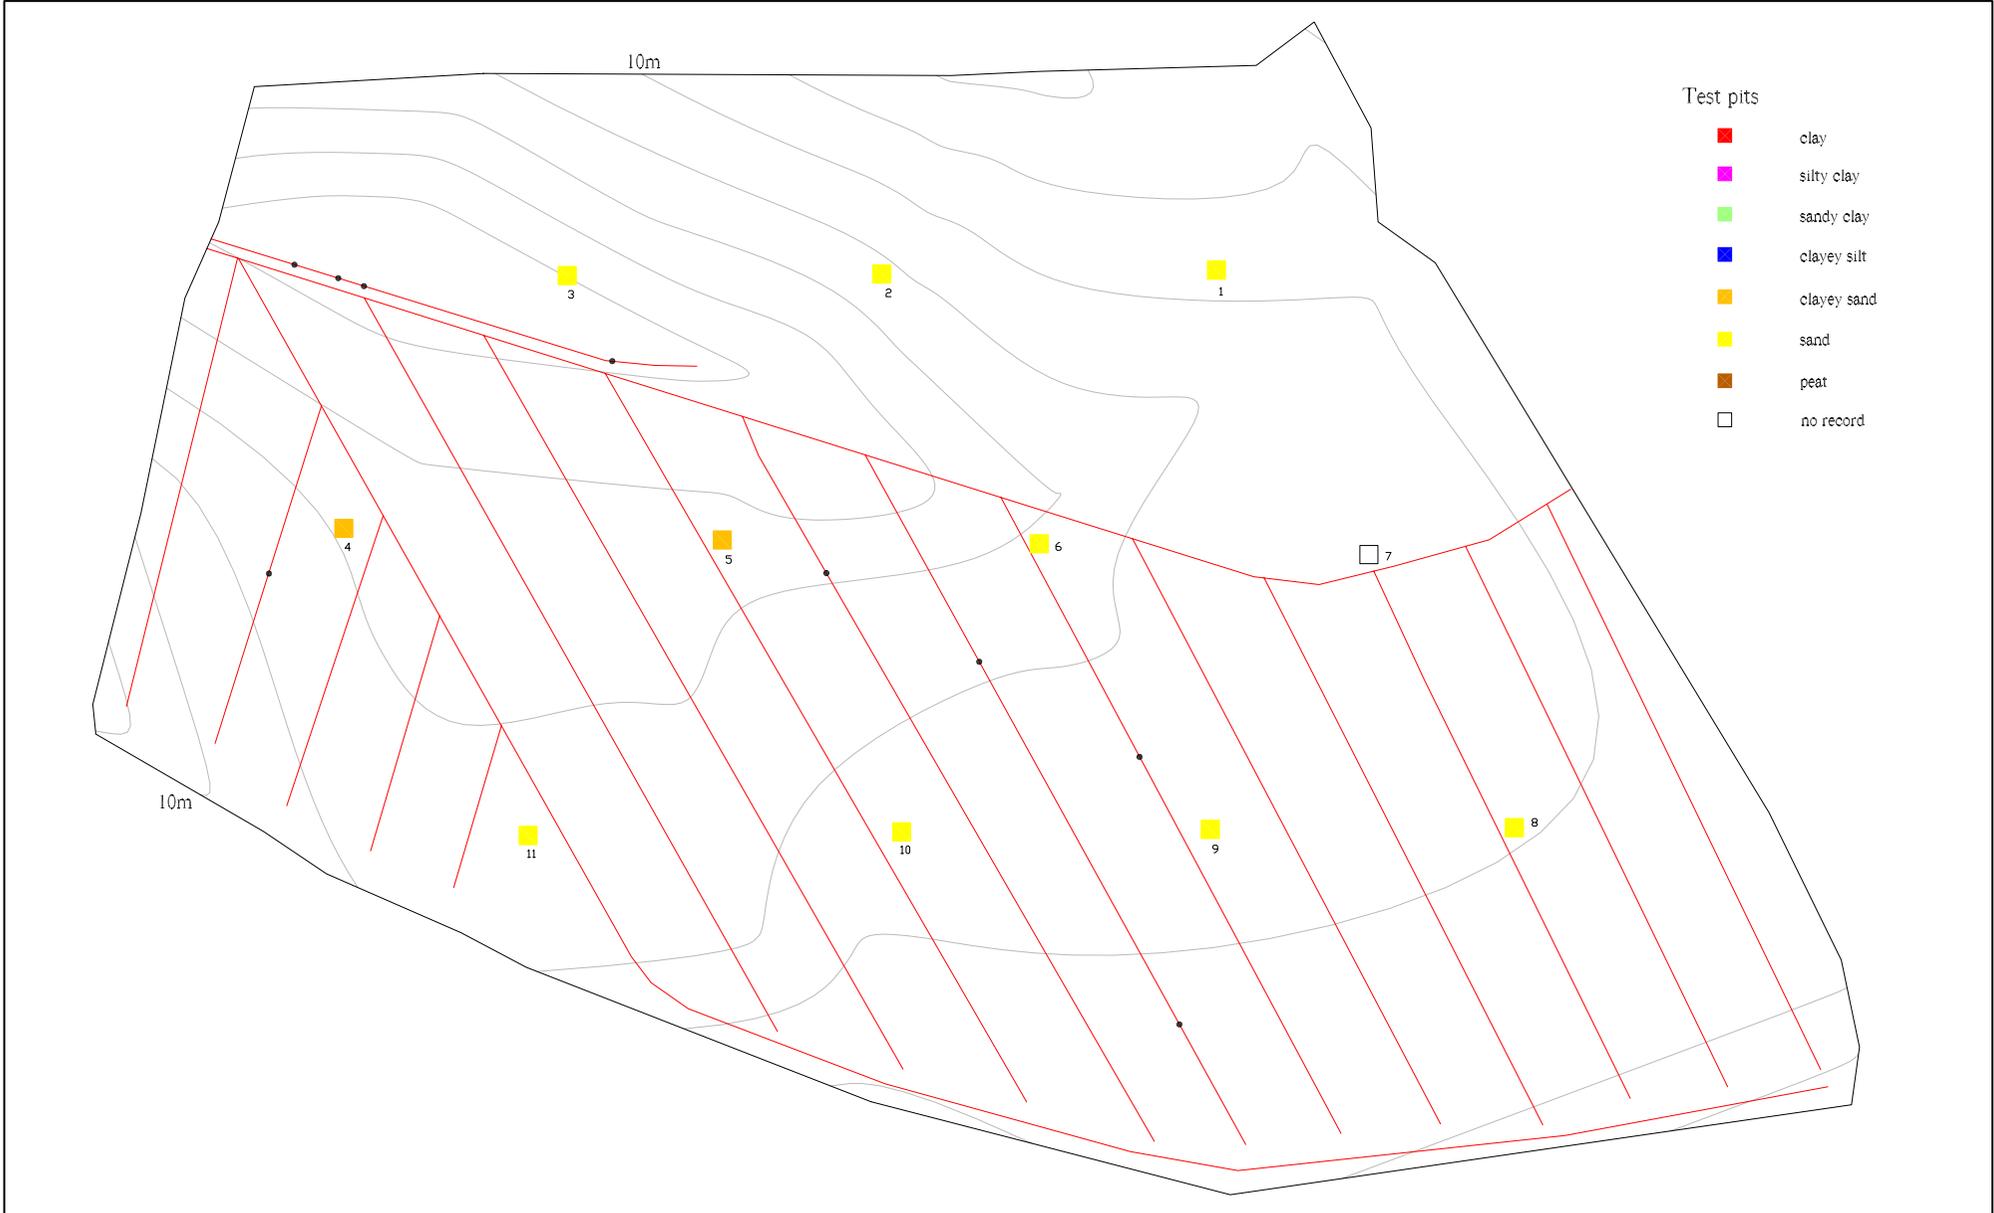
Figure 11

Plan of Int.25 Field 1
