ARCHAEOLOGICAL WATCHING BRIEF
STANLEY MAIN
SKIPWITH

SITE CODE : STM 01
NGR: SE663385

REPORT
October 2001

Client: UK COAL MINING LTD
Harworth Park
Blyth Road
Doncaster
DN11 8DB

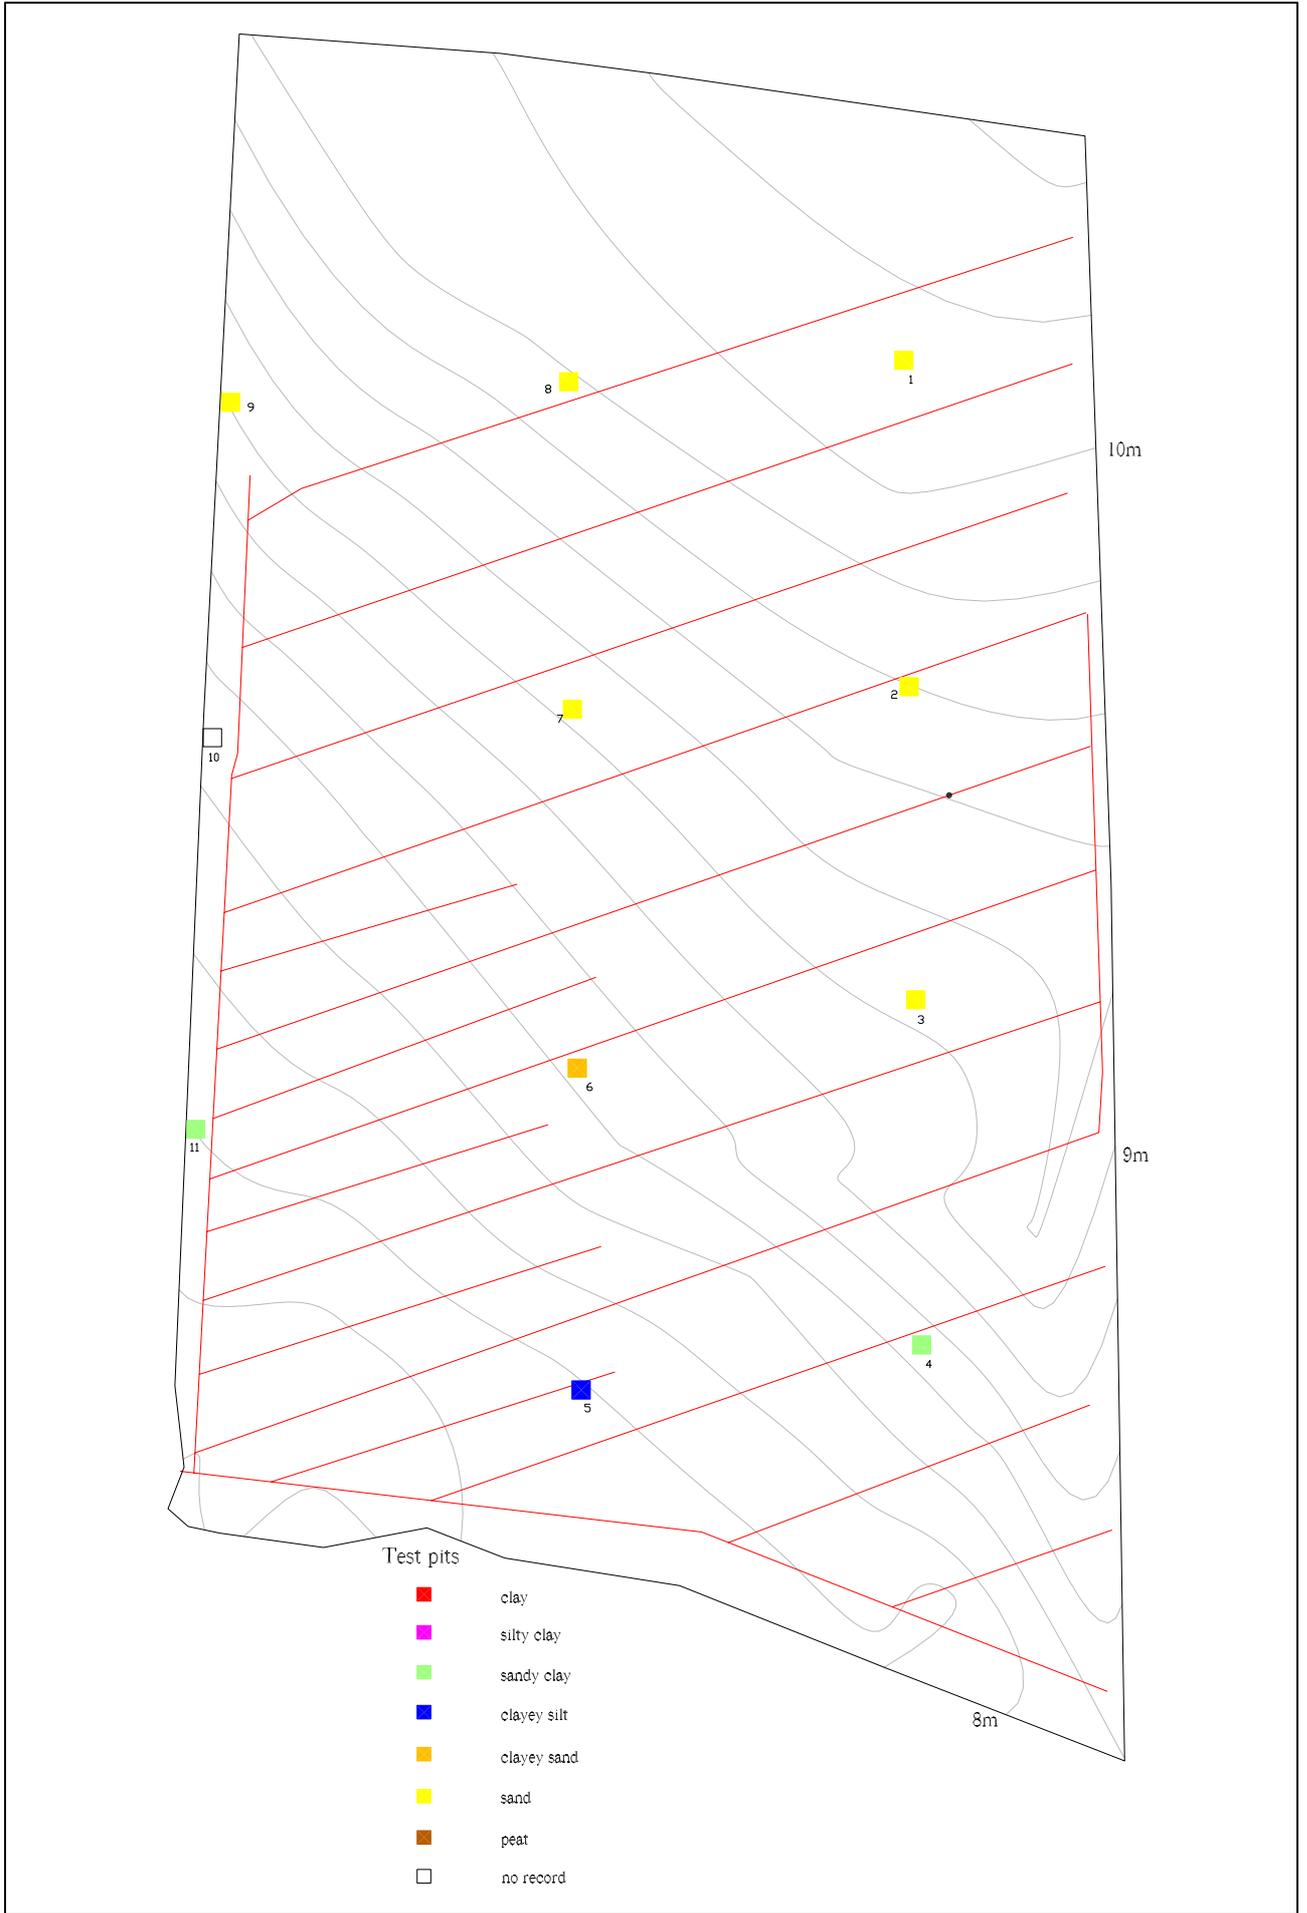
Figure 12

The subsoil consisted of a sandy or silty clay the south and sand across the remainder of the field (Fig.12). TP 6 revealed a clayey sandy subsoil, while subsoil was not encountered in TP 10, which contained an old field drain at 0.52m. Test pitting revealed deposits of windblown sand in all but three test pits in the southwestern corner of the field. The thickness of the deposits was relatively uniform, ranging from 0.20m to 0.34m (Appendix A, Table 11). Only one archaeological feature was observed in the eastern part of the field.

Plan of Int.25 Field 2

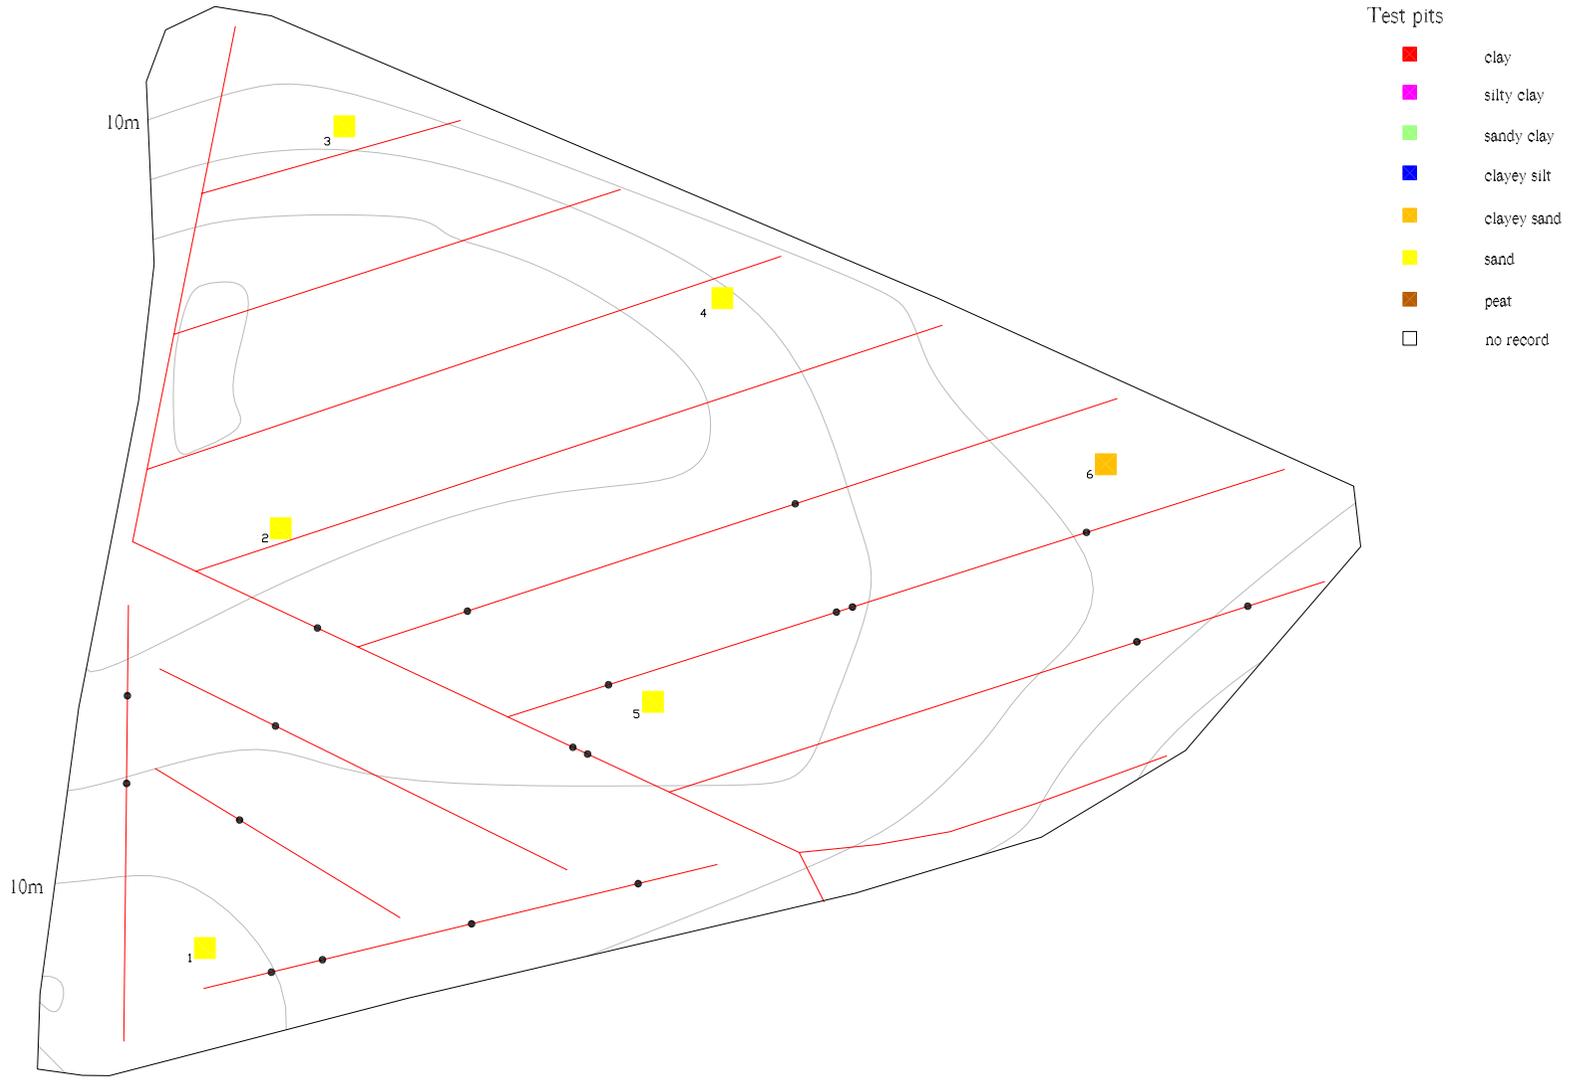
Figure 13

Plan of Int.25 Field 3

Test pitting revealed a sandy subsoil, except in TP 6 (Fig.13), which contained a clayey sand. The subsoil was covered throughout the whole field by aeolian sands, which were between 0.15m and 0.33m thick (Appendix A, Table 12), with no apparent distribution pattern. Nineteen archaeological features were encountered in the southern half of the field.
