Park House

Stanwick Park

Archaeological Watching Brief

**Park House, Appleby Lane, Stanwick Park, Richmond DL11 7RP
Single Storey Extension Planning Decision No. 1/43/7N/FULL**

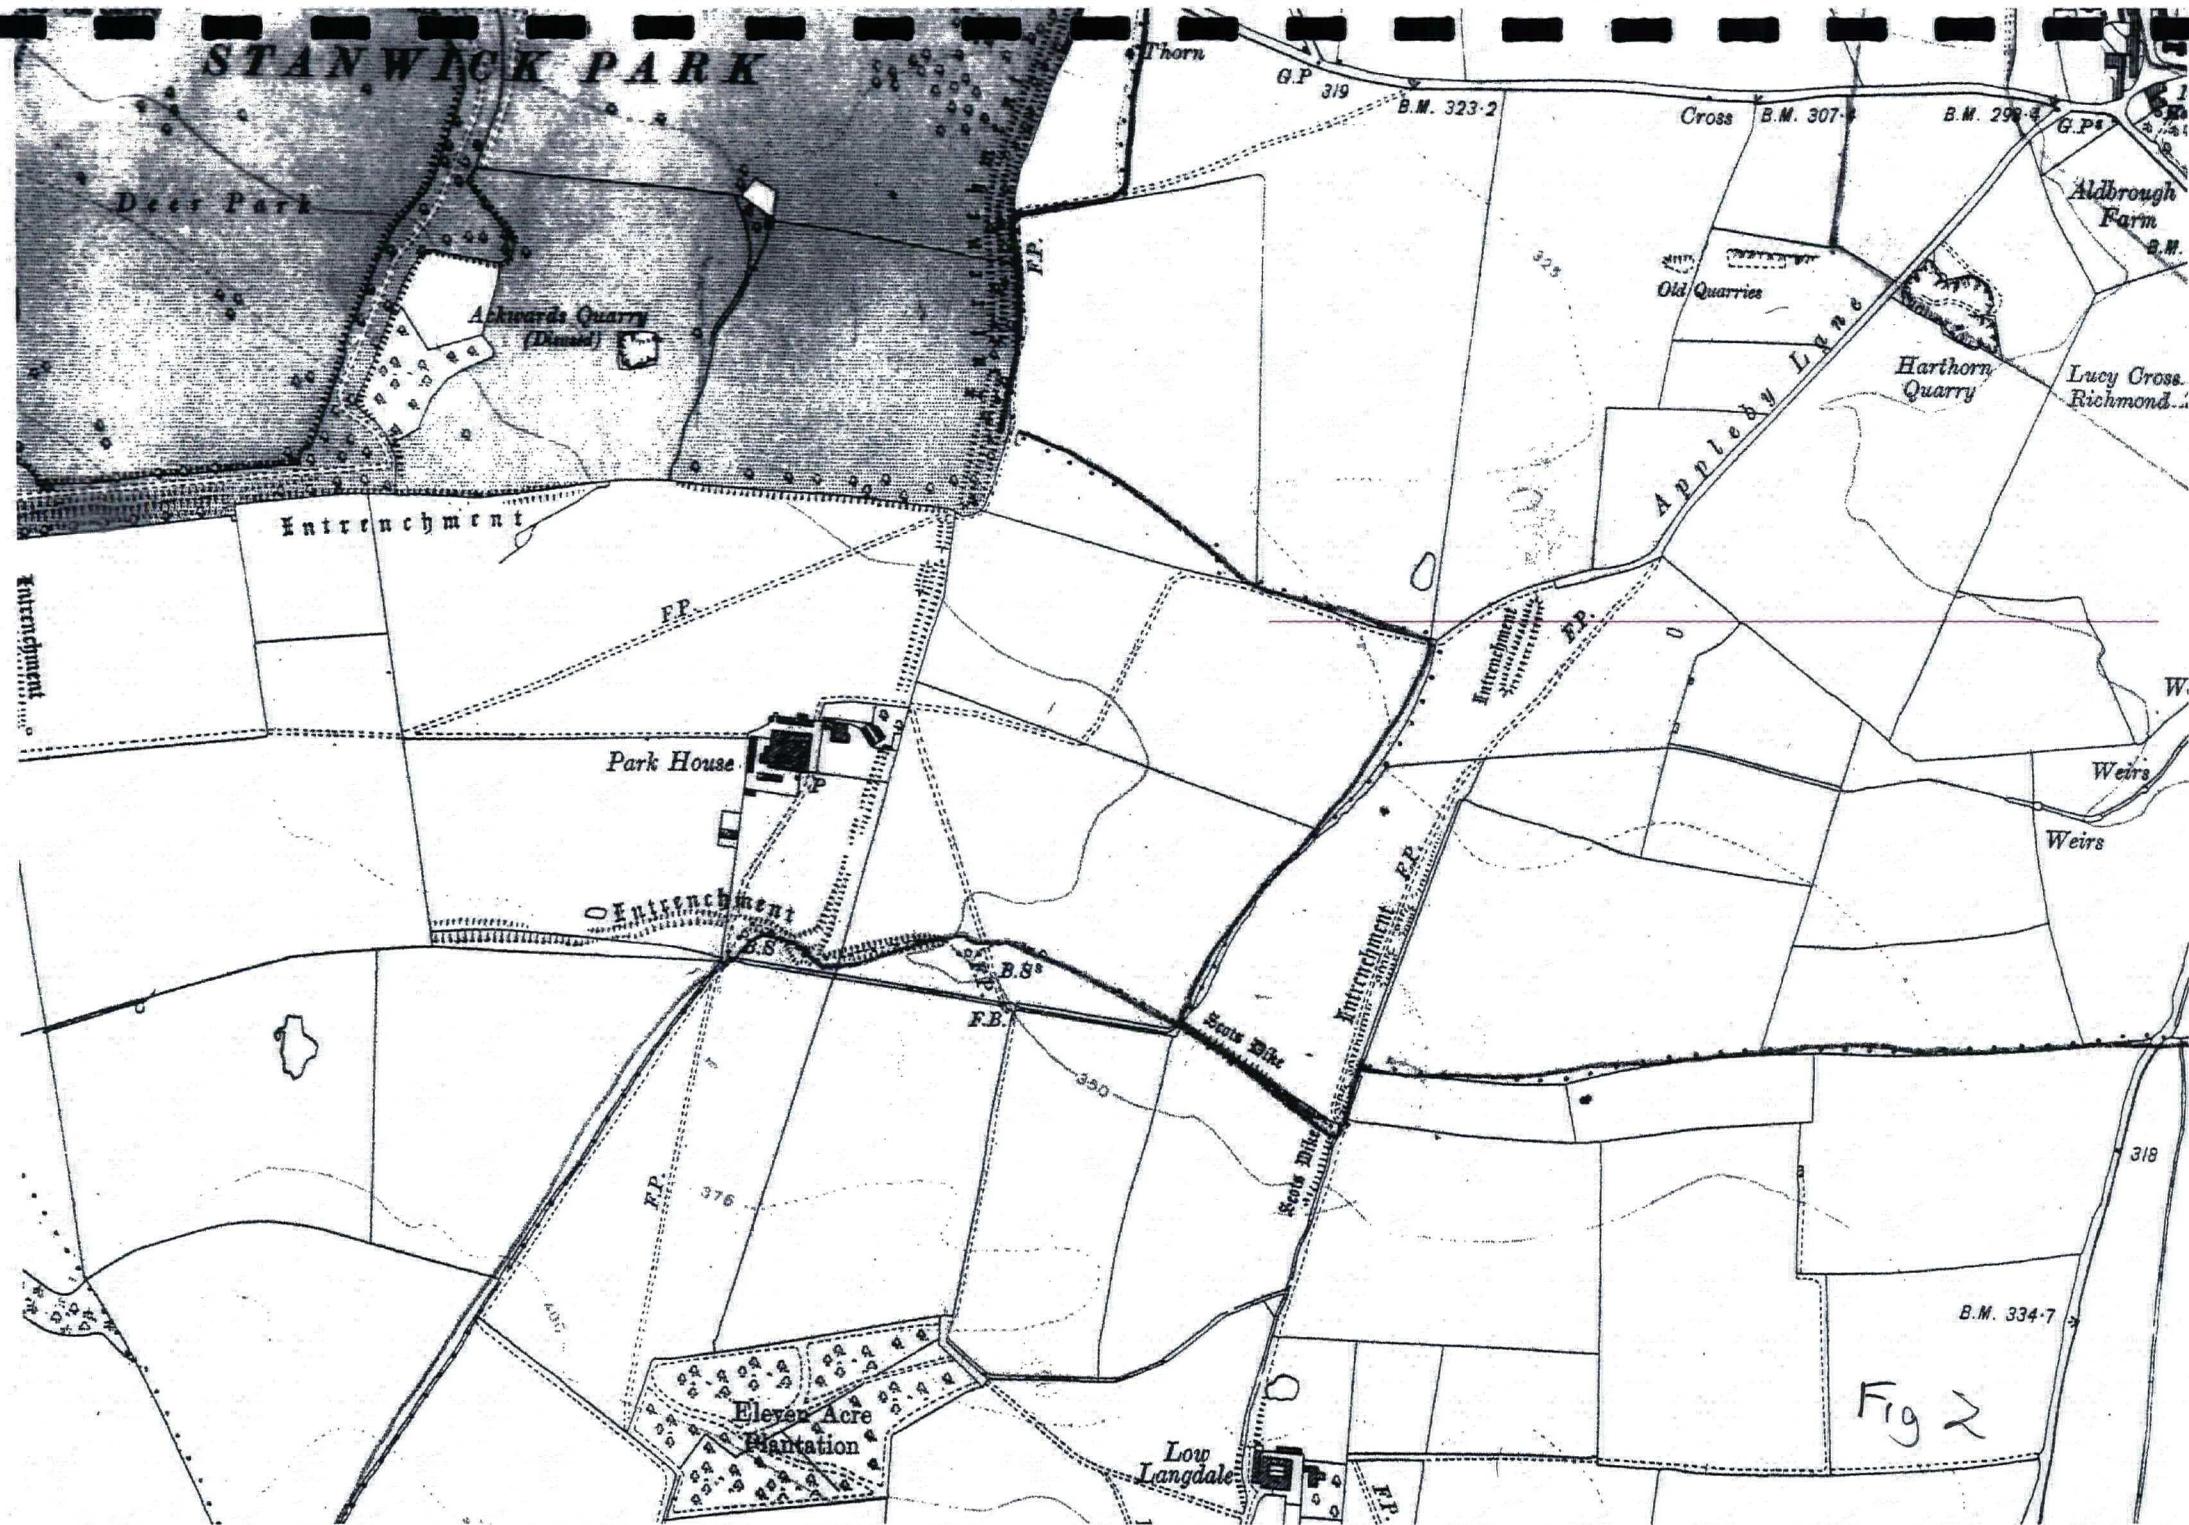
Fig. 2. *U. D.*

Fig 2. 6" OS map sheet 25 dated 1857. NYCRO reference MIC 1831/202

Map evidence indicates the presence of a range of small domestic buildings in this area in the 19th century (Figs 1 and 2). The demolition of these probably provided the material for the makeup of the gravel and paved path.

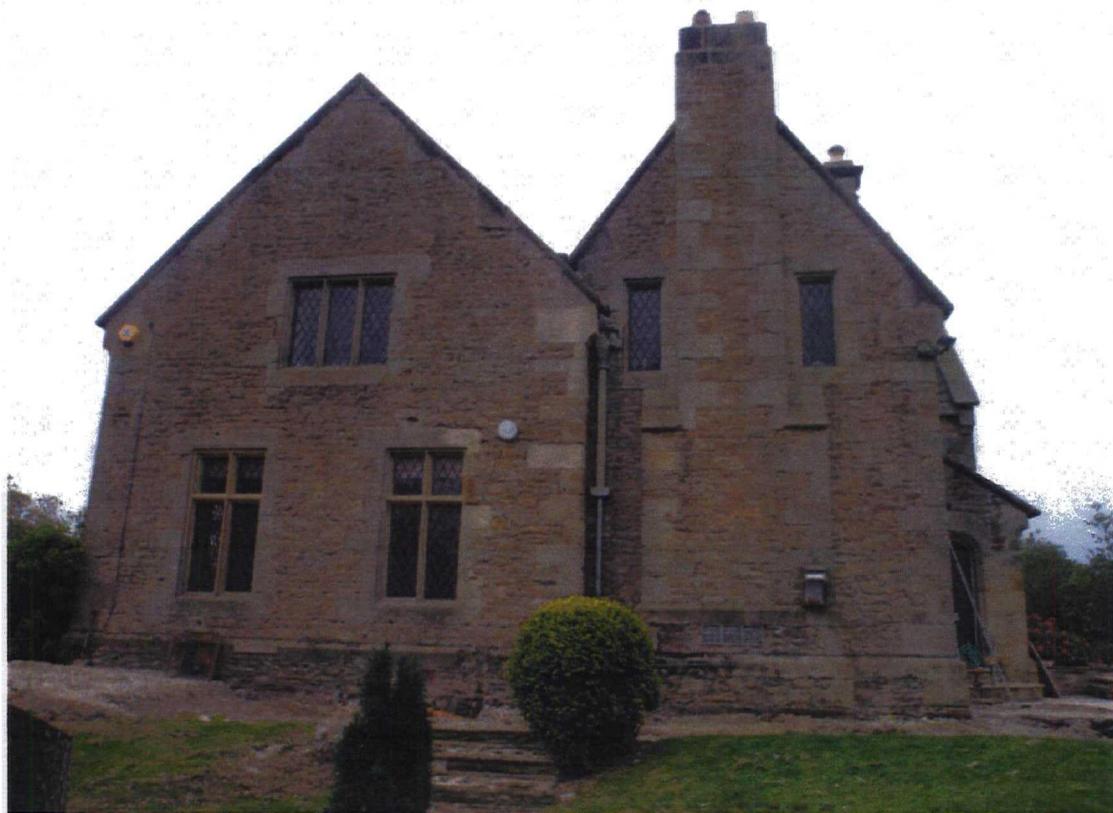
Fig 3. Park House, Stanwick Park. North elevation.

Park House was included on the statutory list of Listed Buildings at Grade II in May 1987 (UID 323409). Further details may be viewed on the National Heritage List website. It was constructed in 1847 for the Duke of Northumberland, of sandstone rubble with ashlar dressings and Westmorland slate roofs. The house is of similar style and quality to 3 other houses of the same period on the estate, which together form an important group. (Fig 3)

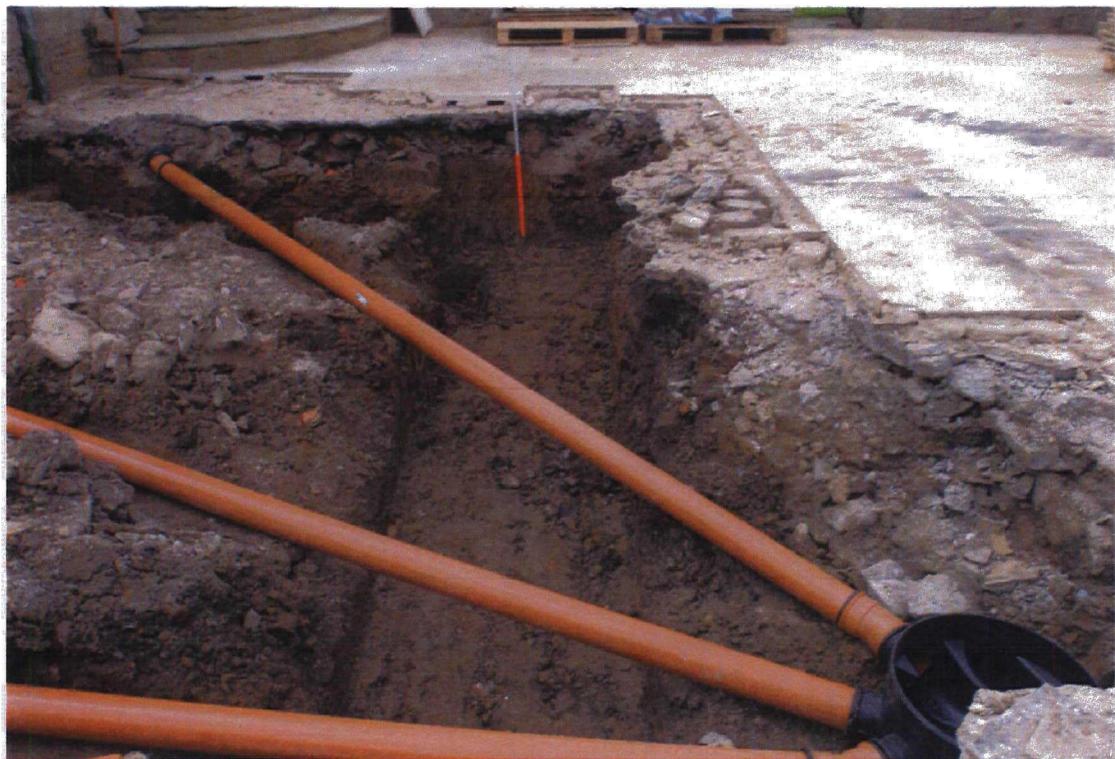
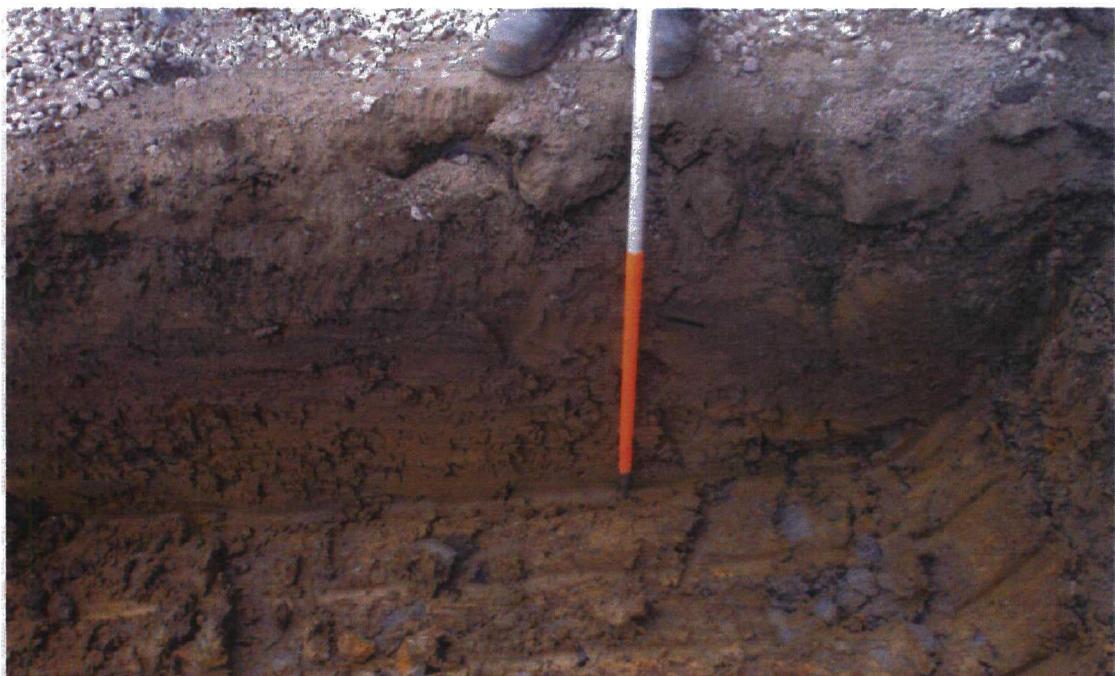
Fig 4 & 5 (below). Park House, Stanwick Park, showing the foundation trenches cut through building rubble overlying clay.

The archaeological watching brief took place on August 1st 2011. The planning consent was for a large conservatory extension on the north side of the house. The dimensions for this were 13m west-east by a maximum of 7m north-south, and the ground disturbance included the excavation of foundation trenches and the replacement and extension of existing drains (Figs 4 & 5). All excavation work was undertaken by mechanical excavator and hand-finished as necessary.

The underlying sub-soil in this area is clay, possibly of glacial origin, of a brownish-ginger colour with a few stone inclusions; these had decayed anaerobically to a dark grey and were friable. For a width of approximately 4m adjacent to the north side of the house this subsoil was overlain with a building rubble and cement makeup to a depth of approximately 300mm, supporting a gravel and paved path of late 20th century date. No finds other than broken brick and some fragments of iron were recovered from this area, and none dated to a period earlier than the early/mid 19th century.

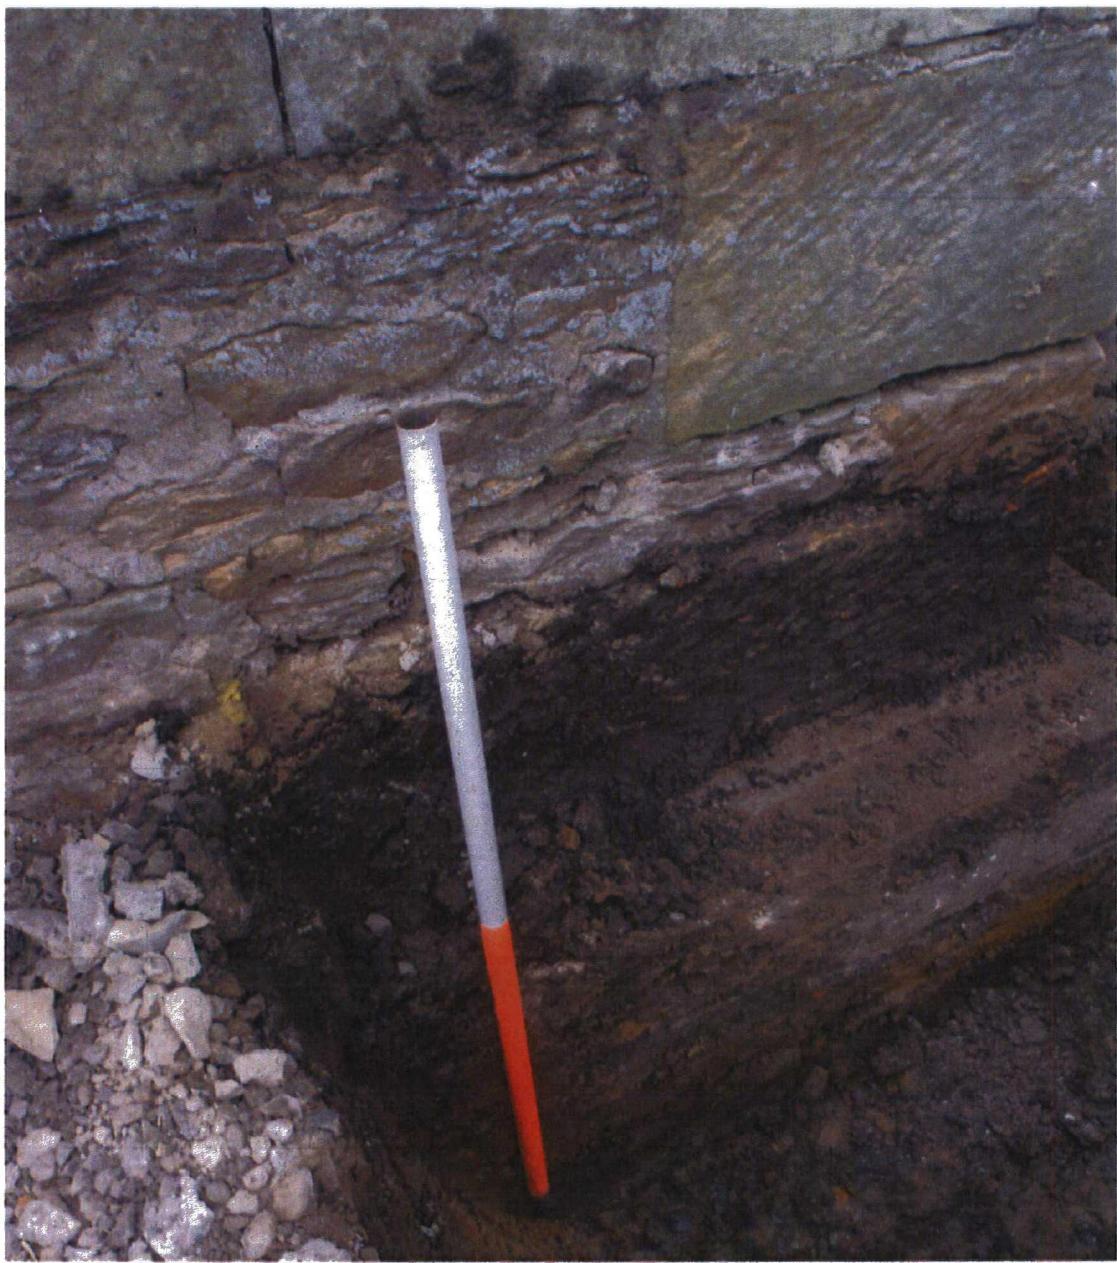
Fig 6 . Park House, Stanwick Park. The north-east corner of the house, showing the offset stone plinth overlying a white-flecked grey concrete foundation.

Excavations close to the house revealed that the building's walls were supported on wider stone plinth foundations, which were constructed on stone slabs approximately 100mm thick, which in turn overlay a layer of mortar or cement which was also approximately 100mm thick. (Fig 6)

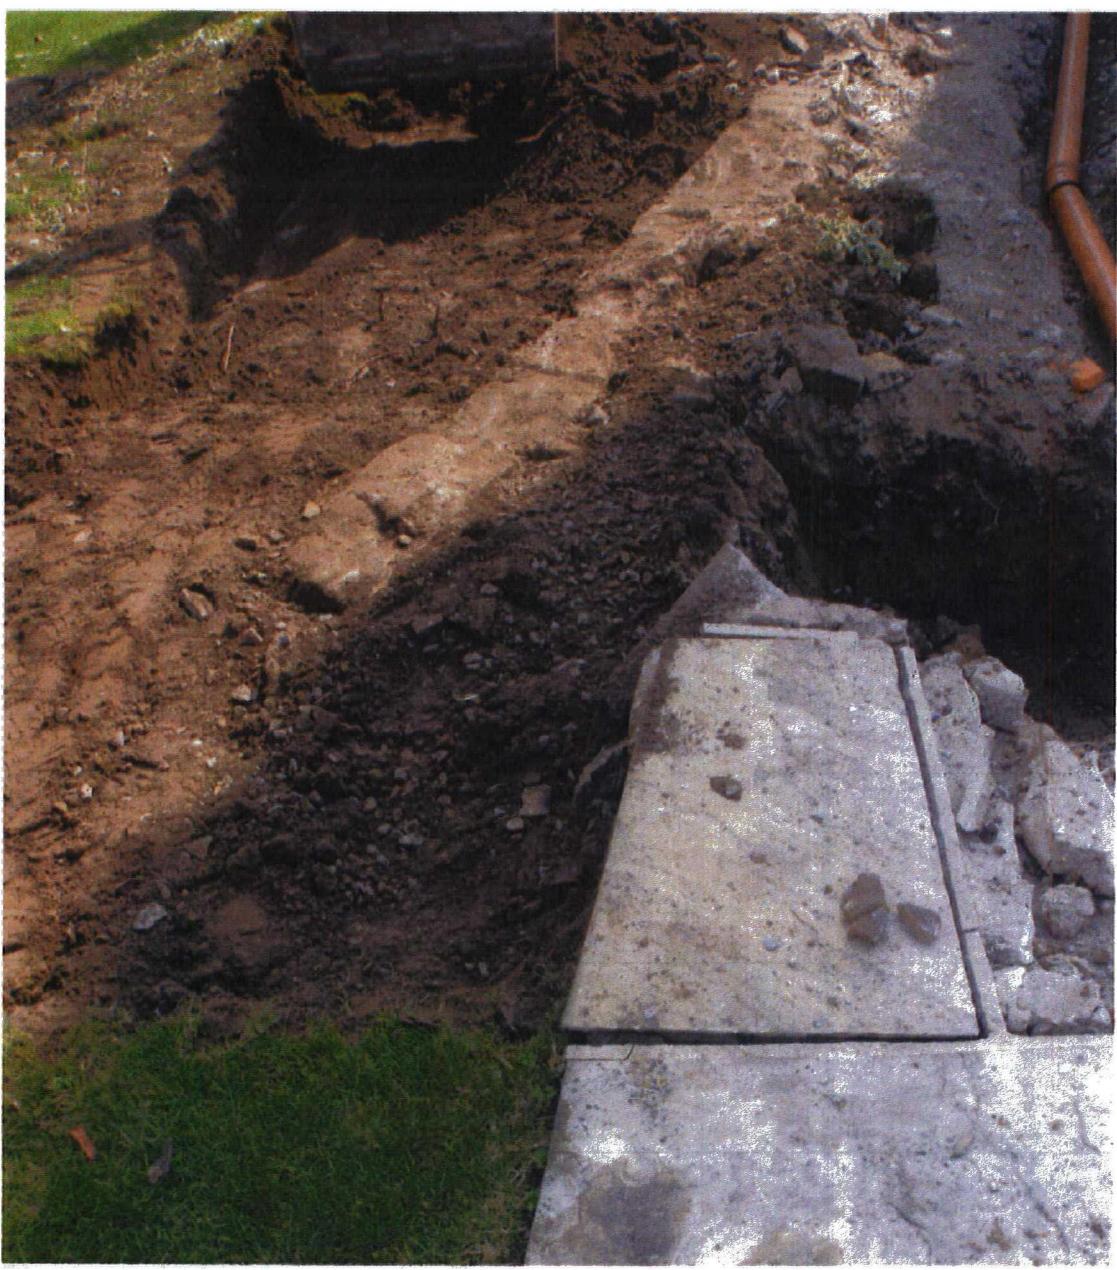
Fig 7. Park House, Stanwick Park. The stone edging of the lawn in the mid-20th century garden, revealed during machine excavation.

Beyond the paved area the ground sloped downwards, and the subsoil was overlain by a dark brown humic garden soil underlying turf. Towards the west end of this a curved line of roughly-dressed stones was preserved in the soil. (Fig 7). This seems to represent an earlier boundary between the lawn and a parking area which is shown on mid-20th century maps dating between 1930 - 1954. These are still in copyright so are not reproduced here; they can be viewed at:
