LOWER DUNSFORTH FLOOD ALLEVIATION SCHEME,  
AN ARCHAEOLOGICAL WATCHING BRIEF.

ON BEHALF OF RKL-ARUP  
OSA REPORT: 98WB03

National Grid Reference: SE 443 648

June 1998

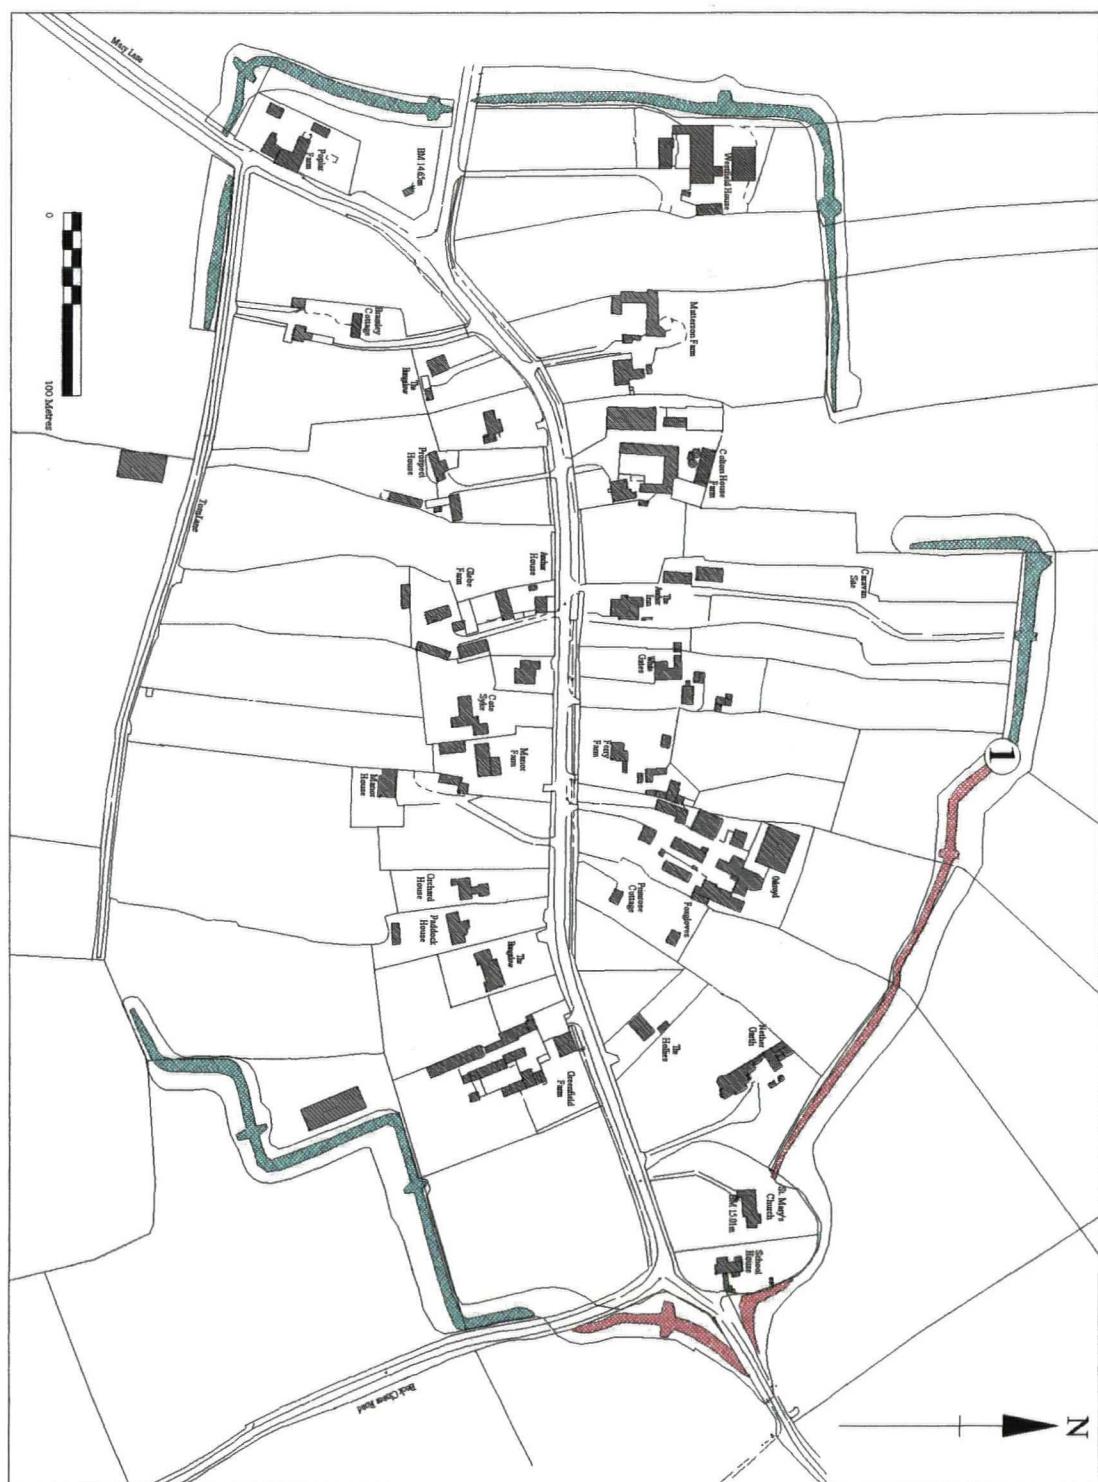
Figure 2:

A single area of archaeological potential was observed. (see location 1 circled on Figure 2 and plates 1 and 2).

Figure 2. Location of areas monitored during watching brief.

The removal of the topsoil was the subject of this archaeological watching brief. Over much of the length of the bund a bulldozer was used to remove the topsoil. In the event it was agreed that this was not the ideal machine to use if it was the intention to observe archaeological features. It was deemed that the watching brief should take place in those areas to either side of the church marked in red on Figure 2. Within these limits a back acting 360 degree tracked excavator (a hymac) was used to remove the topsoil. Unlike a bulldozer, this machine allowed the archaeologist present the opportunity to view the exposed surface before it was tracked over, thus ensuring any features present would be visible. Elsewhere it was decided by the County Heritage Unit that it was only necessary to undertake an intermittent watching brief. In these areas, marked black on figure 2, the choice of machine was left to the engineering contractor, H. J. Banks.

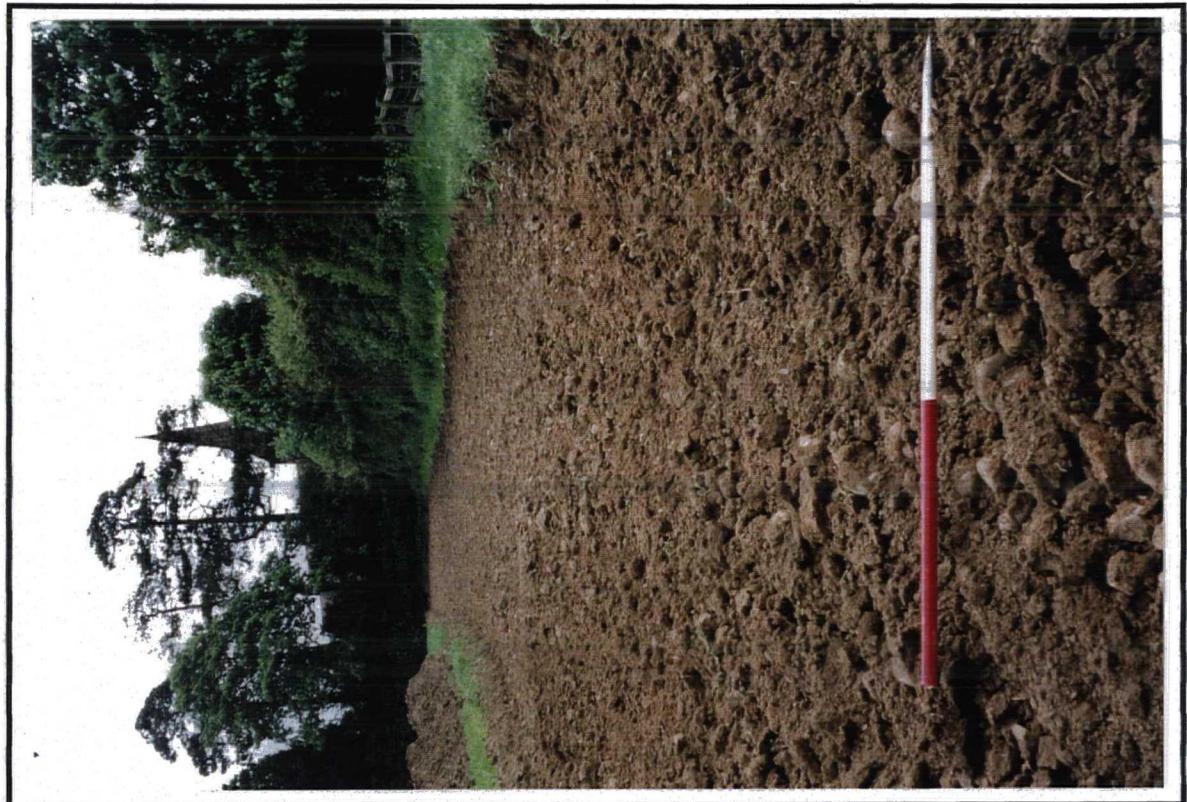
This comprised an area approximately 60 metres in length in which the topsoil across the full width of the easement contained a considerable quantity of large and medium sized rounded cobbles. These were present lying loosely within the soil and did not comprise a well constructed in situ feature or surface. No dating evidence was found associated with this material.

The presence of such a relatively large quantity of cobbles gives rise to perhaps two possible explanations. Either the presence of ploughed out road metalling or simple field clearance.

Plate 1. Cobble feature, looking east (scale of 1 metre).

Given the lack of other evidence it seems perhaps more likely that this cobble spread is in fact field clearance of indeterminate date.

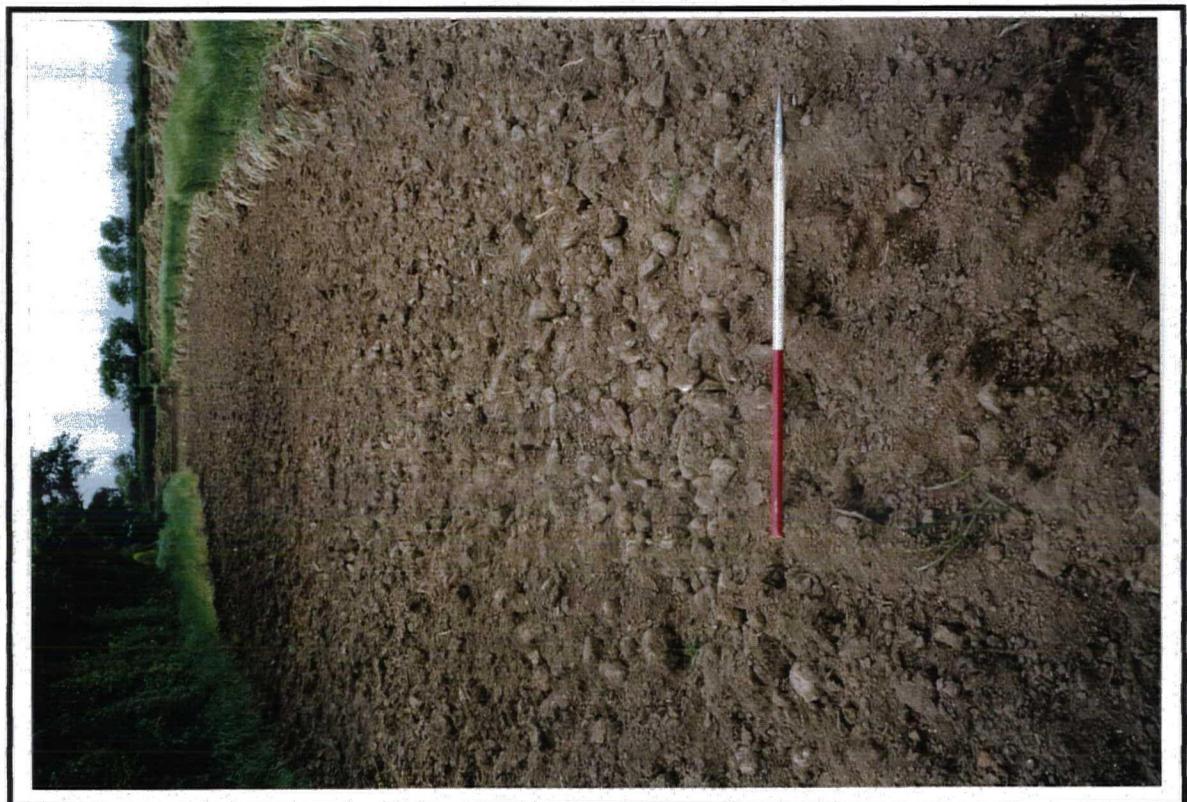
Plate 2. Cobble feature, looking west (scale of 1 metre).
