AN ARCHAEOLOGICAL EXCAVATION

35 CASTLEGATE, SCARBOROUGH

INTERIM REPORT 18

by TREVOR PEARSON

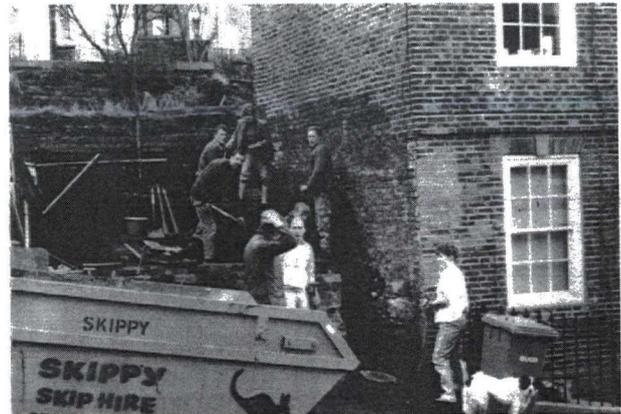
Plate 1 Removing the overburden from the site

The decision was then taken in consultation with the site owner to remove all the overburden between the trench and no 35 Castlegate before investigating the medieval deposits further. However it was deemed unwise to remove the equivalent overburden in the opposite direction up to the northern boundary of the site for fear of the instability this might have introduced to land further up the hill, including Castle Crescent itself. The north of the site was therefore not touched but was used to dump some of the ten cubic metres of overburden which was removed by hand to expose the medieval remains over the south of the site. The remainder of the overburden was dumped into a succession of skips (Plate 1).

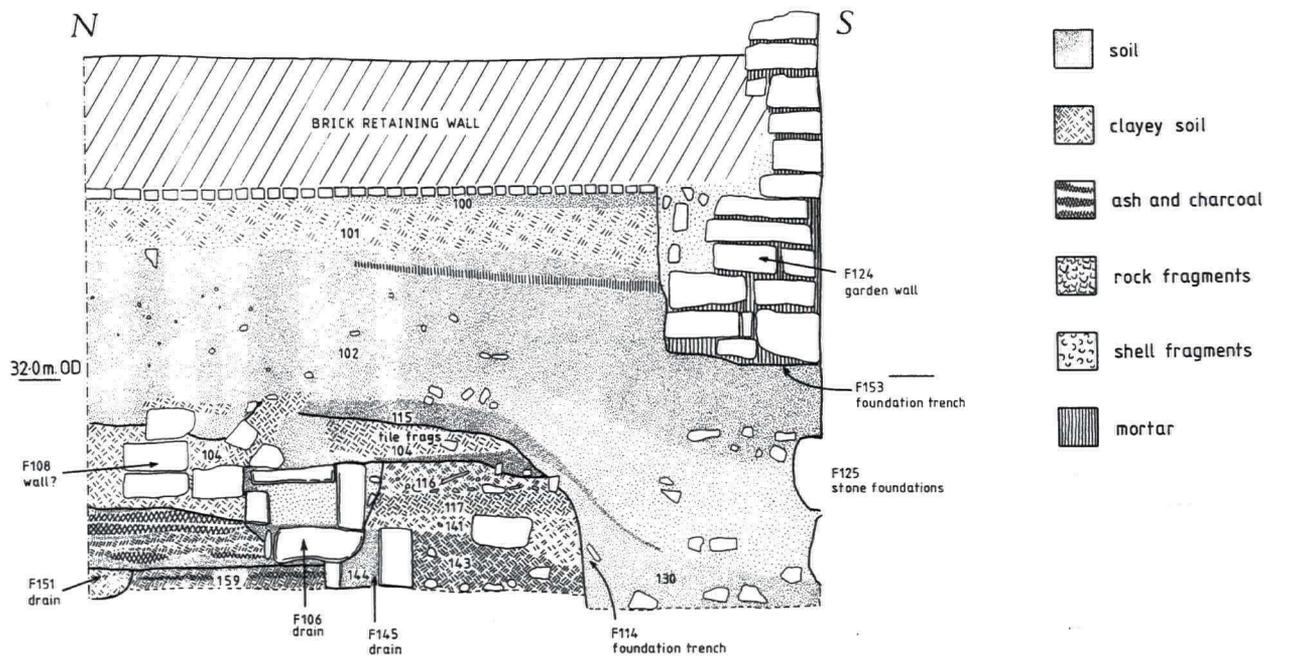
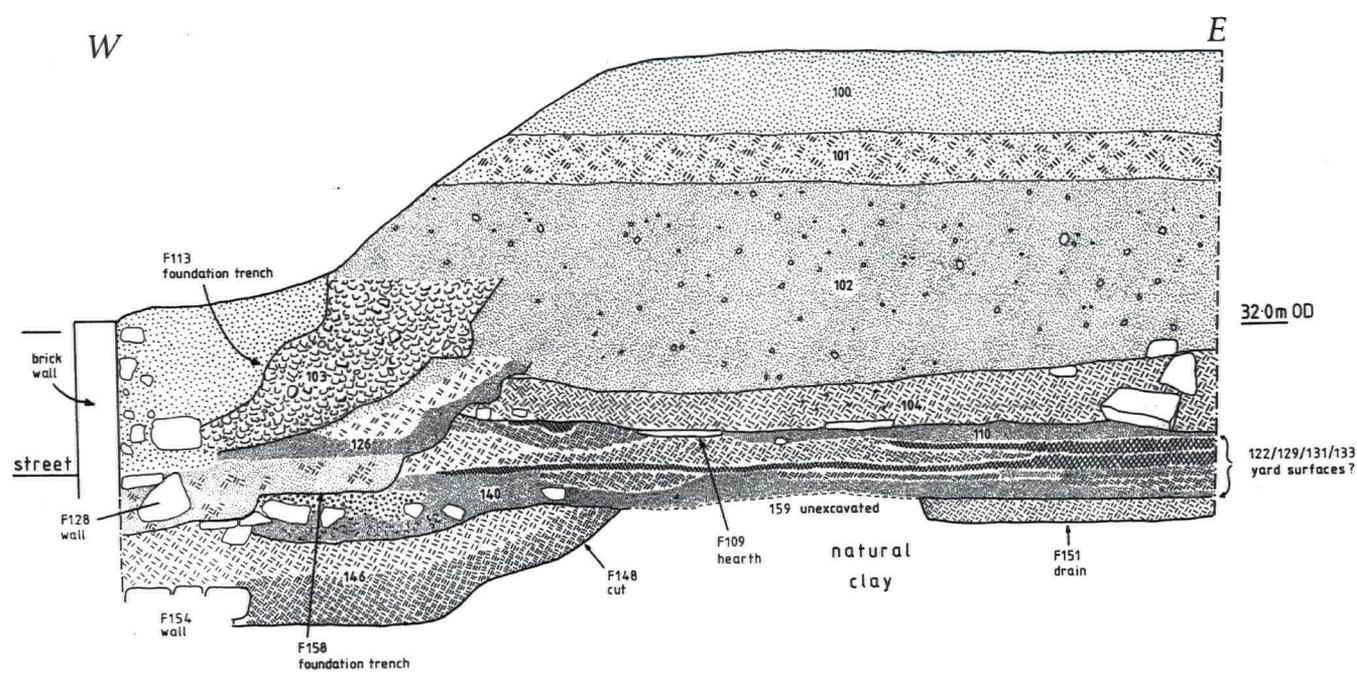
Fig 3 West and south facing sections of the trench

WEST FACING SECTION

SOUTH FACING SECTION

THE EXCAVATION (Fig 3)

The 1989 trial excavation measured 1.9m by 1m and was positioned immediately behind the brick retaining wall bordering the street about 3m north of No 35 Castlegate. The present excavation began by emptying the backfilled 1989 trench and extending

it eastwards as far as the brick wall marking the limits of the development area. This established that medieval deposits, including a hearth, extended as far as the eastern limit of the site although buried by up to two metres of post-medieval overburden.

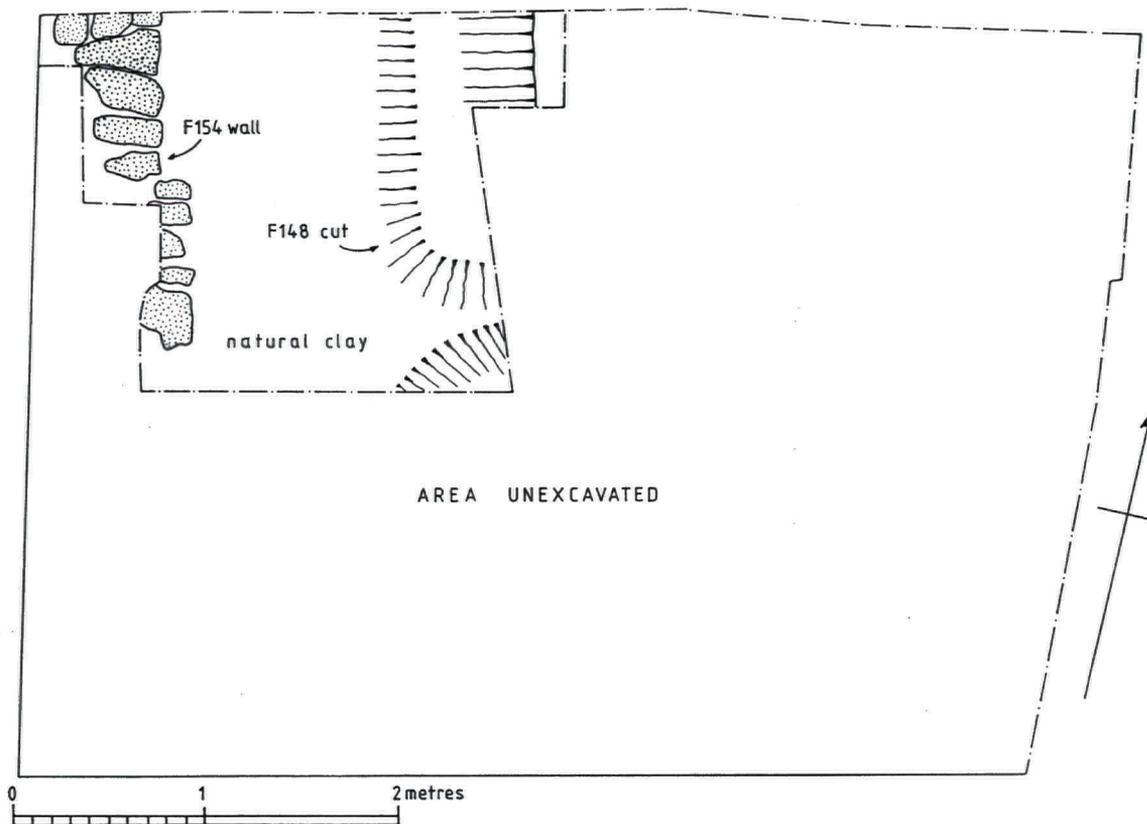
Fig 4 Plan of phase one features

Natural, undisturbed glacial clay was revealed only in the north-west corner of the trench. Elsewhere on the site, excavation was suspended before the natural surface was uncovered so as not to unnecessarily lower the site below the level required by the developer. Cutting the natural surface in the north-west corner of the trench was a shallow sided cut (F148) at the base of which was a wall (F154) along the street frontage of which only one course survived bedded into natural clay. The cut was backfilled with layers of brown and greeney brown clayey soil (146).

The wall F154 and the cut F148 were the earliest two features discovered on the site but due to the restricted area within which they were found, they defie easy explanation. The cut

F148 appeared to turn through 90 degrees, possibly to accommodate a second wall at right angles to the road, which could point to their having been a building on the site at this period. However no floor levels or other signs of a building were found associated with the wall and in the following phase the site was demonstrably open ground with surface drains crossing it. The wall F154 may have simply been a property boundary marking the street frontage with the shallow sided cut, F148, perhaps a relic of the quarrying that initially must have taken place to carve this level plot out of a steeply sloping hillside. If so, then this phase could date to the 12th century although insufficient dateable artefacts, such as pottery, were recovered to confirm this.

**PHASE ONE: THE EARLIEST FEATURES
(Fig 4)**

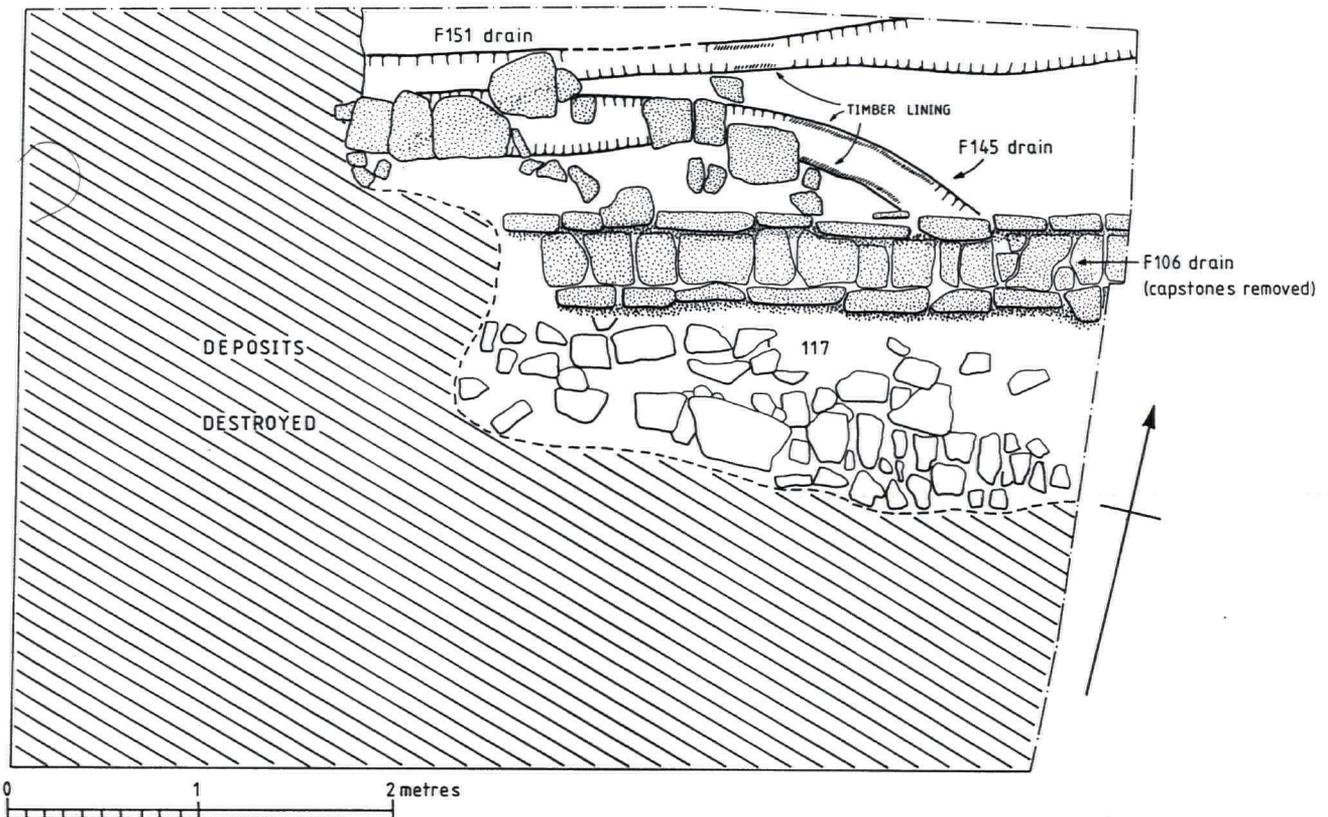
Fig 5 Plan of phase two features

Across the levelled surface of the site ran a sequence of three drains of increasing size and sophistication. The earliest (F151) was little more than a shallow linear scoop cut through the thin soil layer (159) which naturally accumulated on the site after it had been carved out of the hillside. Traces of timber staining indicated that the sides of the drain were lined with wood and the drain probably flowed into the street although this junction had been destroyed when a later foundation trench (F158) was cut along the street frontage (see phase 5 below).

The drain F151 was twice replaced, firstly by one of comparable construction (F145) comprising a

shallow u shaped gully with remnants of a timber lining and stone capping and filled, like F151 before it, with a clayey soil hardly distinguishable from the layers through which it cut. The third drain in the sequence, F106, was by far the most massively constructed with a base of stone slabs, sides of stone blocks, (levelled in places with re-used limestone roof tiles), and capped by substantial limestone slabs (Plate 2). The drain was filled with a thin layer of grey sand at its base with a thicker deposit of soil on top right up to the base of the capstones. Like the first drain F151, the two later drains probably discharged into the street but their junction with Castlegate had been destroyed by the

PHASE TWO: SURFACE DRAINS
(Fig 5)

later cut F158. To consolidate the ground immediately to the south of the drains and to prevent slippage down the slope, successive layers of stones mixed with clayey soil had been dumped (layers 143, 141, 117 and 116). How far south these stone dumps once extended could not be ascertained due to the intrusion of the later foundation trench for No 35 Castlegate (F114, see phase 5 below).

Taken together the three drains and associated dumps of stone rubble testify to increasing use being made of the vicinity. For example, the provision of surface drains implies a local residential population unwilling to tolerate ground water flowing uncontrollably over their properties. Equally, the fact that all three drains are aligned east-west at right angles to the street when the direction of natural drainage would

have been from north-east to south-west indicates respect for existing property boundaries at 90 degrees to the street. Unfortunately, beyond establishing the medieval date of all three drains, insufficient dating evidence was recovered to establish their age more precisely. The stone built drain F106 was evidently intended for prolonged use, so massively had it been constructed and could have lasted at least for several decades.

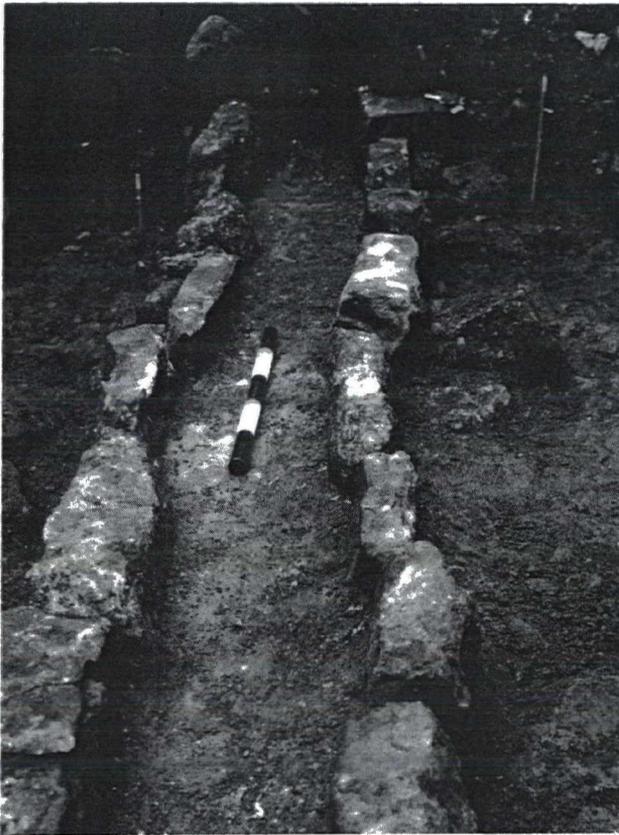
**Plate 2 Drain F106 looking east
with capping stones removed**

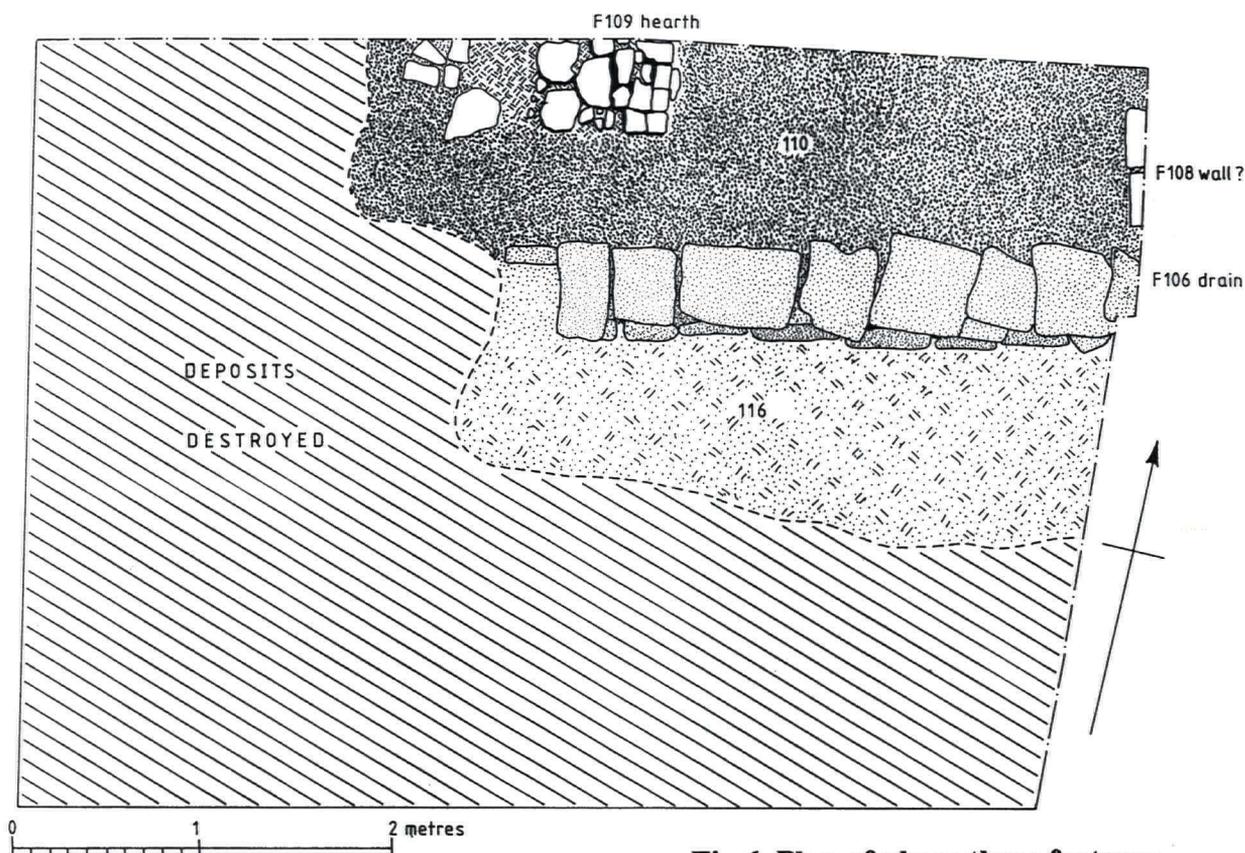
Fig 6 Plan of phase three features

Aside from the sequence of drains, other evidence for occupation on the site was confined to a series of damaged clay and ash surfaces overlaid by a hearth immediately to the north of the last of the drains, F106. The lenses of clay and ash (dug in four 5cm spits 122, 129, 131, and 133) accumulated against the drain and were in turn buried by a layer of dark soil (110) so that by the time that hearth F109 was constructed only the capping stones of the drain were still visible. The hearth itself was crudely constructed of stone roof tiles and bricks laid on a bed of clay.

The clay and ash surfaces continued northwards and eastwards beyond the confines of the trench whilst towards Castlegate they had been destroyed by the later foundation trench F158. Consequently it is impossible to say if these surfaces and the hearth were internal or external to a building. Four squared stones projecting into the trench from the eastern section might conceivably be the face of a wall at right angles to the drain (F108) and the drain itself might have doubled as the foundation for a building. There are several local examples where stone lined and capped drains have been incorporated in medieval house foundations. Two of the buildings excavated at the deserted village of Hatterboard possessed stone

PHASE THREE: YARD SURFACES? (Fig 6)

lined and capped wall drains to provide dry foundations on a wet clay site (Houses 4 and 5) [5]. Similarly a medieval building excavated at Tollergate between 1969 and 1975 incorporated a drain at the base of one of its internal walls [6]. However some care seems to have been taken with drain F106 to find flat capping stones to give the drain a level top which would not have been necessary had a wall been raised above it. More likely is that the site was still open ground in this phase, perhaps the yard of a house, across which flowed the drain F106 and where successive surfaces of ash and clay accumulated overlain by the rudimentary hearth F109. Pottery recovered from the ash and clay layers established the medieval date of these deposits.

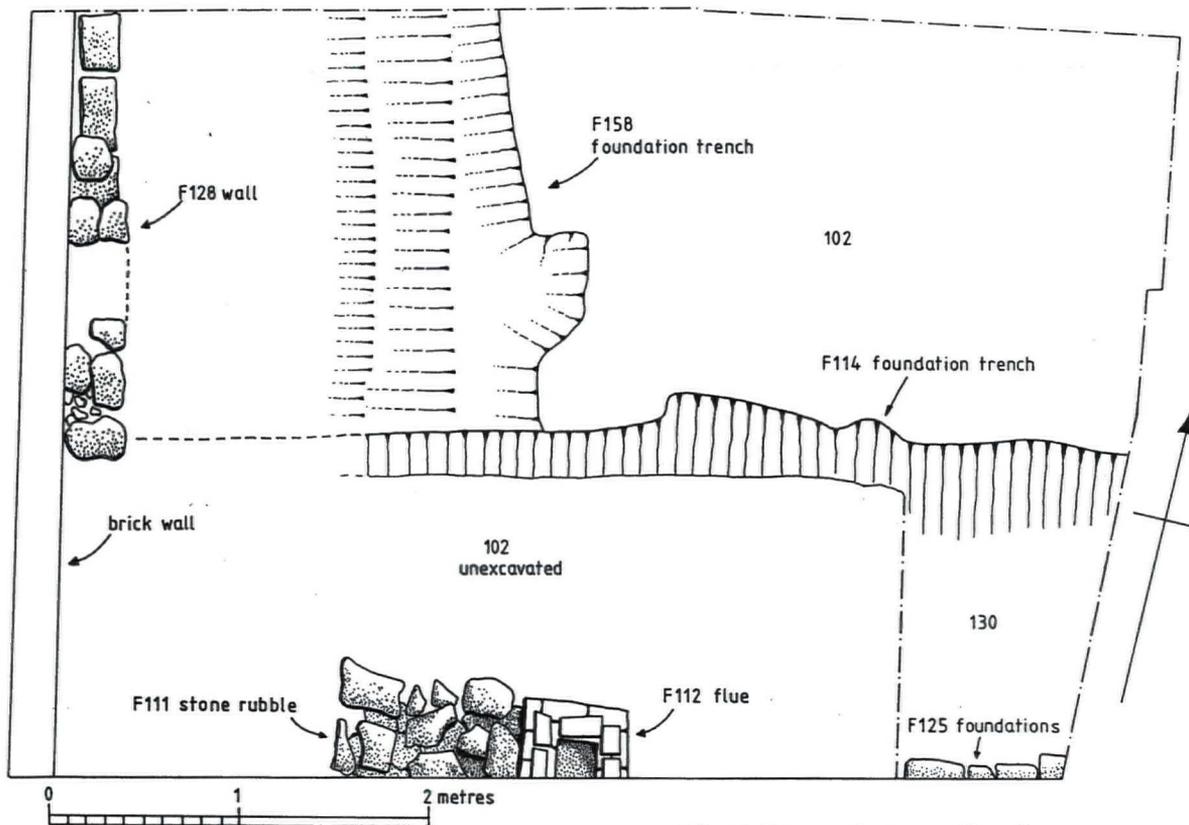
Fig 7 Plan of phase five features

Following the spread of debris across the site from the demolition of a nearby building discussed above, the site has been unoccupied, open ground right up to the present day as is clearly indicated by the 1-2m thickness of featureless stratigraphy which seals the medieval level. For the most part this stratigraphy consists of garden soil, gradually built up over the centuries (layer 102) interleaved with occasional tips of material. Most distinctive of these was the deposit of stone rubble and clay along the western edge of the site (layer 103), most likely natural rock excavated and thrown onto the site during the construction of Castle Crescent. Also along the western edge of the site, two foundation cuts were

identified for successive boundary walls along the Castlegate frontage. The earliest, F158, cut through medieval deposits adjacent to the street to accommodate the rubble footings for a stone boundary wall (F128) whilst the later cut (F113) was made for the existing brick boundary wall.

Far larger than either of the cuts along the street frontage and far more destructive to the underlying medieval deposits was the foundation trench for No 35 Castlegate along the southern side of the site F114. Considerations of safety adjacent to a standing building meant investigation of this feature was confined to a sondage in the south-east corner of the site, the

excavation of which was terminated before the base of the foundation trench was revealed. The brick outer wall of No 35 Castlegate was found to rest on a wall of rough stone blocks (F125) which, judging by the 17th and 18th century pottery contained in the lower fill of the foundation trench (layers 127,130 and 115) cannot be medieval in date and is probably contemporary with the brick wall above. It would have made sense in the 18th century not to squander expensive bricks on house foundations when stone rubble, perhaps re-used from an earlier building, was available as a cheaper alternative. The upper fill of the foundation trench was loose soil of the same consistency as covered the rest of the site (layer 102) although slightly sandier and lighter in appearance.

**PHASE FIVE: OPEN GROUND
(Fig 7)**

At some later date a second, shallower trench was excavated next to the wall of No 35 Castlegate (F153), perhaps to remedy problems with its stability as in one area a length of stone rubble was packed against the outer face of the foundations (F111 and Plate 3). At the same time the opportunity was taken to insert a brick lined flue through the wall into the cellar below the house (F112) and to key a stone retaining wall at the rear of the property into the north-east corner of the building (F124). The spreading of a layer of clay and rock fragments (layer 101) topped by more garden soil (layer 100) across the site brings its development up to the present day.

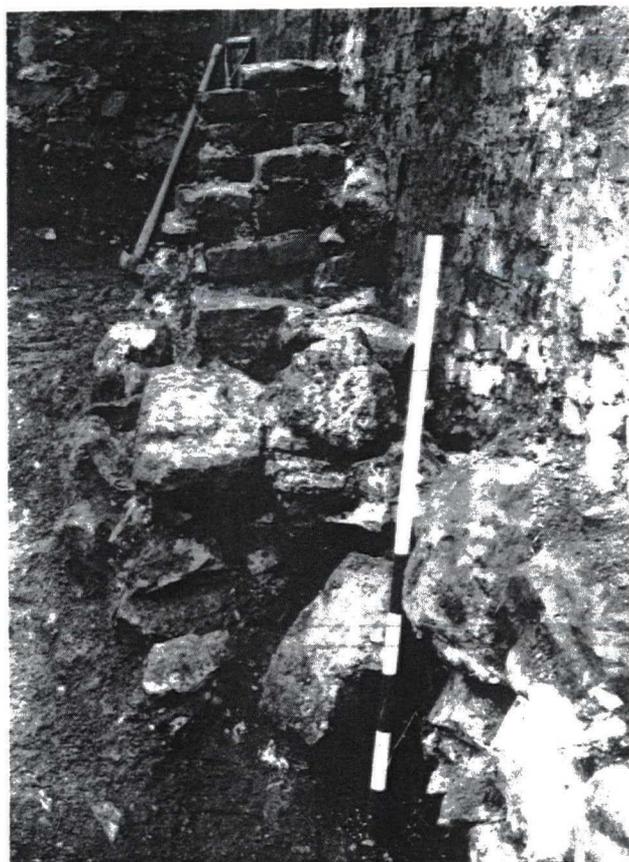
Plate 3 Stone rubble F111 and flue F112 adjacent to wall of 35 Castlegate
