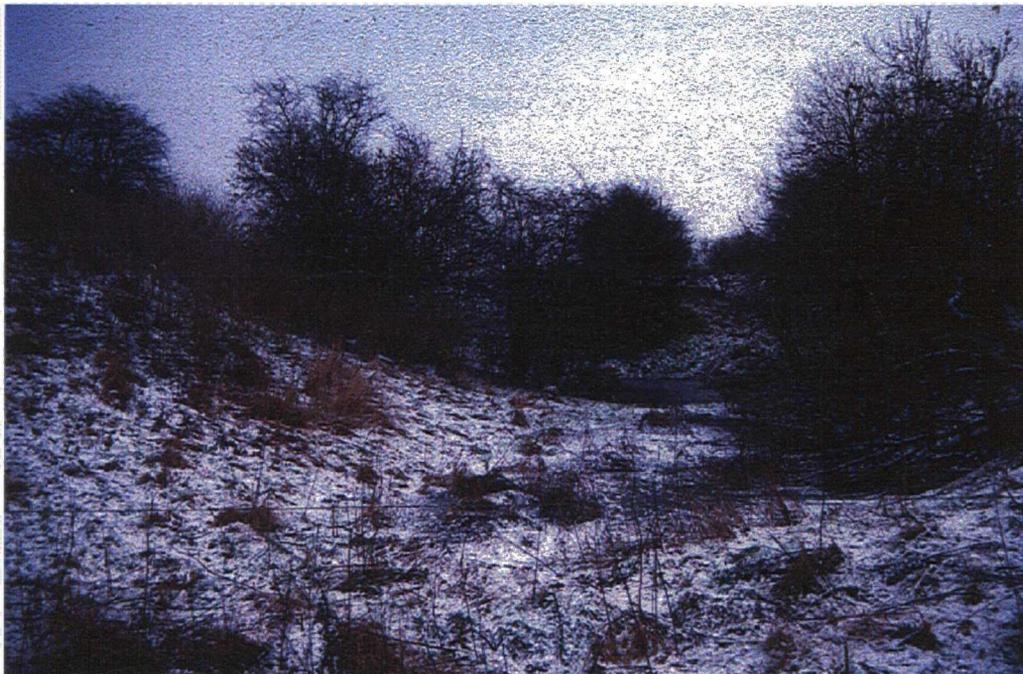
Plate 6: Motte ditch showing former use as track

The motte [1] slopes vary in both height and length. On the east, the motte ditch [2] cuts through the natural slope of the hill providing a much longer slope to the motte than compared to the western side. There is no evidence for the motte ditch around the far east side, where it would presumably have met the river. In recent times part of the north-eastern section of motte ditch has been used by vehicles as a track (Plate 6).

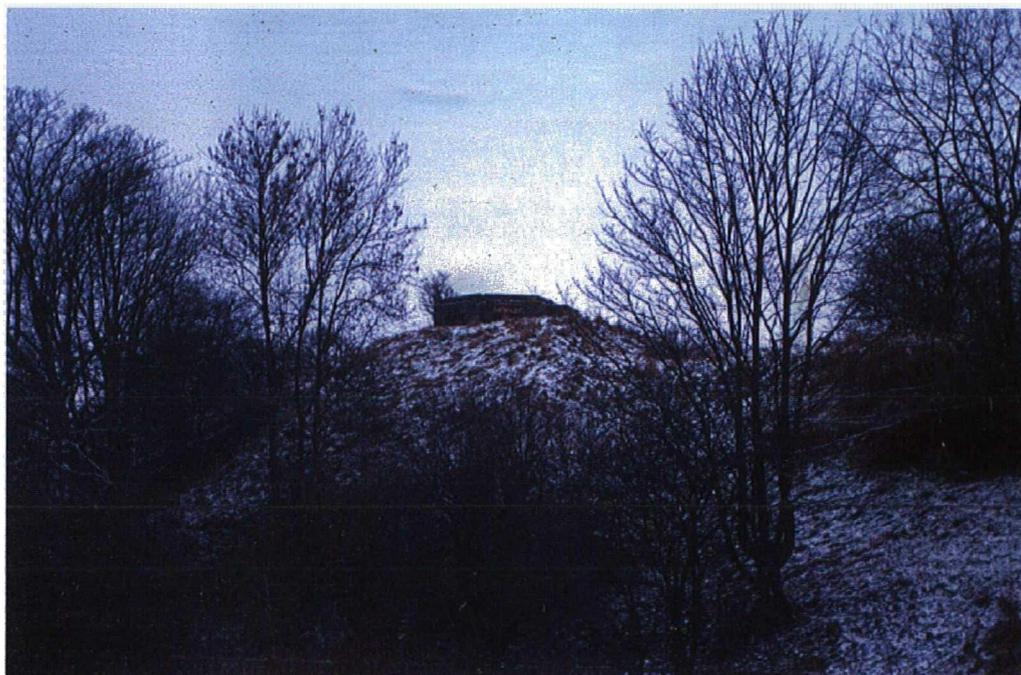
Plate 7: Pillbox at Castle Hills

The eastern mound [12] is currently topped with a WWII pillbox [13] (Plate 7), and the western mound [10] is occupied by a WWII Bofors gun emplacement [11] (Plate 8). It cannot be determined from the survey whether these mounds already existed to their present heights, or if they were enhanced by the scraping up of extra soil from inside the bailey, in order to achieve greater prominence.

The motte top also contains the dug-out remains of a more complex bunker-type structure where brick rubble survives [43]. Other intact structures include a pillbox [13] and gun emplacement [11] built to protect the RAF airfield to the west during the Second World War.
