A684 Bedale – Aiskew – Leeming Bar Bypass

Environmental Statement

Appendix 9.1 Cultural Heritage Desk-Based Survey

Date: November 2009

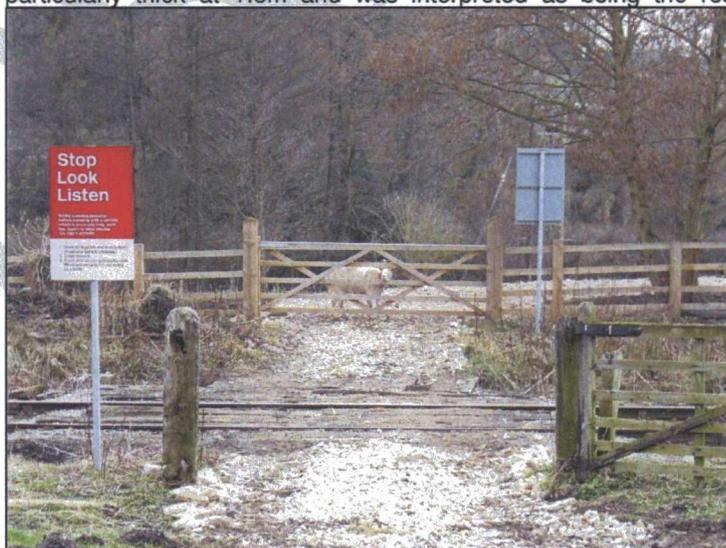
Plate 2 *The Level crossing over the Wensleydale to Bedale railway line (Site 43) looking towards Rectory Wood (Site 21).*

5.3.6 The study area is crossed twice at its western and eastern ends by the line of what was formerly the Northallerton to Leyburn railway (Sites 43 and 110), which loops south to Bedale, where it then turns north-east, passing through Leeming Bar. The line is still operated by the Wensleydale Railway and is in good condition with much of its period trackside equipment such as signals and telegraph poles in place (Plate 2). The value of these sites has been assessed as Low.

5.3.7 Rectory Wood (Site 21) is a plantation on the east side of Bedale Beck (Site 54) and is believed to have been established when the railway (Site 43) was built. Rectory Wood was identified as an area of palaeoenvironmental potential during the geoarchaeological survey and was investigated by taking hand auger samples. Two auger transects within Rectory Wood and auger samples taken on the west bank of Bedale Beck established the presence of well preserved peat layers (Appendix 3). The peat within Rectory Wood was particularly thick at 1.5m and was interpreted as being the result of the

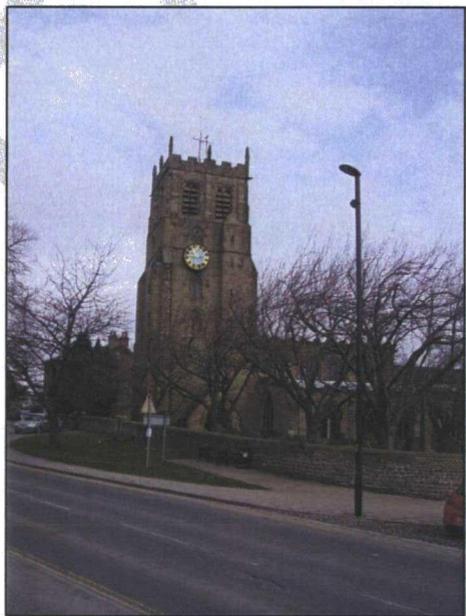
Plate 3 The Church of St Gregory, looking north from North End

6.2.6 The Church of St Gregory (Site 31) is the medieval parish church of Bedale and forms an important townscape feature, both in views along the Market Place and on the approach to the town on the A684 from the north. The church dates from the 13th, 15th and 19th centuries and is characterised principally by its use of the Decorated style. The church has been assessed

to be of High value due to its importance as an example of medieval ecclesiastical architecture, and its importance to the history and development of the town of Bedale.

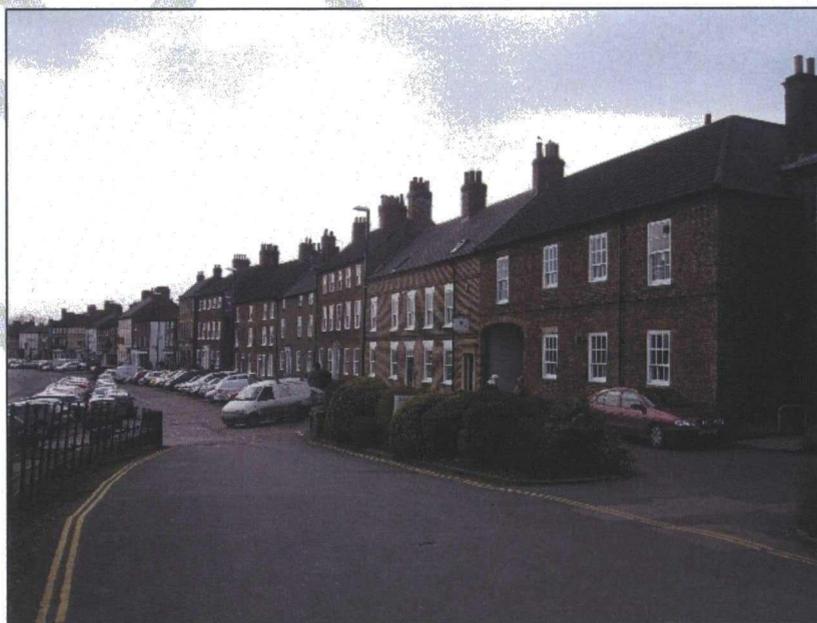
Plate 4 Georgian buildings on the west side of North End in Bedale

- 6.1.3 Georgian domestic buildings are the characteristic building type of this area. Typically these structures are three storeys in height, constructed in brick, with carefully proportioned principal elevations, often symmetrically arranged, decreasing in storey height moving up the elevation. Characteristic features also include the use of sash windows, raised and coped eaves and a decorative cornice or eaves course. These characteristics are most clearly demonstrated by the buildings flanking North End and the Market Place in Bedale. Forming a continuous terrace of large Georgian townhouses, these buildings are demonstrative of Bedale's growing importance and prosperity as a local market centre during the 18th century (Plate 4). Many of these buildings were adapted for use as shops in the 19th century with the insertion of shop fronts at ground-floor level, some of which survive today. Typical examples of this building type include Numbers 1 & 3 Market Place, and Number 14 Market Place, both of which are of early to mid-18th century date, and designated as Grade II Listed Buildings. In the countryside around Bedale, Classical architecture was employed extensively for houses of the local gentry, as demonstrated by buildings such as the Hall in Langthorne (Grade II Listed Building), a three-storey brick hall with advanced central bay and raised eaves level, dating from 1719, and Beechwood House in Aiskew (Grade II Listed Building), a fine three storey building, with symmetrical

principal elevation, sash windows, and central doorway with fanlight over.

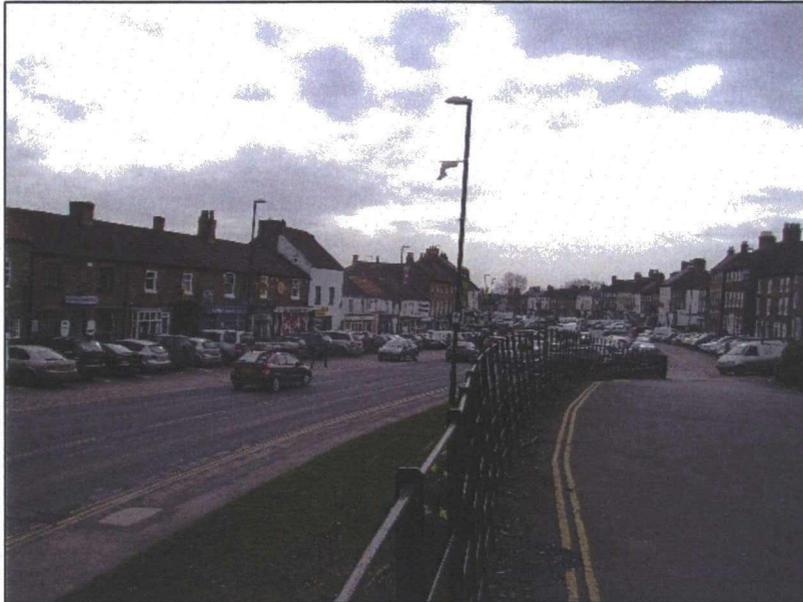
Plate 5 Bedale Conservation Area (Site 34), looking south from Bedale Hall

6.2.5 Bedale Conservation Area (Site 34) covers the historic core of Bedale (Plate 5). The town enjoys a distinctive historic and architectural character, taking in both the high-status, classically-designed Georgian buildings surrounding the Market Place and North End, and the 'low' end of the town around Emgate, comprising modest cottages and workshops of vernacular design and construction, which formerly housed the industries and trades of the town. In plan, Bedale retains its medieval 'toft, croft and garth' plan, and the presence of greens on Wycar and South End. Bedale Conservation Area has been assessed to be of Medium value, due to its inherent historic and architectural quality.

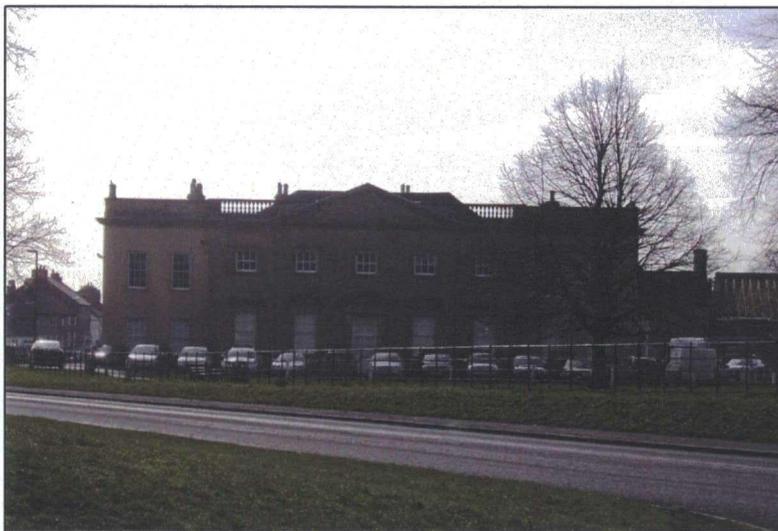
Plate 6 Bedale Hall (Site 19), principal elevation

- 6.2.8 Bedale Hall (Site 19) is located within the former Bedale Park (Site 3) on the northern edge of the town, close to the alleged site of Bedale Castle (Site 22). The hall is substantially a building of 1730s date, however it is likely that this structure results from the remodelling of an earlier building. The principal elevation of the Hall looks north across the park and comprises a classically designed frontage of nine bays, the central three bays of which break forward below a triangular pediment (Plate 6). Ashlar masonry is employed for the central five bays, contrasting pleasantly with the rendered outer bays. A number of associated estate buildings are located to the west of the Hall, including an ice house, former stable block, and stores. Bedale Hall

preserves a fine example of an early 18th century Gentry House and was assessed to be of High Value.

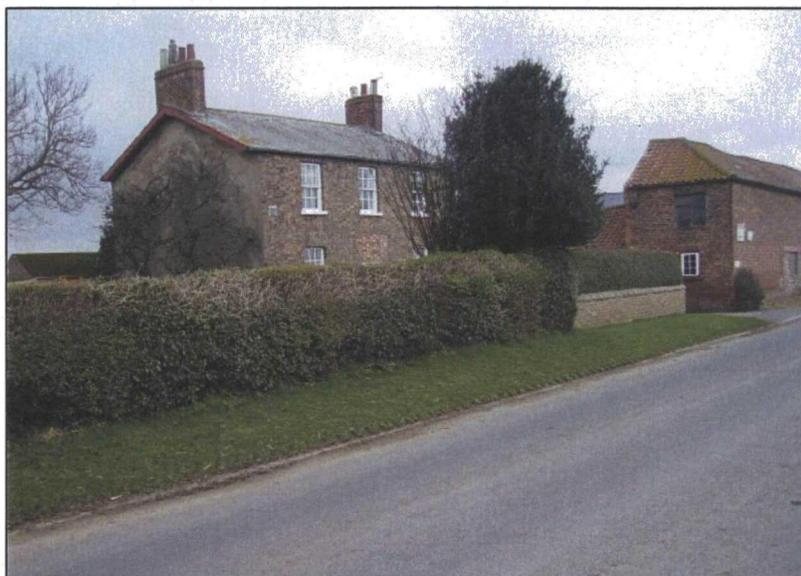
Plate 7 Fairfield Farm (Site 90), elevation to Dere Street

6.2.11 The buildings of Fairfield Farm (Site 90) date from the mid-19th century and results from the improvement of an earlier farmstead. The complex is formed by a three-bay, two-storey farmhouse of brick construction, sited to enjoy long views across the countryside to the east, and formally-planned outbuildings comprising a barn and a series of single-storey outbuildings arranged to form an enclosed yard (Plate 7). Some alteration of the farmstead has occurred with the addition of large-scale modern outbuildings to the north of the yard, and the blocking of the principal entrance to the farmhouse. Fairfield Farm has been assessed to be of Low value, as an example of a mid-19th century formally-planned farm complex.

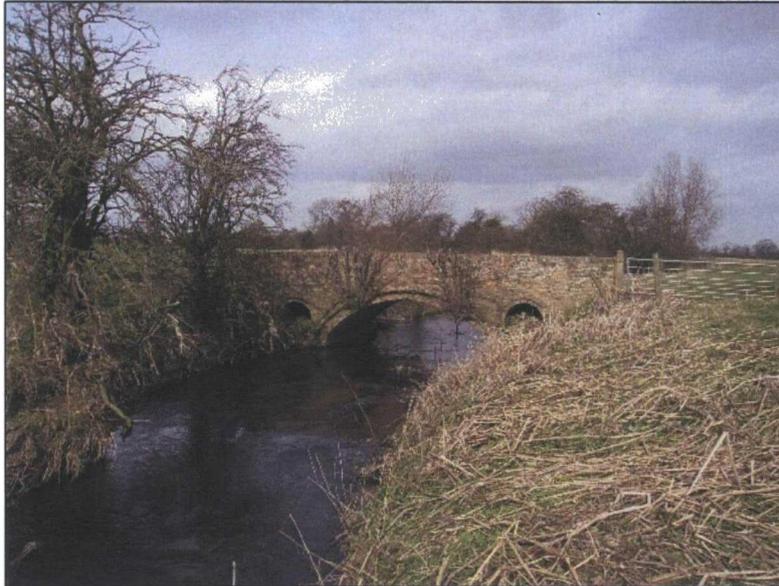
Plate 8 The Brick Bridge (Site 120)

6.2.14 The Brick Bridge (Site 120) is located c.0.5km to the north of Sandhill Farm and is likely to have been constructed contemporarily with the rebuilding of the farm complex in the late 19th century. The bridge comprises a single-span bridge constructed of handmade red bricks (Plate 8). Some architectural pretension is shown with the inclusion of two brick arches to either side of the main span. The bridge was assessed to be of Low value.
