The barbican at Richmond Castle, North Yorkshire

*Archaeological excavations, November 1999 - January
2000: results of a watching brief, January - June 2000*

**ASUD Report 663
August 2000**

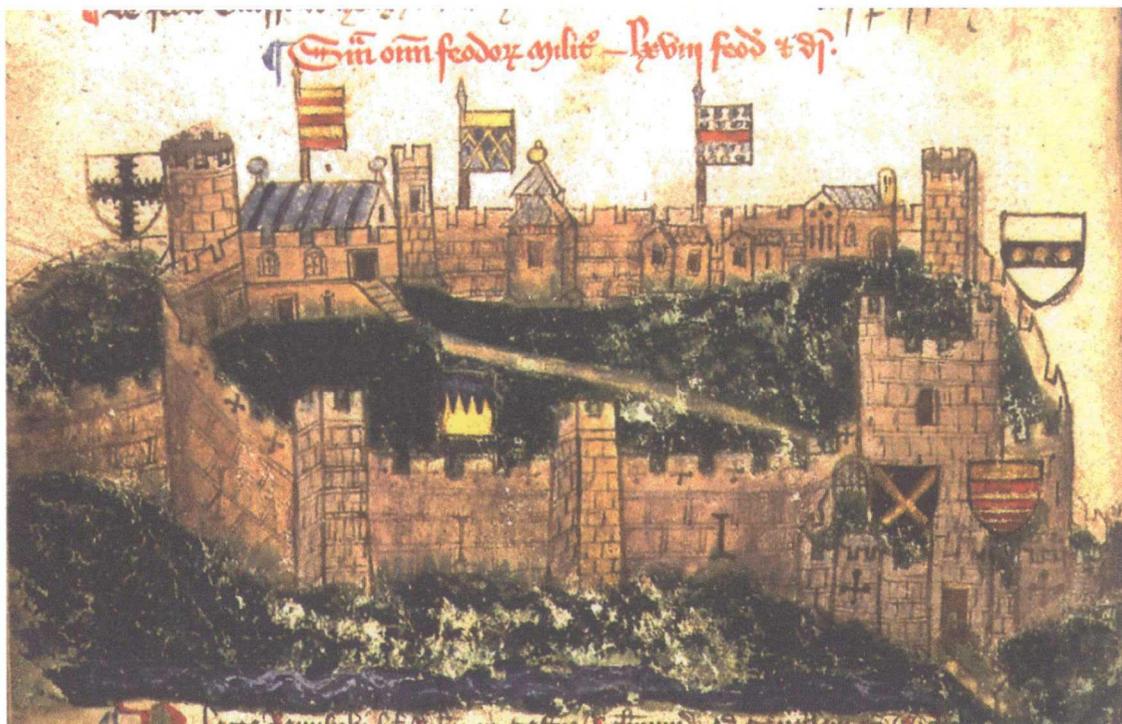
A View of Richmond Castle in 1538
(British Library Cotton MS)

Part of the west side of the gatehouse was found under the drive, together with a large block of masonry that supported the inner end of the drawbridge. The structural evidence from the excavation shows that a fifteenth-century view of the castle is probably correct in showing the gate as a small structure without attached towers.

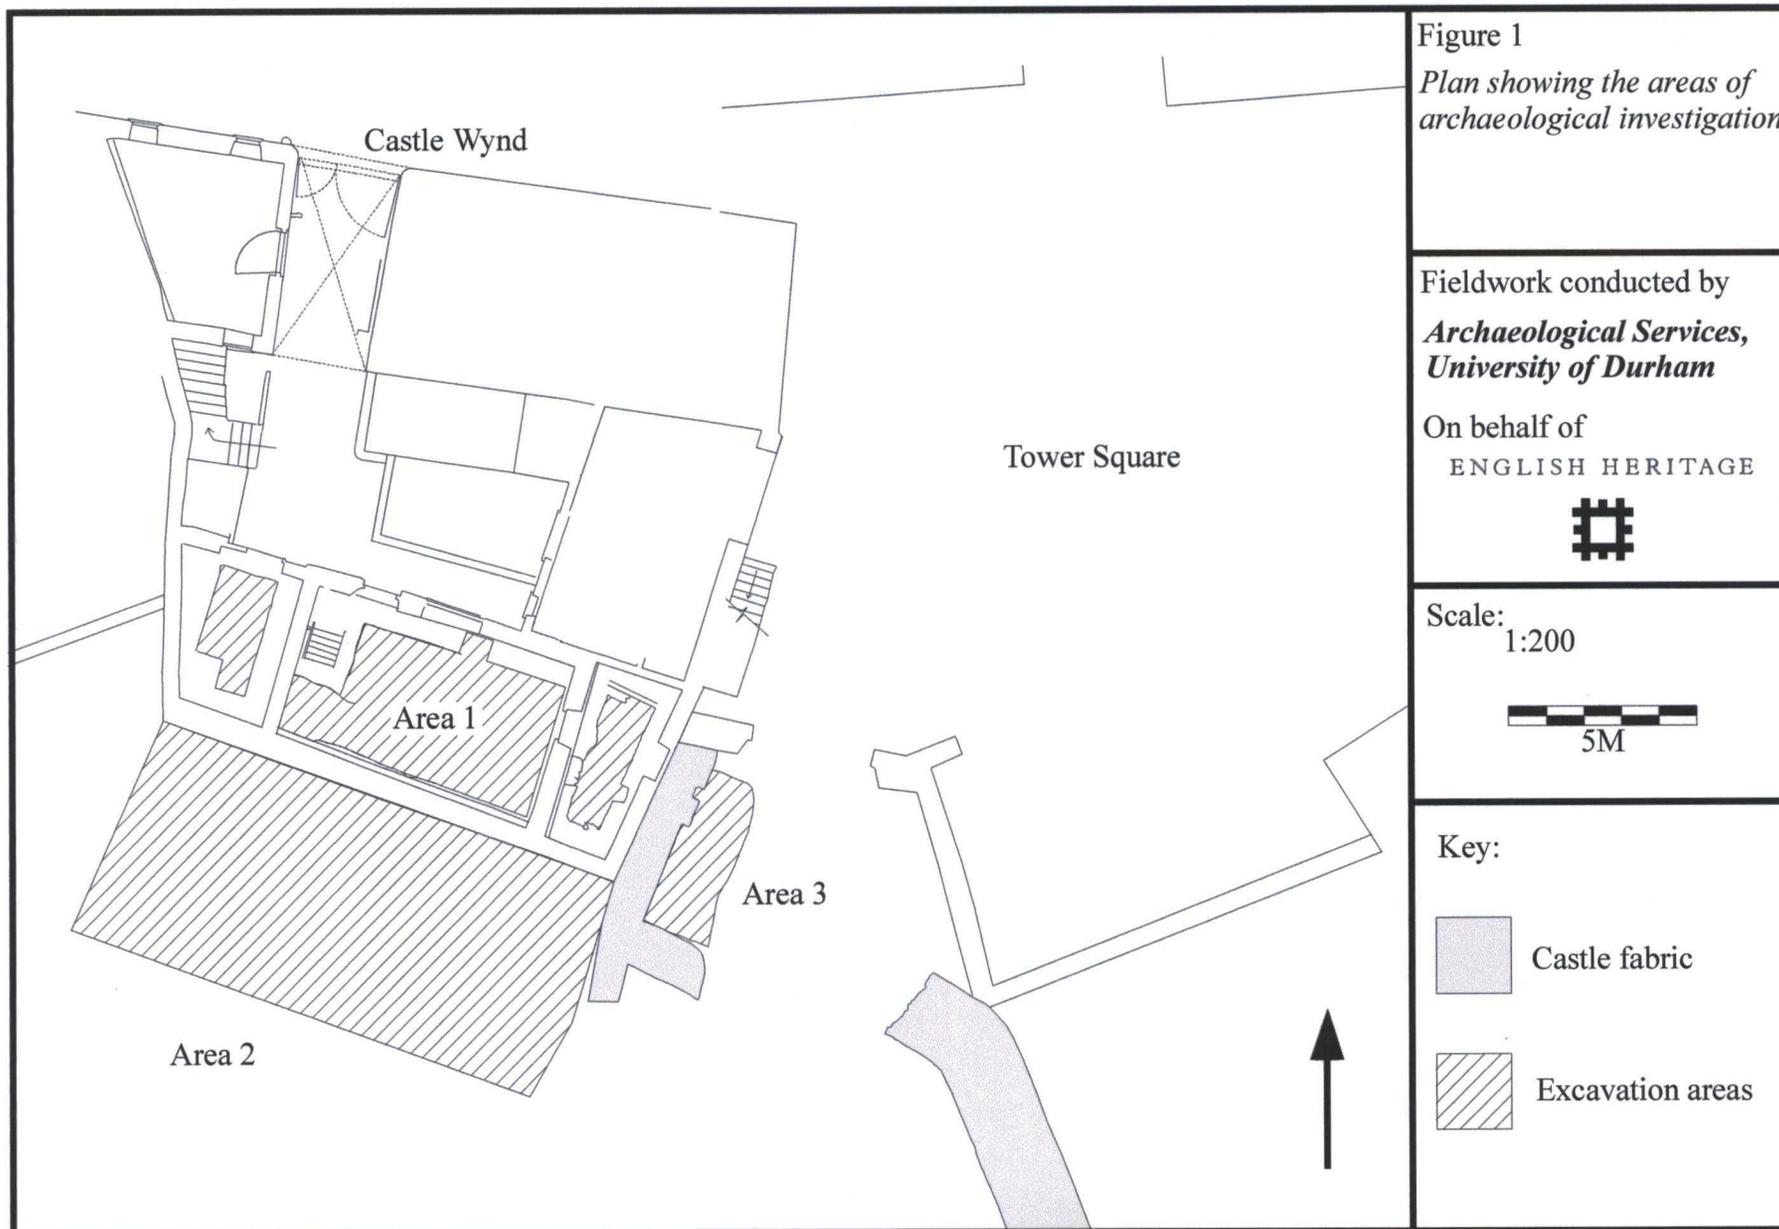
Figure 1
 Plan showing the areas of
 archaeological investigation

The barbican is a roughly semi-circular area between the keep and the recent buildings of Tower Square. The present entrance to the castle is here, and the buildings attached to No. 2 Tower Street stand to the west of the castle gates.

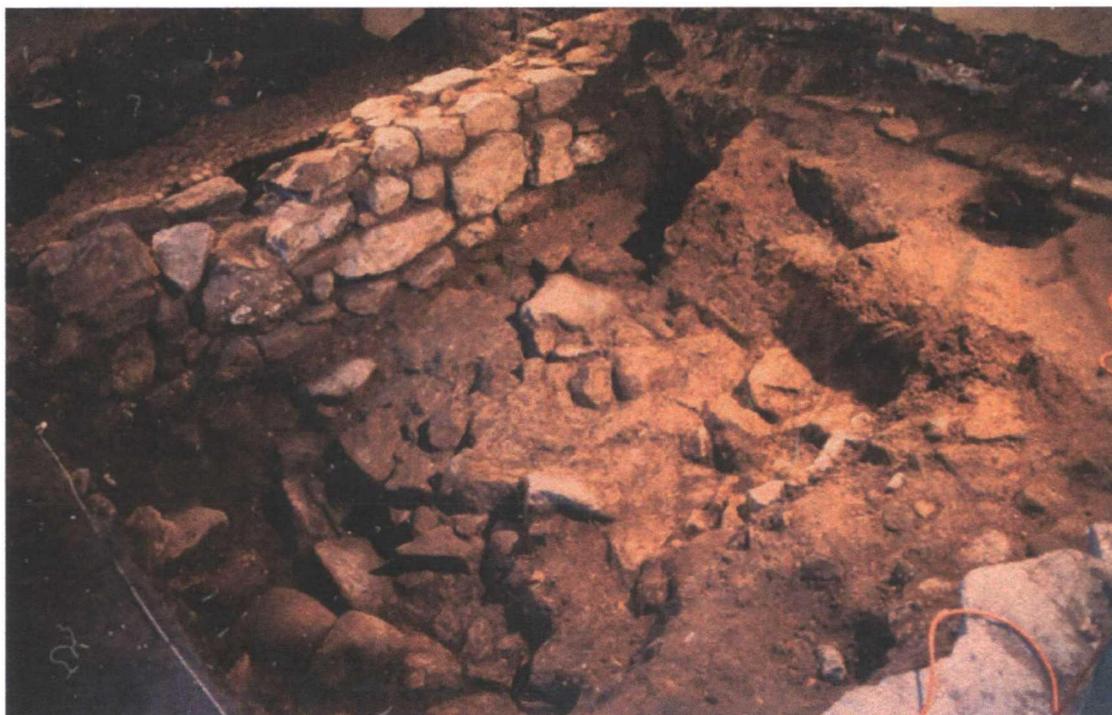
Figure 2 Area 1C, looking south-east. The wall of the eighteenth-century stable crosses the room, and overlies the two-metre-thick medieval curtain wall. At top right is one of the postholes from the stalls of the late stable building.

The wall revealed in the 1989 trench (**F12**) was found to cross the full width of the room from north to south. It returns to the east under the footing of the present south wall, and probably underlies the north wall as well. This could not be checked as it was necessary to leave a block of fill to support the bottom of the walls all round the excavation.

The stony dump to the east of wall **F12** was removed to reveal a cobbled floor **F29**. The lowest layer of the dump was made almost entirely of broken stone roof tiles, with pegs made from sheep metapodials. The floor had a marked slope down from the south wall, which levelled out near the north edge of the excavation. The floor was clearly bounded by the walls **F12** to the west and **F13** to the south. The former stood up to 0.75m high after clearance.

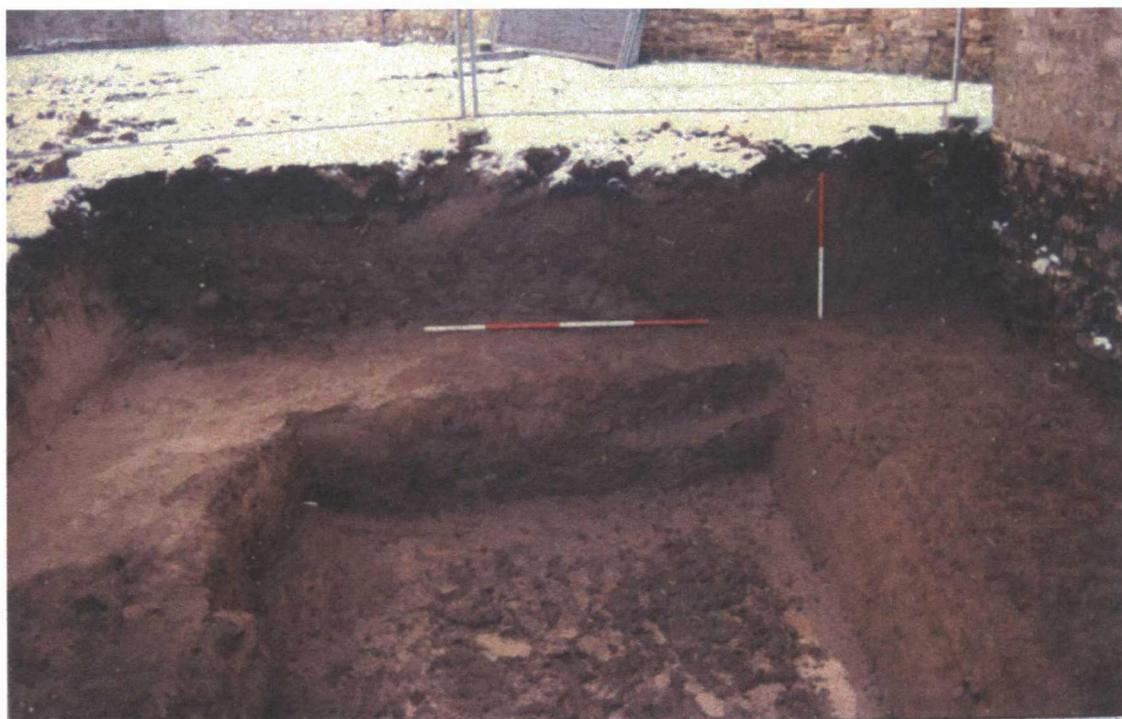
Figure 3 View of the soils in Area 2, looking west.

general it consists of clayey sand with a few small stones, but in places there are large patches of clean running sand, or broad thin lenses of clean red and blue-grey clays. The material must be glacially-deposited.

The sandy subsoil was an unexpected find here, and there was some speculation that it might have been imported to the site in the construction of a motte, perhaps built in 1068-69 by William the Conqueror in his northern campaign. There was also a degree of concern about the pressure of soil against the outside of the wall of the building, as the ground surface there was 1.55m above the floor level within. For both these reasons, the subsoil was removed from a 1.3m-wide strip along the full length of the wall. This excavation was taken to a depth of 1.5m below ground level, and widened out at the west end to encompass the whole of the width of the excavation. The sandy deposit **54** proved to be uniform throughout this depth. This soil is very like the redeposited material seen in Area 1C and Area 1W, where it is numbered **5** and **38** respectively. Though consistent in overall appearance, it is quite a variable deposit; in

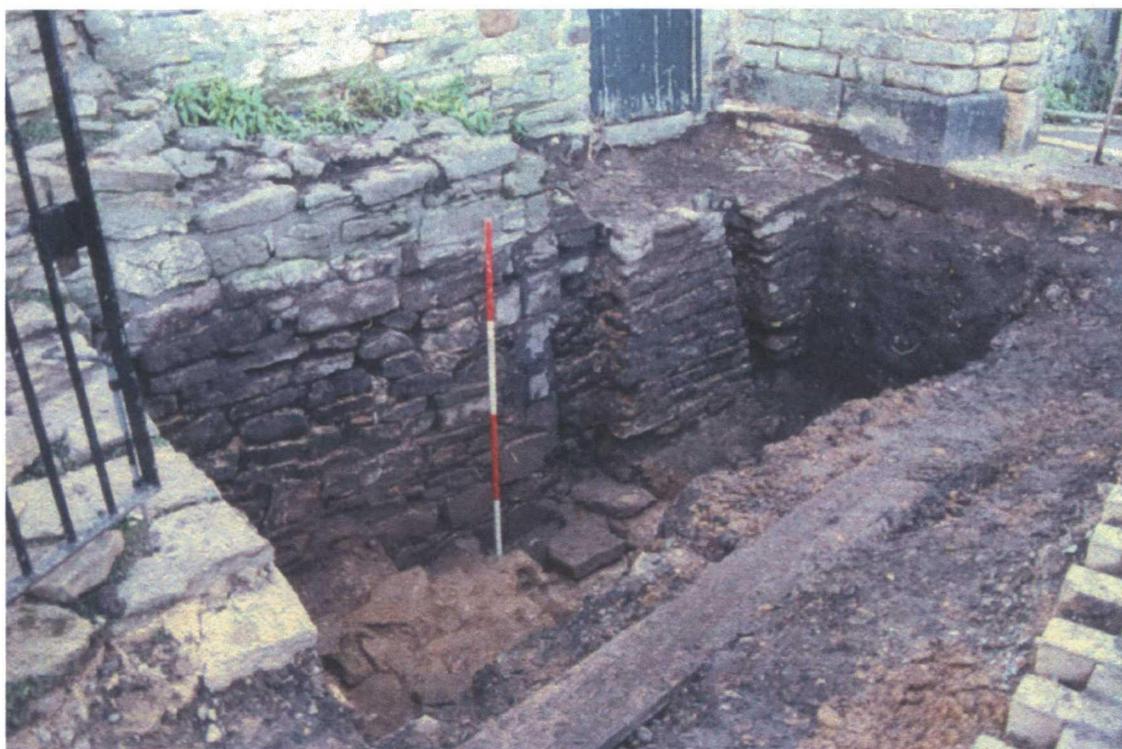
Figure 4 Area 3, looking north-west. The early wall **65** is behind the ranging rod and the later shoring block **66**, with its beam slots, is below the door to Area 1. The late wall **64** is in the left foreground.

The west and south sides of the excavation area were defined by three distinct sections of masonry. The earliest of these features is a stretch of wall that still stands above ground level to the south of the door into the building (Figure 4). This wall, **65**, is a 2.32m-long section, made of rubblestone with dressed quoins at its north-east angle. It was not bottomed in the excavation; the surviving section is 2.15m high immediately south of the door to Area 1. The width of the wall is visible in the above-ground section immediately south of the building, where it measures 1.2m at its

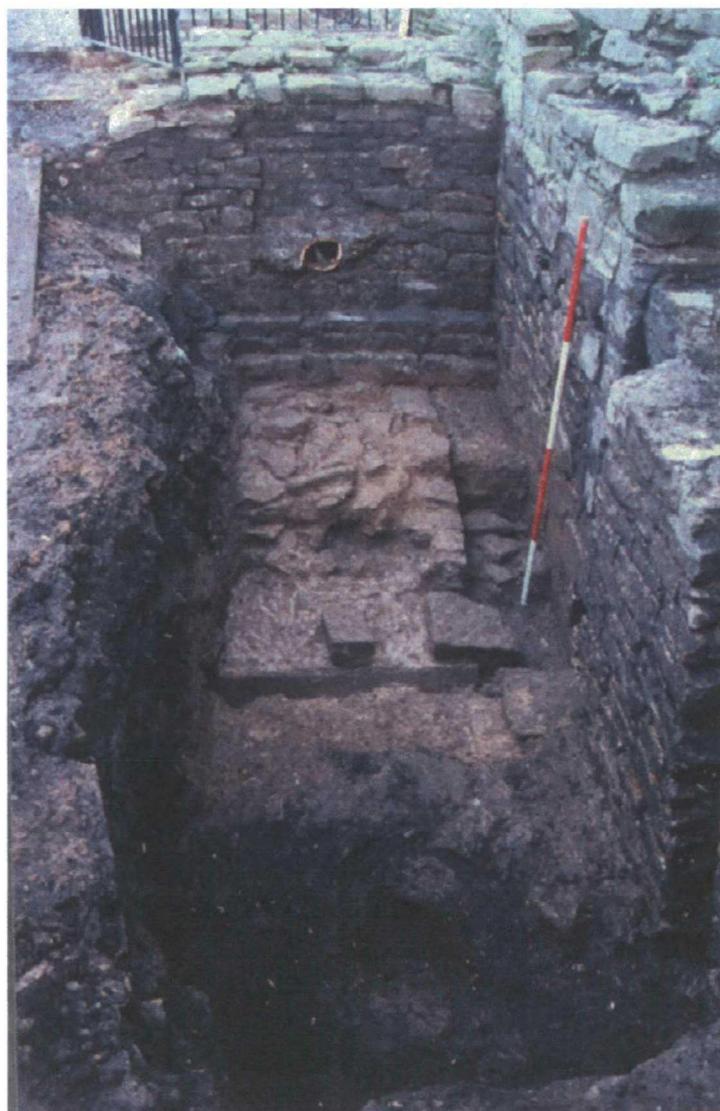
Figure 5 Area 3, looking south, showing the thrust-block 73 and the late wall 64 in the background. Note the projection of the shoring block 66, at the right-hand side

The floor of the gate passage was not found in the excavation, despite the depth of the trench. Instead, the lowest feature uncovered was a separate masonry structure, **73**, which measured 2.13m to the face of the later wall **64** and 1.2m wide (Figure 5). Unlike the adjoining wall of the gate passage, this block of masonry has dressed faces on the three visible sides; on the north face there was a chamfered offset course. The

block continues for at least 0.2m below the bottom of this feature. The block is 0.44m from the face of the wall 65, and the gap between the two was initially interpreted as a slot for a large baulk of timber supporting a roadway or part of a drawbridge mechanism. The slot was filled with a clayey silt deposit 72, which was only partly excavated, but probing with a steel pin found no bottom at depths of up to 0.7m below the highest point of the block, so it appears that this structure is entirely separate from the gatehouse wall. Its shape and position suggest that it acted as a pier or thrust-block which provided resistance against the stresses imposed by the drawbridge during raising and lowering. The gaps on either side of the block would also have acted as a drains, carrying water below the road surface towards the lip of the moat.

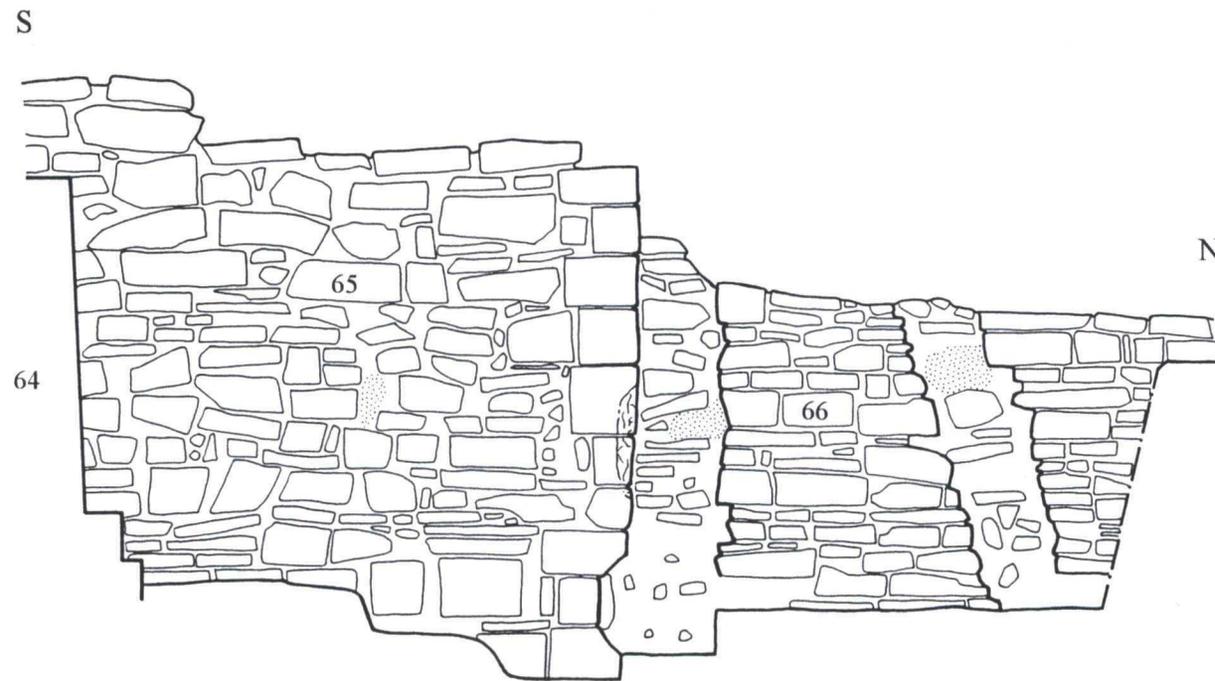
Figure 6: *West face of Area 3, showing the gatehouse wall 65, the shoring block 66, and the later blocking wall 64*

Abutting the north face of the gate passage is a cruder mass of masonry **66**, which projects slightly to the east of the side of the gate passage wall **65** (Figure 6). This block measures at least 2.4m from north to south, and extends beyond the northern limit of the excavation; it is up to 1.45m high. In the east face are two large beam-slots for a raking shore that was erected to support the north face of the gate. These slots are rectangular in profile, and measure 0.3-0.35m wide by 0.2-0.23m deep; both run the full height of this section of wall. The southern slot is vertical, and abuts the angle of the wall, while the northern is at an angle of about 20° to the vertical; inside it a mass of mortar preserves the shape of the corner of the timber that stood in it. The whole of this feature functioned as a crude buttress against the north face of the gate, and the timbers supported the lintel or the head of the opening: when projected, the line of these two timbers meet at a point at least 3m above the present drive surface. It is interesting that this timber shore was placed so close to the side wall of the gate passage, and yet was intended to support the upper part of the building. This may imply that the gate passage was still use at the time of the repair, and that the roadway had to be kept clear. The dump deposit **46** was laid down against the face of this late addition to the face of the gate.

The latest of the three walls (**64**) is a well-made structure of coursed rubblestone, the uppermost course of which was visible in the drive before excavation. The wall is 1m thick, and, including its two offset foundation courses, is 1.7m high. It runs at a right-angle to the early wall **65**, and its foundation trench was cut through the large dump **46**. This wall would have completely blocked the gate passage; its function is unknown, as there is no other practicable entrance to the castle.

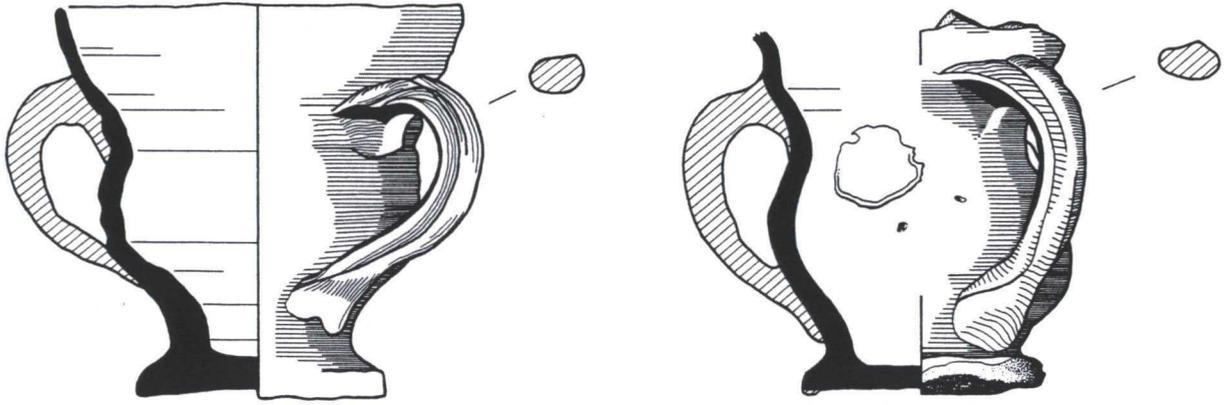
Figure 7: *Two Cistercian ware cups from context 46, the dump in the gate passage*

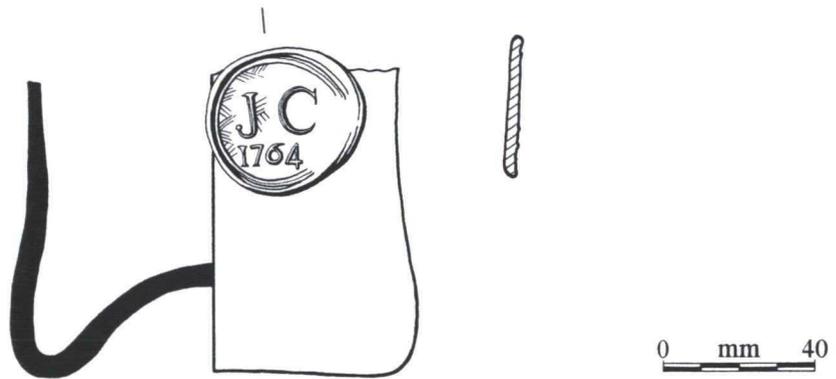
Figure 8: *Base of cylindrical wine bottle with stamped seal from the demolition rubble of early stable building. Area 1C, context 4*

The vast majority of fragments were from wine bottles, which can be divided into two forms. The earliest are two examples of onion or mallet bottles, a form that was quite common in the first third of the eighteenth century. The remaining bottles are all later cylindrical forms that can be dated from the mid- to late-eighteenth century. It is not unusual to find some earlier examples associated with later forms, as at this time wine bottles functioned as decanters to be filled from barrels and could have a long life span. A single example of a cylindrical bottle has a stamped seal attached to its side (Figure 8). This is of a simple form consisting of the owner's initials, JC, and the date 1764.
