Scarborough Castle Master Gunner's House North elevation of basement stairwell showing stonework after removal of surface renderings

2.0 FIELDWORK PROCEDURE

3.0 FIELDWORK RESULTS

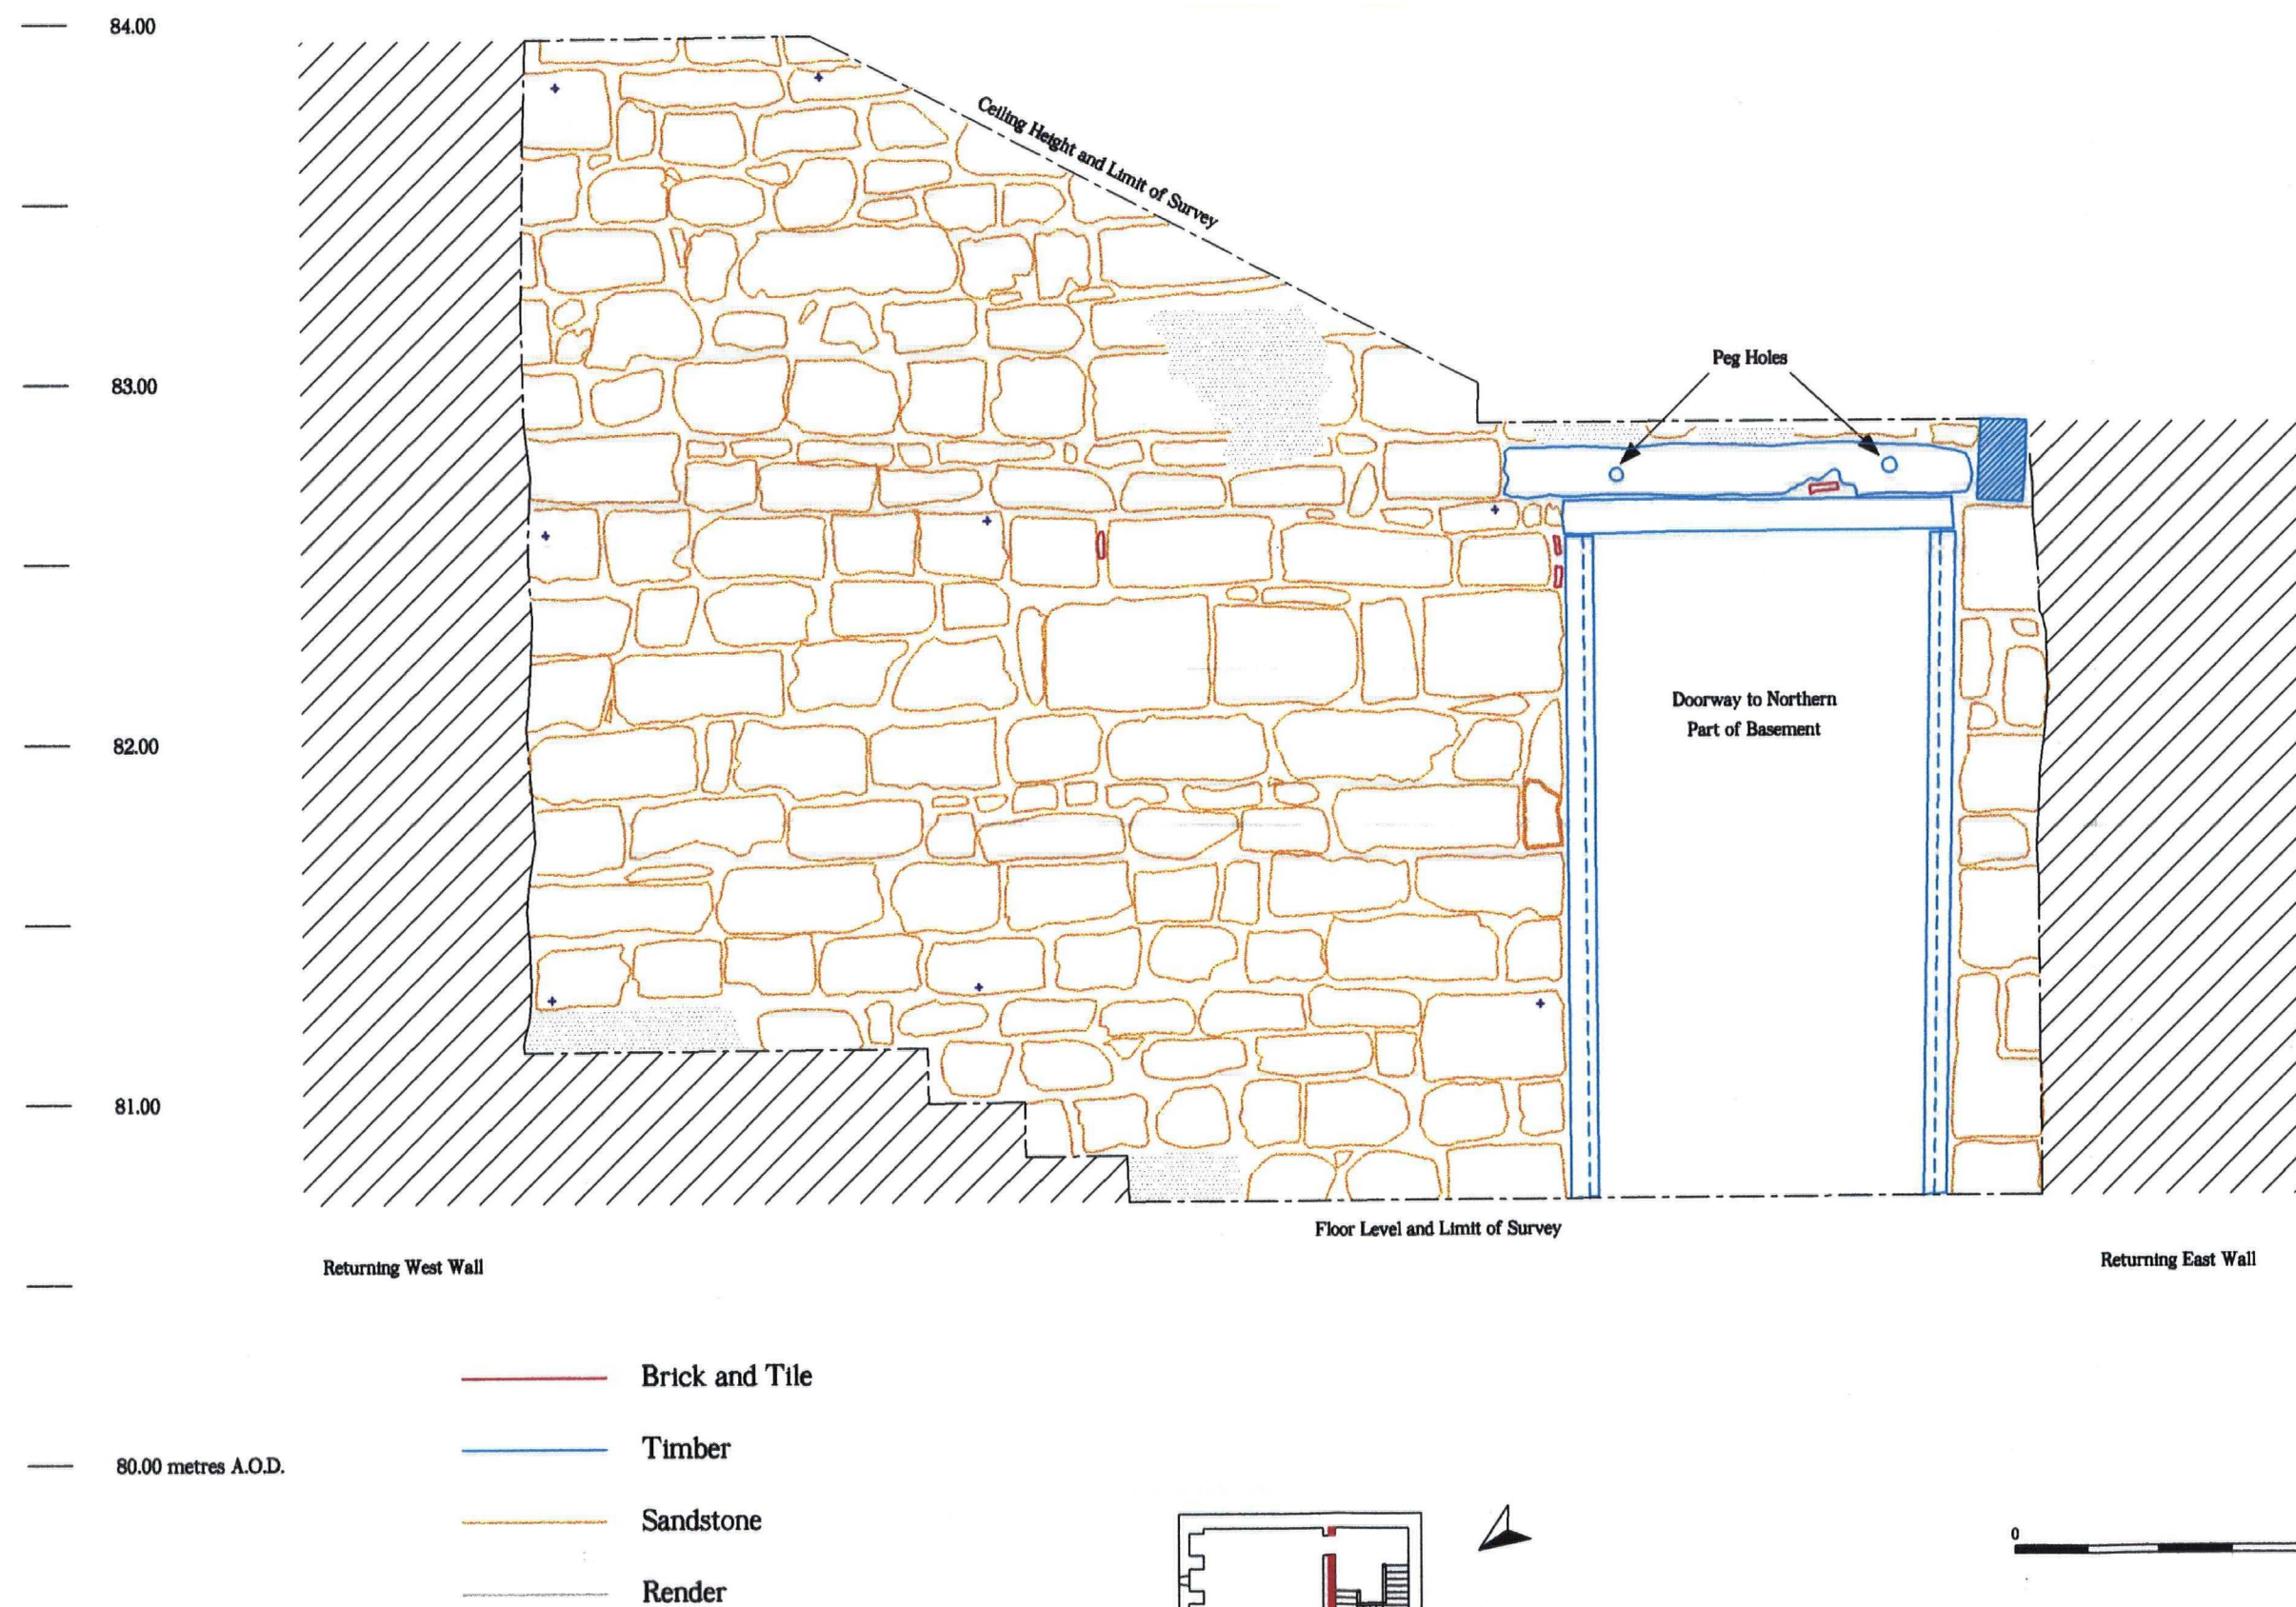
Figure 3

Wall rendering was removed from all surfaces of the basement stairwell. The north, east and west walls were constructed largely of sandstone, with occasional tile or brick packing. The north elevation (Fig.3) includes a doorway which appears to be contemporary with the surrounding fabric. The lintel of the door consists of a timber that has clearly been reused in this context, indicated by two redundant peg holes. It was not possible to examine all faces of this timber to establish if there were mortices cut into the timber, making it difficult to offer an answer as to its previous use. The west

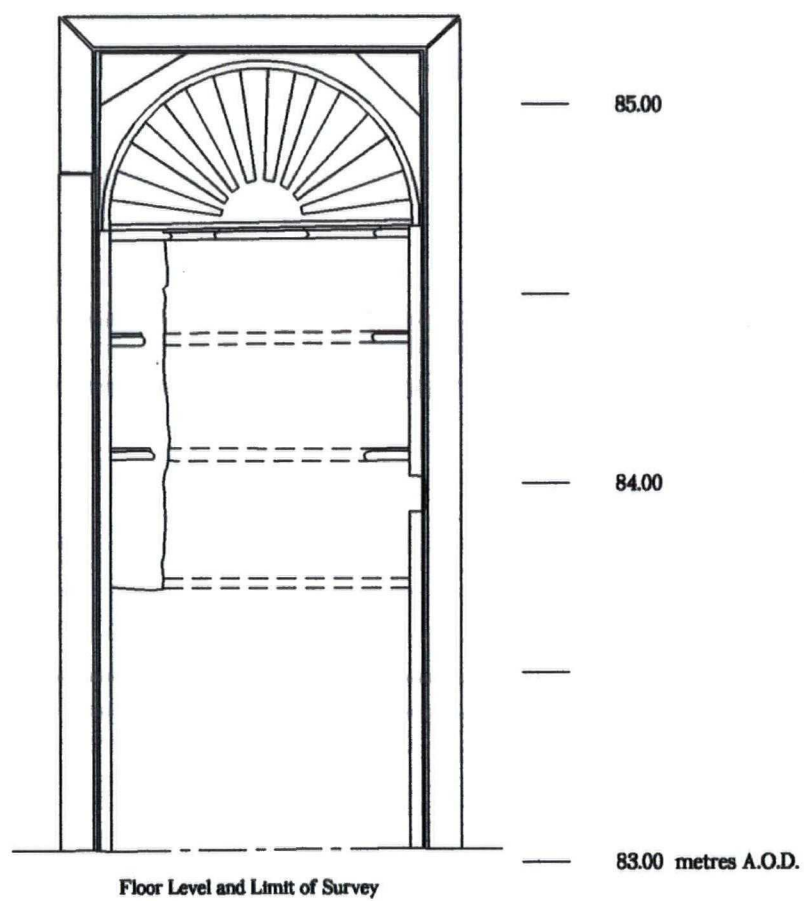
Figure 8

Master Gunner's House Recess in north room ground floor

There was little additional archaeological exposure in the northern room, other than the discovery of a recess in the north-west corner (Fig.8). This can be dated to the early eighteenth century on the basis

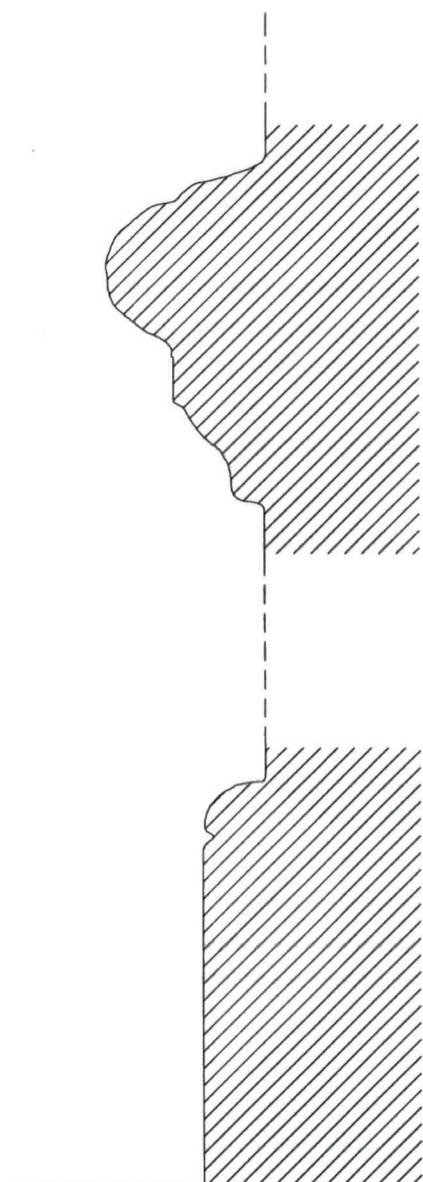
Moulding Profile of Dado Rail and Skirting
on South and West Walls of Ground Floor
North Room

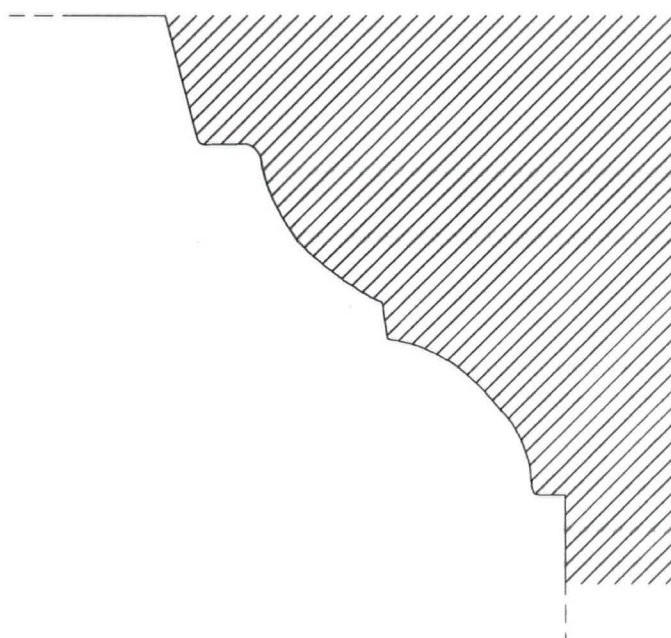
Moulding Profile of Ceiling Cornice on
North and South Walls of Ground Floor
South Room
