Scarborough Castle Master Gunner's House Elevations of south-west recess in south room first floor

Scarborough Castle Master Gunner's House North elevation of north room first floor showing stonework after removal of surface renderings

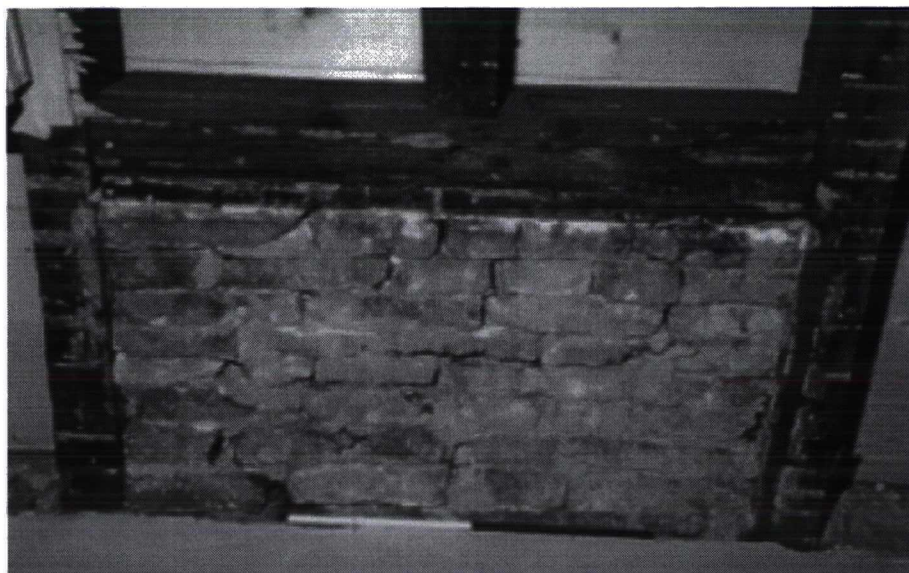
Plate 1: Brick fireplace support in the ceiling void of the south room, ground floor
(Scale 0.5m)

A greater degree of exposure was provided in the southern room, with the partial stripping of render on the east elevation. Comparison between the 1716 and the contemporary plan of the building would suggest that this room had been shortened to create more space for the current lobby and staircase. It is possible to reconstruct the position of the window openings on the 1716 plan in relation to those that exist today (Fig.10). As can be seen generally, the position of the earlier windows have been obliterated by the later fenestration scheme. However, one jamb might survive under an area of rendering that was not removed. The south wall of this room has been thickened with the installation of a fireplace and chimney breast, but it is possible that the door to the 'privy' indicated on the 1716 plan is now represented by the cupboard recess in the south-western corner of the room. There was no archaeological exposure of the west wall of the room, but it can be assumed that this is a rebuild dating to when the building was detached from the curtain wall. The 1716 plan indicates that this wall stepped back or had a long recess towards the northern end of the room. Taken with the fact that this room was divided into a larder and kitchen, it can be tentatively suggested that this recess might have accommodated a cooking range. Partial removal of the ceiling of this room exposed a brick and timber structure in the ceiling void that supports the fireplace at first floor level (Plate 1). There was no evidence that this feature had been cut into the surrounding fabric.

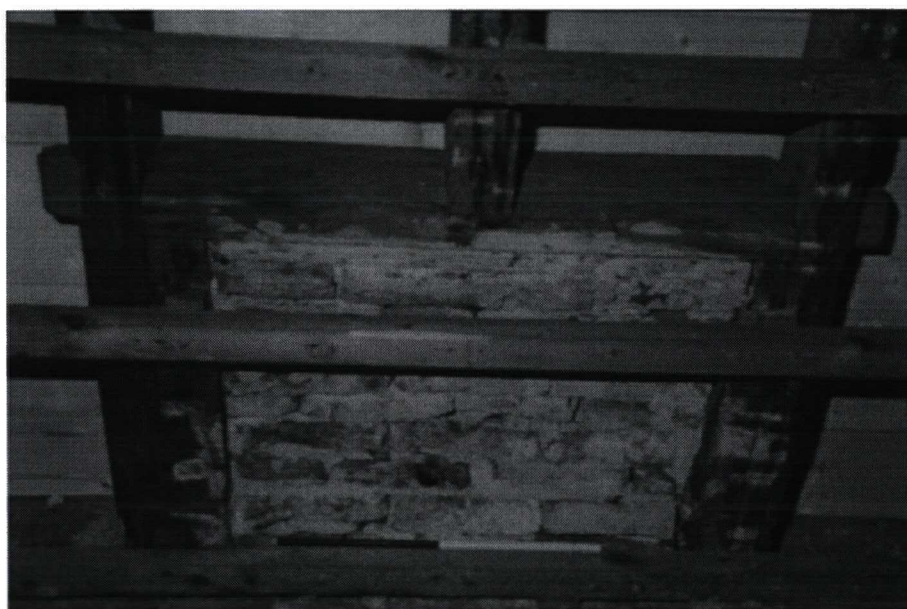
Plate 2: Brick fireplace support in the ceiling void of the north room, first floor
(Scale 0.5m)

the material had been reused in its current context. The heads of the two cupboard recesses were formed by bricks set to act as voussoirs, in a manner consistent with an eighteenth century date. Partial removal of the ceiling in this room revealed the brick and timber support of the fireplace at second floor level, a similar arrangement to that observed in the southern room of the ground floor.

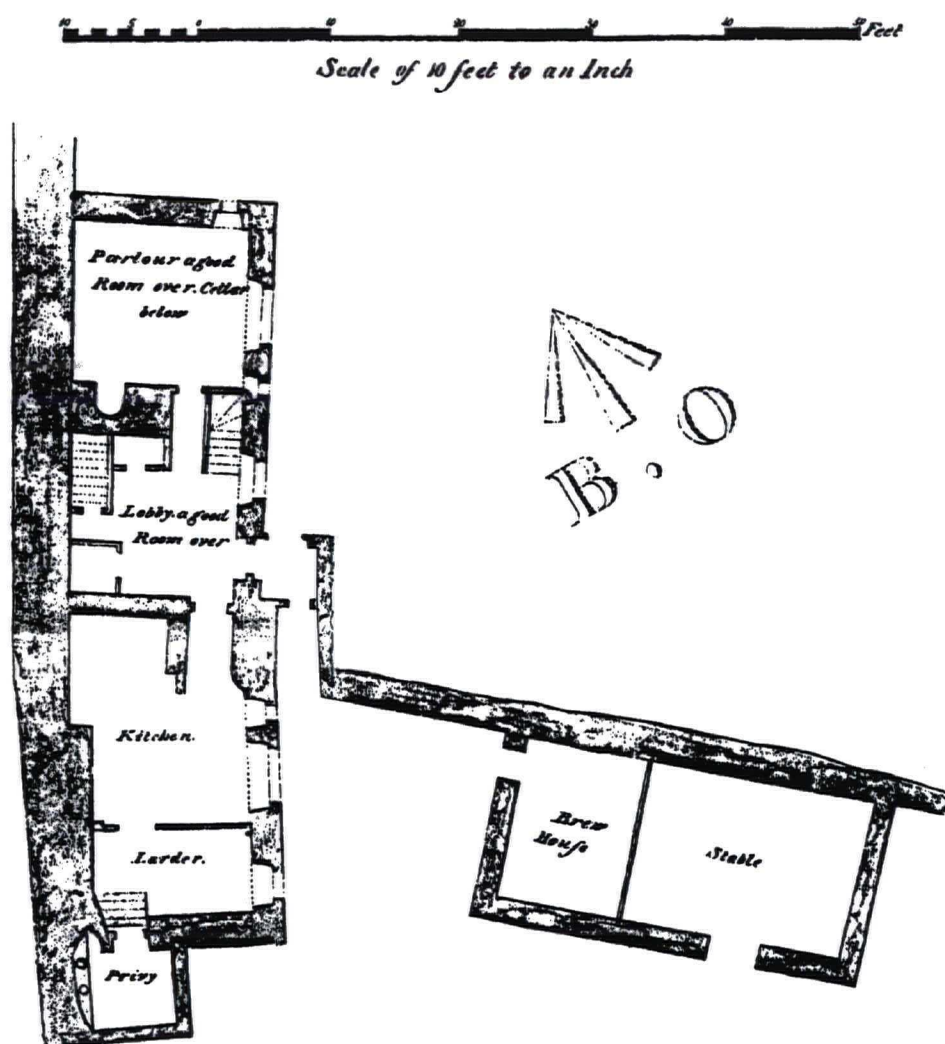
Fig.15: Plan of the Master Gunner's House according to Captain Phillips' survey of 1716 (EH1/42)

here by 1716. The evidence of Captain Phillips (the Duke of Marlborough's chief engineer) in his plan of the castle and the Master Gunner's house in 1716 (EH 1/42 and WORKS 31/1138) suggests that it is in essence a seventeenth century building (Fig.15). It may have been built by the Board of Ordnance to provide a replacement Governor's residence after the collapse of the western wall of the keep had rendered it redundant in 1645. Phillips was responsible for the construction of the most extensive and monumental range of barracks in early eighteenth century England, at Berwick, and he may well have made recommendations for the adaptation of this building to form a separate Gunner's house.

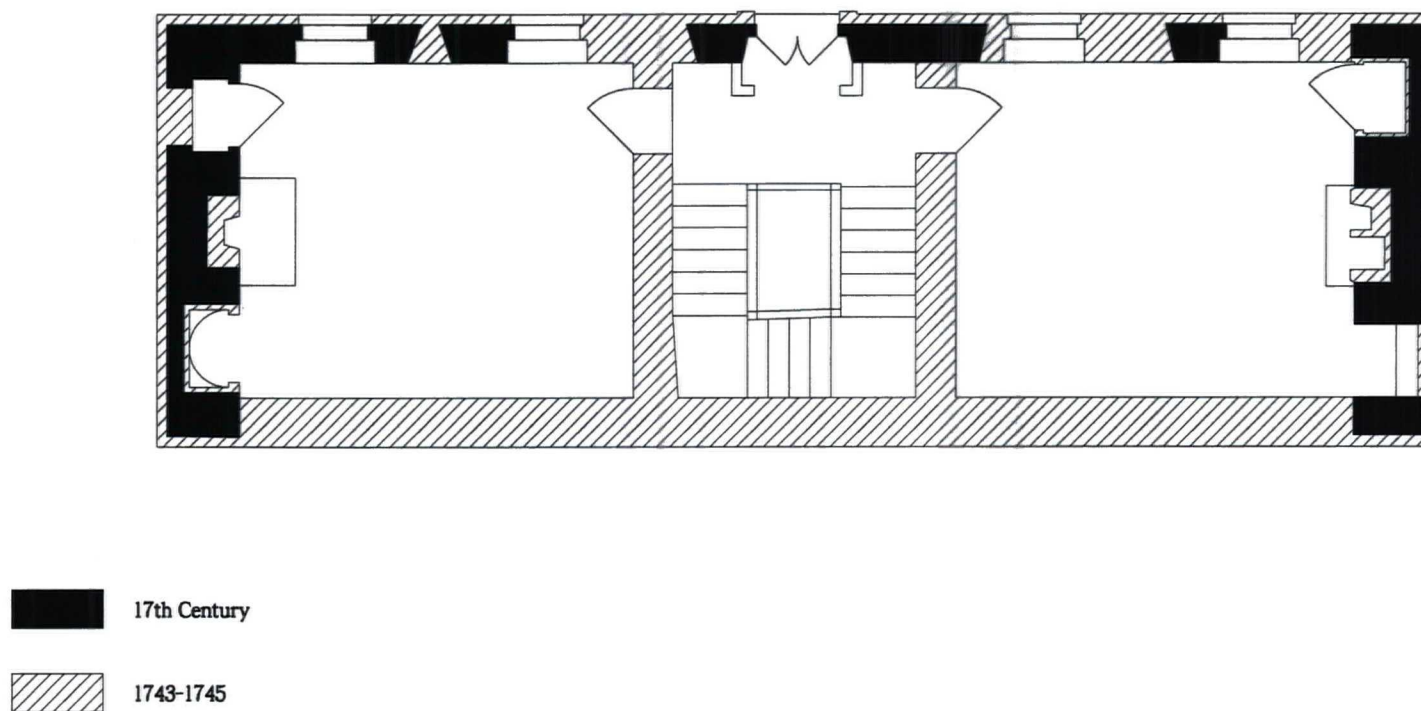
Figure 16

Scarborough Castle Master Gunner's House Ground plan showing provisional phasing

Between 1742 and 1746 this building was drastically altered (Fig.16). The curtain wall which formed the western wall of the building was cut back, leaving exposed the rubble core which is still visible today, and a new wall was built in approximately the same location as the inner face of the curtain. The eastern wall was partly reconstructed to form a homogenous fenestration scheme and the northern and southern walls were partly rebuilt and heightened.

The basement of the northern part of the building was retained largely as it existed. However, that section of the western wall that was to form the stairwell was removed and rebuilt in sandstone. The internal arrangement that existed in 1716 was swept away and a new symmetrical plan imposed.
