OLD HALL, BARDEN
(SE 142 934)
ARCHAEOLOGICAL RECORDING, FEBRUARY 1999

A report to John G. Hills

OLD HALL, BARDEN
ARCHAEOLOGICAL RECORDING, FEBRUARY 1999.

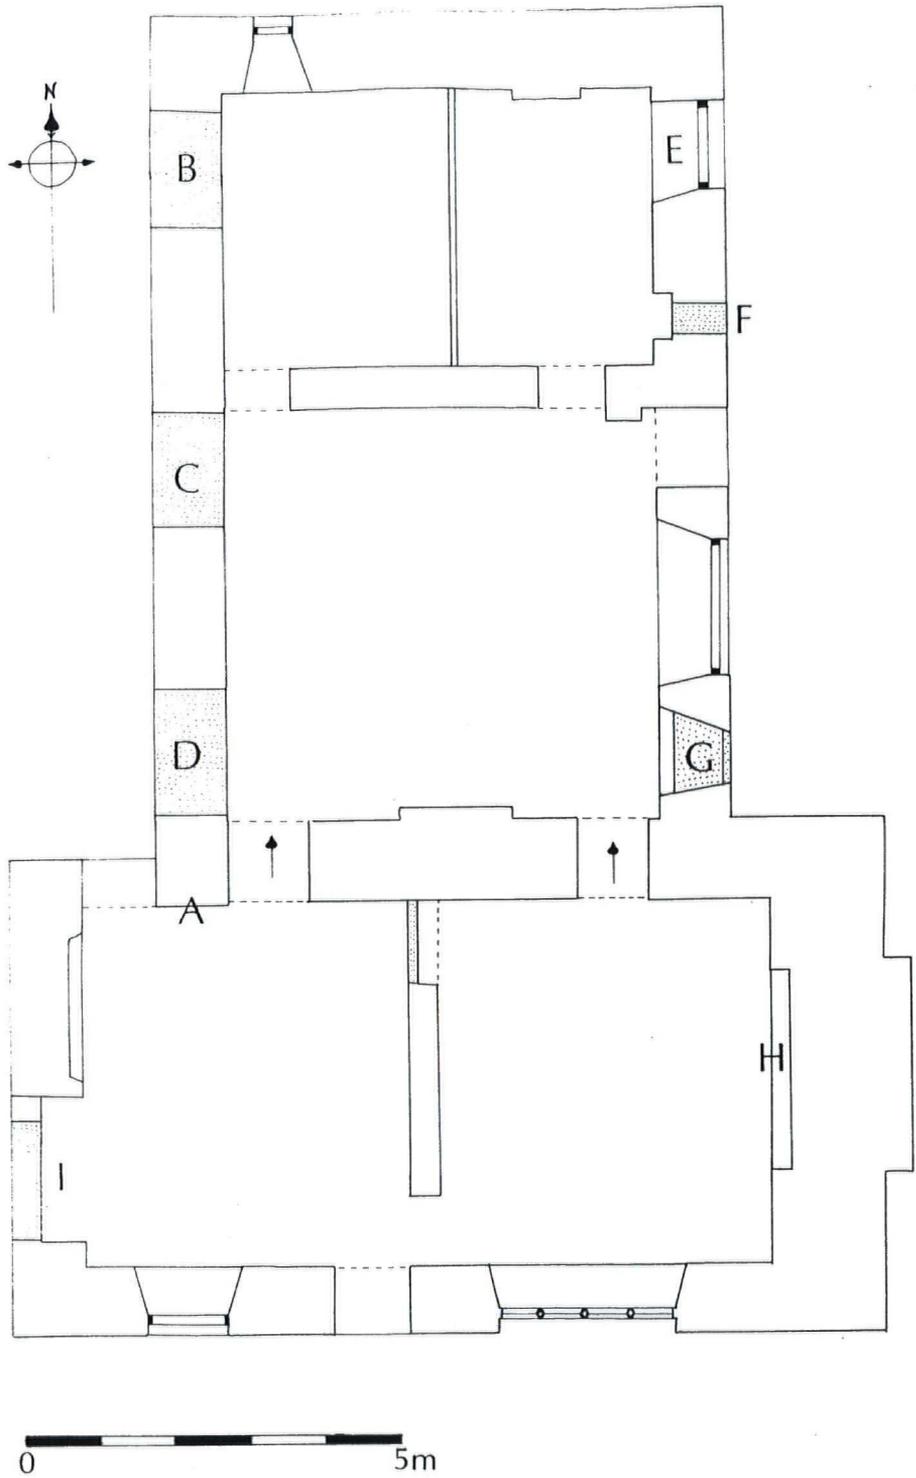
The Brigantia Archaeological Practice
Old Hall, Barden
Fig. 1
Ground Plan

DESCRIPTION OF THE BUILDING (Letters in brackets refer to Fig. 1)

5. Barden Old Hall is a house of two storeys, built in a 'T' plan. Of the two ranges, that aligned north-south is the main Hall range. This shows signs of having been increased in height: there is a change in the coursing of the masonry about half a storey below the level of the eaves, above which the stones used are rather smaller. It is possible that this increase in height was associated with the conversion of an original open hall to a two-storey range. At the level of the change in character of the walling may be seen in a couple of places on the

7. There is some indication that the hall block might be earlier in date than the cross-wing. The southern end of the west wall of the hall, inside the western half of the cross-wing, retains at a high level some cut and dressed sandstone blocks (A) which resemble quoins: they best make sense as the original external south-west corner of the hall, onto which the service wing has later been added. This sequence would also account for the otherwise unnecessary thickness of the wall between hall and cross-wing, east of this point. Unfortunately, no clear relationship between the two parts of the building could be discerned at their junction on the eastern side of the house.

8. The western side of the hall block has three blocked doorways (B-D), which are service doors to the original screens passage of the mediaeval hall. Only two are mentioned by *VCH* and by the Listing description: the southernmost (D) seems until now to have escaped notice, although three, rather than two, screens doors would be more usual. The identification of these doors as the screens seems beyond doubt, and implies the former existence of a service building to the west. No trace of this can be seen.

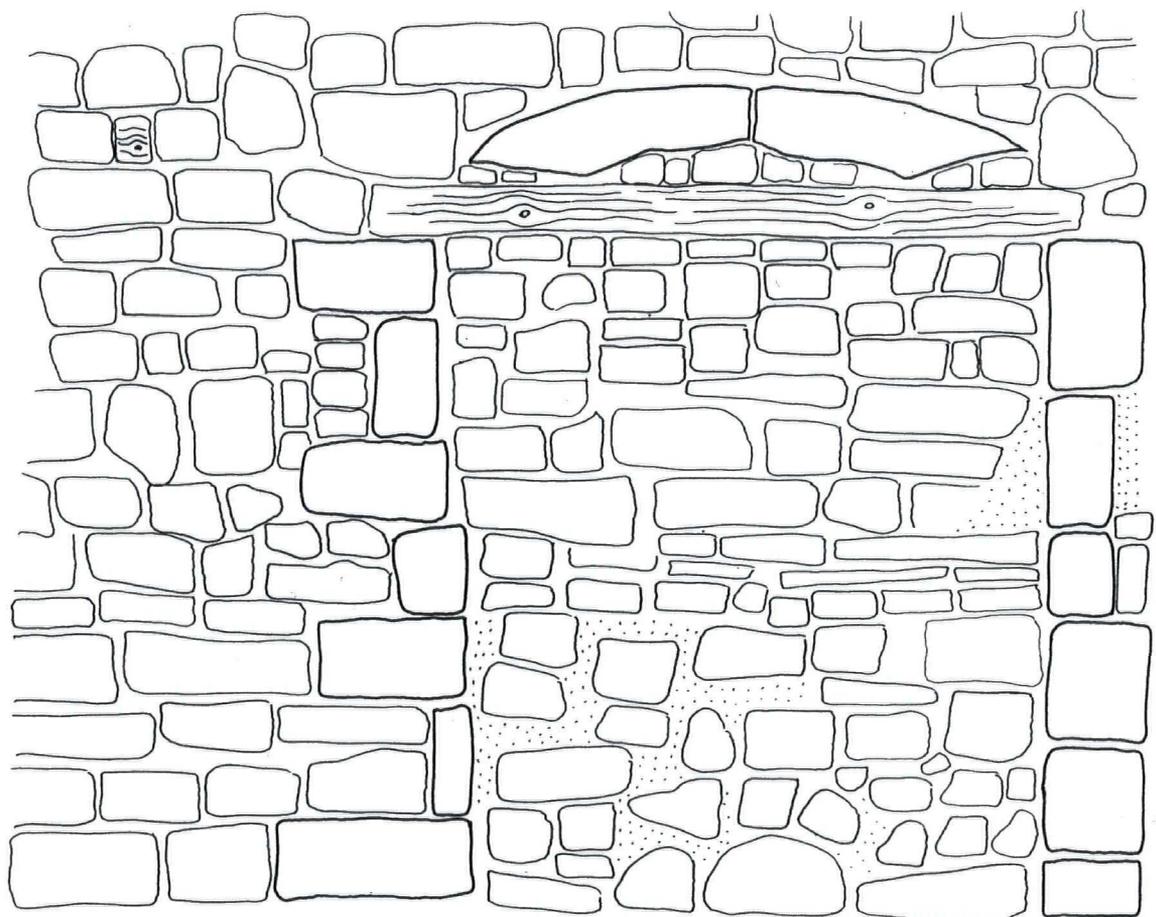
The Brigantia Archaeological Practice
Old Hall, Barden
Fig. 2
Northern screens door, internal
Scale 1:20

9. At the northern end is a blocked doorway (B), which has always been visible on the external wall face. It is wide, with gritstone external facings which feature a four-centred arch with a pronounced, rounded hollow chamfer to the arris. The quality of this masonry is very high. The newly-exposed internal side of this door shows remains of different style and material (Fig. 2): a moulded arch of yellow sandstone with an ogival head, presumably earlier in date than the external dressings. Below this has been inserted a lintel of oak (the sequence is discussed at 10 below).

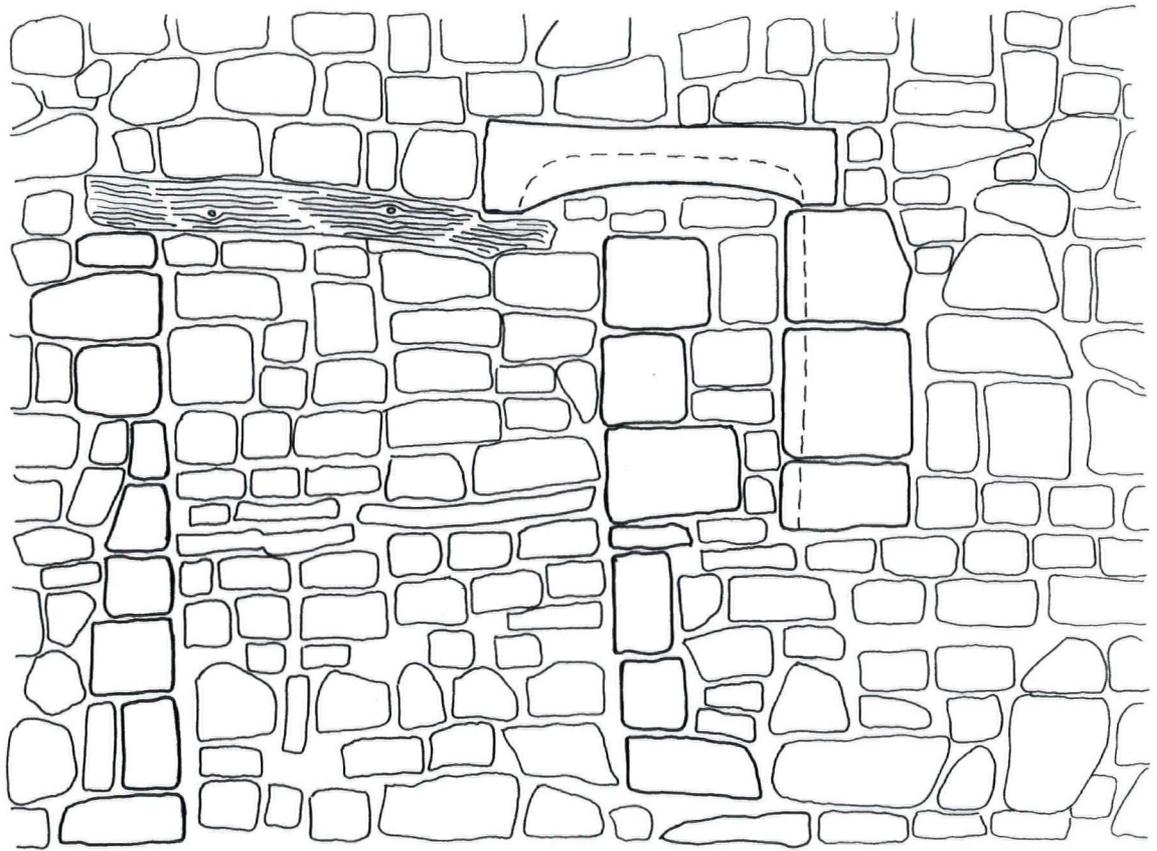
The Brigantia Archaeological Practice
Old Hall, Barden
Fig. 3
Middle screens door, external
Scale 1:20

10. The central screens door (C) shows a more complex sequence. Externally, no real trace survives of the original head, although the masonry above the door does show some signs of disturbance (Fig. 3). The interior aspect,

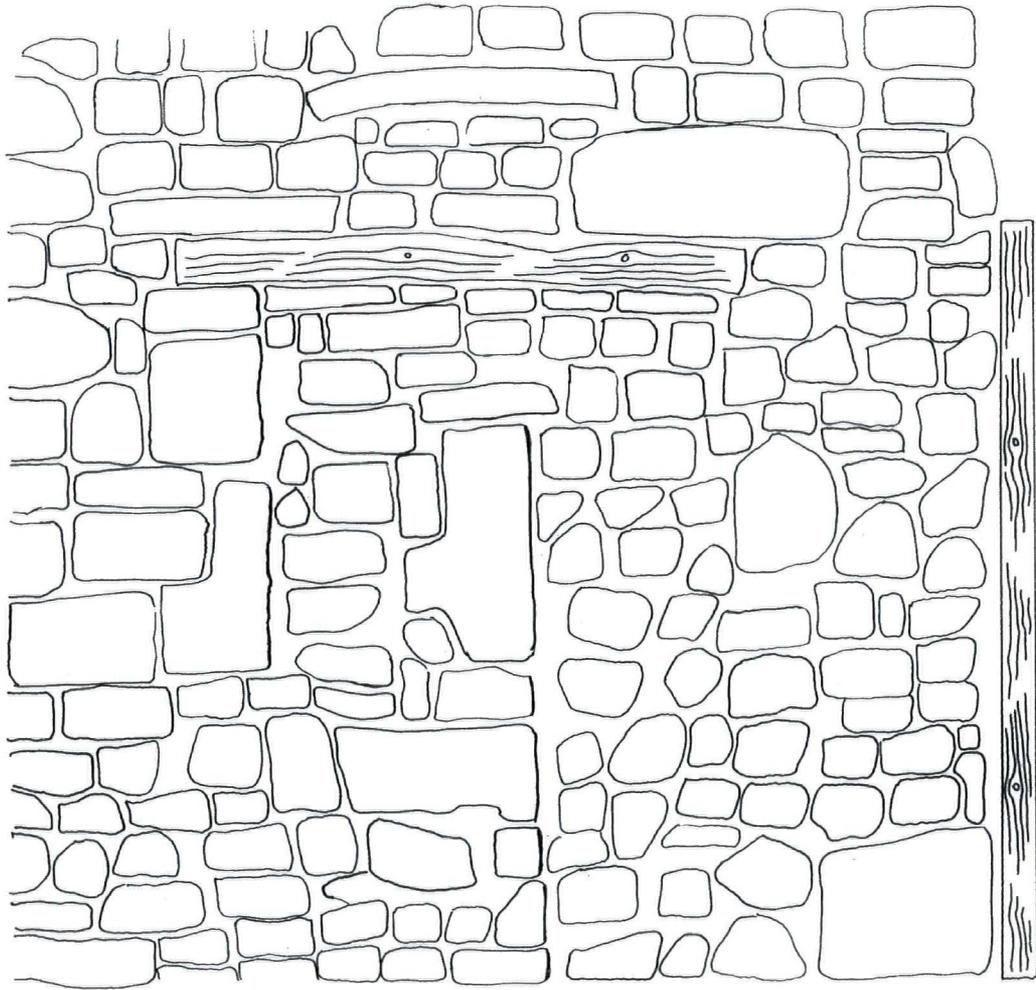
The Brigantia Archaeological Practice
Old Hall, Barden
Fig. 4
Middle screens door, internal
Scale 1:20

however (Fig. 4), shows the remains of the same sort of sandstone, ogee-headed arch as was seen at (B). The blocked door may be seen quite clearly, with original, rather eroded sandstone dressings to the jamb on the north side. To the south of this has been inserted a window, partly destroying the south side of the original door. It is very nearly square-headed, with dressings of the same gritstone, and with the same hollow chamfer, as on the northern screens door at (B). Very similar windows (in the same material) at Marrick Priory are dated to the turn of the sixteenth and seventeenth centuries, and such a date seems reasonable here, too. The northern side of the window has been damaged by the insertion of an oak lintel, below which is more blocking material of a phase of door with newer, uneroded sandstone dressings to the southern jamb. The sequence, therefore, is:

- (i) Construction of the original, central, screens door with sandstone ogival head.
- (ii) Blocking of the door.
- (iii) Insertion of window with gritstone facings.
- (iv) Blocking of the window and insertion of new door with timber lintel and new sandstone jamb on the south side.
- (v) Final blocking of the door.

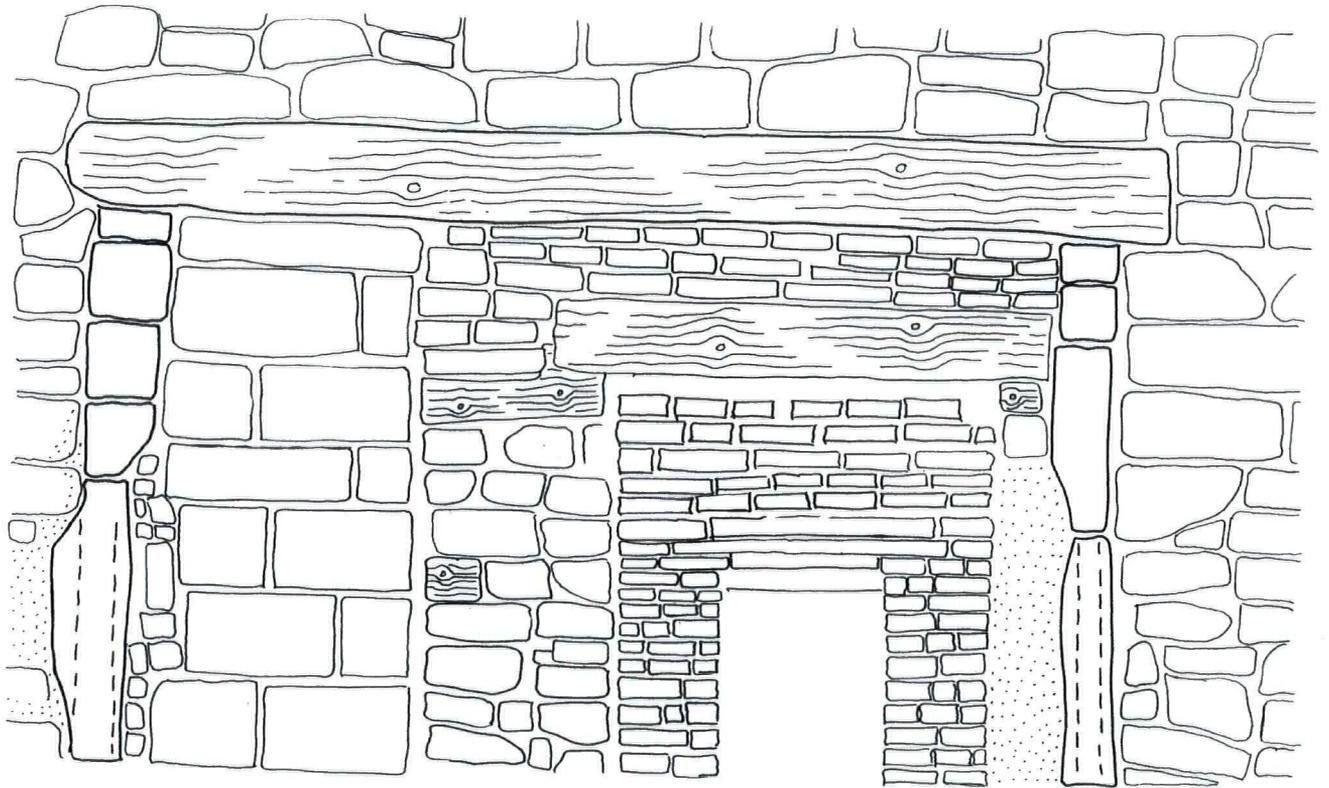
The Brigantia Archaeological Practice
Old Hall, Barden
Fig. 5
Fireplace in cross-wing
Scale 1:20

20. On the internal face of the eastern wall, current works have revealed a large early fireplace (Fig. 5). A huge oak lintel is supported by jambs of sandstone, the lowest parts of which are elaborately chamfered. These obviously represent the earliest period of the fireplace, and a mediaeval date is entirely plausible. Blockings of brick and stone indicate the progressive reduction of the hearth until the present small modern fireplace was inserted: an area left as a cupboard on the north side has recently been filled with breeze blocks. A substantial external stack on the east wall of the wing confirms the early origin of

the fireplace, and adds to the suggestion that this part of the cross-wing was the original kitchen.

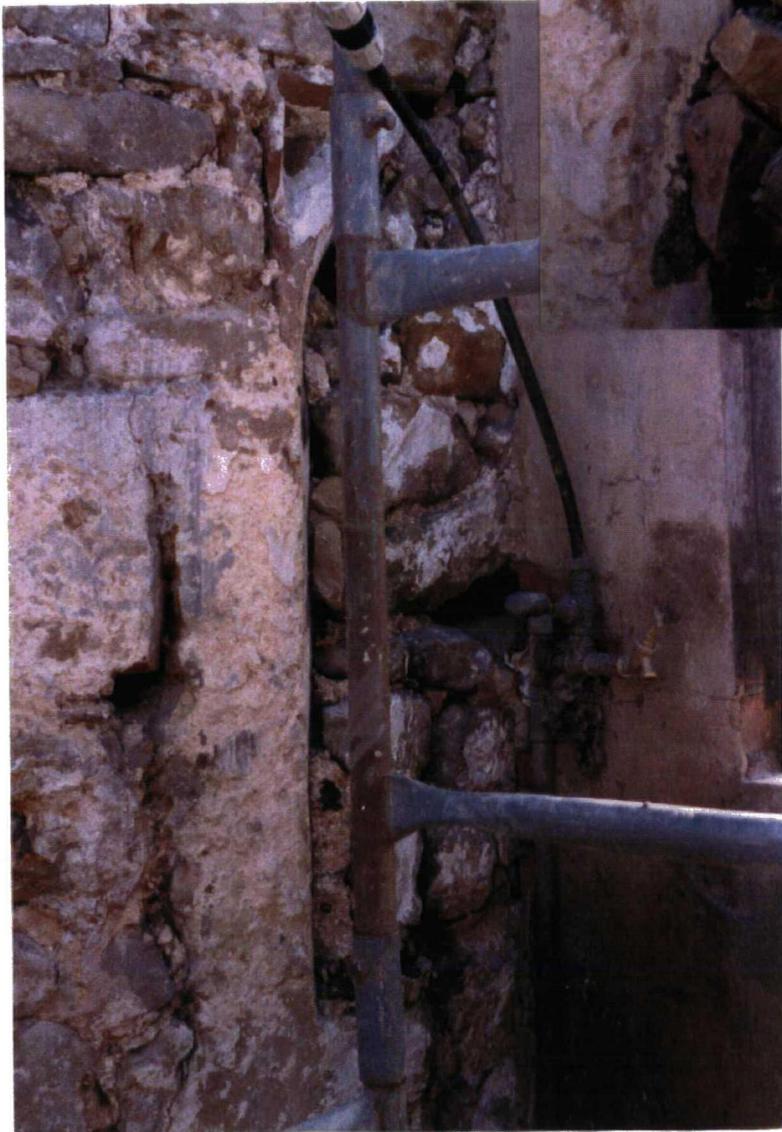
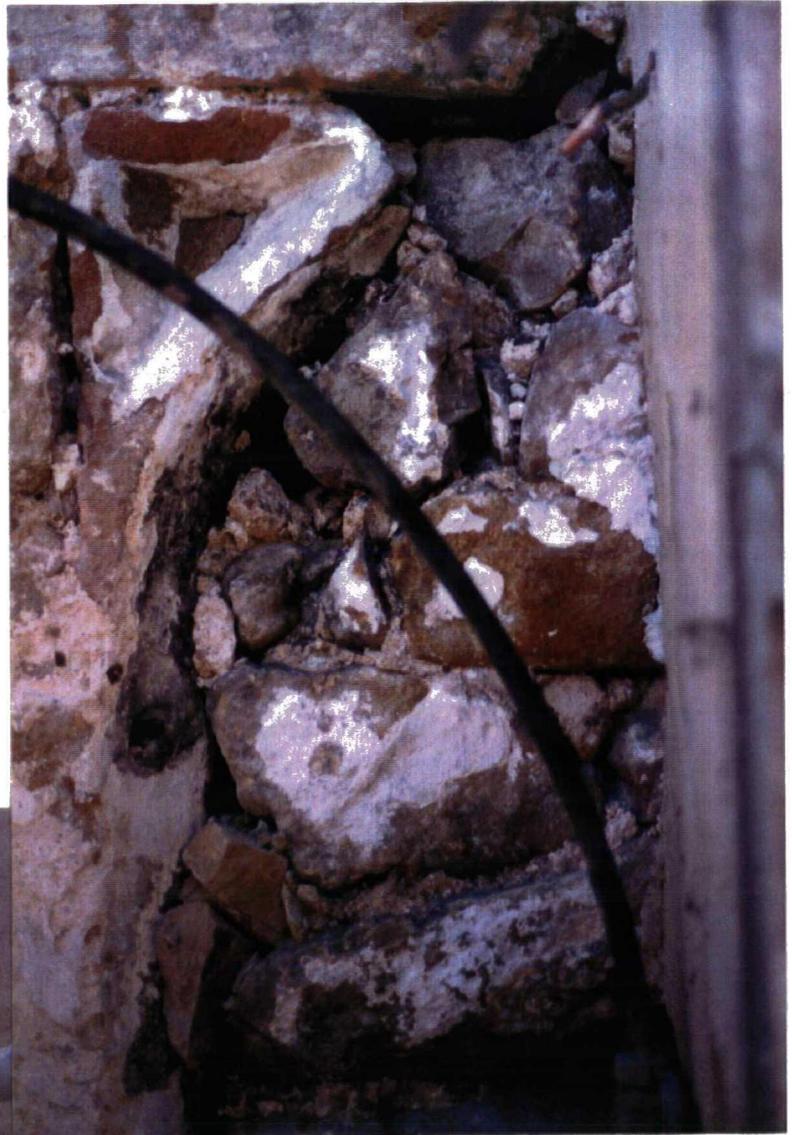
The Brigantia Archaeological Practice
Old Hall, Barden
Fig. 6
Blocked window on west side of cross-wing

21. Another large fireplace, of much more recent origin, has been built in the western end of the wing. To the south of this is a large recess (I), used for a cupboard: it has originated as another blocked door. Virtually nothing of this can be seen on the inside, but removal of external render has exposed the edge of the blocking on its southern side, where a jamb would have been. In the northern part of the opening are the very mutilated remains of a sandstone window (Fig. 6), with a cusped head of late mediaeval type. This area was rather obscured when examined, but it appears that the window has been inserted into the blocking of the door, in which case the door too is mediaeval, and probably belongs to the original construction of the cross-wing.
