**ARCHAEOLOGICAL EVALUATION  
AND WATCHING BRIEF  
SCARBOROUGH CASTLE  
NORTH YORKSHIRE**

**REPORT**  
April 2001

NGR: TA 04945 89250  
Monument No: 13300

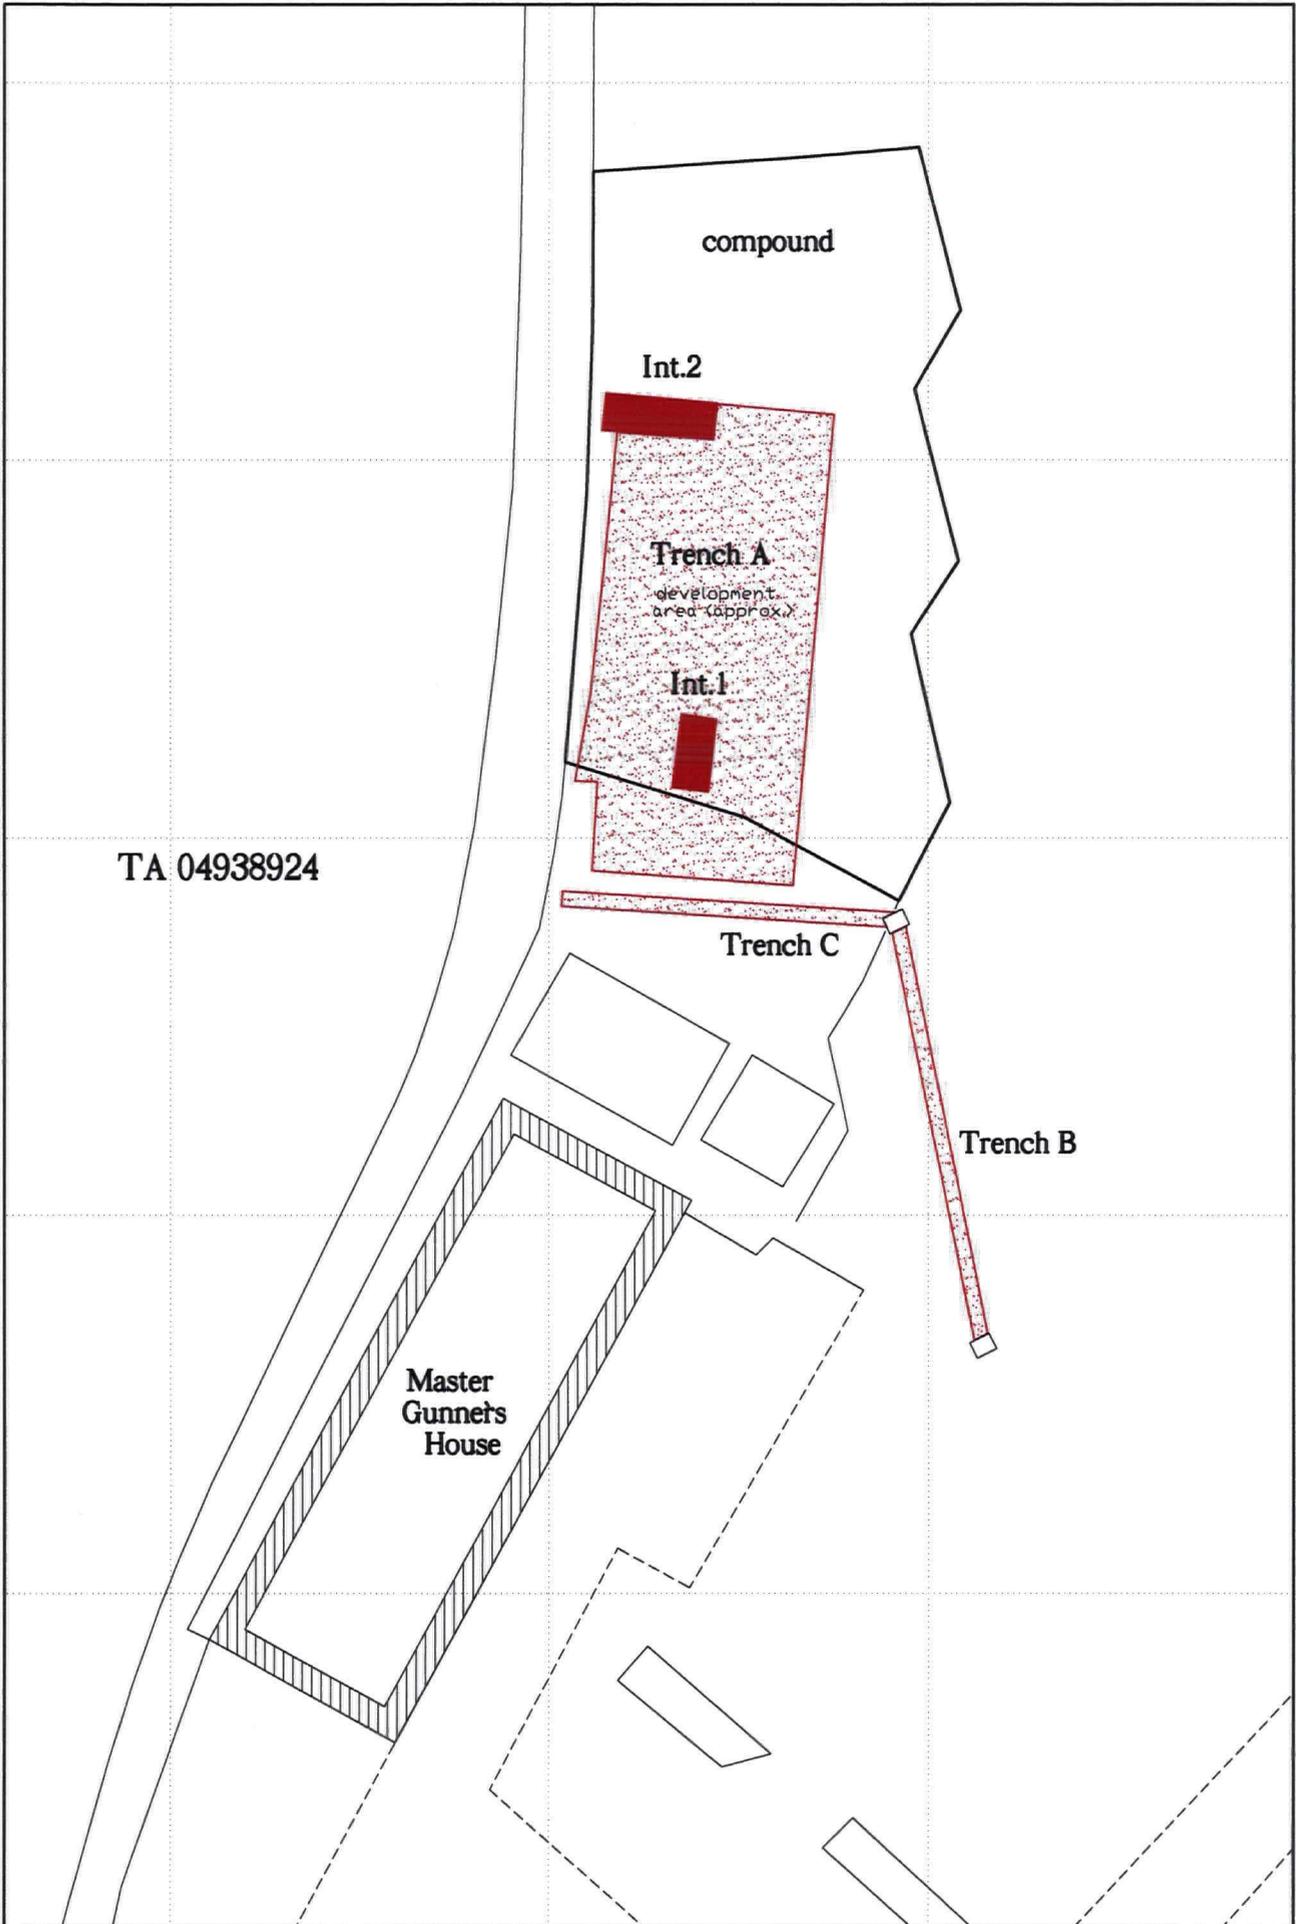
Figure 2

Scarborough Castle Location of interventions and trenches

Two small evaluation trenches, Intervention 1 (2m x 1m) and Intervention 2 (3m x 1m), were positioned within the development area (Fig.2). These trenches were situated to the north of the Master Gunner's House within an area of the Outer Ward currently used as a storage compound. Int.1 was set out parallel to the curtain wall toward the southern end of the development area, and was offset northwards a few metres from its designed location in order to avoid crossing the fence at the edge of the compound, but Int.2 was orthogonal to the wall along the northern edge of the proposed toilet block, in accordance with a location map provided by English Heritage.

Monitoring took place over a larger area roughly encompassing both evaluation trenches (Fig.2) and areas beyond the compound. The compound area and service trenches connecting with it were designated letters A, B, and C respectively. The southern limit of Intervention 1 provided the southern limit of the development area, Trench A. The southern limit of Intervention 2 defined the modified northern limit of the area. Trench A was excavated using a small back-action mechanical excavator with a wide toothless bucket under close archaeological supervision. The excavation was taken to within approximately 0.8m of the curtain wall on the west, and extended approximately 6.4m east from the curtain wall.

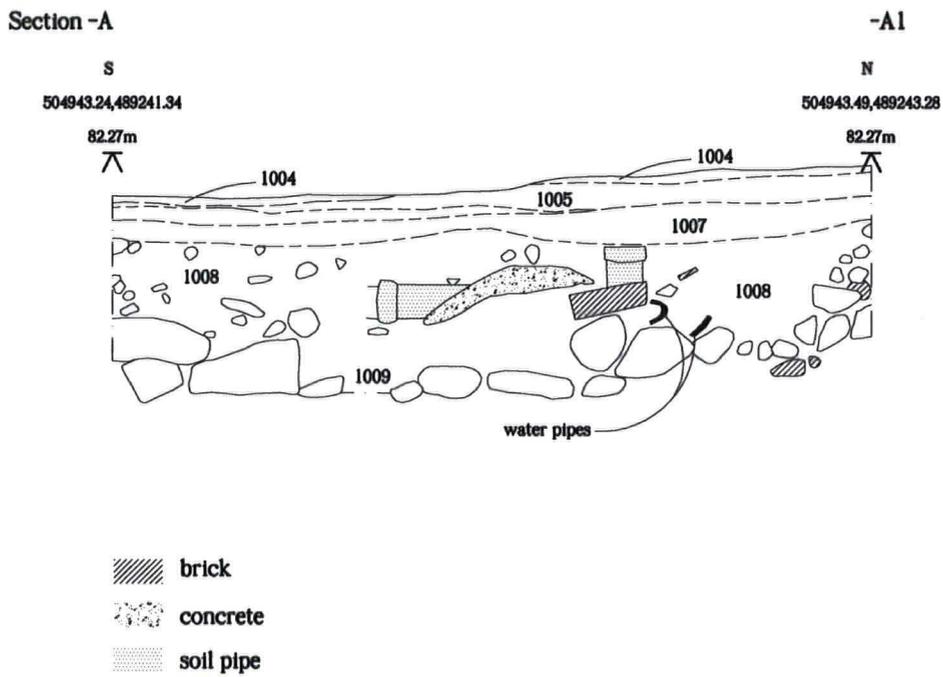
Figure 3

Intervention1 east facing section A-A1

The small trench, 2m x 1m, contained a sequence of superficial deposits and layers (Fig.3). A shallow topsoil (C1004), only 0.04m thick, covered a large and saturated wooden plywood sheet. Beneath C1004 were two layers of sand, C1005, a coarse sterile sand, and C1006, a finer yellow grey sand, which was absent from the northern end of the trench.

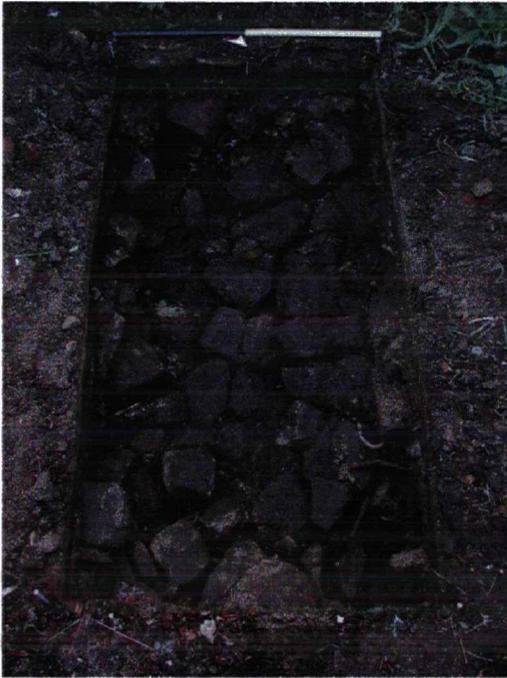
Plate 1 Intervention 1

At a depth of approximately 0.40m the character of the strata changed abruptly. It consisted of a dense stony rubble with voids (C1009) and included were pieces of dressed sandstone blocks, undressed calcereous limestone

and cobbles. Excavations to the required depth were completed within the upper level of the rubble (Plate 1).

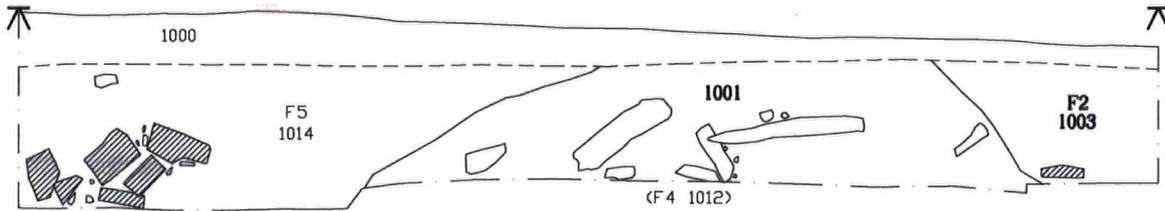
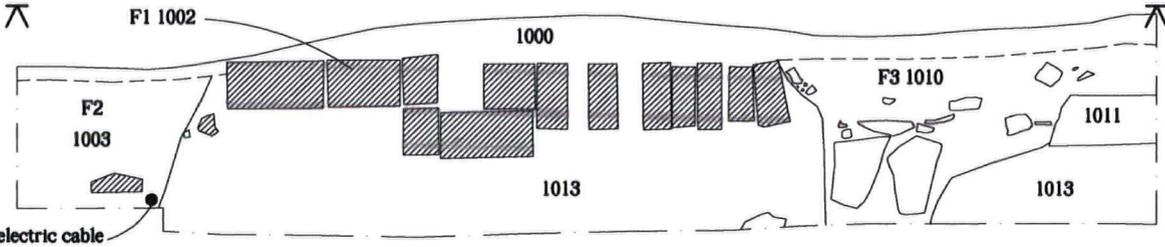
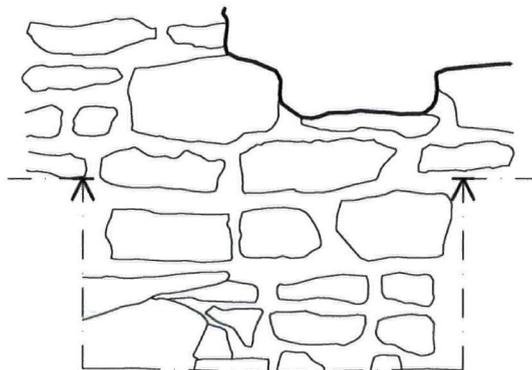
Figure 4

Intervention 2 sections B-B1, C-C1 and elevation of curtain wall (C1-B)

The trench, 3m x 1m, contained a number of modern features, a sequence of layers and a substantial wall faced with cut blocks of sandstone and which abutted the curtain wall of the castle (Fig.4).

Excavation of Int.2 exposed an area of the curtain wall (Fig.4). Its facing consisted of a mix of irregular blocks of sandstone and calcereous limestone. Recent repointing had obscured structural relationships, but the mixed geology suggests that the area had been refaced, 13<sup>th</sup> century facing generally being of sandstone, with limestone restricted to the core of the wall.

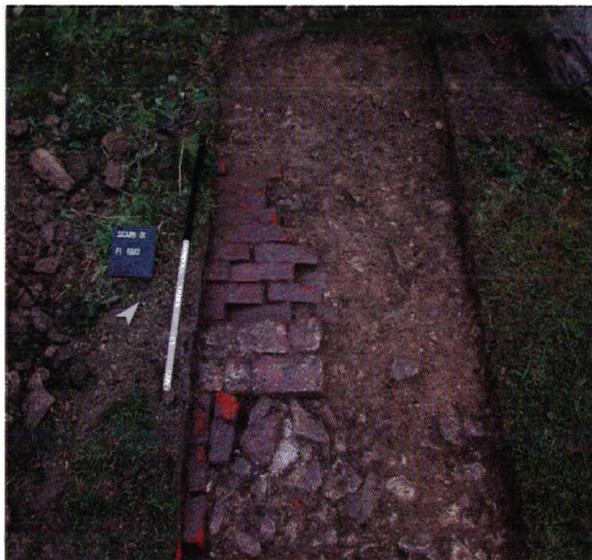
Plate 2 Intervention 2

which ran parallel to the curtain wall, although this only extended across half the width of the trench (Fig.5, Plate 2).

The irregular edge suggests that further bricks had been removed, although no robber trench was defined. The bricks, of 19<sup>th</sup> century date, were set both on edge and flat, and although none were bonded, some were partially covered with traces of mortar, indicating that they had been reused from elsewhere. The bricks had apparently been laid directly and without any preparation onto a soft soil matrix (C1013). F1 is identified as a modern pathway or garden landscape feature.

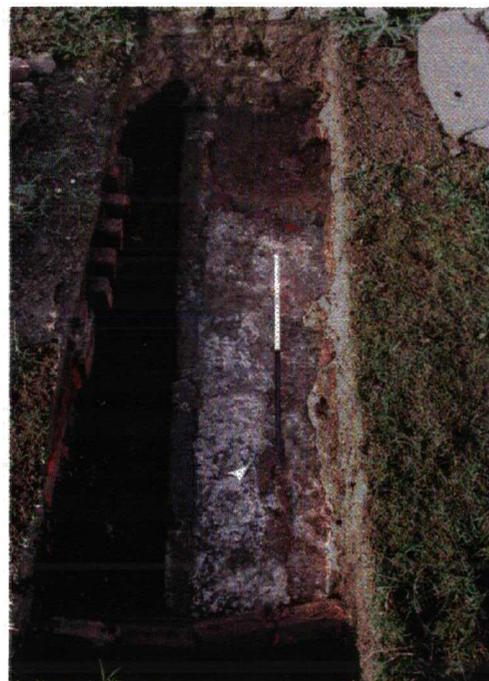
Plate 3 Intervention 2, F4

the entire length of Int.2, running beneath service trench F2 at a depth of 0.40m (Plate 3).

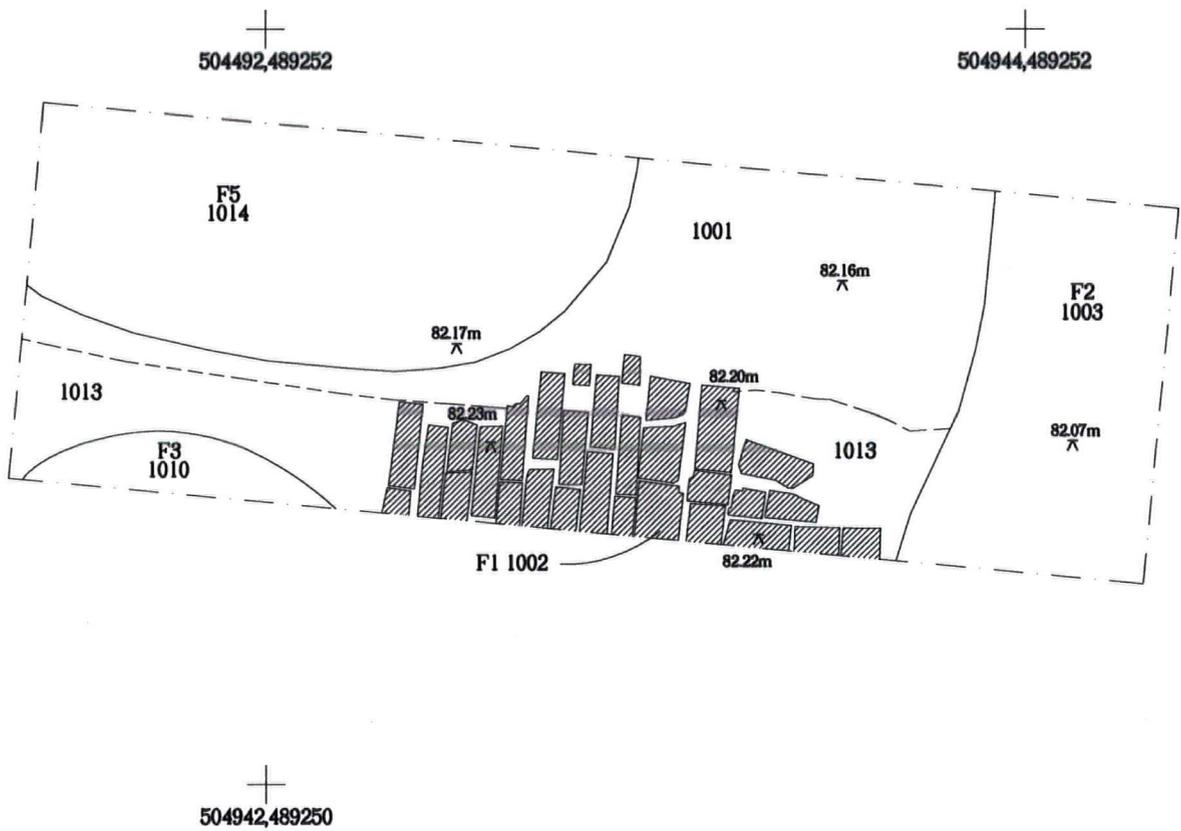
Figure 5

Intervention 2 F1 1002

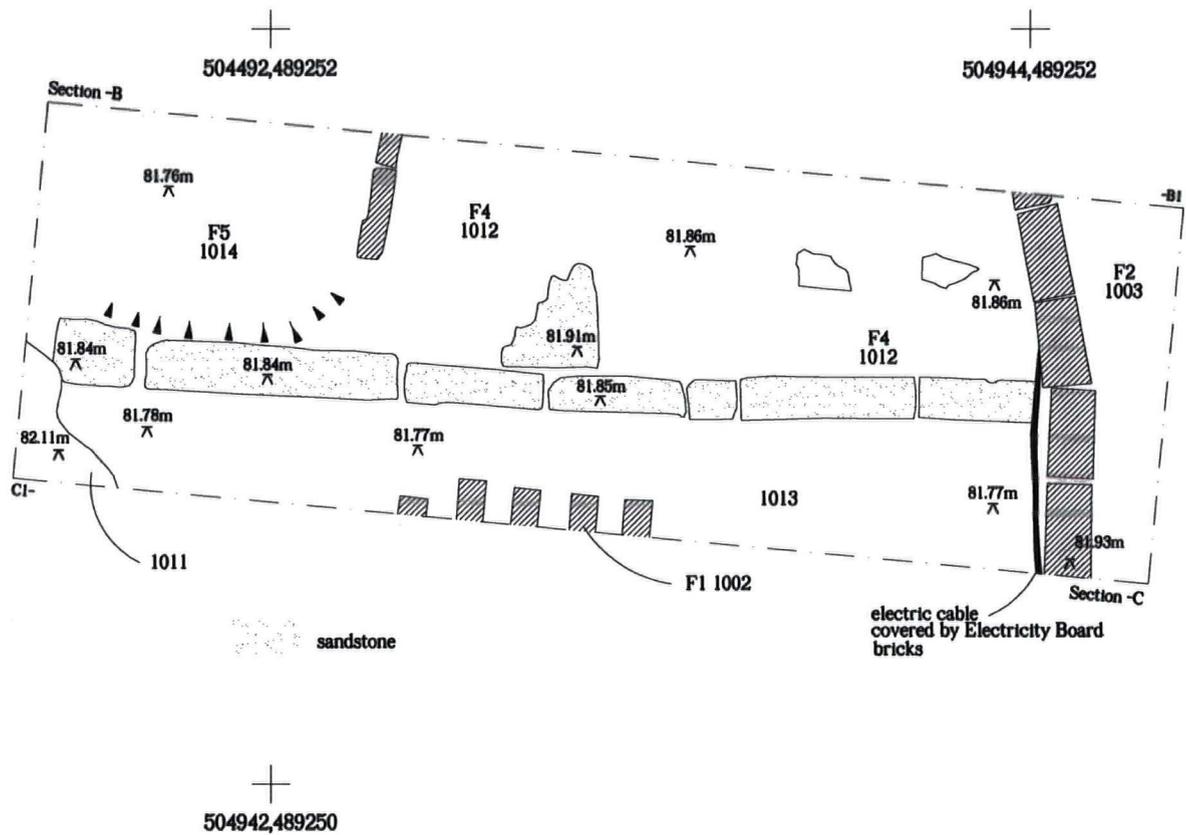
Figure 6

Intervention 2 at base of the trench showing F4 1012

Beneath contexts C1001 and C1013 were the remains of F4, a wall of massed construction which was more than 0.70m wide, but only exposed to a height of 0.10m (Figs.6 and 7). F4 was defined along

The wall had an outer facing of well-cut sandstone blocks. The wall core was filled with brick fragments, tile and irregularly shaped sandstone bonded with a lime mortar. At the west end the core had been robbed to a lower depth (F5 pit), although facing stones had been left. F4 abutted the curtain wall but had not been bonded into the fabric of the wall, at least at the depth excavated (Plate 4).

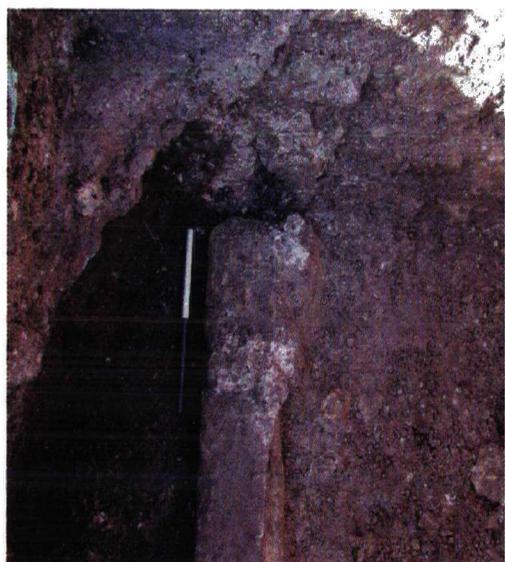
Plate 4 Junction of F4 with the curtain wall

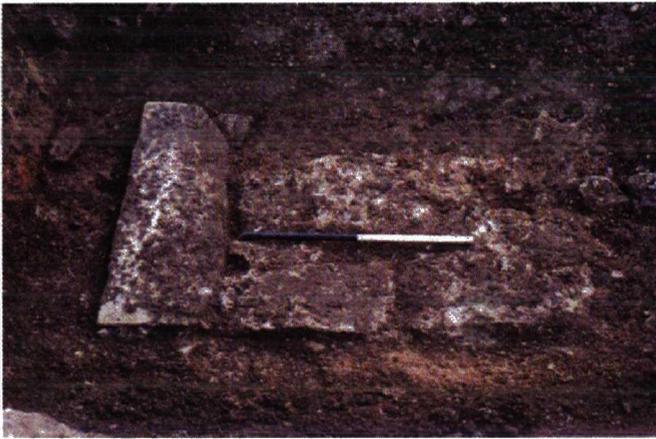
Plate 5 Sandstone wall (F10) in Trench A

favourably with that taken from F4 in intervention 2.

At the north-eastern corner of the excavation area, at 0.55m depth from the present ground surface, the digger uncovered the remains of a mass wall at least 0.65m wide, but only exposed to a maximum height of 0.06m (Plate 5, Fig.7). The eastern extent was marked by a single, well-dressed block of sandstone measuring 0.65 by 0.21m, with two further facing stones extending west from the northern end. The core was made up of fragments of irregularly-shaped sandstone bonded with lime mortar, a sample of which compared

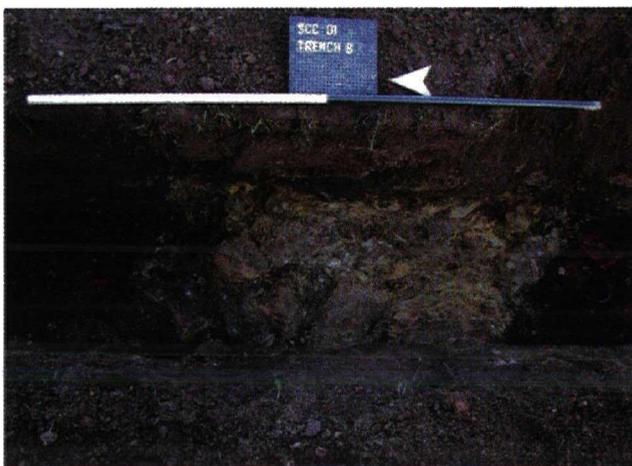
Plate 6 Sandstone wall (F11) in trench B

feature comprised of yellow sandstone and loosely bonded with a sandy mortar (Plate 6, Fig.7).

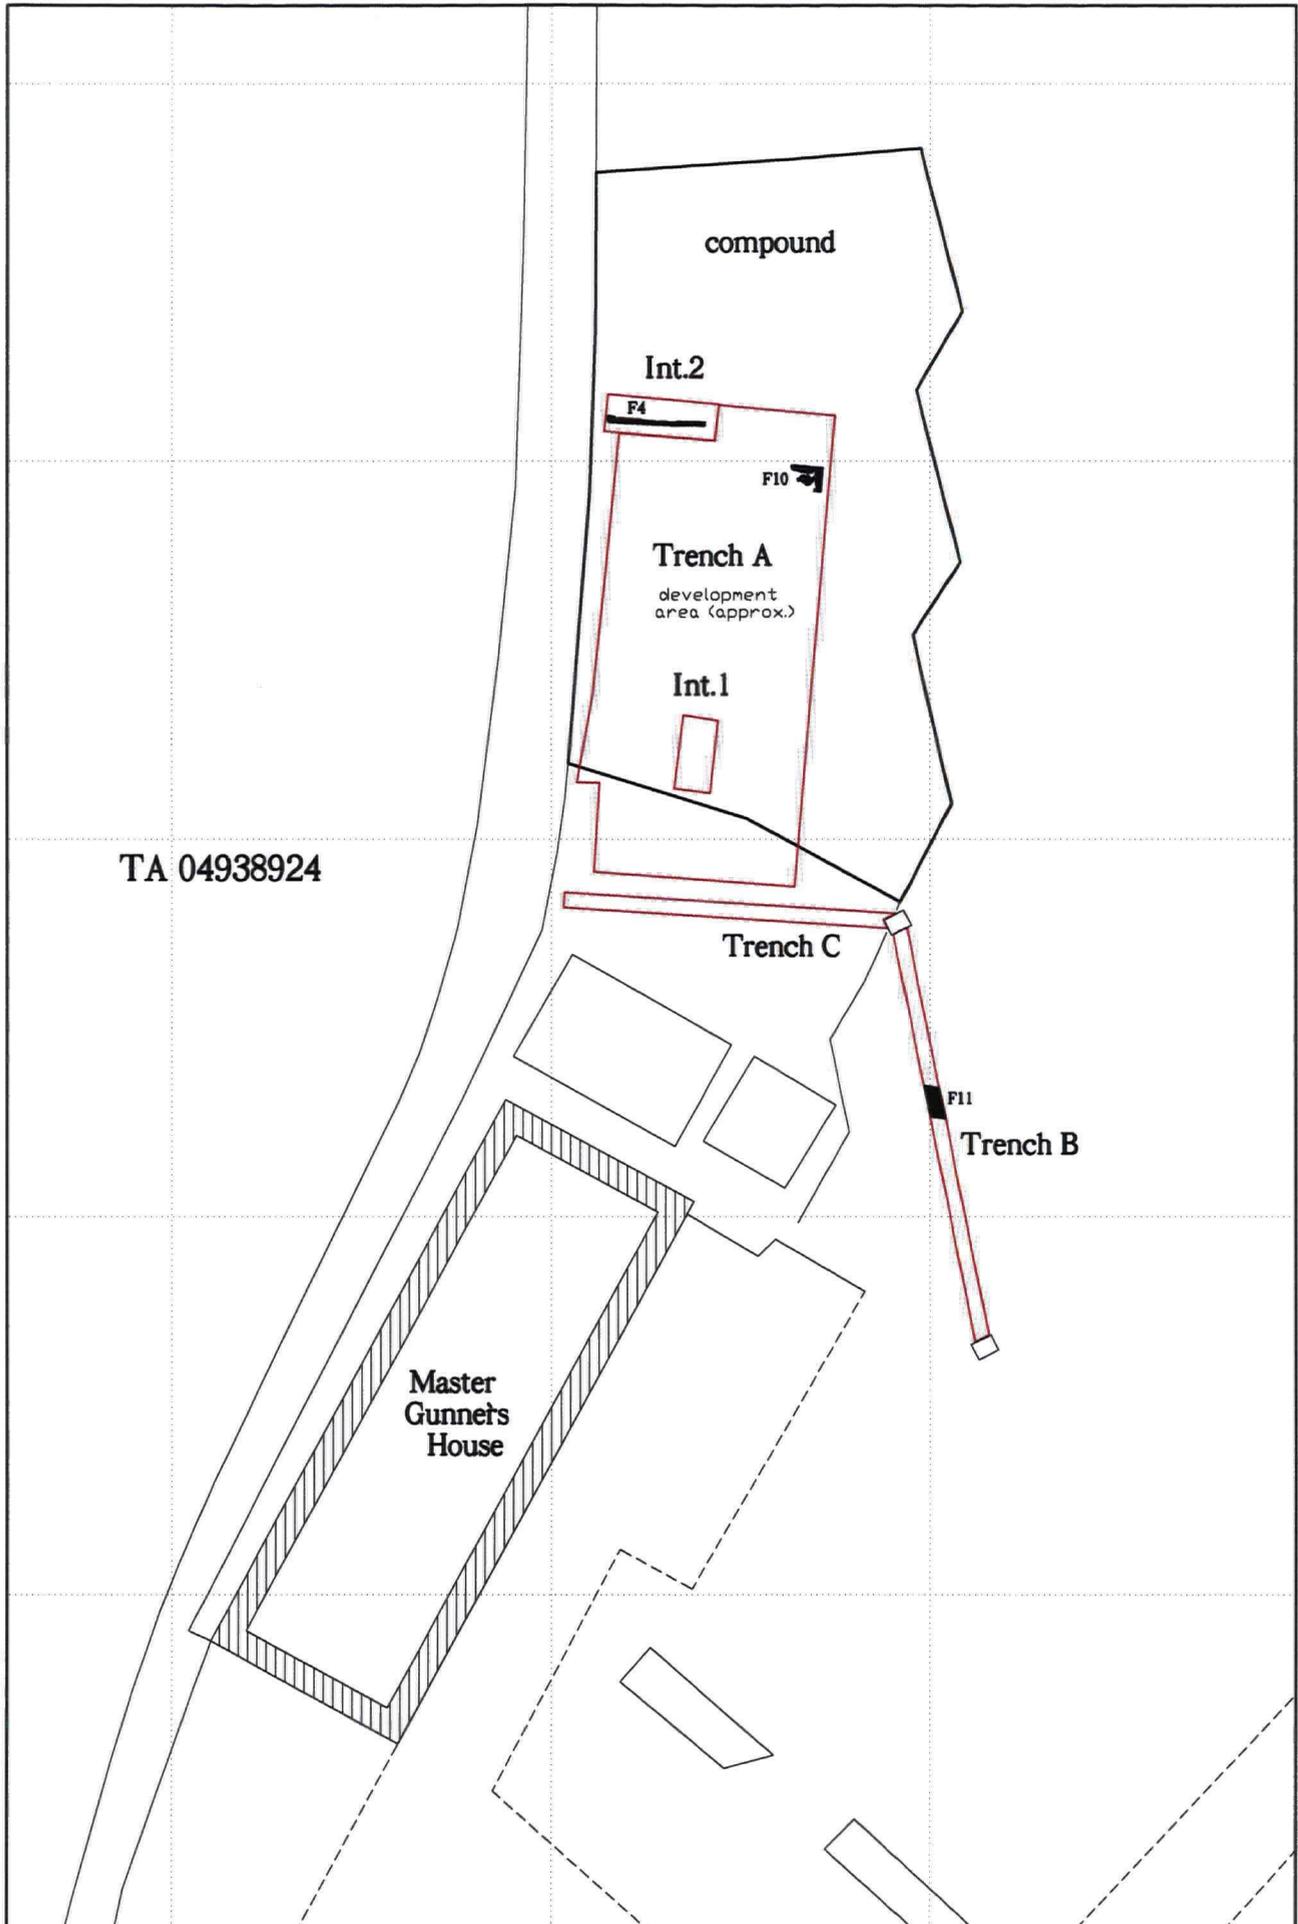
Figure 7

Scarborough Castle Location of walls within excavation areas

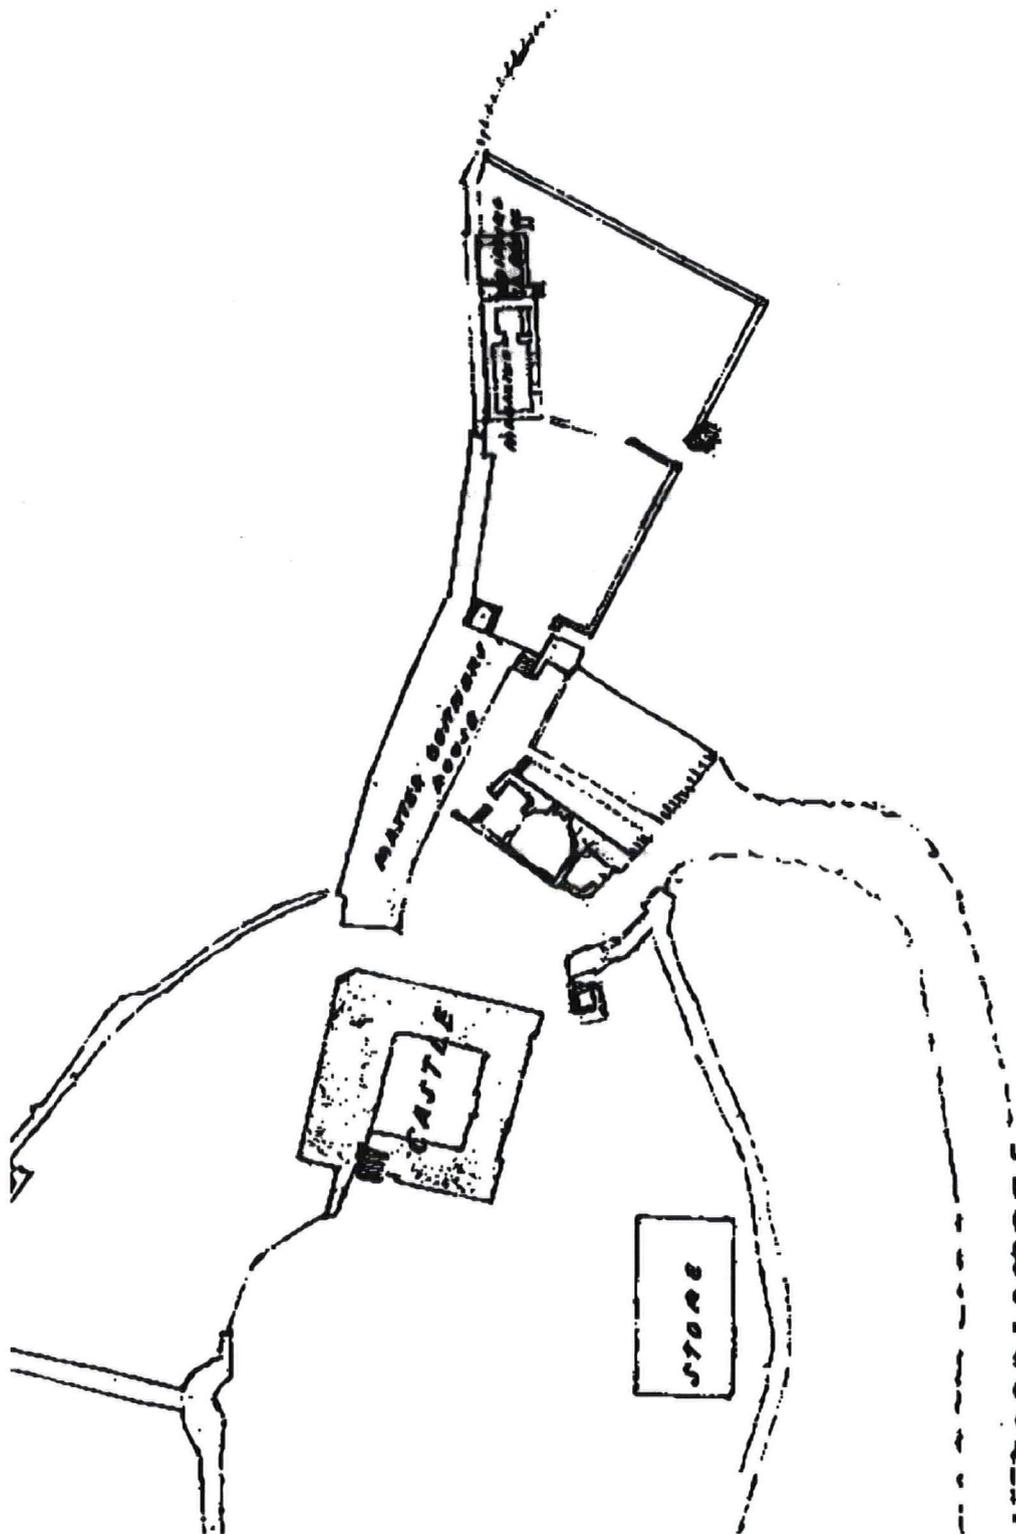
Fig.8: Location of buildings and enclosure walls according to 1851 map (PRO WO44/569)

Although only 0.40m of this wall was exposed, it appears to have been aligned east-west, may correspond with the position of the enclosure wall depicted on the 1851 map of the area (Fig.8).

century maps, specifically a segment of wall running east-west and framing an entrance to the yard at the north of the Master Gunner's house, c.1851 (Fig.8) (PRO W044/568).
