# **Humber Field Archaeology**

# AN ARCHAEOLOGICAL WATCHING BRIEF

# The Former New Tavern, Middleton, North Yorkshire.

Watching Brief Report

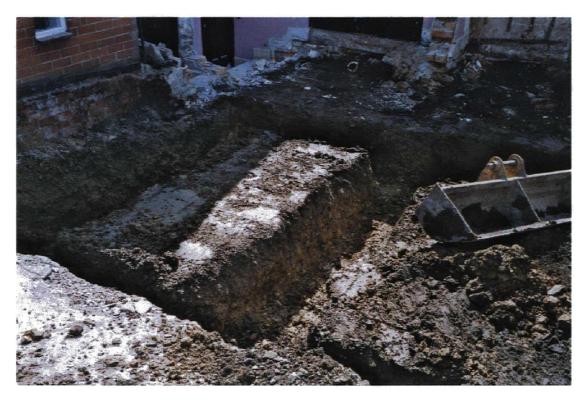
Plate 1. The foundation trenches during excavation, viewed from the north.

- 4.1 Prior to the excavation of the of the foundation trenches the area of the building footprint was reduced by 0.5m. The foundation trenches were then machine excavated to a depth of a further 0.6m and were 0.6m wide. The lowest deposit encountered was natural carboniferous and Jurassic sandstone. This was fragmented and was contained within an orange-yellow sandy matrix and was 0.3m deep. Within the upper part of the foundation trenches yellowish-brown silt subsoil had been exposed, this too was 0.3m deep.
