**WATCHING BRIEF AT THE "RECTORY"
WEST HESLERTON
22.1.1990.**

RESIDENTIAL DEVELOPMENT

(J. WILSON) WEST HESLERTON.

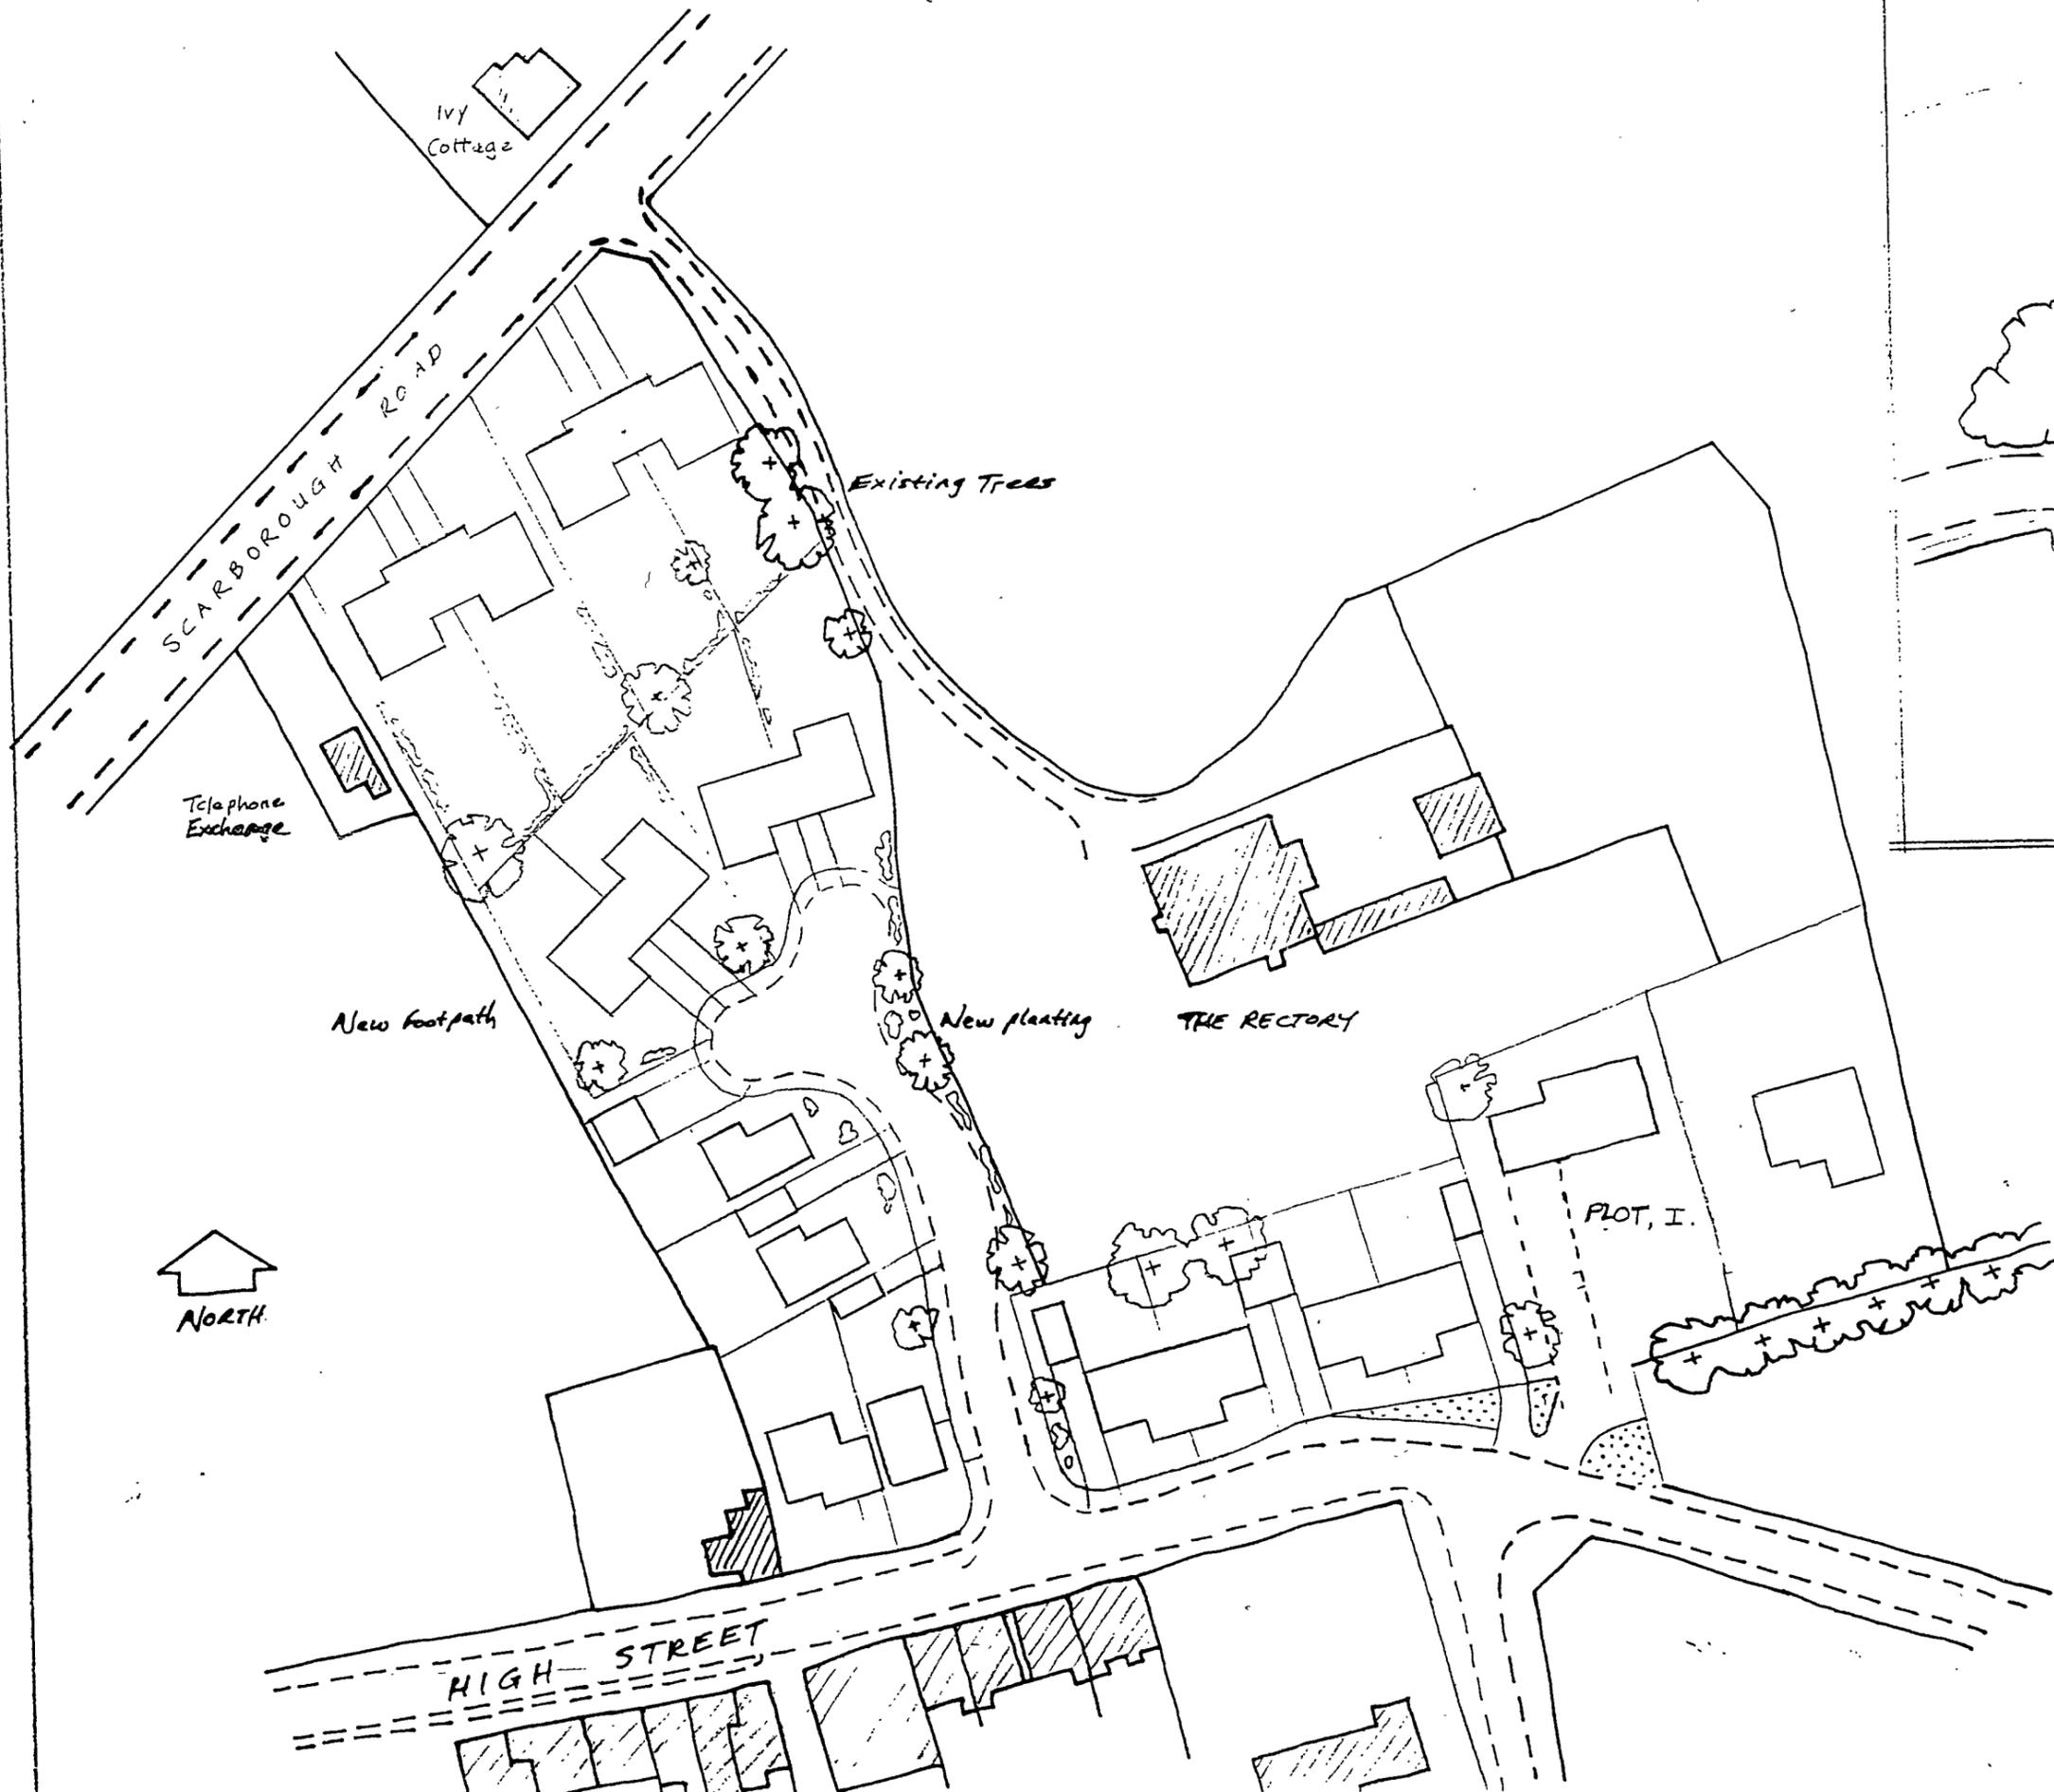
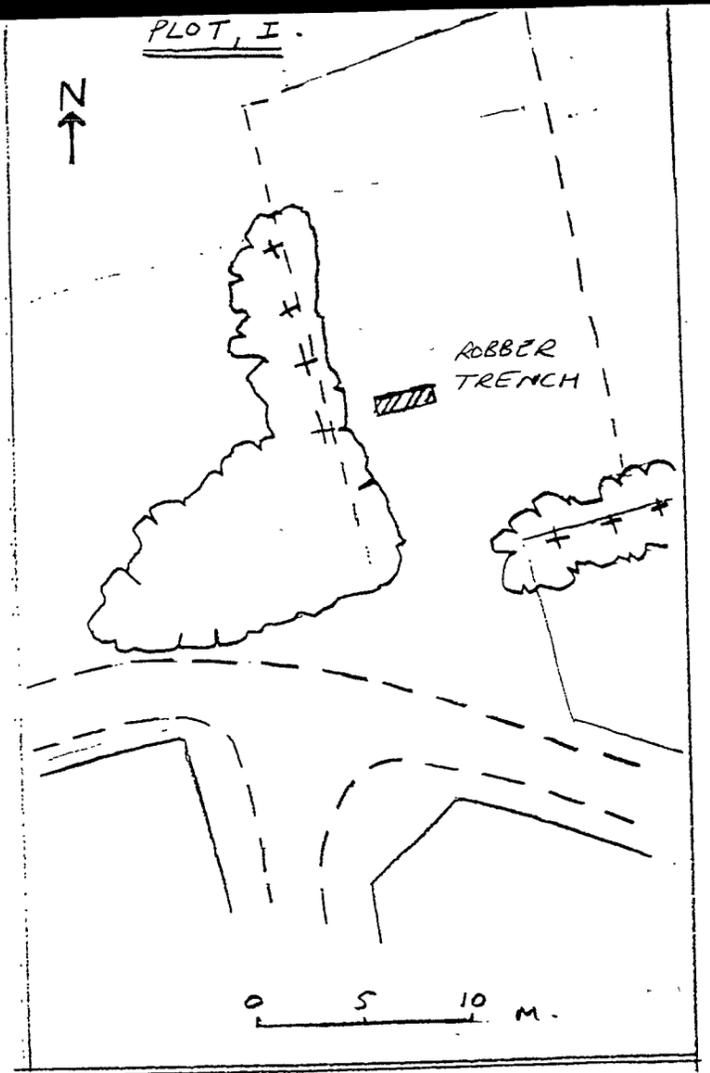
JOHN WILSON - 1st HOUSE SITE

CUTS INTO UNDISTURBED
RED BROWN IL SILTY
CLAY

Visual examination of the surface of the natural strata both during and after machine clearance revealed the presence of only one archaeological feature, in the central area of the drive (see drawing 1). This was an east-west aligned shallow cut with steep sides and an almost flat base that cut into the natural clay and continues to both east and west beyond the limits of the stripped area. The dimensions of the cut revealed within the area were : 4.72m x 1.4m x 0.28m. The fill of the cut was of loosely packed rubble containing a number of air spaces/voids. Its matrix consisted of : 65%, = angular fragments of chalk, the largest 27x19x15cm, but most, approximately 5-12cm. 20%, = broken fragments of brick, mostly of a size 10cm, some of these still had traces of mortar adhering to their surfaces. 15%, = silty loam, this tended to be thoroughly mixed up with the other constituents. There was some evidence of root disturbance of this fill though with the exception of the westernmost part this tended to be slight. A north-south section 1.1m wide was cut across the centre of the fill, this did not produce any finds or dating evidence save for the presence of post medieval brick.

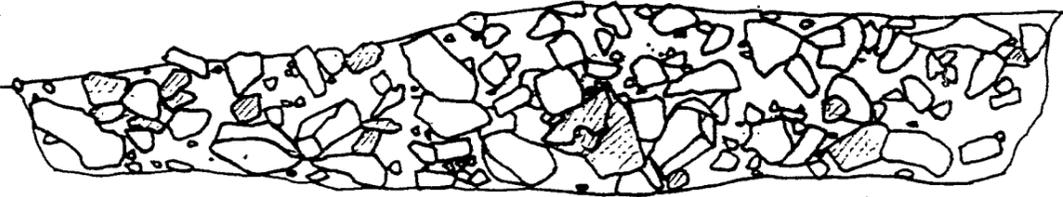
WEST FACING SECTION A - A

1:10 M J 22.1.90.
W FACING SECTION OF ROBBED OUT
WALL TRENCH

MATRIX = 65% CHALK FRAGS - ALL ARE
ANGULAR < 27 x 9 x 18 cm BUT MOSTLY
APPROX 8-12 cm
- 20% = BROKEN FRAGS OF BRICK - SOME
WITH TRACES OF MORTAR STILL ADHERING
- THESE MOSTLY 4-10 cm.
15% = SILTY LOAM - THIS THOROUGHLY
MIXED UP WITH OTHER CONSTITUENTS.

FILL GENERALLY QUITE LOOSE - NOT FIRMLY
COMPACTED ANYWHERE
NO FINDS APART FROM FRAGS OF BLDG MAT.
SLIGHT ROOT DISTURBANCE.

? SHALLOENESS OF TRENCH NOT DUE TO JAN 1990 MACHING - DUE TO
EITHER : ① ORIGINALLY SHALLOW TRENCH , ② POST DEMOLITION
LEVELLING PROCESS.
- J. WILSON STATES BLDG PROB DATES FROM 1760.
- BELIEVED DEMOLISHED LATE 19th - EARLY 20th CENTURY

The cut is interpreted as a foundation trench, probably of a building. The owner of the land, J. Wilson, informed the archaeologists that documents held at the Borthwick Institute of historical research, University of York, record a building built circa 1760 as being located approximately in this area. It is likely therefore that the excavated foundation trench relates to the north wall of this documented structure it being noted that no other indication of a wall was located to the north of it within a distance of 20 metres.

The shallowness of the foundation trench may owe to its originally having been so, or alternatively could be due to truncation/levelling of the old ground surface during or after the buildings demolition.

It is very unlikely that the fill of the foundation trench relates to an original rubble wall foundation. Rather, the loose, mixed nature of the fill suggests that it represents a backfilling of unwanted small fragments of building detritus left over from building and foundation trench demolition/robbing. This was further supported by a surface examination of the extreme west part of the foundation trench fill where its matrix consists primarily of a heavily rooted silty loam with very little in the way of brick and stone debris. It is suggested that this differential filling of the foundation trench was caused by a probable piecemeal approach to the final backfilling of the robbed foundation trench.

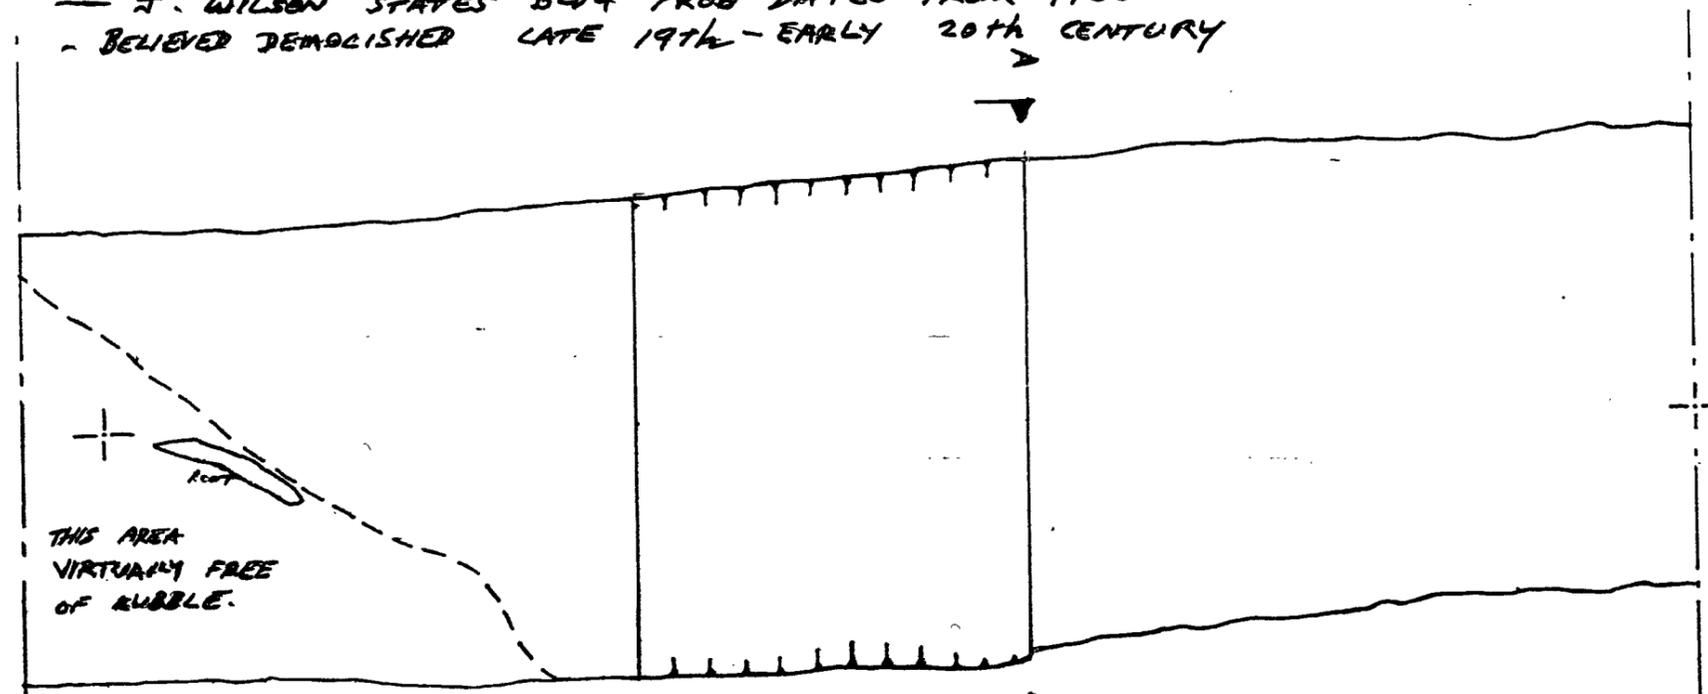
PLAN 1:20

THIS AREA
VIRTUALLY FREE
OF RUBBLE.

WALL TRENCH BELIEVED TO BE ROBBED - FILL NOT BELIEVED TO BE FOUNDATIONAL
MATERIAL AS IS V. MIXED MATRIX WHICH IS V. LOOSE - EVEN HAS AIR BUBBLES
IN IT. FILL ∴ PROB. UNWANTED DEBRIS FROM DESTRUCTION / ROBBING THROWN BACK
INTO TRENCH.
