**20-22 High Skellgate, Ripon, North
Yorkshire**

archaeological monitoring

ASUD Report 1044
November 2003

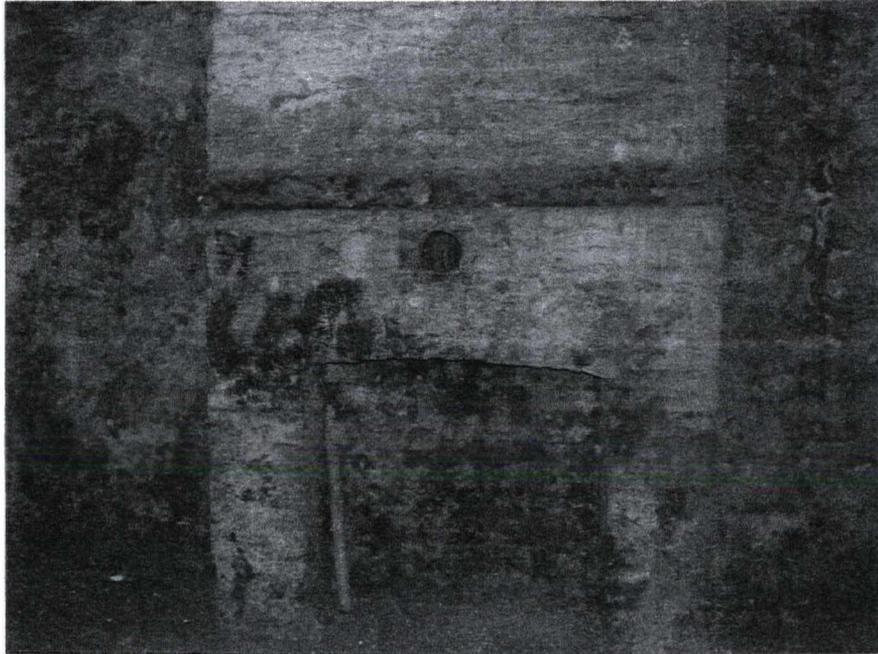
Figure 3; Fireplace in north wall of north room

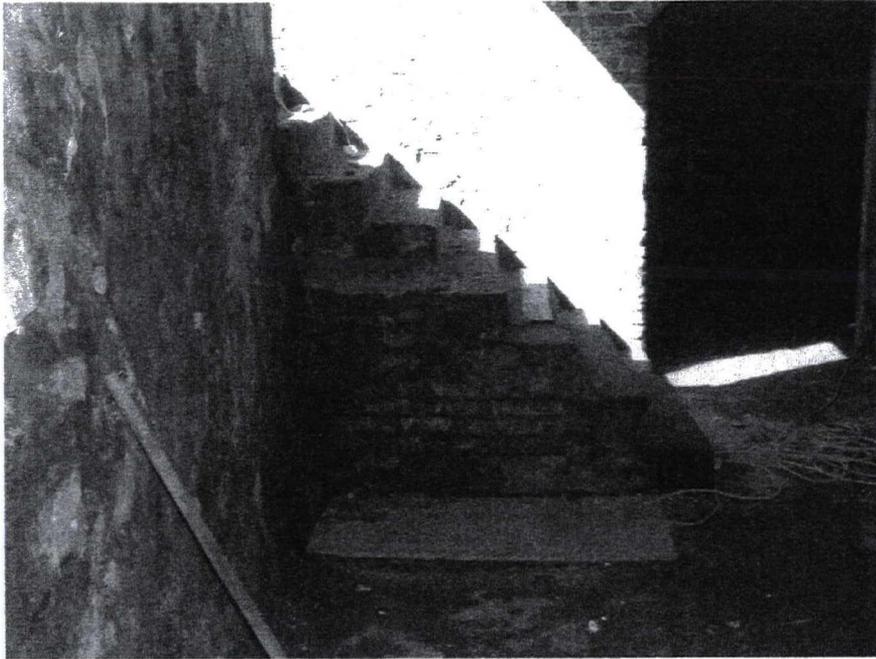
Figure 4; Stairs in central room

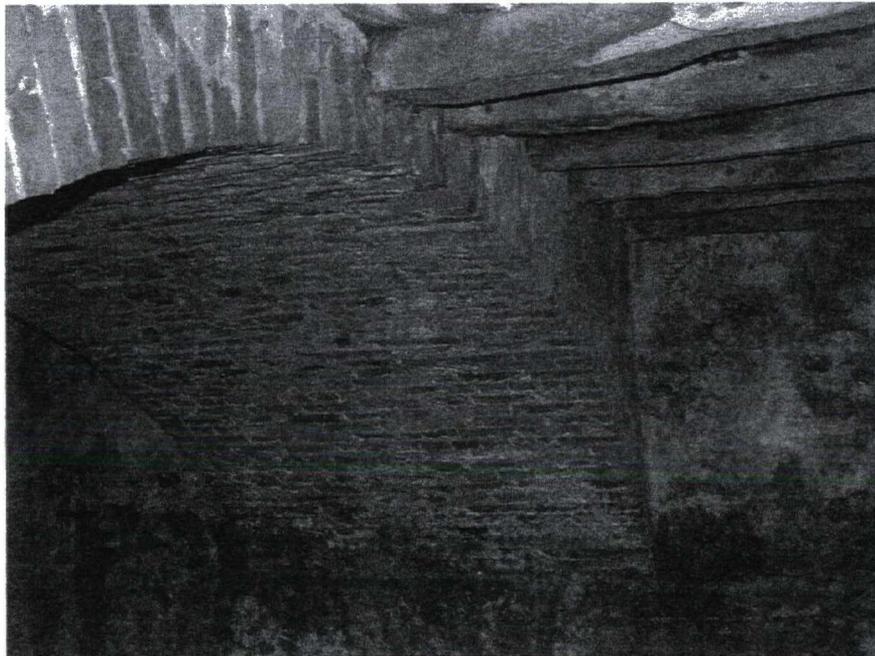
- 5.6 The southern room is partly spanned east to west by a brick vault, (**Figure 5**) 1.9m wide. The reason for the insertion of this vault is unclear. It was presumably incorporated into the cellar in order to support some structure

above it; however, no evidence for any form of structure which would necessitate the construction of such a vault now exists.

Figure 5; The brick vault

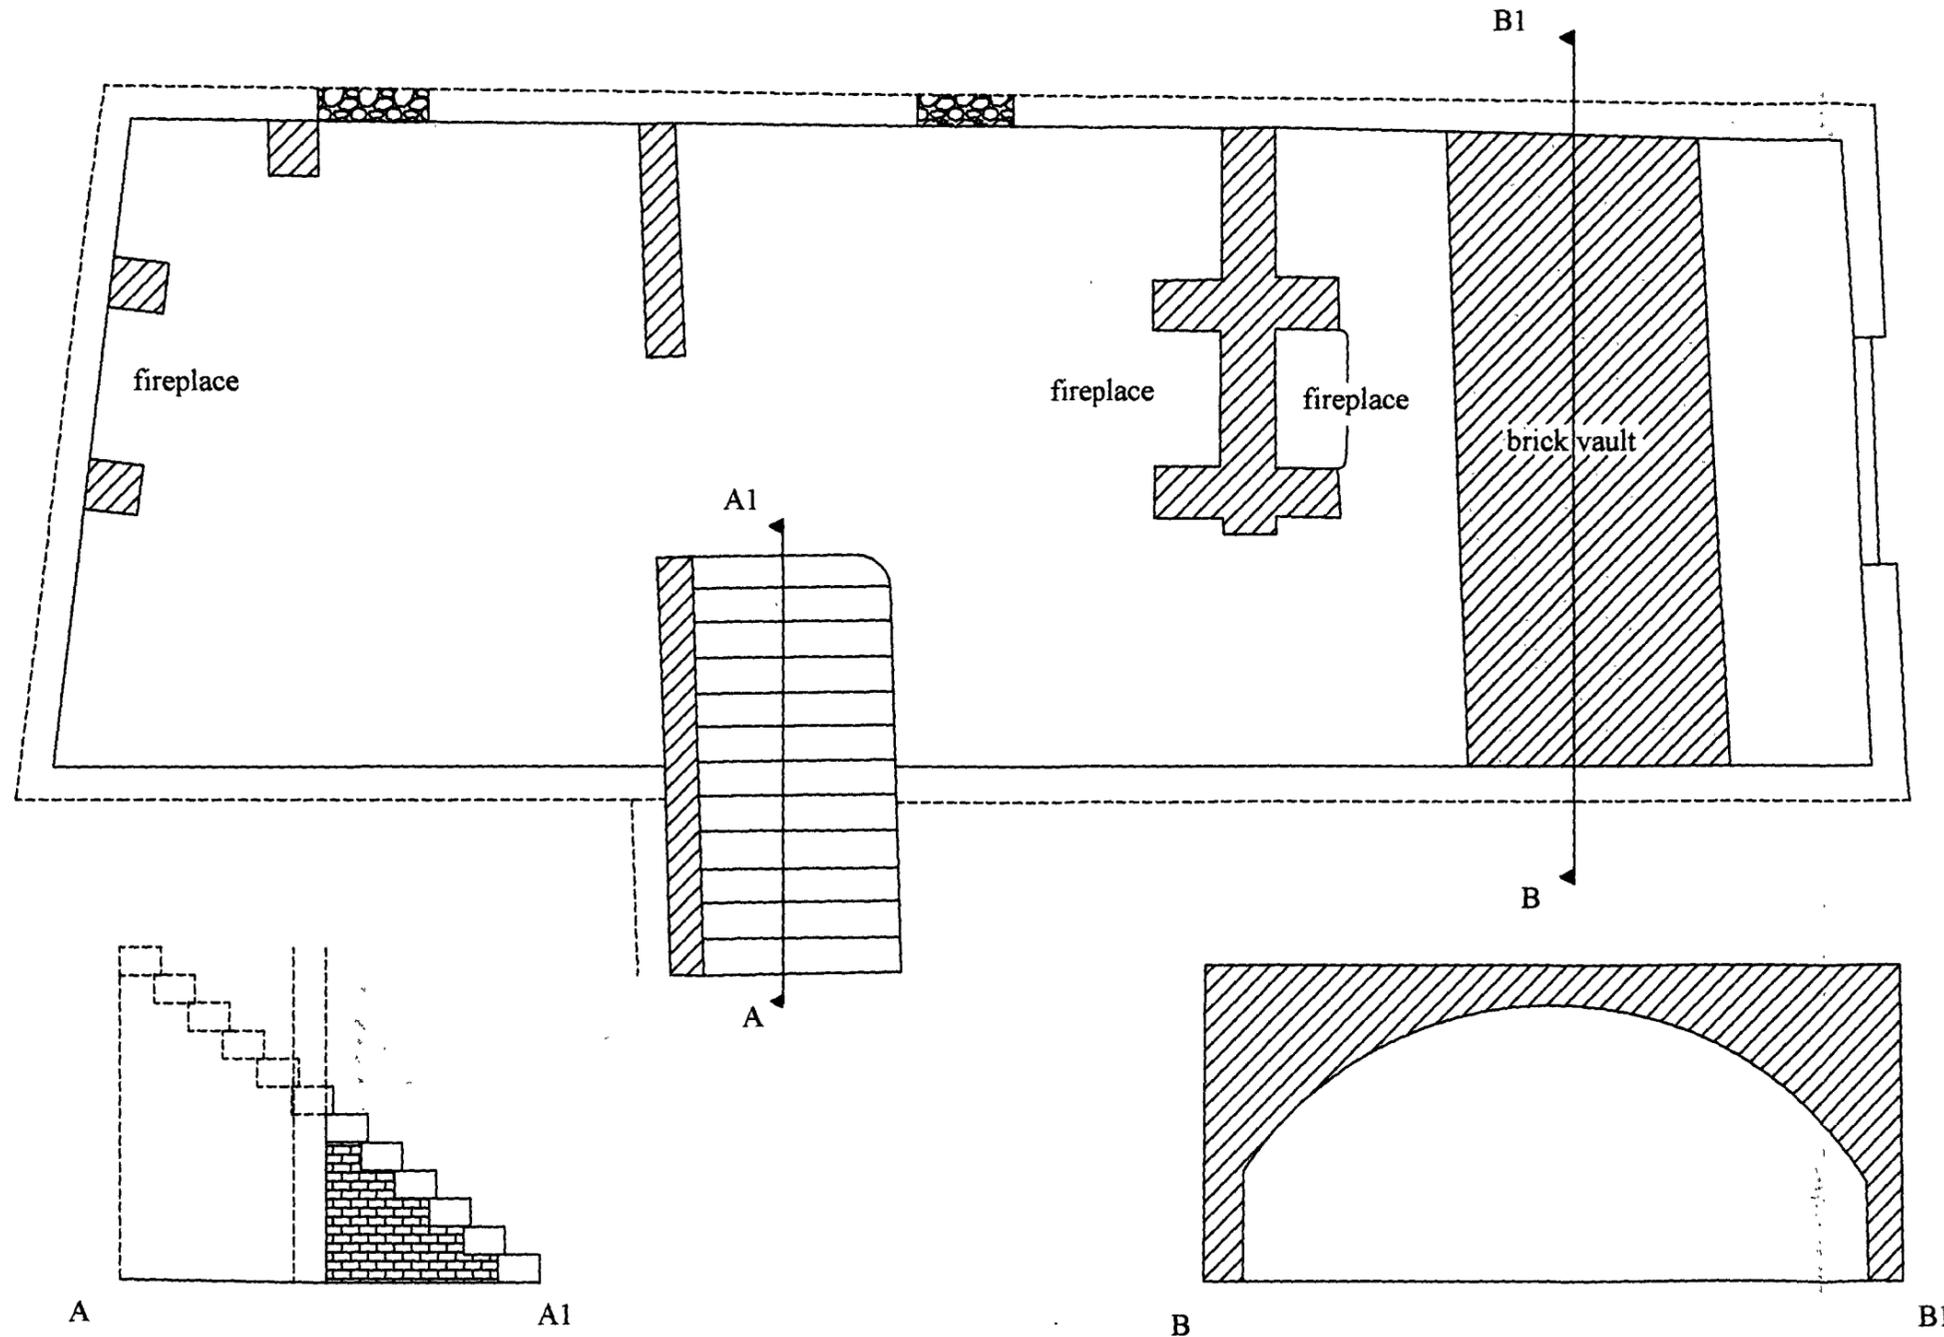
Figure 2

- 5.4 The cellar discovered during the initial ground clearance of the development site was investigated. The overall internal dimensions of the cellar are 13m by 4.5m; the exterior walls are of a rubble construction with a lime mortar bonding to a height of 1.50m above the floor surface. Above this point the walls are brick built.
- 5.5 The insertion of two brick walls has divided space into three rooms, each with a fireplace, suggesting that at some point the cellar was used for domestic or service purposes (**Figure 3**). There is also a window in the southern exterior wall where the exterior ground surface falls away. Access to the cellar is by a flight of 12 stone steps (**Figure 4**) situated in the west wall of the central room. The floor of the cellar, which is covered with 50mm thick stone flags laid on a bed of red sand, is 2m below the existing ground surface.

- 5.7 There are blocked openings in the east walls of both the northern and central rooms. These are situated in the upper section of the east wall and do not appear to be doorways. It is possible that they are cellar drops, through which materials and goods could be placed in the cellar directly from the access road

Plan of cellar
