**CHURCH CLIFF HOUSE**  
**FILEY, NORTH YORKSHIRE**  
**ARCHAEOLOGICAL INVESTIGATION**

John Buglass

October 2005

**ARCHAEOLOGICAL INVESTIGATION**

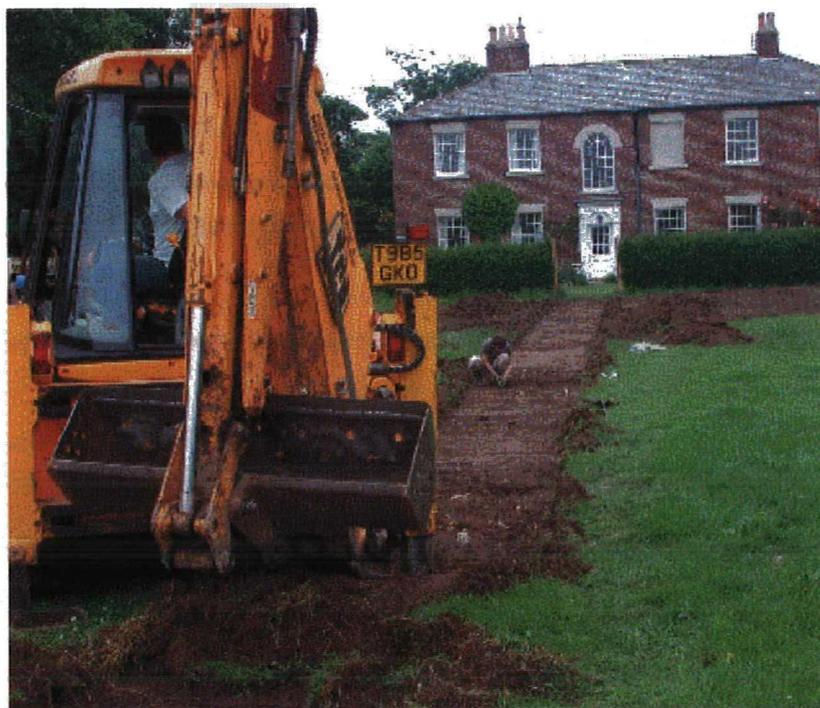
**Plate 1. Machine Stripping Footpath.**

- 4.1 A wheeled mechanical excavator using a toothless or ditching bucket undertook the stripping of the turf and topsoil (Plate 1). The resulting stripped area was inspected visually and any areas of potential archaeological remains were then cleaned by hand and recorded photographically. The resulting spoil was also scanned for artefactual material.

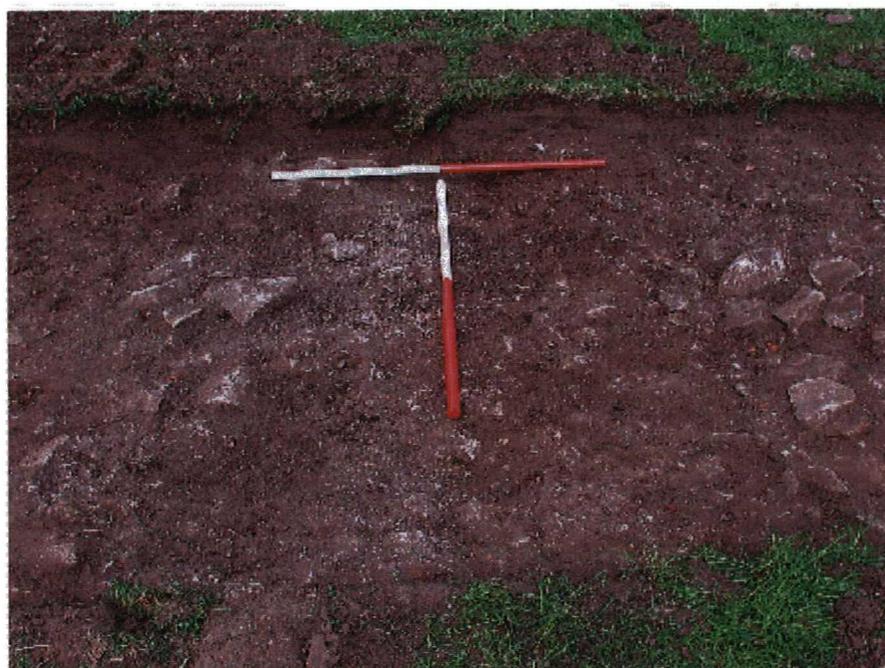
**Plate 2. Wall 001. Scales 1m**

- 5.1 As a result of the topsoil stripping portions of two archaeological features were revealed (Figure 2). The first of these was located some 10m to the east of the garden boundary and was aligned in a north-south direction. This feature appeared to be the remains of a

- robbed out wall (001) that appeared to have been constructed from sandstone rubble on a crushed chalk base. There was no evidence for an internal floor surface though this could have been completely removed previously or was of a simple packed earth construction. The feature measured approximately 2.25m wide and survived to a depth of 0.15m (Plate 2). Due to the linear nature of the excavation no limit to the north or south of the feature was determined. However, it was noted that it did line up with the western end of St Oswald's church to the south. Artefactual material recovered from the feature consisted of ceramic sherds, ironwork, glass and a small amount of animal bone.

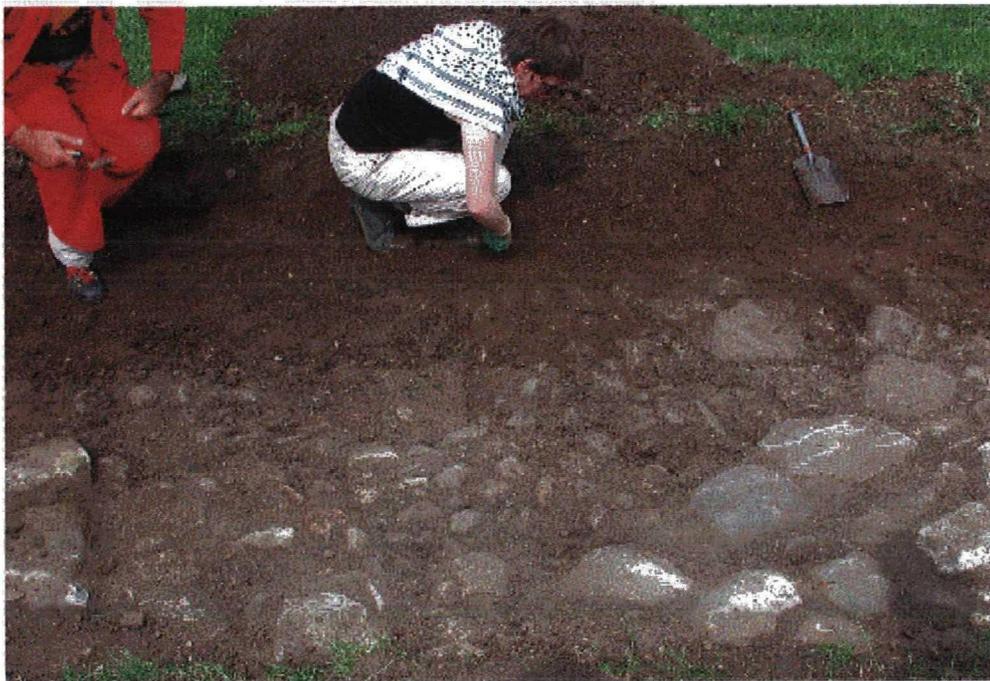
**Plate 3. Part of Cobbled Surface.**

- 5.2 The second feature recorded was the substantial remains of a cobbled surface with the possible remains of a doorway/threshold at the eastern end of the feature (Figure 2). The cobbled area extended approximately 12m along the trench; however, there was insufficient time to reveal the whole of its extent heading westwards in the trench (Plate 3). The surface was formed from water worn cobbles of varying sizes and are probably from the foreshore. Within the area of cobbling there were two distinct differences. The first was in a band orientated north-west/south-east and was composed of larger stones (002) (c.0.30m diameter) which then appeared to form a corner on the southern edge of the trench. Within this was an area of smaller stones (003) (c.0.10m diameter) which may have formed a working surface with the larger cobbles acting as footings for a wooden wall (Plate 4). All of the cobbled areas had a shallow but noticeable slope down to the north-east.

- 6.1 The archaeological investigation at Church Cliff House during the cutting of the footings for the new footpath recorded the remains of one, probably two stone buildings one of which had a cobbled courtyard or working surface. The slope on the cobbles could be indicative of a livestock handling area to allow waste material to be channelled away, or could be as a result of subsidence into an earlier, unknown feature underneath.

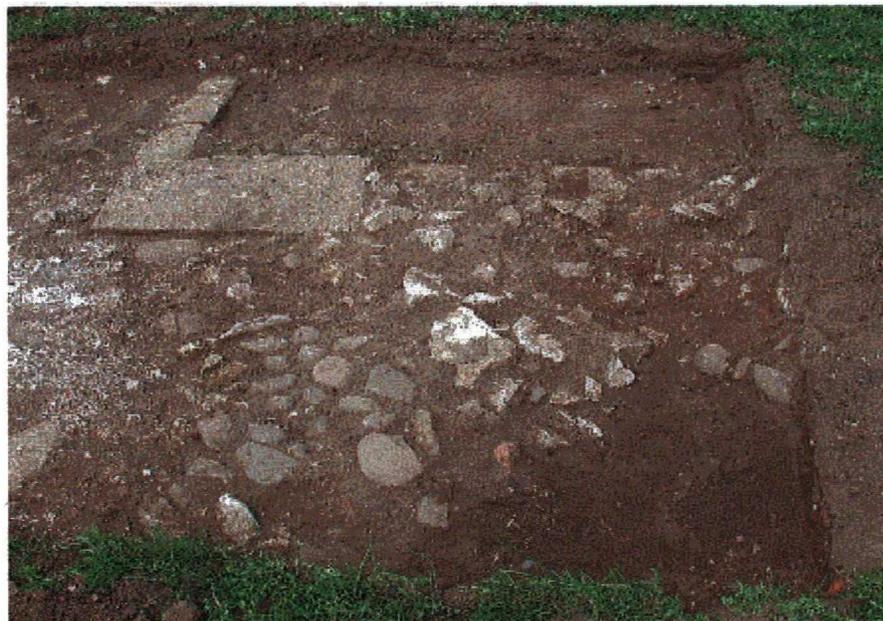
**Plate 4. View to north showing possible threshold (007), wall 005 to right & path 004 to left.**

- 5.3 To the east of the larger cobbles was a further area of smaller stones, which lie directly to the south of the dressed threshold. These stones may represent an area of 'walkway' between internal divisions of a building (004). Further to the east again from this patch was a discrete area of angular sandstone blocks that probably represents the remains of the wall of the building (005). The possible threshold was represented by a well-dressed sandstone block (006), which retained evidence for dressing with a c.20mm chisel. To the north of this block there were three further, smaller, sandstone blocks (007) all of which had been dressed in a similar manner (Plate 4).

- 6.2 The presence of the possible threshold of dressed stonework suggests a building of better quality and could easily be associated with the remains of the 18/19<sup>th</sup> century buildings that still exist today. However, the excavated remains could equally be associated with the features recorded in the excavations between 1924-26 in the field to the east which were attributed to the Bucks family manor house of the 17<sup>th</sup> century (Eaton 2005).

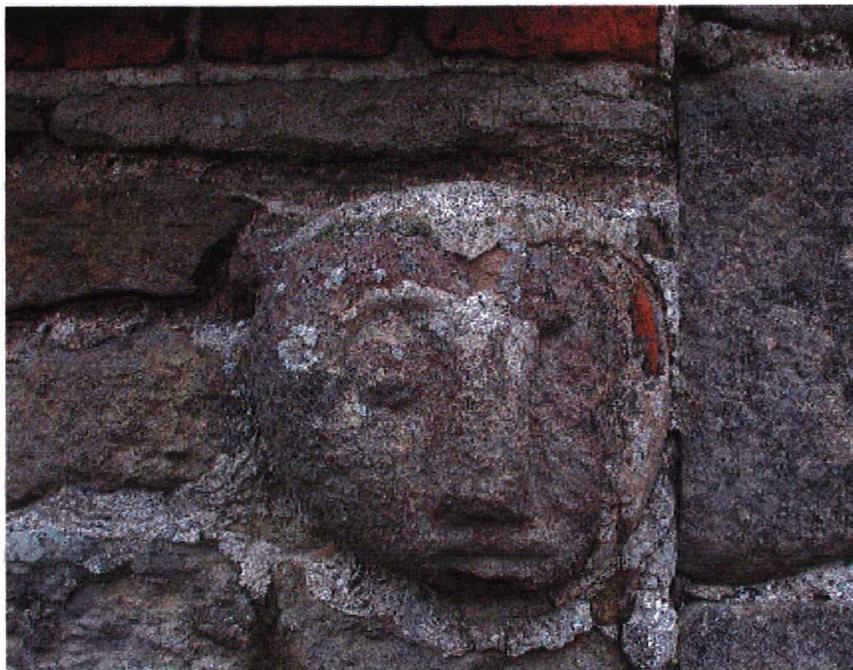
Plate 5. Carved head reused in stone building.

- 5.7 In addition to the ridge and furrow the surviving buildings to the north of Church Cliff House, although predominantly 18<sup>th</sup> century in date, could well relate to the remains excavated in the 1920s. Incorporated within the fabric of one of the buildings was the eroded remains of a carved head (Plate 5). The carving has obviously been re-used from its original location and appears to have once been covered with cement/mortar. The original origin of the carving is unknown. The present owner has no knowledge of where it came from as it was already in place when the property was purchased a few years ago and local knowledge cannot account for it either. There are two surviving examples of a medieval table corbel on St Oswald's church but a comparison of the styles, even allowing for erosion, does not appear to make them contemporary. It is possible; therefore, that this originates from a building no longer recorded on the site.
