PHOTOGRAPHIC RECORD

Bassett House, Southampton: Elevations

1M - 17M (MAIN HOUSE)

1N - 7N (NORTH WING)

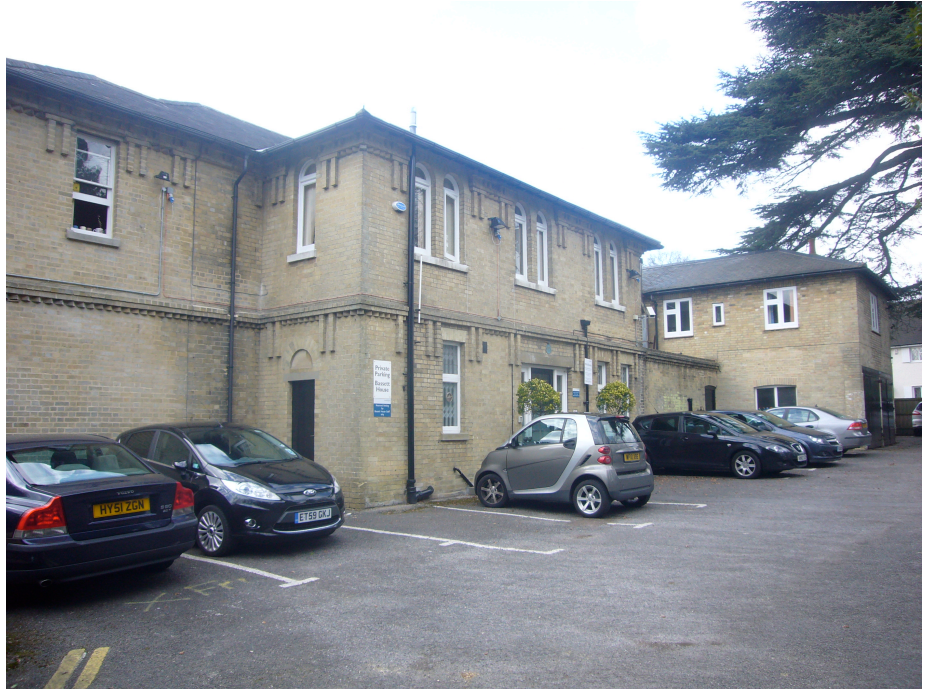
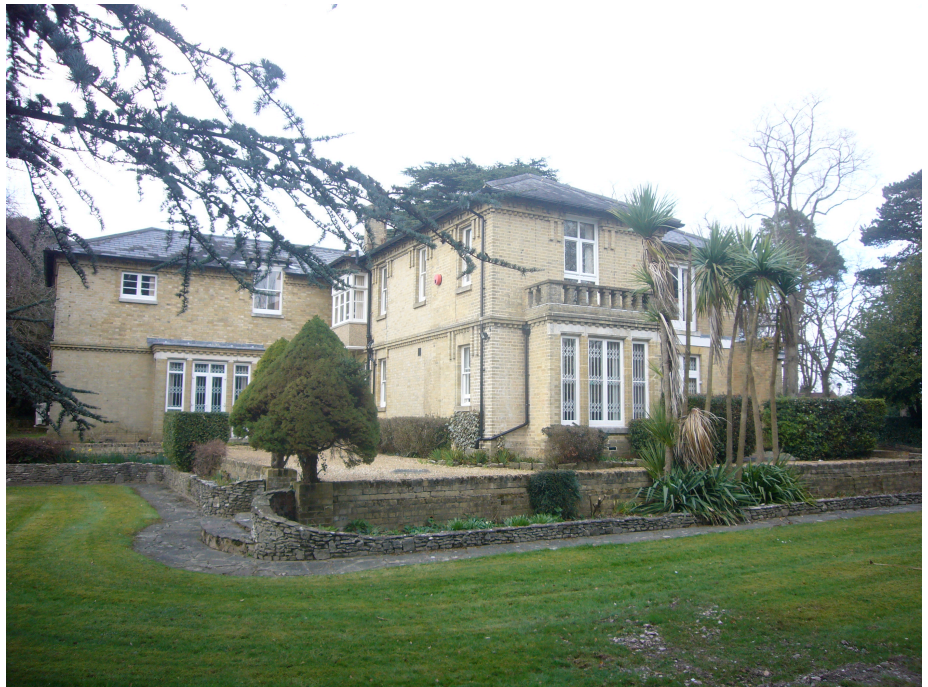
Bassett House, Southampton: General views

General views - from south-east (top) and south-west (bottom)

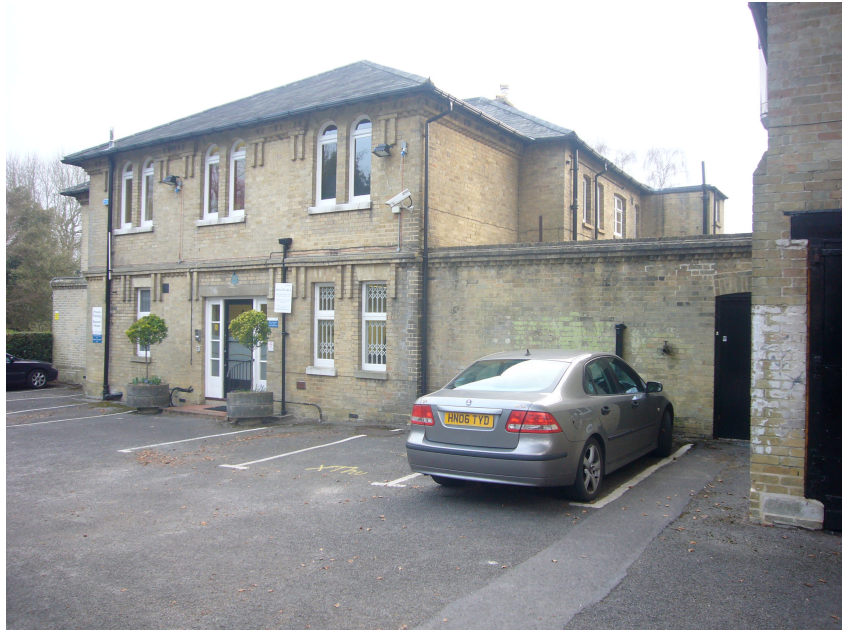
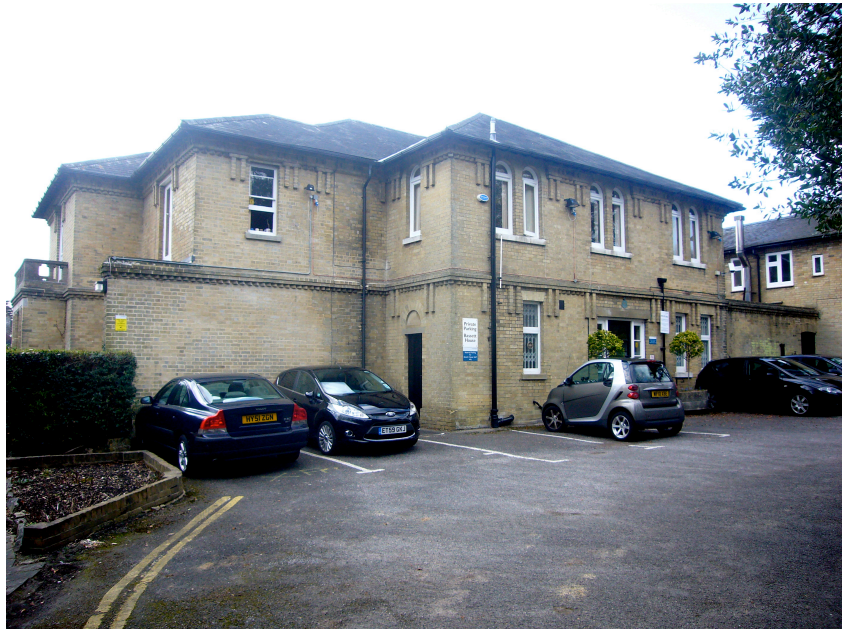
Bassett House, Southampton: Elevations: 1M
MAIN HOUSE

East Elevation of House
Top - from north-east
Bottom - from south-east

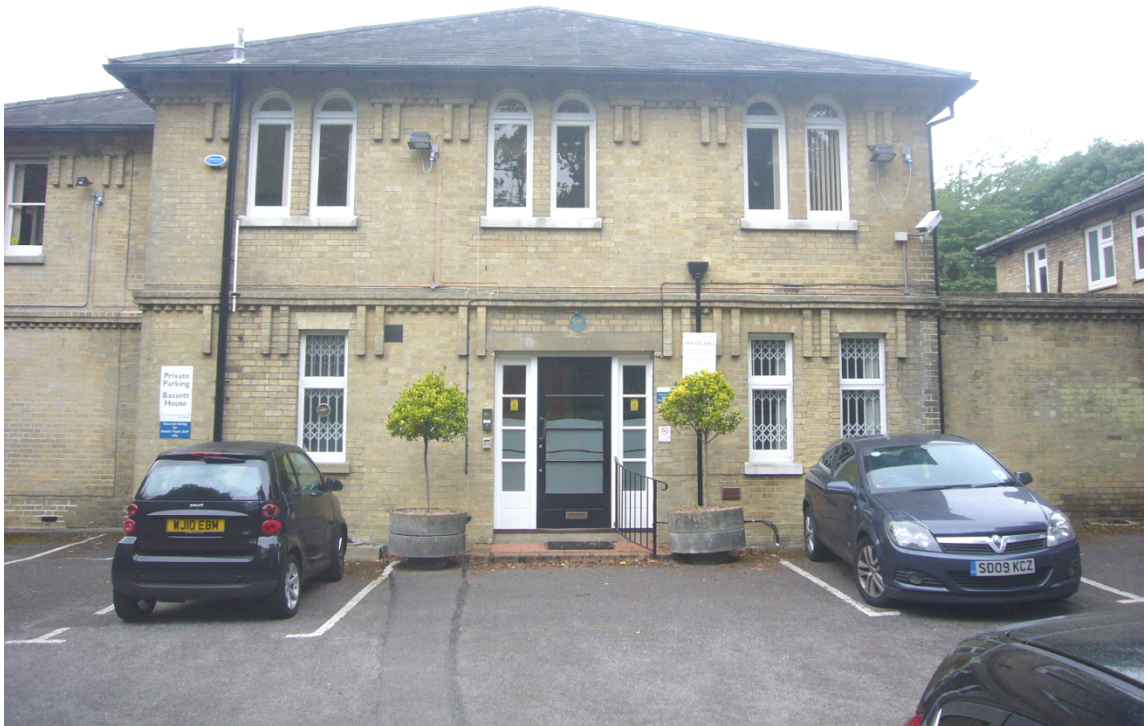
Bassett House, Southampton: Elevations: 2M

East Elevation of Entrance Front
(details to follow)

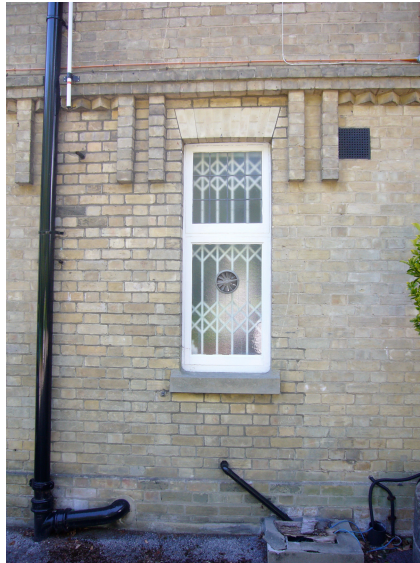
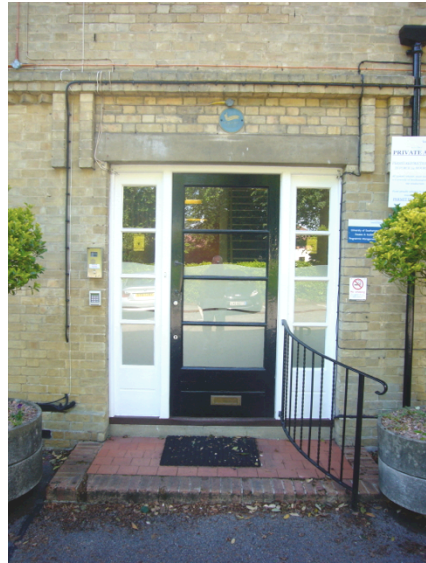
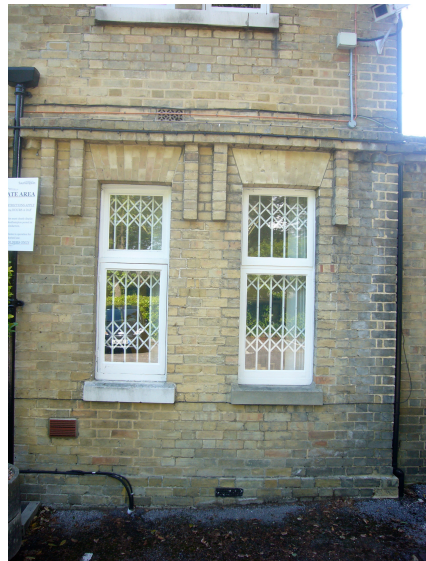
Bassett House, Southampton: Elevations: 3M

East Elevation - Entrance Front - Details
Ground Floor

Top left - window to small Kitchen - formerly Porch
(note stone entrance step at bottom course from vent pipe to gully)
Top right - 1950's entrance door and screen- replacing former window to Hall
Bottom - two windows at north end - left window pre-1950, right window post-1950

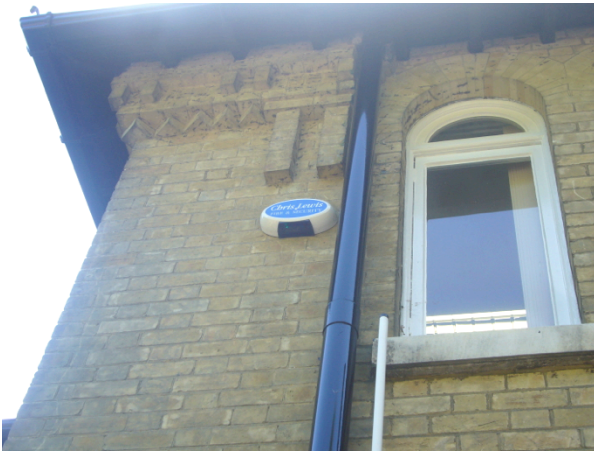
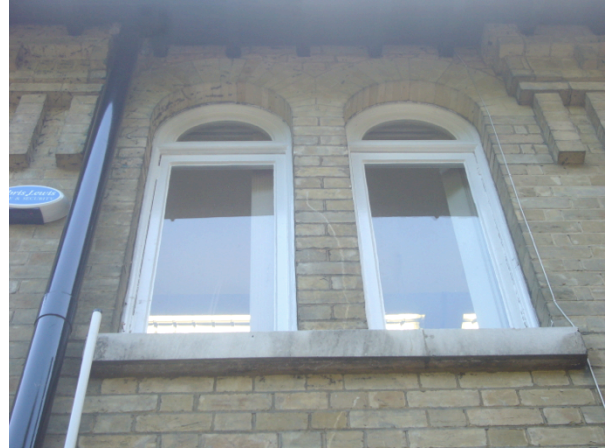
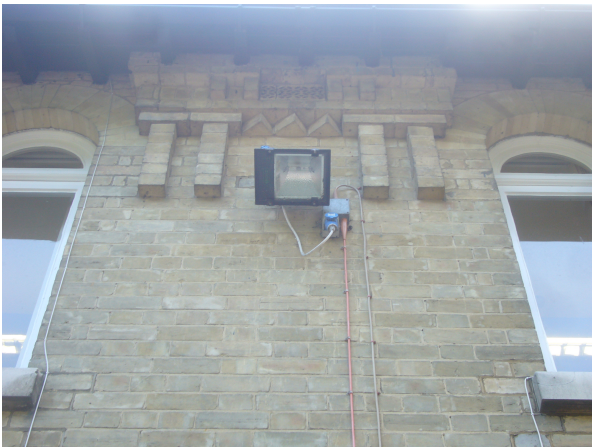
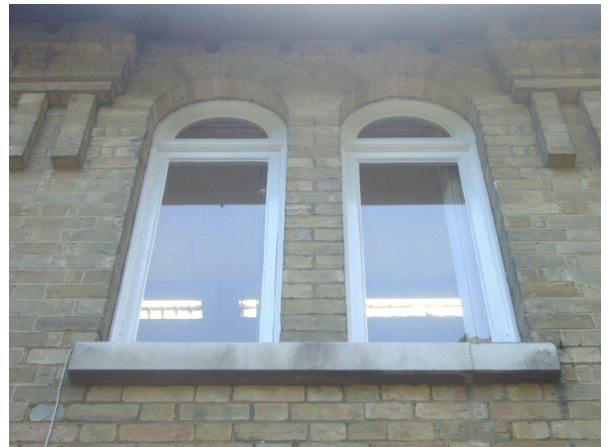
Bassett House, Southampton: Elevations: 4M

East Elevation - Entrance Front - First Floor - Details
Northwards sequence from top left to bottom right
Continued next page

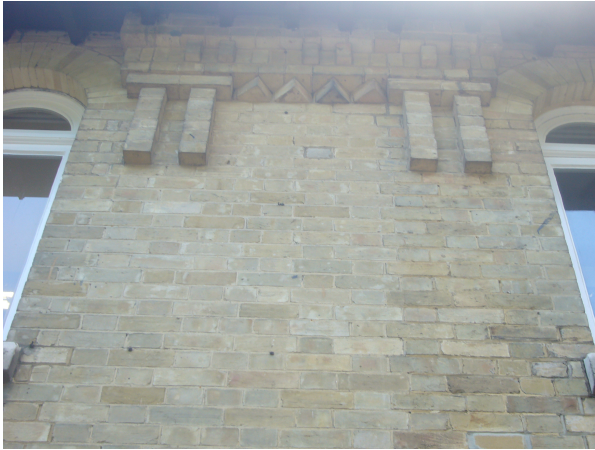
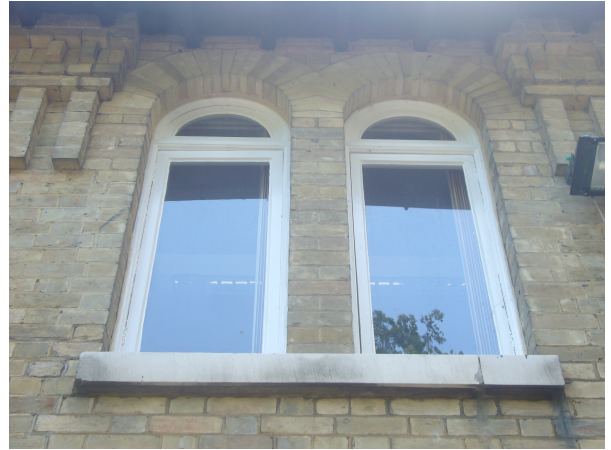
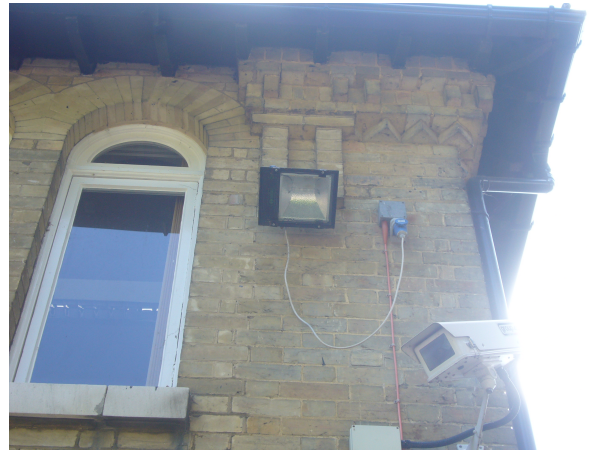
Bassett House, Southampton: Elevations - 5M

East Elevation - Entrance Elevation - First Floor - Details
Continued from sequence on previous page

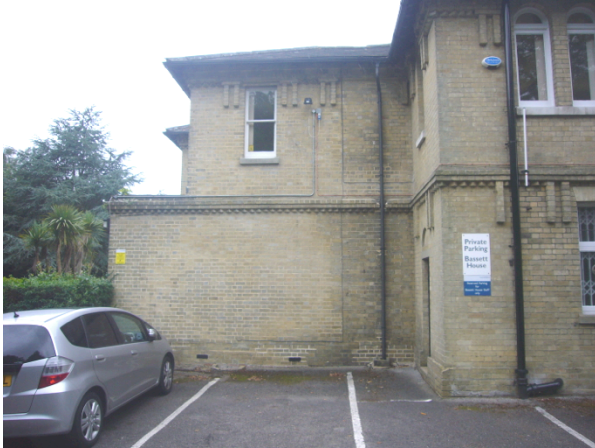
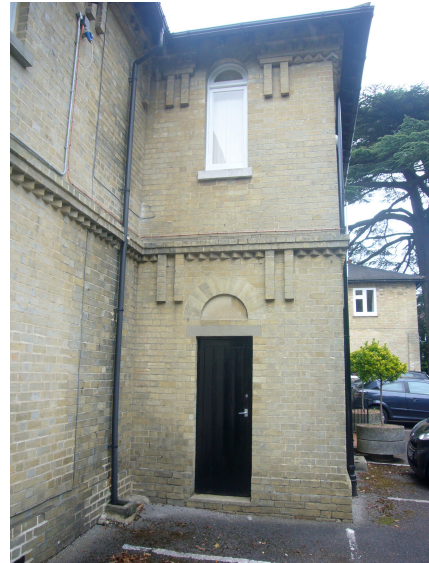
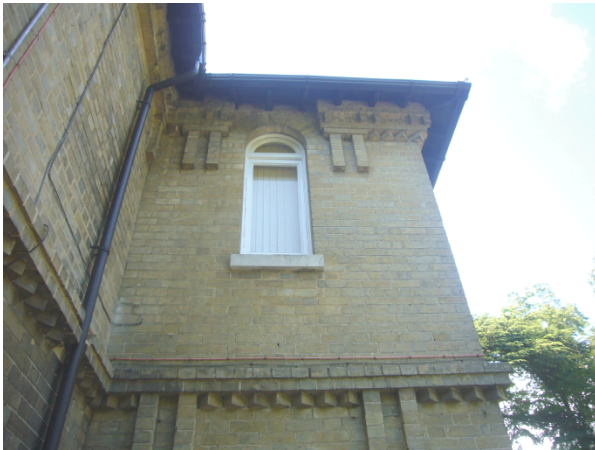
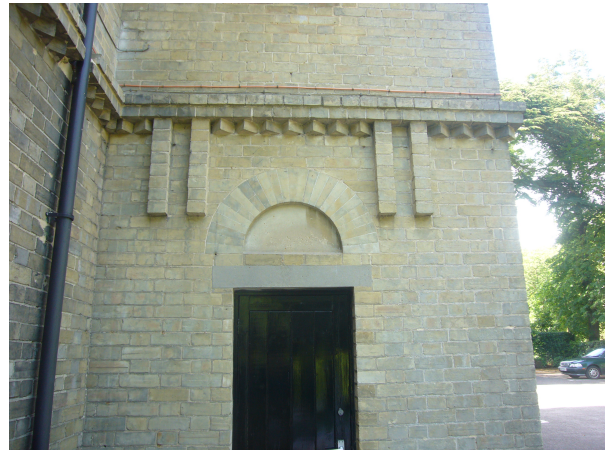
Bassett House, Southampton: Elevations - 6M

South end of East Elevation with South return
Top left - east elevation - window certainly pre-1950,
probably C19

Top right - door at ground floor probably only round arch in
original position, formerly window

Bottom left - detail of window, raised pre 1950, at first floor
Bottom right - detail of probably original arch

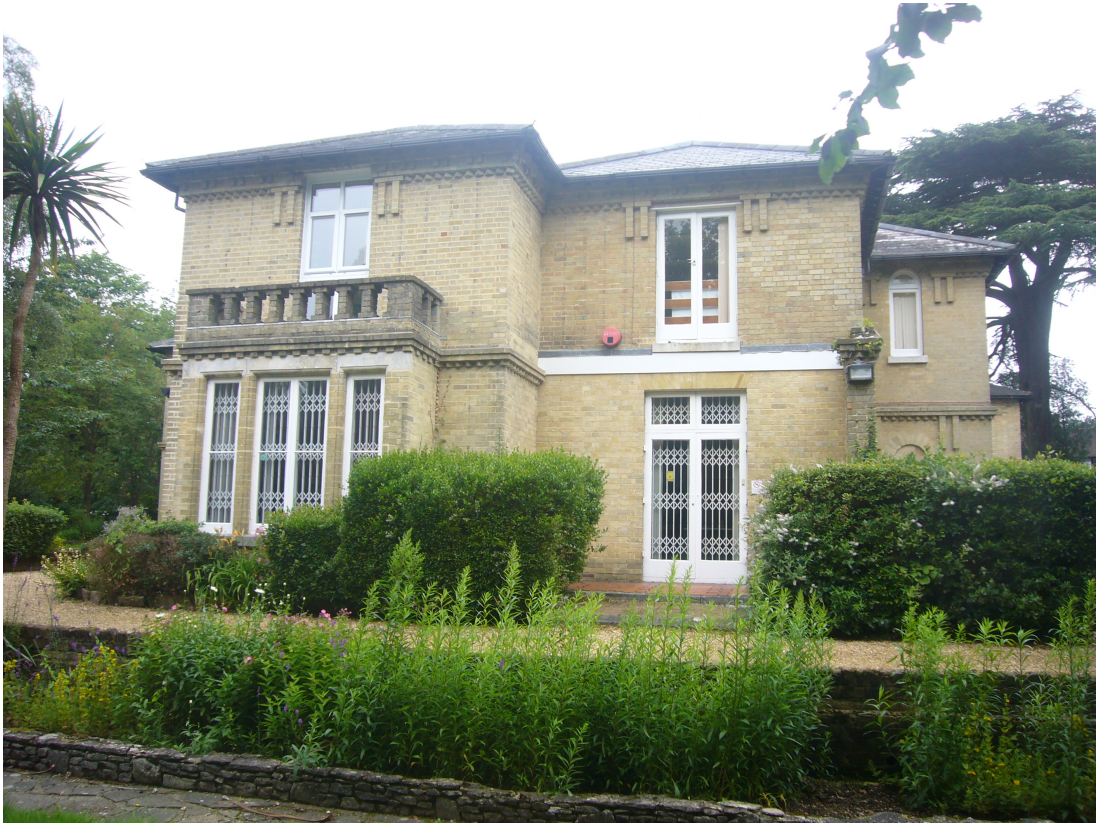
Bassett House, Southampton: Elevations - 7M

South elevation of 'main block' of house
South-east Balcony structure missing - removed
post-1966?

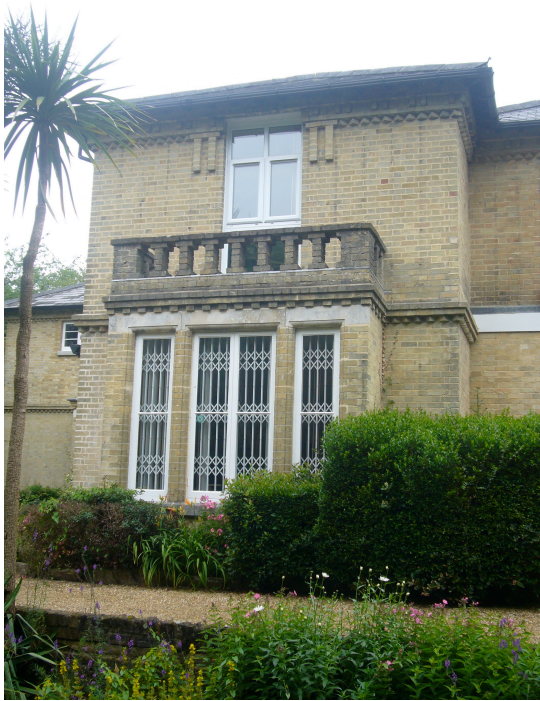
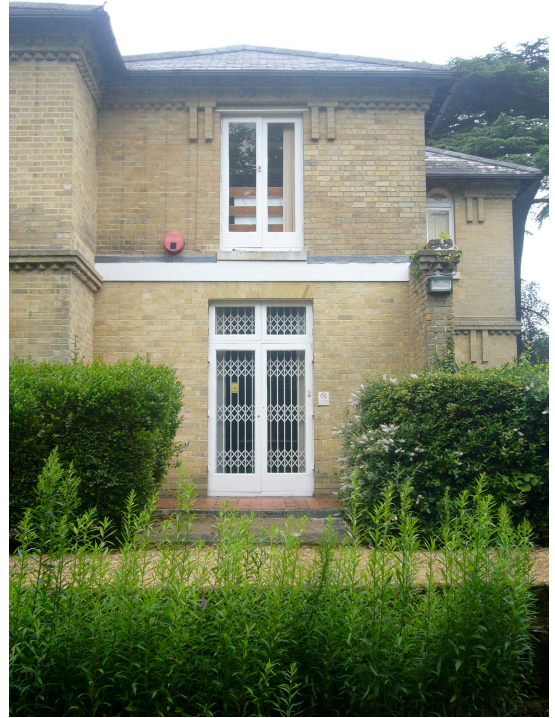
Bassett House, Southampton: Elevations - 8M

Left - bay window (probably structure later than 1855-65)
Right - first floor french window without balcony

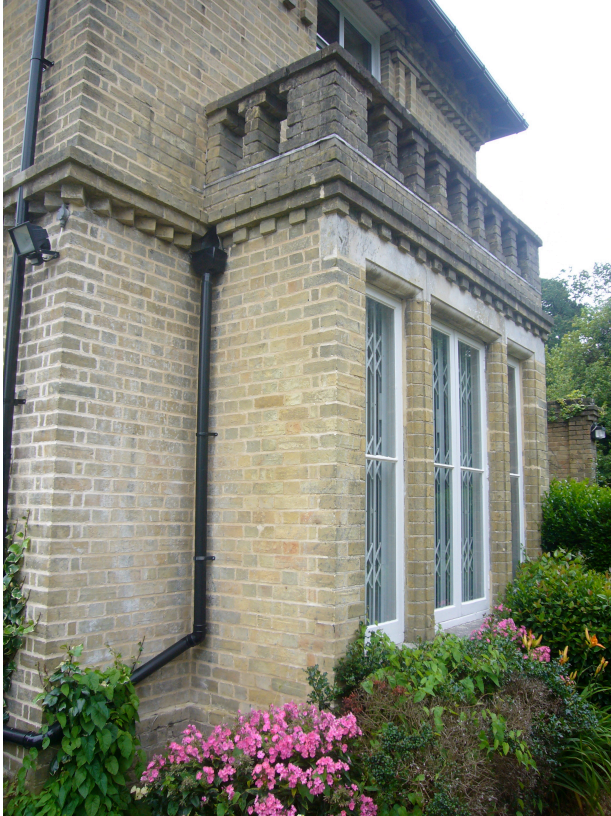
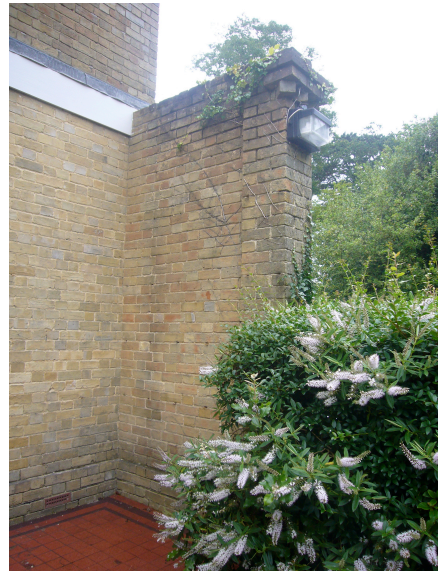
Bassett House, Southampton: Elevations - 9M

Details of bay to South Elevation ('main block') and former Balcony support wall

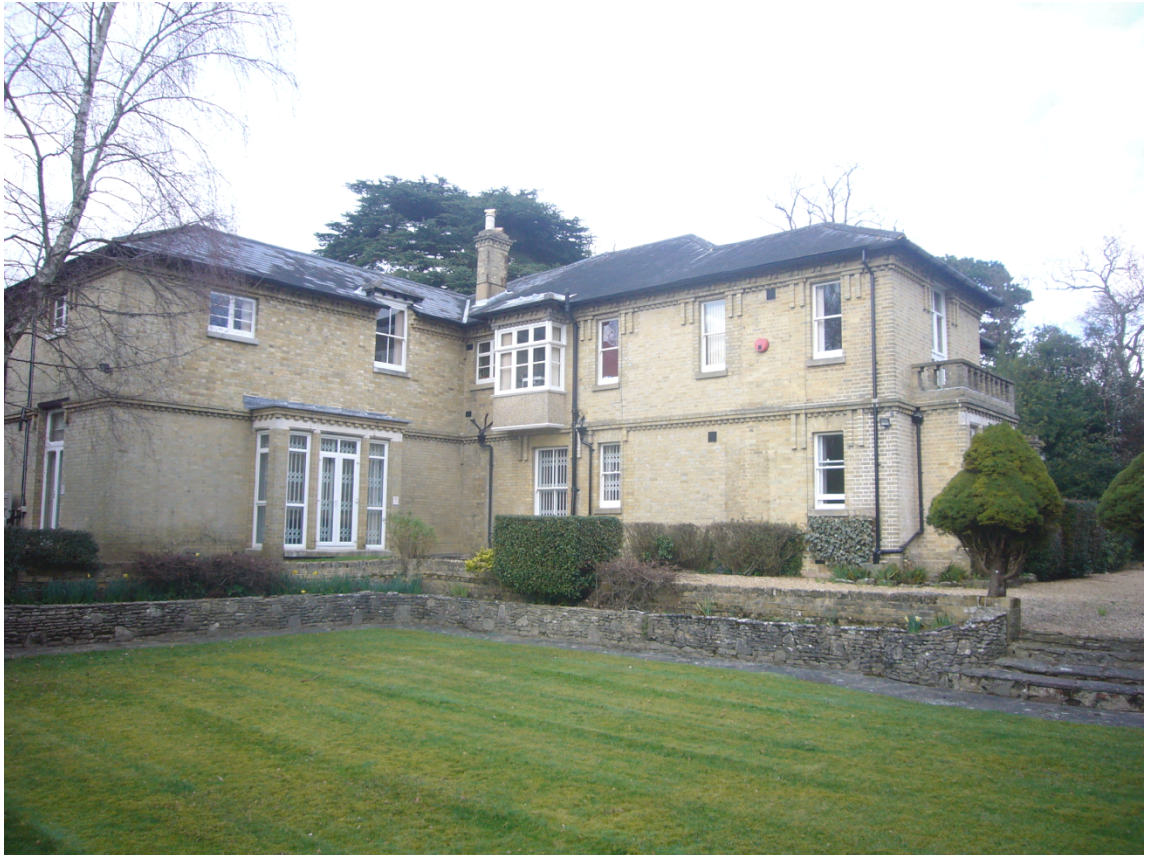
Bassett House, Southampton: Elevations - 10M

West Elevation of 'main block 'and South Elevation of
'west wing" from south-west

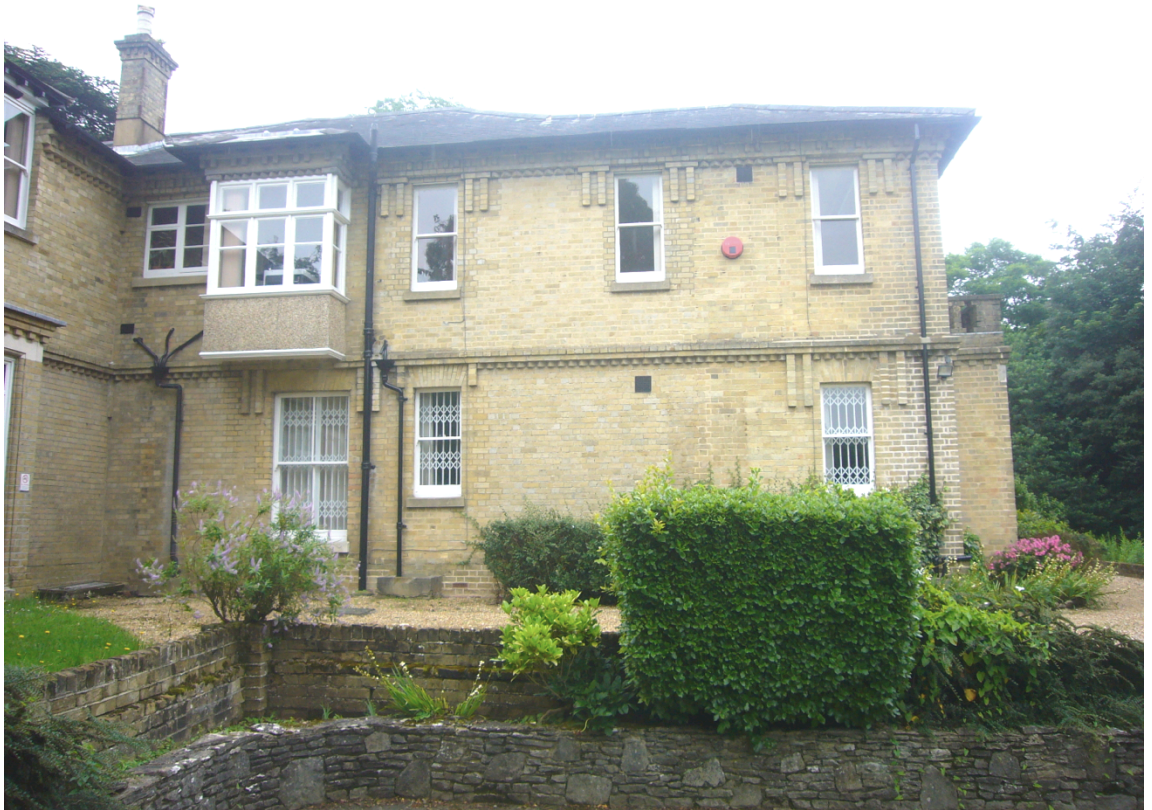
Bassett House, Southampton: Elevations - 11M

West Elevation of 'main block' of House
(details to follow)

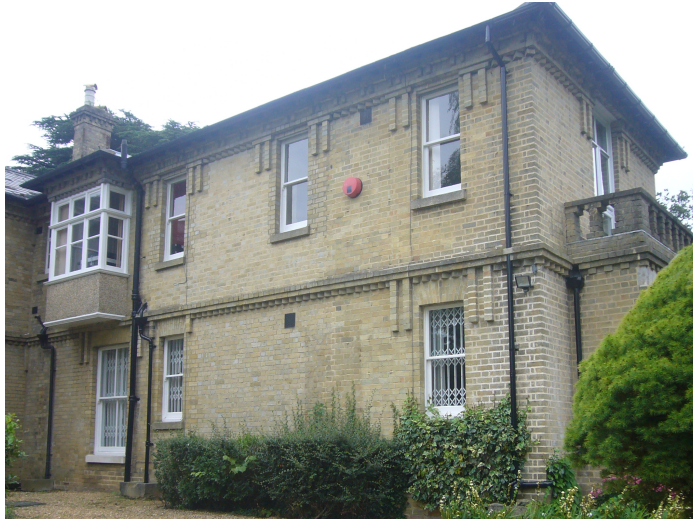
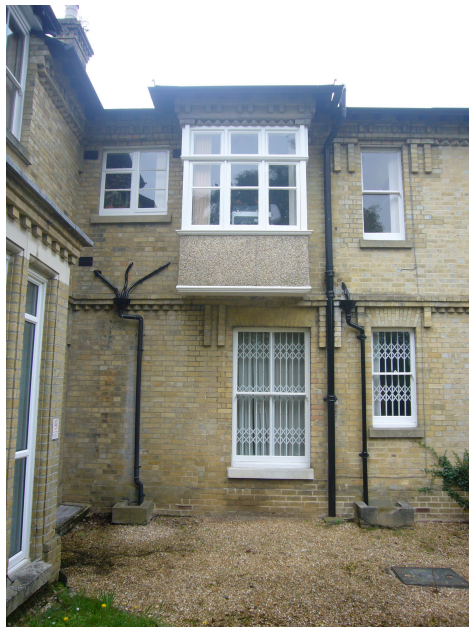
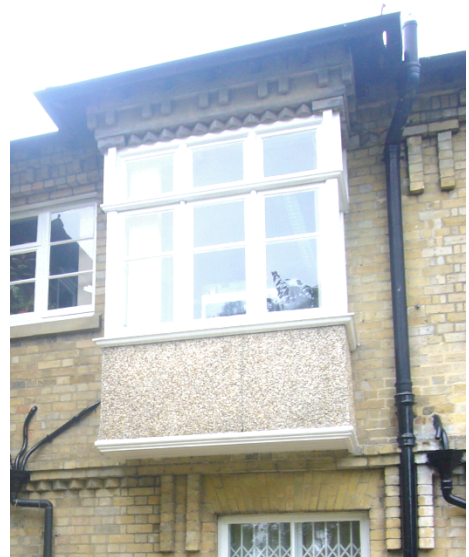
Bassett House, Southampton: Elevations - 12M

Details of West Elevation of 'main block'
Top - ground floor windows - left hand window right of bay
inserted c 1950; first floor - first two windows to right of bay
inserted c 1950
Bottom left - window to left of bay inserted c. 1950; bay
(with timber dentil details and pebble-dash finished
spandrel) inserted pre-1950

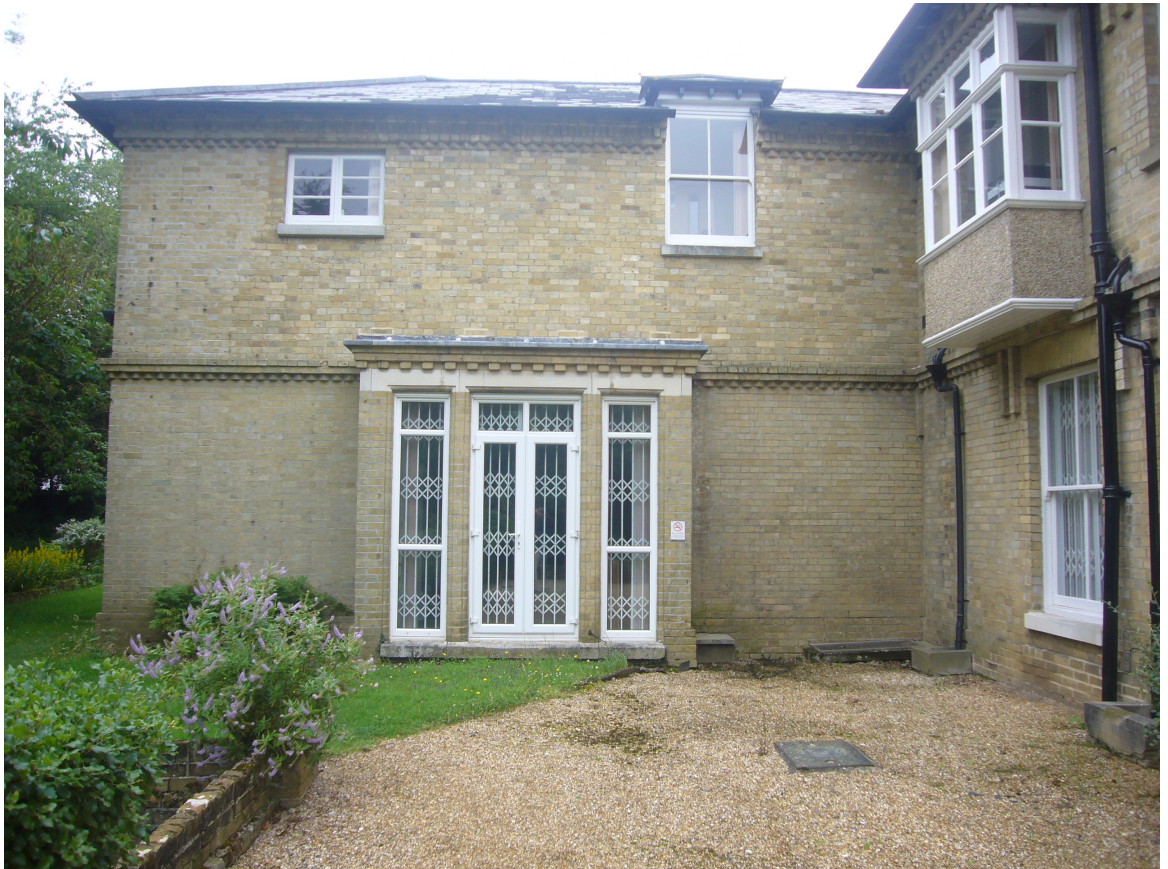
Bassett House, Southampton: Elevations - 13M

South Elevation of 'west wing'

First floor brickwork almost totally rebuilt (except 1.5 to 2m at extreme western end) - possibly in 1950's alterations (thickening of wall shown on 1947 plans no longer existing)

Bay - similar to bay to south Elevation of 'main block' - added pre-1950; west window at first floor added c.1950, other window added pre-1950

(Note - no dentilled cornice or brackets)

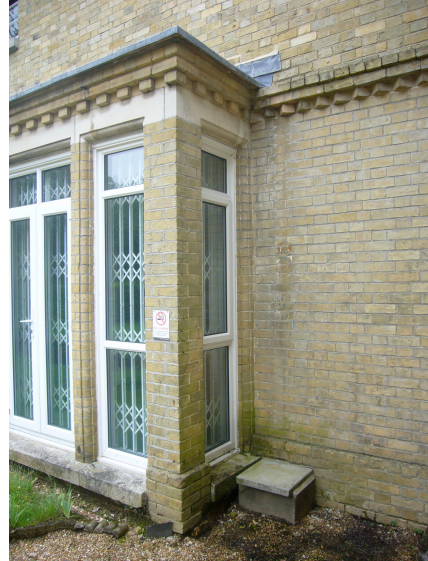
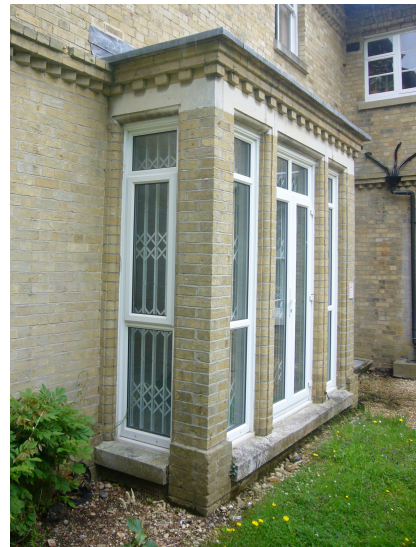
Bassett House, Southampton: Elevations - 14M

Detail of bay to South Elevation of 'west wing'
(Note absence of dog-tooth detailing)

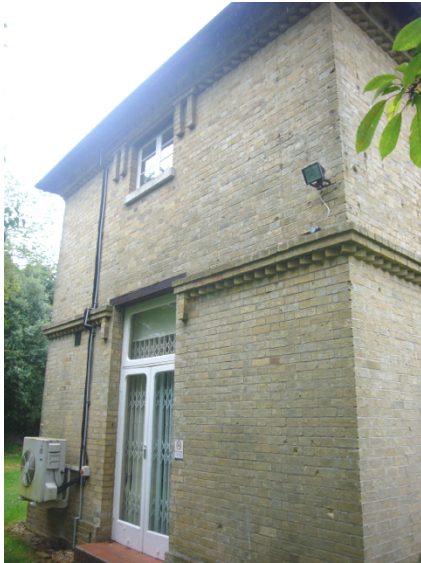
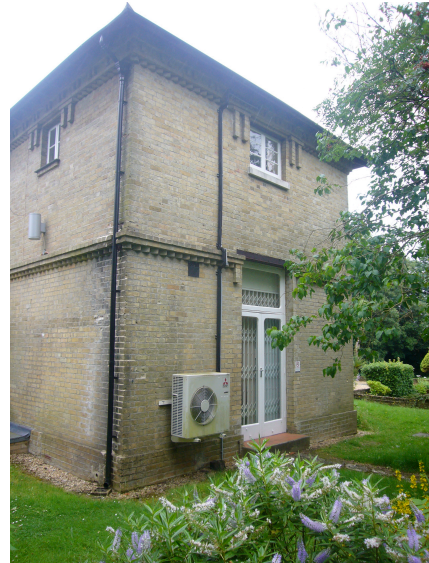
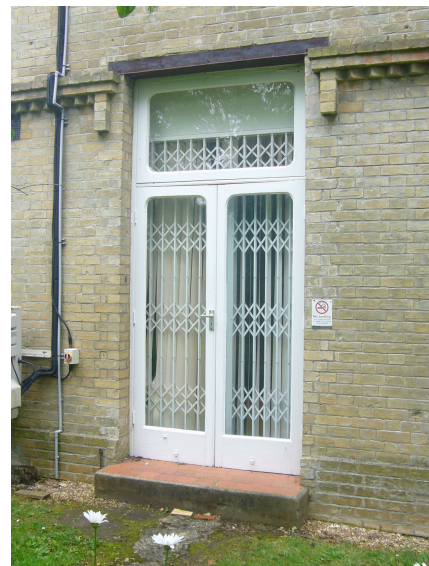
Bassett House, Southampton: Elevations - 15M

West Elevation of 'west wing'

Top left - from south-west

Top right - from north-west

Bottom detail of french doors and top light breaking through
dog-tooth string course - note short brackets - inserted
pre-1950

First floor window may be c.1865, cp. with window on north
elevation of 'west wing'

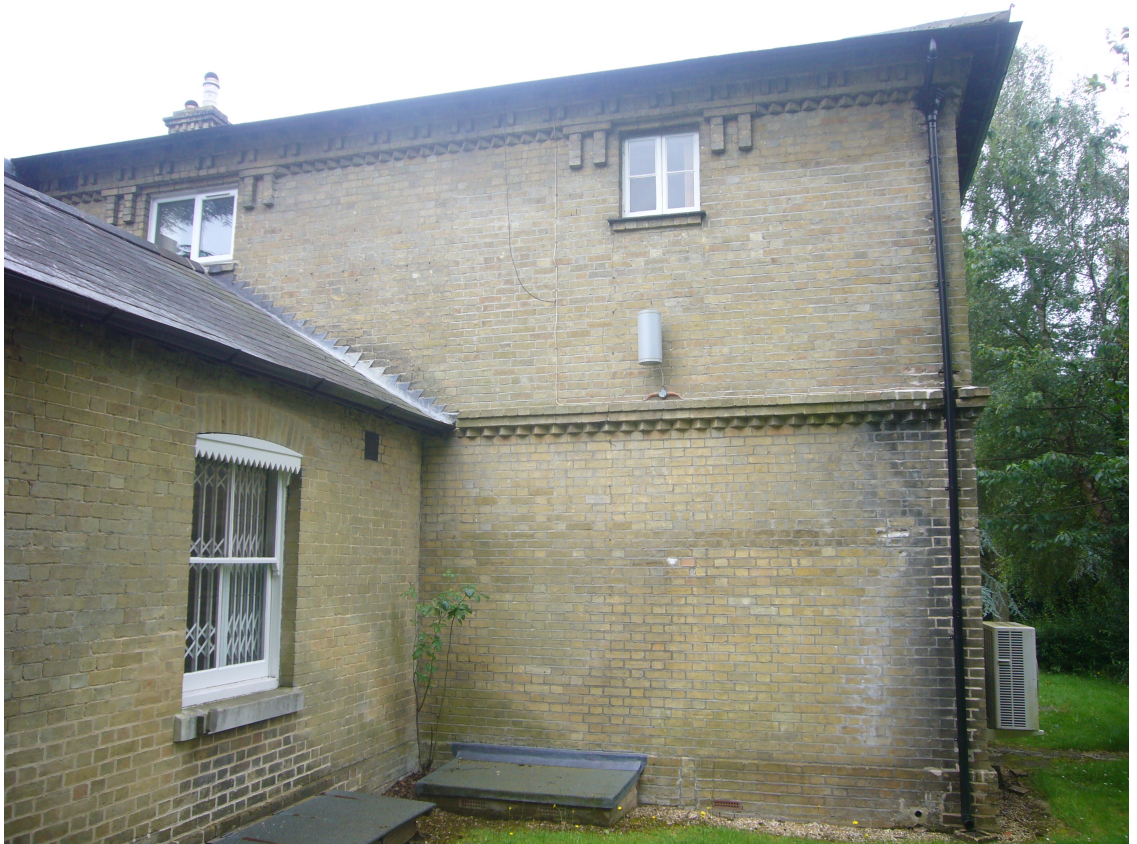
Bassett House, Southampton: Elevations - 16M

North Elevation of 'west wing'

First floor windows - left hand window - widened in c. 1950;
right hand window almost certainly from c.1865
construction of 'west wing'

Note marked brickwork towards right - location of former
Boiler House - also covers to coal chute and former cellar
entrance (see 1947 plans)

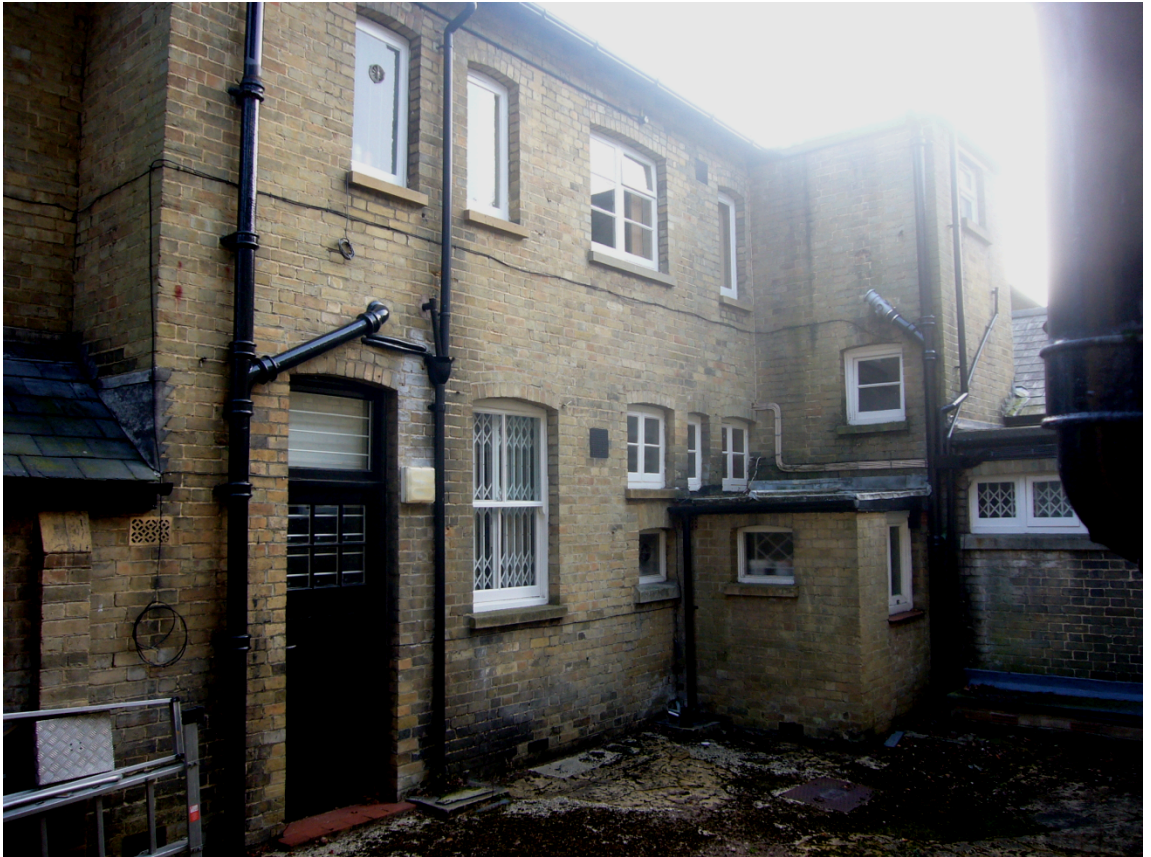
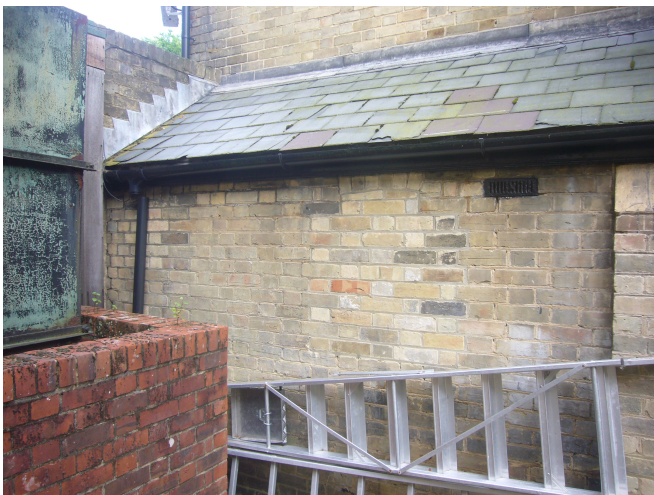
Bassett House, Southampton: Elevations - 17M

Top: North elevation of
Main House
Bottom: North elevation
of former Cloakroom
(now Office 14 - see Main
House Photographic
Record) showing two
bricked-up windows

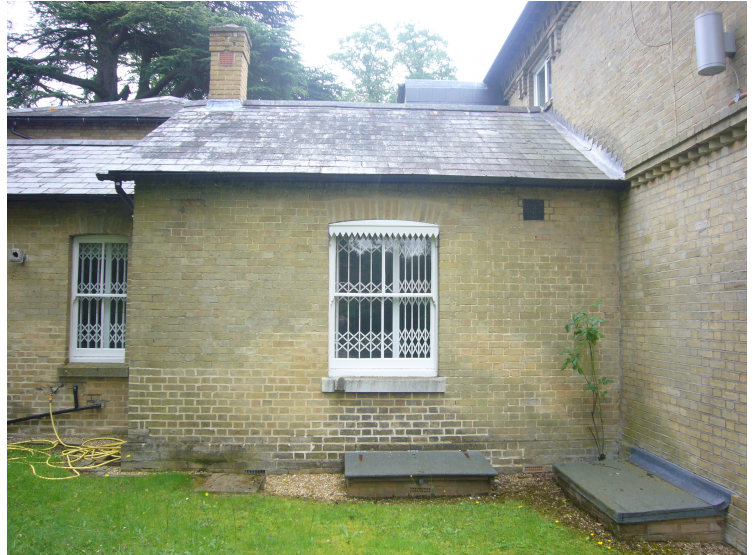
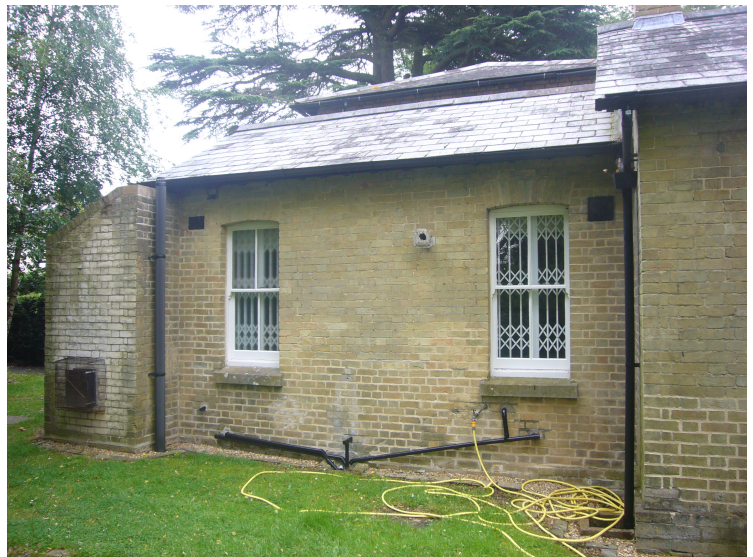
**Bassett House, Southampton: Elevations - 1N
NORTH WING**

West Elevation of 'north wing'
Constructed after (c. 1865) 'west wing' - probably later
C19

Top - south section
Bottom north section with added former WC
accommodation at north end

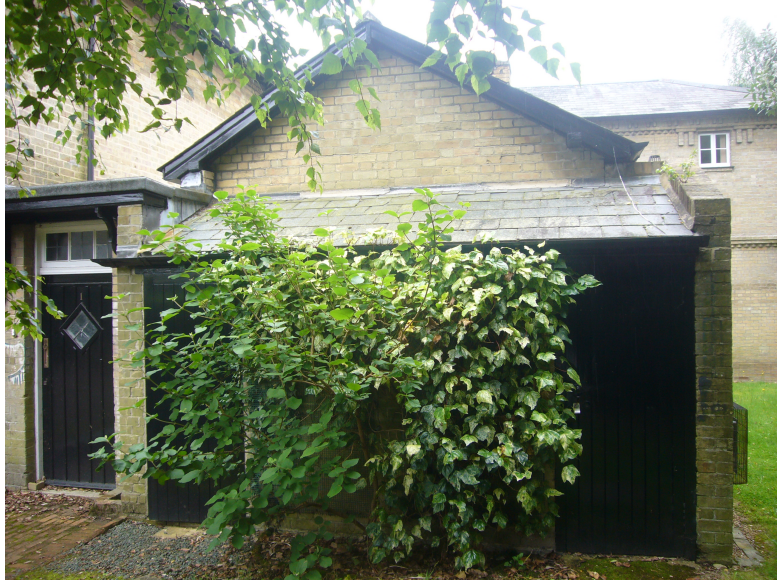
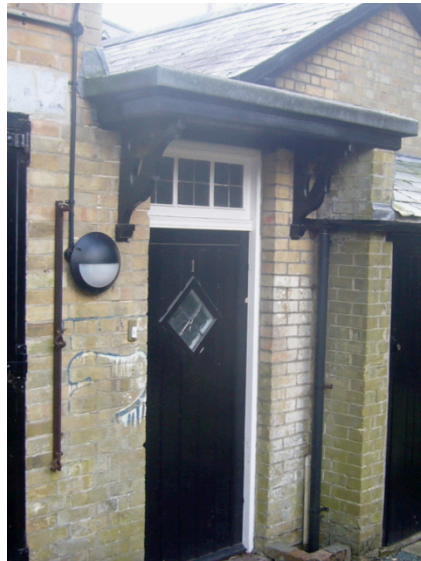
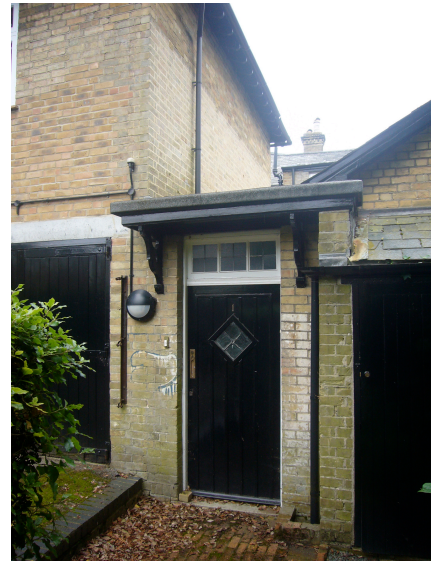
Bassett House, Southampton: Elevations - 2N

North Elevation of former WC accommodation and north entrance door to 'north wing'
Note 'mouchette' brackets (timber) to canopy and leaded lights - later C19 detailing

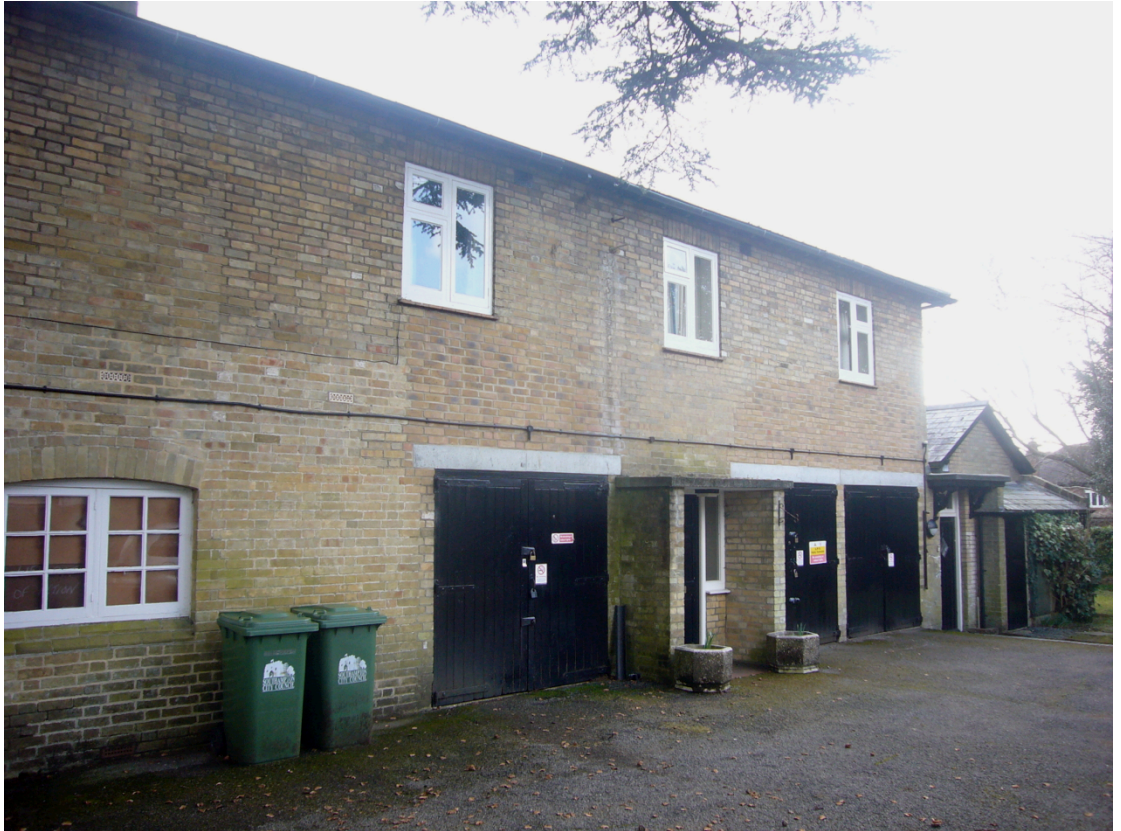
Bassett House, Southampton: Elevations - 3N

North Elevation to 'mews block' section of 'north wing'
Much altered c. 1950 - roof jacked up 600mm, garage
doorway and doors and entrance door and windows
inserted, all windows at first floor inserted

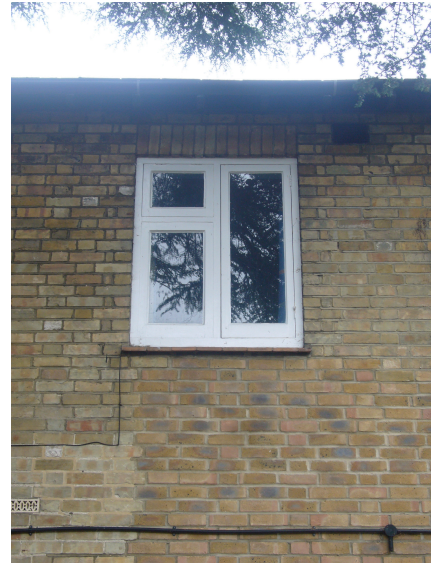
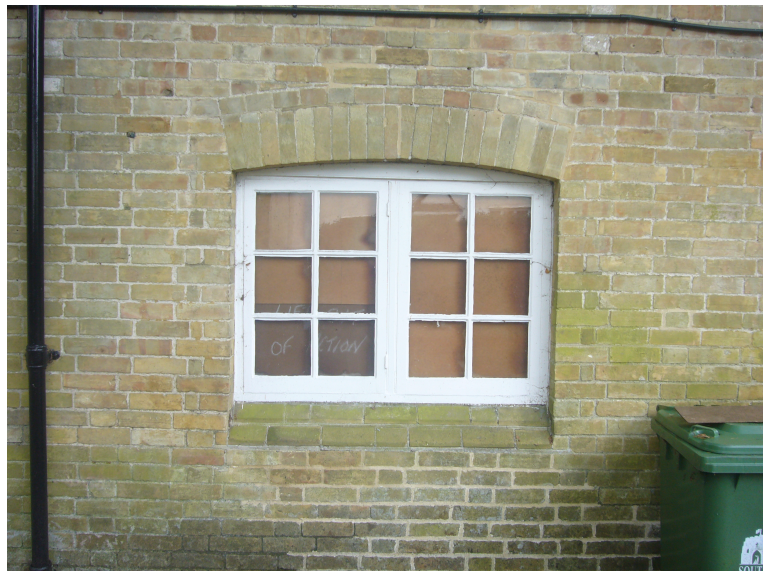
Bassett House, Southampton: Elevations - 4N

Windows to North Elevation of 'mews block' of 'north wing'

Top - typical window inserted at first floor C. 1950

Bottom - segmental arched window at ground floor level -
probably original to building (later C19?)

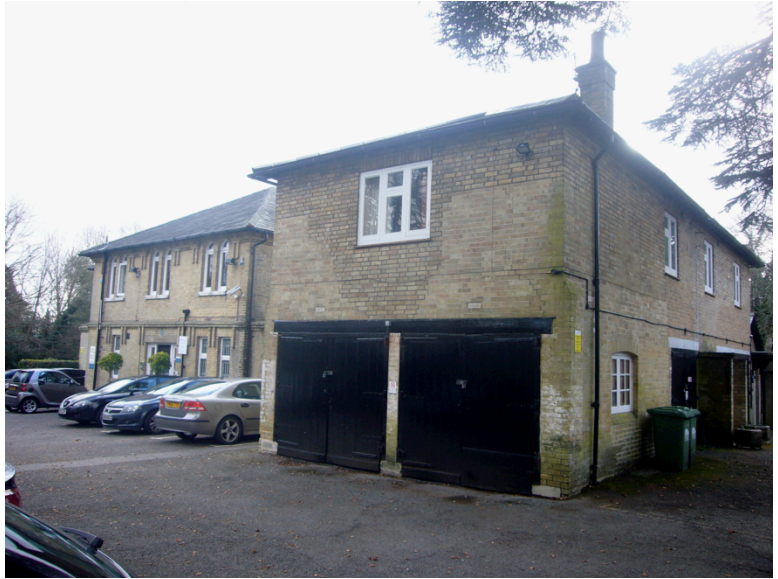
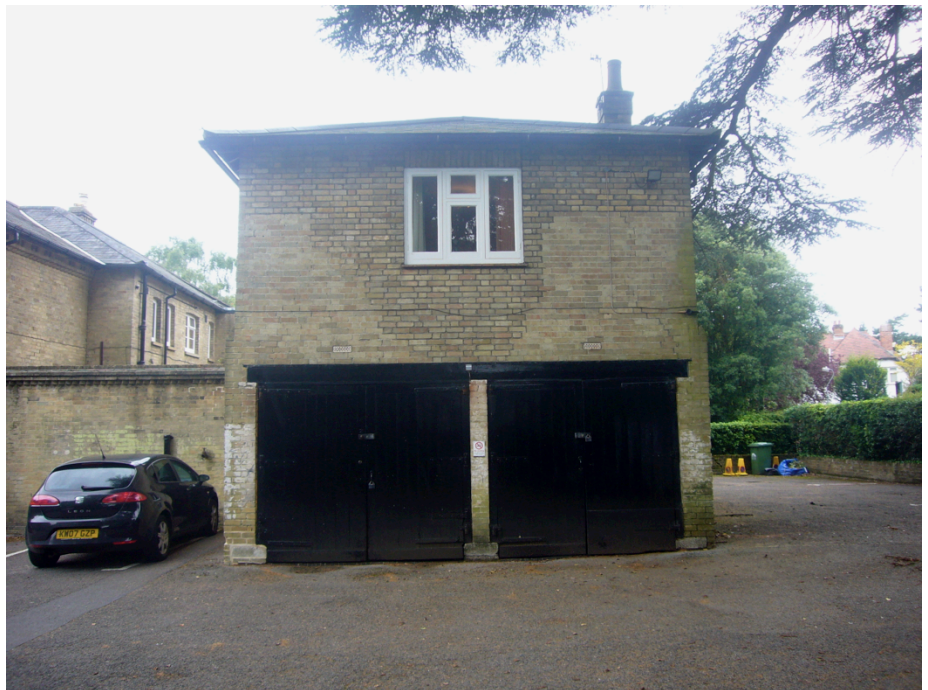
Bassett House, Southampton: Elevations - 5N

East Elevation - 'mews block' - 'north wing'
Garage doors - pre-1950 but into double garage - divided in
c1950 alterations
First floor window inserted c. 1950
