PHOTOGRAPHIC RECORD

Bassett House, Southampton: Elevations

1M - 17M (MAIN HOUSE)

1N - 7N (NORTH WING)

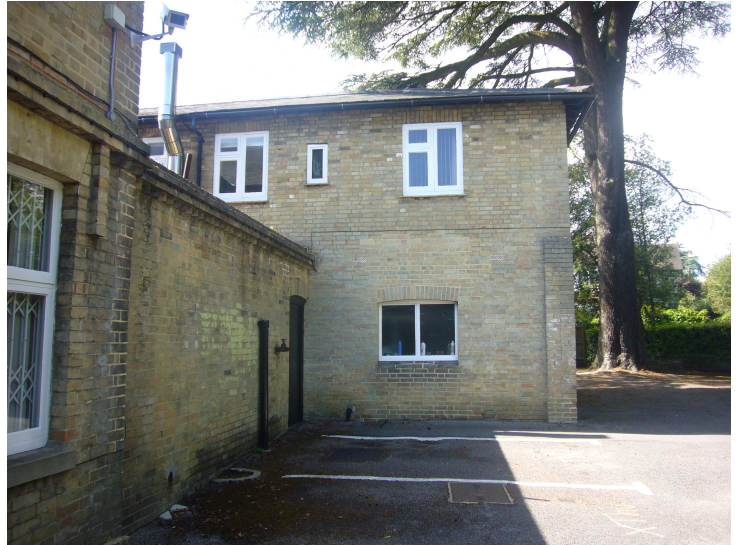
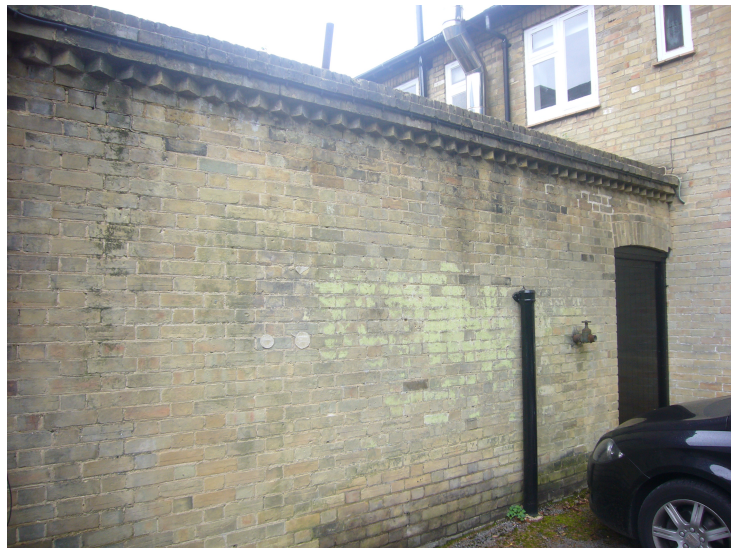
Bassett House, Southampton: Elevations - 6N

South Elevation of 'mews block' and Yard Wall
Top - South Elevation of 'mews block' of 'north wing' -
ground floor window pre-1950;
first floor windows inserted c.1950
Bottom - Yard Wall - differing positions shown on historic
OS sheets

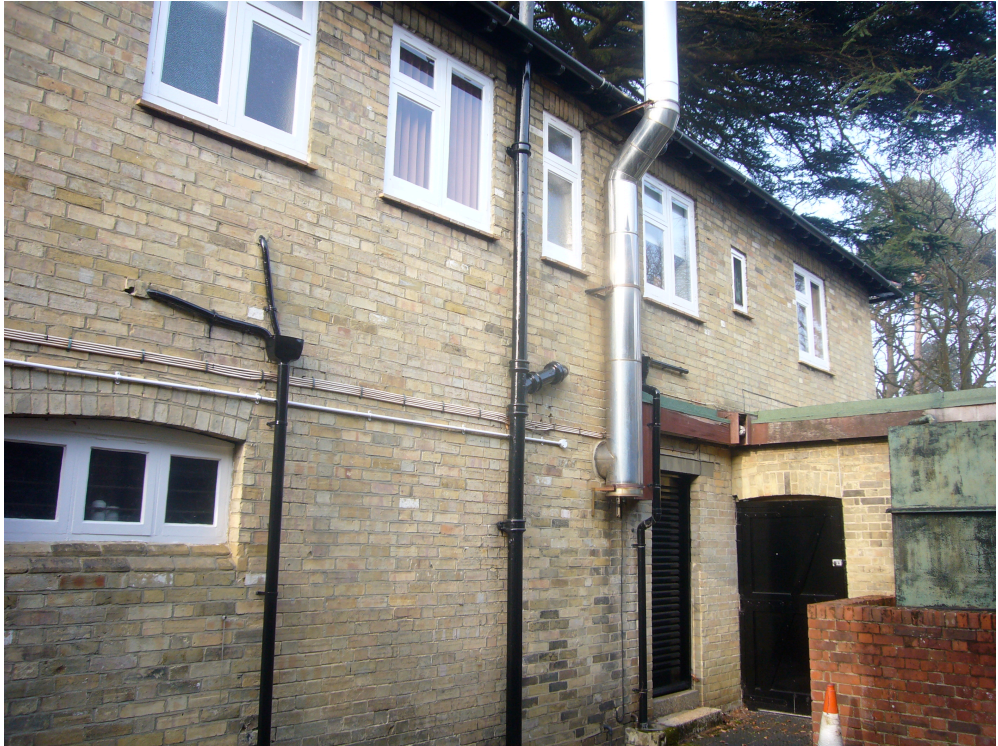
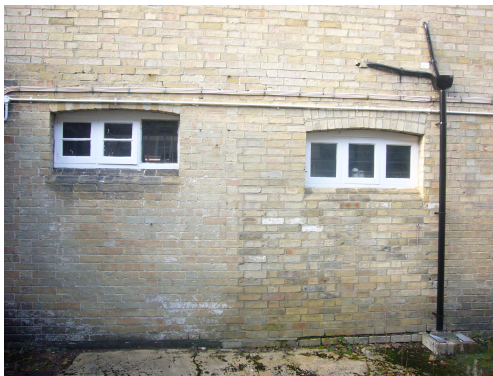
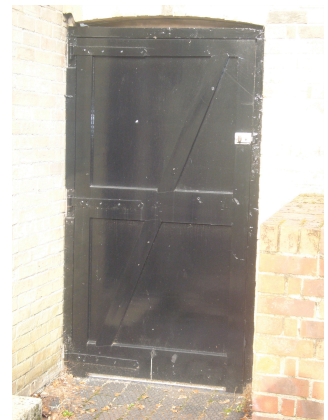
Bassett House, Southampton: Elevations - 7N

Top - South Elevation of 'mews block' of 'north wing'
Ground floor window (right hand window - bottom left)
inserted c.1950 in place of former doorway; window further
to right bricked up c.1950; first floor windows inserted c.
1950

Bottom left - left hand window pre-1950, right hand window
c. 1950

Bottom right - detail of Yard door
