# **Wrenbury Marina, Cheshire East**

Archaeological Desk Based Assessment

Project Code: A0002

Client: Oligra Town Planning Services

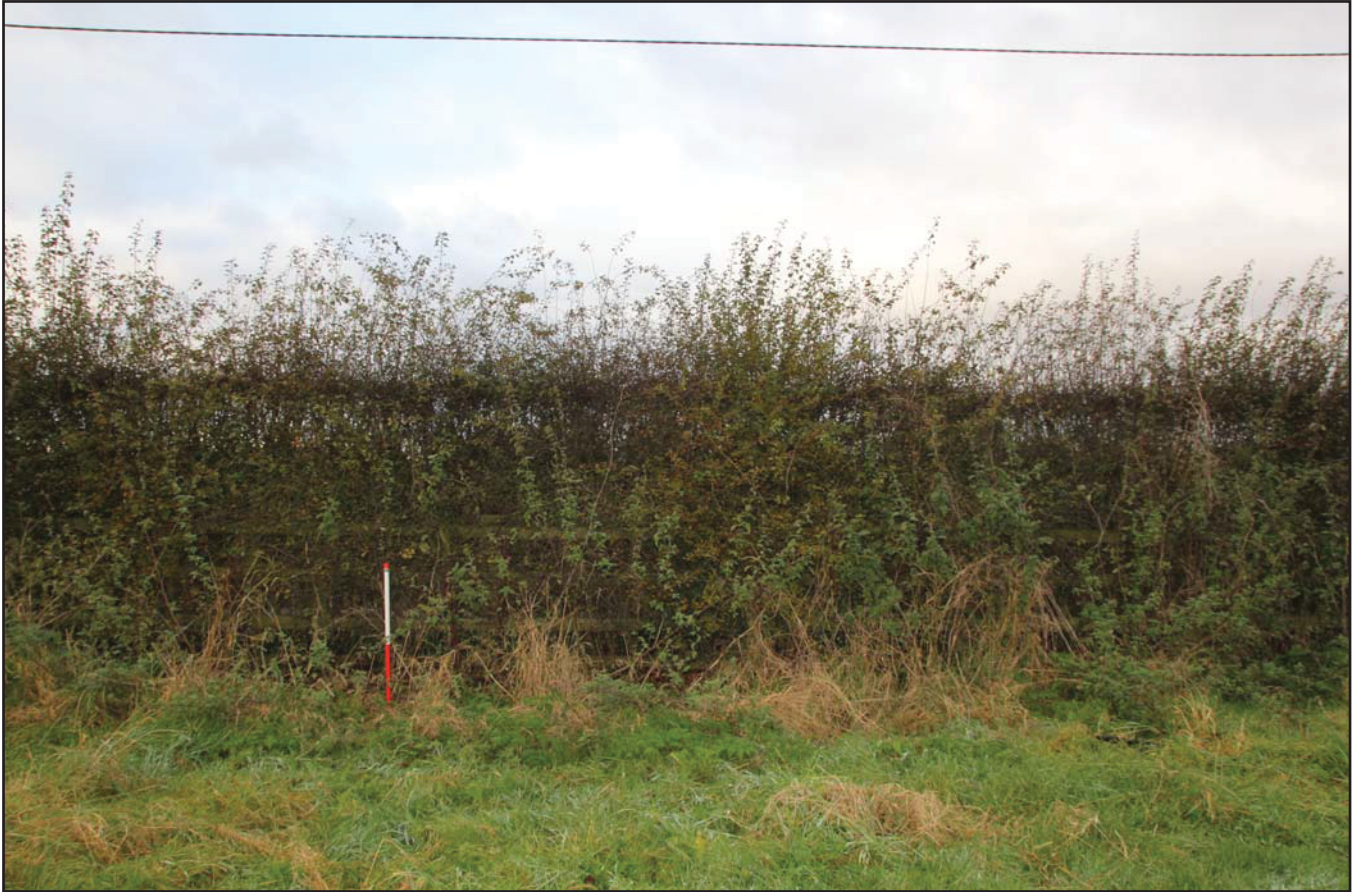
development area. It measures approximately 3.0m in height and is made up mostly of hawthorn and reinforced with a wooden stock fence. The field boundary is depicted on the 1843 tithe map although the hedgerow itself was planted approximately 15 years ago by the landowners. This feature will not be impacted upon by the proposed development as access to the site will be gained by an existing gate. This field boundary provides a visual screen between the proposed development area and the Wrenbury Conservation Area and it is recommended that it is retained in-situ (see feature 19).
<b>Recommendations for further assessment:</b> None
<b>Recommendations for mitigatory measures:</b> Retain in-situ

**Plate 01:** Hedgerow (feature 1) from the northeast. Scale 1.0m.

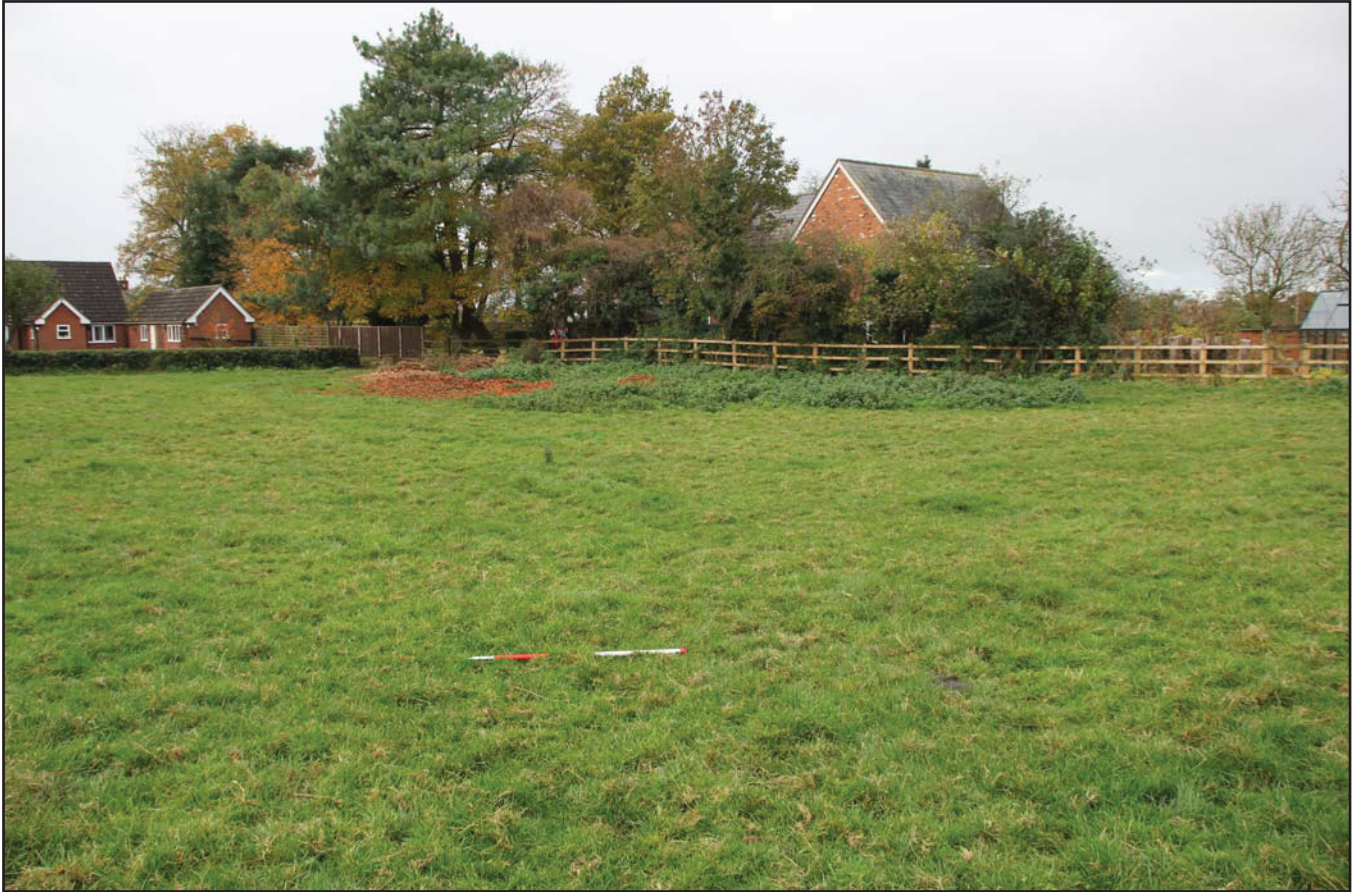
**Plate 05:** Possible quarry site (feature 5) from the northeast. Scale 1.0m.

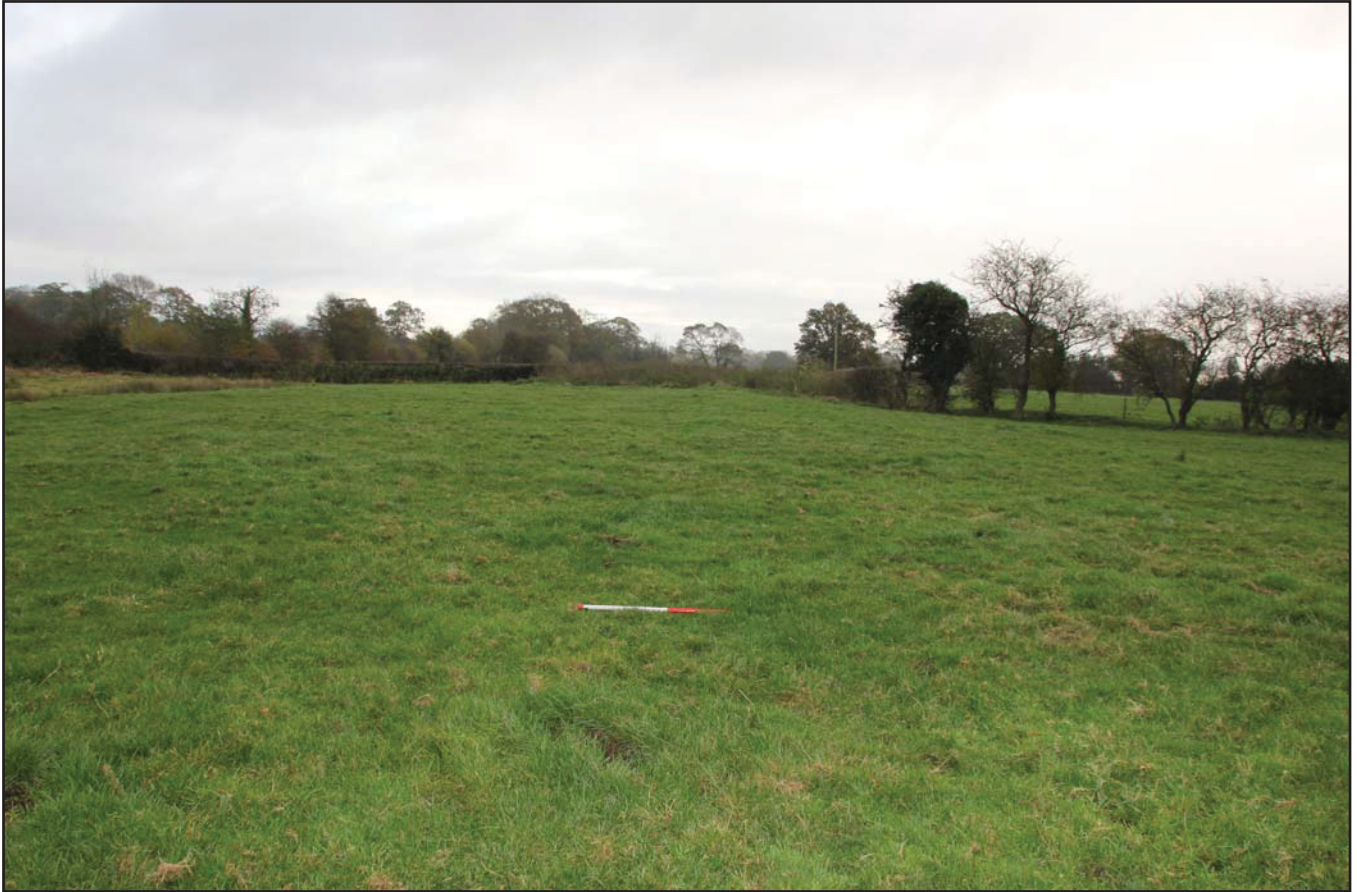
<b>7. Bank (plate 7)</b>	Category: Local	Ref: Unassigned
SJ 59372 48031	Impact: High adverse direct	
A wide bank measuring approximately 8.0m in width runs from east to west across the northern part of the field. The bank is almost certainly part of the flood defences of the Shropshire Union canal and is most probably of 19 <sup>th</sup> century date. This feature will require total removal by the proposed development.		
<b>Recommendations for further assessment:</b> None		
<b>Recommendations for mitigatory measures:</b> None- recorded as part of the desk based assessment.

**Plate 07:** Bank (feature 7) from the west. Scale 1.0m.

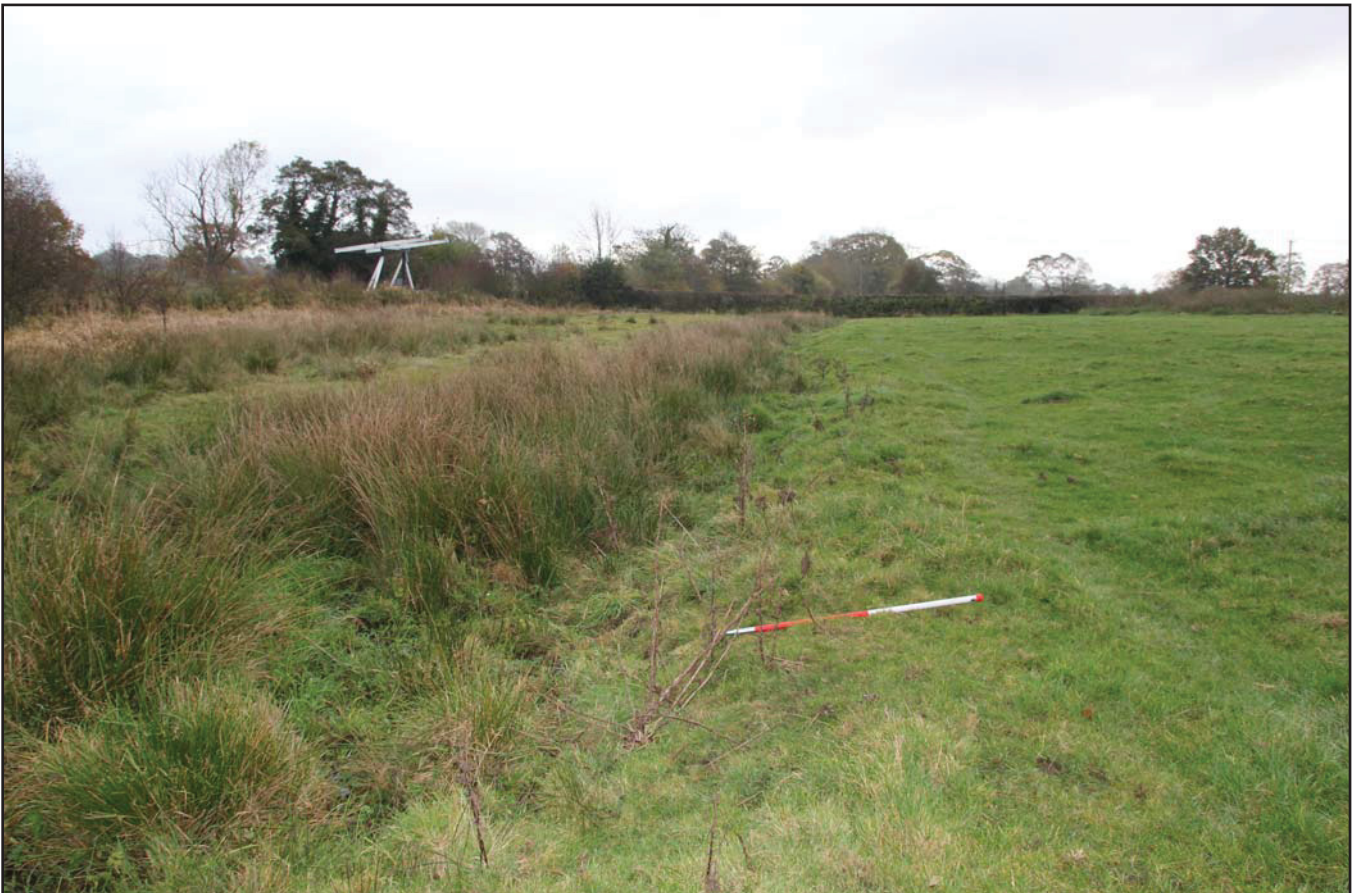
<b>8. Drainage ditch (plate 8)</b>	Category: Local	Ref: Unassigned
SJ 59367 48047	Impact: High adverse direct	
A drainage ditch runs from east to west across the northern part of the field and measures approximately 2.0m in width. The drainage ditch is first depicted on the first edition Ordnance Survey map of 1875 and is most likely of mid 19 <sup>th</sup> century date. The ditch was almost certainly excavated to alleviate some of the water logging in the northern part of the field caused by the proximity to the Shropshire Union canal. This feature will require total removal by the proposed development.		
<b>Recommendations for further assessment:</b> None		
<b>Recommendations for mitigatory measures:</b> None- recorded as part of the desk based assessment.

**Plate 08:** Drainage ditch (feature 8) from the west. Scale 1.0m

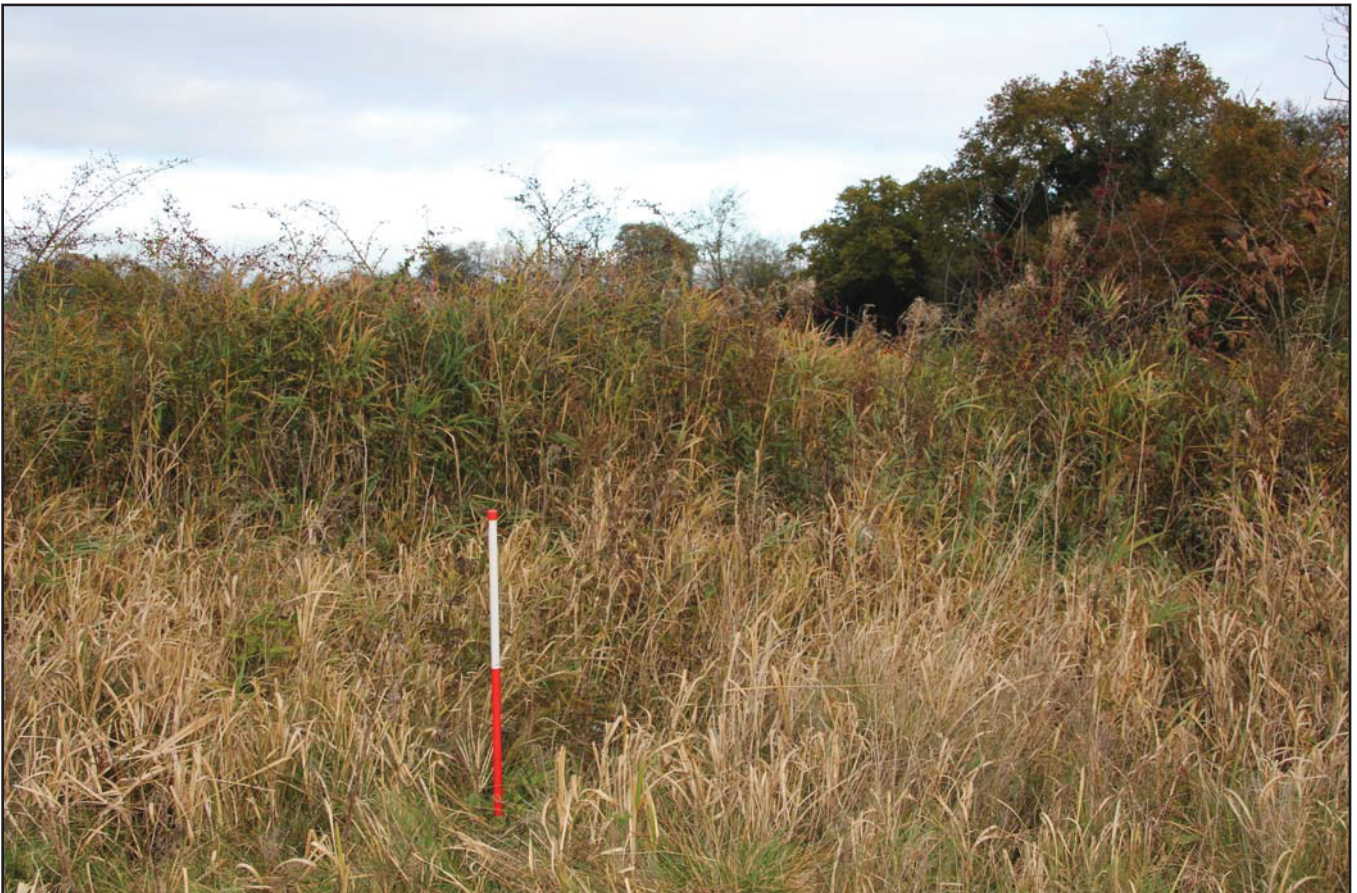
**Plate 12:** Hedgerow (feature 12) from the south. Scale 1.0m

<b>Recommendations for further assessment:</b> None		
<b>Recommendations for mitigatory measures:</b> Avoidance, retain trackway (feature 13), limit size of marina boat entrance/ exit, and retain as much of hedgerow (feature 12) as possible.

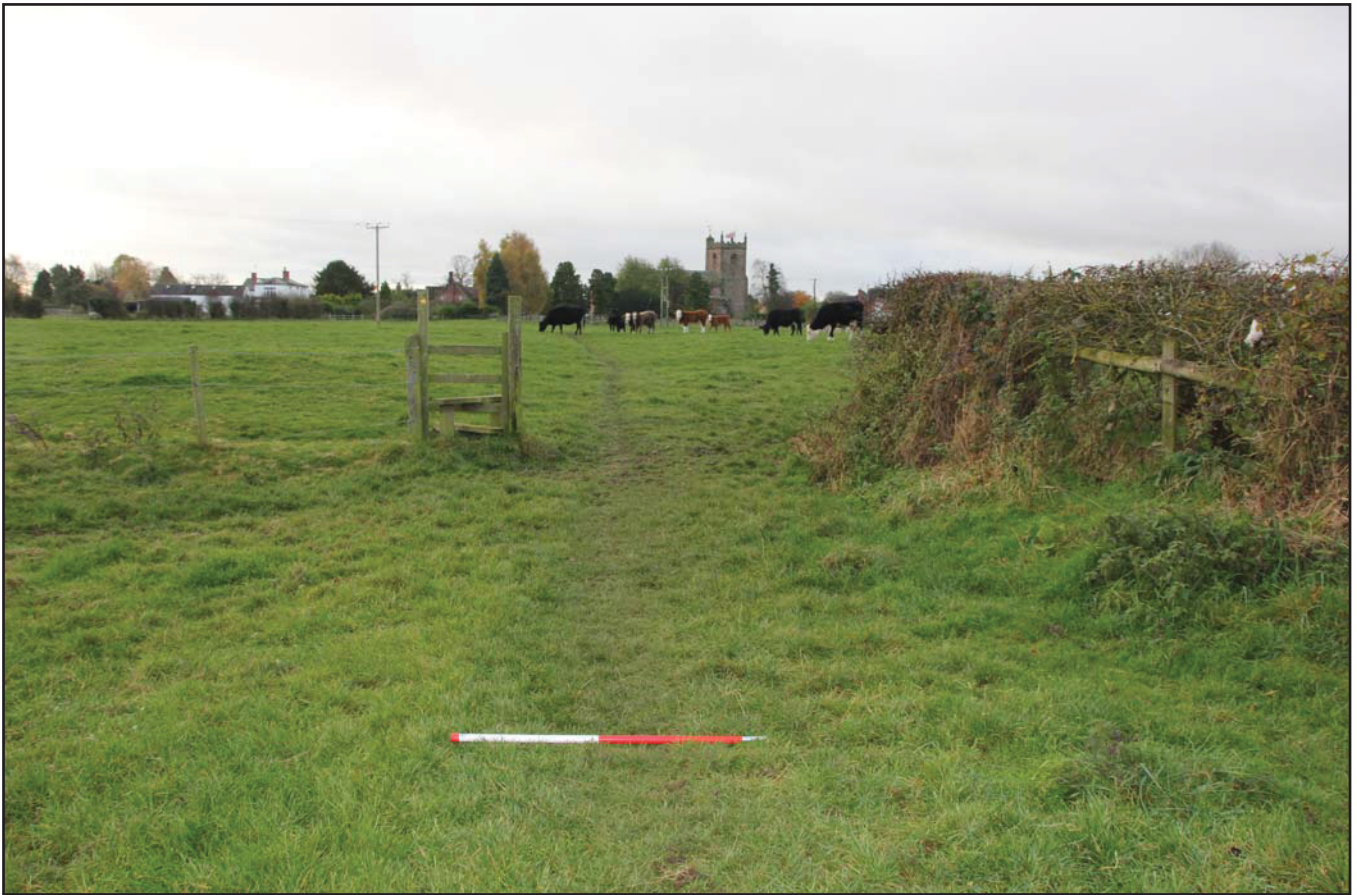
**Plate 13:** Trackway (feature 13) from the north. Scale 1.0m.

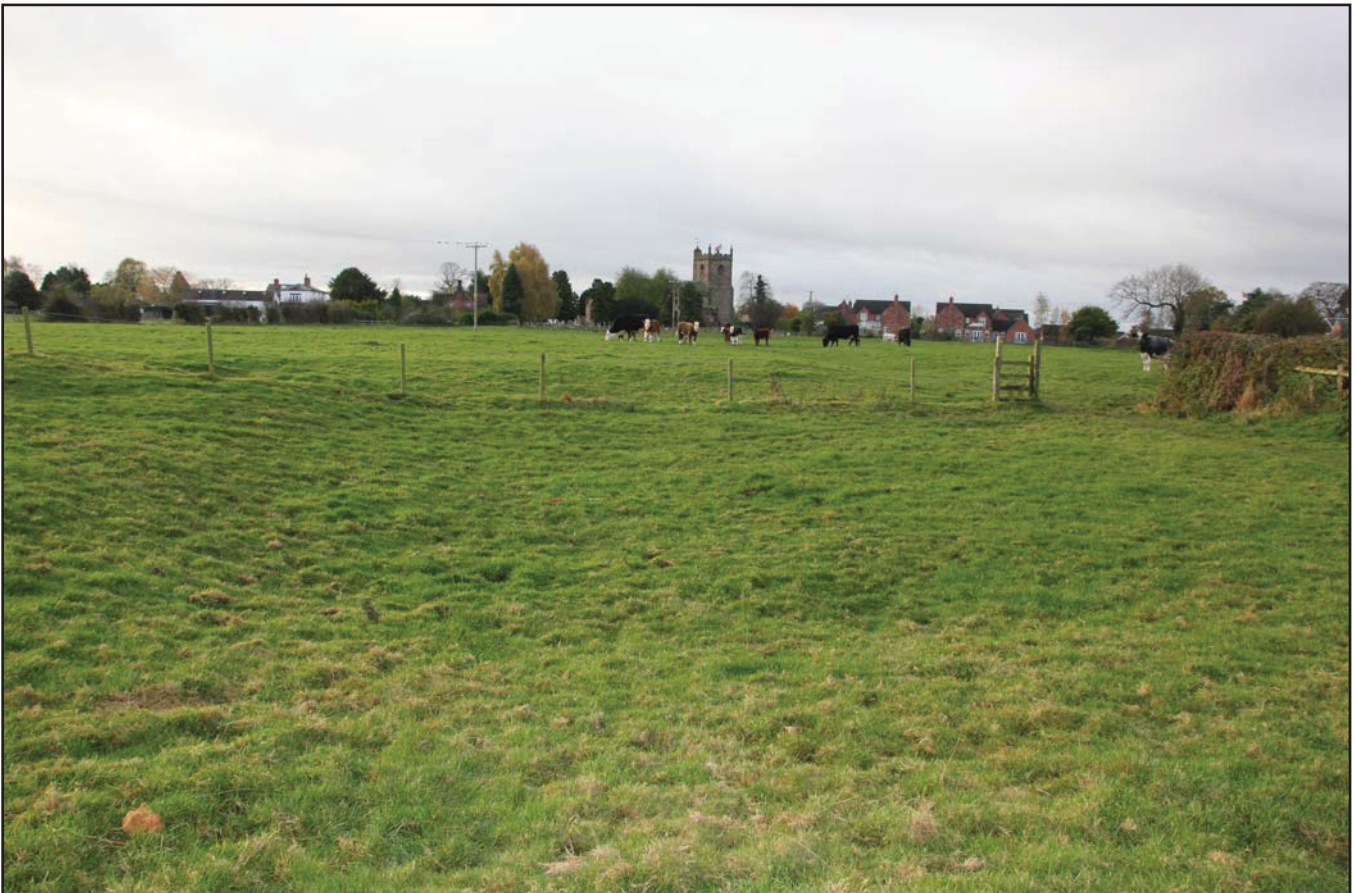
<b>14. Possible quarry site (plate 14)</b>	Category: Local	Ref: Unassigned
SJ 49452 48010	Impact: None	
A shallow hollow in the field at this point may be indicative of an area of localised quarrying or gravel extraction. The feature lies outside the proposed development area and will not be impacted upon.		
<b>Recommendations for further assessment:</b> None		
<b>Recommendations for mitigatory measures:</b> None

**Plate 14:** Possible quarry site (feature 14) from the north. Scale 1.0m

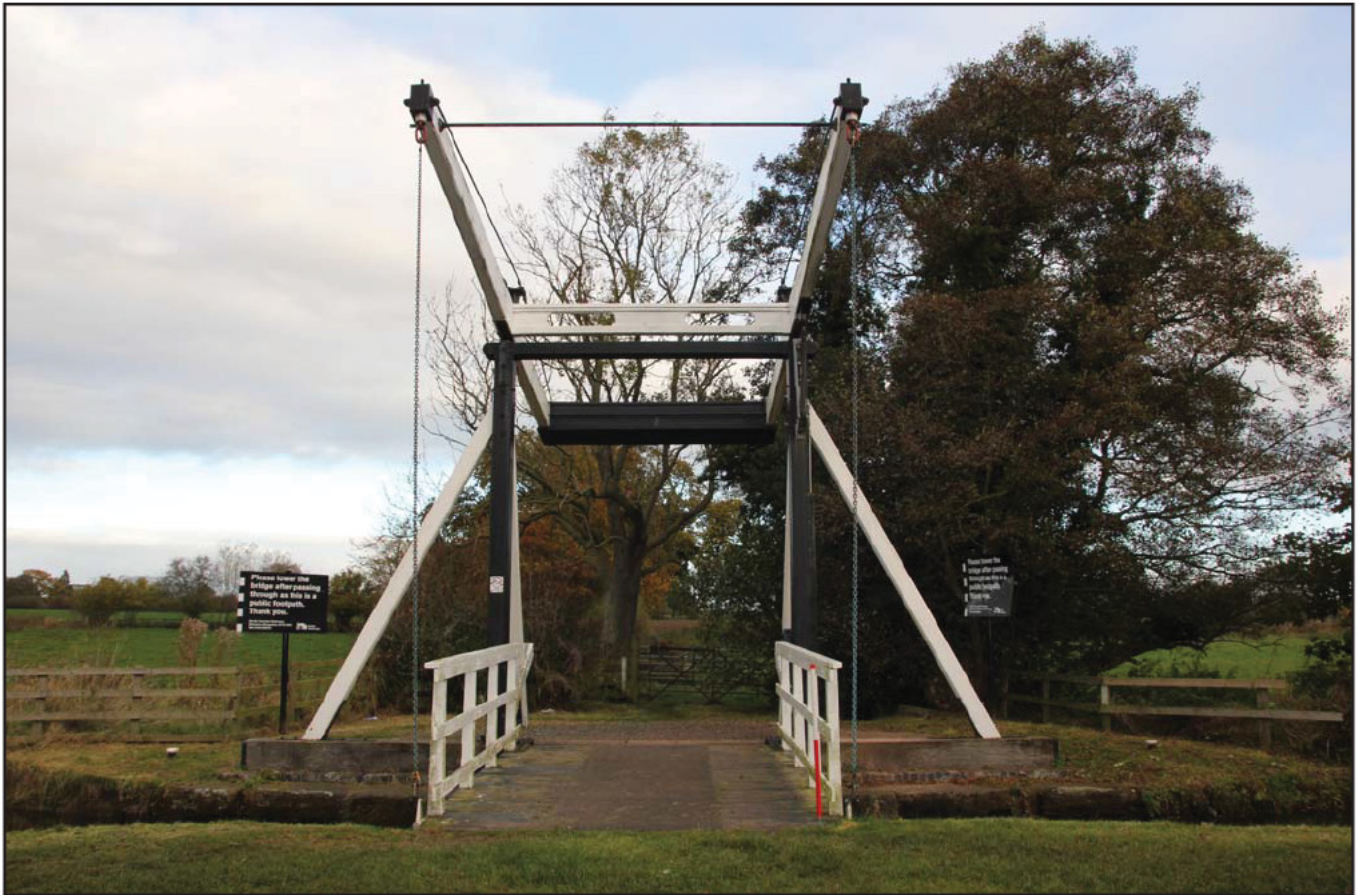
**Plate 15:** Wrenbury Church Bridge grade II\* Listed Building (feature 15) from the south. Scale 1.0m.

It is expected that the proposed development will have a medium adverse indirect impact upon the grade II\* Listed Building of the Wrenbury Church Bridge (feature 15) and as such it is recommended that the hedgerow (feature 12) and trackway (feature 13) be retained to minimise the impact upon the setting of the monument. In the case of the former, it is recommended that the boat entrance into the marina be limited to the smallest size practical and as much of the hedgerow be retained as is possible.

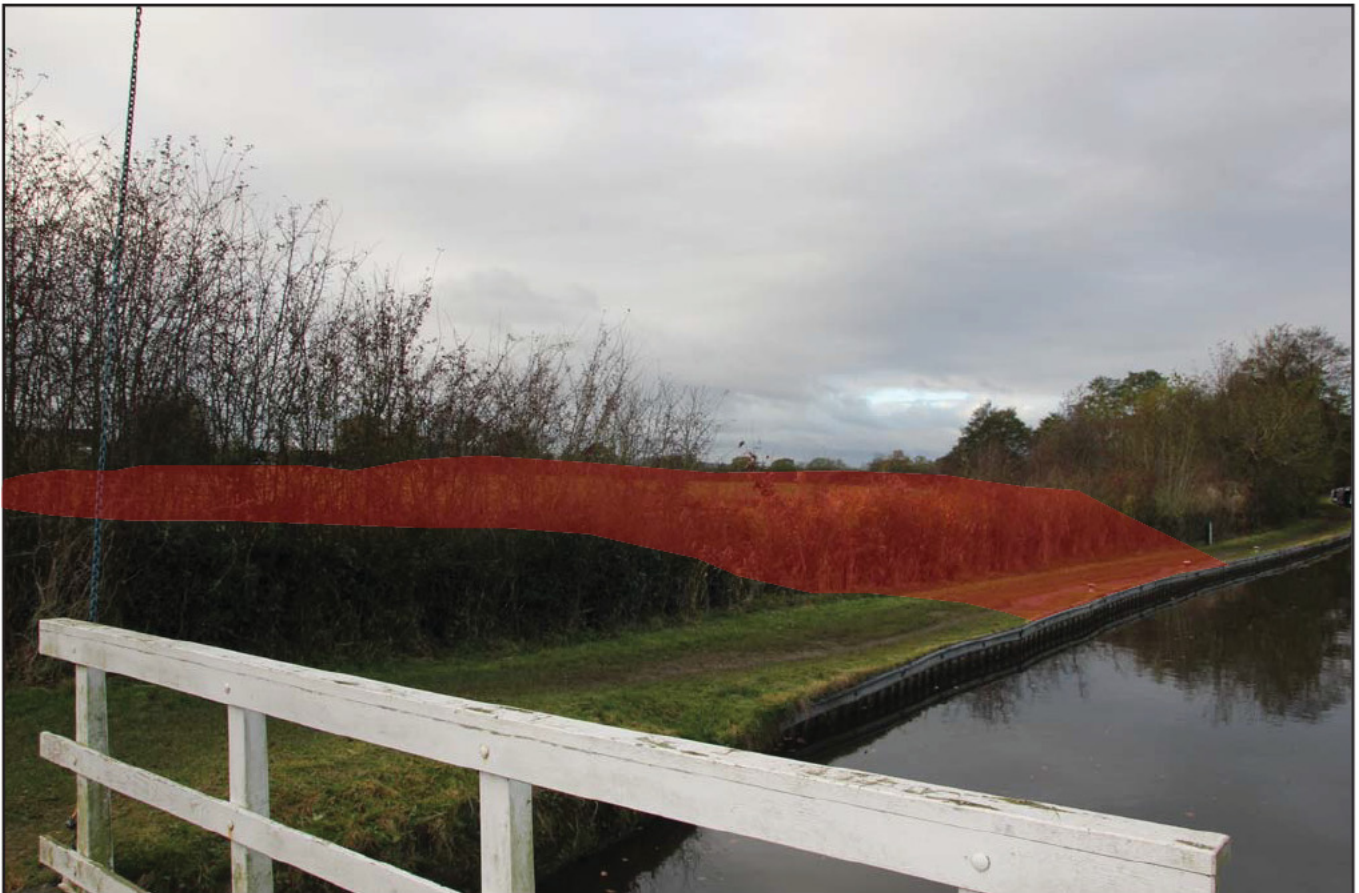
**Plate 16:** View from Wrenbury Church Bridge grade II\* Listed Building (feature 15) towards the proposed development area, from the northeast. Approximate proposed development area shaded in red.

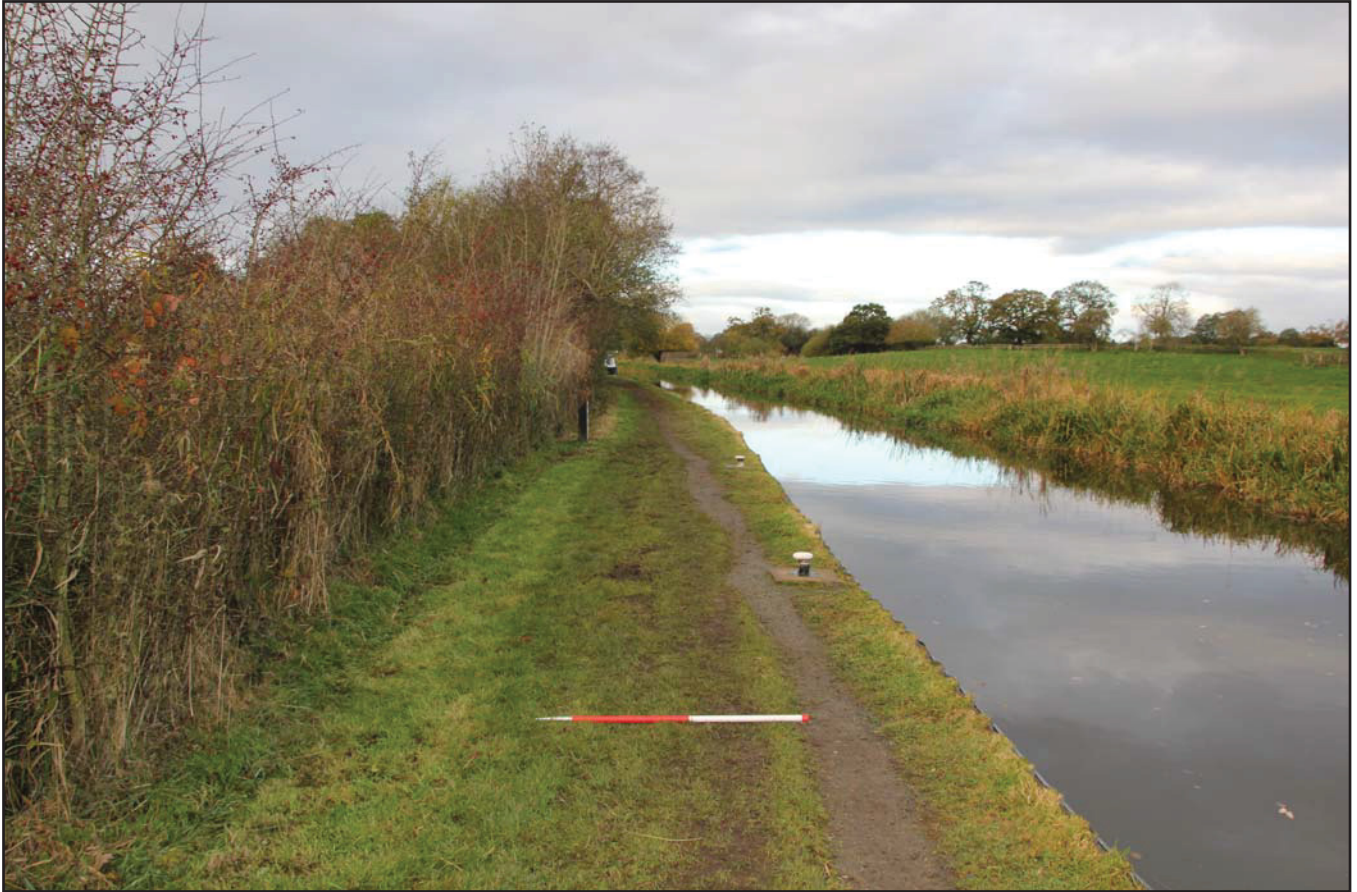
**Plate 17:** Llangollen branch of the Shropshire Union canal (feature 16) from the east. Scale 1.0m.

The proposed development is expected to have a low adverse direct and indirect impact upon the Llangollen branch of the Shropshire Union canal, however the impacts are deemed to be of such a low level that no further assessment or mitigation is recommended.

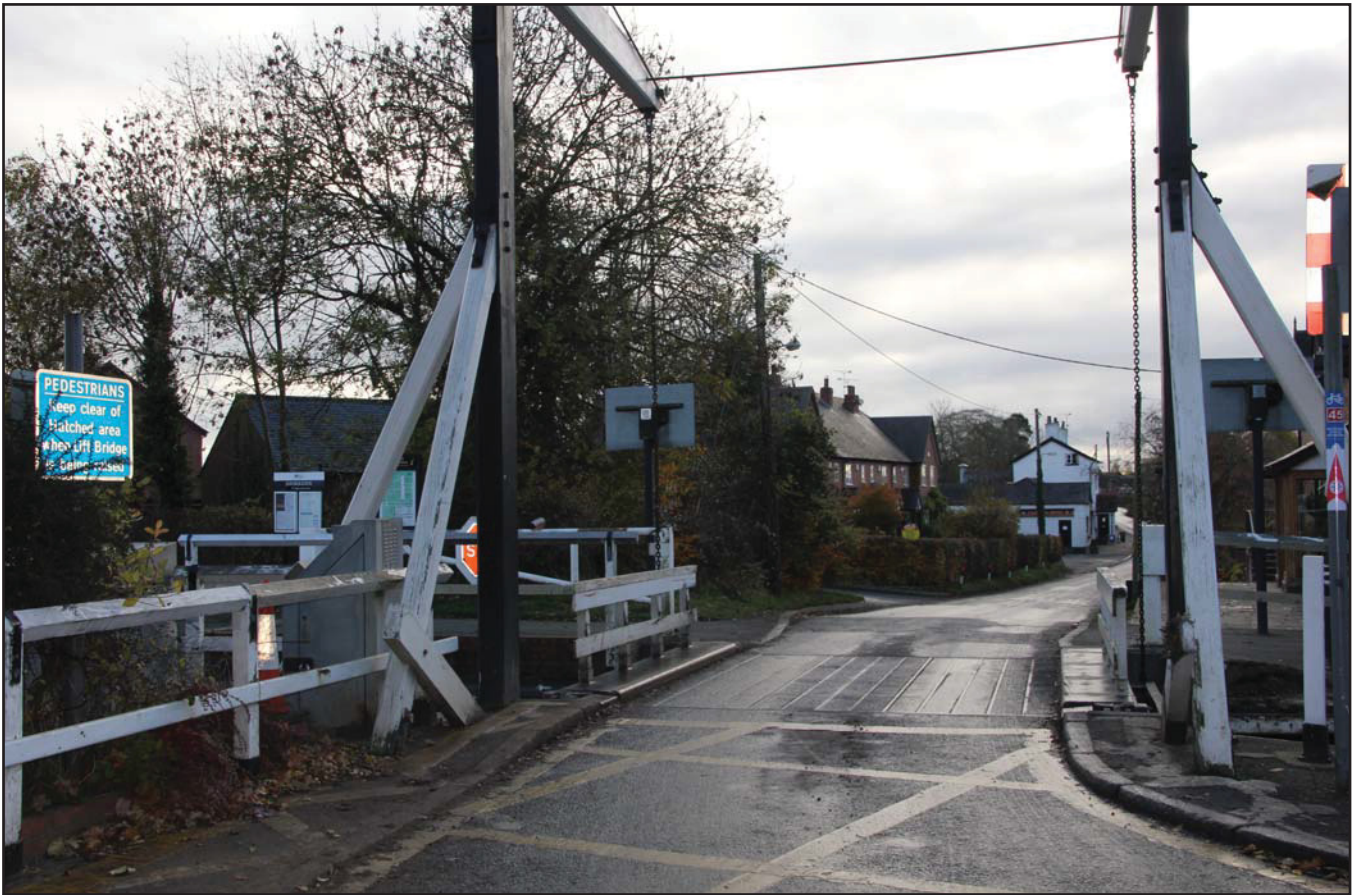
**Plate 19:** View from Wrenbury Wooden Lifting Bridge Scheduled Ancient Monument and grade II Listed Building (feature 18) towards the proposed development area, from the northeast.

The expected indirect physical impact of the proposed development upon the Scheduled Ancient Monument and grade II Listed Building of the Wrenbury Wooden Lifting Bridge (feature 18) is currently unknown. There exists the possibility that indirect physical damage may be caused through the increased volumes of traffic utilising the monument to cross the River Weaver to access the proposed marina. This potential impact will be limited to the operational phase, as heavy plant will be directed eastwards out of the village during the construction phase and will not utilise the bridge. Moreover, it is the intention of the client to erect brown tourist signs to direct the majority of vehicular traffic to the site from the east during the operational phase, thus reducing the potential increase in traffic utilising the bridge for access to the site. The advice of English Heritage has been sought regarding the monument, and it is therefore recommended that the client contacts British Waterways and the Highways Agency to ascertain the suitability of the bridge.

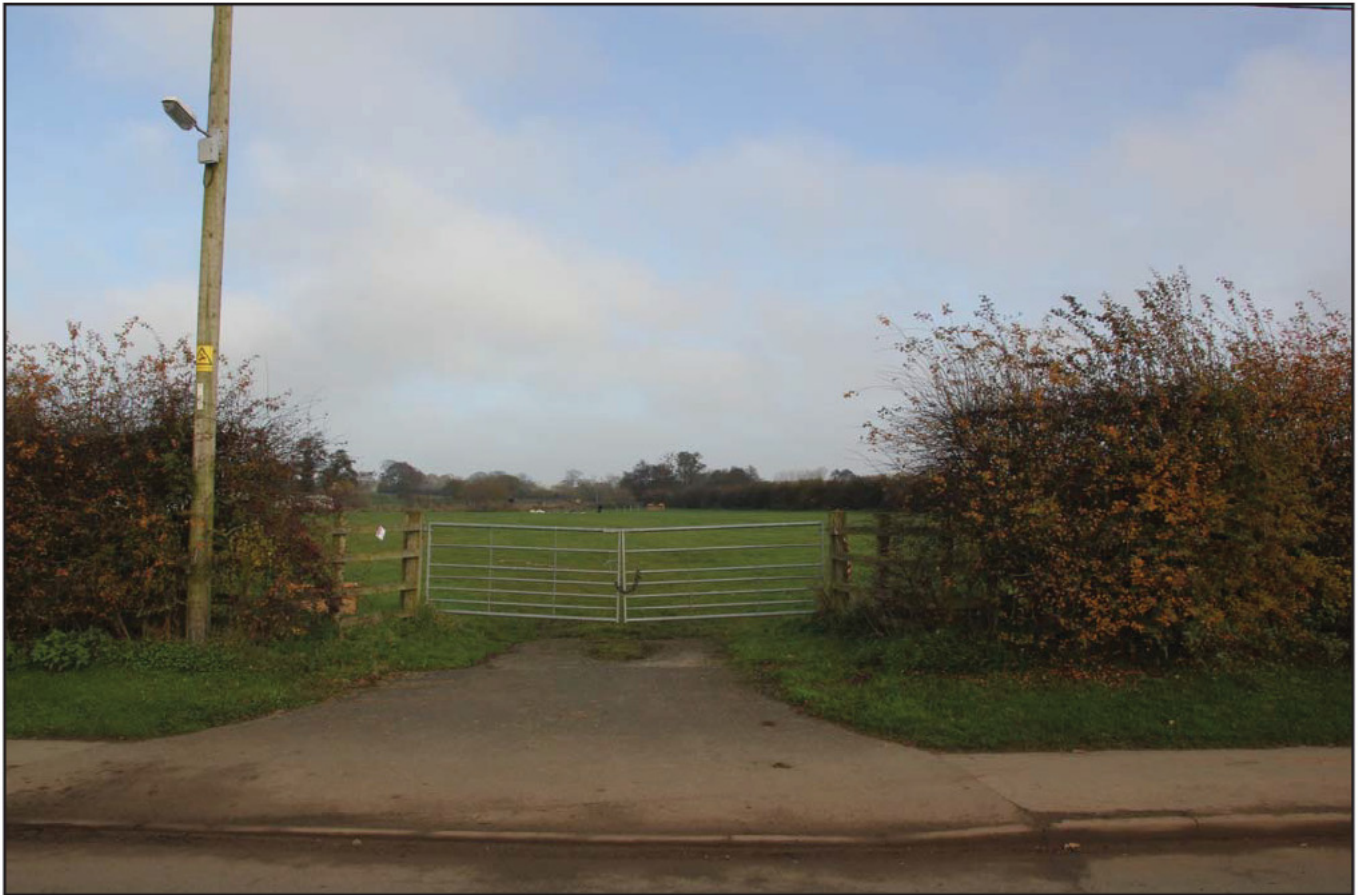
The proposed development is expected to have a low adverse indirect impact upon the conservation area. There will be some adverse impact through the change in historic landuse from an enclosed fieldscape to car parking for the marina. Furthermore, the change of historic landuse from enclosed fieldscape to marina will impact upon the views northwards out of the designated area in proximity of the churchyard, as well as southwards looking into the designated area. It is recommended that the hedgerow (feature 1) be retained and access into the proposed car park be through the existing farmer's gate. Furthermore, it is expected that the impact upon the significant historic views northwards from the area in and around St. Margaret's Church from the proposed marina lake could be negated somewhat by the planting of a new hedgeline around the perimeter of the lake.

**Plate 21:** View from the Wrenbury Conservation Area (feature 19) towards the proposed development site, from the south. The hedgerow (feature 1) should be retained and access to the site should be via the existing farm gate.

***Recommendations for mitigatory measures:*** Retain hedgerow (feature 1) and provide access to the marina car park via the existing farmer's gate. Cultivate a new hedgerow around the southern perimeter of the proposed marina lake.

The proposed marina development is expected to have a low adverse direct and a low adverse indirect impact upon the Wrenbury Conservation Area (feature 19). The direct physical impact of the marina car park upon the designated area amounts to a physical loss of part of the Conservation Area, however due to the actual land take being relatively low, no further assessment or mitigation measures are recommended. The adverse indirect impact of the marina upon the designated area is also limited to a relatively small area that shall lose its agricultural historic landuse. The indirect visual impact out of the Conservation Area towards the development site is limited to breaks in the hedgeline, gaps between houses, and within the churchyard of St. Margaret's, and is thus deemed to be of low impact. Furthermore, although the views towards the Conservation Area will be lost when viewing south from the development area, the land is currently enclosed fields and, aside from the trackway (feature 13), mostly inaccessible. However, to help mitigate the indirect visual and non-visual impacts of the development upon the Conservation Area it is recommended that the hedgerow (feature 1) be retained in its entirety, the access to the site is granted through the existing farmer's gate
