**Upton-by-Chester High School,  
Chester, Cheshire.  
August 2013**

Archaeological Watching Brief  
Project Code: A0021  
Report no. 0020

Client: Upton by Chester High School

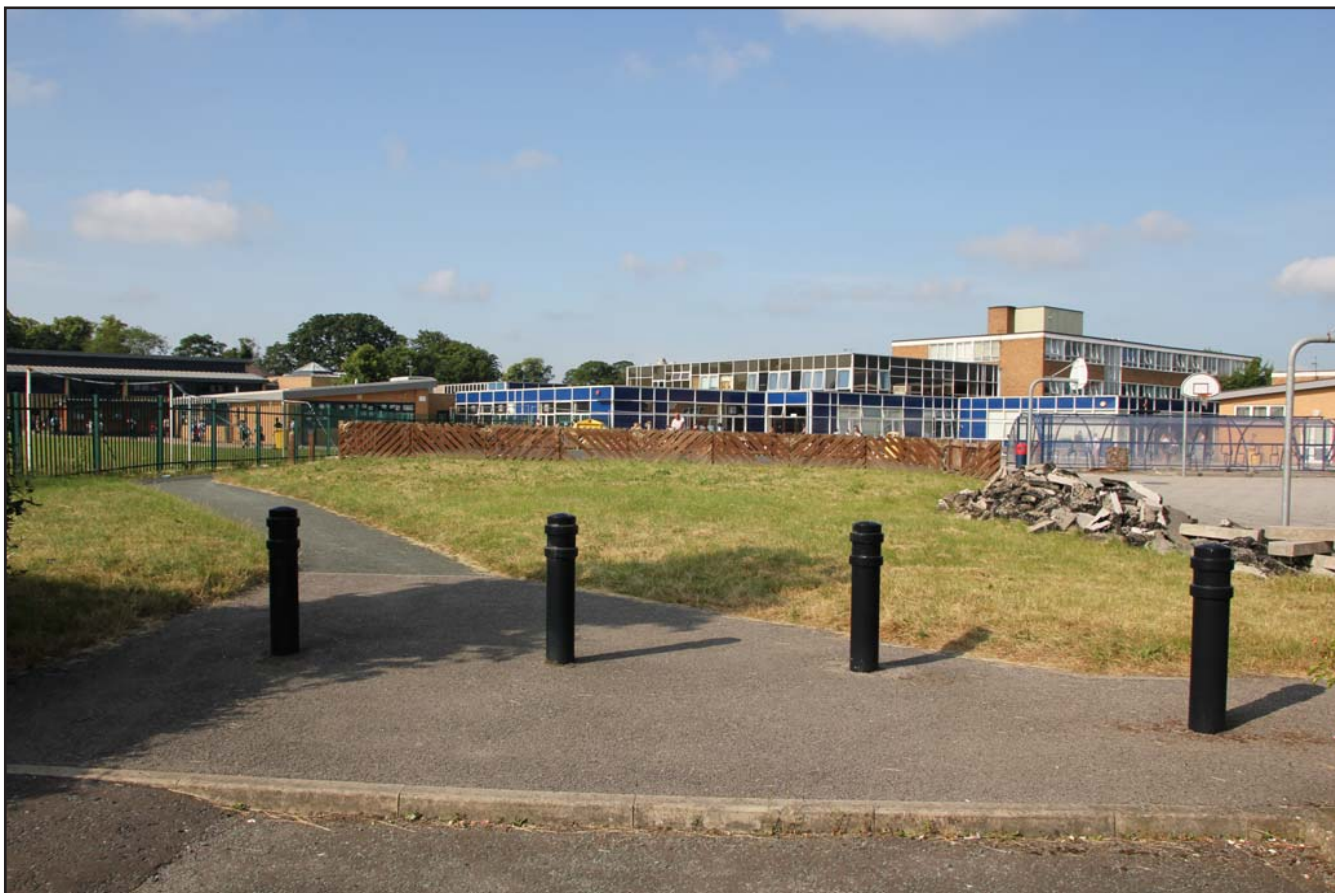
**Plate 01:** Former bungalow site/grassed area prior to ground reduction, from the northeast.

The area consisted of a 0.6 hectare site located to the immediate southeast of the existing tennis courts. The site was divided roughly in two by a grassed area to the northeast (plate 1) and an area of raised tarmac surrounded by a fence to the southwest (plate 2), marking the site of a former bungalow that had been demolished and capped. The tarmac area was raised approximately 0.4m above the height of the existing tennis courts and was reduced using a toothed ditching bucket. As the bungalow foundations were removed it was found that a 0.1m thick layer of tarmac had been placed over a thick demolition layer of hardcore rubble comprising stone, brick and concrete and measuring approximately 0.6m in depth (plate 3).

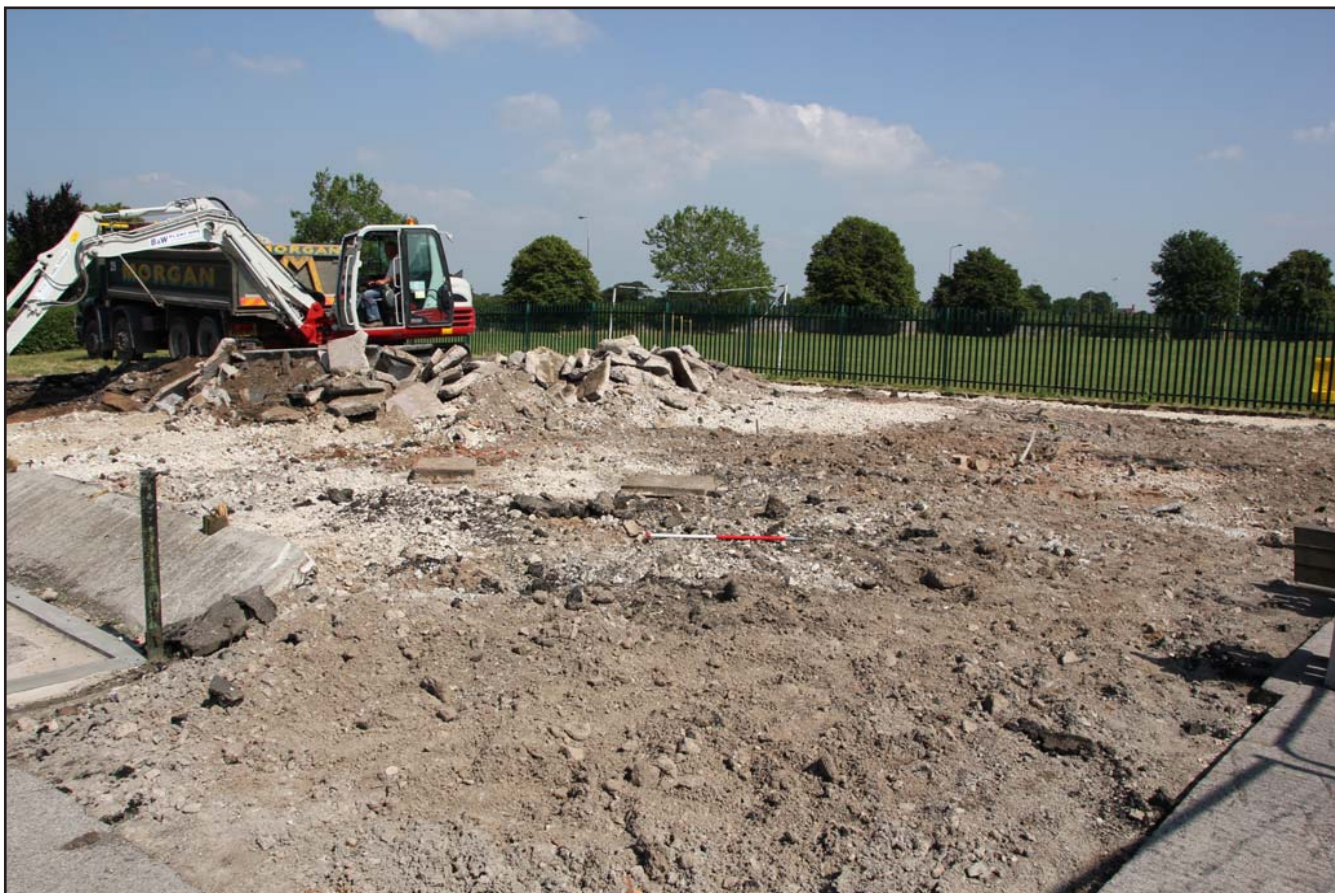
**Plate 03:** Demolition material from the former bungalow, from the west. Scale 1.0m.

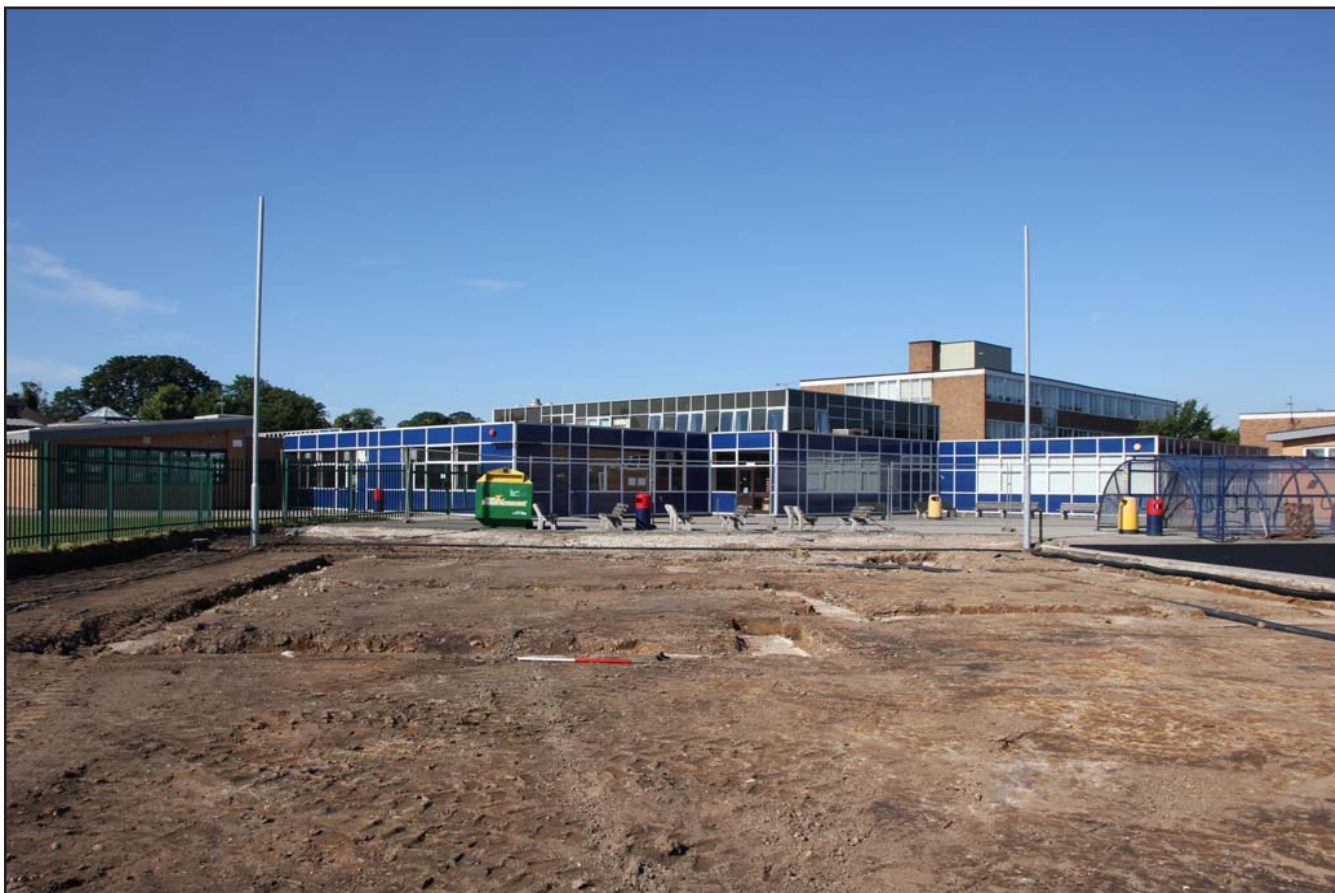
**Plate 04:** Foundations of the former bungalow, from the northeast. Scale 1.0m.

The demolition material from the bungalow was removed on to a natural glacial substrata (1003) comprising mixed beige and black mottled clay with fairly frequent small angular stone inclusions. The substrata had almost certainly been truncated by the construction of the bungalow and was found to be highly disturbed by the foundations, utilities, and numerous field drains (plate 4). No archaeological features, deposits or structures were identified within the area of the former bungalow.

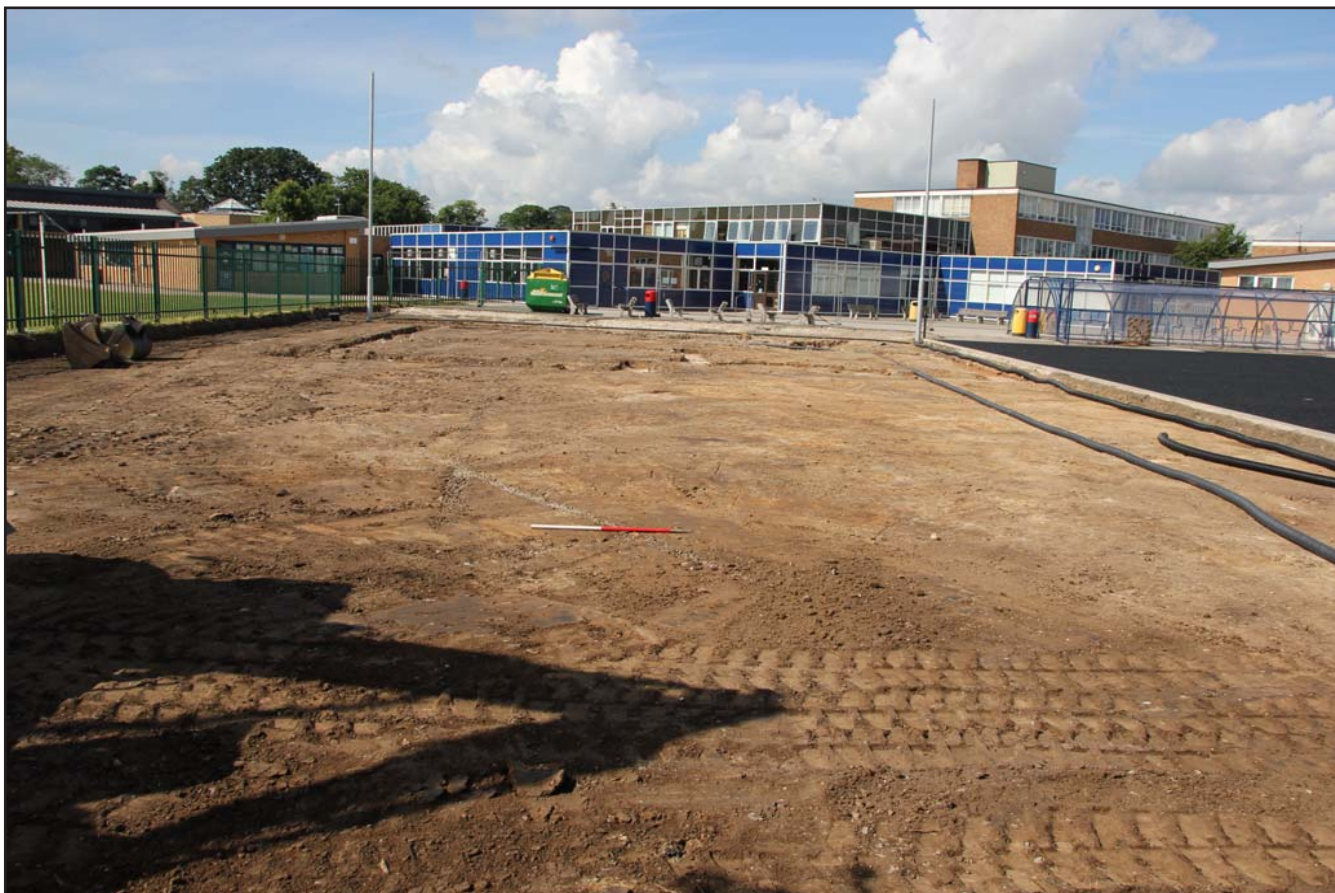
**Plate 05:** Removing the topsoil and subsoil layers within the grassed area, from the northwest. Scale 1.0m.

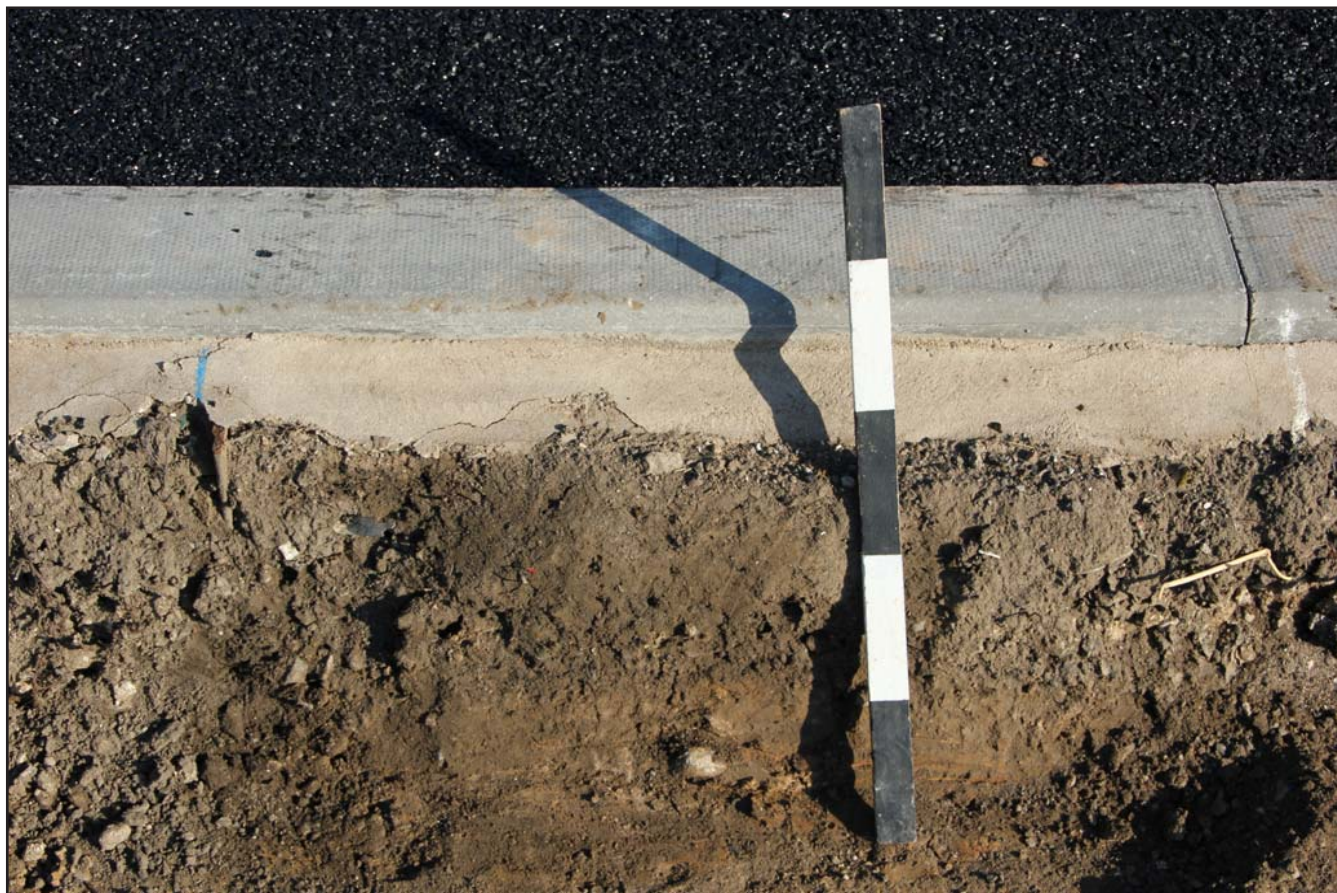
**Plate 06:** Watching brief area stripped down to natural glacial substrata and remaining subsoil layer, from the northeast. Scale 1.0m.

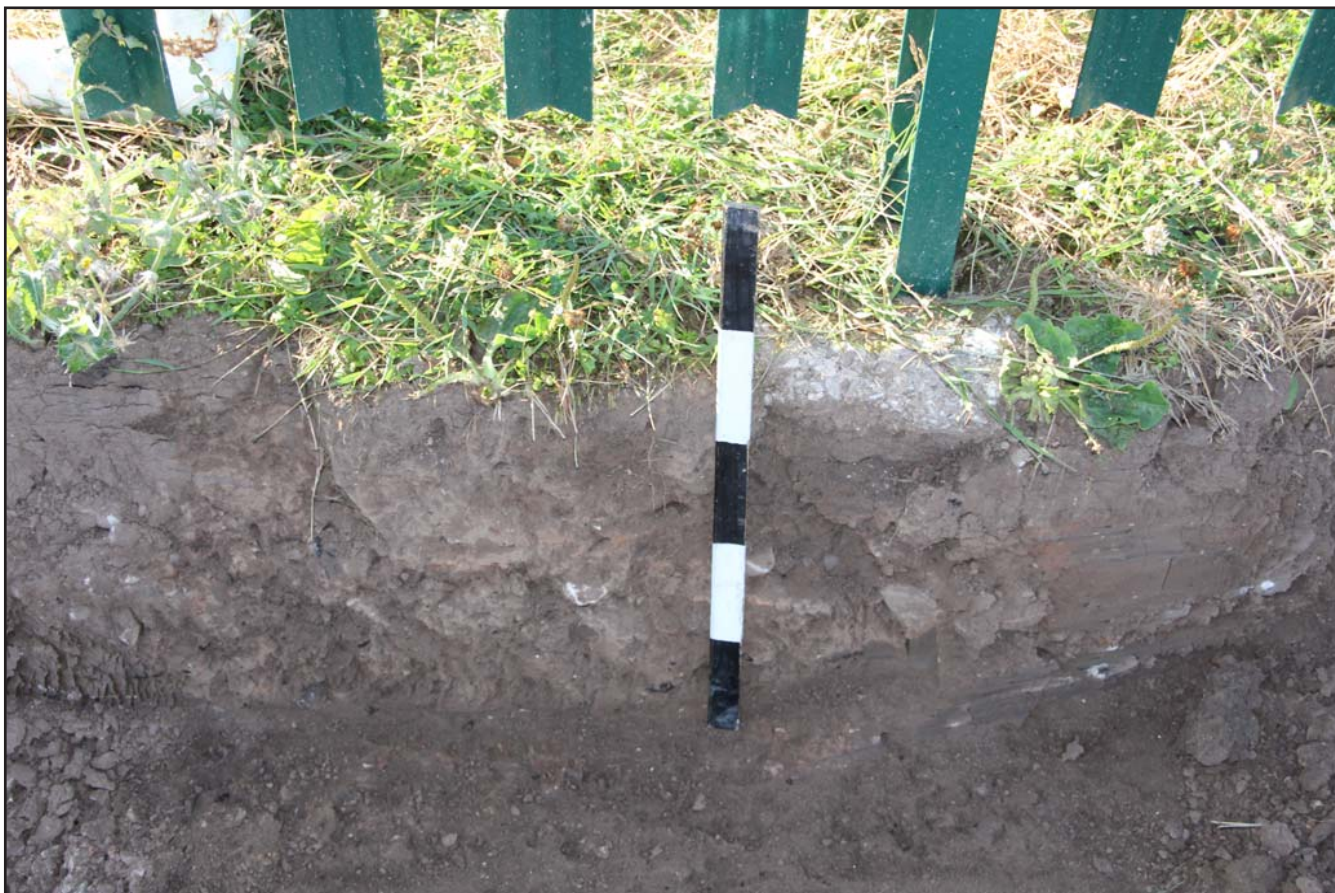
**Plate 08:** Trench section showing the ground reduction beneath the existing playing fields, from the northwest. Scale 0.5m.

The subsoil layer lay above the natural glacial substrata (1003) of mixed beige and black mottled clay as seen beneath the former bungalow, although due to the 80% gradient of the ground reduction level the natural substrata was only visible in a band measuring approximately 8.0m in width at the north-western edge of the site (plate 6). The substrata was not as disturbed as the area beneath the bungalow but was criss-crossed by modern utilities and field drains. Overall the ground was reduced by approximately 0.35m beneath the level of the existing tennis courts to the immediate northwest (plate 7) and by approximately 0.4m beneath the level of the existing grass playing fields to the immediate southeast (plate 8). No archaeological features, deposits or structures were observed.

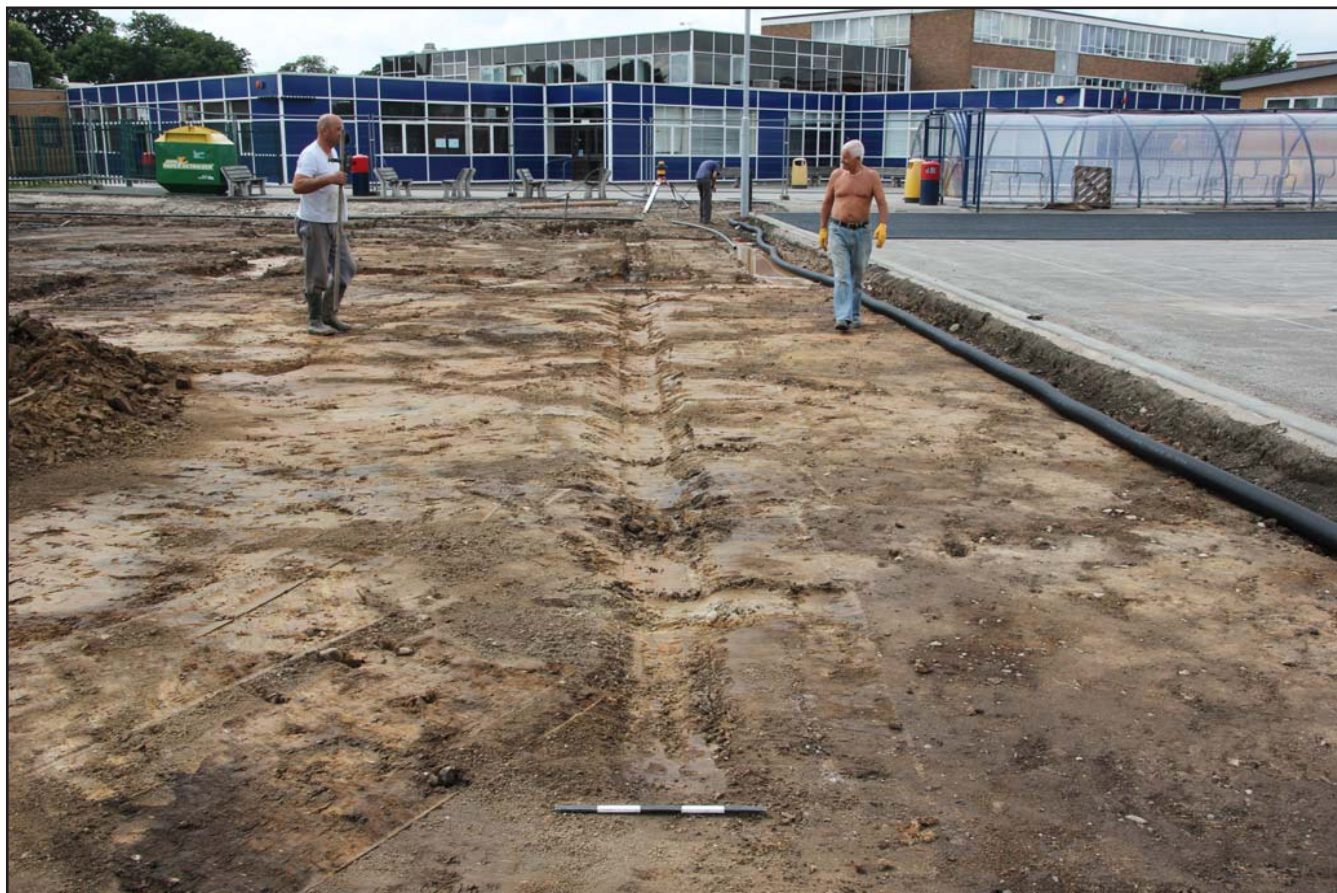
**Plate 09:** New drain excavated through the natural glacial substrata, from the northeast. Scale 0.5m.

Once the ground level had been reduced and graded, the contractor used a toothless ditching bucket to excavate a new drain and manhole (plate 9). The drain measured approximately 0.4m in width and was excavated to a depth of 0.5m into the glacial substrata at its south-eastern point. From there the drain ran for approximately 12.0m southeast to northwest before turning and heading northeast for approximately 20.0m, where it rose to a depth of 0.1m. Several field drains and utilities were observed within the drain section, some of which were not apparent on the surface of the substrata (plate 10).

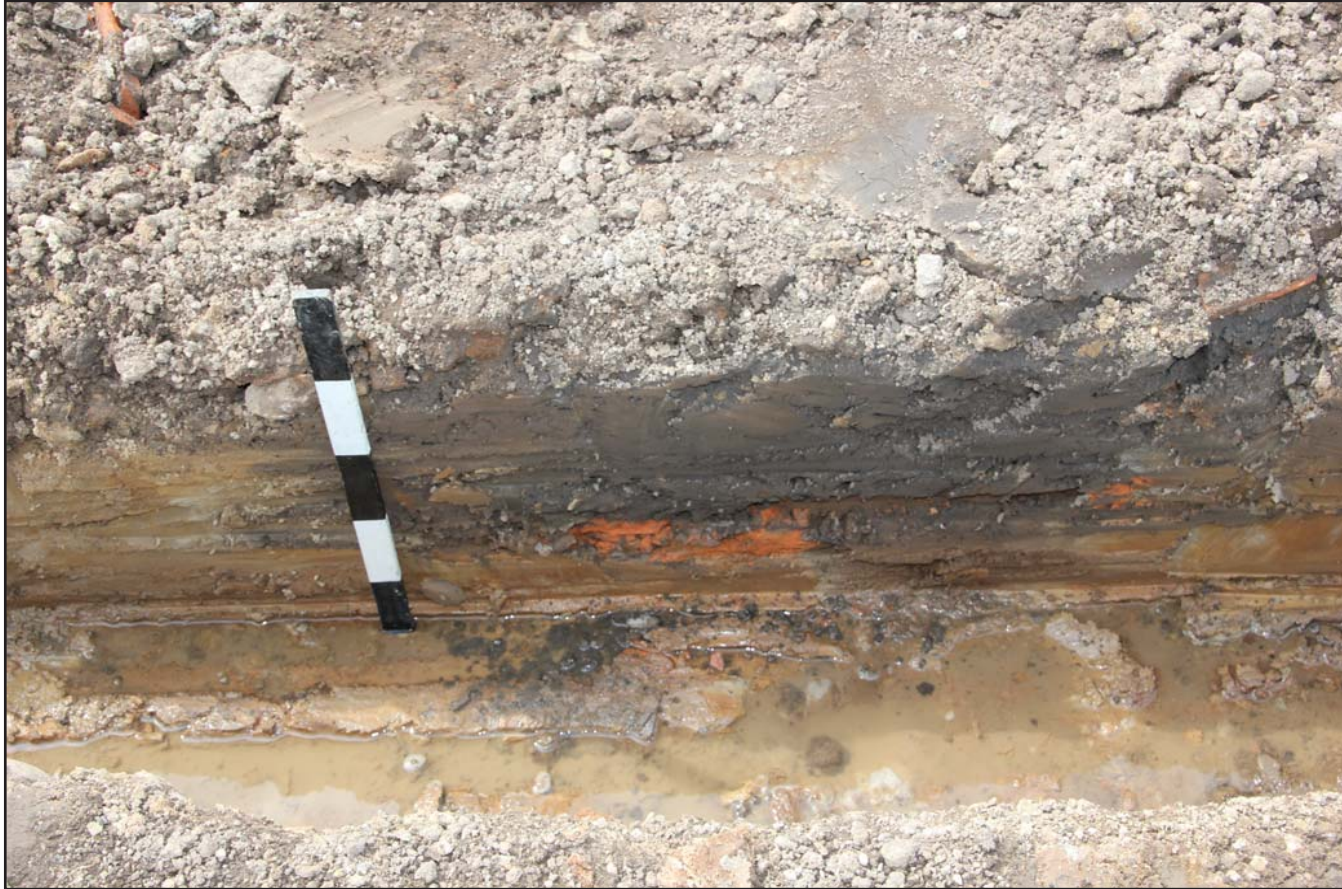
**Plate 10:** Section of new drain showing buried ceramic field drain, from the northeast. Scale 0.5m.

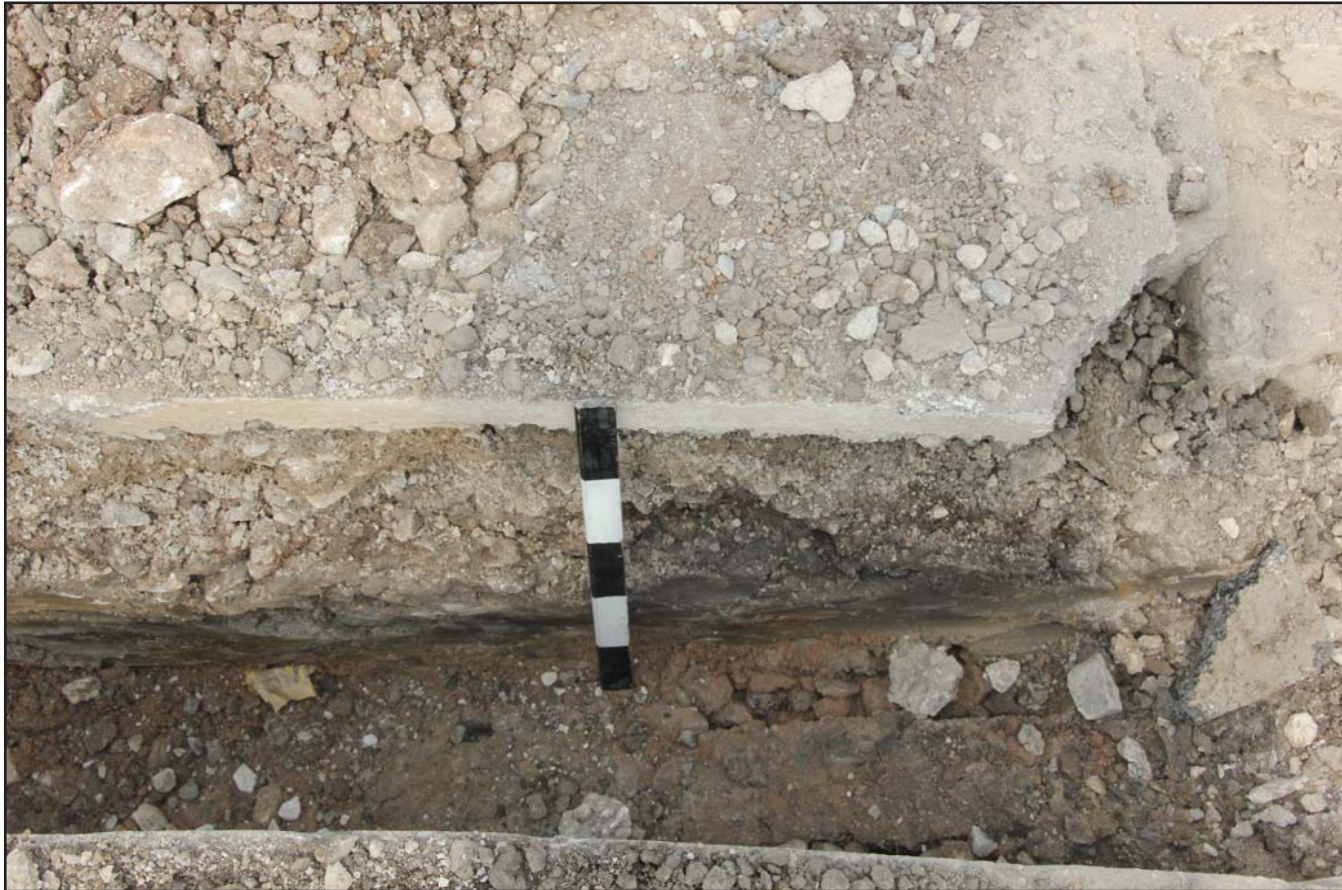
Lighting column A was located at NGR SJ 42040 69049, towards the west of the existing tennis courts. A trench measuring 0.3m in width and 0.5m in depth was excavated by hand for approximately 4.0m in length from the edge of the existing tennis courts southwest towards the main school building. The trench cut through a layer of tarmac measuring 0.3m in depth and then cut through the natural glacial substrata (1003) comprising mixed beige and black mottled clay. No archaeological features were observed and no artefacts were recovered.

**Plate 11:** Lighting column trench A, from the southeast. Scale 0.5m.

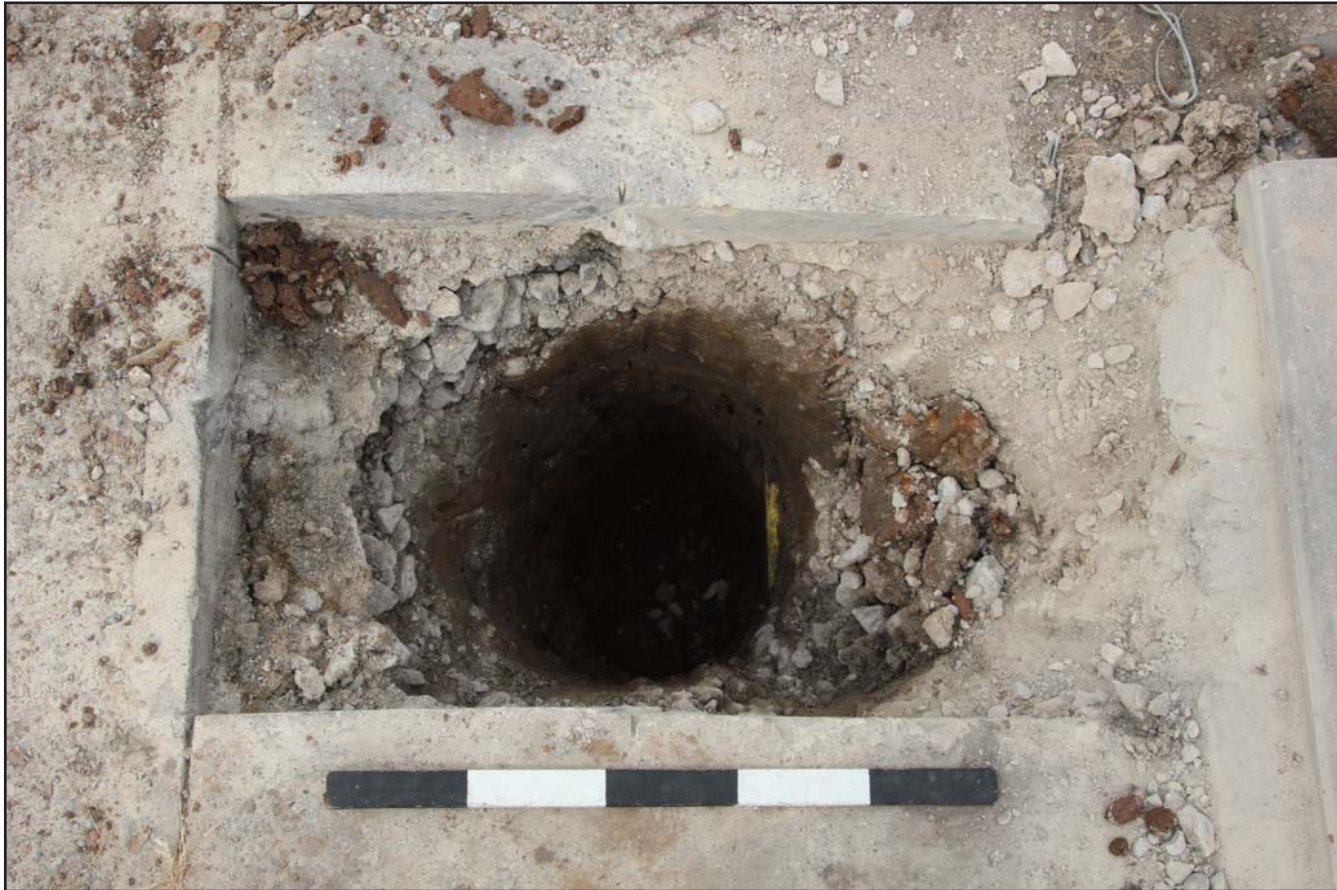
Lighting column B was located at NGR SJ 42024 69066, in the northwest corner of the existing tennis courts. A foundation hole measuring 0.8m by 0.4m and orientated from northeast to southwest was excavated by hand to a depth of 1.1m. The trench cut through a layer of tarmac measuring 0.22m in depth and then cut through the natural glacial substrata (1003) comprising mixed beige and black mottled clay. No archaeological features were observed and no artefacts were recovered.

**Plate 12:** Lighting column trench B, from the southeast. Scale 0.5m.

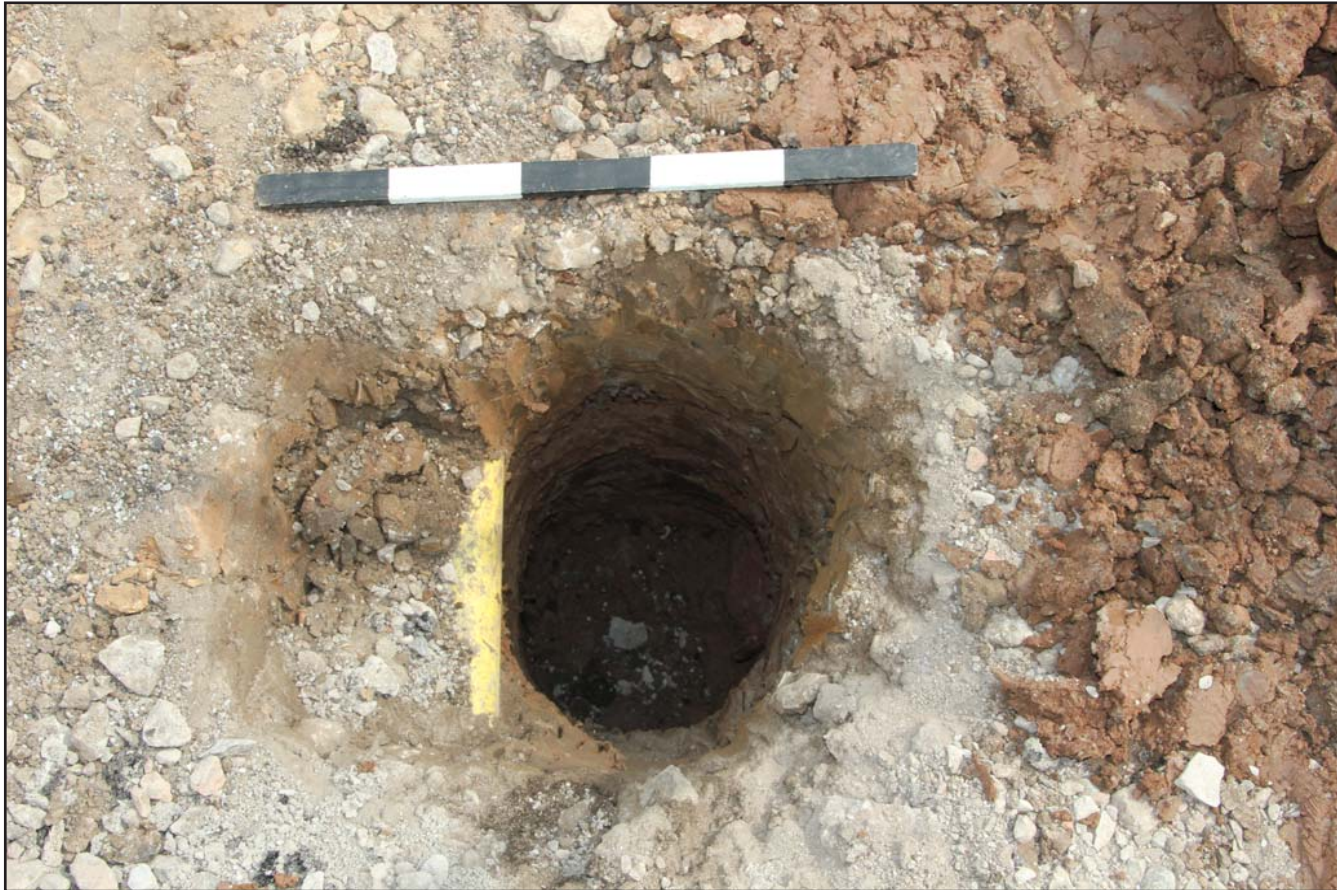
Lighting column C was located at NGR SJ 42052 69030, towards the west of the existing tennis courts. A foundation hole measuring 0.5m by 0.4m and orientated from northeast to southwest was excavated by hand to a depth of 1.1m. The trench cut through a layer of tarmac measuring 0.1m in depth and then cut through the natural glacial substrata (1003) comprising mixed beige and black mottled clay. No archaeological features were observed and no artefacts were recovered.

The stratigraphy in the lighting column trench shows that the natural glacial substrata had not been truncated in this part of the site. However the lighting column lay to the immediate southwest of the bungalow site which was heavily disturbed by utilities and field drains.

**Plate 13:** Lighting column trench C, from the northwest. Scale 0.5m.

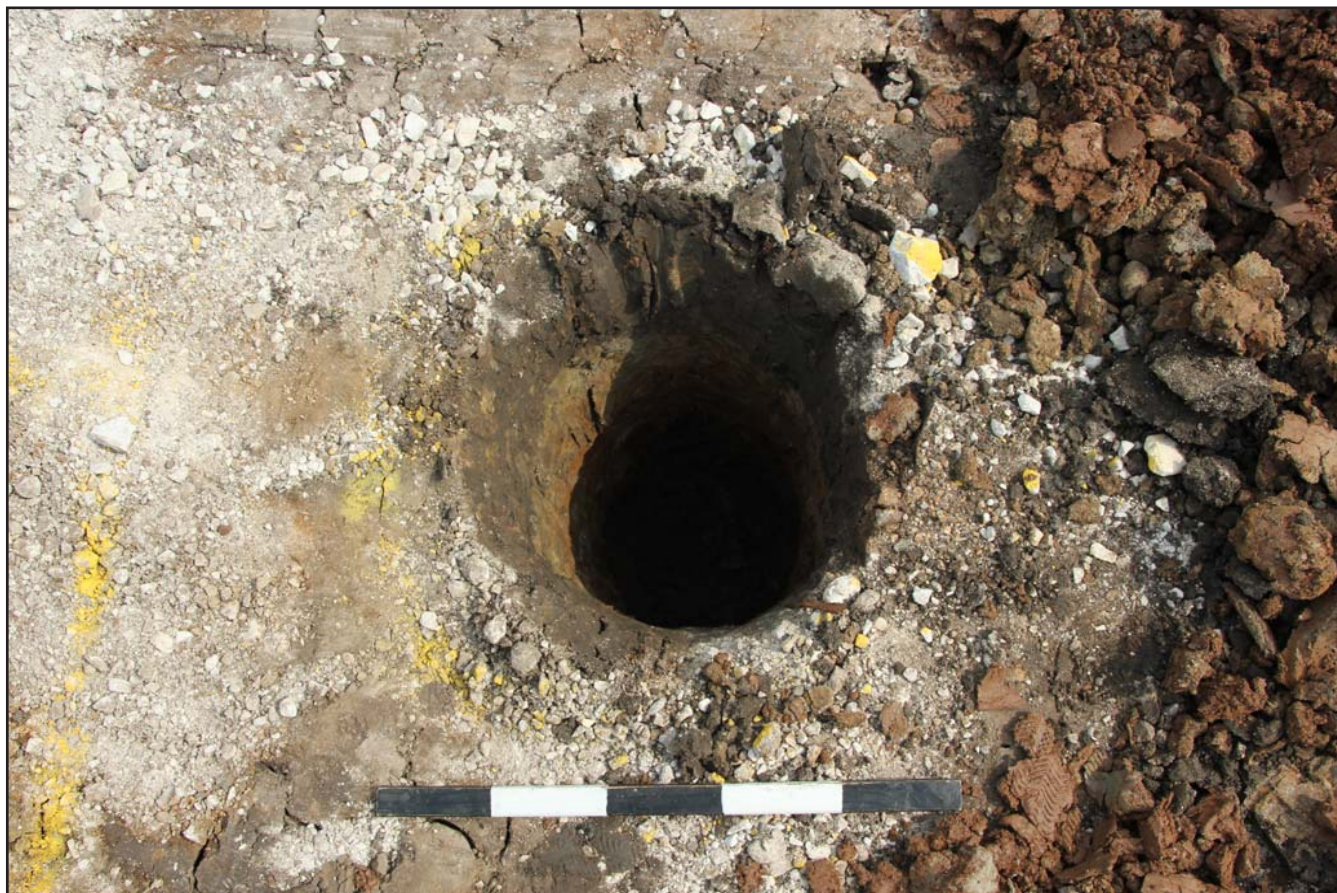
Lighting column D was located at NGR SJ 42065 69016, to the southeast of the former bungalow site. A foundation hole measuring 0.4m in diameter was excavated by hand to a depth of 1.1m. The trench cut through a layer of tarmac measuring 0.4m in depth and then cut through the natural glacial substrata (1003) comprising mixed beige and black mottled clay. No archaeological features were observed and no artefacts were recovered.

**Plate 14:** Lighting column trench D, from the northwest. Scale 0.5m.

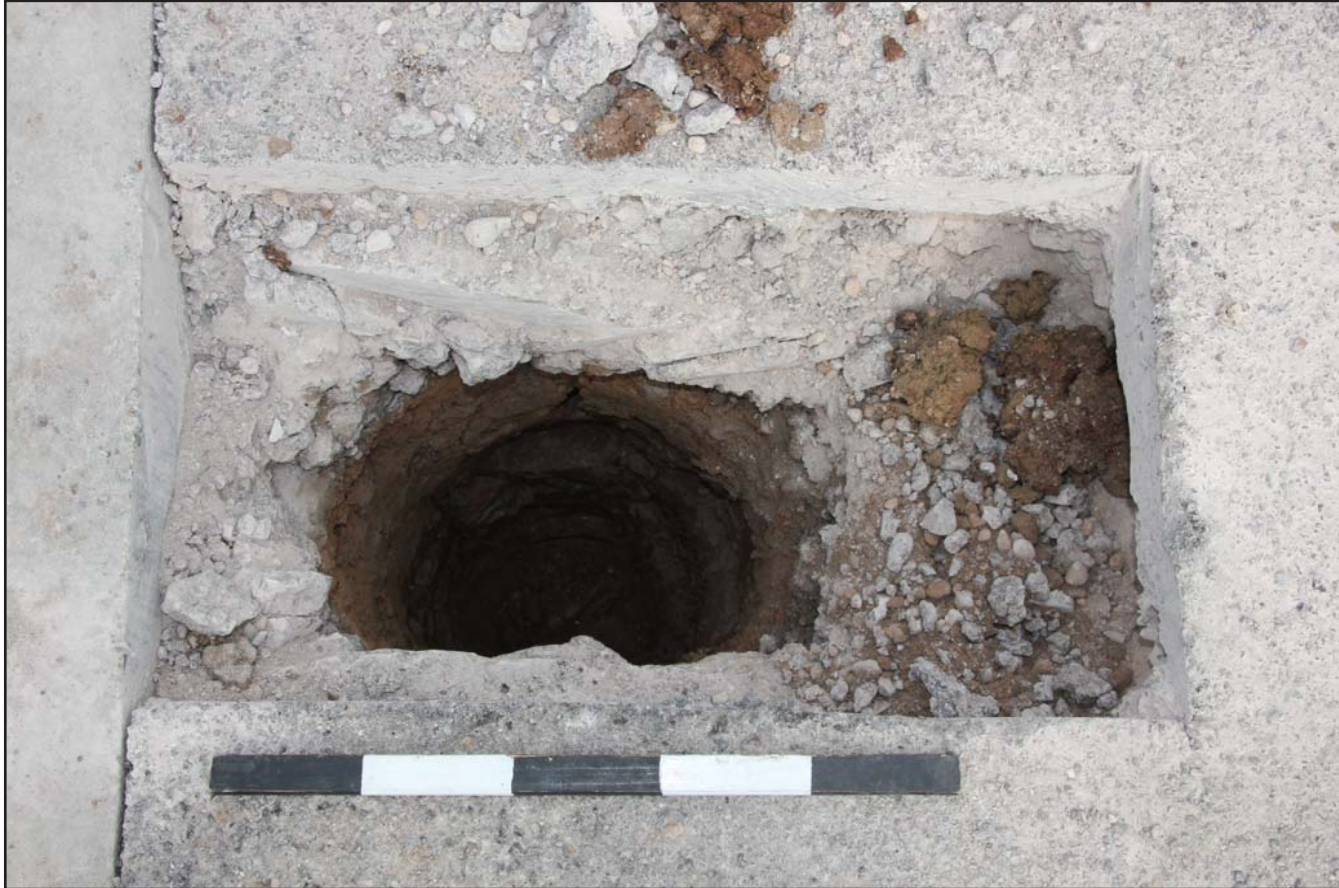
Lighting column E was located at NGR SJ 42066 69070, towards the east of the existing tennis courts. A foundation hole measuring 0.7m by 0.4m and orientated from northeast to southwest was excavated by hand to a depth of 1.1m. The trench cut through a dark black-brown silt-clay subsoil layer (1002) measuring 0.15m in depth and then cut through the natural glacial substrata (1003) comprising mixed beige and black mottled clay. No archaeological features were observed and no artefacts were recovered.

**Plate 15:** Lighting column trench E, from the southeast. Scale 0.5m.

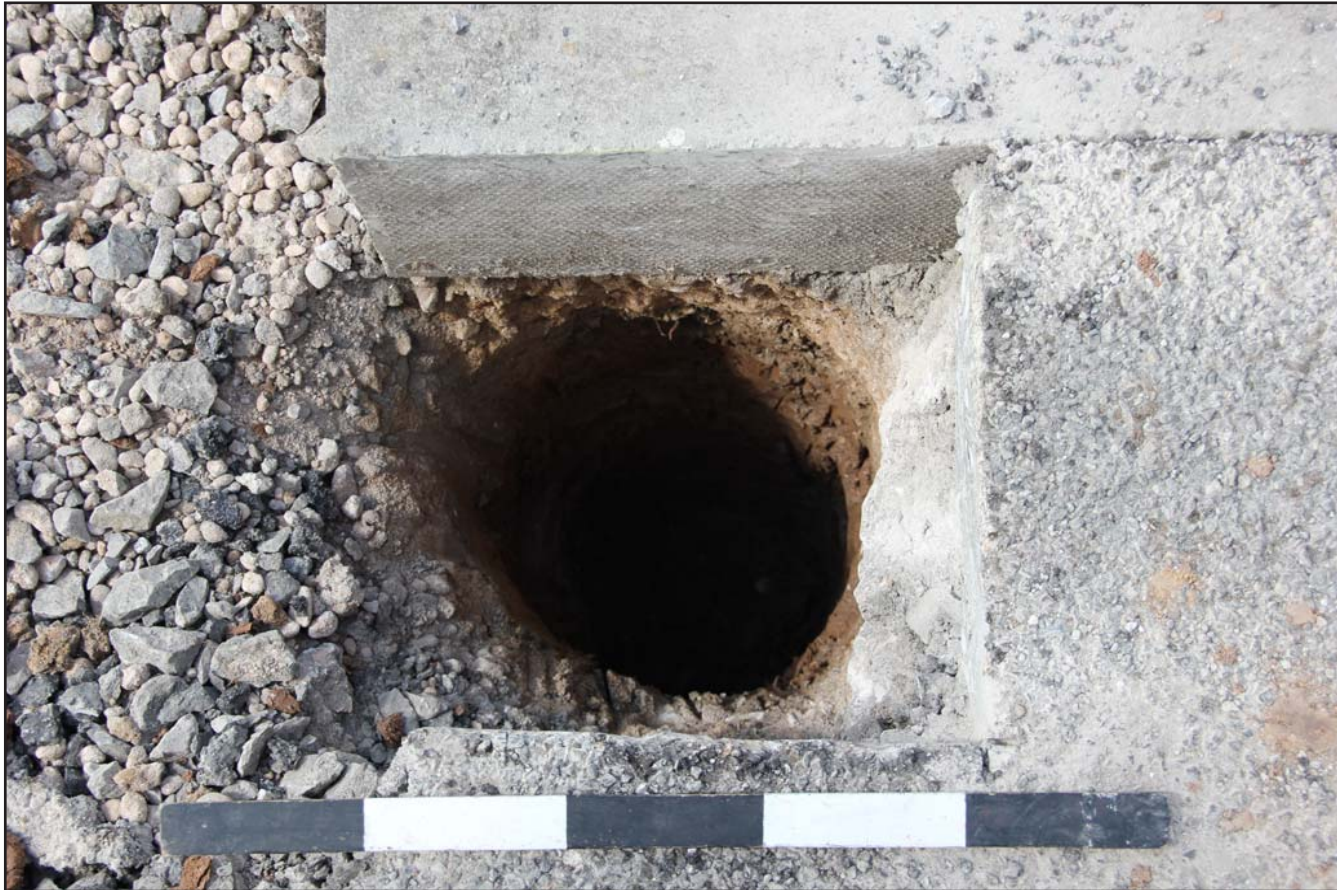
Lighting column F was located at NGR SJ 42080 69050, towards the east of the grassed area. A foundation hole measuring 0.4m in diameter was excavated by hand to a depth of 1.1m. The trench cut through a layer of tarmac measuring 0.4m in depth and then cut through the natural glacial substrata (1003) comprising mixed beige and black mottled clay. No archaeological features were observed and no artefacts were recovered.

The stratigraphy in the lighting column trench shows that the natural glacial substrata had been truncated prior to the deposition of the tarmac layer, and as such all but the deepest of cut archaeological features would have been removed by the works.

**Plate 16:** Lighting column trench F, from the northeast. Scale 0.5m.

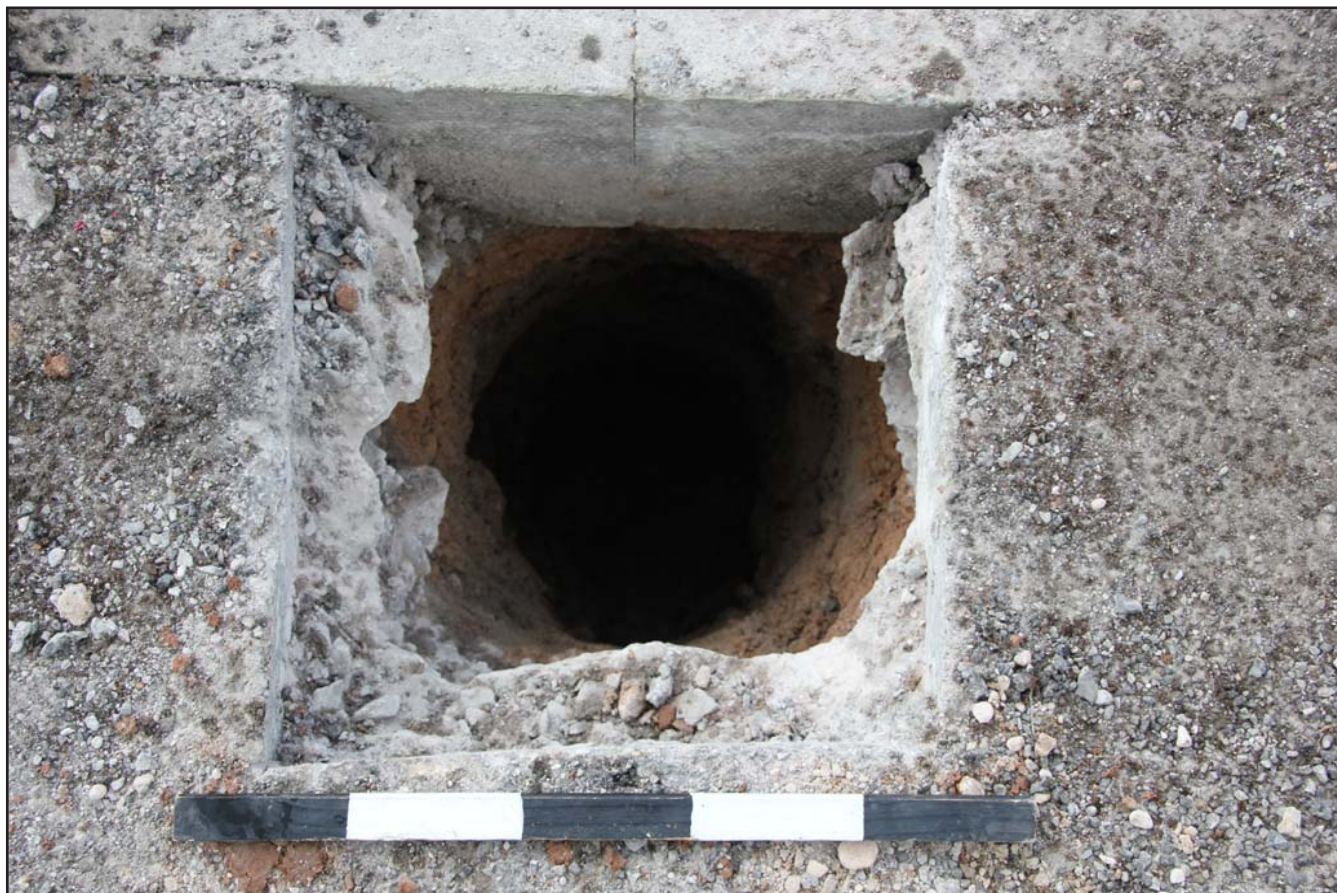
Lighting column G was located at NGR SJ 42051 69090, towards the northeast corner of the existing tennis courts. A foundation hole measuring 0.4m in diameter was excavated by hand to a depth of 1.1m. The trench cut through a layer of tarmac measuring 0.25m in depth and then cut through the natural glacial substrata (1003) comprising mixed beige and black mottled clay. No archaeological features were observed and no artefacts were recovered.

**Plate 17:** Lighting column trench G, from the northeast. Scale 0.5m.

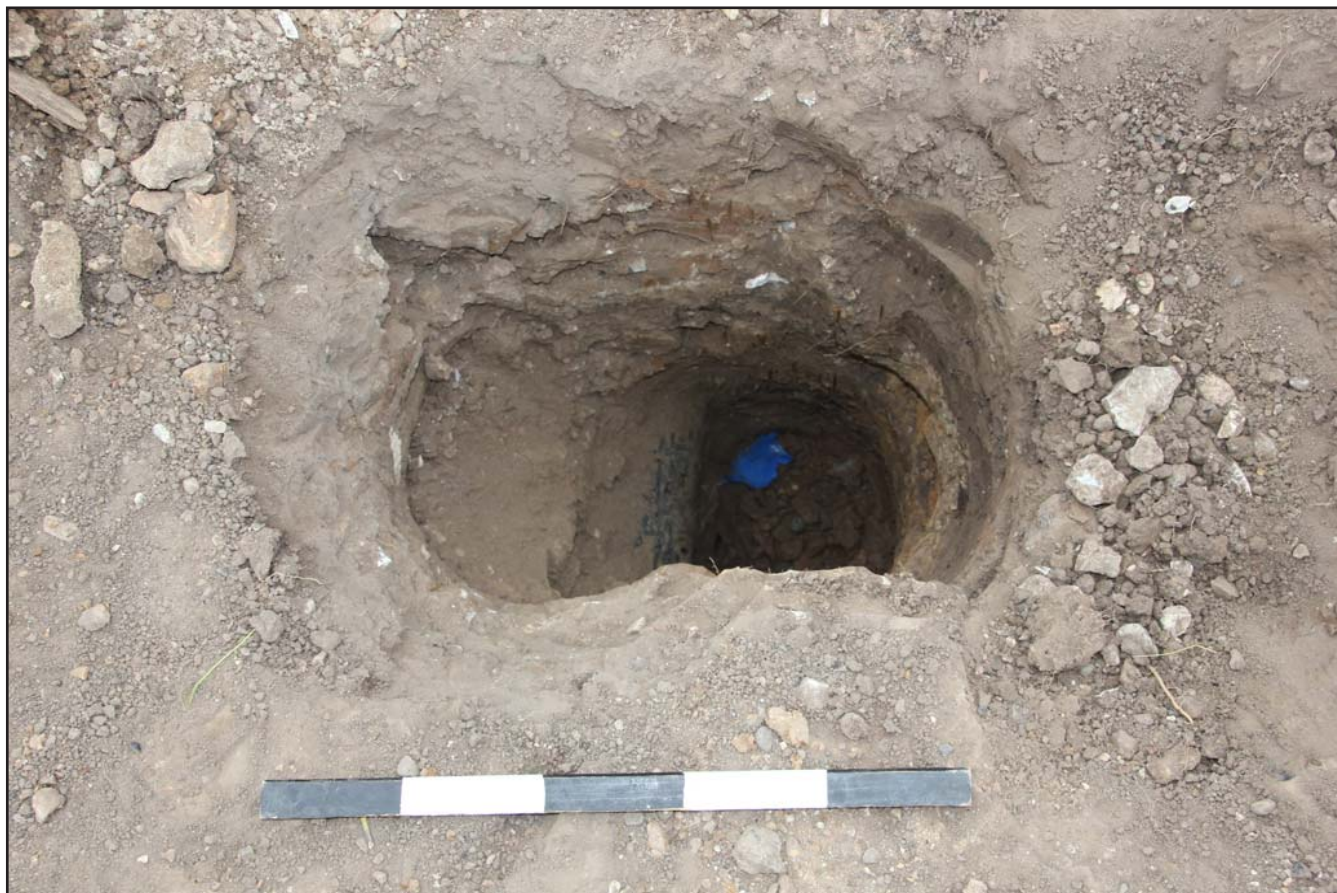
Lighting column H was located at NGR SJ 42093 69034, in the southeast corner of the grassed area. A foundation hole measuring 0.6m by 0.4m and orientated from northeast to southwest was excavated by hand to a depth of 1.1m. The hole was widened to the northeast to avoid a water main discovered during excavation. The northeast side of the trench cut through a dark black-brown silt-clay subsoil layer (1002) measuring 0.3m in depth and then cut through the natural glacial substrata (1003) comprising mixed beige and black mottled clay. The stratigraphy of the southwest side of the trench was entirely disturbed by the water main. No archaeological features were observed and no artefacts were recovered.

The stratigraphy in the lighting column trench shows that the natural glacial substrata had not been truncated in this part of the site. However the lighting column lay immediately adjacent to an area of land disturbed by a buried water main.

**Plate 18:** Lighting column trench H, from the southeast. Scale 0.5m.

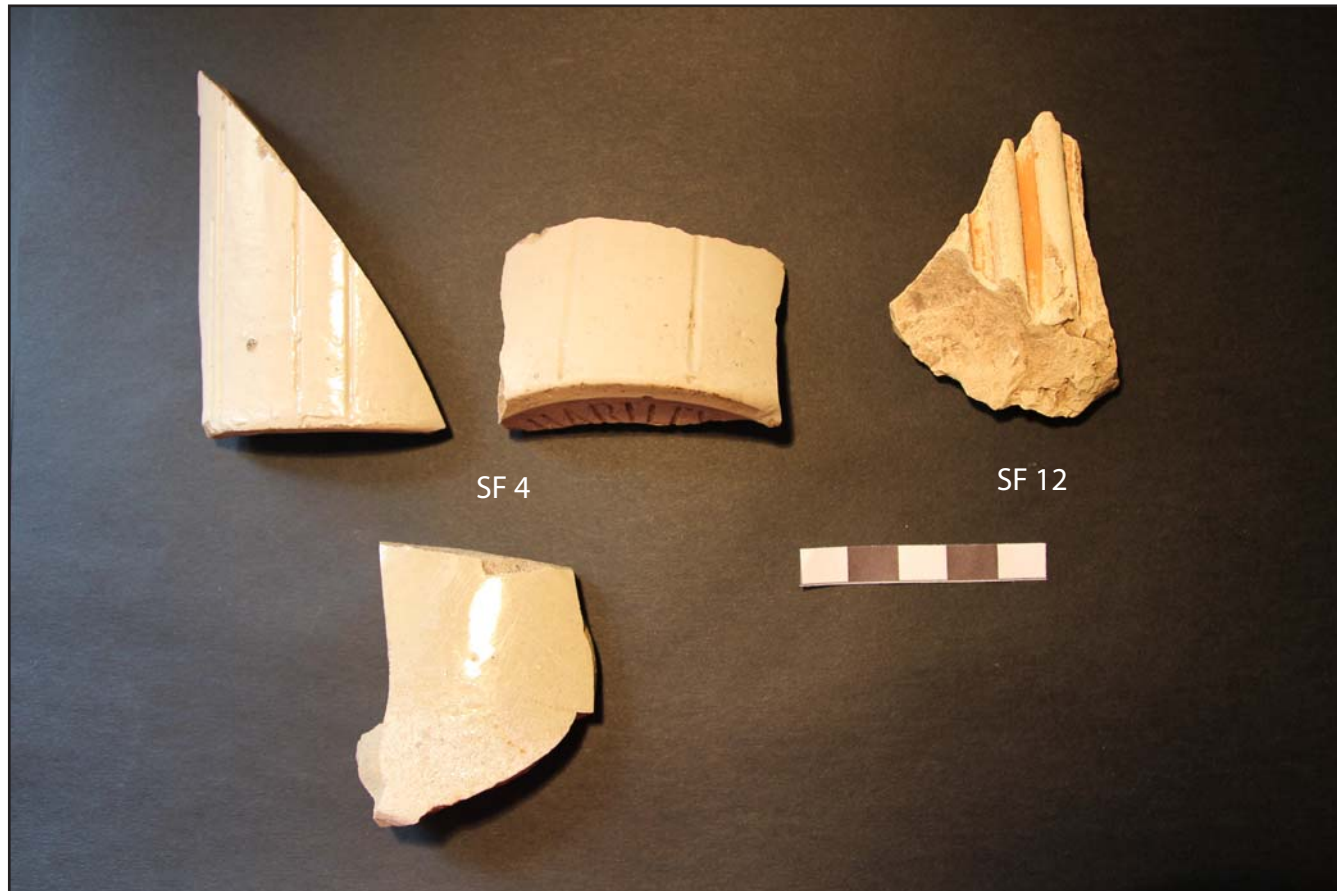
**Plate III:** Artefacts recovered from the topsoil (1001) (Numbers refer to small find numbers, see appendix II). Scale 5cm.

<b>Finds no.</b>	<b>Context</b>	<b>Description</b>	<b>Photograph</b>
1	1001	1x base sherd and 1x handle sherd 18 <sup>th</sup> Century Midlands Black Ware/ Buckley Ware	I
2	1001	4x clay pipe stem fragments	I
3	1001	7x sherds of modern ceramic wall tile	II
4	1001	3x sherds of 19 <sup>th</sup> Century Victorian cream glazed earthenware	III
5	1001	7x sherds of assorted modern white glazed china	IV
6	1001	8x sherds of modern glass	V
7	1002	17x sherds of 18 <sup>th</sup> Century Midlands Black Ware/ Buckley Ware	VI
8	1002	14x sherds of 19 <sup>th</sup> Century Victorian white and yellow glazed earthenware	VII
9	1002	1x sherd of 19 <sup>th</sup> Century Victorian unglazed ridged earthenware	VIII
10	1002	1x sherd 20 <sup>th</sup> Century modern brown and yellow glazed earthenware	VIII
11	1002	1x half iron horse shoe	VIII
12	1001	1x sherd of 19 <sup>th</sup> Century Victorian unglazed ridged earthenware	III
