**Upton-by-Chester High School,  
Chester, Cheshire.  
August 2013**

Archaeological Watching Brief  
Project Code: A0021  
Report no. 0020

Client: Upton by Chester High School

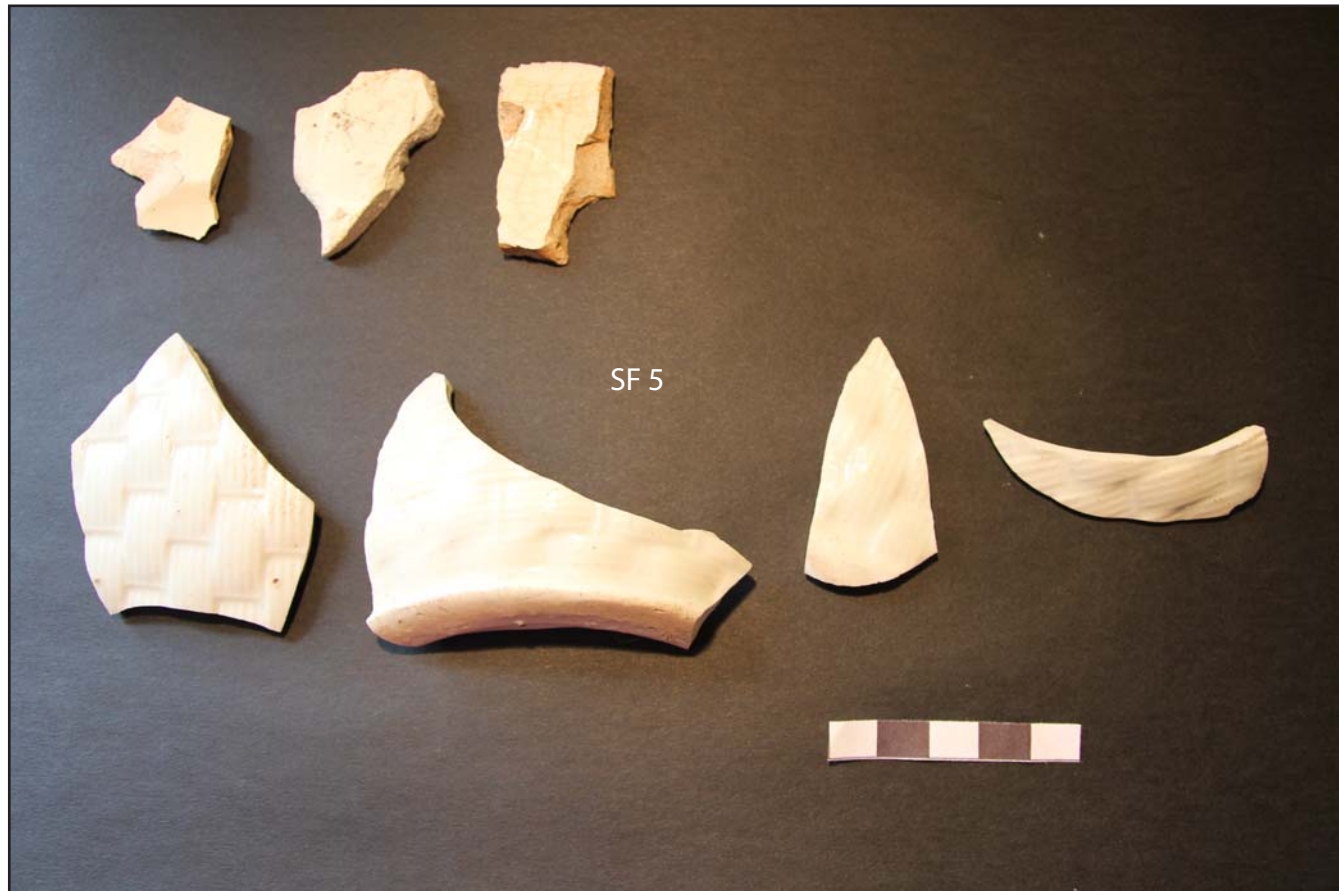
**Plate IV:** Artefacts recovered from the topsoil (1001) (Numbers refer to small find numbers, see appendix II). Scale 5cm.

<b>Finds no.</b>	<b>Context</b>	<b>Description</b>	<b>Photograph</b>
1	1001	1x base sherd and 1x handle sherd 18 <sup>th</sup> Century Midlands Black Ware/ Buckley Ware	I
2	1001	4x clay pipe stem fragments	I
3	1001	7x sherds of modern ceramic wall tile	II
4	1001	3x sherds of 19 <sup>th</sup> Century Victorian cream glazed earthenware	III
5	1001	7x sherds of assorted modern white glazed china	IV
6	1001	8x sherds of modern glass	V
7	1002	17x sherds of 18 <sup>th</sup> Century Midlands Black Ware/ Buckley Ware	VI
8	1002	14x sherds of 19 <sup>th</sup> Century Victorian white and yellow glazed earthenware	VII
9	1002	1x sherd of 19 <sup>th</sup> Century Victorian unglazed ridged earthenware	VIII
10	1002	1x sherd 20 <sup>th</sup> Century modern brown and yellow glazed earthenware	VIII
11	1002	1x half iron horse shoe	VIII
12	1001	1x sherd of 19 <sup>th</sup> Century Victorian unglazed ridged earthenware	III

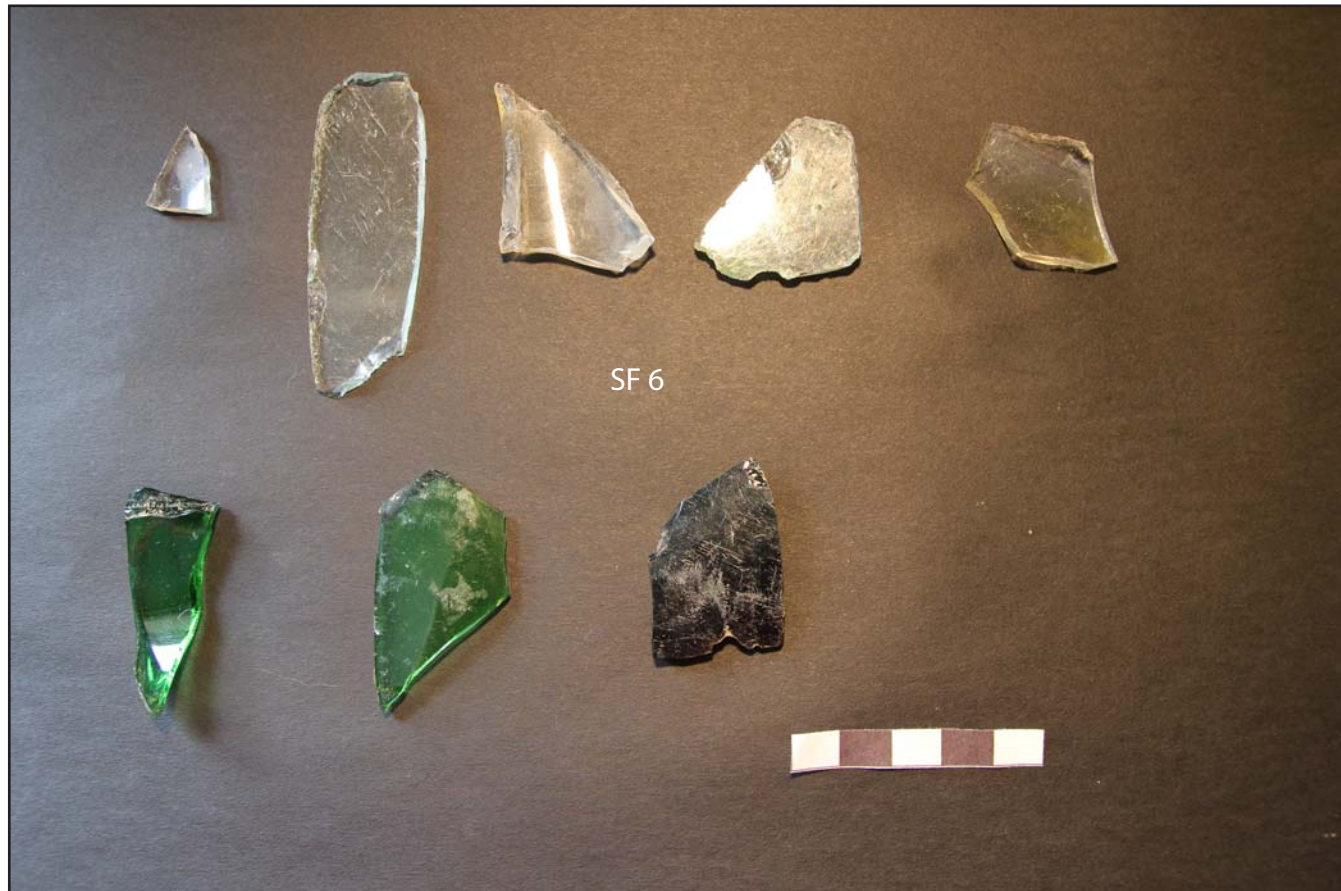
**Plate V:** Artefacts recovered from the topsoil (1001) (Numbers refer to small find numbers, see appendix II). Scale 5cm.

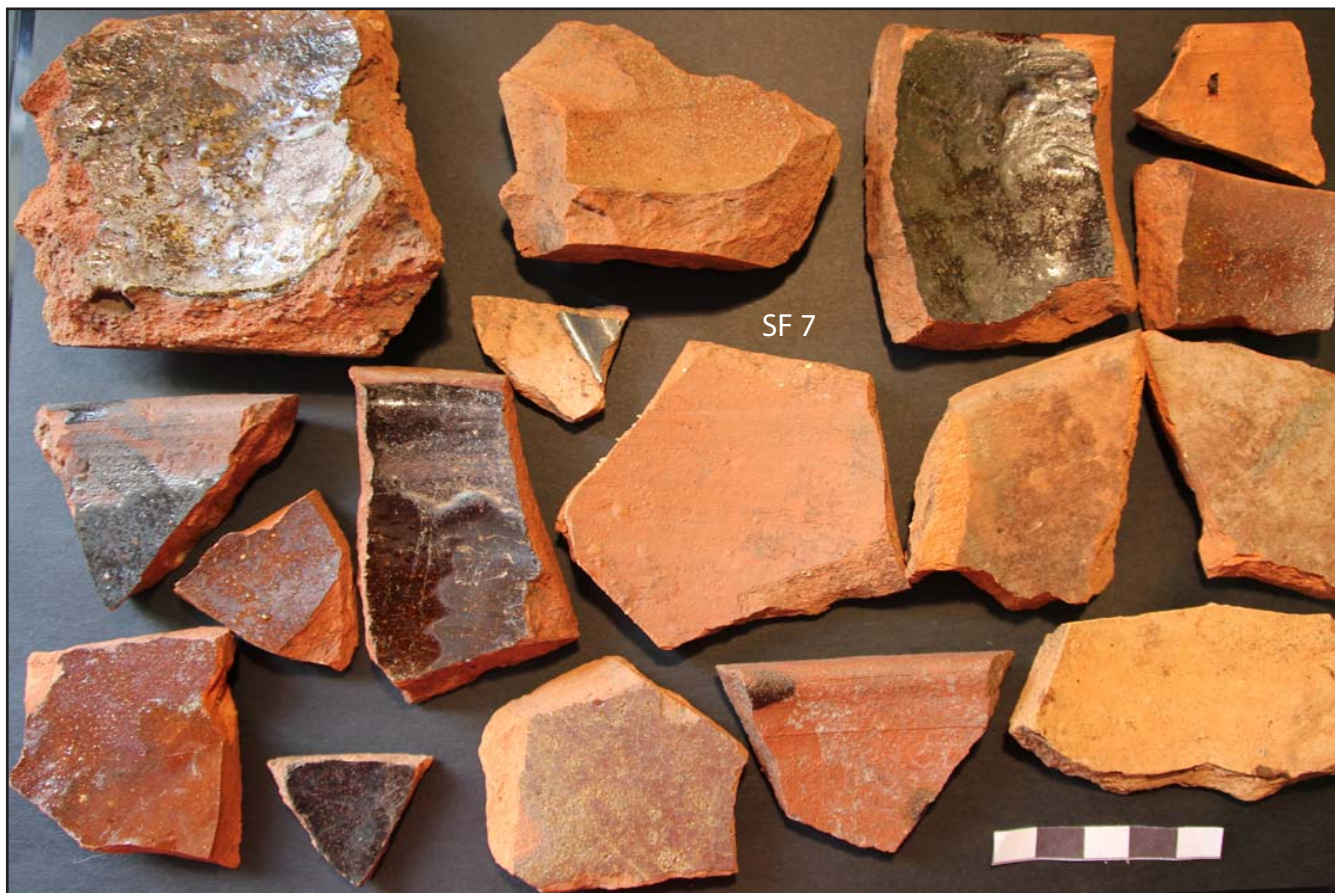
**Plate VI:** Artefacts recovered from the subsoil (1002) (Numbers refer to small find numbers, see appendix II). Scale 5cm.

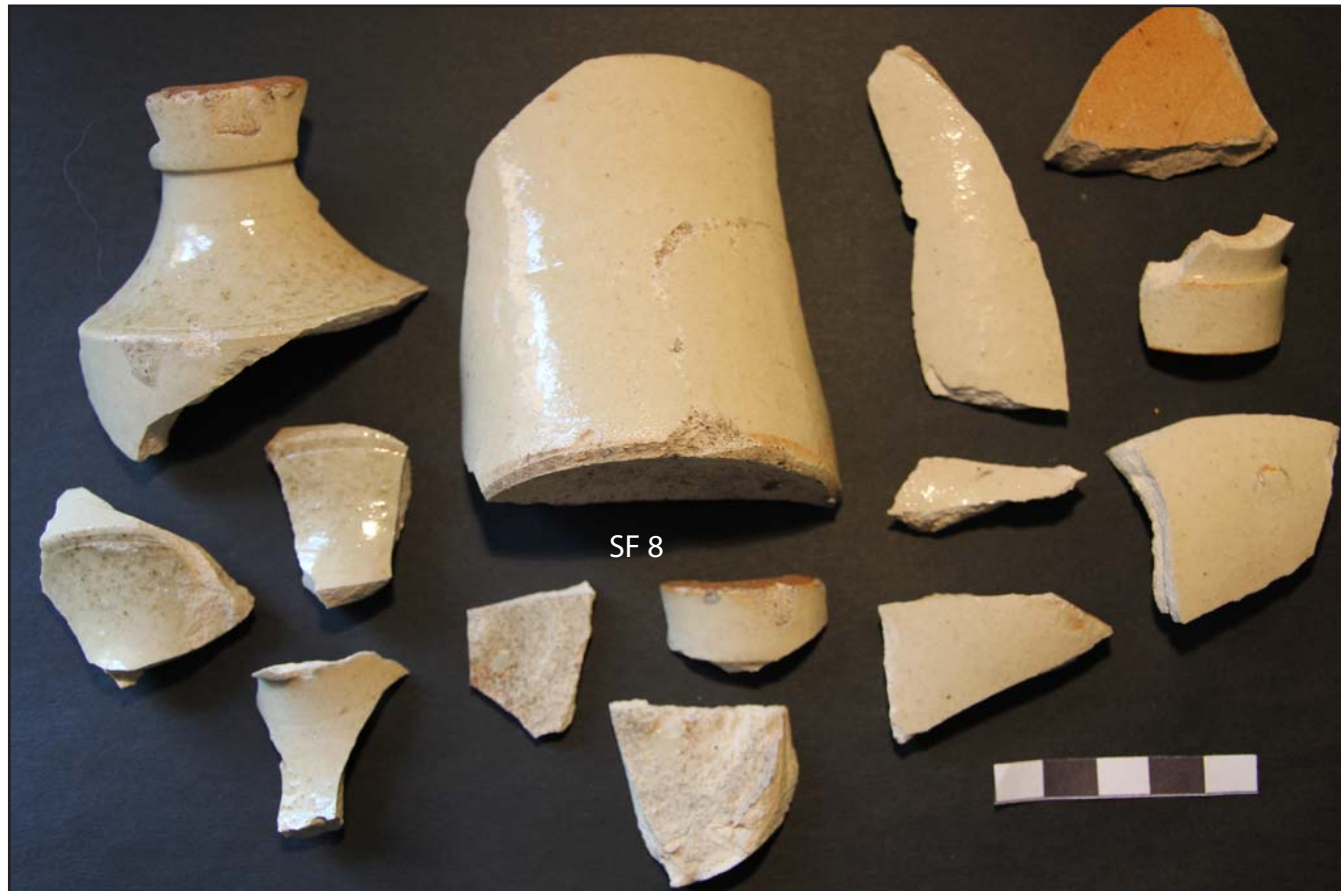
**Plate VII:** Artefacts recovered from the subsoil (1002) (Numbers refer to small find numbers, see appendix II). Scale 5cm.

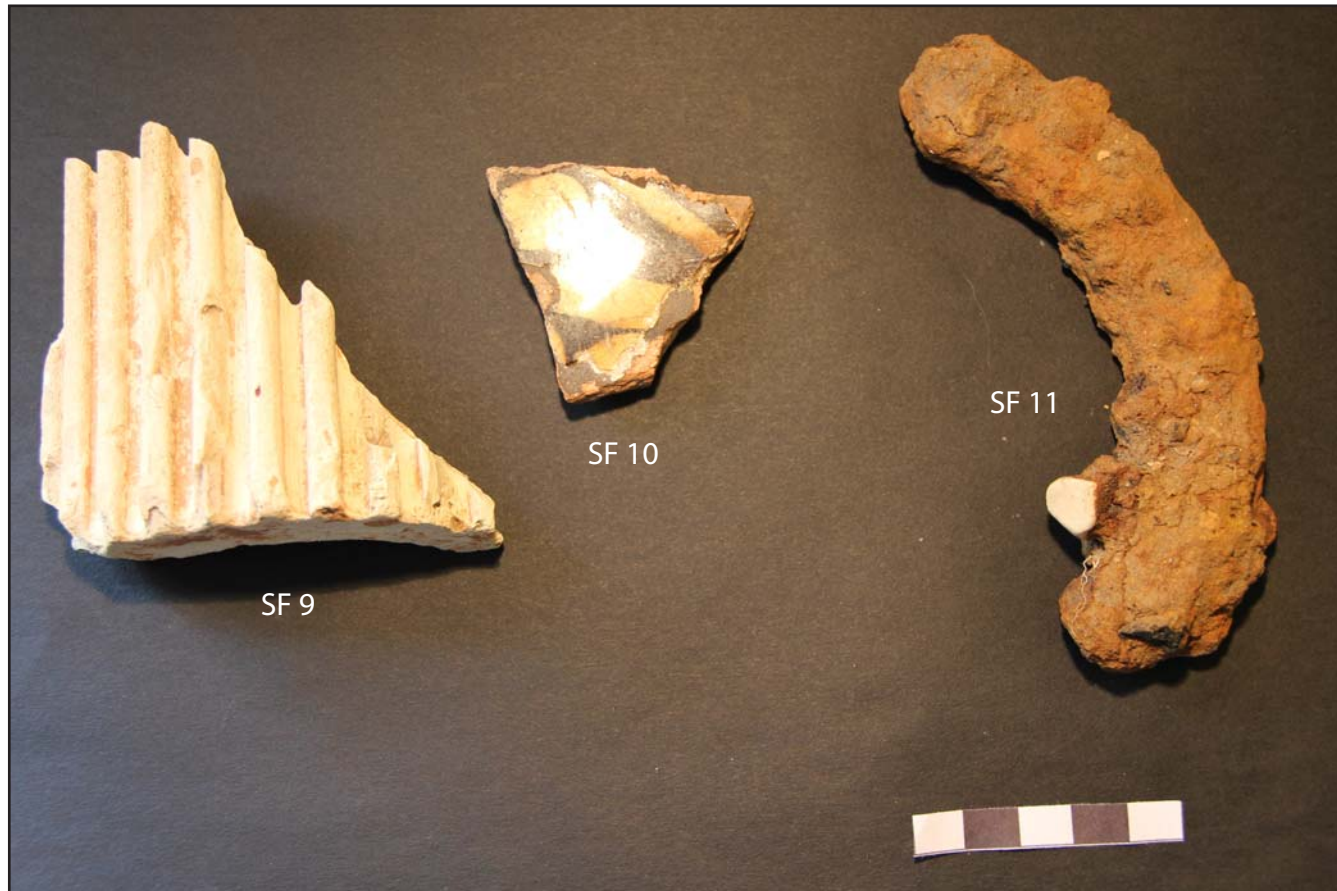
**Plate VIII:** Artefacts recovered from the subsoil (1002) (Numbers refer to small find numbers, see appendix II). Scale 5cm.
