# **Stainsby Wetlands, Stainsby, Derbyshire - Archaeological Desk Based Assessment The National Trust**

Report Title: **Stainsby Wetlands, Stainsby, Derbyshire –  
Archaeological Desk Based Assessment**

Revision: **Final**  
Issue Date: **June 2011**  
Report Ref: **3240**

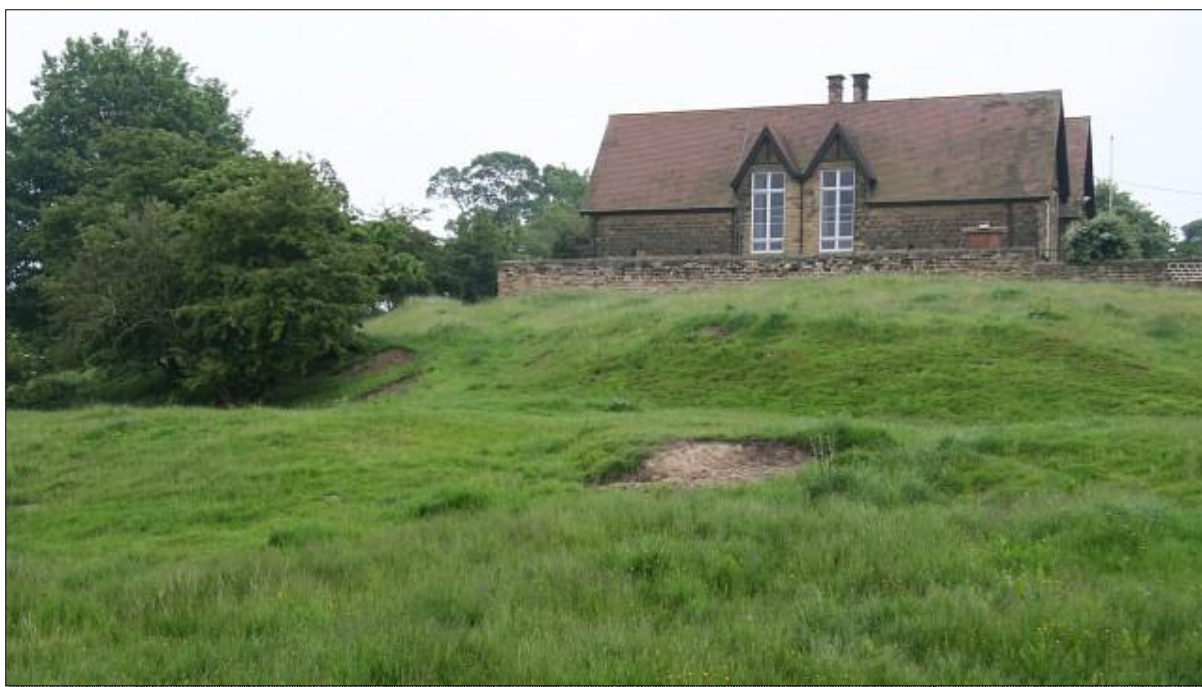
The only Scheduled Ancient Monument in the vicinity of the area proposed for redevelopment is the medieval defended manor of Stainsby. This survives as earthworks (plate 2) however these are truncated by later development, including the construction of several Second World War air raid shelters. The earthworks are most complete on the northern edge of the site. It was noted that the internal mound for the moated site was very large as were the defensive ditch and bank. This evidence is suggestive of either a Motte and bailey castle or Anglo Saxon defended settlement pre dating the manor. Further investigatory work will be required to develop this theory.

**Plate 2:** Earthworks of Stainsby Manor looking south east.

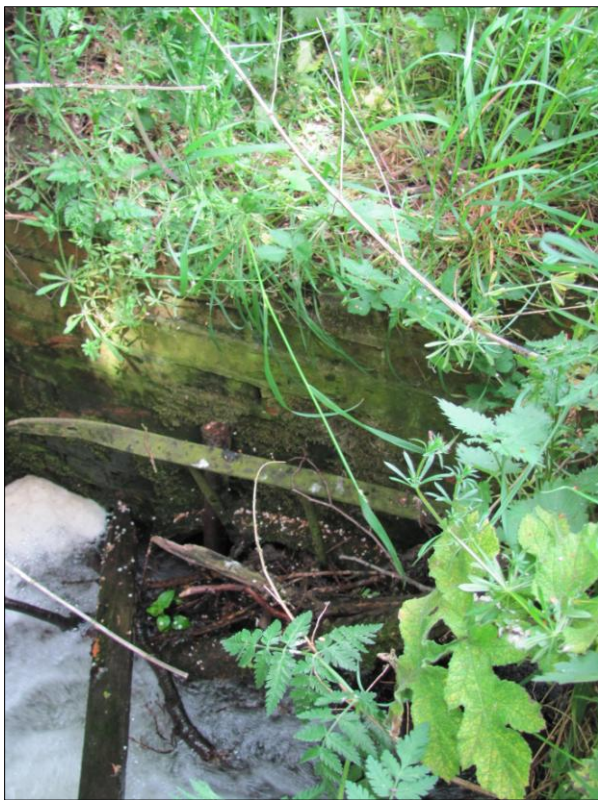
- 5.1.1 19<sup>th</sup> century Ordnance Survey mapping shows that the site was part of open agricultural fields throughout the 1800s. There is no evidence of substantial development in the vicinity. However site A to the north of Stainsby Pond is unusual in that it has a triangular shape, presumably dictated by the outflow of the dam from the sluice located at the eastern end and the 17<sup>th</sup> century track way (Figure 3) that was located to the north of the dam. The outflow can be traced on the historic and current mapping to Stainsby mill and this pond presumably formed part of the original mill system. Stainsby pond and dam both appear on the 1<sup>st</sup> Edition 1:10560 (1884) mapping and are potentially much earlier. On the 1967 OS mapping the outflow from the sluice is shown as channelled and can still be seen as a brick built channel along the edge of site A (Plate 3).

**Plate 3:** Brick lined culvert at Site A

8.1.2 There has been extensive 1960s open cast mining in the area surrounding Stainsby and this has dramatically impacted upon archaeology. This has somewhat reduced the archaeological potential, however the open casting has not destroyed all of the archaeology and only a small section of brick lined leat seems directly affected. There is still potential for medieval archaeology to survive within the landscape.

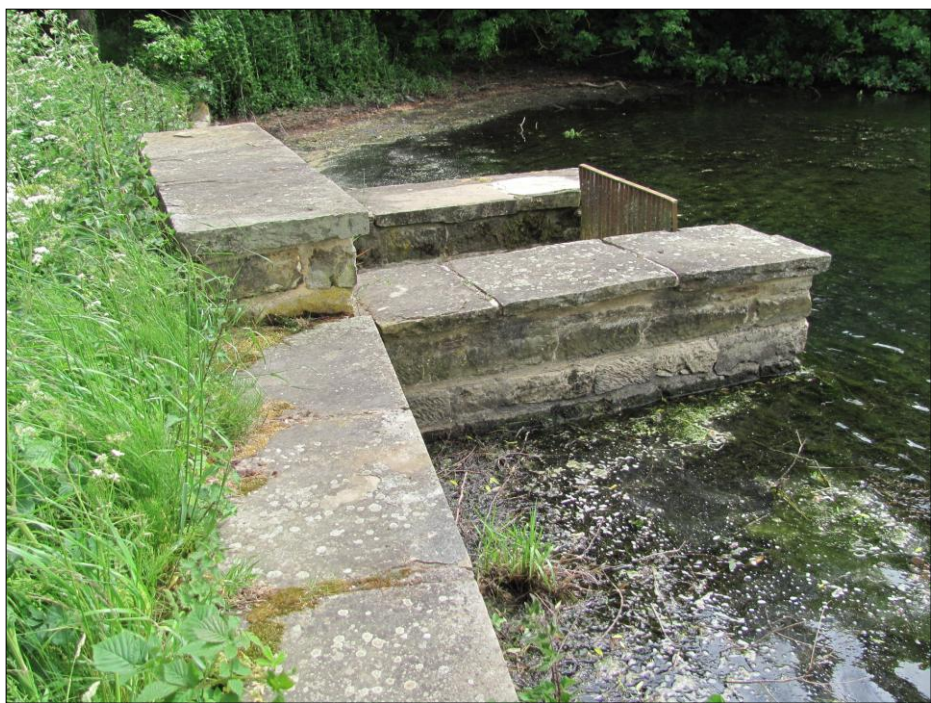
- 6.1.1 The Dam located next to area A is shown as having a sluice at its eastern end from the earliest available OS mapping onwards. This however appears to have been a later addition as it is out of character with the rest of the dam which is an earthen bank, reinforcing the interpretation of the dam as potentially older. It is possible that the current sluice was altered during the construction of the brick culvert and possibly related to the open cast mining of the 1960s. The current sluice is stone built and dates from the 19<sup>th</sup> century (Plate 4), although some later repairs suggest that it may have been altered when the 1960s culvert went in.

**Plate 4:** Sluice at eastern end of dam in at Stainsby Pond proximal to site A.

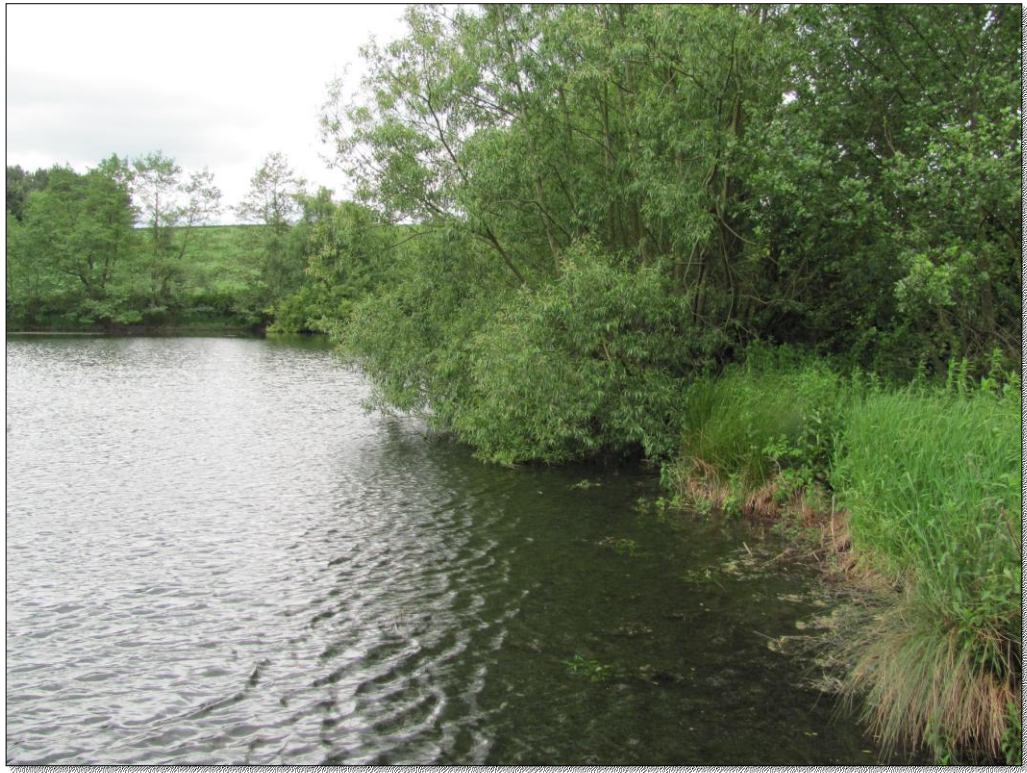
6.1.2 It is possible that the current dam is an improved medieval dam relating to an earlier mill serving the manor at Stainsby. A large defended manorial complex such as this would have had a mill and the most likely location for one would be in the vicinity of Stainsbybrook, possibly to the east of this small settlement. An initial walkover alone does not provide enough information to prove this theory either way and further investigation in the field will be required in order to fully understand the historic water management of the area. Historic mapping also demonstrates that the outflow from Stainsby pond runs through areas B and C as well.

**Plate 5:** Face of the earthen section of the dam at Stainsby pond.
