**London Road, Brentford, Hounslow –  
Archaeological Watching Brief**

**Planning Application: P/2012/3369 and 00707/29/P3  
LAG 018/406**

**LAARC Site Code: LDO15**

Report Title: **London Road, Brentford – Archaeological Watching Brief**

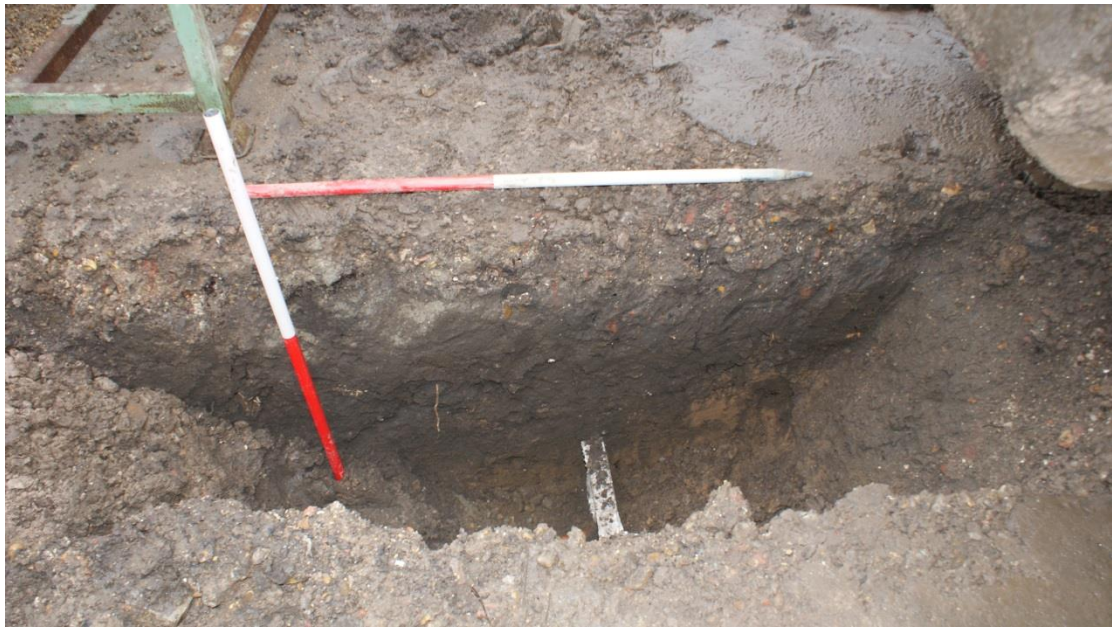
**Plate 1: Central Pipe Trench east facing section**

- 4.3.2 The central pipe trench was excavated to 0.85 m deep and 0.45 m wide and extended northwards from the cut for the recently installed soakaway. Similar deposits as previously observed as part of the previous evaluation trench was observed and the presence of pottery and animal bone confirmed the presence of the ditch.

- 4.3.3 The trench comprised of modern made ground and dark brown garden loam (100) to a depth of 0.6 m in depth. This overlies dark brown silt with extensive root intrusion (101), to a depth of 0.15 m. This in turn overlies mid-orange brown silt which was slightly cohesive with occasional small angular gravel inclusions (102). The full depth of this deposit was not exposed within the depth of the trench. The majority of artefacts were recovered from this lower deposit. The northern end of the trench indicated that lower pitting had truncated any earlier remains.

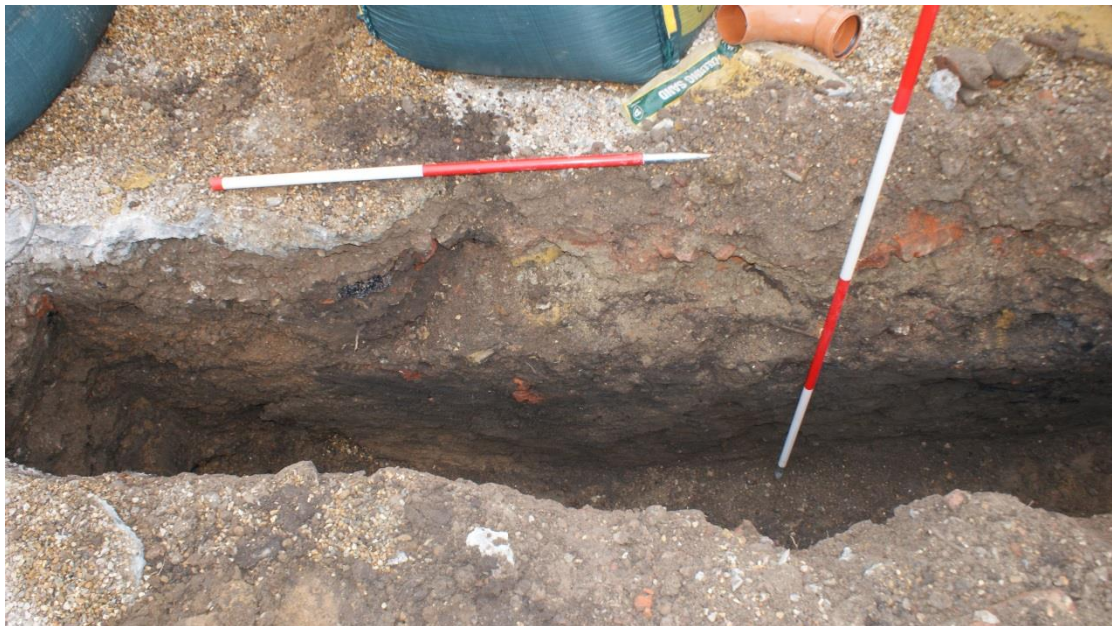
**Plate 2: Western Pipe Trench east facing section**

its southern end and 0.45 m in width. A total length of 6.3 m was observed from the northern edge of the cut for the soakaway [201]. Modern made ground was 0.7 m deep [202] and [203]. The northern end of pipe trench was revealed to be extensively truncation with modern pits and deposits of building debris [206].

- 4.3.5 The southernmost 2.5 m length of pipe trench nearest to the soakaway indicated earlier deposits to be better preserved and the fill of the Romano-British ditch could be distinguished. The pipe trench confirmed that the cut of the soakaway had missed the southern edge of the Romano-British ditch. Underneath the made ground was the same dark brown soft sandy silt previously observed as the upper fill of the ditch (204) which overlies a mid brown orange clay silt with few inclusion (205).

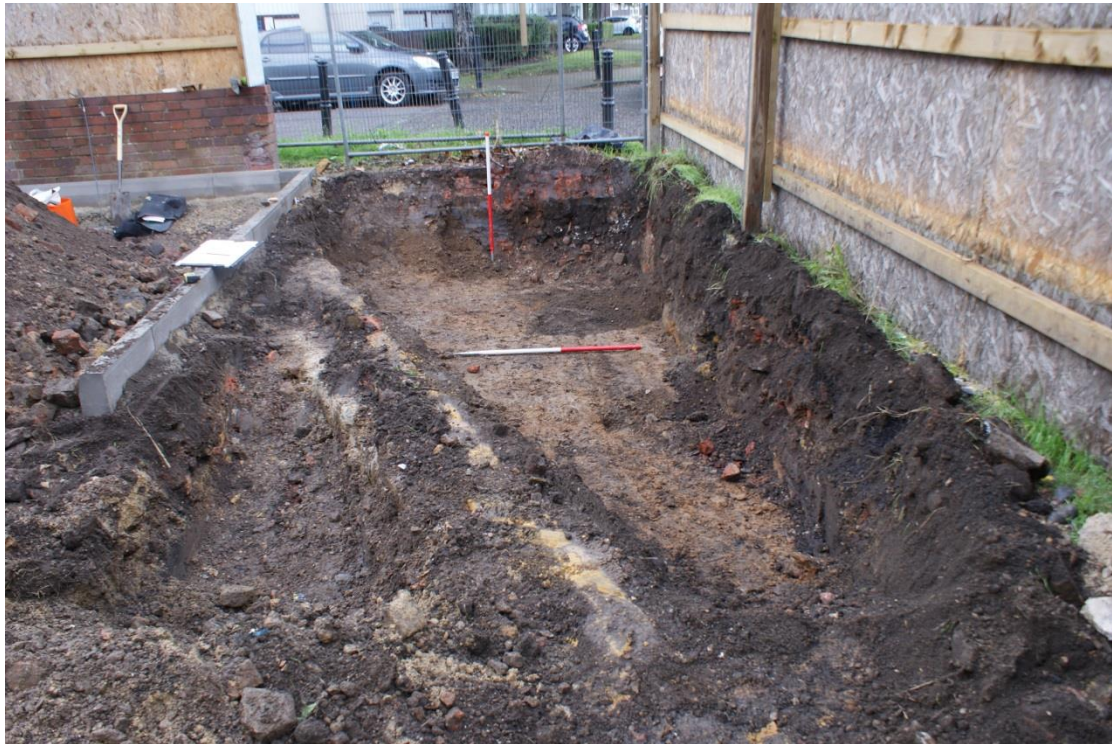
**Plate 3: Remediation Area looking south**

- 4.4.1 In the southwest corner of the Site an area of contaminated land remediation was excavated to a maximum depth of 0.7 m (Figure 2). The area comprised of extensively modern made ground to a depth of 0.6 m and included the foundations of the former boundary wall to the property which crossed the area on a southeast to northwest alignment. In the very southwest corner of the site was a brick lined (303) rectangular refuse pit. The fill (302) comprised of very mixed fragments of CBM, oyster shells and brick fragments with dark brown silt.

- 4.4.2 To the north the brick lined pit cut into an earlier larger pit (306) from which large fragments of glazed pottery were retrieved (305). The full extent of the pit was not excavated as it extended beyond the depth of the required remediation. No further features were observed with the excavated area. The base of the trench comprised of light mid-orange brown sandy silt.
