**Castleward Derby: Park Street Canal Tunnel –
Archaeological Recording
Compendium Living**

Report Title: Castleward Derby: Park Street Canal Tunnel – Archaeological Recording

Report Ref: 7134_Castleward_Canal_AR_v1.1

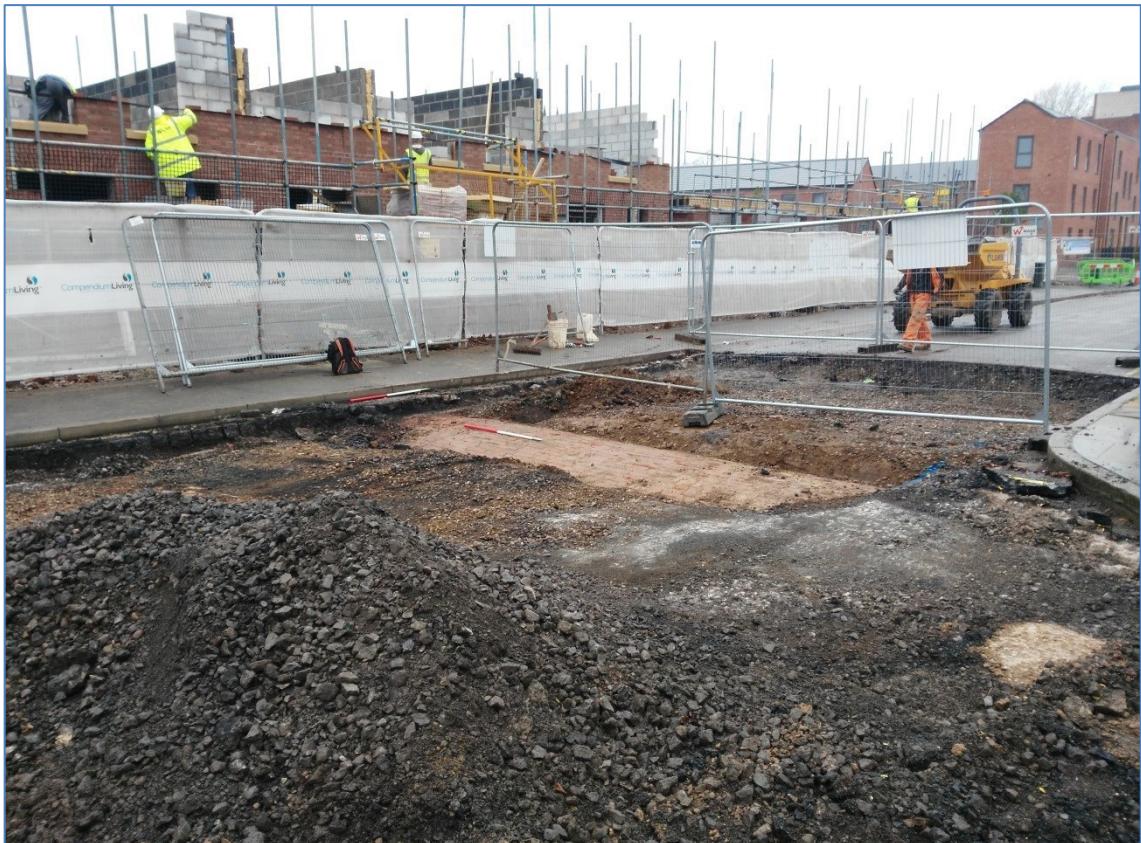
Plate 1: View of the exposed upper surface of the tunnel, looking west along Park Street

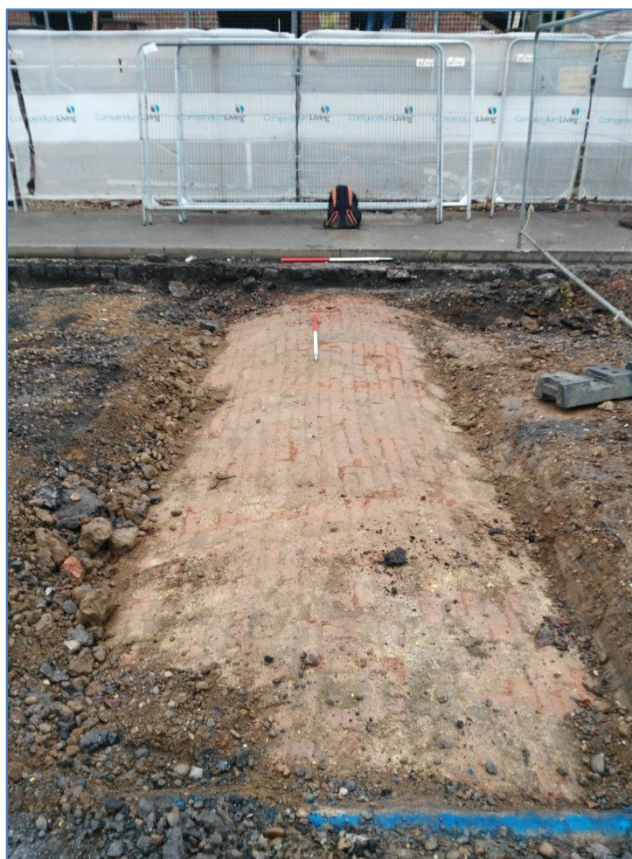
Plate 2: View of the exposed upper surface of the tunnel, looking north towards Park Street

- 3.2.1 The Park Street Canal Tunnel formed part of the former Bemrose Arm of the Derby Canal, comprising a masonry and brick structure measuring 12.88 m long by 4.84 m wide with a height of approximately 3.25 m (**Plates 2, 3 & 4**).

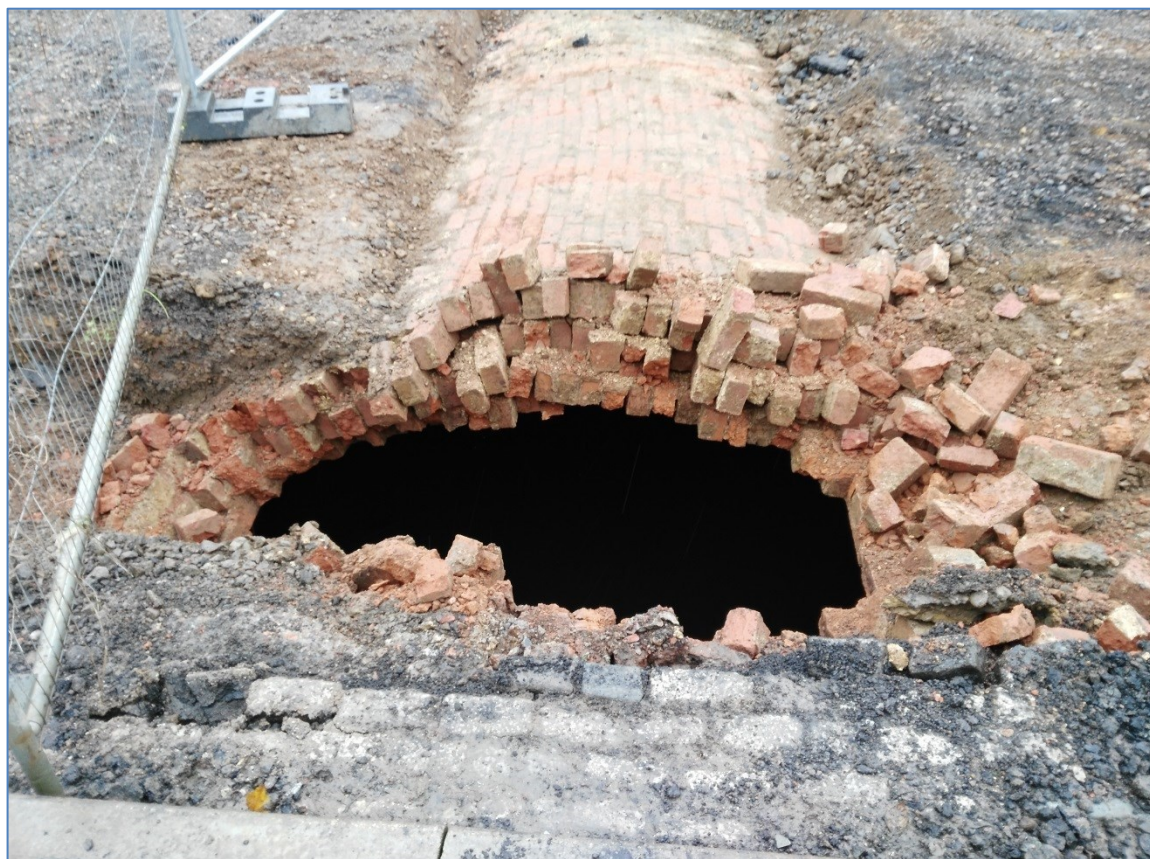
Plate 3: View of section through the top of the tunnel facing south

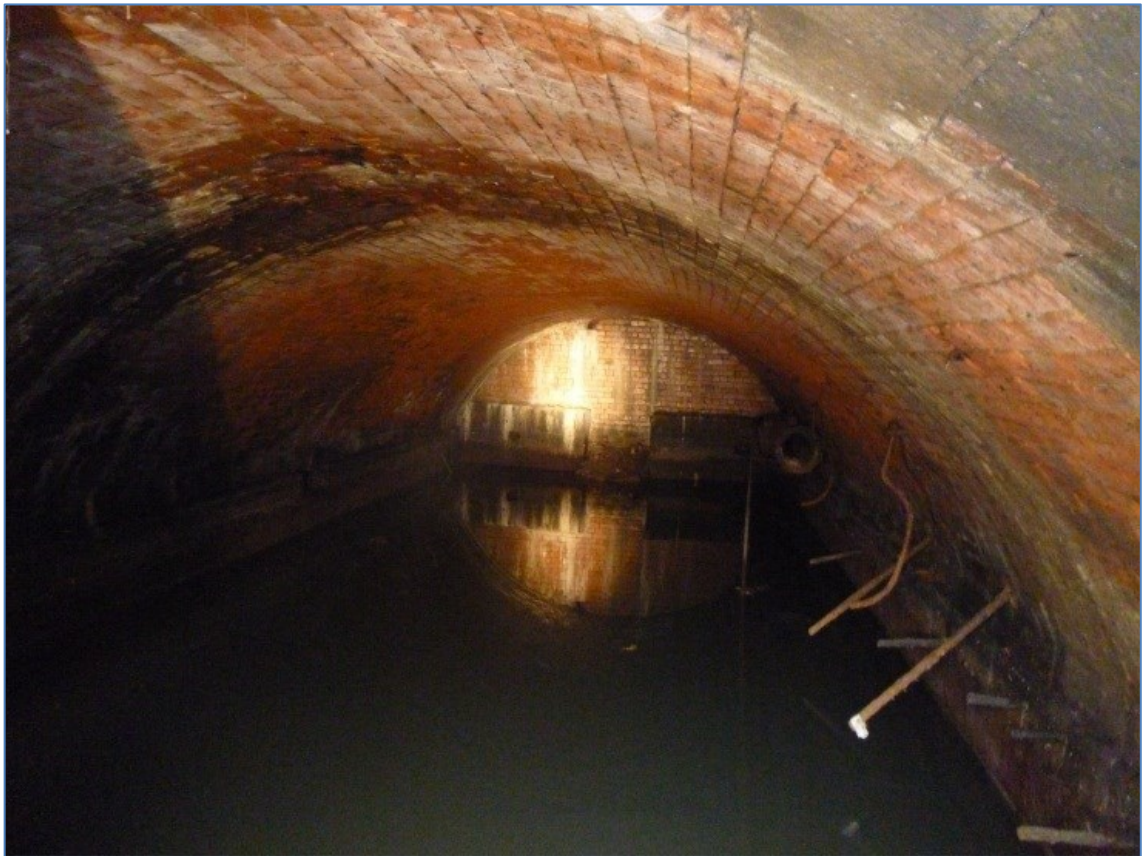
Plate 4: General view of the Park Street Canal Tunnel, looking north (2014)

- 3.2.3 The eastern and western walls of the canal tunnel were masonry built, comprising five courses of dressed sandstone blocks, laid to regular courses (**Plates 6-7**). Tooling was clearly evident across the majority of blocks, comprising rough pointed work. Whilst the foundation of the wall was not exposed, an additional wider masonry course was observed at depth below the main faces of the canal walls (**Figure 2**). Within the centre of the first course of each of the masonry walls was a rectangular void (**Plate 8**). Whilst there was no access to investigate these openings, it is hypothesised that they may have represented outfalls for water collected by drains on Park Street. This is due to the low level of cover between the top of the canal tunnel arch and the road surface of Park Street (less than 20cm), which evidently left insufficient room to accommodate drains across the top of the tunnel. A service run had been constructed along the eastern wall of the canal tunnel, comprising a large diameter cast iron pipe carried on regular iron brackets set into the masonry blocks of the canal wall (**Plate 4**).

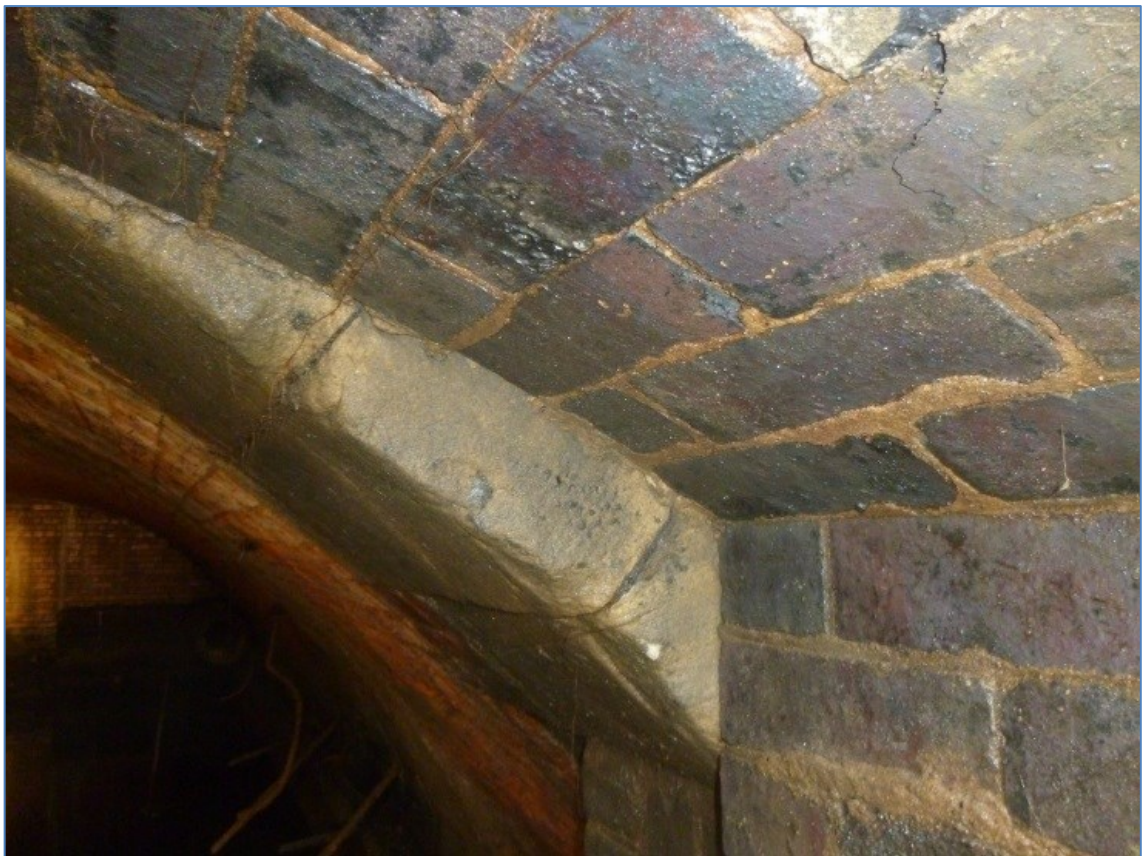
Plate 5: Detail of sandstone voussoirs of the canal portal (2014)

- 3.2.2 Observations made of the southern portal during a previous phase of work (Ecus 2014) indicated that the portals of the canal tunnel possessed segmental arched entrances constructed of ashlar voussoirs (**Plate 5**).

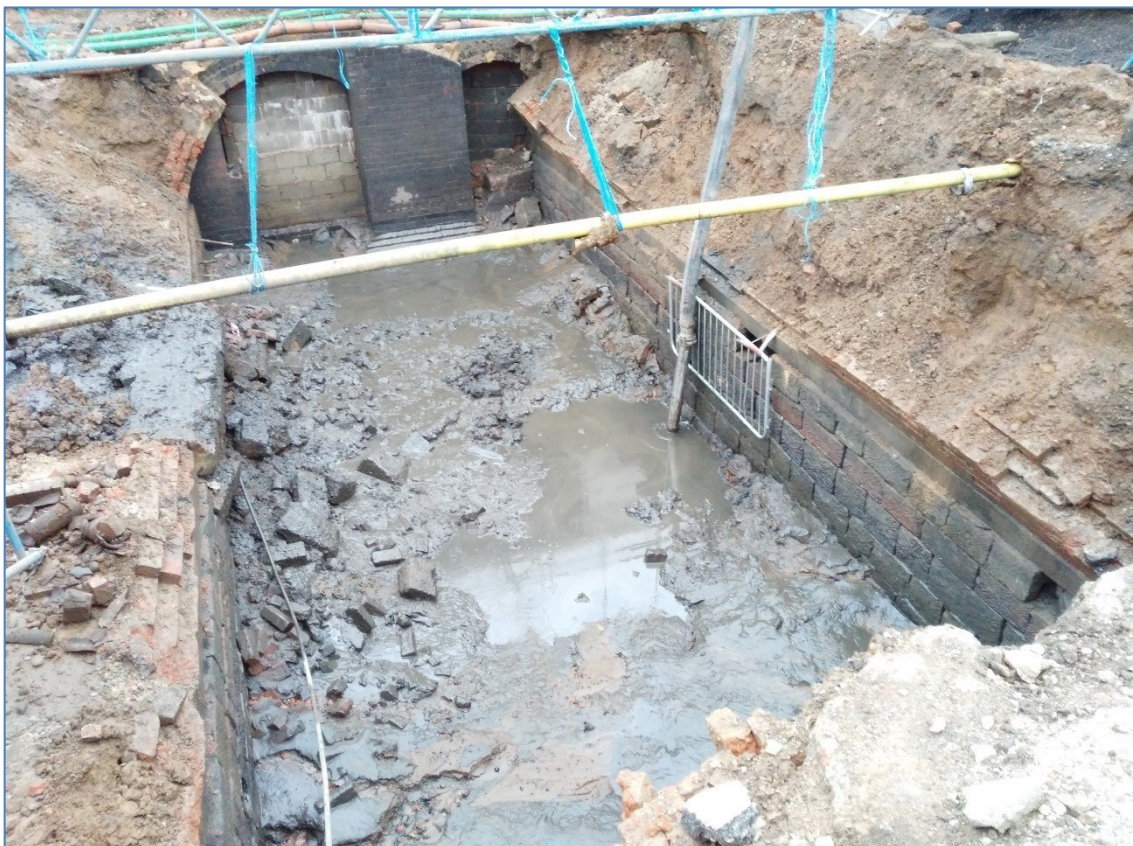
Plate 6: General view of the interior of the canal tunnel following the removal of the arch, looking south

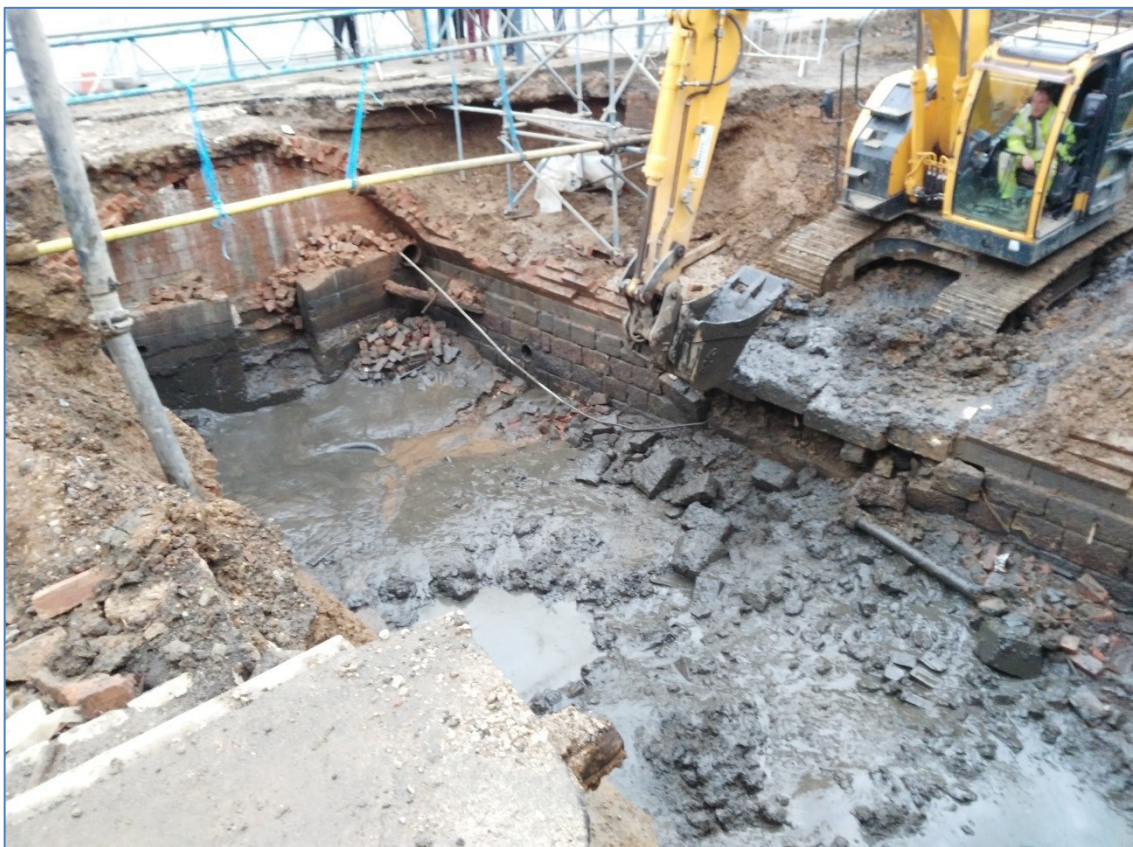
Plate 7: General view of the interior of the canal tunnel following the removal of the arch, looking north

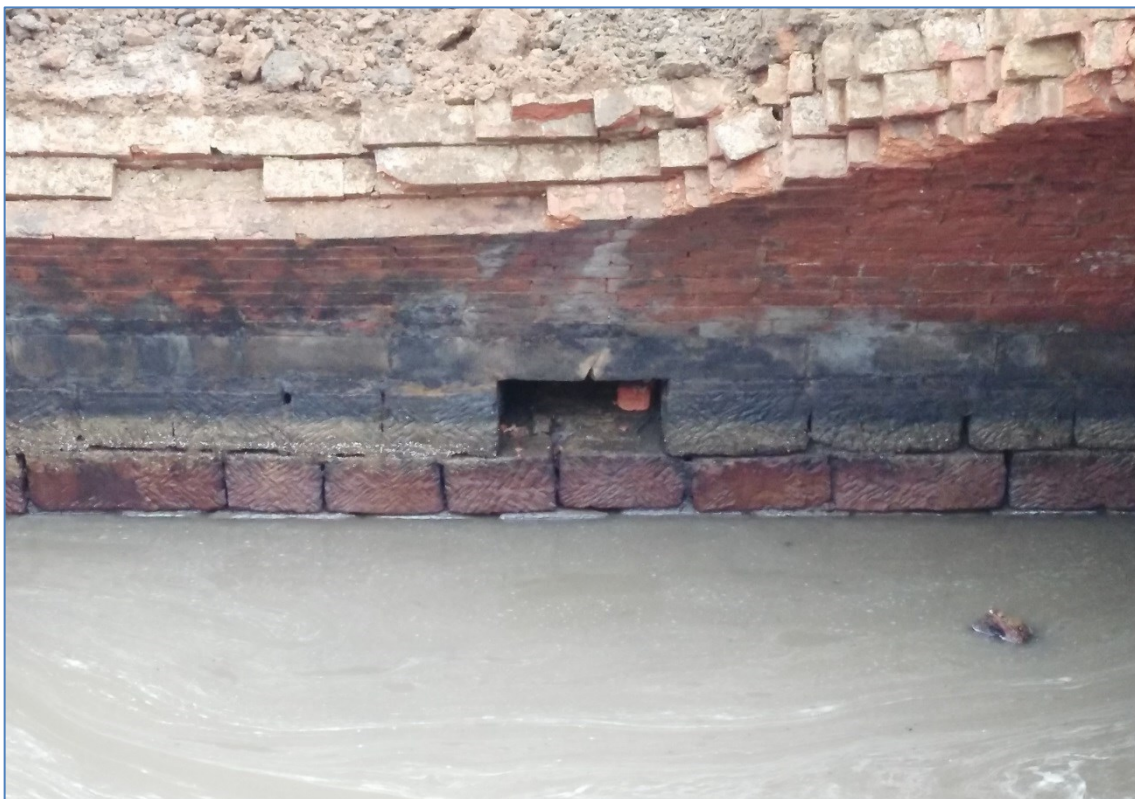
Plate 8: View of the rectangular void within the centre of the west facing elevation of the canal tunnel wall. An identical void was present within the opposite wall.

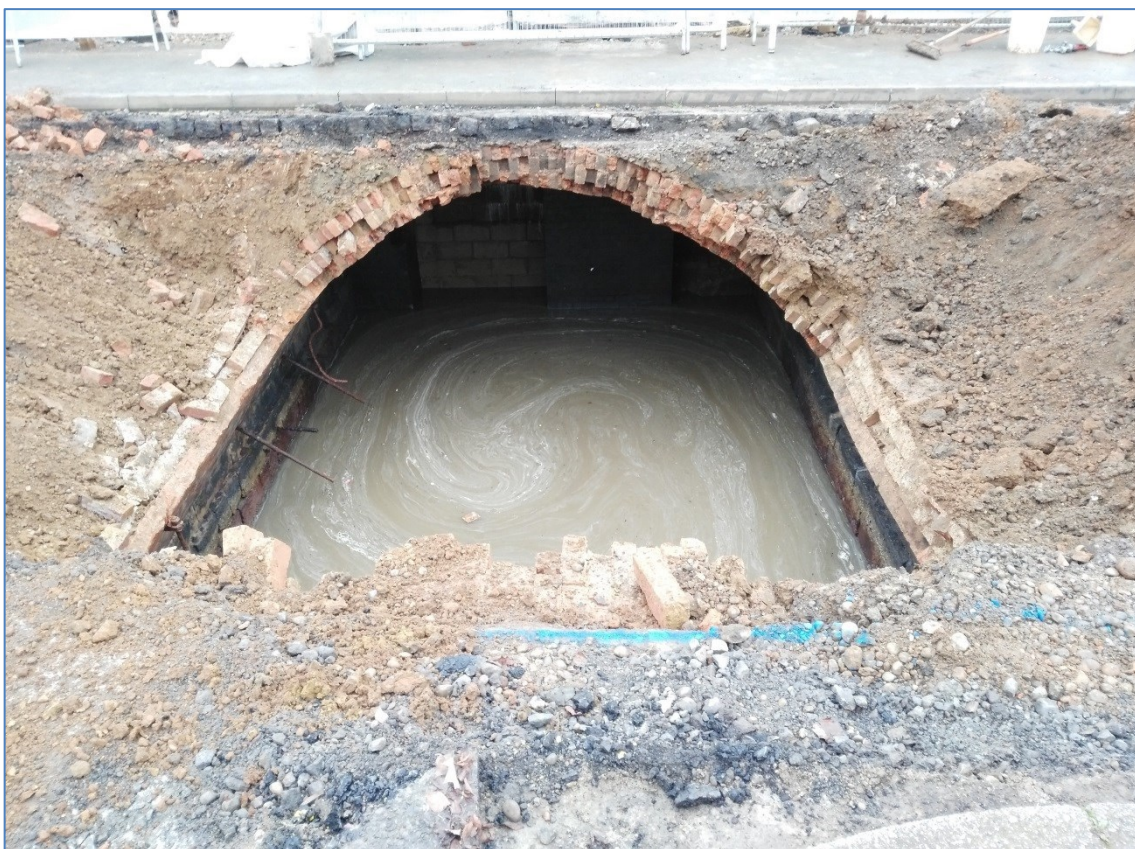
Plate 9: Image taken during breaking out of the arch, looking south, illustrating its construction

- 3.2.4 Above the masonry wall laid a continuous band of ashlar, comprising the springer for the subsequent three course thick red brick arch which spanned the tunnel (**Plate 9**). The arch was formed from two types of red brick, comprising: a frogged brick (measuring 24 x 12 x 8 cm, with 'PATENT' stamp) commonly used within the soffit of the arch; and a non-frogged brick (measuring 24 x 11.5 x 7) commonly used in the outer two courses.

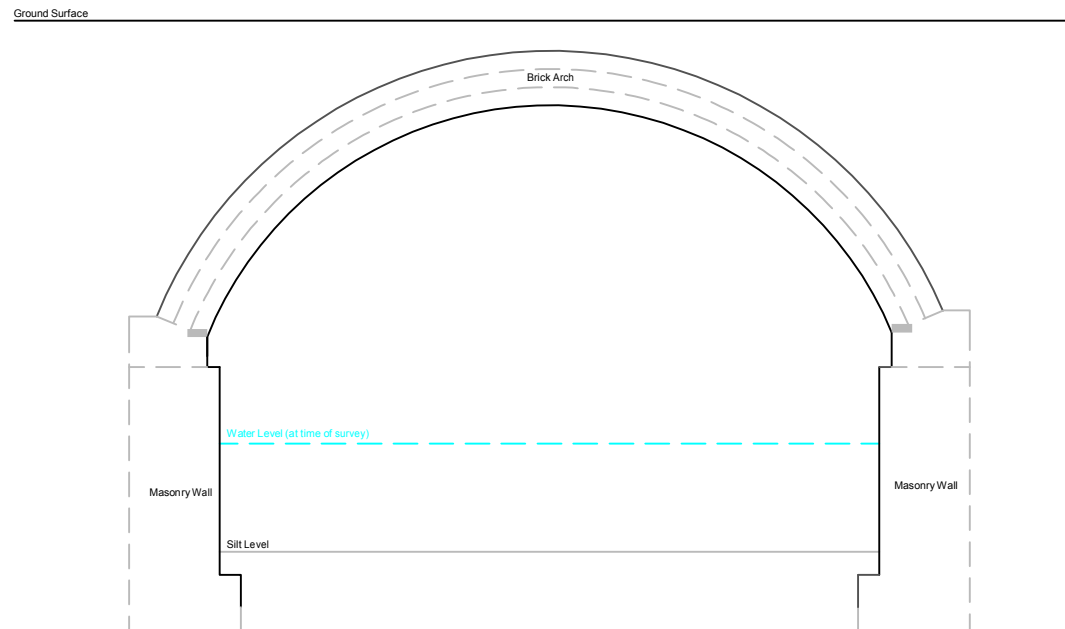
- 2.2.3 Sketch plans and elevations were produced to illustrate photo location viewpoints and any observations made during the works and are reproduced as **Figure 2**.
