# HOLDSTONE DOWN INCLOSURE BOUNDARY AND MARKER STONES

## PROJECT REPORT

Date of report: March 2015

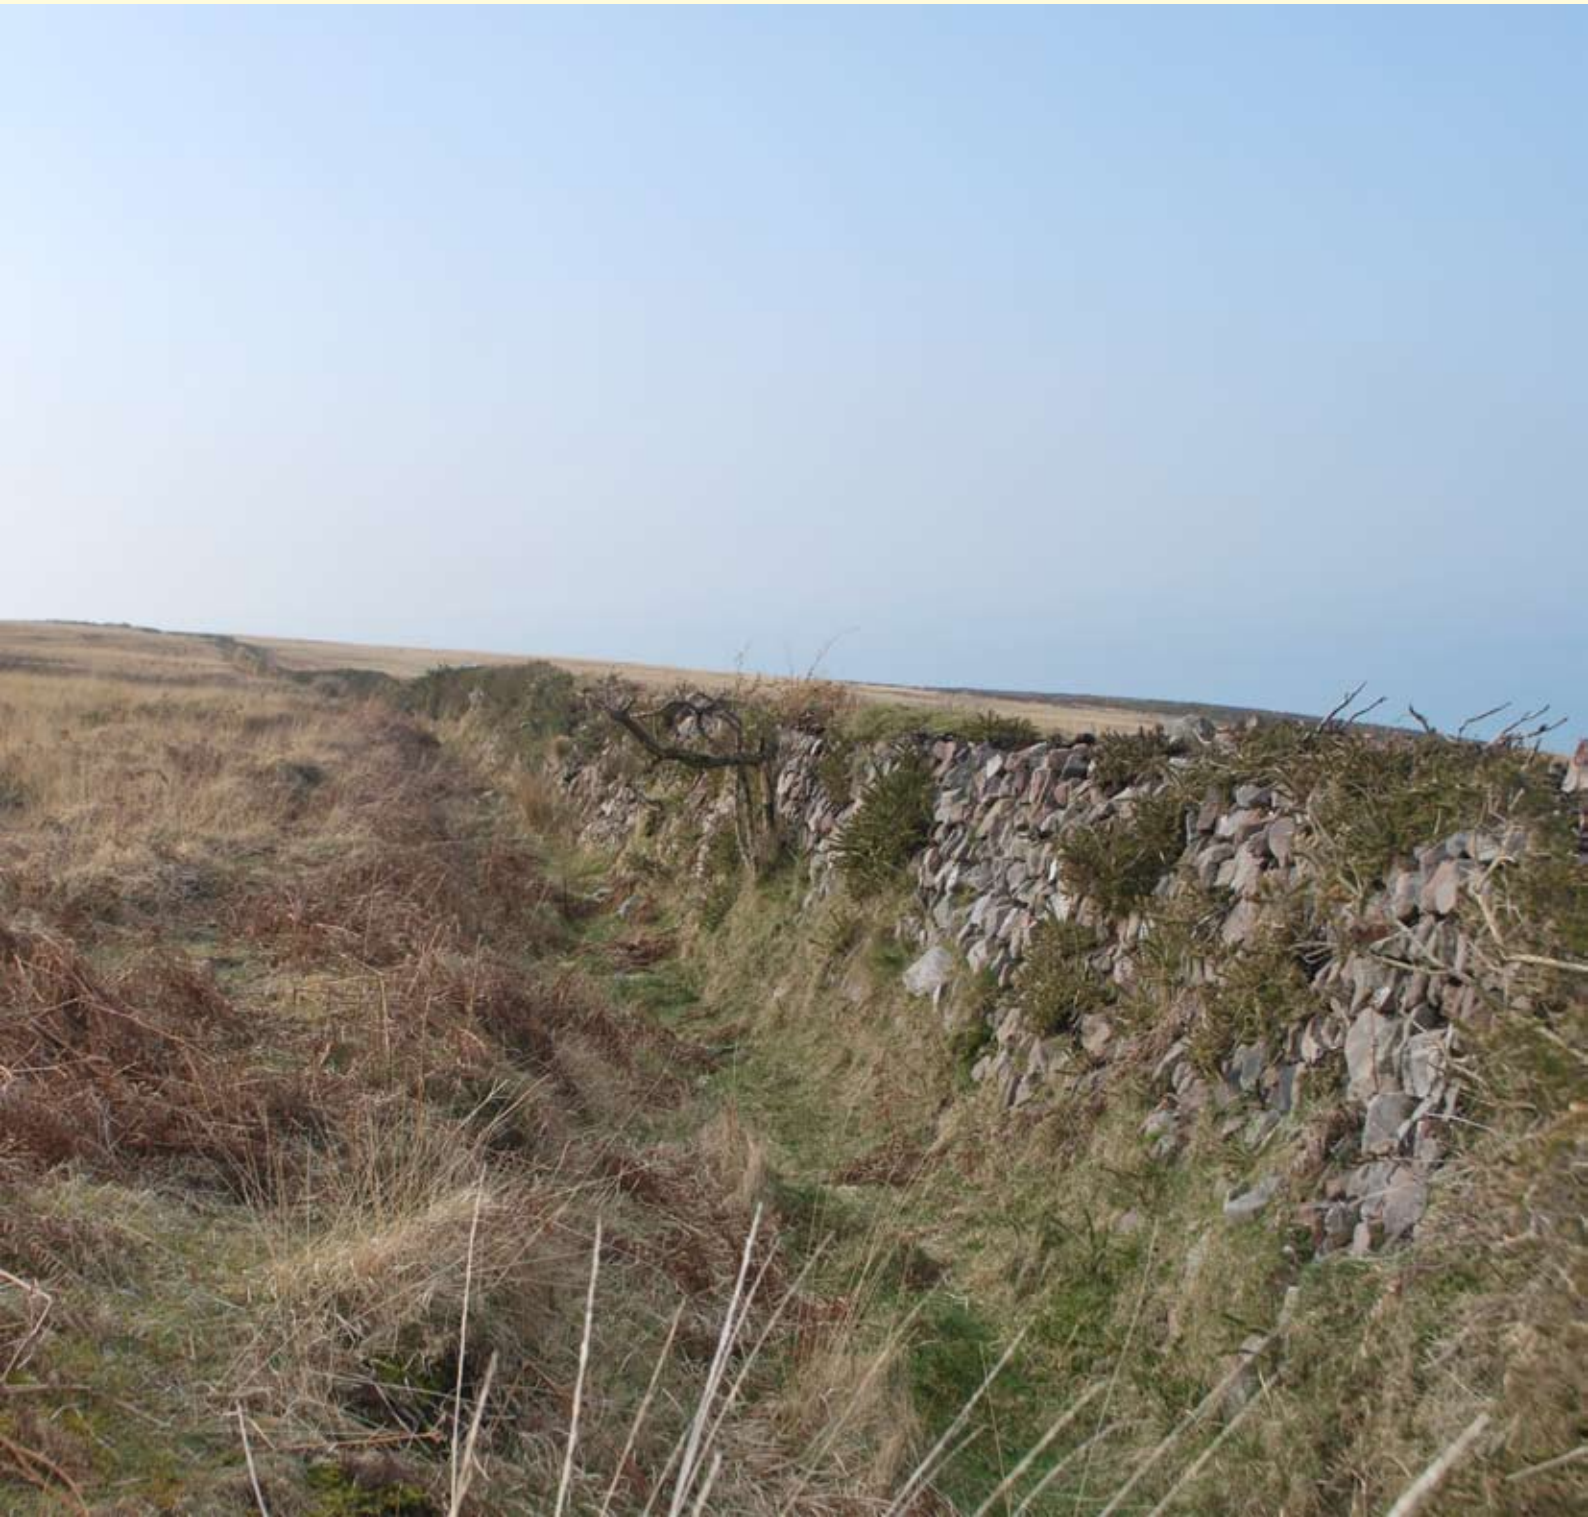
Front cover NE part of inclosure boundary on Holdstone Down (Hazel Riley)

The main inclosure boundary of the NE part of Holdstone Down lies to the north of the survey area. Part of it has been incorporated in to the boundary of Moorlands garden, the remainder survives in good condition (Front cover). It is a substantial stone-faced bank, with a ditch on its SW side. The stone-faced bank is 1.5m high, 0.8m high and has a capping of earth, gorse and turf; the ditch is 1m wide and 0.7m deep (Fig 12)

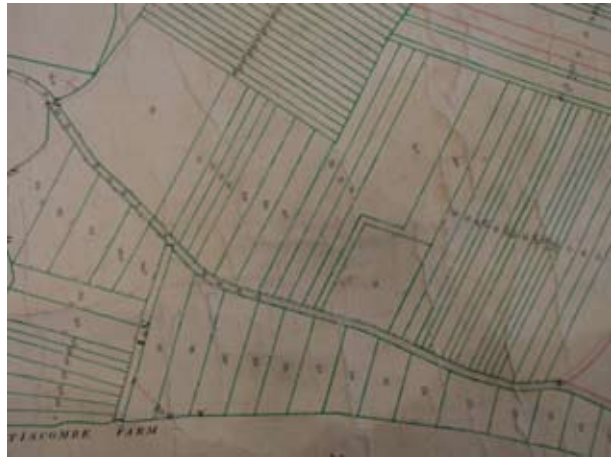
Fig 4 (left)  
Extract from  
Combe Martin  
Inclosure Map  
1871

those with common rights in the parish (DRO Q/RR1/25). These are delineated on the map and details of the allocations are given in the award (Figs 4 & 5). The land was allotted according to the rights which already existed. For example, John Boyle, the owner of 63 acres at Wester Park, was awarded three plots: 219 on Purwell Down and 111 and 112 on Holdstone Down, a total of 6.5 acres. William Lathem, who owned a cottage at Wringers Meadow with rights of turbary, was allotted a plot of just over an acre on Holdstone Down (Beaumont 1989, 139).

The cost of the work involved in the process of this enclosure was offset by the Commissioners who sold 409 acres of the commons. Mr W B Hawkins from Surrey bought 235 acres on the coastal side of Holdstone Down for £655 which were later part of an unsuccessful scheme to develop the down as a coastal resort (Beaumont 1989, 139-140). These costs included the survey, copying the map and schedule, constructing new roads and marking out 270 plots on the four commons. The plots on Holdstone Down were marked by upright stones, inscribed with a number which corresponded to the plots shown on the Inclosure Map (Fig 5).

The Inclosure Map shows one existing road across the commons, the 'Ancient Public Road,' now the metalled road between Trentishoe and Stoney Corner NE of Combe Martin. A road along the NE enclosure boundary on Holdstone Down, no IV on the map and award, was to be constructed to give access to plots following enclosure (Fig 4). Plot 35, 3 acres on Holdstone Down, was awarded to the Surveyors of the Highways for Combe Martin to be used as a public quarry for the repair of roads with the parish. This is now the ENPA car park.

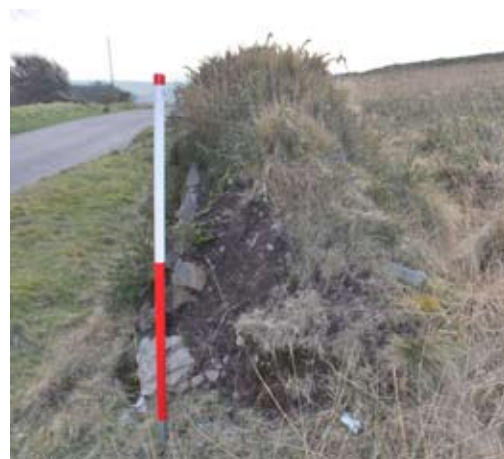
Fig 10 Stone facing on the SE side of the inclosure boundary HD2 (1m scale) (Hazel Riley)

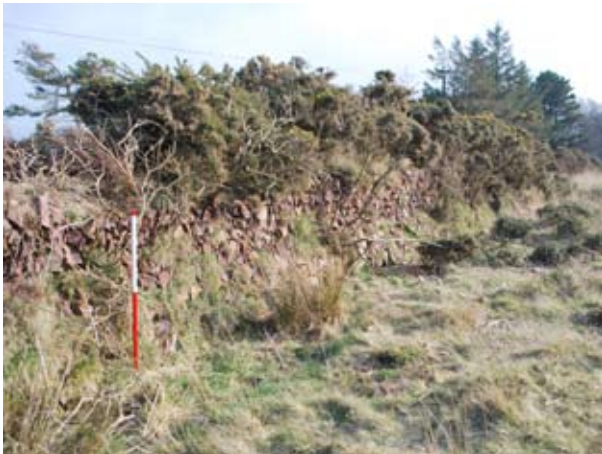
*Fig 11 (above left) Stone facing on the west side of the inclosure bank HD1 (1m scale) (Hazel Riley)*

Description and interpretation: A stone-faced bank, 0.8 m wide, 1m high and 53m long, on the SE edge of Holdstone Down. It was constructed as part of the 1871 inclosure of Holdstone Down and formed the SE boundary of three plots numbered 22, 23 and 24 on the 1871 Inclosure Map.

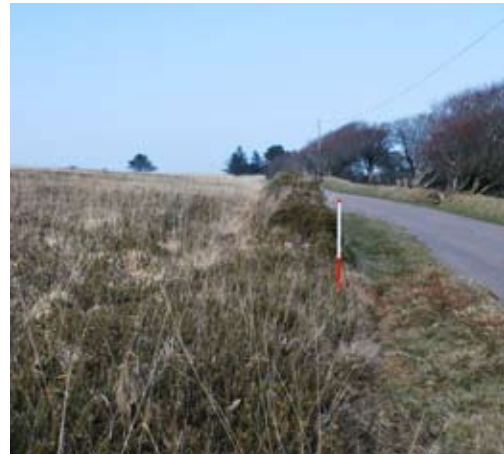
Two low, stony banks lie within the study area (HD5,6). A low bank, HD5, between two stone-faced banks NE of the ENPA car park is the best example. It is 43m long, 1m wide and 0.6m high (Figs 7 and 13). A similar bank lies to the south of the ENPA car park (HD6). A slight bank to the south of the car park by Moorlands is more likely to be either a feature of the vegetation (stands of dead bracken) or perhaps tracks or routes across the down before enclosure.

*Fig 13 (Above) Low, stony bank and the stone-faced bank HD2 and HD3 (1m scale) (Hazel Riley)*

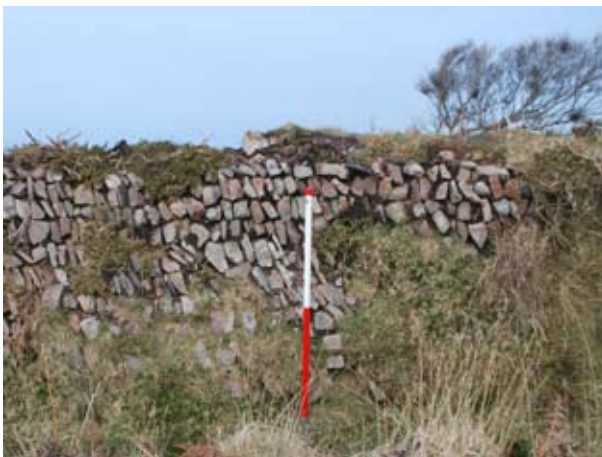
*Fig 12 (left) Detail of the inclosure boundary on the NE side of Holdstone Down (1m scale) (Hazel Riley)*

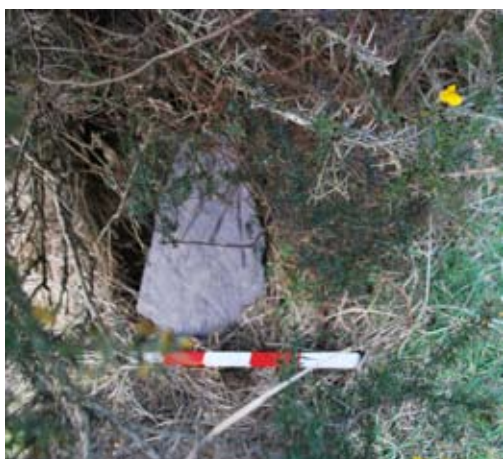
Three inscribed stone slabs lie within the study area. At the southern end of the stone-faced bank SW of the ENPA car park (HD4) is a thin stone slab, with a broken top, inscribed with the number 36 (HD7) (Fig 14). Marker stone 24 (HD8), lies at the south end of the stone-faced bank HD1, (Fig 15). A stone slab (HD 9) set into the west face of the stone-faced bank HD1 is probably marker stone 23, although the stone is broken and the inscription is unclear (Fig 16).

Fig 14 (above right) Marker stone for plot 36  
(0.5m scale) (Hazel Riley)

Description and interpretation:An inscribed stone slab set into the SW end of a stone-faced bank on the SE side of Holdstone Down. The stone is 36cm long, 27cm high and 1cm thick, with a broken top. The number 36 is just visible on the stone. The stone is

one of many marker stones set out on Holdstone Down as part of the 1871 inclosure of the down.

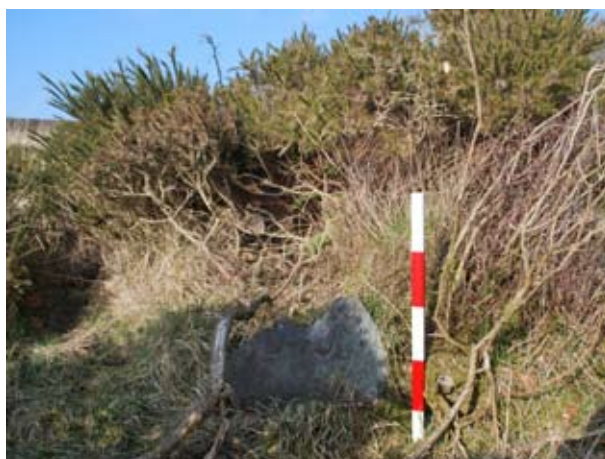
Fig 15 (above) Marker stone for plot 24  
(0.5m scale) (Hazel Riley)

Description and interpretation: An inscribed stone slab set against the SW end of a stone-faced bank on the SE side of Holdstone Down. The stone is 30cm long, 35cm high and 1cm thick. The number 24 is inscribed on the stone. The stone is one of many marker stones set out on Holdstone Down as part of the 1871 inclosure of the down.

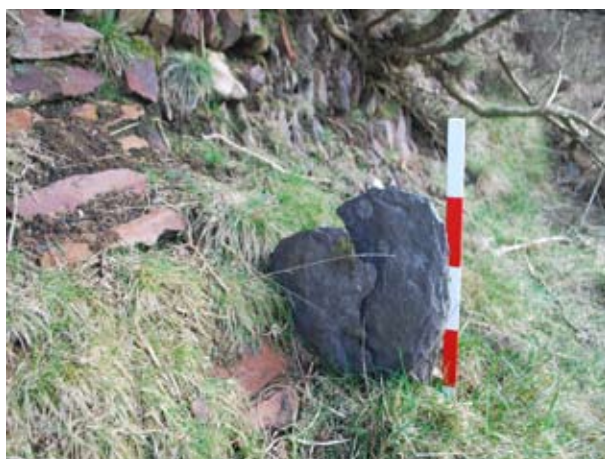
Fig 16 (right) Marker stone for plot 23  
(0.5m scale) (Hazel Riley)

Description and interpretation: An inscribed stone slab set into the west side of a stone-faced bank on the SE side of Holdstone Down. The stone is 25cm long, 30cm high and 2cm thick. The stone is broken but the number 3 is just visible and it is probably marker stone 23. The stone is one of many marker stones set out on Holdstone Down as part of the 1871 inclosure of the down.
