Archaeological Monitoring at St. James' Hospital Chapel, Horning, Norfolk.

Report No: 32

Archaeological Monitoring of drainage improvement works and a cable trench at St. James' Hospital Chapel, Horning, Norfolk.

Location: Horning
Grid Ref: TG 3722 1631
NHES Event No: ENF131296
Date of fieldwork: 17th to 20th June 2013

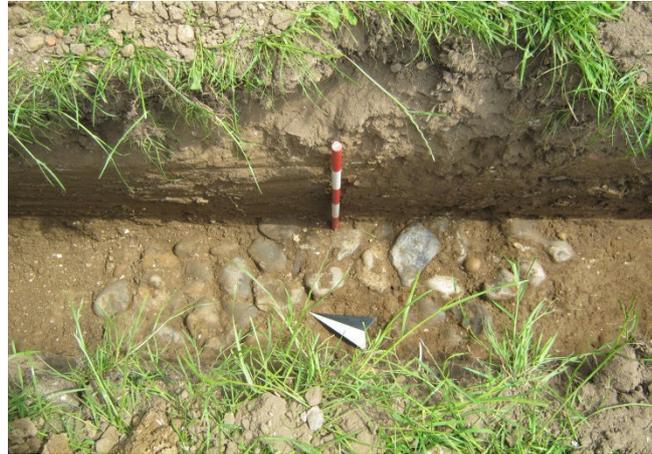
Plate 3: Stone packed feature (10)
(looking NE) [1x0.5m scale]

The lowest deposits revealed by groundworks, on the southern side of the chapel, consisted of a dense mid-grey sandy-clay (09) below a more mottled layer of similar material (11) both of which were stained by organics. At the interface of the two, a seemingly linear patch of densely packed flint cobbles was revealed within the confines of the cable trench (10). This enigmatic feature was aligned c.east-west. A similar feature (20) was recorded within the confines of the pipe trench at the same stratigraphic horizon, although the alignment of this cobble feature was less clear but may have been roughly north-south. Interpretation of these features must remain tentative although they appear to resemble linear footings or pads for a timber or robbed out stone structure.

Finds collected from the lowest deposit (09) (within which the cobble feature (10) was inset) amount to oyster shells, a fragment of butchered animal bone and three sherds of unabraded medieval pottery with a broad late 12th to 14th century date range.

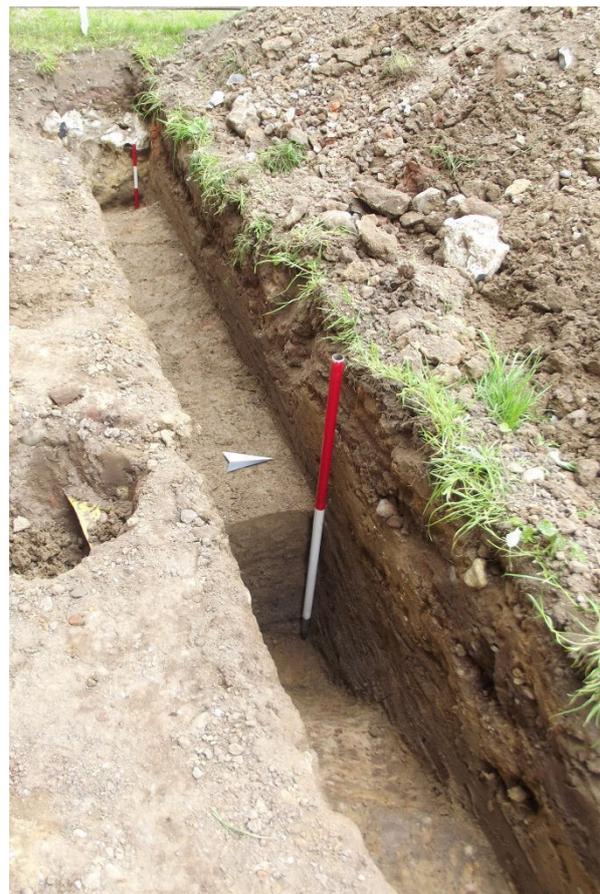
Plate 4: Medieval Ditch [05]
(looking WNW) [1x1m scale]

A large ditch ([05]) was revealed by the drainage trench on the north side of the chapel. It measured c.2.15m wide and was orientated on a NNE-SSW alignment, running below the north-west corner of the chapel. The ditch therefore clearly pre-dates the existing 14th century building. An investigation slot found the ditch to be c. 0.7m deep, with a profile which may suggest at least one significant recut event. The base of the ditch was filled by silting deposits followed by a fairly homogenous deposit of dark-brown clay-silt with moderate frequencies of charcoal and degraded burnt-clay lumps/flecks (08). A single cow bone, a residual prehistoric flint and two sherds of medieval pottery were collected from the main fill. The pottery sherds offer only a broad date range of late 12th to 14th century.

The discovery of a medieval boundary/drainage ditch which both predates the existing building and runs below its western end suggests a reorganisation of land use prior to the construction of the existing building sometime in the 14th century, possibly coinciding with a rebuilding programme at the hospital site following fire damage to an earlier building documented in the 1340s. It can be conjectured that the current 'chapel' building may have been significantly extended or even re-sited at this time.

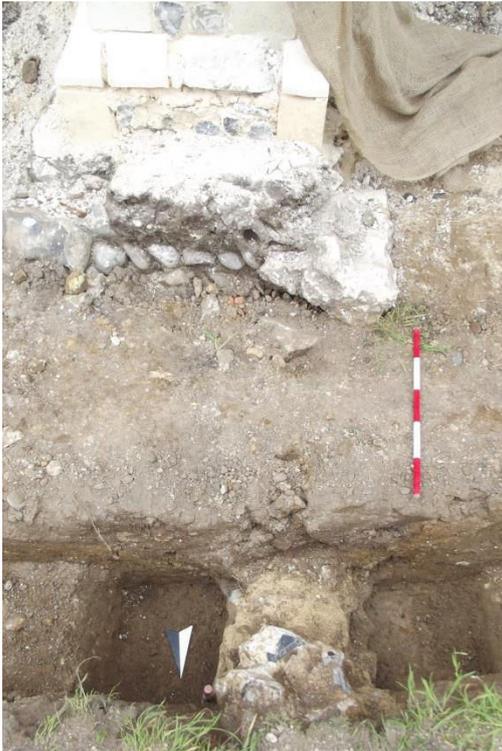
Plate 5: B7 & Wall-footing 24
(looking south) [1x0.5m scale]

Both buttresses were in a highly ruinous state prior to recent consolidation and repair work. The below ground fabric of Buttress B7 had suffered some damage to its northern elevation in recent years, during the installation of an electric power cable trench. Both buttress pads make use of exceptionally large nodules of flint (up to 300mm in diameter). The pads are fairly regularly constructed and extend out beyond the buttresses they support by between 0.2 to 0.3m. The partly damaged buttress pad of B7 showed that the core of the pad was evenly constructed of smaller rounded flints (unstruck) in alternating bands of material. These banded layers measured c. 150mm thick and consisted of firm silty-clays and sandy-clays and a layer of crushed mortar and sand.

North-south flint & mortar wall footings of similar construction (24) were also discovered at B7 where the flints included very large unstruck nodules up to 350mm in diameter. A modern electric cable trench had broken up the wall here, large flints from which were noted within the backfill, although some remnant of the wall fabric survived where it met with the corner of B7 – no clear joint was present and the wall footings appeared to be well bonded with the buttress pad foundations.

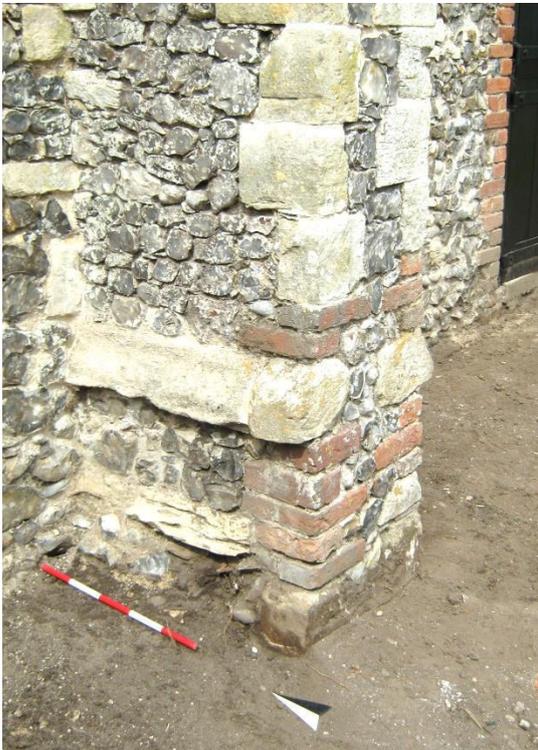
Plate 7: B4
(looking north-east) [1x0.5m scale]

The ground level was temporarily reduced at the bases of both buttresses by up to 0.3m which allowed for the recording of the exposed footing work. Although both buttresses feature significant late 19th century to 20th century above ground repair, which has made use of red brick, below this the footing construction remains unmodified. The exposed footings consisted of regular courses of medium to large flint cobbles (with very rare use of chalk lump). The larger flints were partly fractured and shaped prior to use. Much of the mortar has washed out at this level although traces of coarse yellow sandy mortar were present. The buttress pads were not significantly larger than the buttresses they supported (extending out by only c.0.2m to 0.25m).

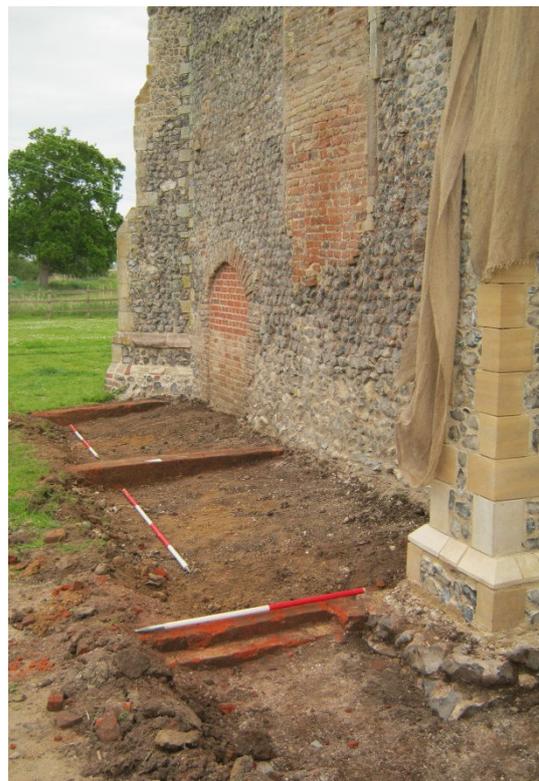
Plate 9: Brick-walls 22 at NE corner of the Chapel (looking east) [1x1m + 2x2m scales]

Evidence for former agricultural lean-to buildings was recorded on the north side of the chapel. At the western area the fragmentary remains of a thin concrete slab floor were noted just below the modern surface while more substantial brick footings were recorded further along the chapel (22). These footings match with former lean-to buildings cleared in 1972 which are reported to have housed pigs. The presence of lean-to buildings on the north side of the building was first recorded on the 1st Edition OS plan of 1889. Two north-south ranges were also depicted on the southern side of the building, one brick wall of which partly survives at the south-west corner of the chapel. The earliest maps which depict the chapel building at any meaningful scale, show extensions only to the southern and eastern sides of the building – as depicted on the 1822 Map of the Bishop’s Estate at Horning.

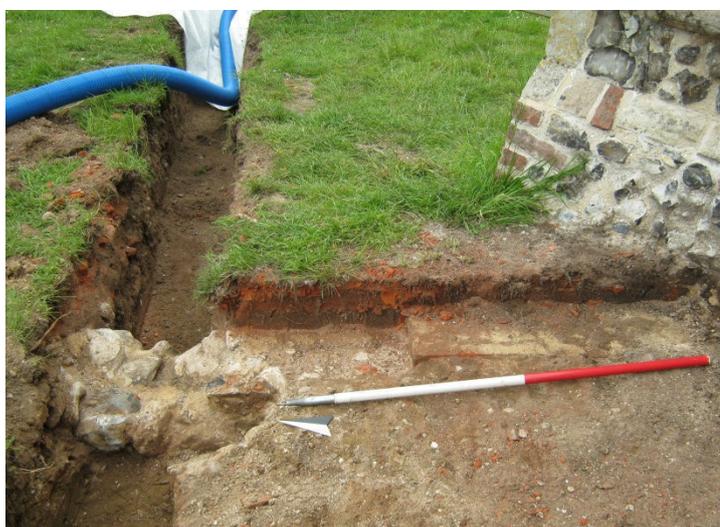
Plate 10: Brick-wall 22 at NE corner of the Chapel directly above flint footing 23 (looking east) [1x1m scale]

A north-south flint & mortar wall (23) footing was revealed at the eastern end of the chapel at B1, discovered below the brick wall here (22). The mortar bond was a soft pale sandy-mortar while the large fractured cobbles were set upon a thin bed of silty-clay with occasional small fragments of mortar and limestone.

The flint footings were only exposed within the confines of the narrow drainage trench, although they appear to represent reused medieval fabric for the construction of footings for agricultural lean-to

buildings, rather than evidence for earlier structures. The flint mortar wall at B1 was found directly below the line of the 19th century brick wall, but it should be noted that no such footings were revealed below the other two brick walls. The walls at the western end could be the footings for the second lean-to building, if so the dimensions are very similar at just over 6m in length and mirrors well the position of the other.

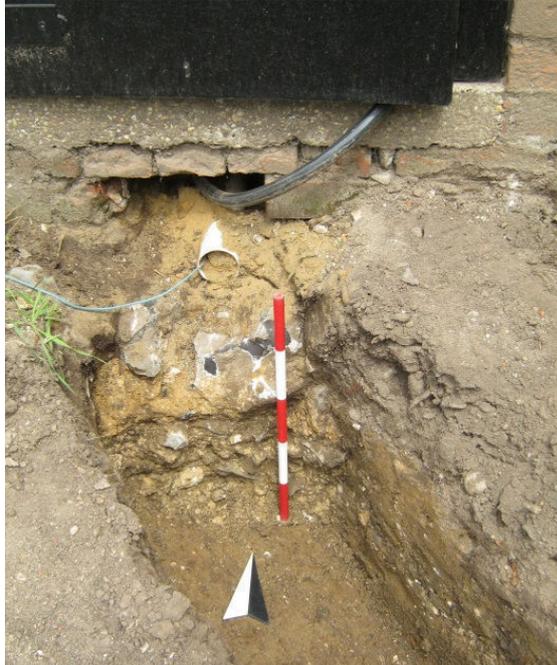
Plate 11: Chapel footings
(looking north) [1x0.5m scale]

The foundations of the south wall of the chapel were partly exposed by the electric cable trench below the late post-medieval doorway. Below two courses of post-medieval bricks for the door threshold, was a wall footing fabric (stepped out by 0.2m from the line of the chapel wall) of firm sandy-mortar with partly fractured flint cobbles (19). This was set upon a thin bed of sticky silty-clay & crushed mortar (18), above a densely packed uncoursed mix of friable mortar debris with frequent angular flints and occasional small fragments of limestone (17). This appears to demonstrate that the chapel wall footings here are shallow but may sit upon a construction trench containing crushed building debris, possibly the sorted residue from the pre-14th century hospital building.

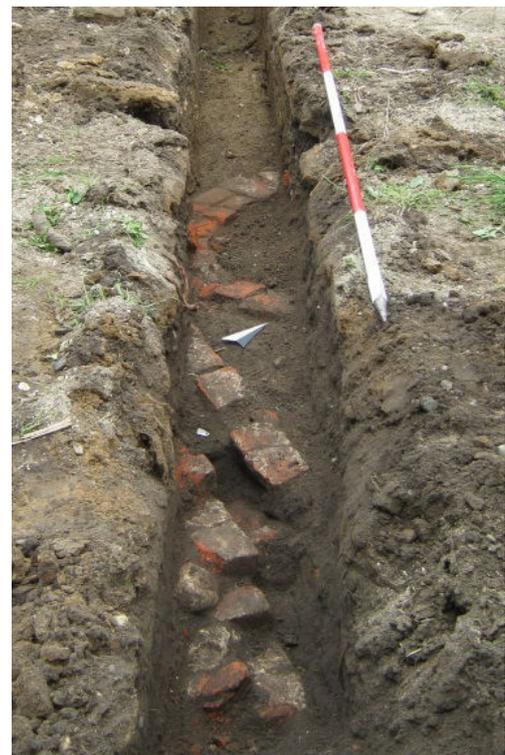
Plate 12: Brick Soakaway & conduit
(looking NW) [1x2m scale]

The southern half of the cable trench on the southern side of the chapel encountered two brick features of late post-medieval date; a circular brick lined soakaway and a brick lined drainage conduit. They were both constructed of the same sandy Norfolk-red brick and sherds of pottery collected within them are domestic fabrics of 18 to 19th century date. These subsurface structures testify to a significant investment of resources to improve drainage on what is historically a wet piece of land prone to seasonal flooding.

The sherds collected from the brick soakaway and associated brick drain (features 13 & 14) were both late post-medieval and confirm an 18th to 19th century date for the features. A small quantity of unabraded medieval pottery was collected, two pieces from the medieval ditch ([05]) and three from a deep subsoil (09) which suggest a 12th to 14th century date for both. No sherds indicative of high status were found, with the sherds representing storage or cooking vessels of common use in domestic kitchens and households.
