Historic Environment Survey and Palaeoenvironmental Assessment
Barden Fell and Hazlewood Moor
Final Project Report

Peat Restoration Historic Environment Survey and Palaeoenvironmental Assessment: Barden Fell and Hazlewood Moor

Final Report

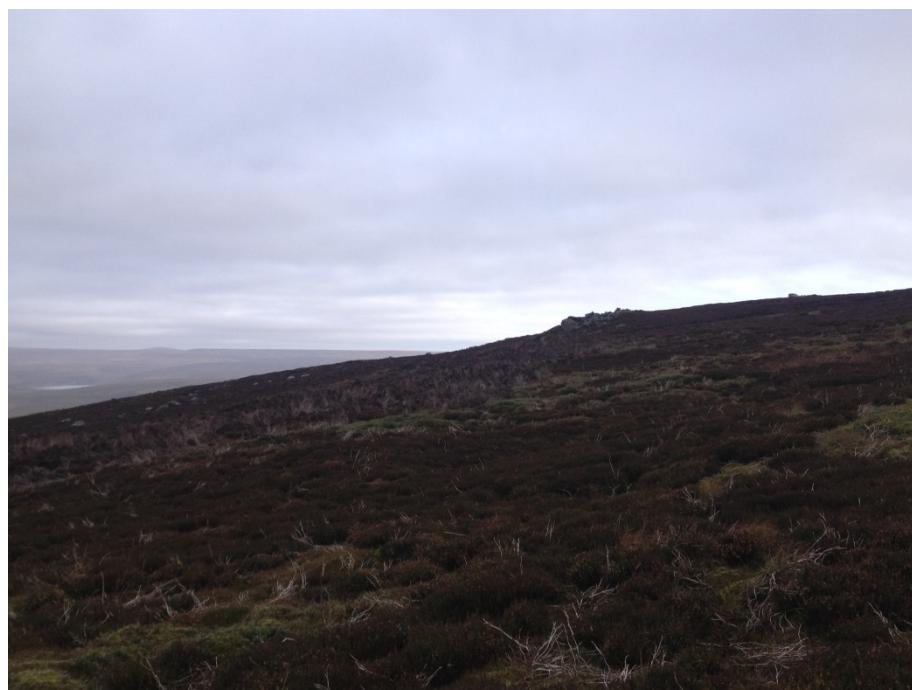
Fig. 1 The Devil's Apronful scheduled cairn in its landscape context

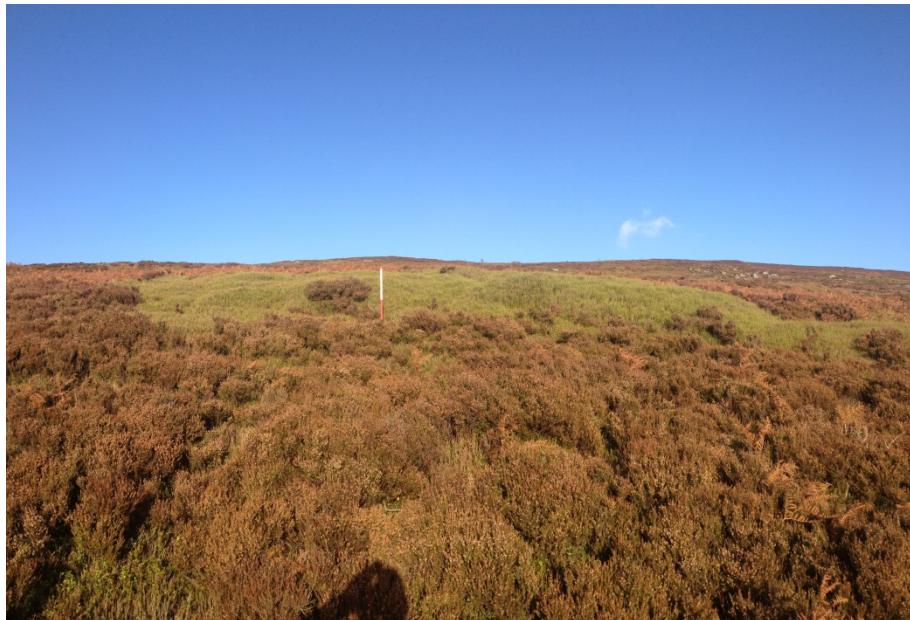
noticeable change in vegetation from the surrounding heather which may represent buried remains locally altering the pH or drainage. Basic probing confirmed that the lighter vegetation covered a roughly circular stone mound and its position, visible from below on a false crest, is common to Late Neolithic – Bronze Age cairns. The second potential cairn (7) is more truncated and comprises loosely-packed stone, c.8m in diameter, positioned on a plateau south of Lord's Seat.

Fig. 2 Probable round cairn below Cloven Crag evident partly through differential vegetation cover.

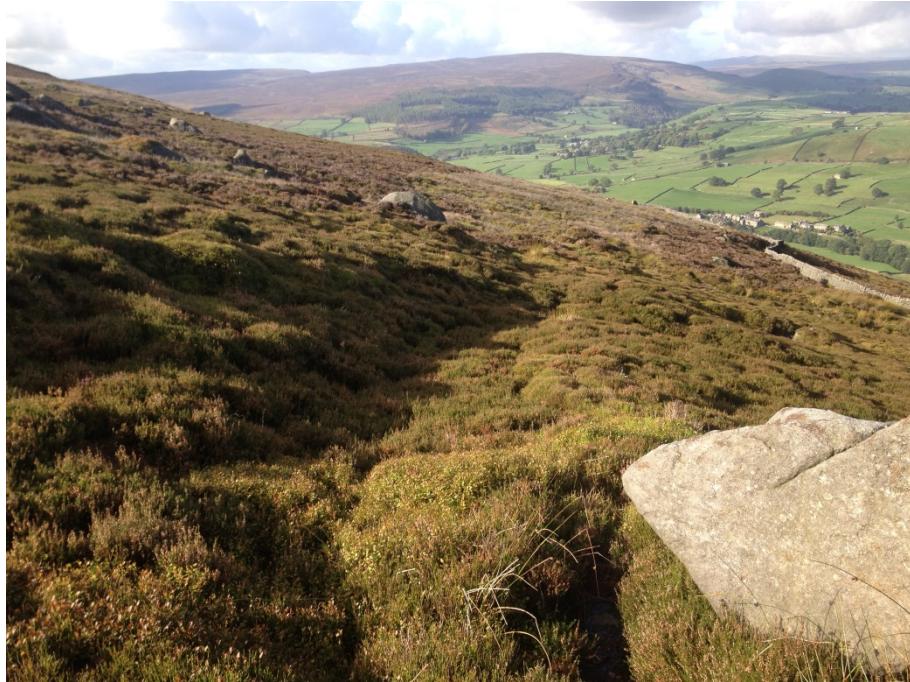
Fig. 3 Hollow way north of Simon's Seat providing access to and from the areas of quarrying close to the moorland boundary wall.

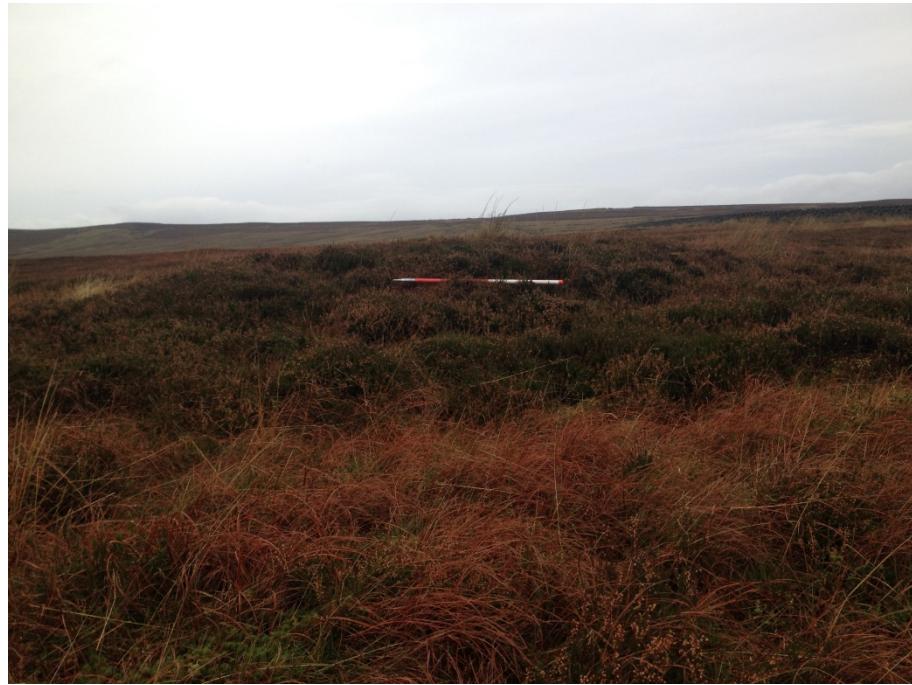
Fig. 4 Large cairn at the east edge of the Hazlewood Moor survey area.

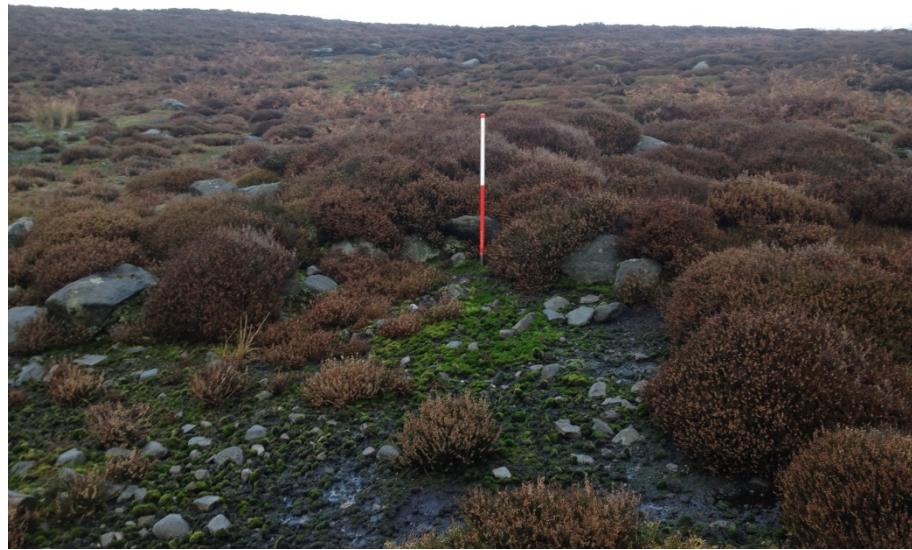
Fig. 5 Spread stone of a cairn on the southern flanks of Brown Hill in an area of peat erosion.

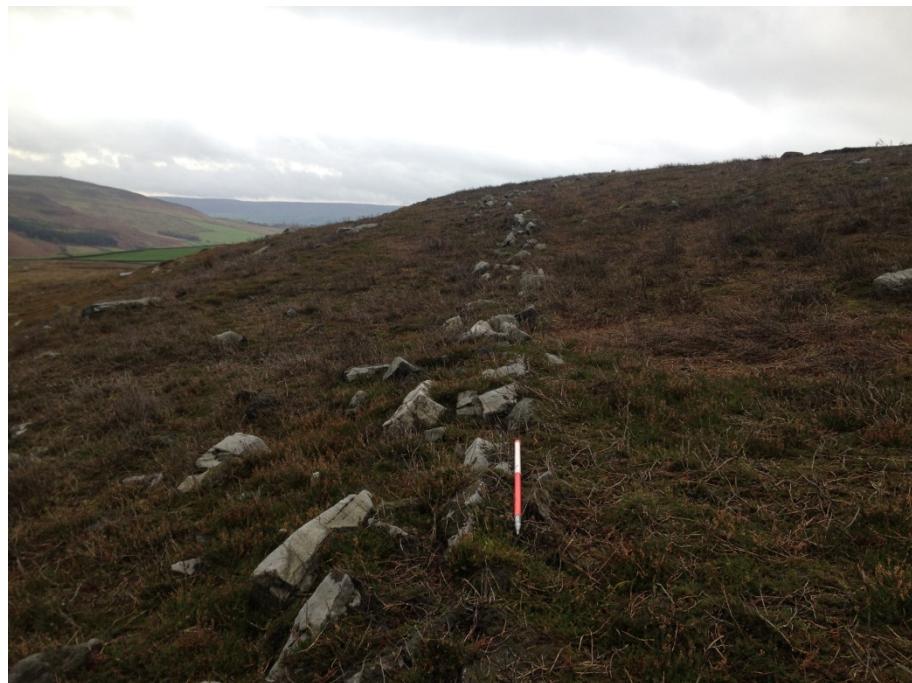
Fig. 6 Stone bank/wall of possible prehistoric date on the east side of Pike Stones Hill.

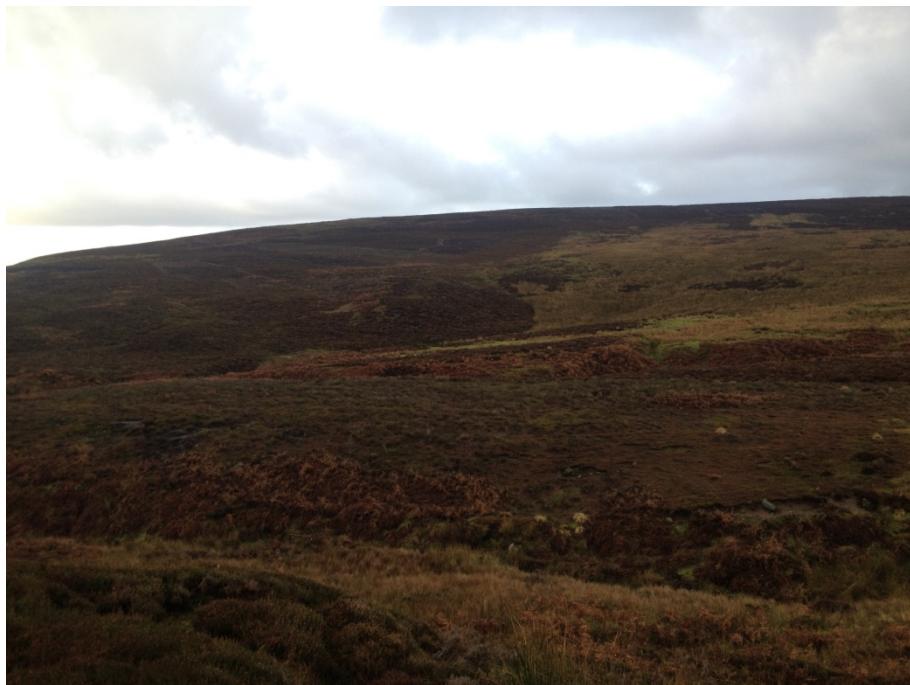
Fig. 7 The possible settlement at White Stones Green is located on the tongue in the middle distance before the land rises to Hazlewood Moor.

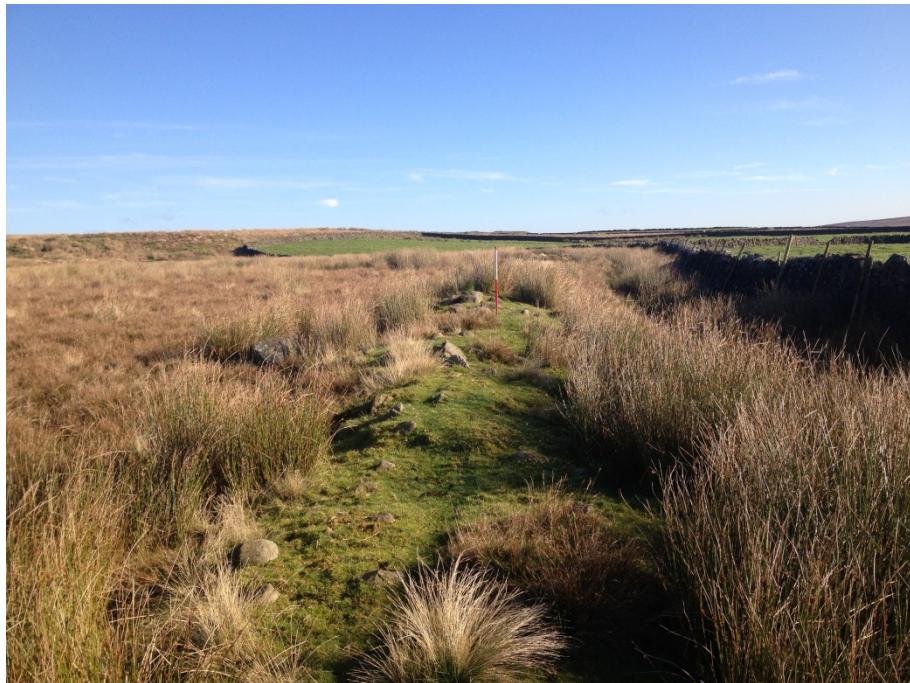
with this and similar activities. There is one feature which may pre-date the post-medieval use of the moor, an earth and stone bank (**62**) (Fig. 9) which reflects the line of the modern moor walling (or possibly *vice versa*). The bank is c.350m in length, averages 1-2m in width and c.0.5m in height. There were no other boundaries observed in the survey area with similar form, and there is the potential that it relates to a medieval boundary feature now largely lost.

Fig. 9 Earth and stone boundary feature in the south of the Hazlewood Moor survey area.

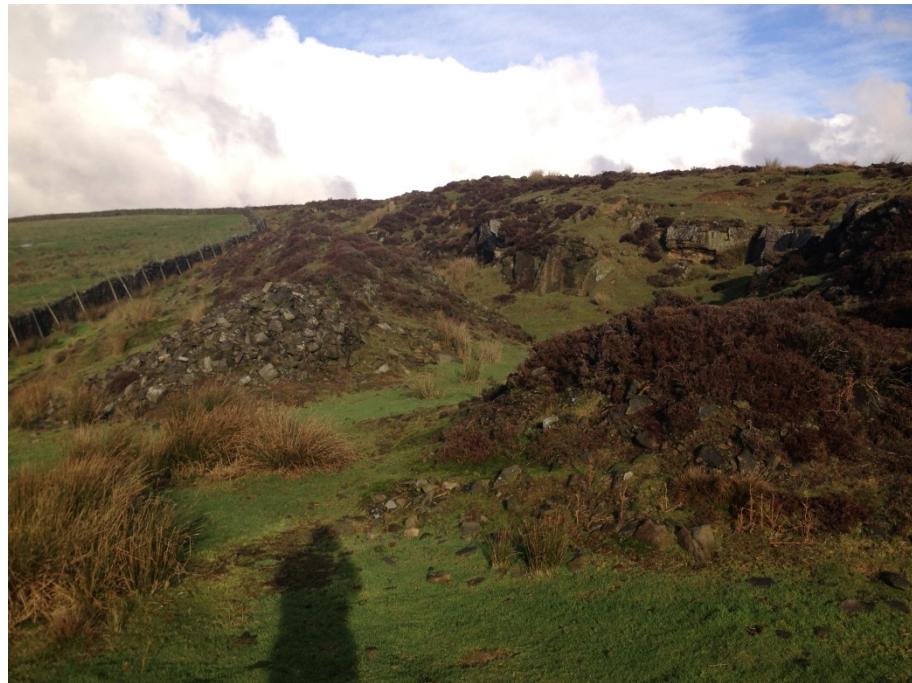
Fig. 10 Part of the Maidenkirk Quarry complex.

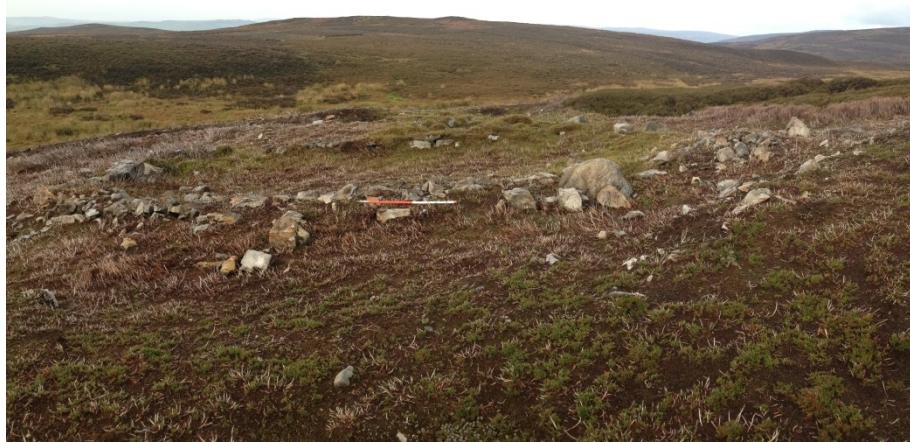
12). The placement of the building, in association with the hollow way overlooking the marshy confluence, means it is likely that all the features observed are of post-medieval date. The stone walls and associated hollow way have only been recently revealed by heather burning.

Fig. 12 Wall footings of a rectilinear stone building associated with the hollow ways at Incan Slade.

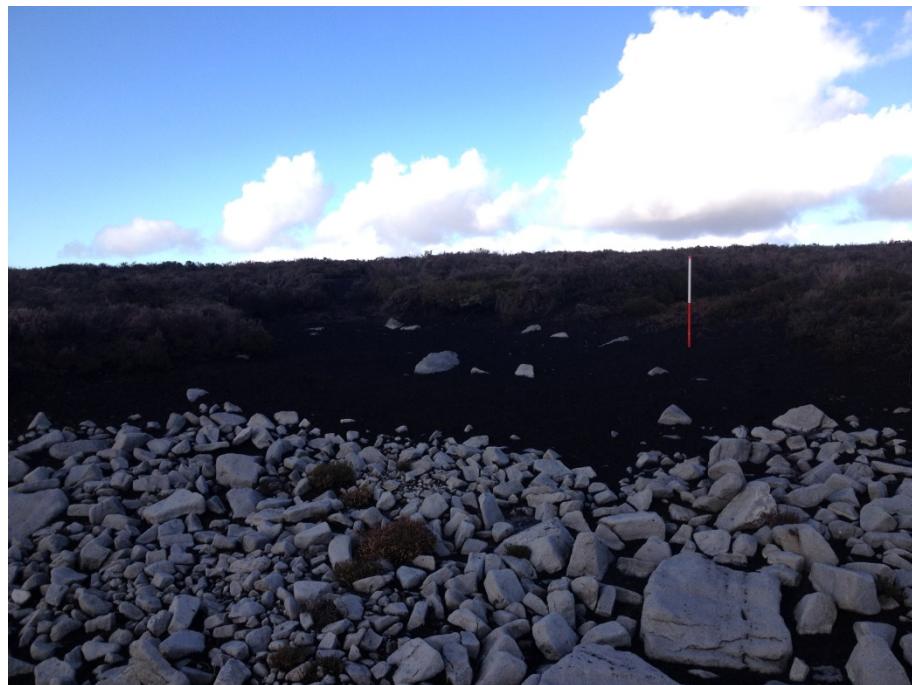
Fig. 13 Typical area of blanket exposure and erosion near Simon's Seat.

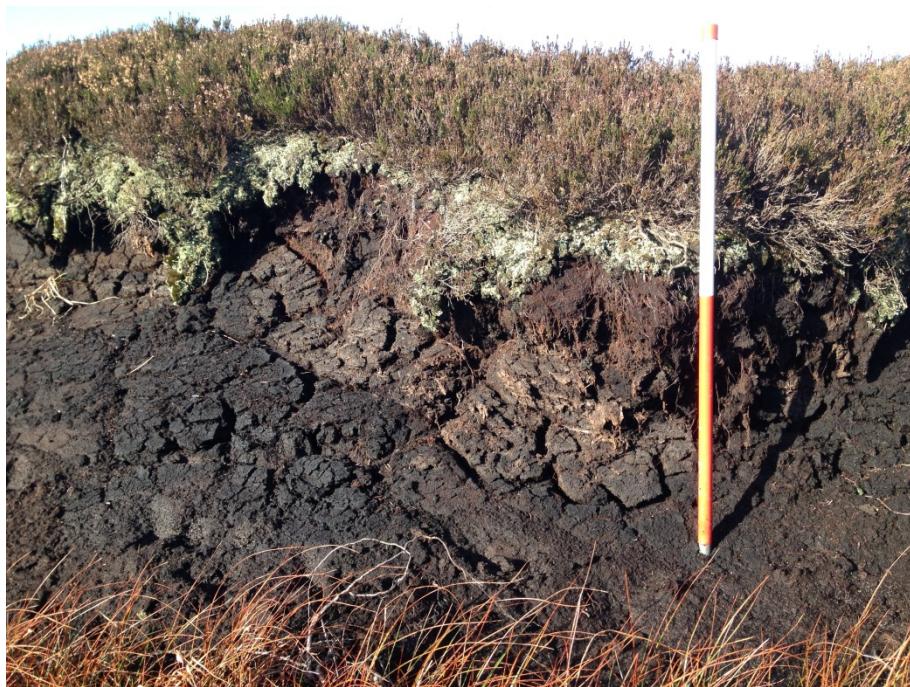
Fig. 14 Hagged peat near Simon's Seat and close to Section A (see below). Here a preserved organic material can be seen in the upper layers of the peat sequence.

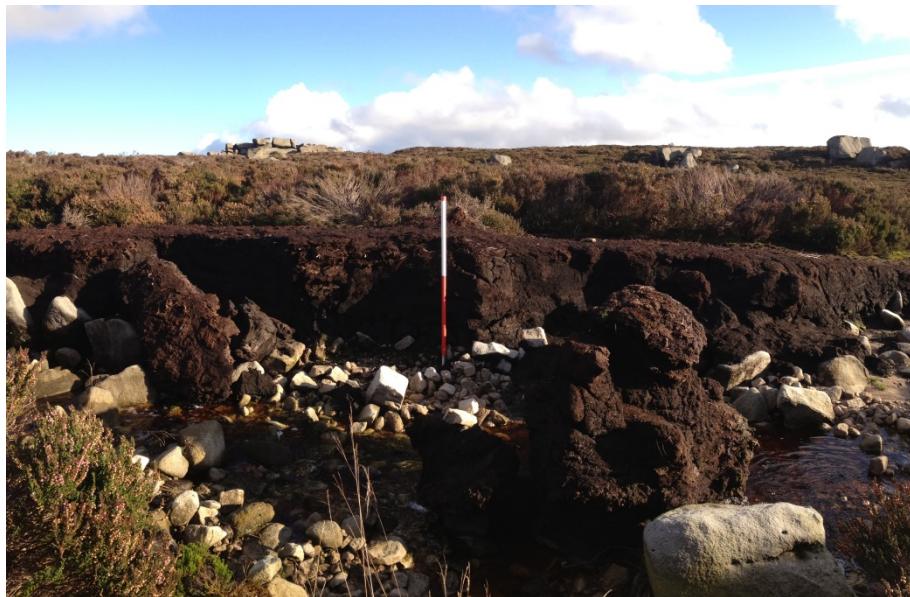
Fig. 15 Extensive and active erosion of a deep peat sequence on the edge of a gully at Agill Heads.

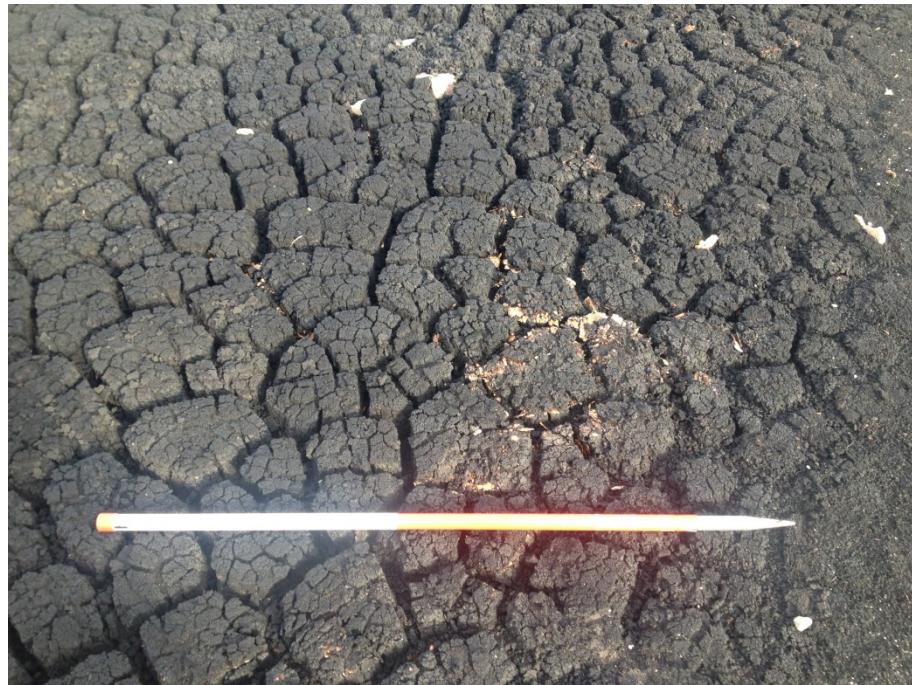
Fig. 16 Preserved organic material visible within a heavily dried and eroding carpet of peat near Little Agill Beck.

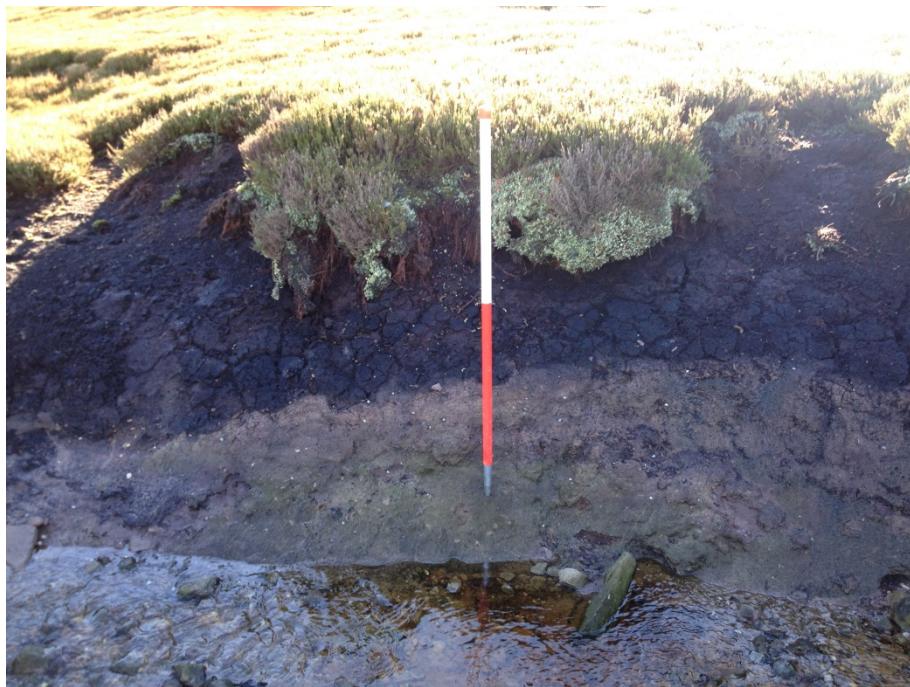
Fig. 17 One of the more developed areas of peat cover in the south of Hazlewood Moor south of Great Turmer Hill.
No clear horizons can be made out, but there is a clear delineation between the peat and the underlying till substrate.

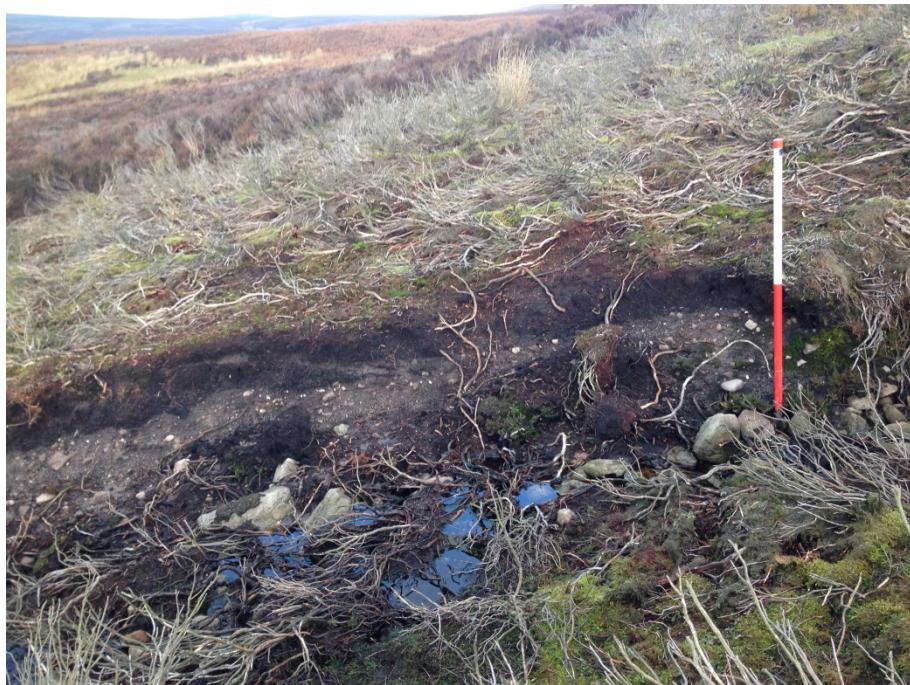
Fig. 18 Typical sequence of deposits for much of Hazlewood Moor with a thin and fibrous topsoil, a semi-developed peaty 'subsoil' and a mineral clay-heavy substrate.

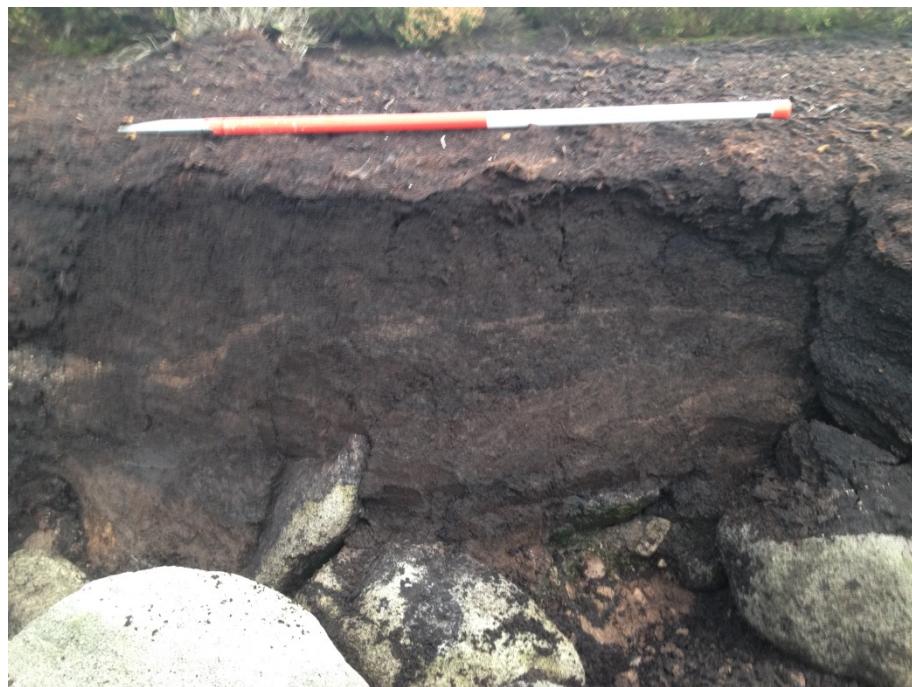
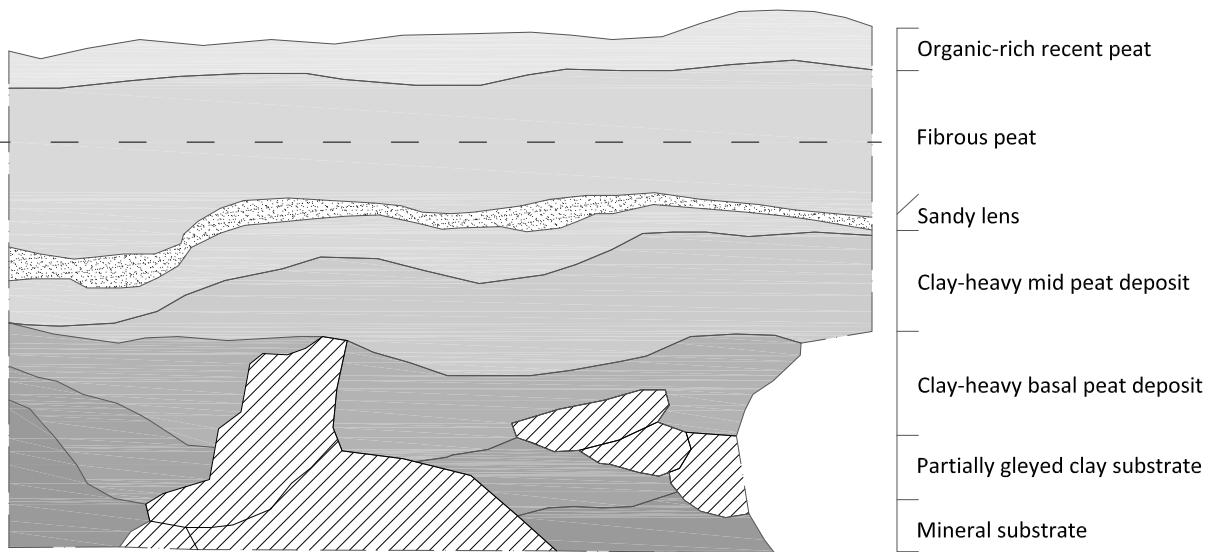
Fig. 19 Section A.

Section A (Figs 19, 24) was examined in the area of Great Agill Heads where the most complete deep peat deposits in the survey area were observed. It was part of an erosion scar cut by a fast-flowing tributary gully of Great Agill Beck and there was active erosion occurring within that gully as substantial blocks of peat were observed falling into the watercourse (Fig. 15 above). This section is also the most developed and complex peat sequence with at least four observable peat layers, potentially indicating different episodes of aggradation. Due to the level of erosion and its situation on the edge of a gully there is no modern vegetation and root mat layer at the top of this sequence.

The upper deposit is an organic-rich recent fibric peat layer where the composite rotting vegetation is still largely discernible and is c.0.06m thick. Beneath this there is a more-developed, though still fibrous, peat deposit similar in form to the upper peat observed in Section D (see below). This contains a substantial orange sandy lens towards its base, presumably relating to a single flooding deposition event during a period of peat accumulation. The upper peat deposit, including the sandy lens measures an average of c.0.25m thick. Beneath this upper peat there are two distinct deposits of well-developed peat with significant clay fractions presumably derived from the thin veneer of partially gleyed till substrate beneath. The two lower peat horizons measure a total of c.0.25m in thickness and the clay beneath is c.0.1m thick. Beneath the clay there is a mineral substrate derived from the weathering of the parent bedrock. The total depth of the peat sequence from the modern ground surface to the natural substrate was c.0.6m.

The proposed peat restoration will, by necessity, impact on the peat resource, principally through re-profiling of vertical faces and cutting of plugs for grip blocking. Although no artefacts or ecofacts were recovered as part of this survey, the peat deposits have the potential to contain significant palaeoenvironmental remains and also to seal archaeological deposits within buried horizons. Caution should be exercised during the restoration work and, where possible, it is recommended that excavations aim to not disturb soils or sediments beneath the peat horizons.

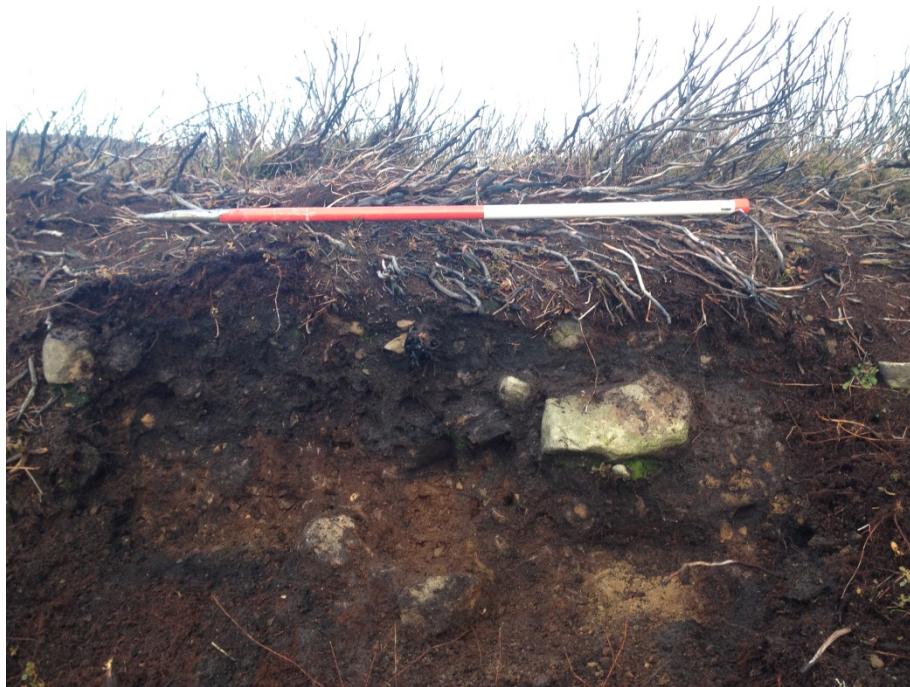
Fig. 21 Section C.

Section C (Figs 21, 25) was examined on the high ground immediately north of Pickles Gill in an area of recently burnt heather. This illustrates a stratigraphic sequence which is typical of much of Hazlewood Moor, where a spongy, peat-like 'A' or 'O' horizon overlies a developed 'subsoil' with some fibrous peaty content providing the organic fraction within the deposit. In this area there is a mineral substrate comprising rough orange sandy clay, probably deriving from a combination of weathered bedrock and sub-glacial till deposits. In total, the 'active' layers above the natural substrate had a total depth of c.0.5m from the modern ground surface.

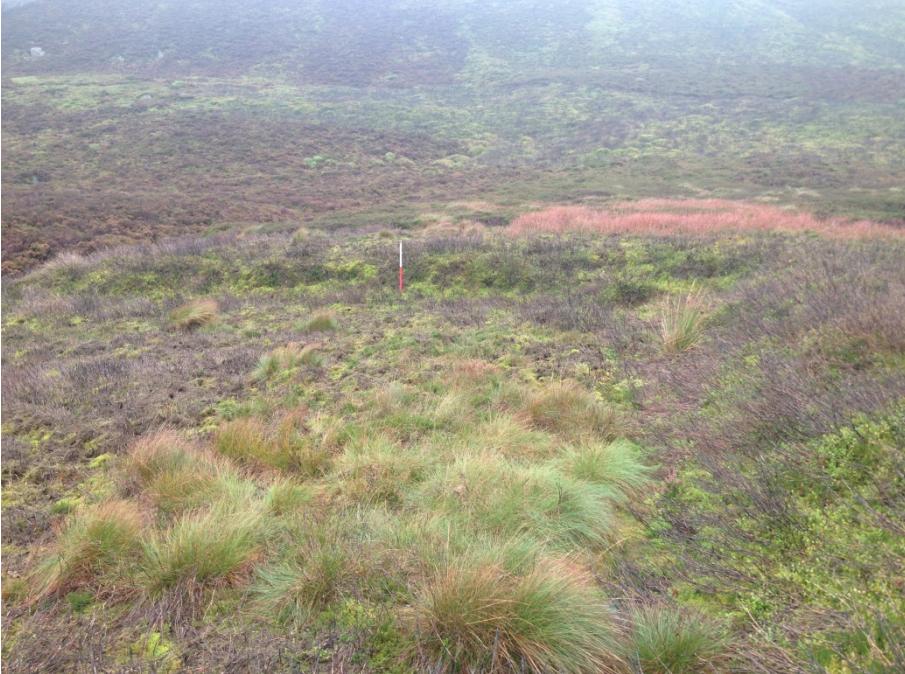
Project UID(s)	3, 4, 5
HER No	-
Site Name	-
Site Type	Monument
Monument Type	Quarry
Period	Post-medieval
Summary	Scattered quarry scoops ranged along the northern boundary of the survey area on the steep downslope north of Simon's Seat. These tend to lie close to the enclosure-period wall and it is likely they are 18 th -19 th century in date and originally provided ready stone for the walling in this area.
Image

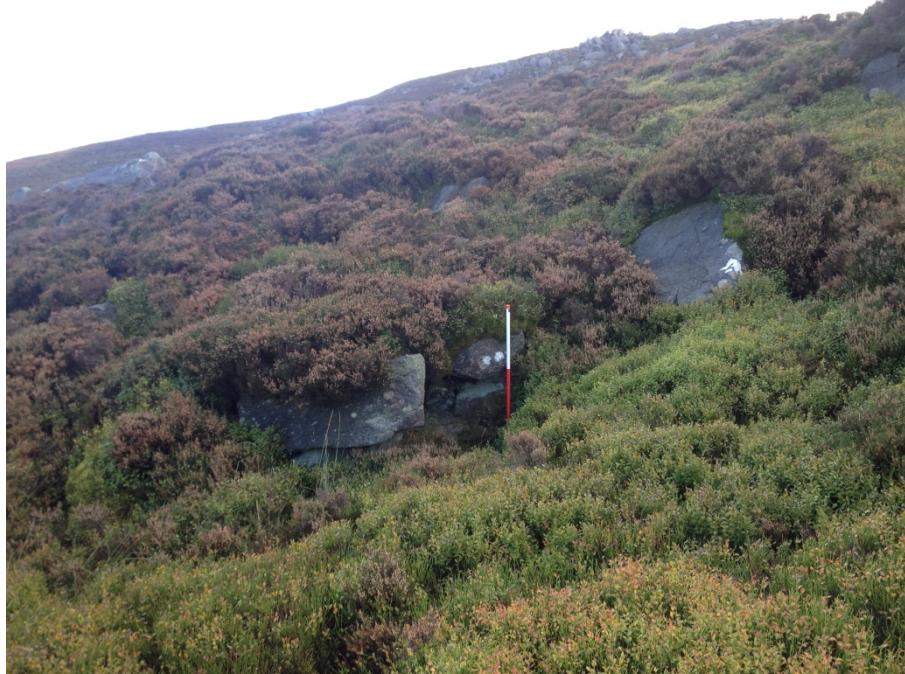
Project UID(s)	6
HER No	-
Site Name	-
Site Type	Monument
Monument Type	Quarry
Period	Post-medieval
Summary	Area of possible quarry hollows and delves near Lord's Seat. Unknown date and some of the hollows may be augmented natural depressions.
Image

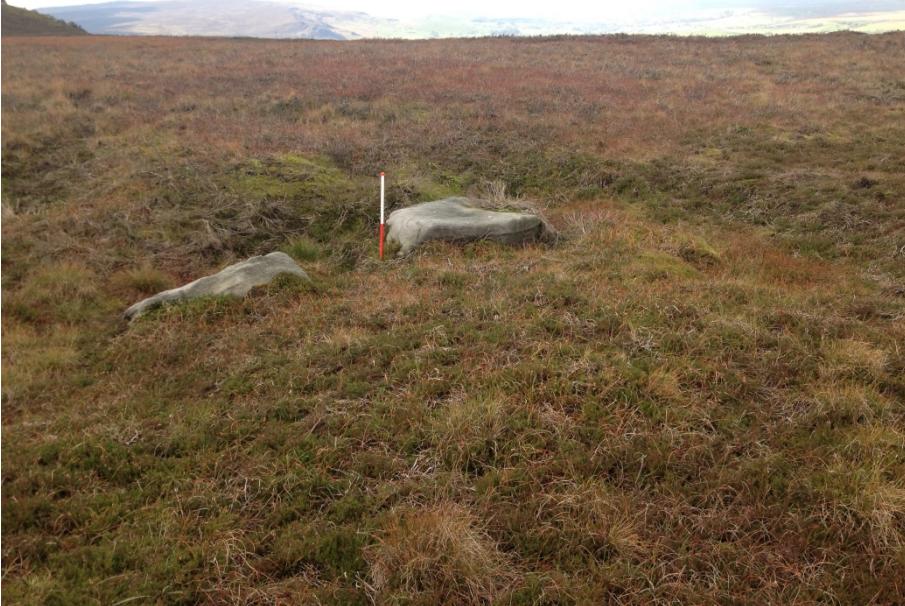
Project UID(s)	7
HER No	-
Site Name	-
Site Type	Monument
Monument Type	Cairn
Period	Unknown
Summary	Small cairn of unknown, though potentially prehistoric, date. The stones that comprise the cairn are fairly loosely bound together so there is a potential that this represents a more-recent clearance cairn.
Image

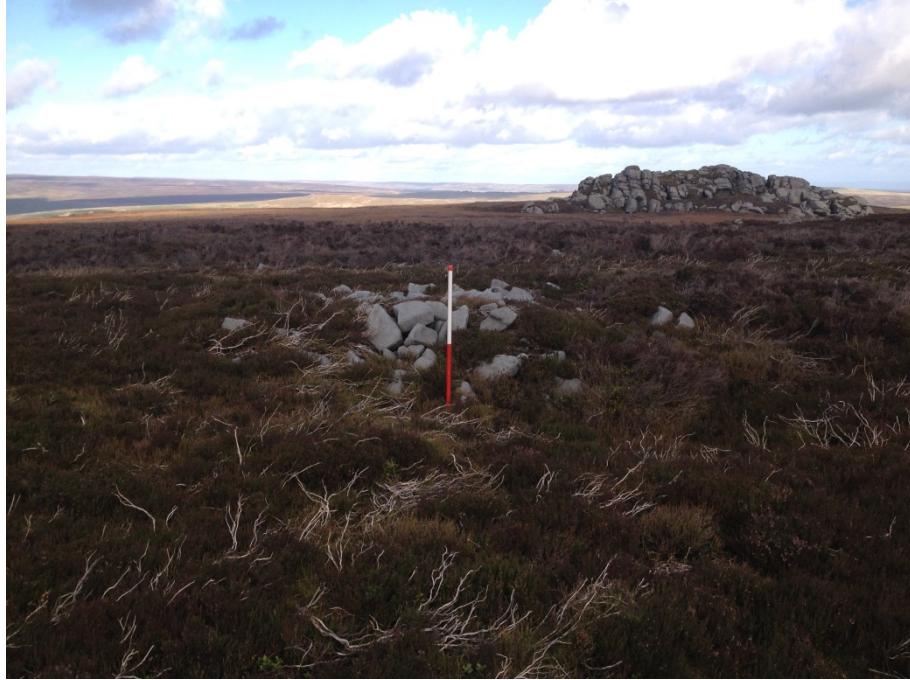
Project UID(s)	8
HER No	-
Site Name	-
Site Type	Monument
Monument Type	Quarry
Period	Post-medieval
Summary	Large area of quarrying on the moortop between Henstones and Lord's Seat. Quarried face still evident and, more-recently, some stone has been dumped in the quarry.
Image

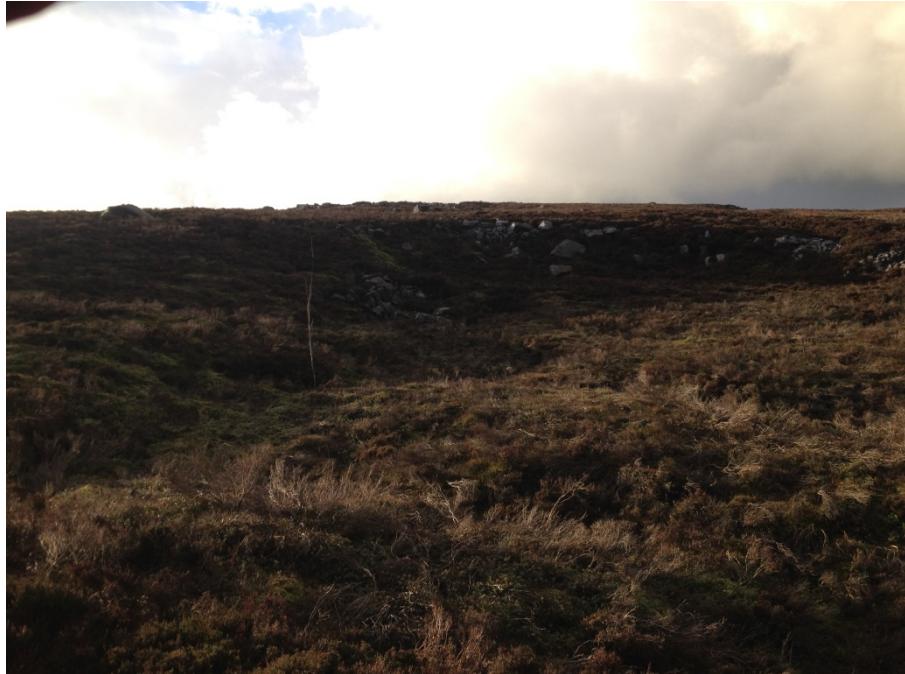
Project UID(s)	9
HER No	-
Site Name	-
Site Type	Monument
Monument Type	Cairn
Period	Prehistoric
Summary	Small, possibly prehistoric cairn. Now largely overgrown with heather and soil aggradation though the well-set stones are visible in places. Positioned on a high point above Calfley Gill with wide visual aspects in all directions. Some of the stones have been moved to accommodate a small grouse feeder on the top of the cairn.
Image

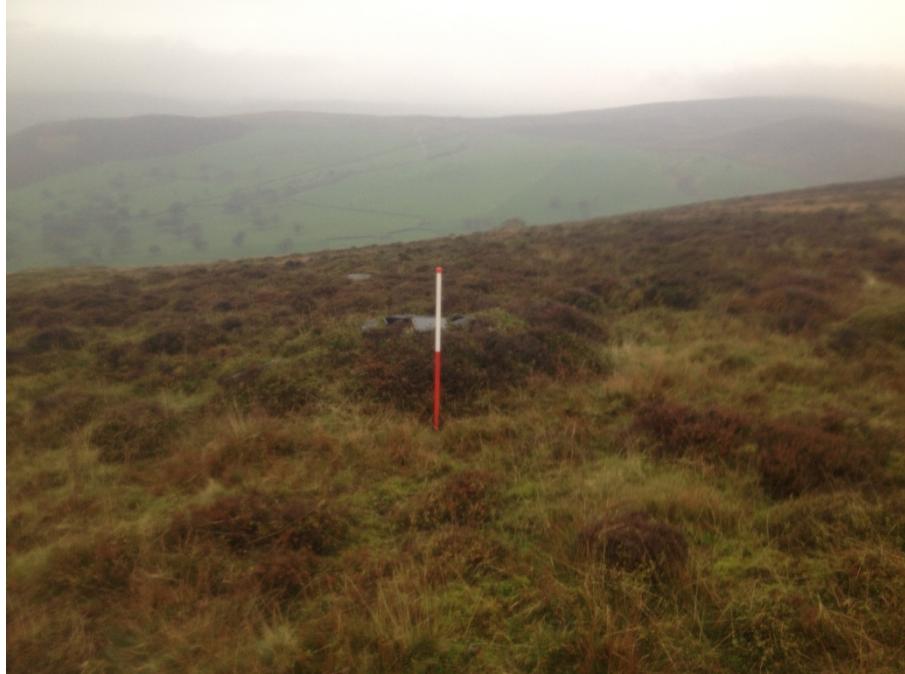
Project UID(s)	10, 17, 59
HER No	-
Site Name	-
Site Type	Monument
Monument Type	Quarry
Period	Post-medieval
Summary	Area of quarrying representative of many of the small delves and hollows along Pickles Gill. This large quarried area sits below Noska Brow and a trackway links it to other areas of extraction and dressing further up the gill.
Image

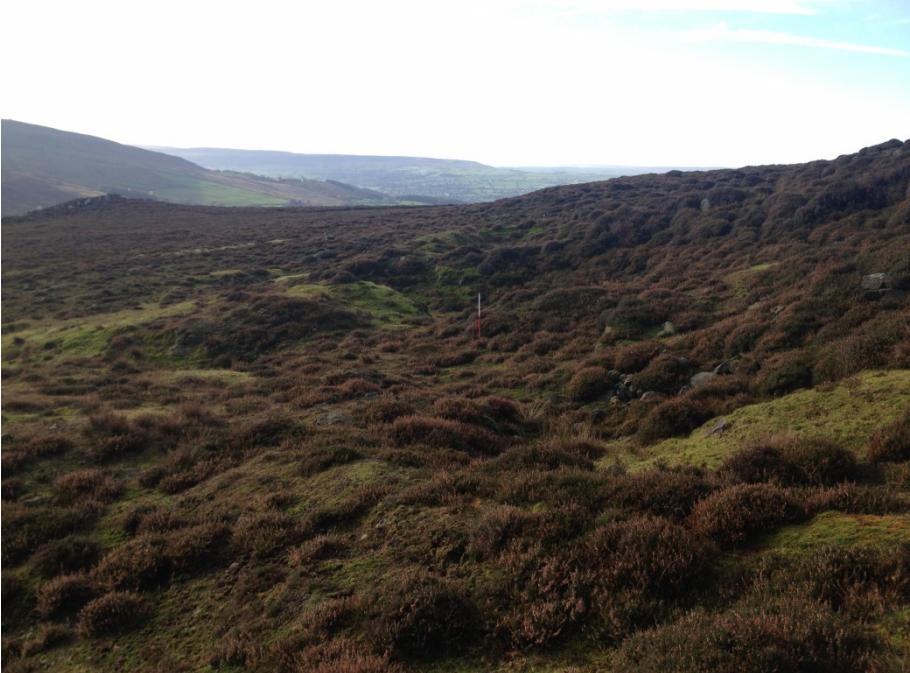
Project UID(s)	14, 41, 43, 48
HER No (s)	MYD43243, MYD14833, MYD14834
Site Name	Maidenkirk Quarries
Site Type	Monument
Monument Type	Quarry
Period	Post-medieval
Summary	Series of post-medieval quarries surviving as earthworks and including associated spoil and a series of trackways and hollow ways providing access from the south.
Image (s)

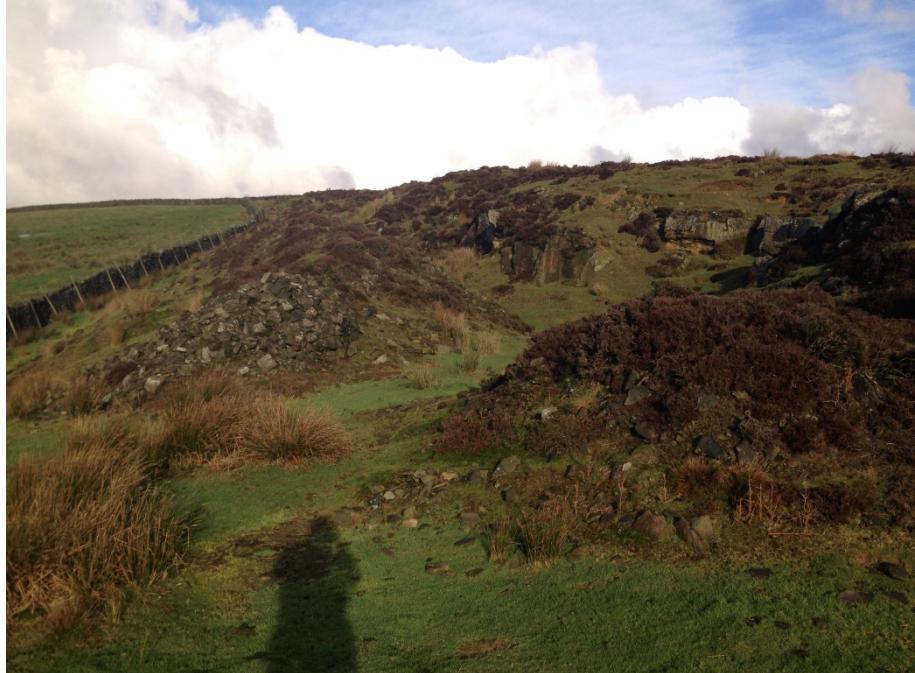
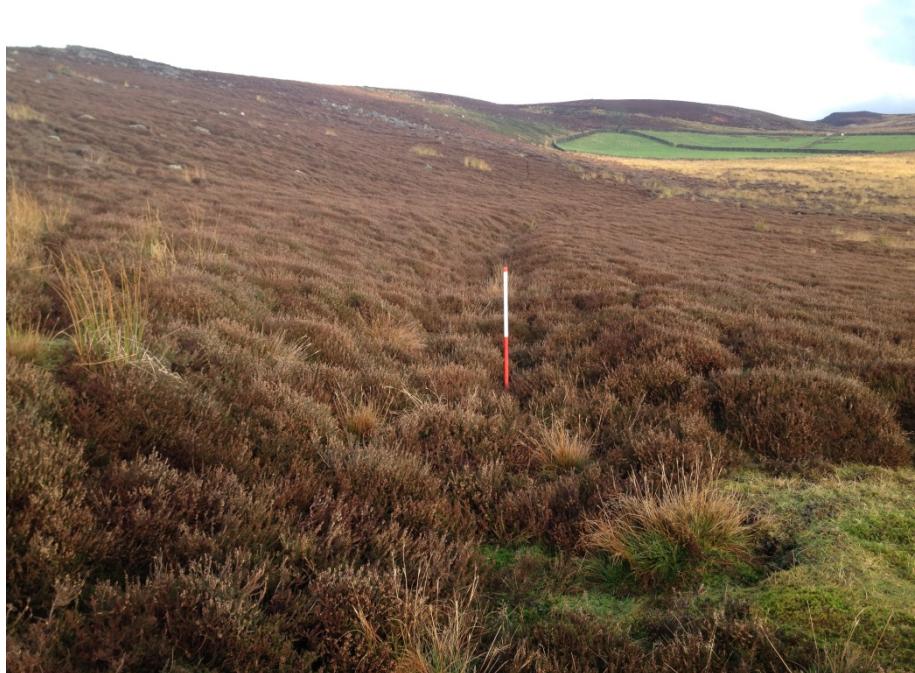
Project UID(s)	15, 50
HER No	MYD17723
Site Name	Old Pike Quarry
Site Type	Monument
Monument Type	Quarry
Period	Post-medieval
Summary	Two adjacent areas of quarrying of on a prominence to the east of Hey Shaw Slack. Extant as earthworks and including quarried blocks of gritstone in the larger area.
Image

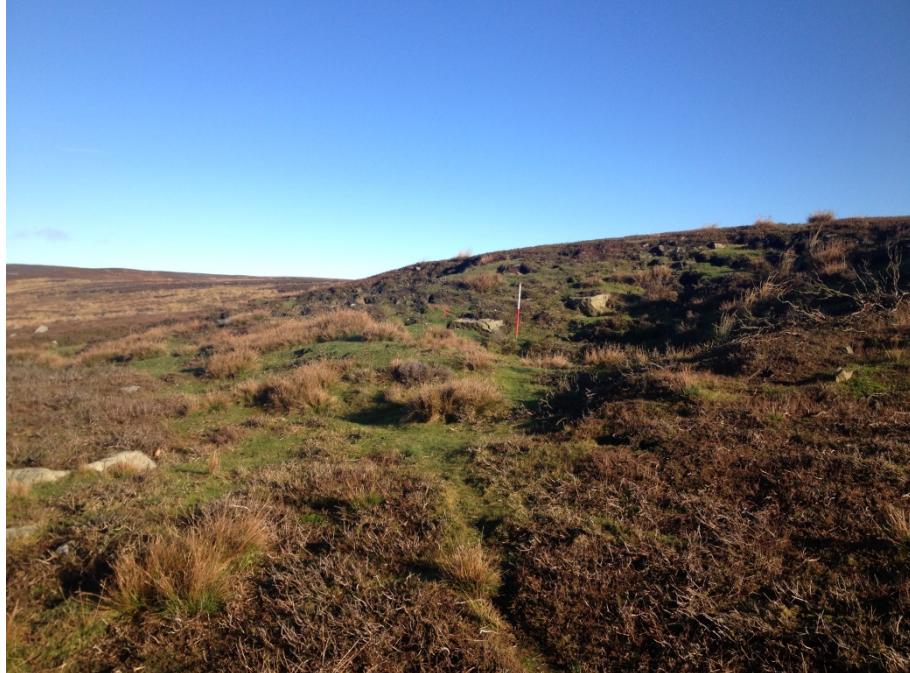
Project UID(s)	16
HER No	-
Site Name	-
Site Type	Monument
Monument Type	Spoil Heap
Period	Post-medieval
Summary	Substantial area of spoil tipping on the southern side of Pickles Gill, presumably associated with the dressing of quarried or other extracted material both along the gill and in the surrounding area.
Image

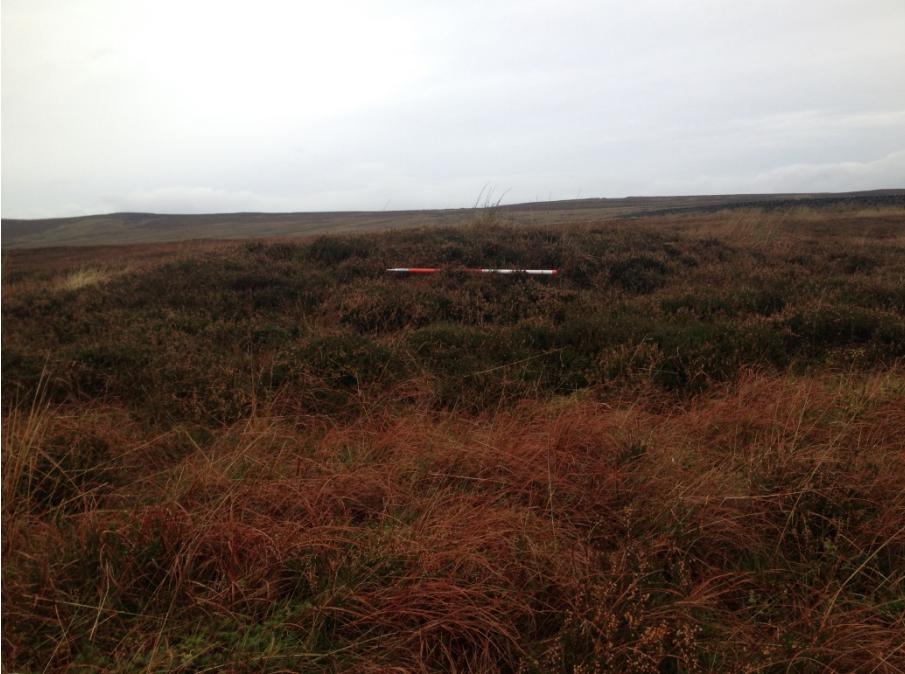
Project UID(s)	19
HER No	-
Site Name	-
Site Type	Monument
Monument Type	Shooting Stand
Period	Post-medieval to Modern
Summary	Rough semi-circle of stones c. 4m in diameter. Most likely represents a former grouse butt which has become ruinous. Similar in form to the nearby feature 21 .
Image

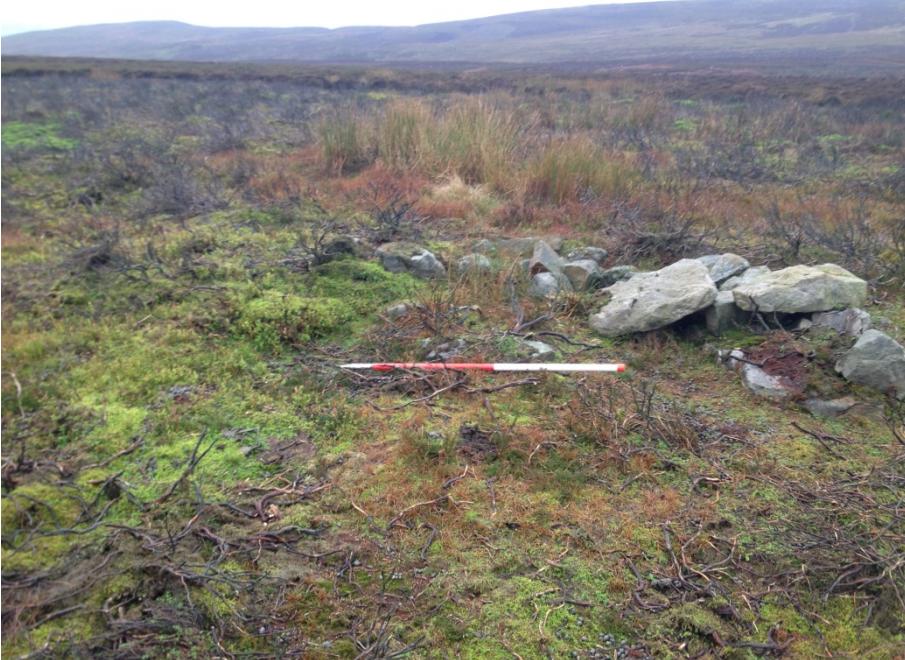
Project UID(s)	20
HER No	-
Site Name	-
Site Type	Monument
Monument Type	Cairn
Period	Prehistoric
Summary	Possible prehistoric cairn, sub-circular in shape and measuring c. 10m x 8m and c. 1m in maximum height in the centre. Currently overgrown with grass and heather and very similar in form to feature 18 (described above), which site close by.
Image

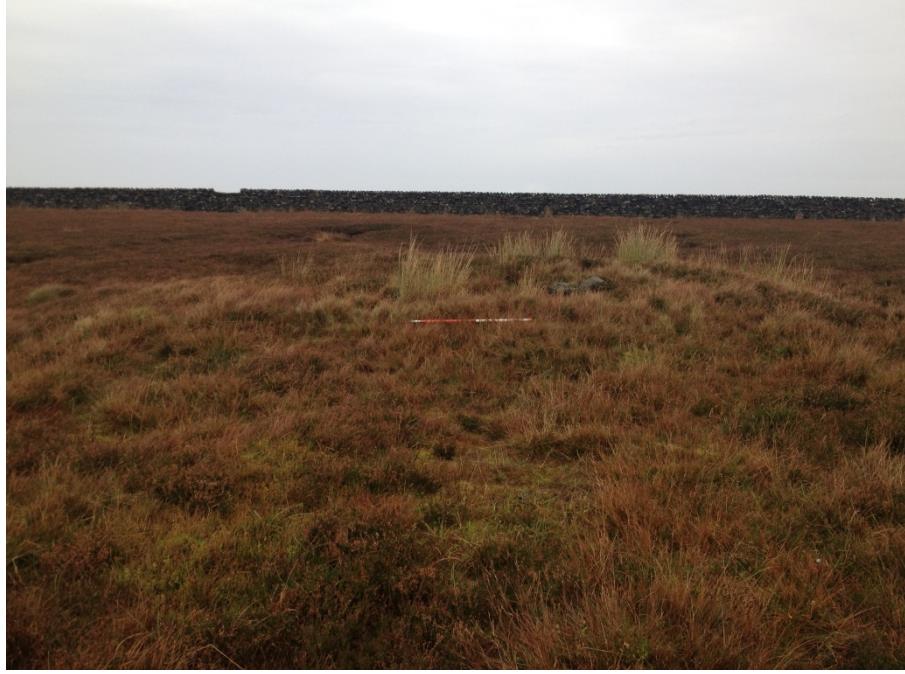
Project UID(s)	21
HER No	-
Site Name	-
Site Type	Monument
Monument Type	Shooting Stand
Period	Post-medieval to Modern
Summary	Rough semi-circle of stones c. 4m in diameter. Most likely represents a former grouse butt which has become ruinous. Similar in form to the nearby feature 19 .
Image

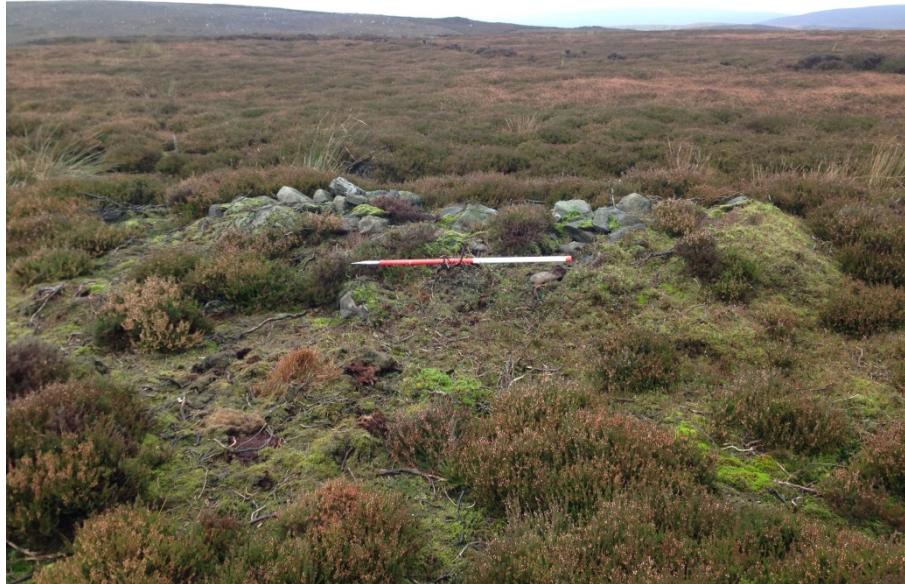
Project UID(s)	22, 67, 68, 135
HER No	-
Site Name	-
Site Type	Monument
Monument Type	Quarry
Period	Post-medieval
Summary	Series of small quarry scoops and delves on a raised prominence overlooking the marshy confluence at Incan Slade, associated with a prominent series of hollow ways (67, 68, 135) and facing the hollow way (26) and small building footing (65) on the north side of Incan Slade. Along with these other features, likely to represent a concentration of, probably, post-medieval activity in the immediate area.
Image
