Historic Environment Survey and Palaeoenvironmental Assessment
Barden Fell and Hazlewood Moor
Final Project Report

Peat Restoration Historic Environment Survey and Palaeoenvironmental Assessment: Barden Fell and Hazlewood Moor

Final Report

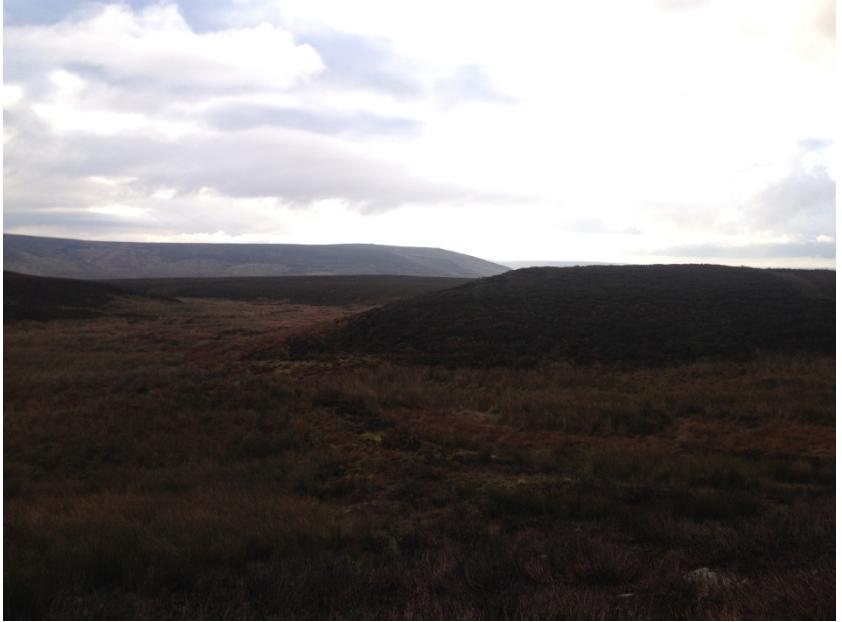
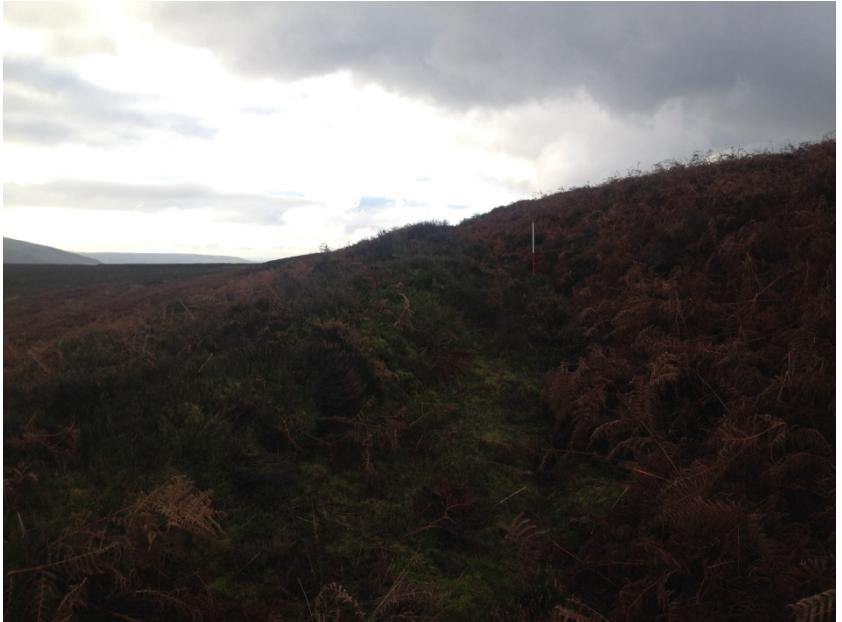
Project UID(s)	23
HER No	-
Site Name	-
Site Type	Monument
Monument Type	Cairn
Period	Prehistoric
Summary	Small, stone-built cairn in a prominent position on the plateau east of Rotten Hill. Probably of prehistoric date and quite small, measuring c. 5m x 4m in plan. The stones forming the body of the cairn are well-set.
Image

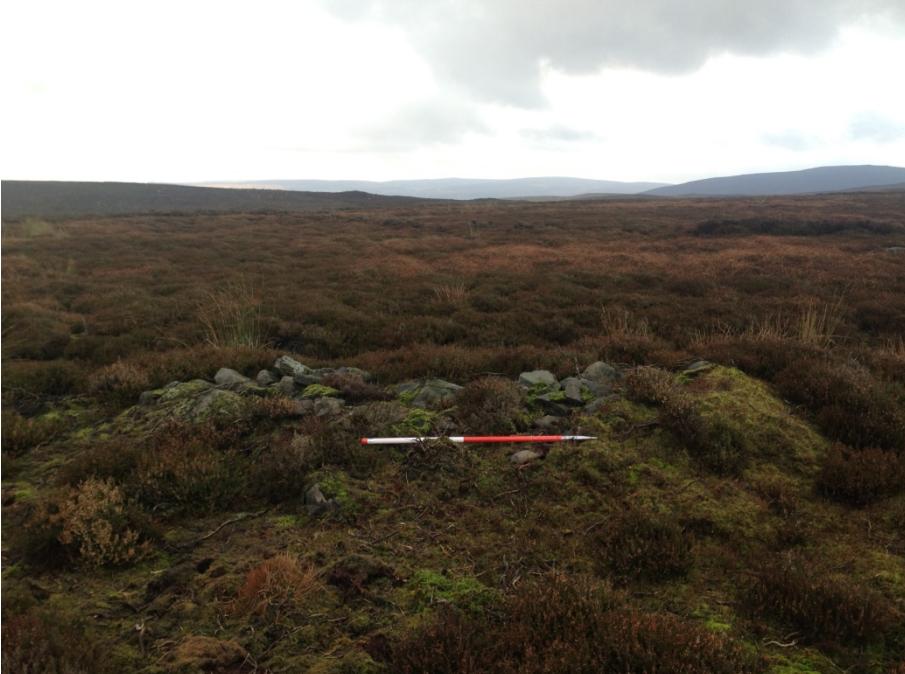
Project UID(s)	24
HER No	-
Site Name	-
Site Type	Monument
Monument Type	Cairn
Period	Prehistoric
Summary	Small cairn of possible prehistoric date on the south-facing crest of Rotten Hill. Measuring c. 5m in diameter, there has been significant aggradation of soil and peat cover over the stones and the feature was identified due to it lying in an area which has been relatively recently burnt off.
Image

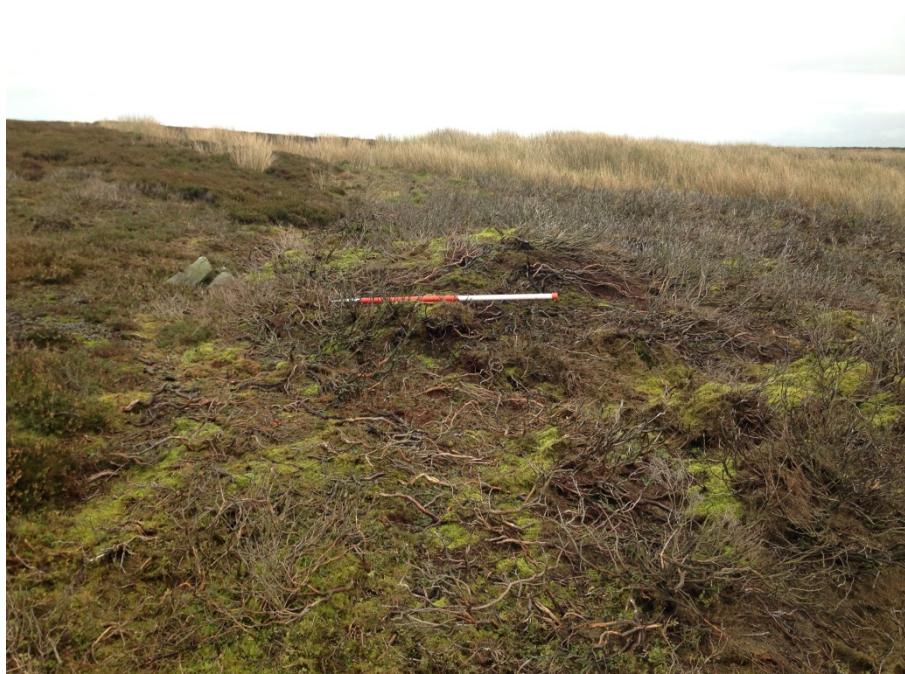
Project UID(s)	26
HER No	-
Site Name	-
Site Type	Monument
Monument Type	Structure
Period	Medieval to Post-medieval
Summary	Rough stone footing of a rectilinear structure measuring c. 13m x 8m. The building sits on the high ground north of Incan Slade overlooking the marshy area where a series of hollow ways and trackways (66, 67, 135) converge around a number of quarry scoops and delves (22). The surviving walling is rough with no evidence of mortaring, and using only coarsely dressed or undressed material. The building sits in an area described by a hollow way (65) and probably served as shelter for those undertaking quarrying and other activity in the immediate area.
Image

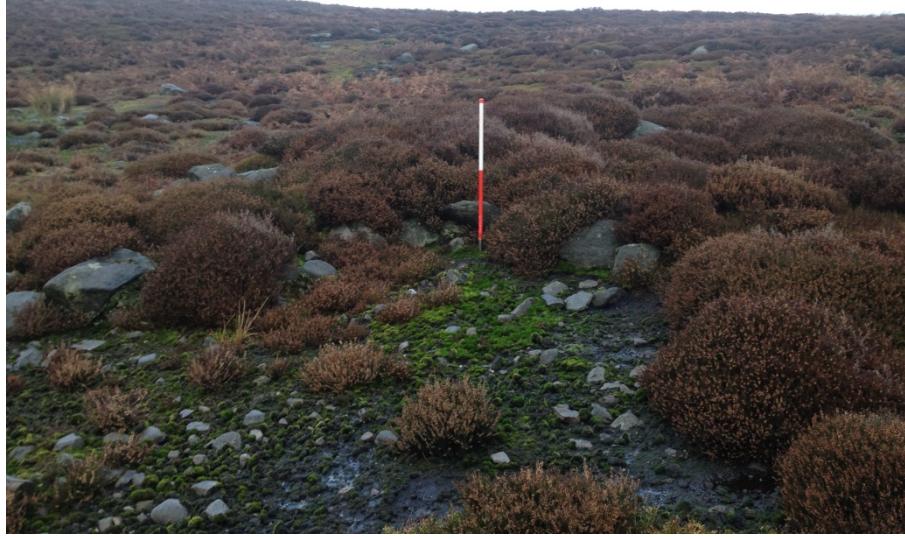
Project UID(s)	28
HER No	-
Site Name	-
Site Type	Monument
Monument Type	Cairn
Period	Prehistoric
Summary	Possible cairn of potential prehistoric date partially exposed as well-set stonework at the edge of a recently burnt section of moor. The cairn material is relatively well-spread and the overall dimensions of the cairn in plan are c. 7m x 6m.
Image

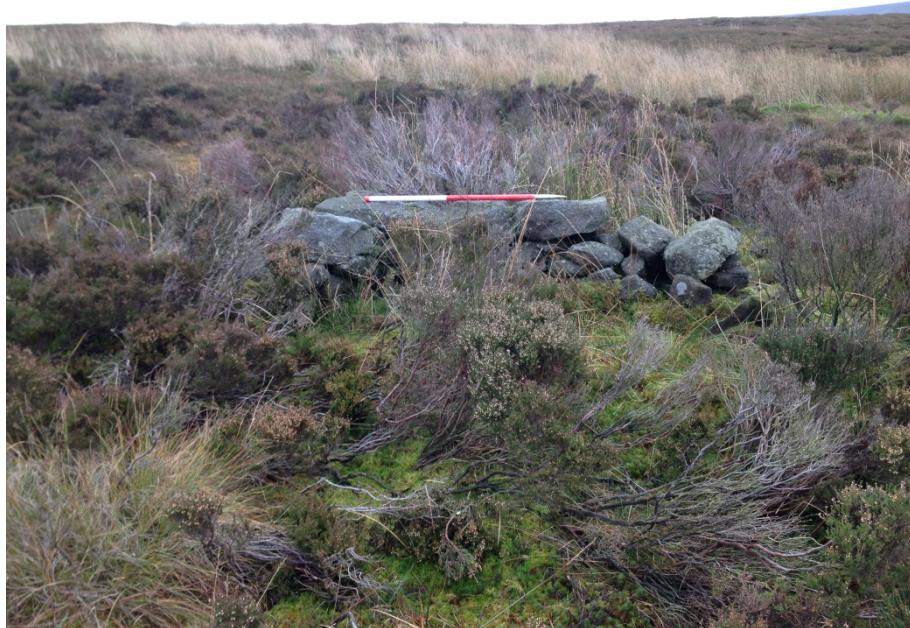
Project UID(s)	30
HER No	-
Site Name	-
Site Type	Monument
Monument Type	Structure
Period	Late Prehistoric
Summary	Stone footing of a rectilinear structure on a tongue between two gills at White Stones Green, associated with a hut circle (31) and a fragmentary enclosure bank/wall (75). The rectilinear structure measured c. 15m x 10m in plan, with up to two possible entrances signified by breaks in the south-west long wall. The walls were substantial, up to 1m thick with turf cover, and some portions of the wall appeared to have an orthostat style of construction with large, flat uprights forming the external and internal faces.
Image

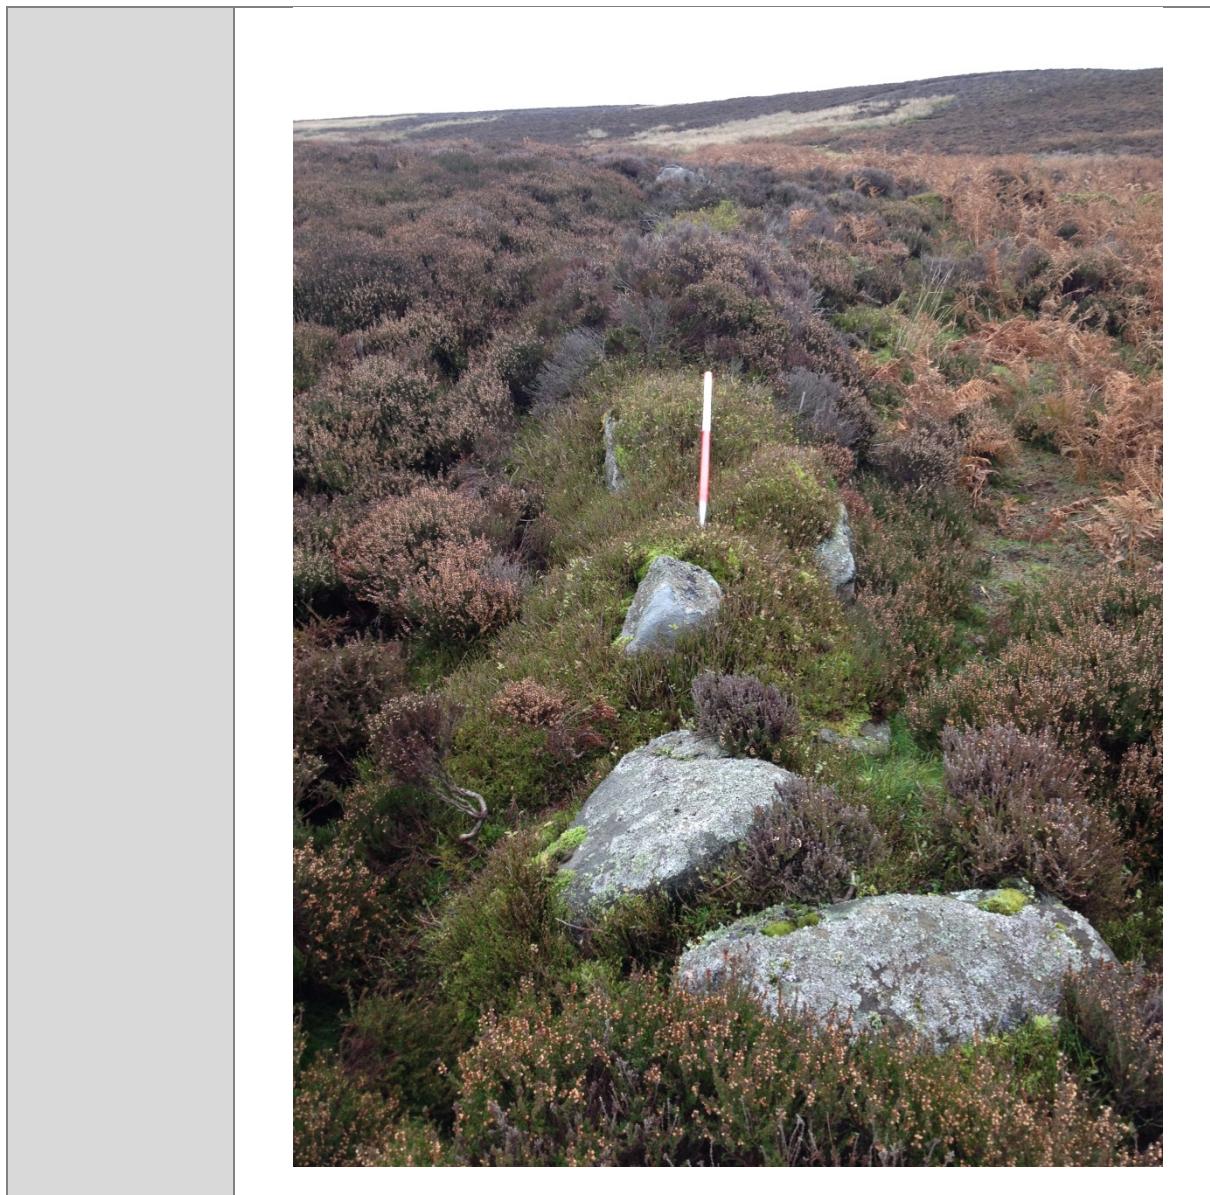
Project UID(s)	31
HER No	-
Site Name	-
Site Type	Monument
Monument Type	Hut Circle
Period	Prehistoric
Summary	Remains of a well-defined but overgrown hut circle on a tongue between two gills at White Stones Green. The hut circle is part of a small settlement or concentration of activity associated with rectilinear structure (30) and an enclosure bank/wall (75). The hut circle measured c. 9m in diameter and the wall was a low footing comprising some large, rough single blocks of stone where visible. No discernible entrance.
Image

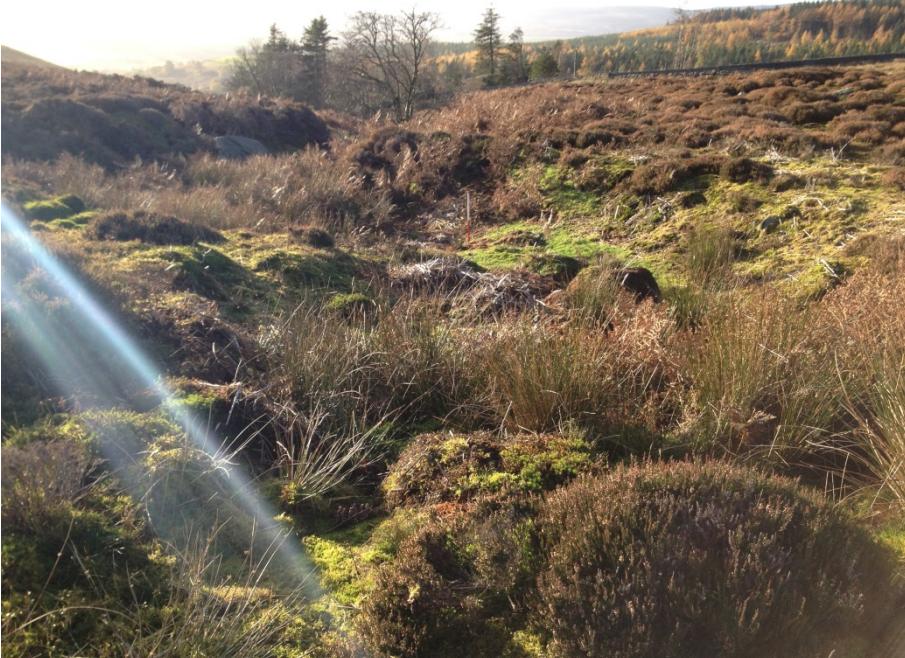
Project UID(s)	37
HER No	MYD14730
Site Name	-
Site Type	Monument
Monument Type	Lime Kiln
Period	Post-medieval
Summary	Earthwork remains of a relatively small field lime kiln. It is now largely gone but the depression of the main chamber can be discerned, as can the draw hole channel facing downslope towards the adjacent trackway.
Image

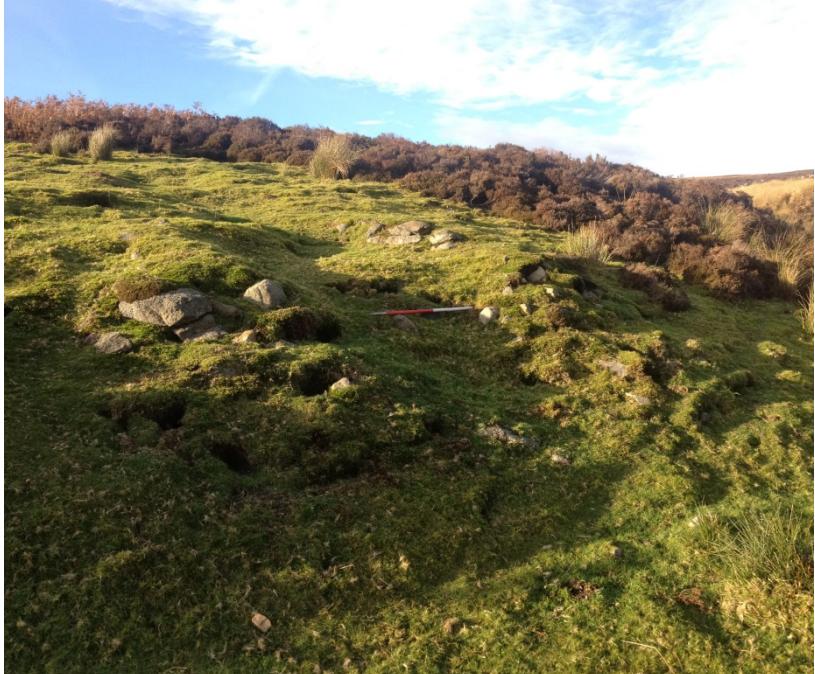
Project UID(s)	38
HER No	-
Site Name	-
Site Type	Monument
Monument Type	Cairn
Period	Prehistoric
Summary	Possible cairn of potential prehistoric date occupying a false crest south of Cloven Crag. The cairn comprises a slightly raised area, roughly oval, measuring c. 16m x 11m, and defined by a change in vegetation from the surrounding heather. Beneath the aggradation of peat and soil there is a stone mound of some form discernible by probing.
Image

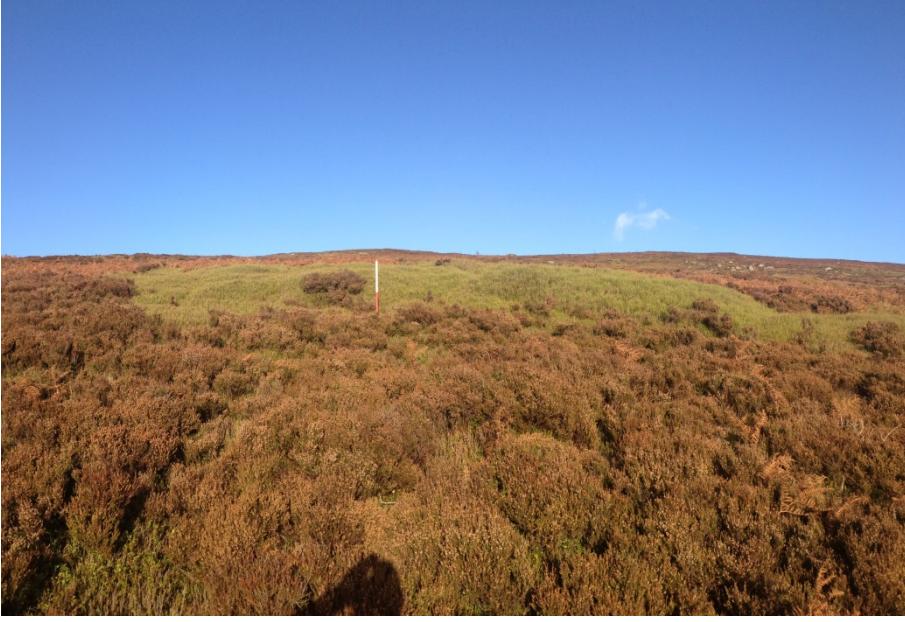
Project UID(s)	39
HER No	MYD4313
Site Name	Devil's Apronful
Site Type	Monument
Monument Type	Cairn
Period	Late Neolithic to Bronze Age
Summary	Large, well-defined, scheduled cairn sitting on the crest of the hill to the west of Simon's Seat. No new observations to those already given in the scheduled listing and HER summaries.
Image

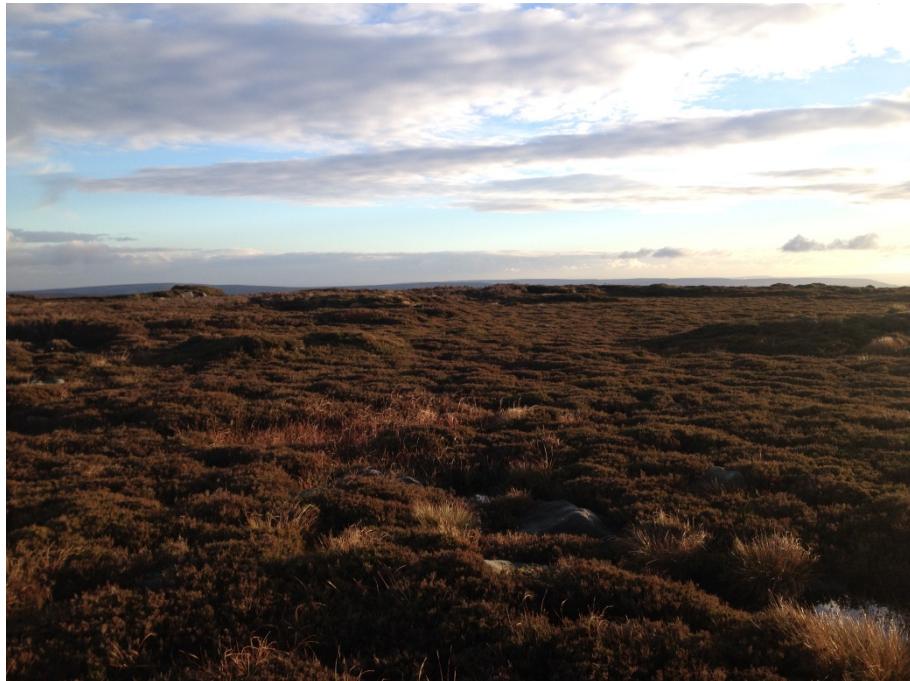
Project UID(s)	42, 44, 45, 46, 47
HER No	MYD41507
Site Name	Gill Bank Quarries
Site Type	Monument
Monument Type	Quarry
Period	Post-medieval
Summary	Group of disused quarries clustered around Gill Bank in the south-west corner of the survey area. Associated with a series of hollow ways, in particular (58) and (102).
Image

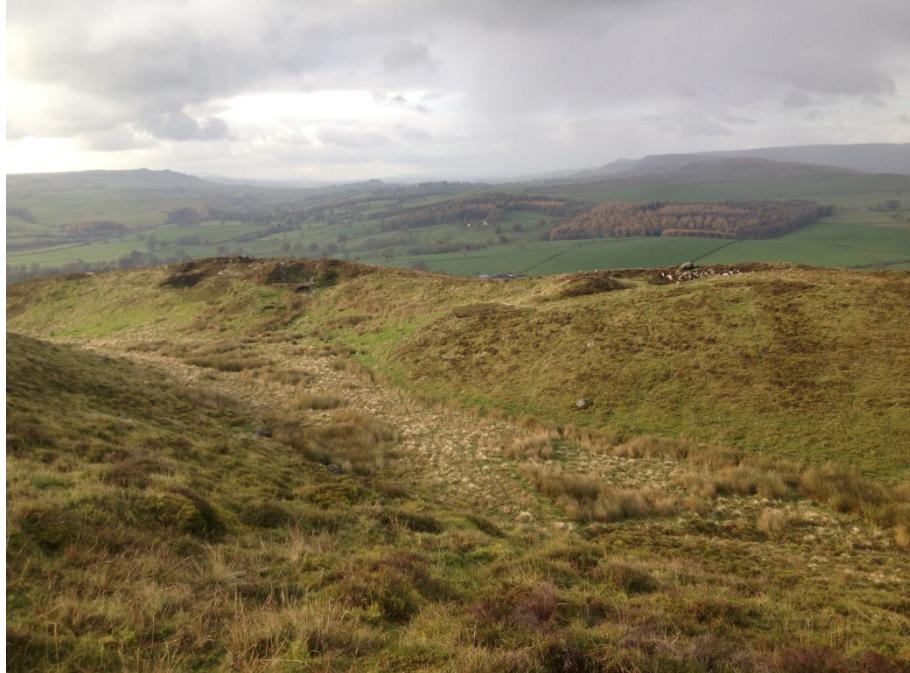
Project UID(s)	49
HER No	MYD17711
Site Name	Hey Shaw Intake Barn
Site Type	Building
Monument Type	Field Barn
Period	19 th century
Summary	Semi-ruinous field barn, heavily altered so now acting as a roofless animal shelter. The portion of the original barn still standing is constructed from well-coursed gritstone blocks with sandstone quoins, jambs and lintel with the yellower sandstone acting as a decorative feature.
Image

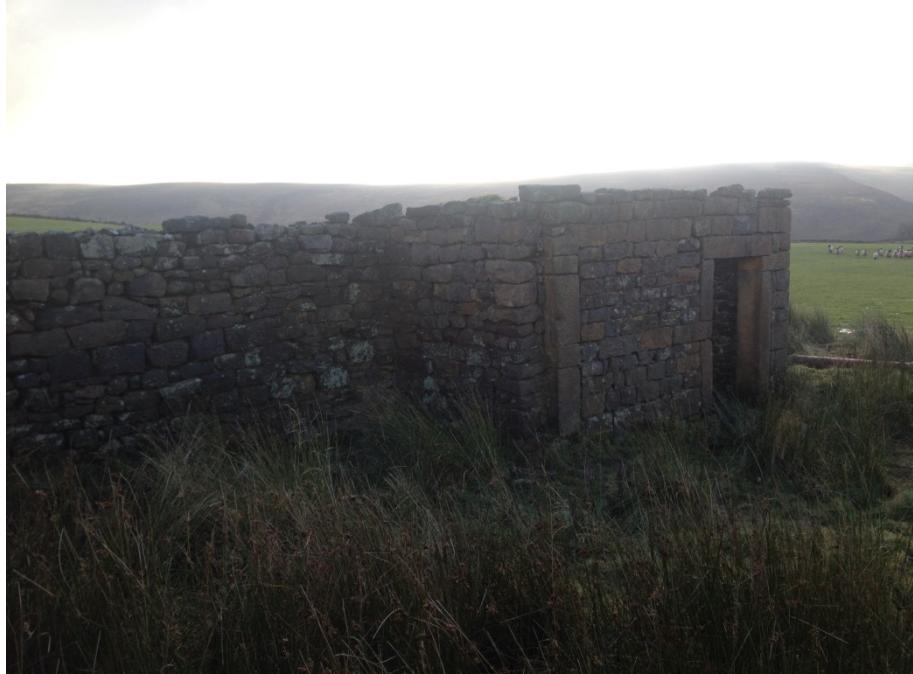
Project UID(s)	51
HER No	MYD14728
Site Name	-
Site Type	Monument
Monument Type	Sheepfold
Period	Post-medieval
Summary	Sheepfold built on two levels and into the steeply incised north slope of Pickles Gill at the main fording point. The walls are mainly in good condition and the fold may still be stockproof, though it is no longer in use.
Image

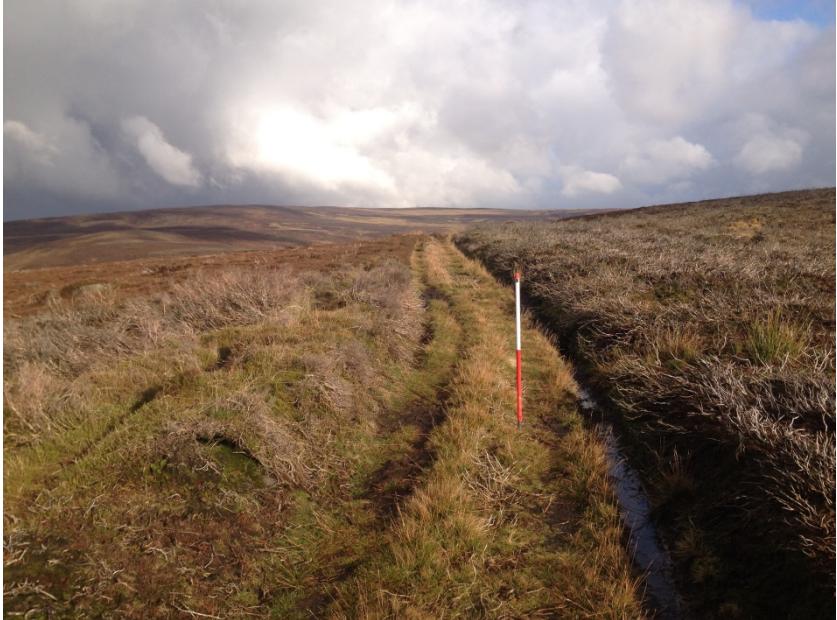
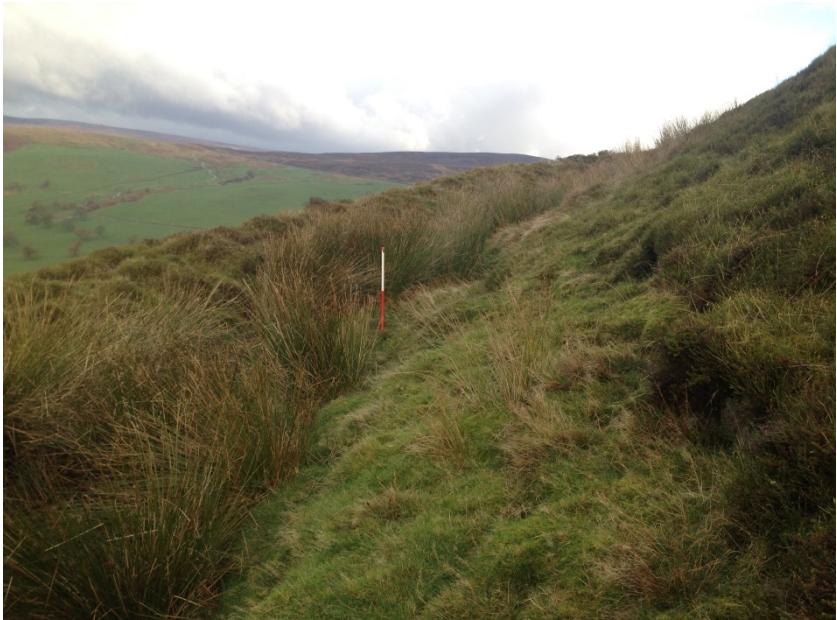
Project UID(s)	60, 61, 111-116
HER No	MYD41512
Site Name	-
Site Type	Monument
Monument Type	Hollow way, Trackway
Period	Medieval to Post-medieval
Summary	Series of braided and interlinked trackways and hollow ways serving the Maidenkirk Quarries south of Dib Intake. Surviving relatively well though with some of the trackways more pronounced than others.
Image

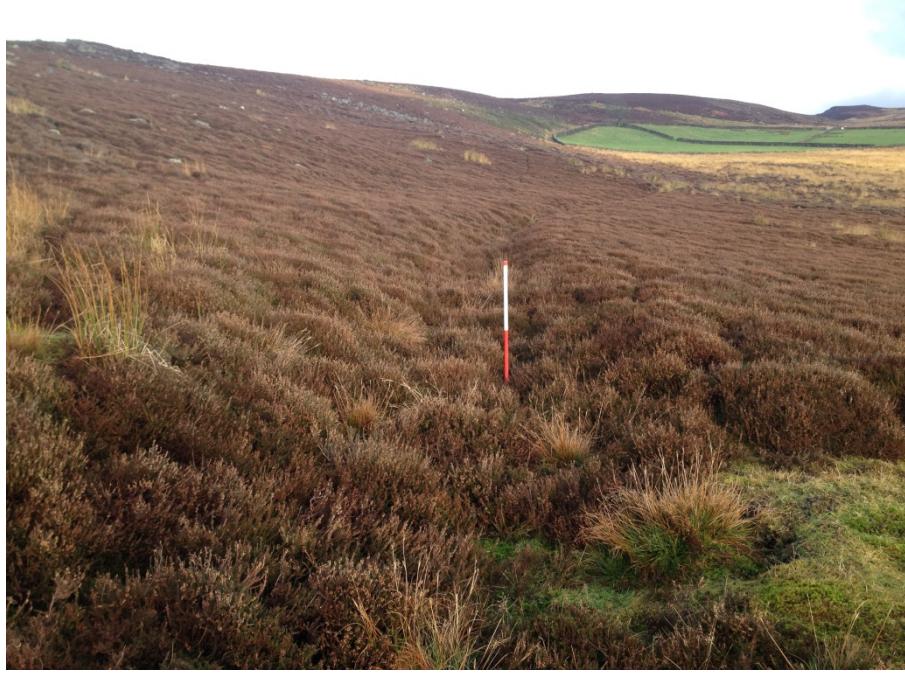
Project UID(s)	62
HER No	-
Site Name	-
Site Type	Monument
Monument Type	Bank
Period	Medieval to Post-medieval
Summary	Short length of earth and stone bank east of Maidenkirk running c. 35m along the southern boundary of the survey area. The bank is unlike any other boundary feature at the limits of the survey area, and it is possible that it is older, potentially representing the medieval land divisions. The bank is c. 2.5m in width at its widest point.
Image

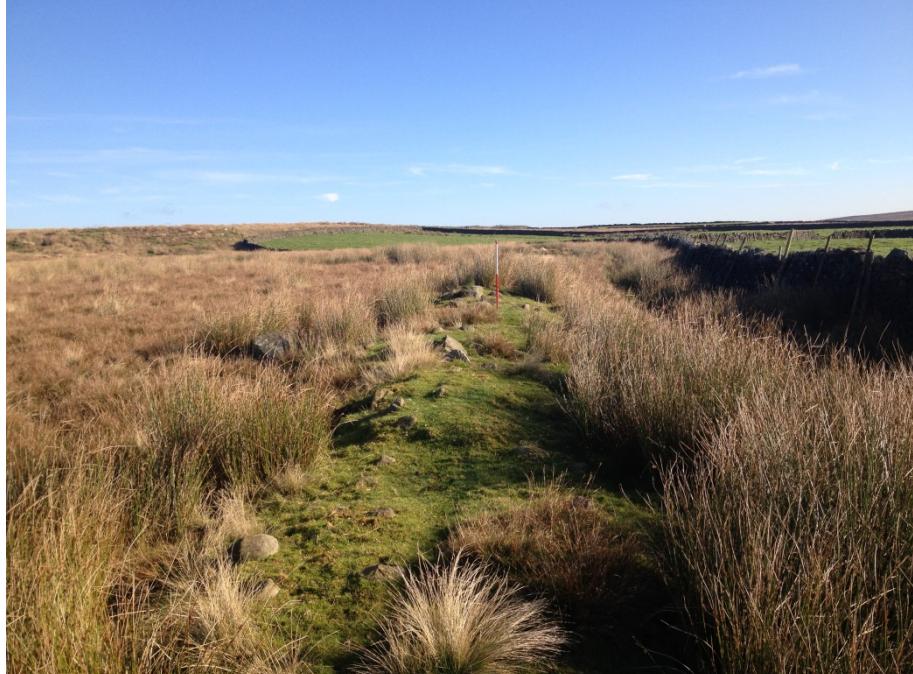
Project UID(s)	63, 64, 66, 70
HER No	-
Site Name	-
Site Type	Monument
Monument Type	Hollow way, Trackway
Period	Medieval to Post-medieval
Summary	Series of trackways and hollow ways which run roughly south-west to north-east around the west and north flanks of Winnhaugh hill, following the course of Pickles Gill, ultimately to cross Incan Slade at Doncaster Bridge or traverse Incan Slade Bents further north. In generally good condition, some are still used as foot access into the central parts of Hazlewood Moor.
Image

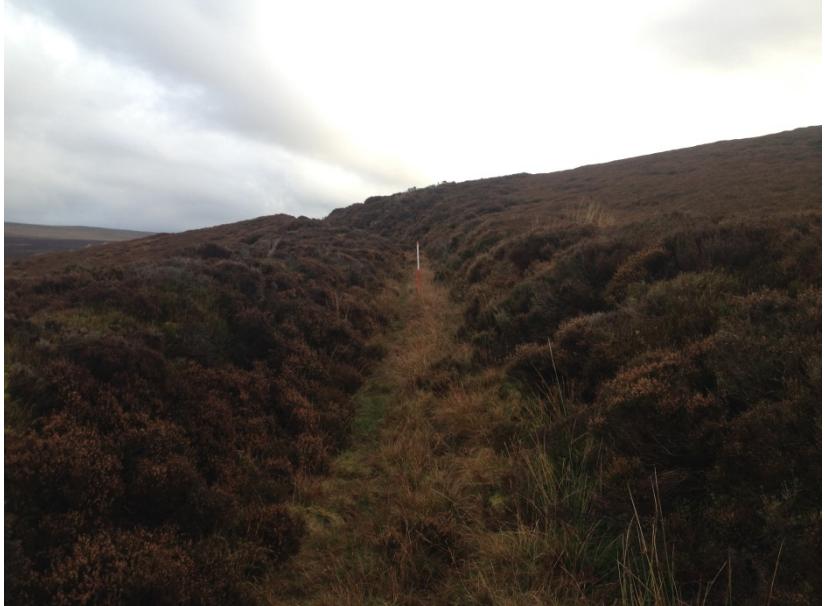
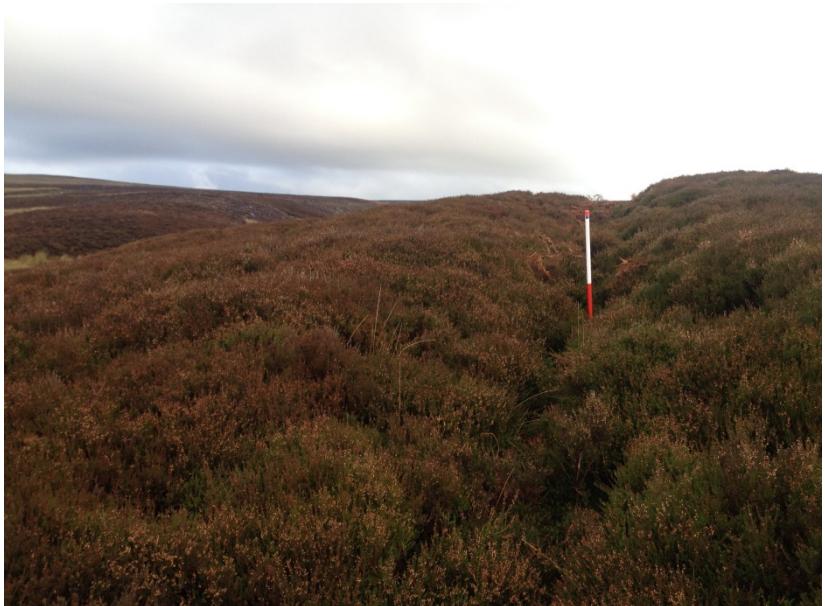
Project UID(s)	65, 67, 68
HER No	MYD49899
Site Name	-
Site Type	Monument
Monument Type	Hollow Way, Trackway
Period	Medieval to Post-medieval
Summary	Series of trackways around the marshy confluence at Incan Slade and both south and north from there across the localised high ground. The concentration at Incan Slade is associated with the small quarrying scoops (22) on the south side, and the rough stone footing of a rectangular building on the north (26).
Image

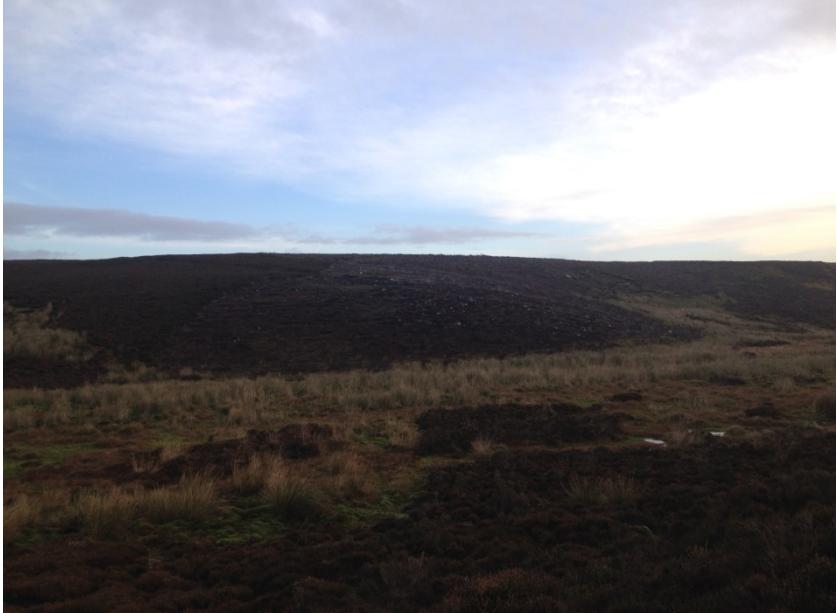
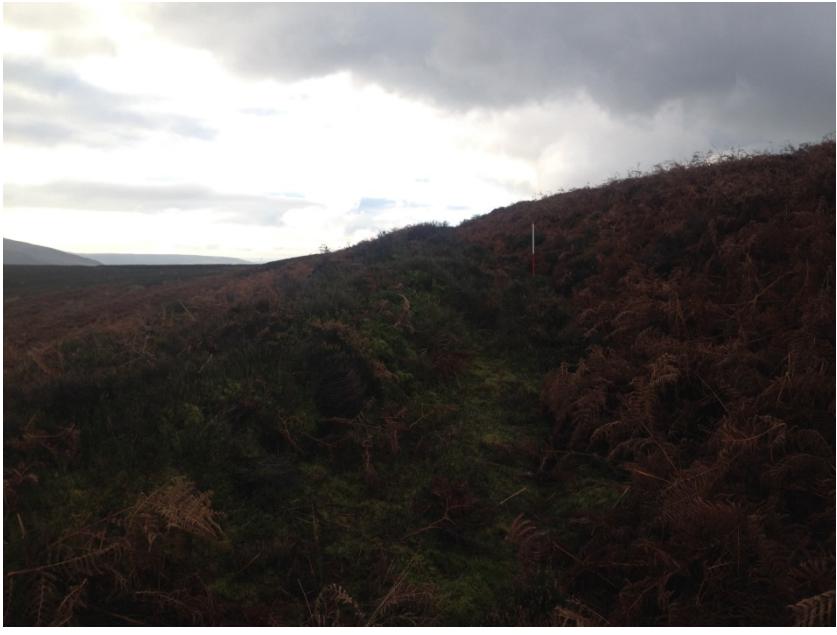
Project UID(s)	69
HER No	-
Site Name	-
Site Type	Monument
Monument Type	Bank
Period	Late Prehistoric
Summary	Small low stone bank c. 170m in length and averaging less than 1m in width. The stones are rough, tend to be non-dressed and are well-bedded with significant soil aggradation having covered them. The feature is in a relatively recent area of burning and so it is possible that this feature is not isolated, though no other similar features could be identified in its immediate vicinity. In form the stone bank has no parallels within the survey area, but does appear similar to some of the stone banks associated with the late prehistoric coaxial field systems, principally found in Wharfedale and Swaledale.
Image

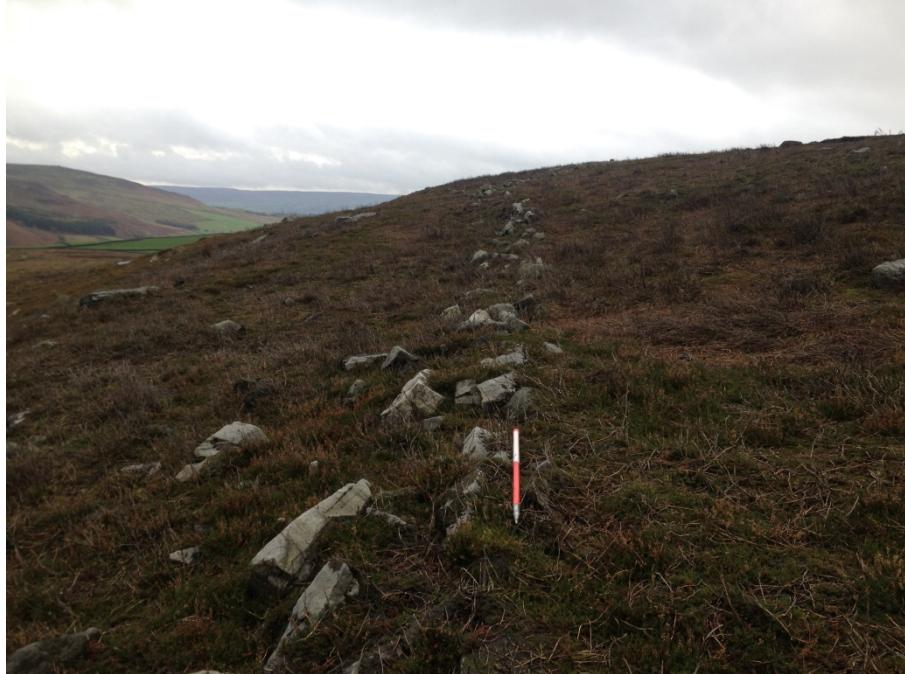
Project UID(s)	72
HER No	-
Site Name	-
Site Type	Monument
Monument Type	Hollow way, Trackway
Period	Medieval to Post-medieval
Summary	Reasonably well-defined hollow way running around the southern flanks of Brown Hill and following the north side of Pickles Gill.
Image

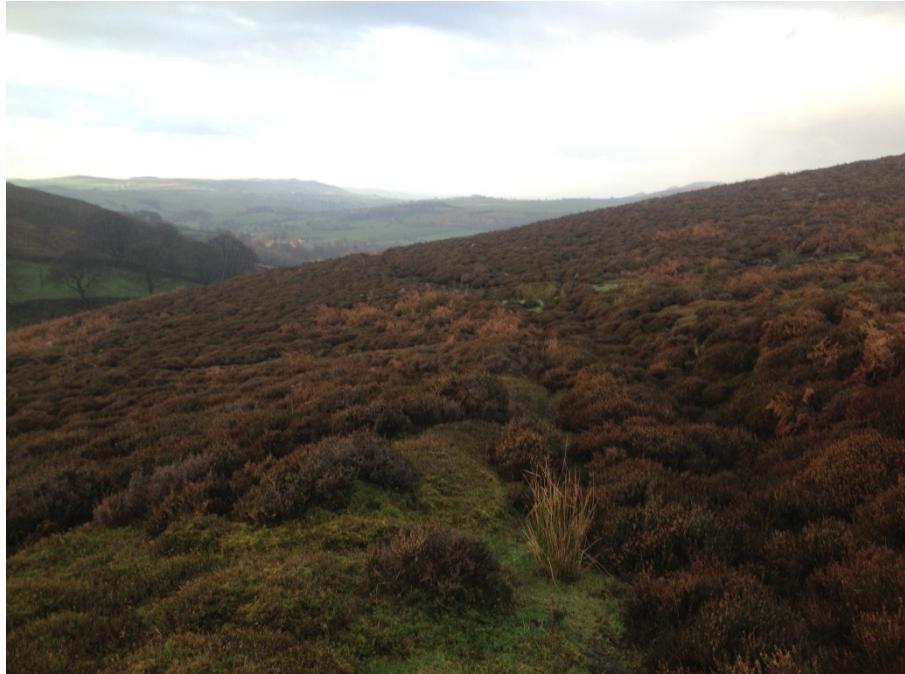
Project UID(s)	73
HER No	-
Site Name	-
Site Type	Monument
Monument Type	Hollow way
Period	Medieval to Post-medieval
Summary	Isolated section of hollow way east of Hammerthorn Hill running north from the main access track onto Hazlewood Moor towards Dicken Nook.
Image

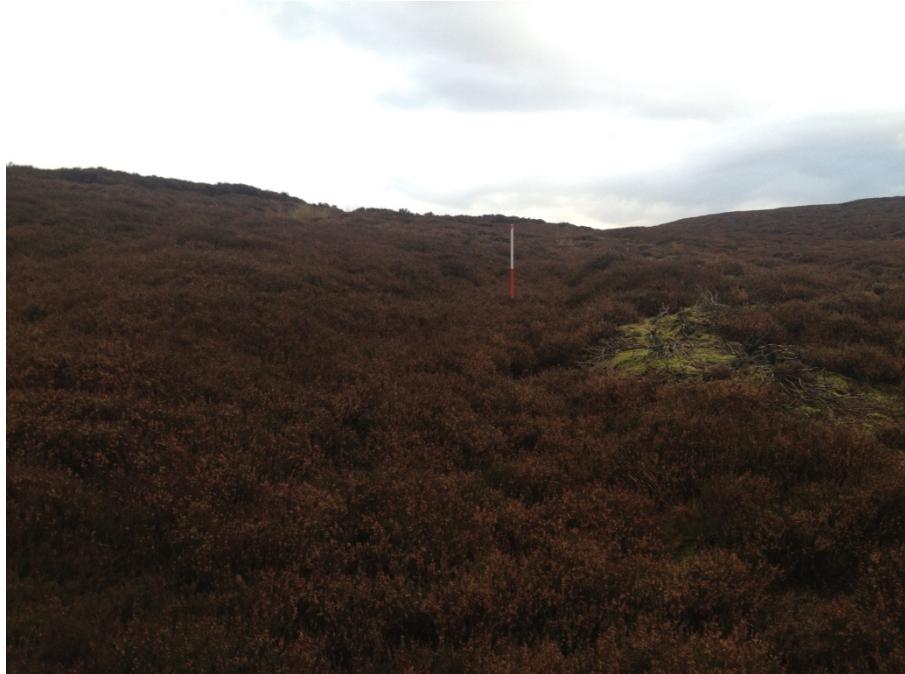
Project UID(s)	74
HER No	-
Site Name	-
Site Type	Monument
Monument Type	Hollow way
Period	Medieval to Post-medieval
Summary	Isolated section of Hollow way curving around a spur of Hazlewood Moor and accessing the gully north of Cowmes Hill.
Image

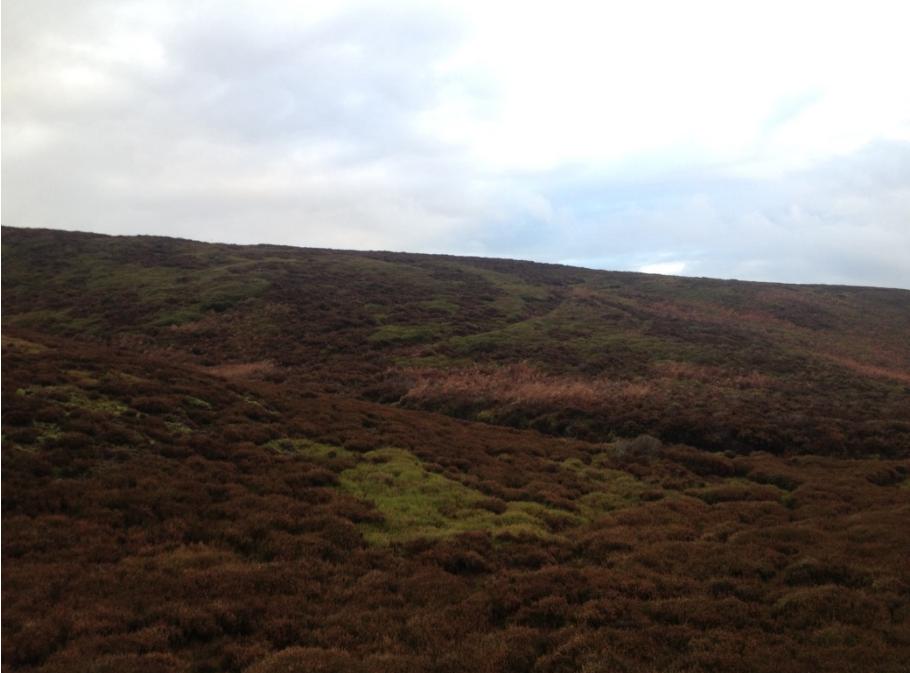
Project UID(s)	75
HER No	-
Site Name	White Stones Green
Site Type	Monument
Monument Type	Enclosure
Period	Late Prehistoric
Summary	Fragmentary remains of an enclosure bank/wall describing part of a circuit around a raised tongue between two gills. The bank encloses at least two structures, one rectilinear (30) and one circular (31). Where visible, the bank comprises a mix of large and small stone blocks and banked earth. There was no clear evidence of an external ditch but this area was substantially overgrown at the time of survey.
Image
