**Archaeological Standing Building Inspection  
& Recording,  
The Stable Block,  
Boughton House, Geddington  
Northamptonshire.  
(NGR SP 90077 81559)**

**December 2013-May 2014**

**Planning Permission No  
KET/2013/0537**

**ABRS Project No 2013-SBHN**

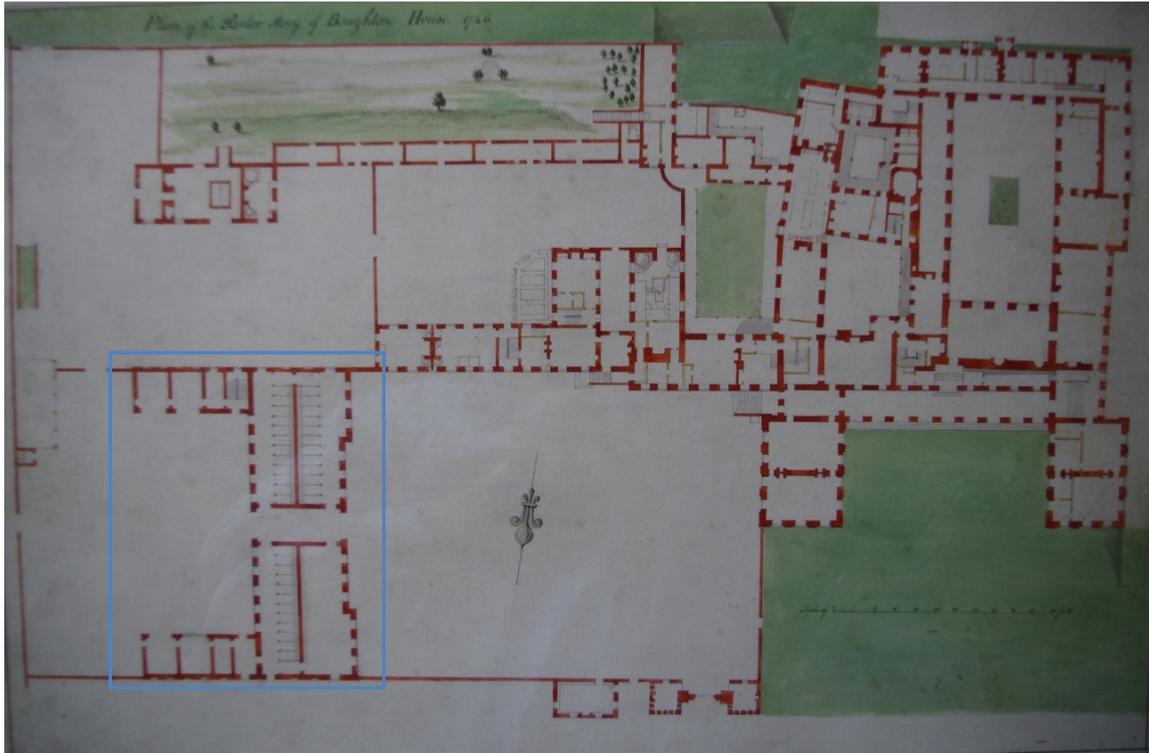
**Figure 2**  
Plan of Boughton House (Ground Floor) 1746.  
(Boughton Estate Archives)

One of the earliest estate plans to record the house and stable in detail is that drawn in 1746 (*Figures 2 & 3*). There is stabling for 36 horses within the stables as well as room for at least four carriages in the east – west bays. Elizabeth Montagu married the 3rd Duke of Buccleuch, 5th Duke of Queensberry in 1767. The Duke, being one to the principal landowners in Scotland had established seats in Scotland, as a result Boughton was seldom used throughout the 19th century, so it was likely that the stables were rarely at full capacity. It is likely, however that some horses would have been stabled continuously at Boughton. Documentary evidence held by the Boughton House archives indicates that the household, when visiting the Estate, which could be as infrequently as only two weeks in the year travelled with grooms from Scotland, so it is likely that there was only a limited staff of full time grooms, if any.

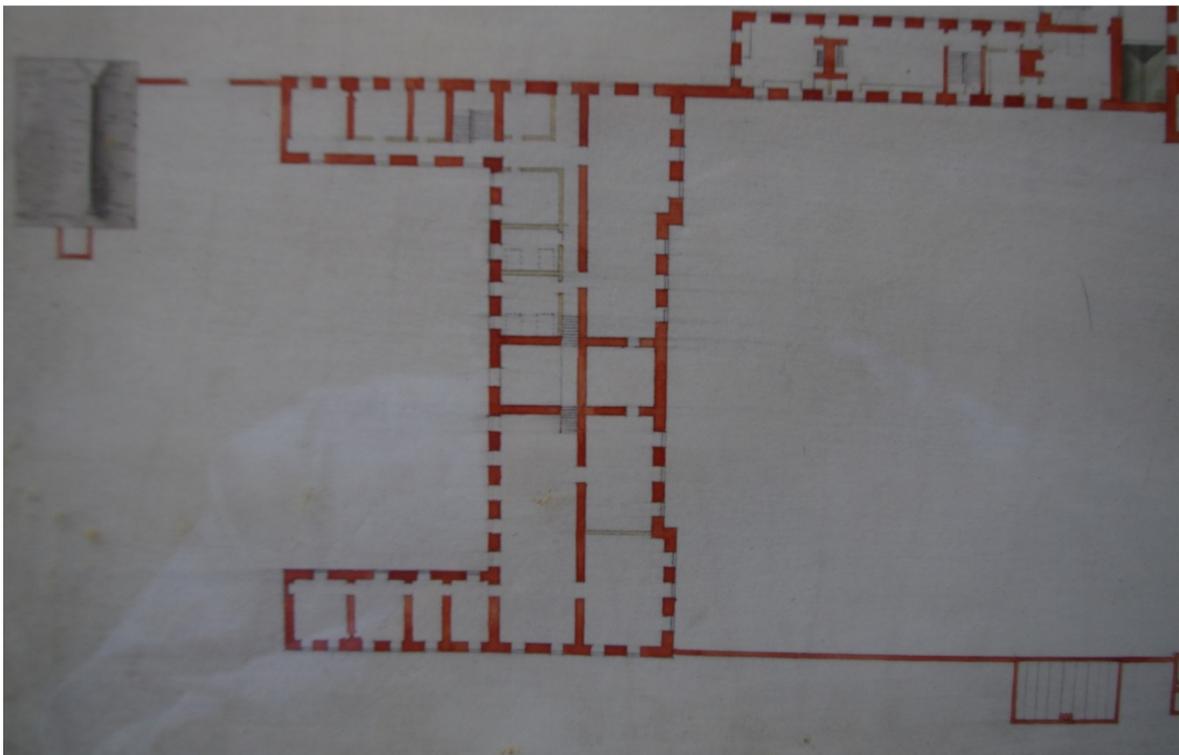
**Figure 3**  
Plan of Boughton House (Stable Block, 1st Floor Detail) 1746.  
(Boughton Estate Archives)

A plan showing the first floor of the stables (*Figure 3*) does not record any specific evidence that the upper floor was in any way domestic; there are a number of smaller rooms which in all likelihood served as grooms' accommodation during the family's stay at the house. A plan of the roofs shows only one chimney within the stable, located on the south facing wall of the southern range. So, at least this part of the stables was heated and was likely to have had a domestic use.

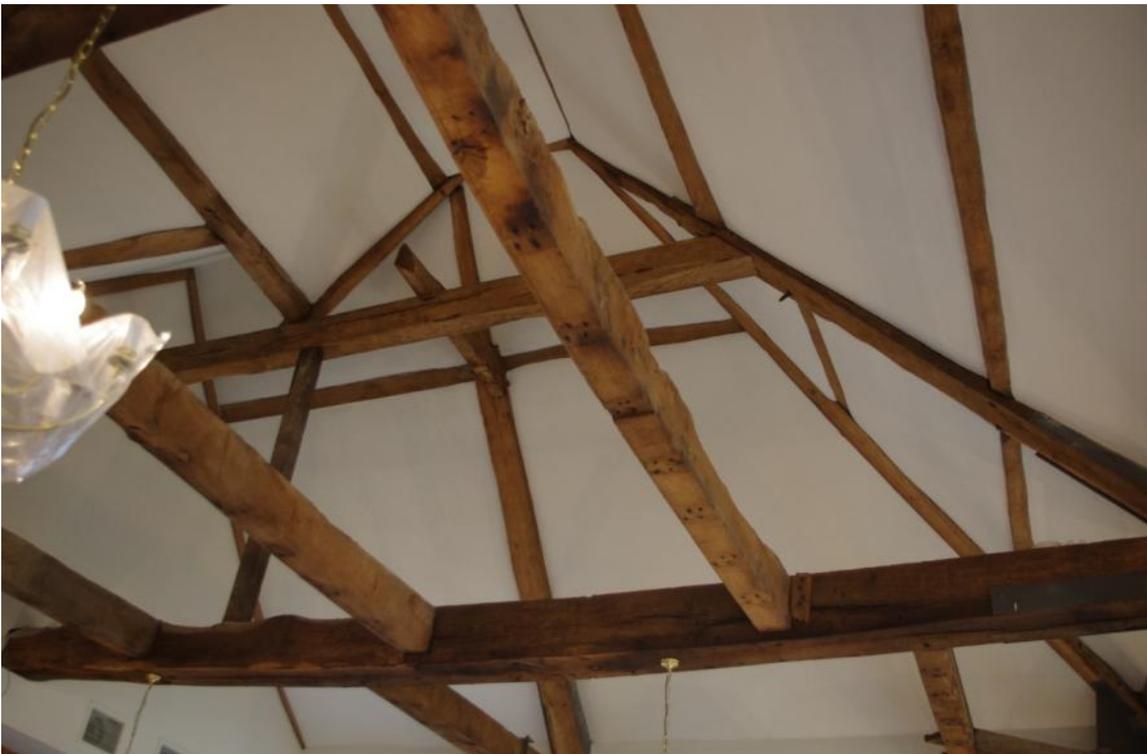
**Figure 10**  
Truss 5 (Looking South).

The recorded roof structure consists of bridled common rafters carried on five trusses with paired butt purlins and a ridge beam. The trusses are numbered 1 to 5 in Roman numerals (*Figure 11*), I being to the north and V being the southernmost. The trusses are of three different designs. The three northernmost trusses are simple collared trusses all identical in design (*Figures 7, 8 & 21*), the two southernmost trusses are of a different design and do not match each other. Truss IIII is a modified version of trusses I – III with a collar yoke and a plated yoke rather than a bridled apex (*Figures 9 & 24*). This allows the roof to step forward and follow projecting ends of wings within the roof. Truss V forms the hipped roof with the collar beam forming the ridge beam of the east – west wing (*Figure 10 & 25*).

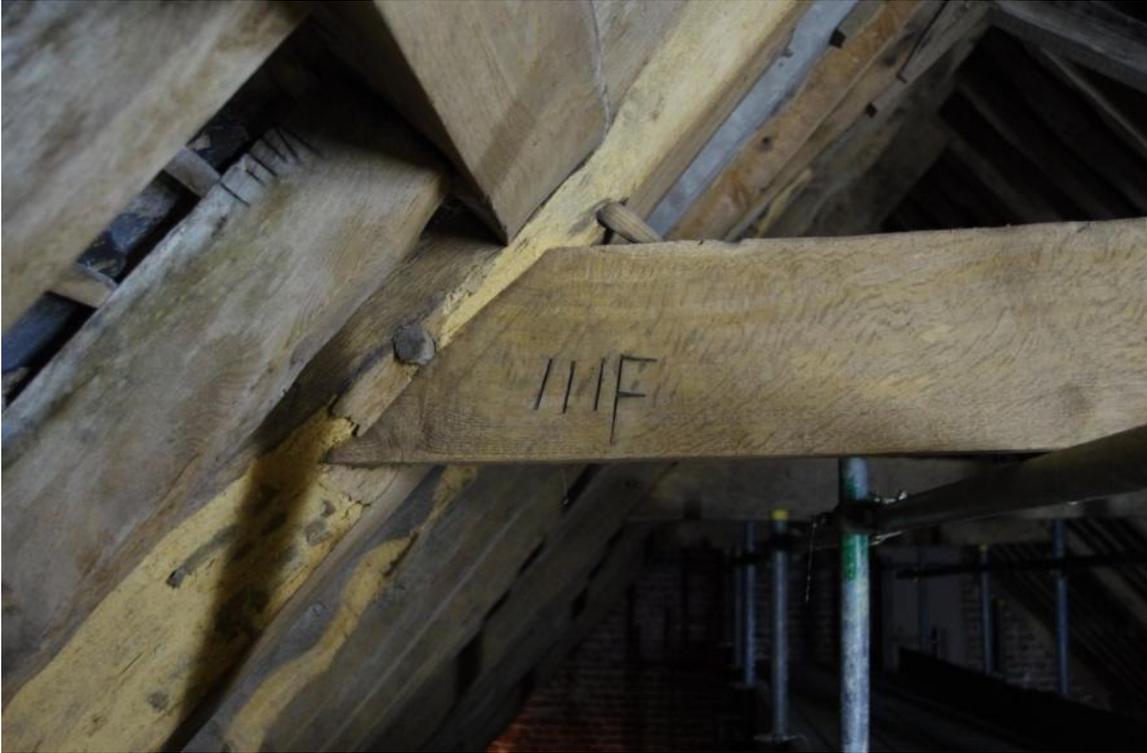
**Figure 11**  
Assembly Marks on Truss 3 (South Face).

The trusses, the common rafters as well as the purlins are all sawn oak. Some of the common rafters are also numbered with Roman numerals as is the lower west purlin. However, these numbers are not complete or in sequence and do not consistently match those numbers on the adjacent purlin. This is likely to be as a result of the remedial works carried out on the roof in the 1980s. Although it is unclear is possible that the un-marked common rafters date to

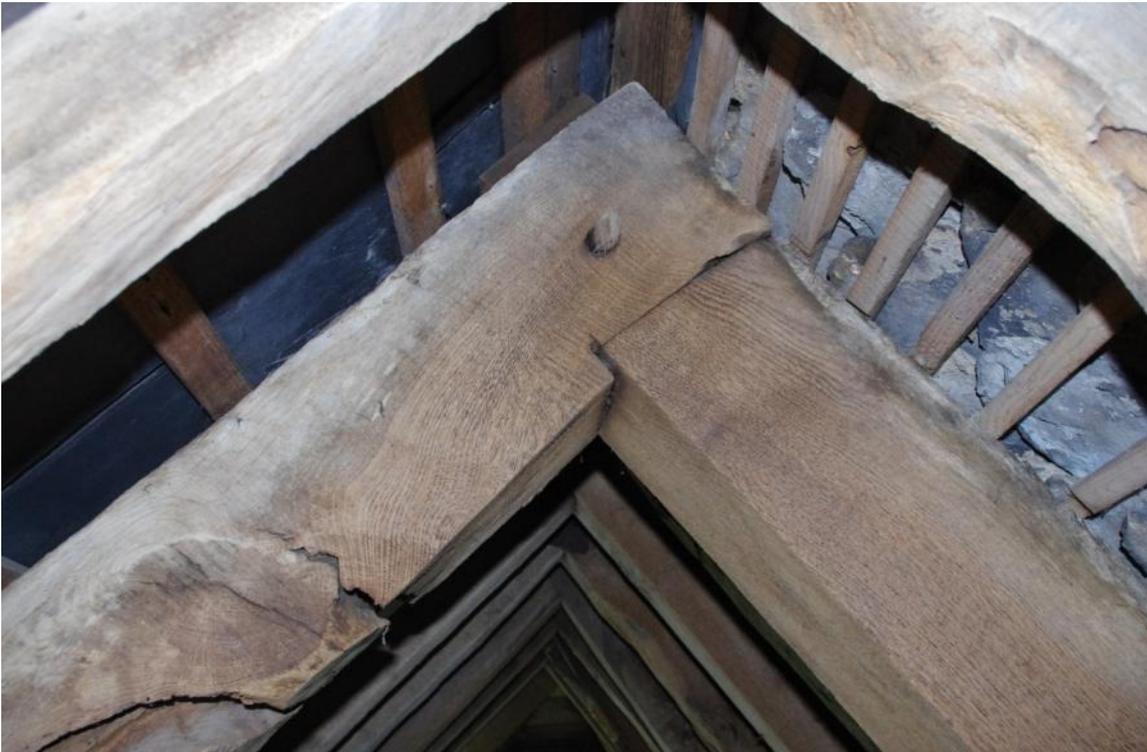
**Figure 12**  
Bridled Rafters (South Face).

this period and are not original. This is again apparent at the apex of the common rafters with a number of different coupling styles (*Figure 12*).

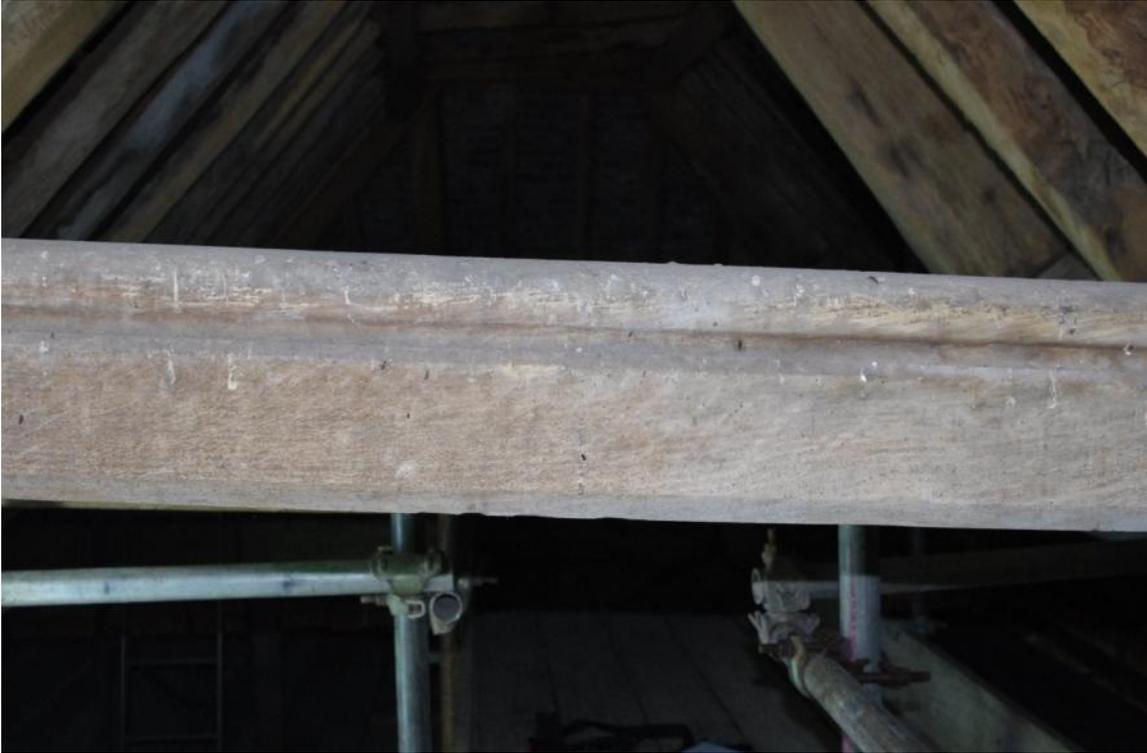
**Figure 13**  
Re-used Moulded Timber (South Face).

As a single phase roof which has been repaired in the modern era, there is little of historical significance. The only two significant features are the re-used moulded beam roughly nailed between the two purlins between trusses II and III (*Figure 13*). The beam has the appearance of a collar beam, but apparently serves no structural purpose, it is possible it was added to support two weak rafters only to become redundant following the works carried out in the 1980s but not removed. Truss III has an empty mortice, the size and location of which suggests it may have originally held a wind brace.

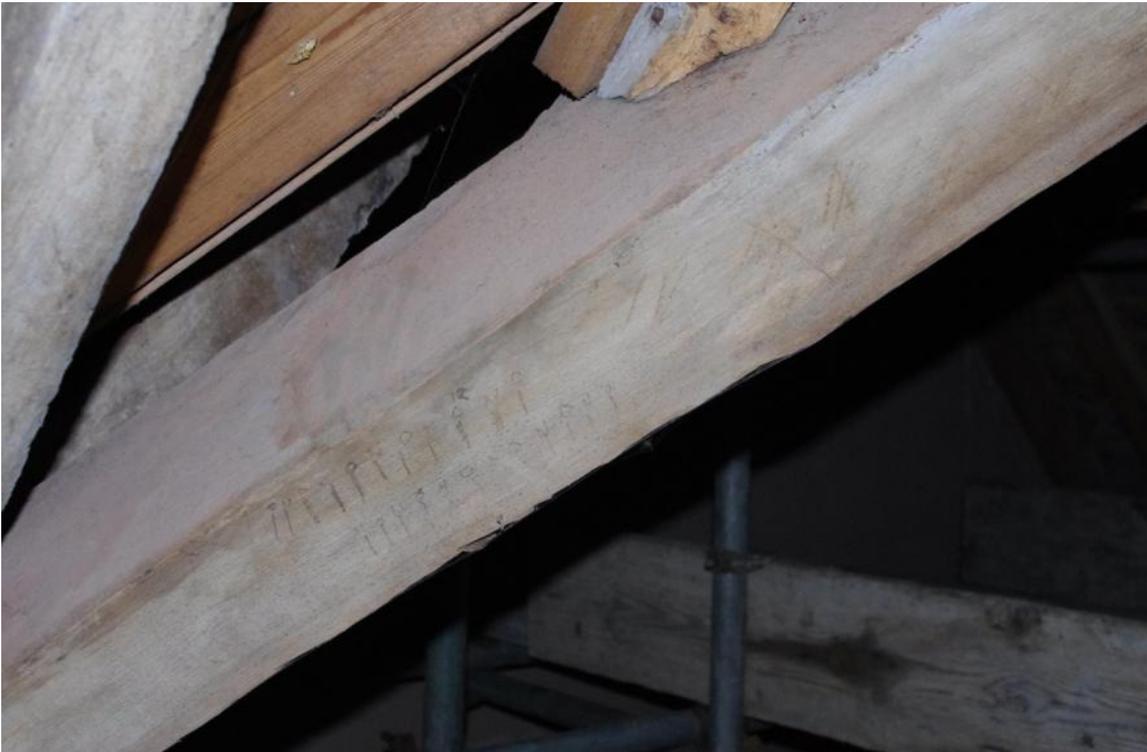
**Figure 14**  
Unusual Tally Marks(?) on Valley Beam (North Face).

The second unusual feature is a series of score marks on the northern valley beam (*Figure 14*). The score marks consist of a series of vertical pencil strokes over which appear to be the letters N and O. The exact purpose or date of these marks is unclear, their inaccessible location means they are unlikely to be idle graffiti and being pencil, the marks may have been drawn during the 1980s work. The beam also has a number of more traditional incised Roman numerals, which are likely to be original to the construction of the roof in the 18th century.

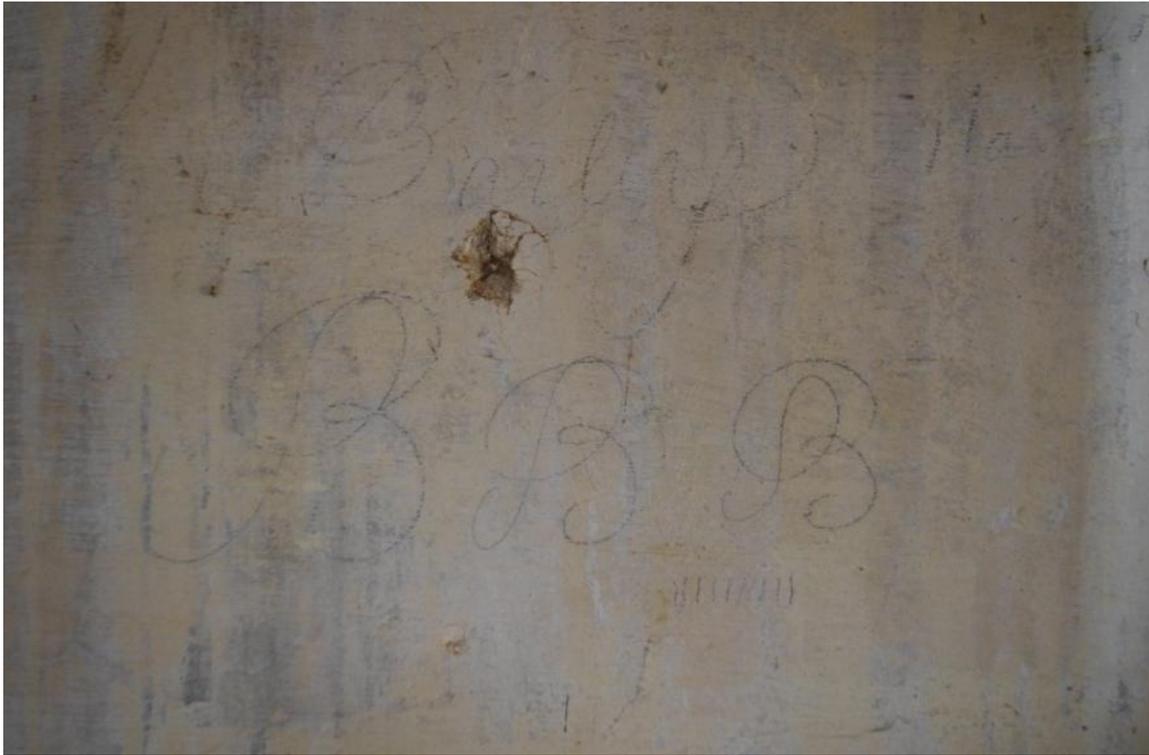
**Figure 17**  
Letter B and Barley on East Wall.

century, the earliest being 1784 carved into the plaster. Other earlier graffiti includes a tally of bushels of wheat recorded on the 7th of August 1787 as well as a tally of wheat in on May 5th 1791 (*Figure 15*). There is also an extravagant series of 'B's, possibly written by an individual practicing writing, the Bs apparently overlap the word Barley (*Figure 17*).

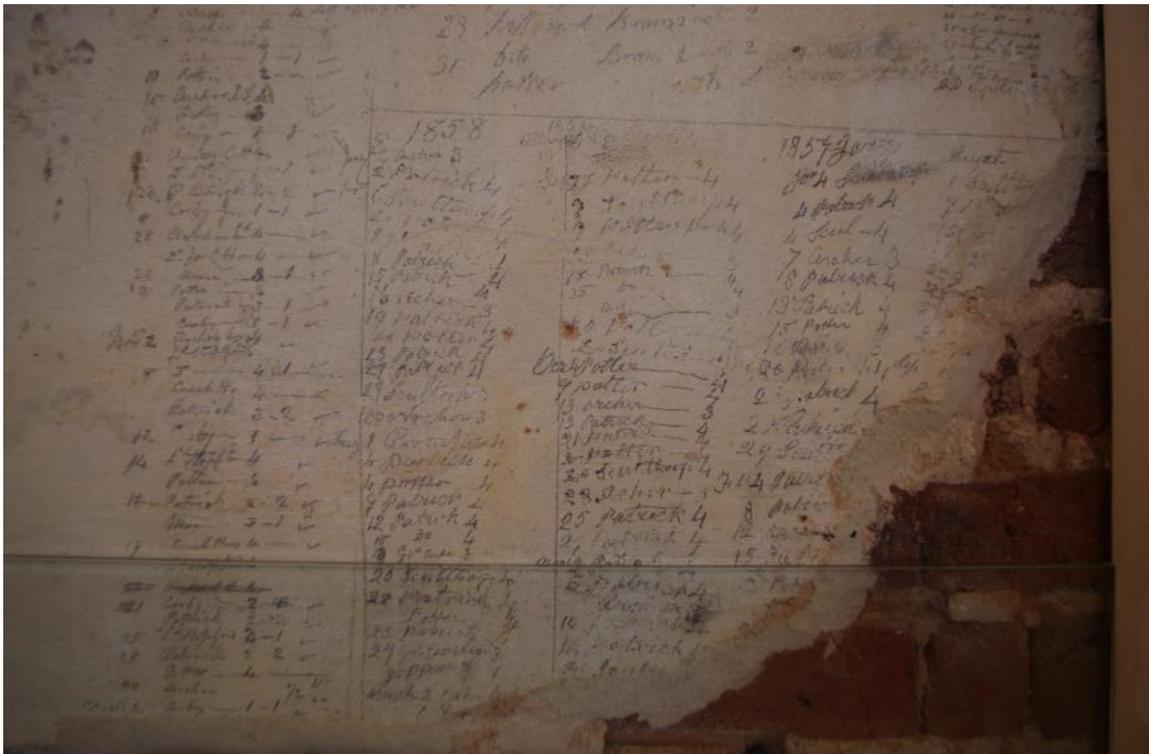
**Figure 18**  
Extensive List of Names on East Wall.

The graffiti consists, by and large of pencil drawn lists of names, dates and other figures, most likely money owed/paid. The clearest group of names are located adjacent to the northernmost door (*Figure 18*). Names, dates and years are clearly identifiable. The years 1857, 1858 and 1859 are obvious as are the months March, June, July, September and October. Some of the names are illegible, but the names Bovis, Corby, Davies and Patrick appear regularly throughout the lists and throughout the years. Other less frequent names include Archer, Potter, Smith and Southorpe. In all likelihood the lists are casual labourers employed in the stables or throughout the estate. The “*Accounts – Rents of Estates within Boughton Collection Due Lady Day*” (1857 & 1858) held by NRO lists the “*Labours Account – Paid Samuel Sculthorpe what he advanced to sundry labourers employed about the Boughton House, Park & Premises as by particulars in the Day Book*”. It is likely, that by design or by accident the list for these months in 1857, 1858 and 1859 were recorded on the wall of the stable, it is possible that the list was then transferred to the Day Book.

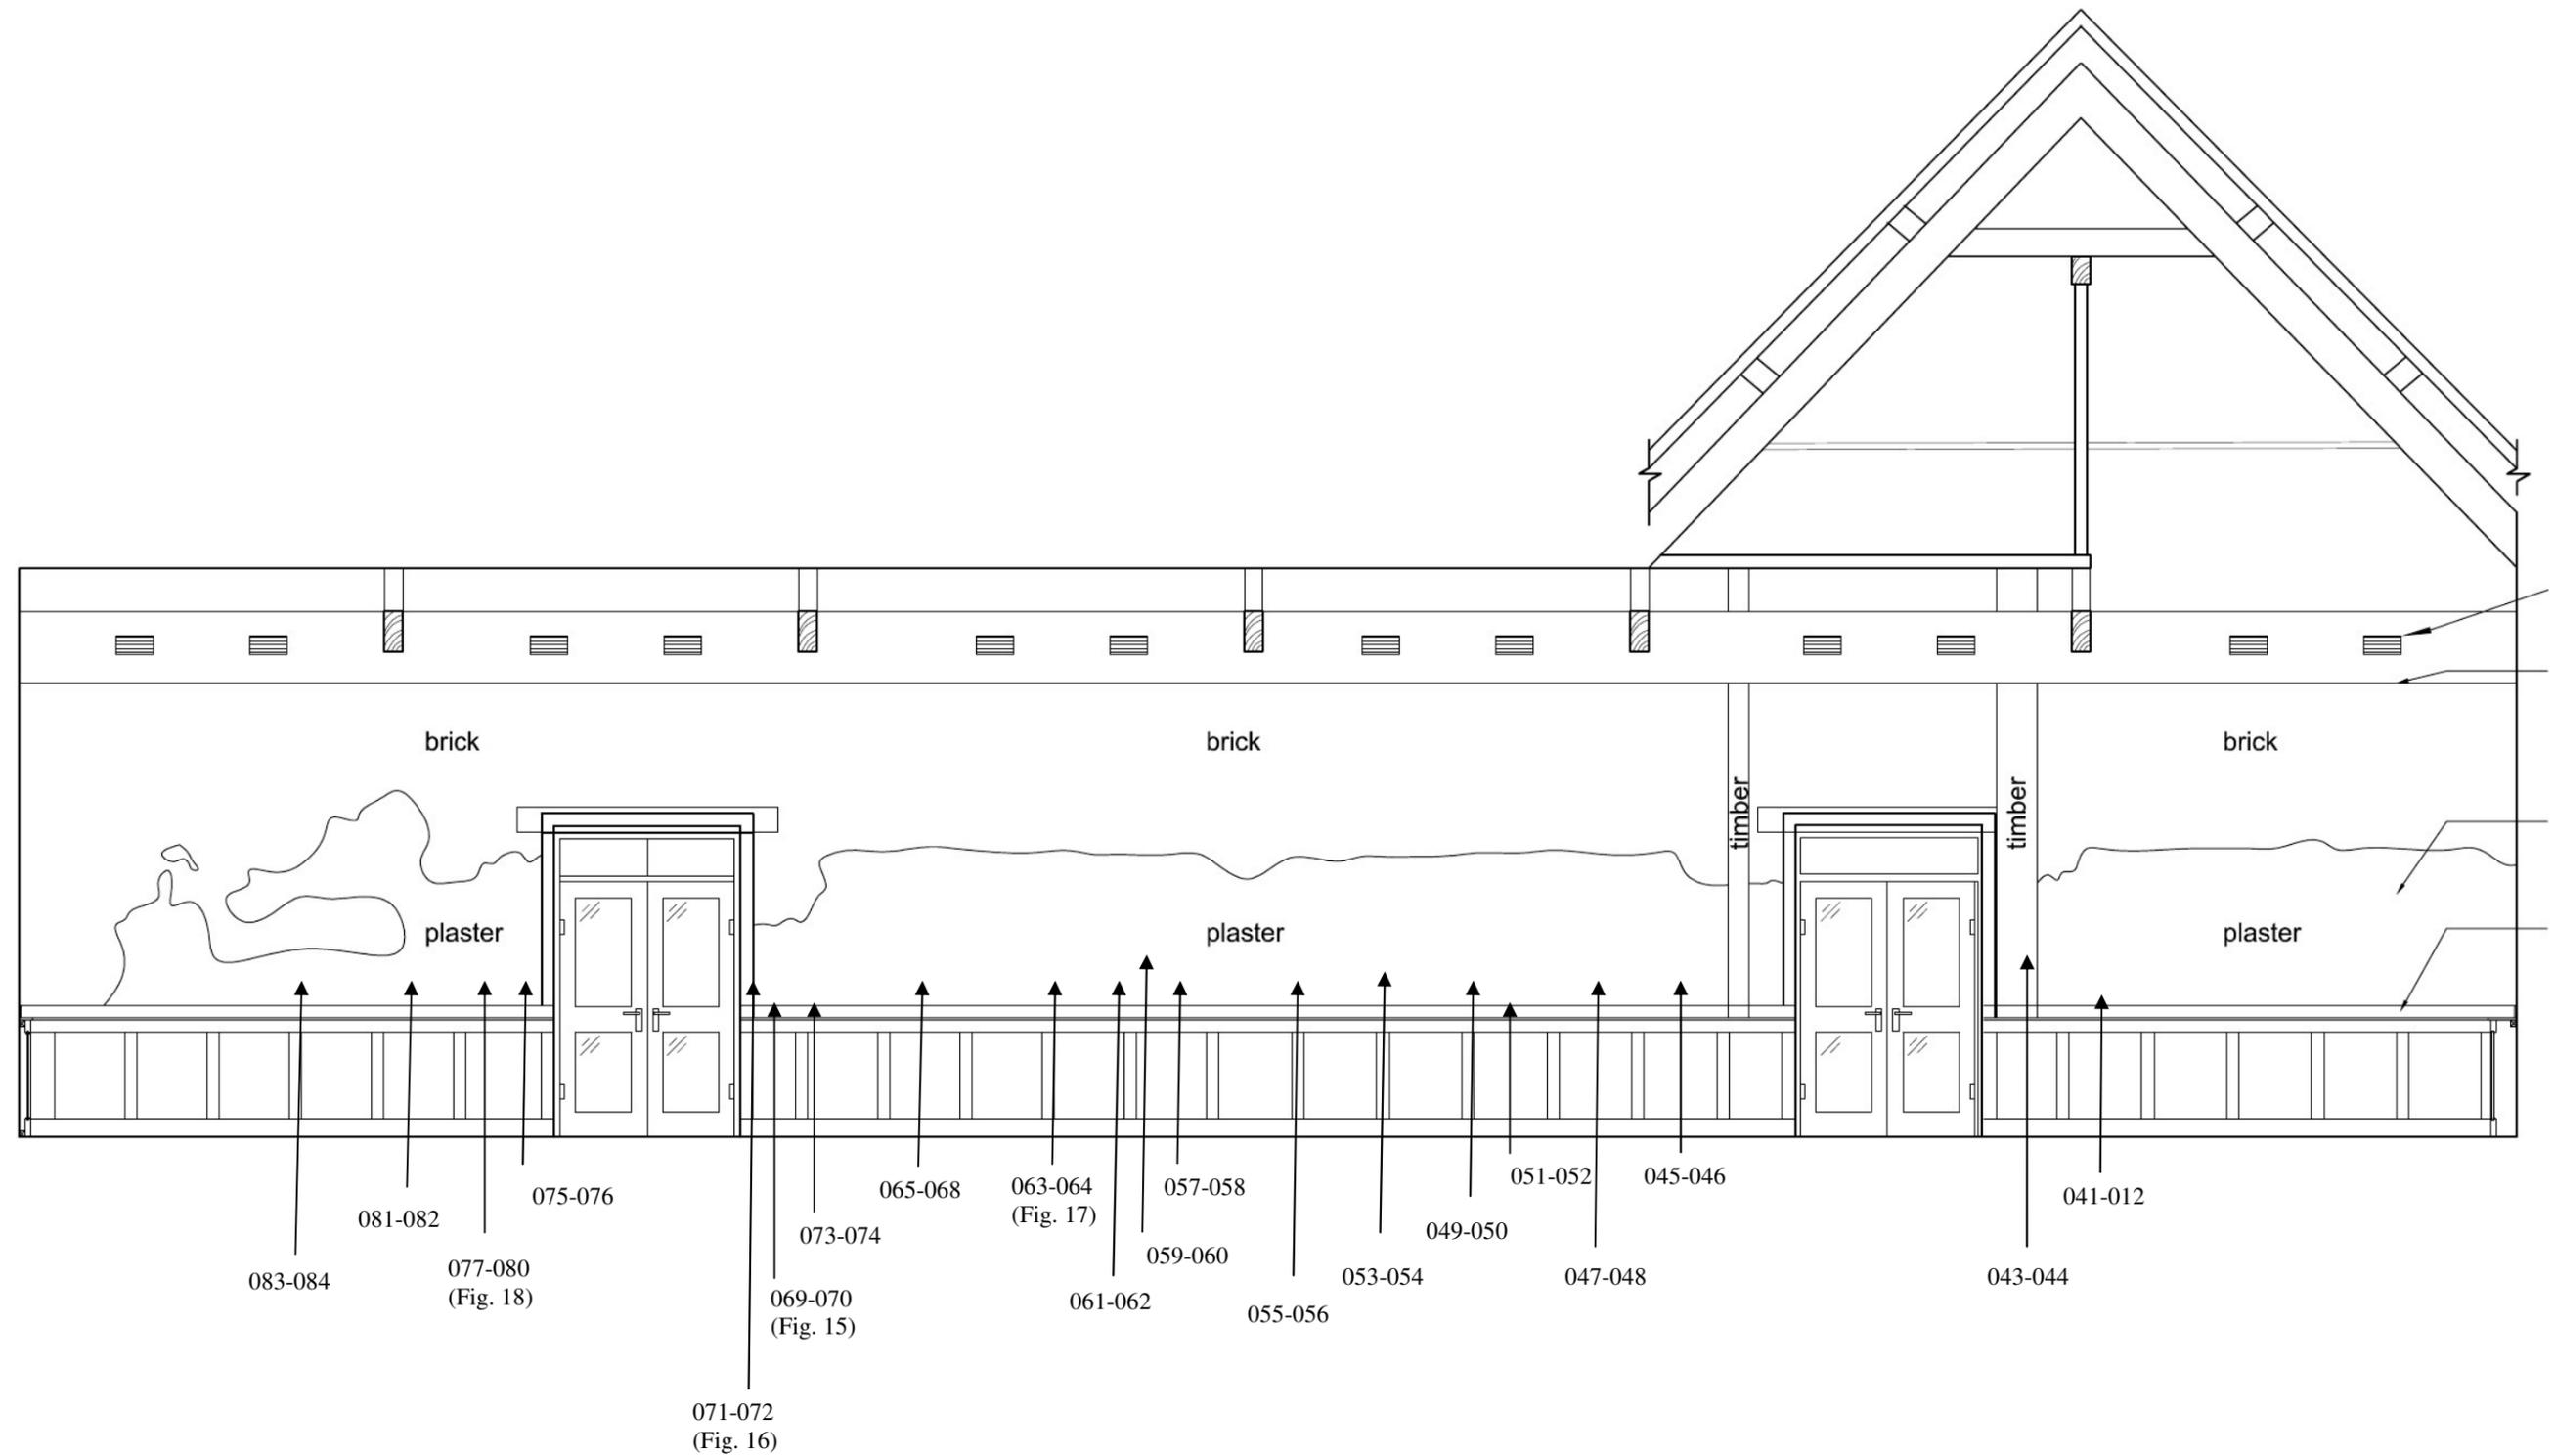
**Figure 24** Photo Locations of Graffiti on East Wall Photo Archive Number & Report Figure Number.  
(Not to Scale)

There are a number of areas of original lime plaster adhering to the east wall of room 112 (*Figure 24*), there are clear traces of animal hair within the plaster. Given the extent of the surviving plaster on the east wall, it is likely that the whole of room 112 was originally plastered; all of the walls, with the exception of the east wall are now bare brick. The bricks themselves are 9inch x 2 ½ inch x 4 inch handmade bricks laid in an English Cross Bond (alternate courses of headers and stretchers).
