**An Archaeological Standing Building Survey.
Broughton Grange,
Kettering,
Northamptonshire.**

June 2014

ABRS Project No 2014-BGKN

**An Archaeological Standing Building Survey of Outbuildings at Broughton Grange,
Kettering, Northamptonshire (NGR SP 85797 76497).**

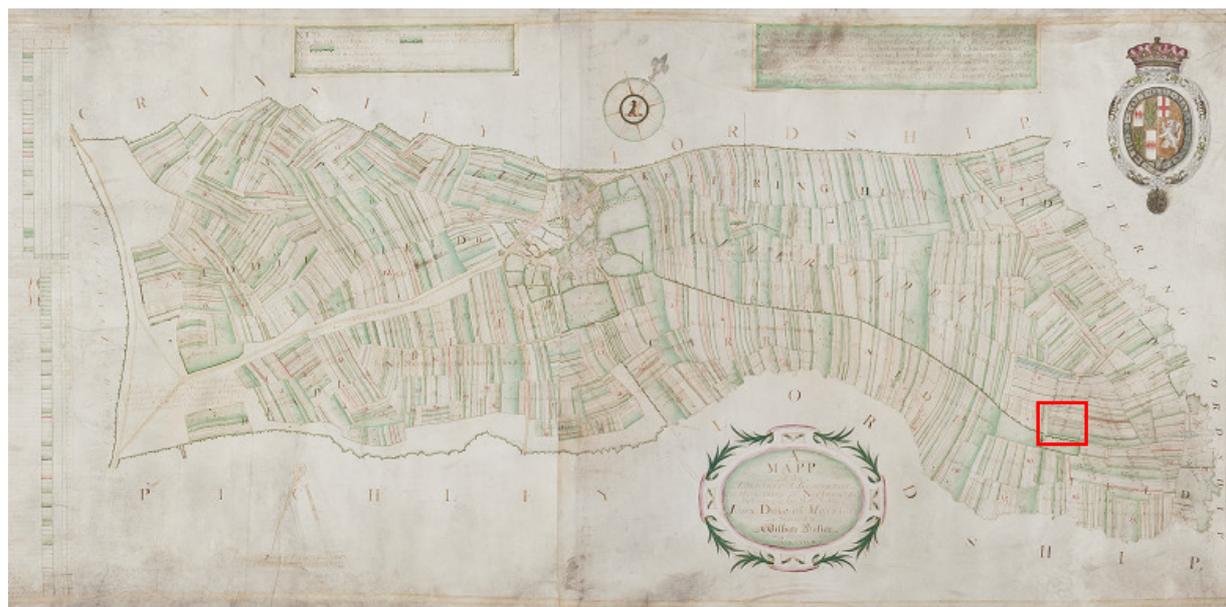
Figure 2

Boughton Estate Map 1728 (location of Broughton Grange highlighted).
Courtesy of Boughton House Archives.

The parish's open fields were enclosed in 1786, an estate map drawn in 1728 (*Figure 2*) shows Broughton open fields. There is no clear evidence of Broughton Grange suggesting the farm is an enclosure farm built after 1786, this supports the VCH evidence that the Grange was built in around 1800.

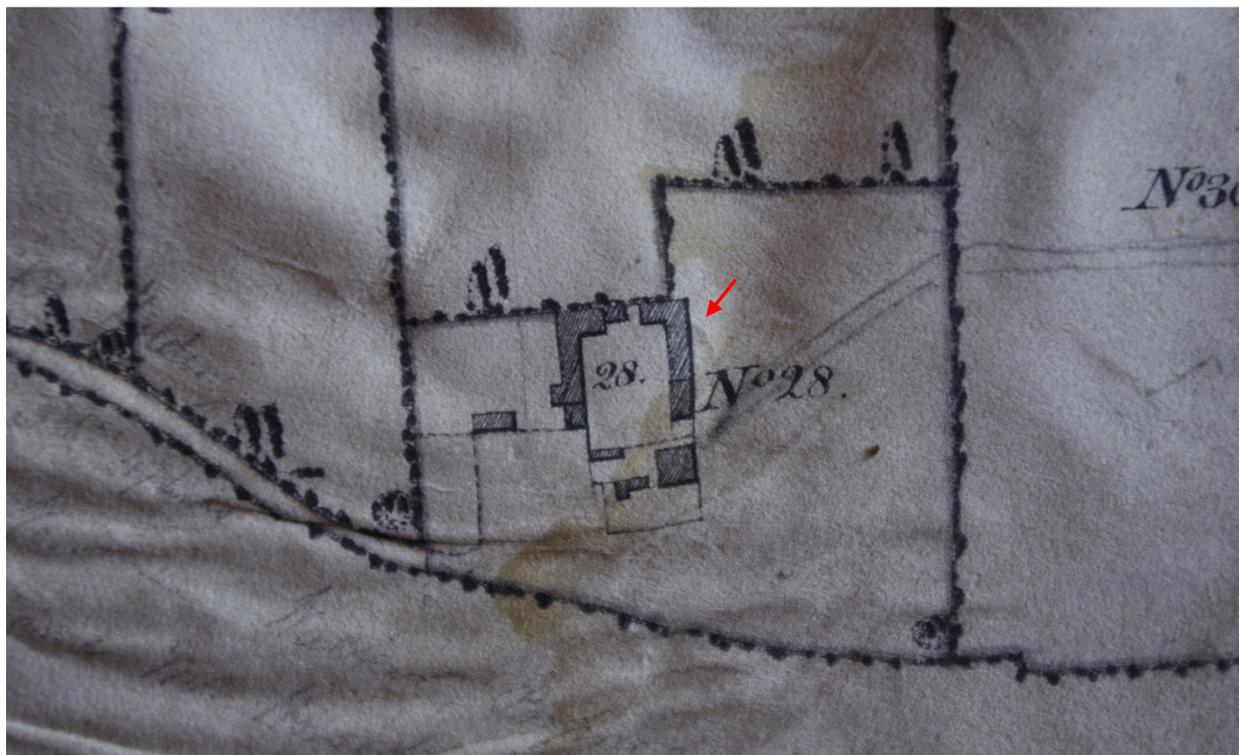
Figure 3
Broughton Estate Map 1797, with Recorded Building Arrowed.
Courtesy of Boughton House Archives.

An estate map produced in 1797 (*Figure 3*) clearly records Broughton Lodge as well as one of the buildings subject to this building recording, indicating that the building dates from at least the 18th century, thus earlier than previously assumed. The Lodge is identified as 28, the accompanying key lists it as “*House, Homestead and Home Close*”; the map records that access to the Lodge, at the time was from the west and there is also a pencil drawn trackway leading to the Lodge from the north west. This trackway is the current access and appears, based upon the map to be a later addition. The farm itself is of a simple layout of a yard to the north of the house. The westernmost range of buildings on the map was confirmed by the site visit to consist of a rather impressive threshing barn.

Building C is, according to cartographic sources potentially the earliest of the recorded buildings having been recorded on the 1797 Estate Map (*Fig. 3*), it forms the eastern and northernmost parts of the southern yard (*Figure 21*). The building has coursed iron stone-built north and east walls, while the southern and western, yard walls are brick-built; the bricks themselves are 9inch x 3inch x 4inch laid in a Flemish Garden Wall bond (3 stretchers to 1 header in each course) with original lime mortar pointing (*Figure 9*). The roof is clad in unusual “zig-zag” or saw-toothed tiles (*Figure 18*). Identical tiles seen at Cedar Farm, Fleckney, Leicestershire were stamped MAJOR BRIDGEWATER – REGISTERED, the undersides of these tiles were not visible. It is likely, however that they are of the same manufacture. These tiles are uncommon in the region and are sometimes called “triple delta” tiles in the south west of England, where they are more common. The tiles are likely to originate in the town of Bridgewater, where by the 1890s there were 16 brick and tile companies.

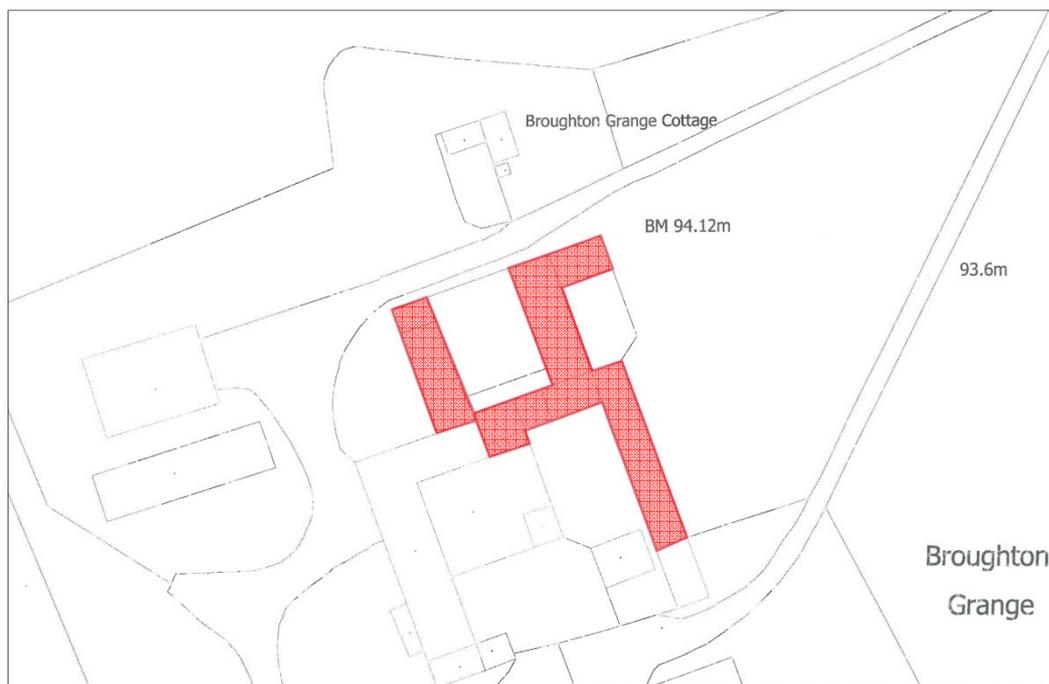
Figure 6
Plan of the proposed development area & Recorded Buildings in Red.
(Provided by client. Not to Scale).

Orientation: There are three groups of buildings subject to this historic building recording; two are “L” shaped, while the second is simple linear building all arranged around two yards. The long axis is orientated approximately north-north west south-south east (*Figures 6 & 21*) for ease of description this is taken hereafter to be north to south with the principal elevations facing the yard. Where the terms ‘left’, ‘right’, ‘front’ and ‘back’ etc are used in the report, this is in relation to this principal elevation as viewed from the yards. For the purposes of this historic building recording a letter prefix has been allocated to each building and a number prefix added for significant partitions where required.

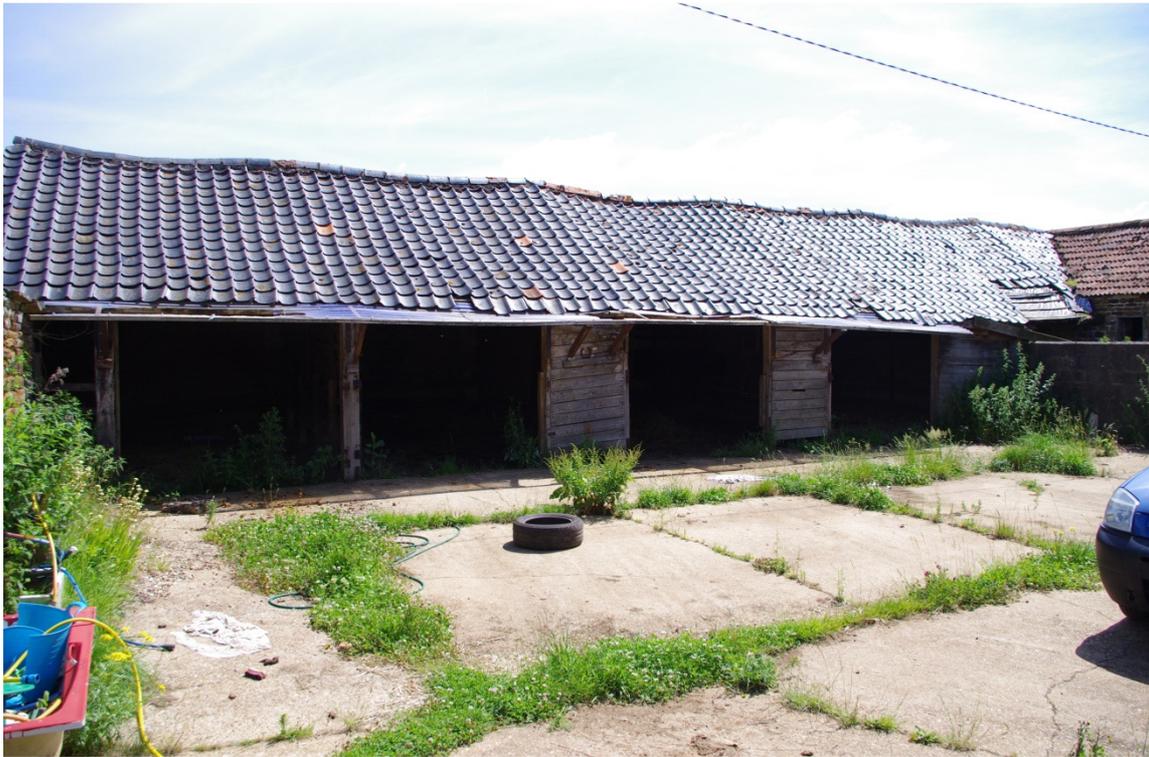
Figure 7
Building A Principal Elevation (Looking East).

Building A is aligned north - south and forms the eastern part of the yard (*Figure 21*), the building, according to cartographic sources dates to the early 20th century having been built to replace two earlier buildings. The building is red brick with a roof of charcoal pantiles (*Figure 7*). The bricks themselves are 9inch x 2 ½inch x 4inch laid largely in a stretcher bond with occasional courses in a Flemish Garden Wall bond (3 stretchers to 1 header in each

course) and in English Cross Bond (alternate courses of headers and stretchers) with modern lime mortar pointing. The building is a five bay open-fronted building, in all probability originally built as a cow hovel, with the open front facing to the west. There is a door on the rear wall of the southernmost bay providing access to the small yard and building B.

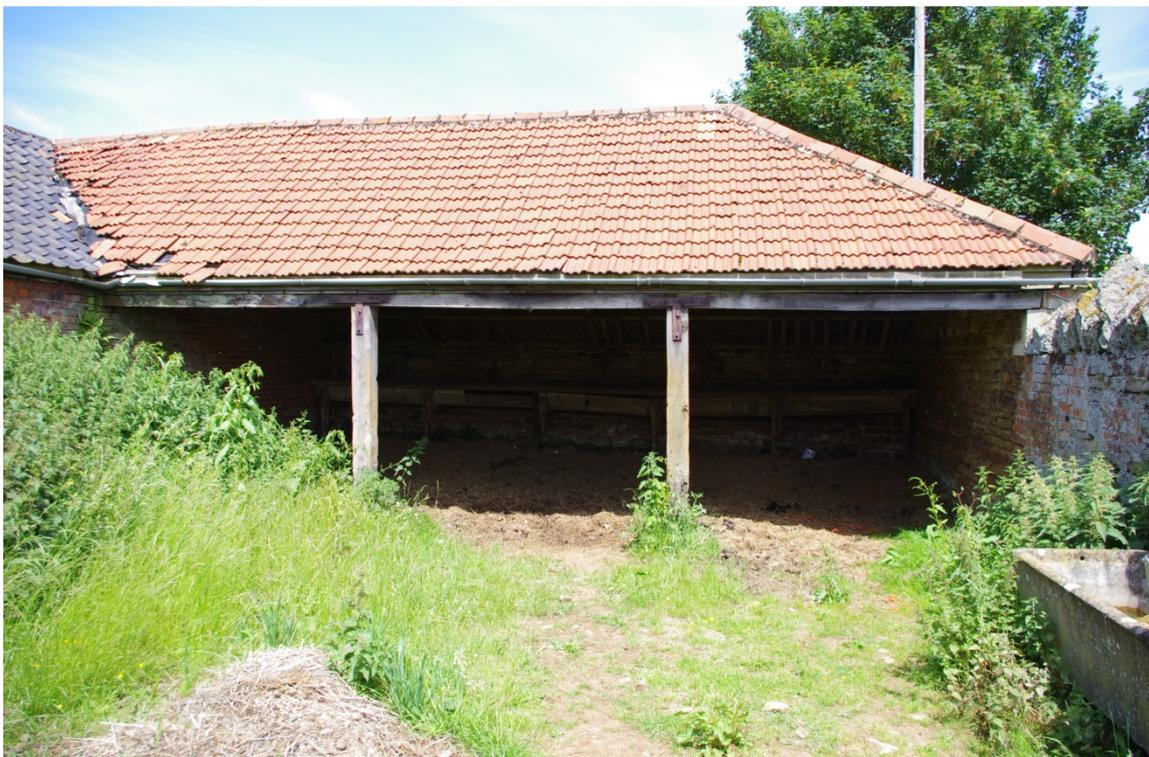
Figure 8
Building B Principal Elevation (Looking North-North West).

Building B is an off shoot to the north easternmost corner of building B (*Figure 21*). The building is stone-built with a hipped tiled roof clad in red triple roman roof tiles (*Figures 8 & 17*); such tiles are not commonly seen in the region. The stone work is squared and coursed iron stone with lime mortar pointing. The building is again open fronted, opening to the yard to the south. On the north east corner there are exceptionally fine chamfered and stopped quoins in contrasting lime stone (*Figures 19*), their quality is far in excess of anything expected on a 19th century agricultural building and are in all likelihood re-used, potentially from the demolished Newtown House, there are similar, but un-chamfered quoins on Broughton Grange itself. A detailed examination of the first edition Ordnance Survey suggests that this wall may be early or mid 19th century in date and was only roofed in the early 20th century. This would add further weight to the argument. However, why the quoins were used in this remote corner of the farm, away from the house is unclear.

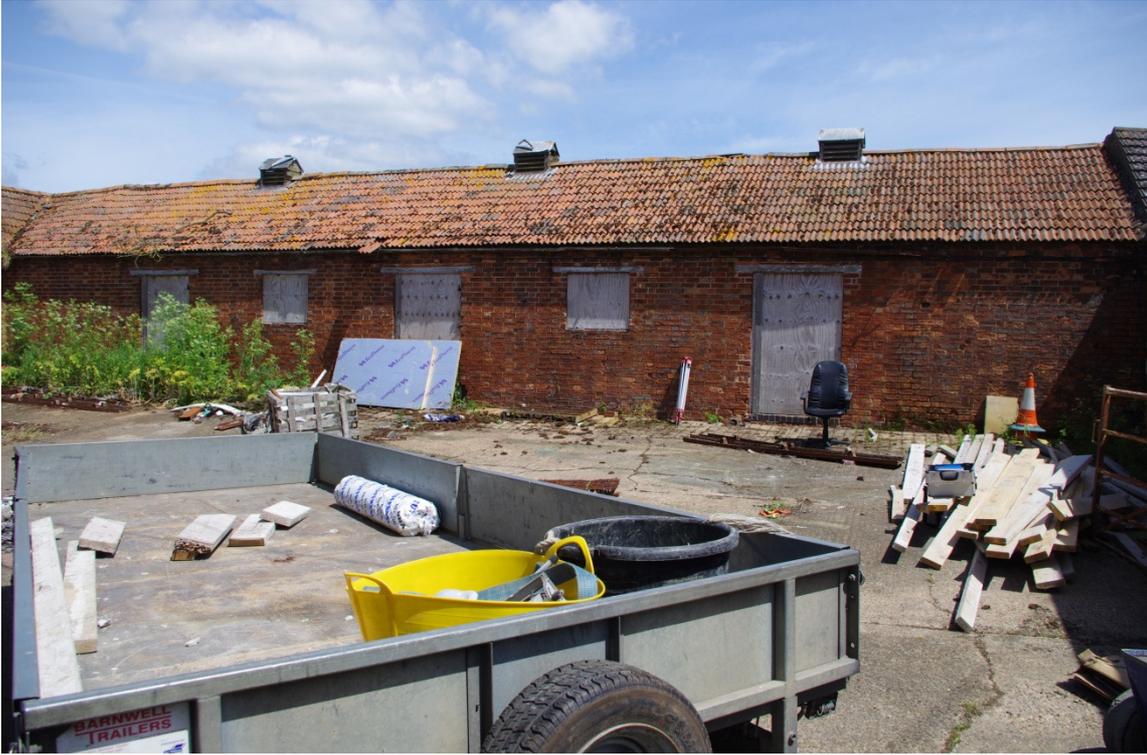
Figure 9
Building C (3) Principal Elevation (Looking North-North East).

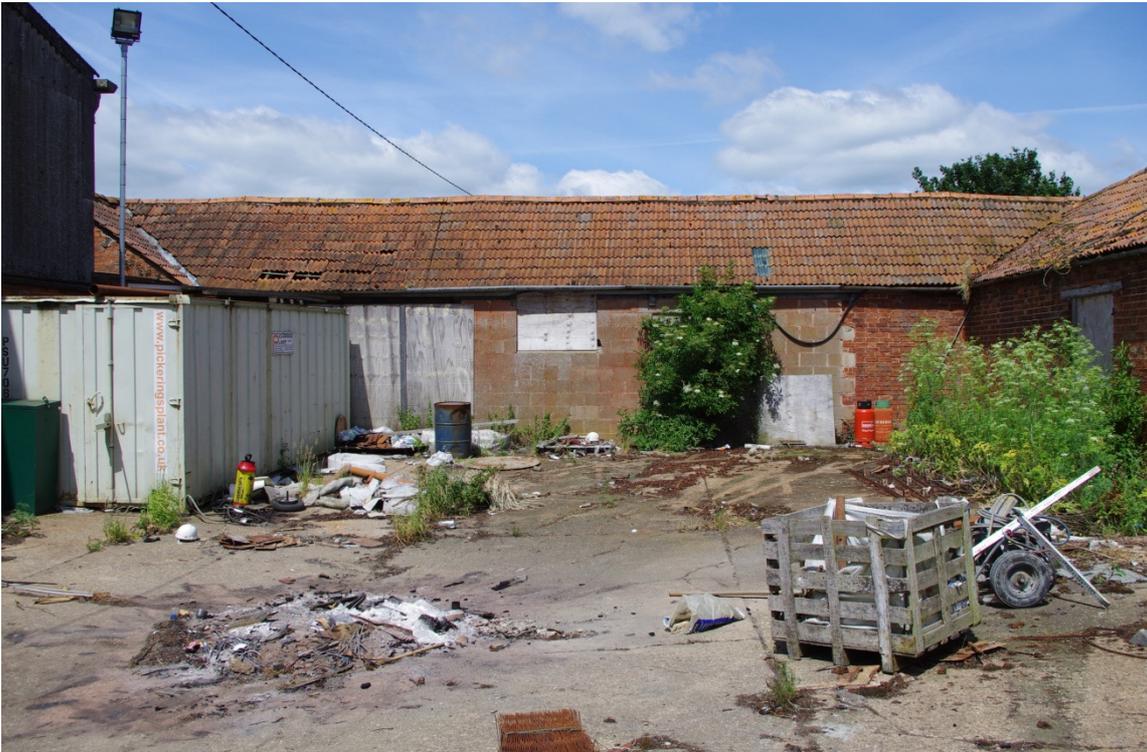
Figure 10
Building C (1) Principal Elevation (Looking North-North West).

The east – west range (1), was originally largely open-fronted but there is inserted modern block-work in the south facing openings (*Figure 10*). There is a covered wagon way between the two yards at the western end of (1). There is a straight joint between the brickwork of the southernmost gable of (3) and the adjacent stone-built building (not included in this recording). The straight joint suggests the two are not contemporary despite both being recorded by the 1797 map (*Fig. 3*). Further evidence of which are the straight joint visible in the rear, stone-built wall and the change in the roof line between the two buildings. The bricks of the yard elevations are also later 19th century in date. It is almost certain that building C has been largely rebuilt using the same footprint as the previous building and most likely retaining the north and east walls.

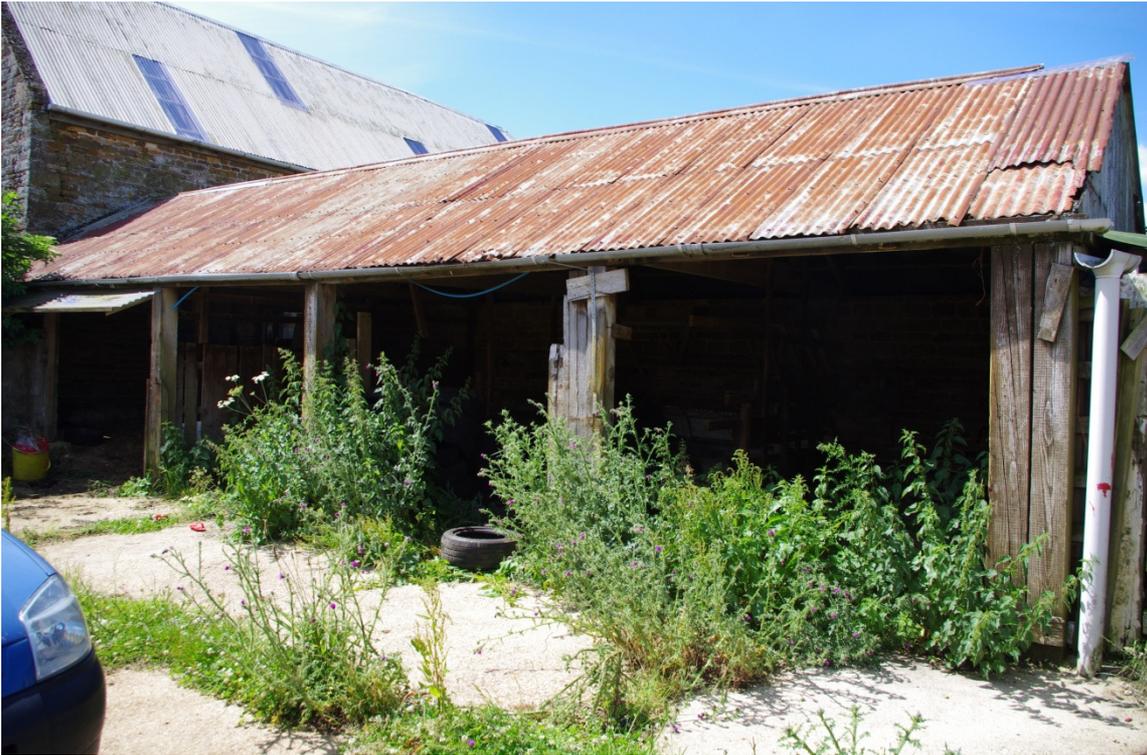
Figure 11
Building D Principal Elevation (Looking South-South West).

Building D forms the westernmost part of the northern yard (*Figure 21*); again it is open fronted (*Figure 11*). The rear (west) wall is built of coursed iron stone and the roof is clad with corrugated tinned steel sheets. The wall appears on the first edition Ordnance Survey (*Fig. 4*), so pre-dates the building.

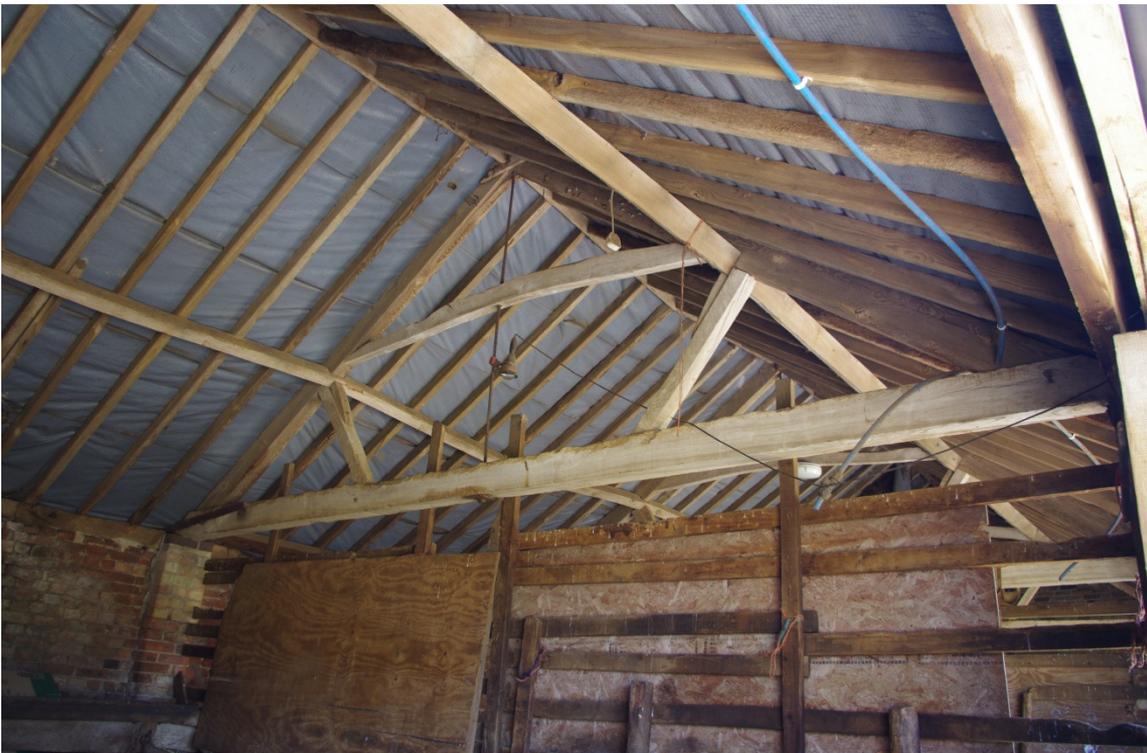
Figure 12
Building A Clasped Purlin Roof Truss.

Internally, there are the remnants of the original timber troughs and racks on the rear wall. The partitions are all modern. The roof is carried on four composite king bolt trusses with raking struts and an arched collar beam. The trusses are of an idiosyncratic design, but essentially a clasped purlin roof (*Figure 12*). The clasped purlins allow the common rafters to sit in line with the backs of the principal rafters. The clasped purlin design originated in the 17th century and continued to be used into the 19th century when they were used on poor quality roofs in farm buildings (*RCHME Northamptonshire vol. VI, Architectural Monuments in North Northamptonshire (1984, xlvii)*); these are a very late example as illustrated by the use of a wrought iron king bolt. The trusses also make interesting use of cleats attached to the raking struts to support the underside of the purlins.

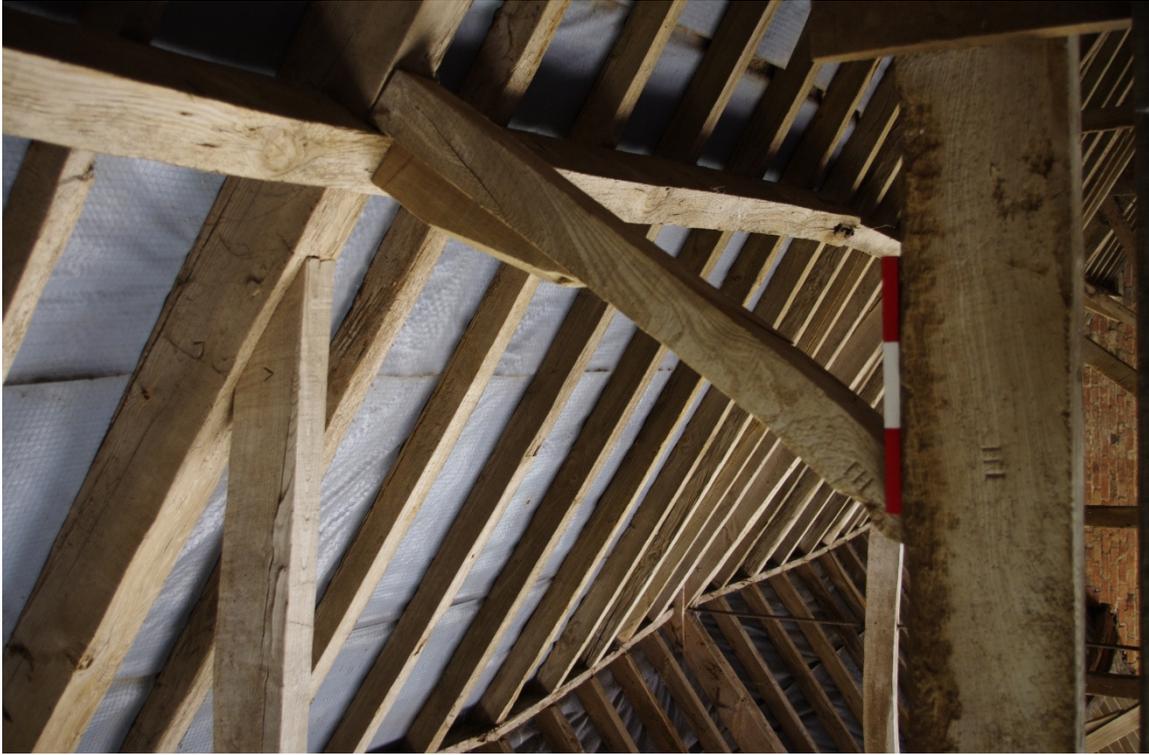
Figure 13 Building A, Assembly Marks in Roman Numerals on Clasped Purlin Truss.

Of further interest on the roof structure is the use of both Roman numerals and drilled holes to potentially number and identify the trusses (*Figures 13 & 14*). The exact purpose and origin of which is unclear.

It is possible that the trusses are re-used. The building, at approximately 6.5metres wide is large for a cow hovel and it is possible that it was built to fit existing trusses. This would also explain the late date.

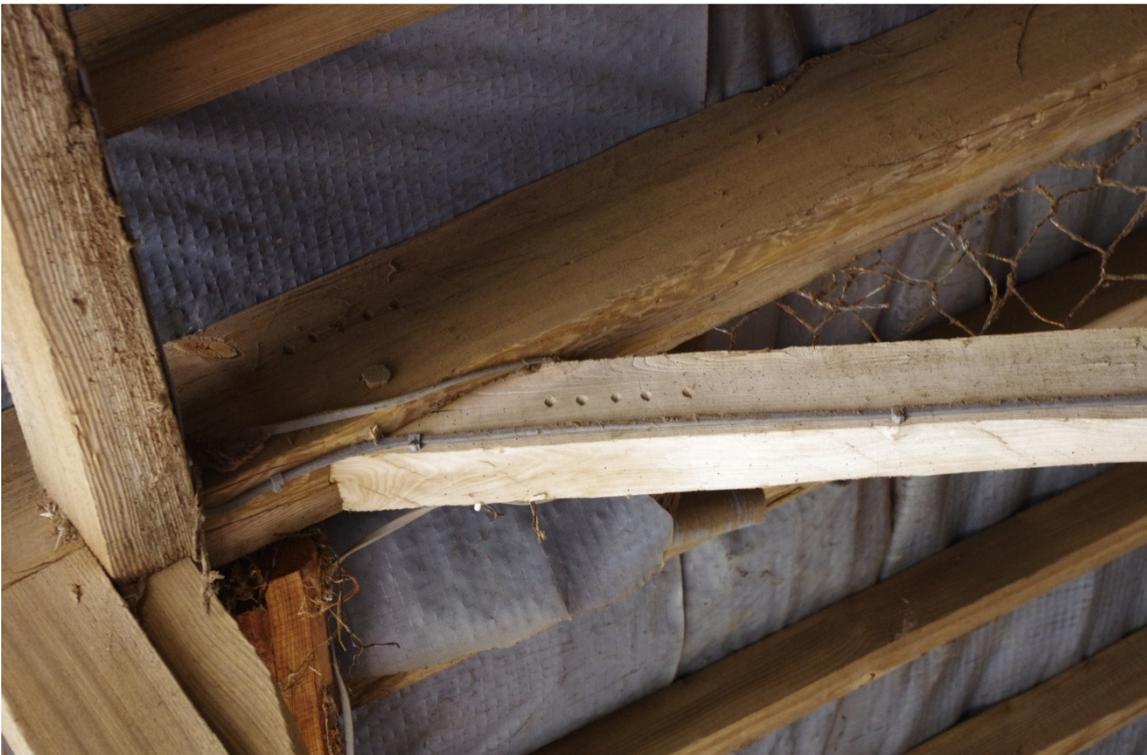
Figure 14
Building A, Drilled Assembly Marks on Clasped Purlin Truss.

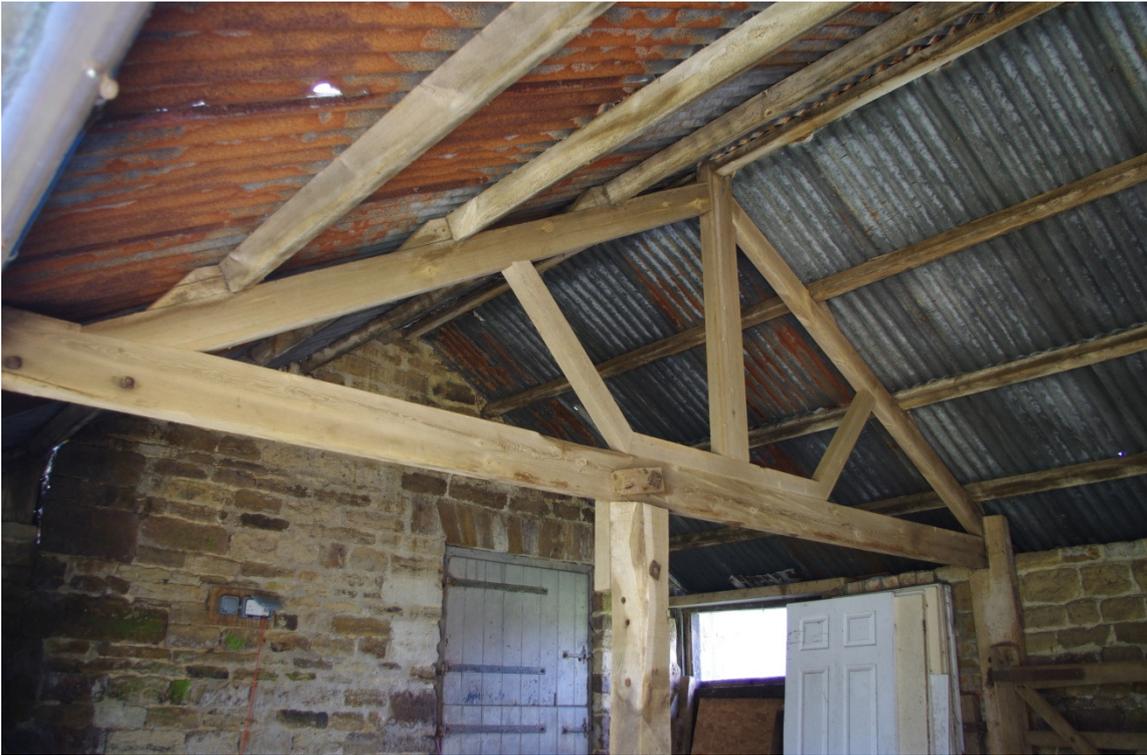
Figure 15
Building D, Modified King Post Truss.

Internally the building has five unusual king post trusses with raking struts (*Figure 15*). The struts are “U” shaped with a third piece stat atop the tie beam on which the king post sits. An unusual design which suggests that the roof may have originally been heavier. There is a partially blocked door in the southern end of the rear wall. The building again has all the appearances of an open-fronted cow hovel.

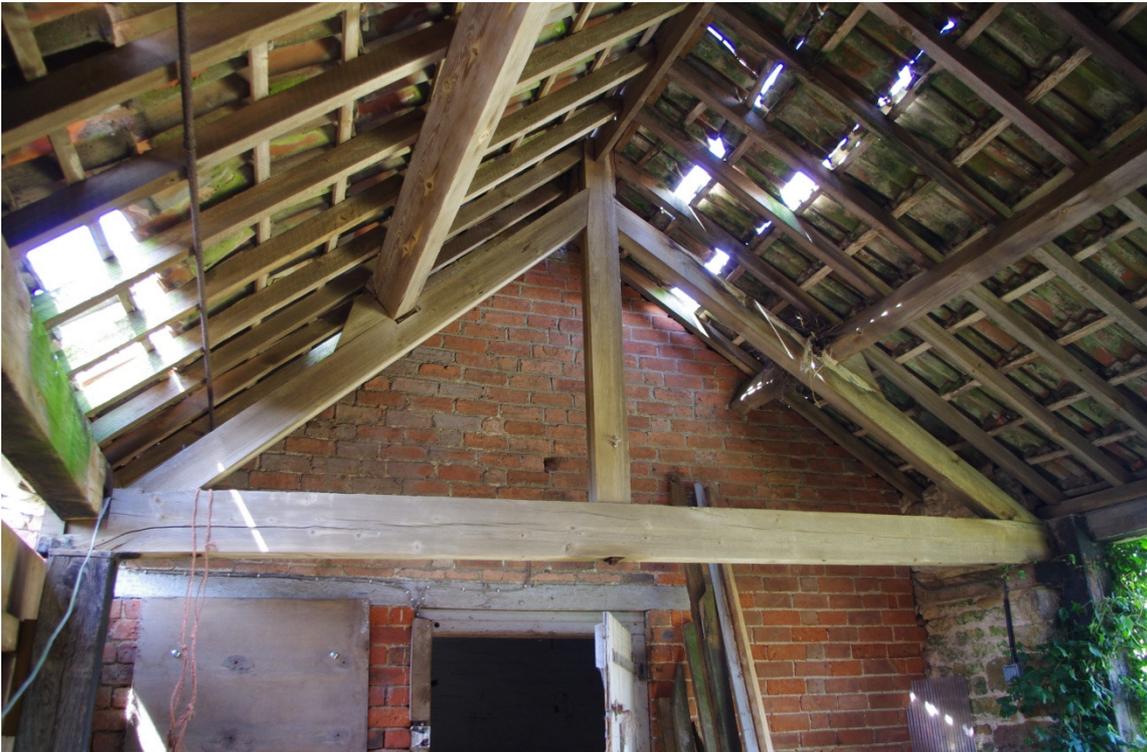
Figure 16
Building C (1) Asymmetrical King Post Truss Roof & External View of Building E.

Unusually the king post trusses carrying the roof of the east – west range (1) are asymmetrical (*Figure 16*). It is possible that they were built especially in order utilise the north and east walls which are likely to be earlier than the remainder of the building.

Building E is a small brick-built space at the far western end of building C (*Figure 21*), the straight joints between the brick-built walls and the northern stone-built wall (*Figure 16*) as well as the straight joint with the threshing barn suggests the space is a significantly later partition of the east – west part of the threshing barn. There was no access to exterior of the space, so establishing its exact relationship with the barn is impossible. The brickwork is red 9inch x 3inch x 4inch machine made bricks, again confirming it as a later structure.

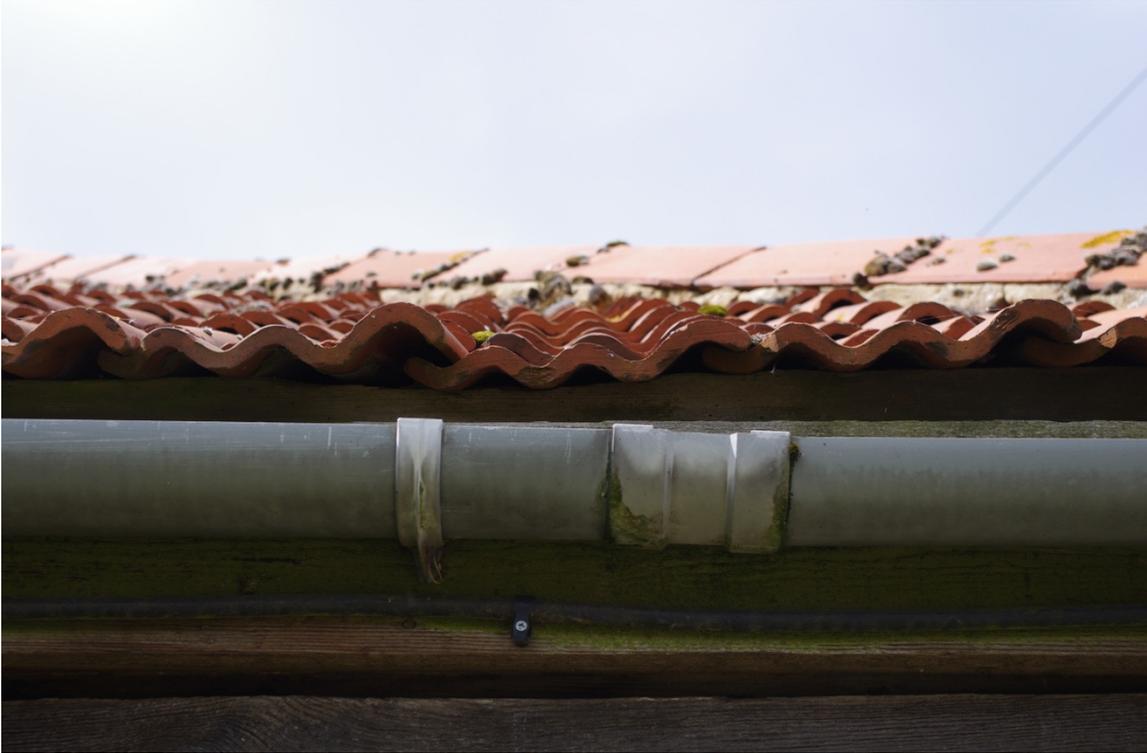
Figure 17
Building B, Profile of Triple Roman Roof Tiles.

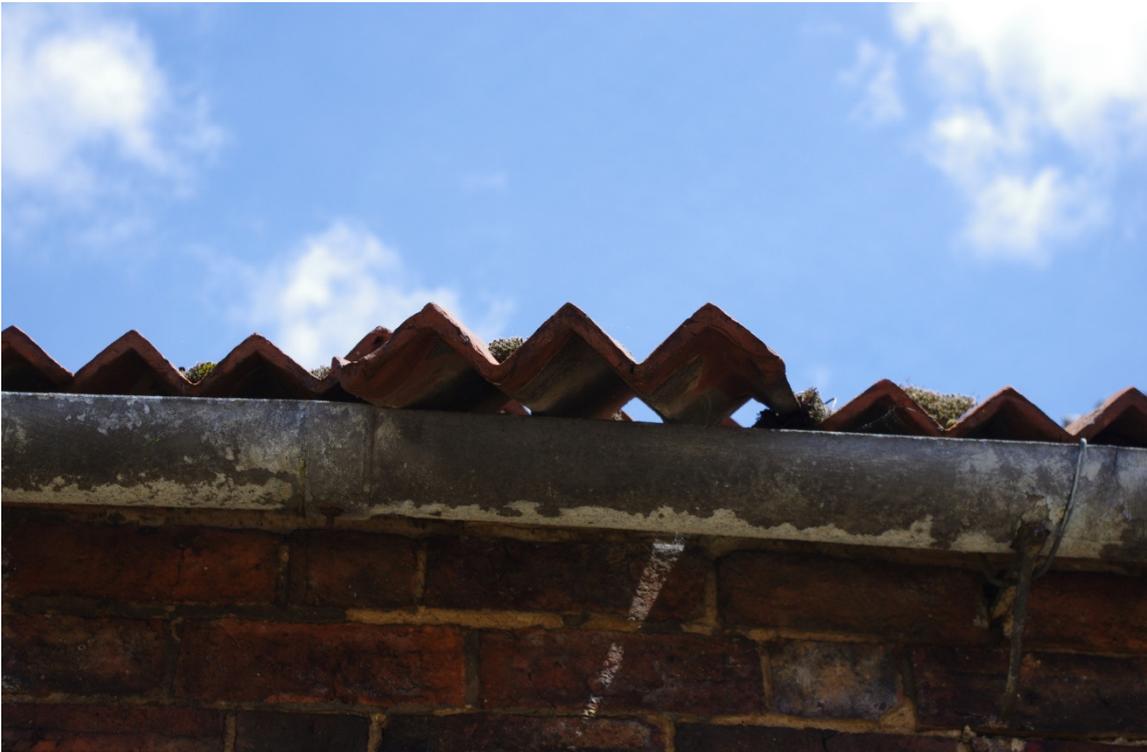
Figure 18
Building C Profile of Triple Delta Roof Tiles.

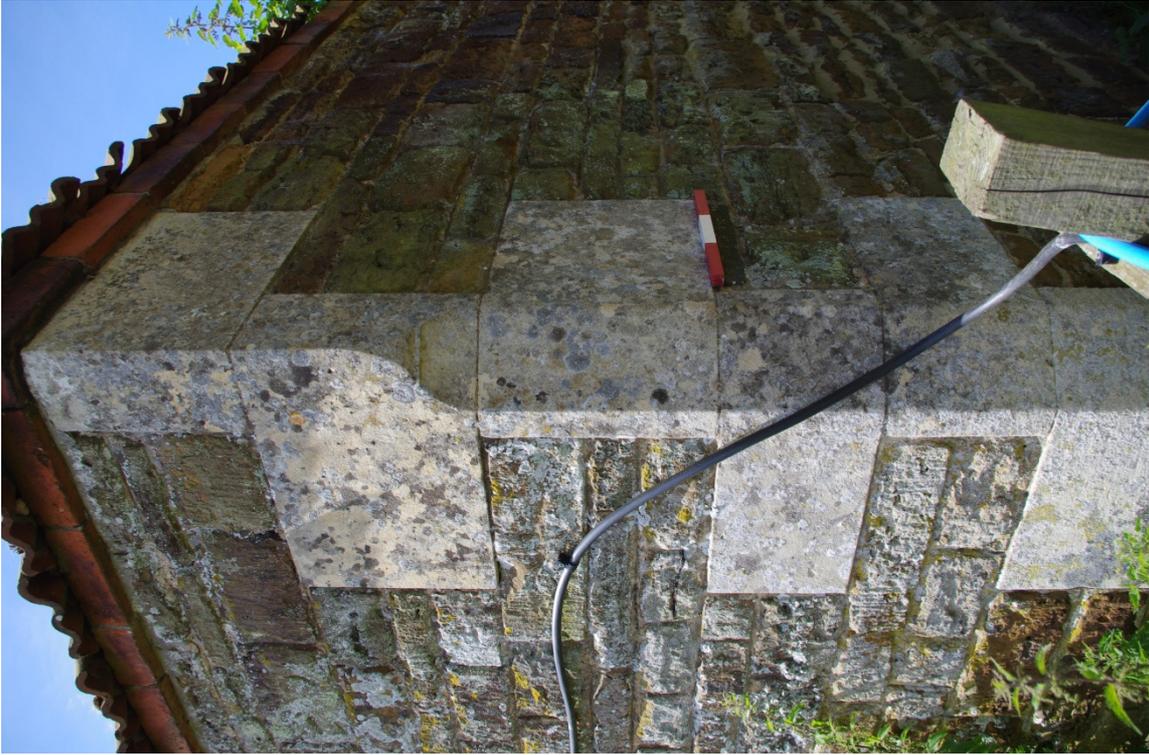
Figure 19 Building B Stopped Quoins
on North East Corner.

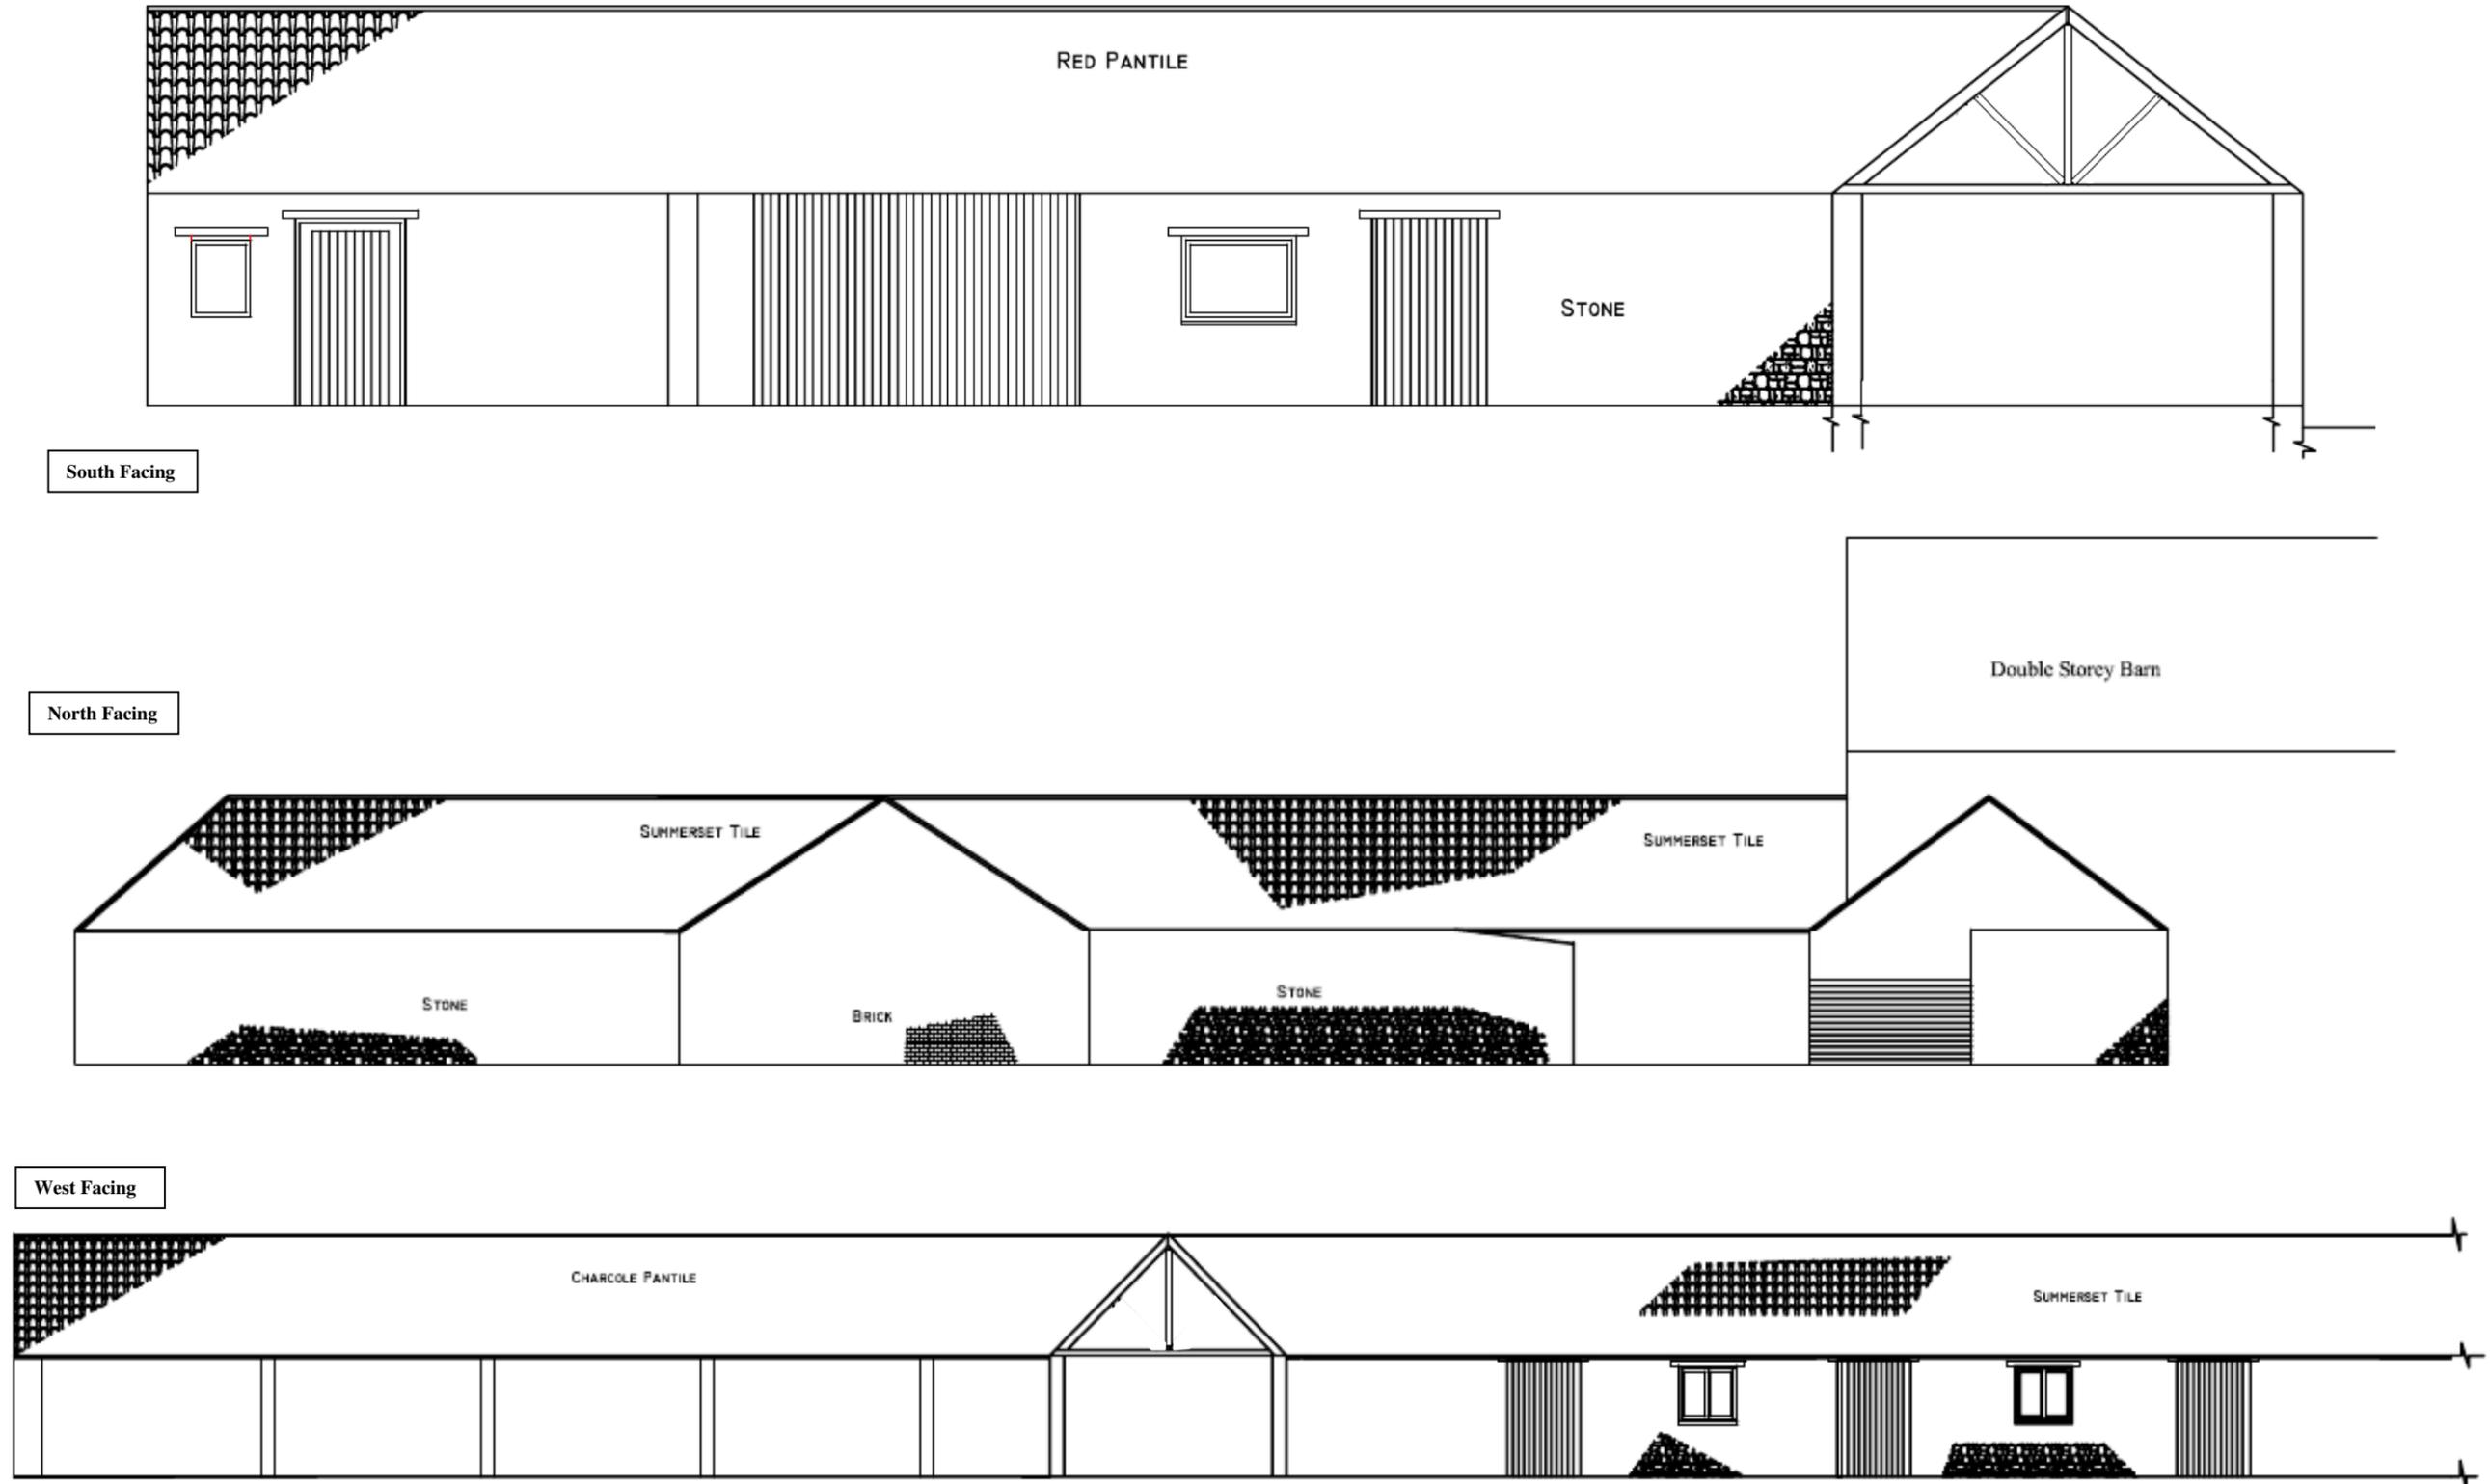
Figure 22 Annotated Elevations & Profiles Supplied by Client (Not to Scale).
