Ken Browns Garage, 42-44 Potter Street, Harlow, Essex.
Recording the ground works at the site prior to development.
Surveyed 06 10 2011. Harlow District Council HW/PL/11/00059.

**ESSEX HISTORIC ENVIRONMENT RECORD
ESSEX ARCHAEOLOGY AND HISTORY
SUMMARY SHEET**

Objectives and Scope

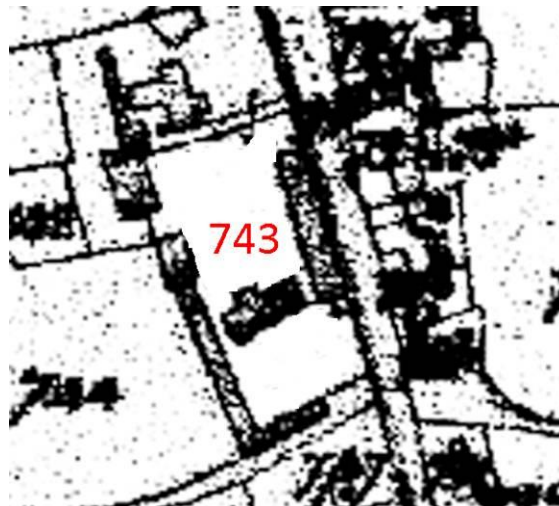
By 1849 the two plots are amalgamated and the White House is shown to the north while the barn is clearly shown with a midstrete off-centre to the west. Long buildings line the boundaries in a formation which would have been recognised by the High Farmers. Plot 743 is recorded as 'White house premises and garden' owned and occupied by the Revd Jos. Arkwright.

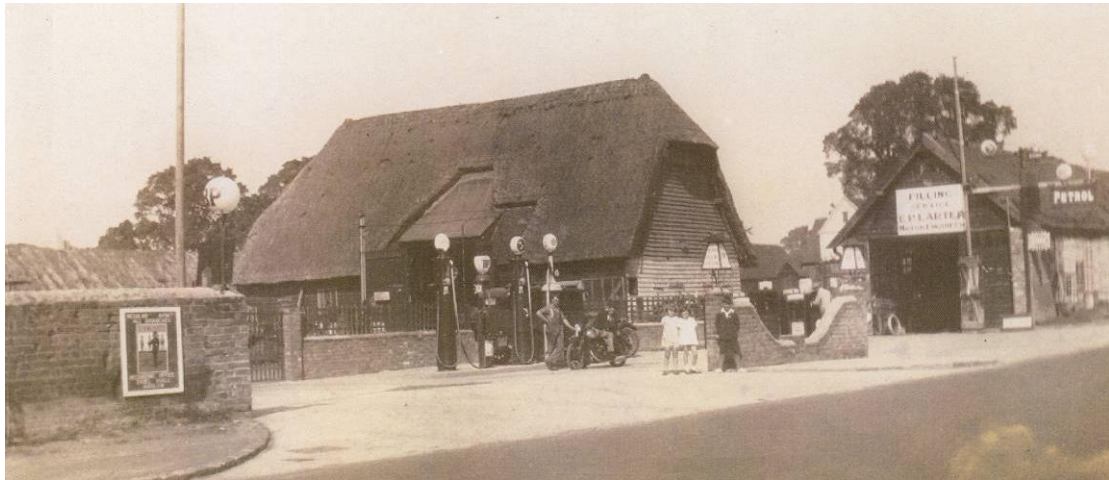
Larter's garage in the later 1920's or 1930's.

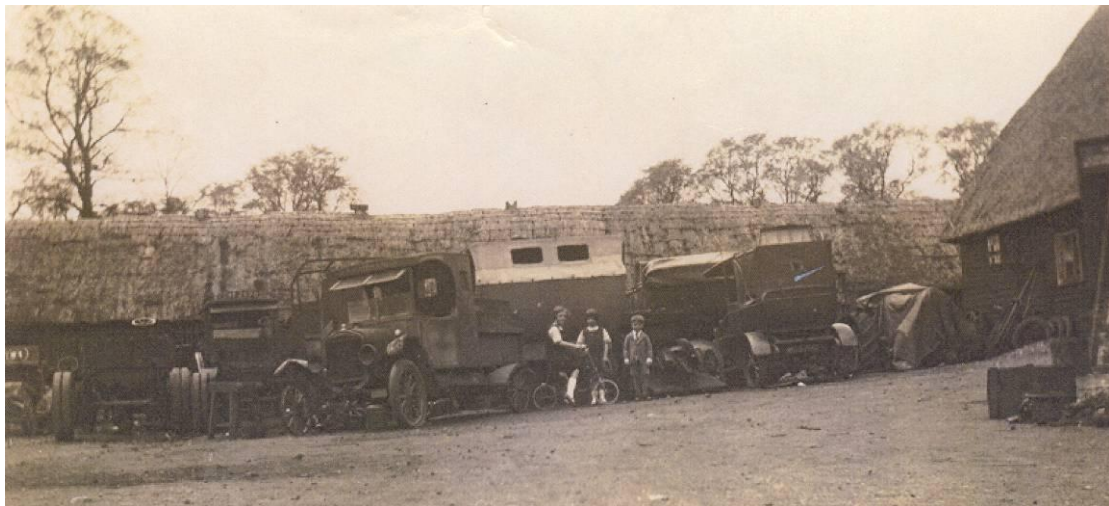
The SW corner of the barn (rhs) and the range of buildings on the west boundary. All thatched. The little girls have grown up a bit in this photograph.

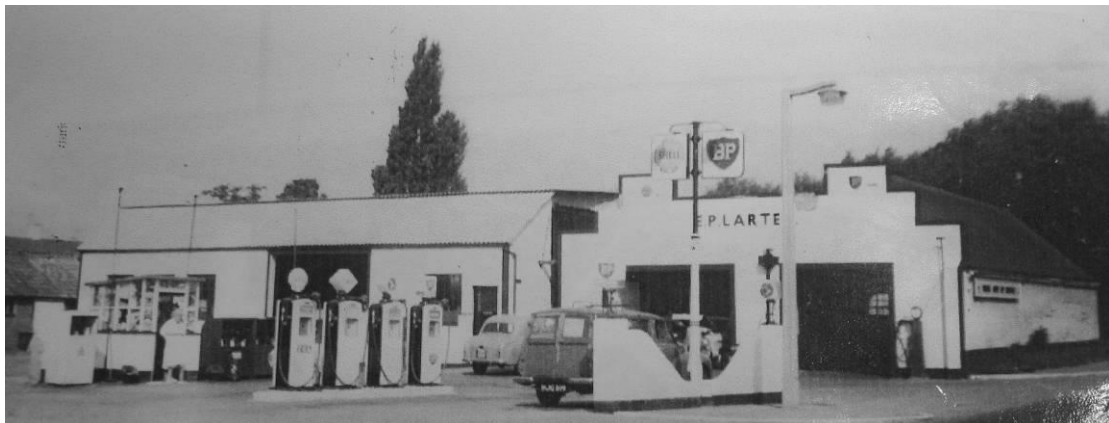
1930's facade of Larter's garage.

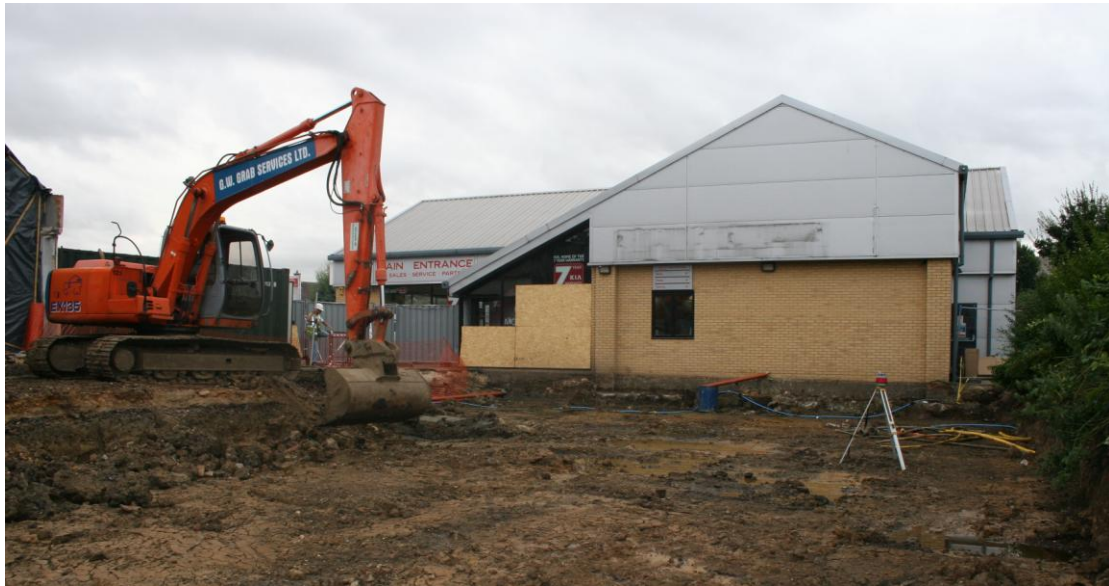
Excavator with ditching bucket. Looking S.

The westernmost bay of the Maintenance Workshop was removed and the building made water tight with plastic sheeting as it was still in use. The site was excavated with a tracked excavator using a 1.8m ditching bucket leaving a clean scraped surface.

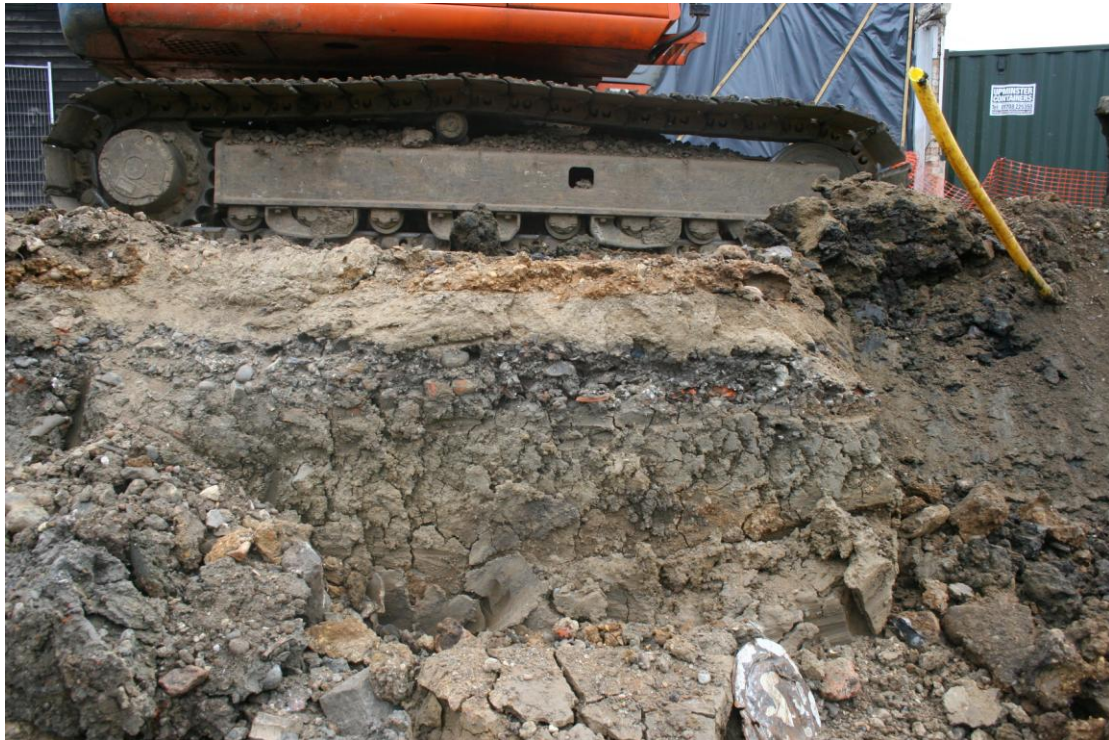
Layers of road make up adjacent to the Maintenance Workshop. Looking E.

The only true archaeological sequence that was recorded was that of the successive layers of the roadway to the north of the Maintenance Workshop. Here there was a build up of road making materials with the earliest being broken brick and roof tiles and gravel straight onto the London clay. Because the soil was permeated with oil it was decided not to excavate by hand but a clean section was created by the machine.

In the section 500mm of London was overlain with crushed brick and tile identifiable as peg and pan tiles. This was intermixed with coarse gravels and pebbles to a depth of 200mm. On top of this was a 200mm layer of gravel hoggin (commonly called Type 1) and the surface finished with layers of concrete and asphalt representing many path repairs. A number of sawn off railway sleepers were pulled out and these were no doubt post repairs from the range of timber buildings that lined the western side of the site until the later C20th.

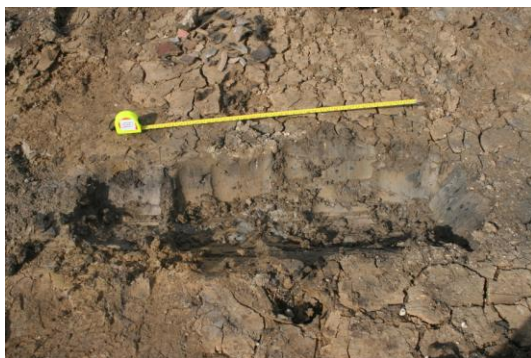
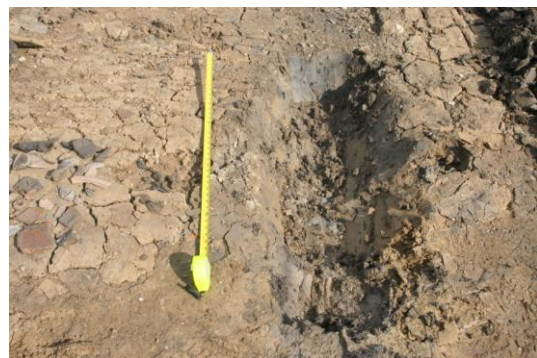
Linear feature containing oil soaked clay and some finds. Scale is 1m. Looking W then N.

There was one feature of interest that was excavated by hand because it contained pieces of a salt glazed Bellarmine bottle and a piece of undecorated Metropolitan slipware from a platter. This was a linear feature with a dished profile that descended 200mm into the London clay at a depth of 1.0m from the present surface level. A 1.0m long section was removed to test the feature.

The oil soaked clay soil contained a small cache of pottery, a leather boot sole, roof tile and ironwork consisting of a door latch, square shouldered staple and a hexagonal nut. At the very base of the deposit was a chunk of concrete rubble and so it had to be concluded this was all redeposited into the feature in the C20th. There had been a drainage pipe running across the site at this point to a C20th brick built sump. The rest of the feature was sterile of finds and lensed out to the south.

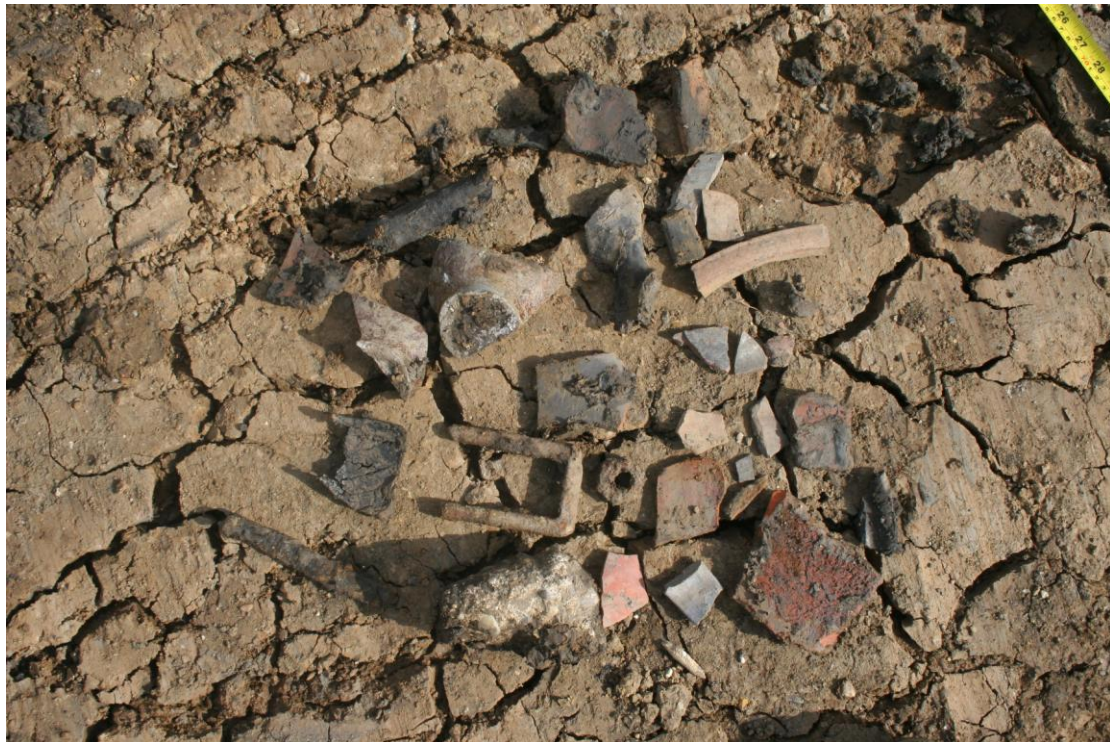
Finds recovered from a C20th pipe trench.

The finds from the C20th pipe trench are of interest because they imply an occupation of the site at least as far back as the C16th when Bellarmine bottles were commonplace. They were also reused as witch's bottles when pieces of cloth, material or hair were put inside them and used as charms to ward off evil. The metal fittings must come from the C19th buildings and the hexagonal nut from a C20th machine.

Because they were found in a C20th context they were reburied where they were found. There were a number of other discrete dumps of C20th car parts, metal and a front roller from a lawn mower all apparently buried on purpose.
