Clees Hall Bungalow, Clees Hall, Althamstone, Essex. CO8 5DZ.
Description and analysis of the bungalow. Surveyed 19 06 2012.

Site name/Address: Clees Hall Bungalow, Clees Hall, Alphamstone, Essex. CO8 5DZ.	
Parish: Alphamstone	District: Braintree
NGR: TL8813034408.	Site Code: N/A
Type of Work: Historic Building Recording	Site Director/Team: Barry Hillman-Crouch
Date of Work: 19 06 2012	Size of Area Investigated: 100x100m
Location of Finds/Curating Museum: N/A	Funding source: Owner
Further Seasons Anticipated?: No	Related EHER Nos:
Final Report: Description and analysis of the bungalow. Surveyed 19 06 2012. Barry J Hillman-Crouch MStPA DipFA BSc HND.	
Periods Represented: C19th - C20th	
<p>SUMMARY OF FIELDWORK RESULTS:</p> <p>Open-sided agricultural building with red brick walls erected between 1876 and 1897 outside the complex of Clees Hall farm probably as a cart or implement shed. Converted to a farm workers cottage between 1923 and 1957. Set in its own garden with new access lane. Later burnt down and rebuilt c.1970 with new roof and brick facade. All doors and windows of this period.</p>

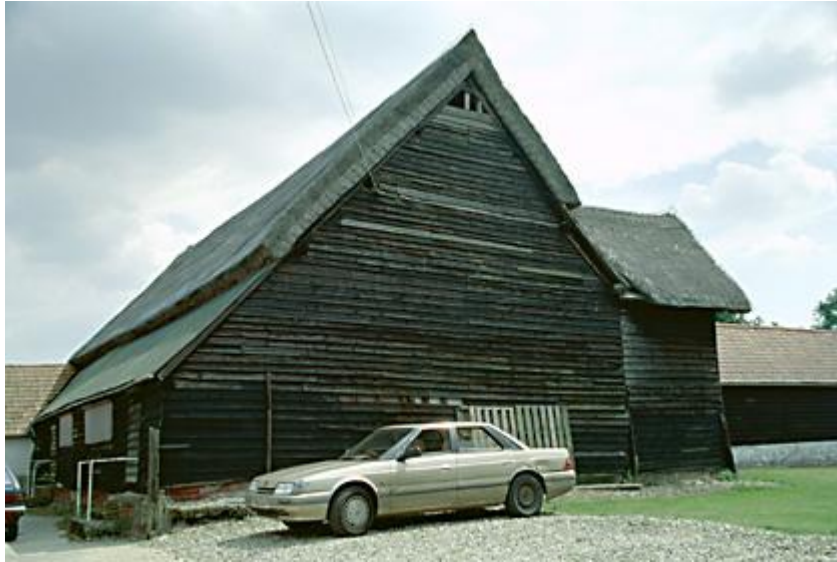
IoE Number:114792

ALPHAMSTONE. TL 83 SE. 4/3 (27/90) Barn approx. 55 metres south-east of Clees Hall.
GV II. 24.2.82

Barn. Late C15/early C16. Timber framed, thatched roof with valleys of hand-made red clay tiles, aisle roofed with corrugated iron. 6 bays aligned E-W with C17 midstrey to S of W bay. Reported by RCHM to have been then of 10 bays and 120 feet long, the 4 western bays later removed, reportedly to North America. Originally without aisles, aisle added to N in C18. Jowled posts, heavy studding and girts in E and S walls, edge-halved and bridled scarfs in wallplates, queen post roof. One pair of arched braces to tiebeam present, others replaced by hanging knees in C17/C18. Some wattle and daub present in S wall. E bay bricked and floored in C20. Moated site. RCHM 4.

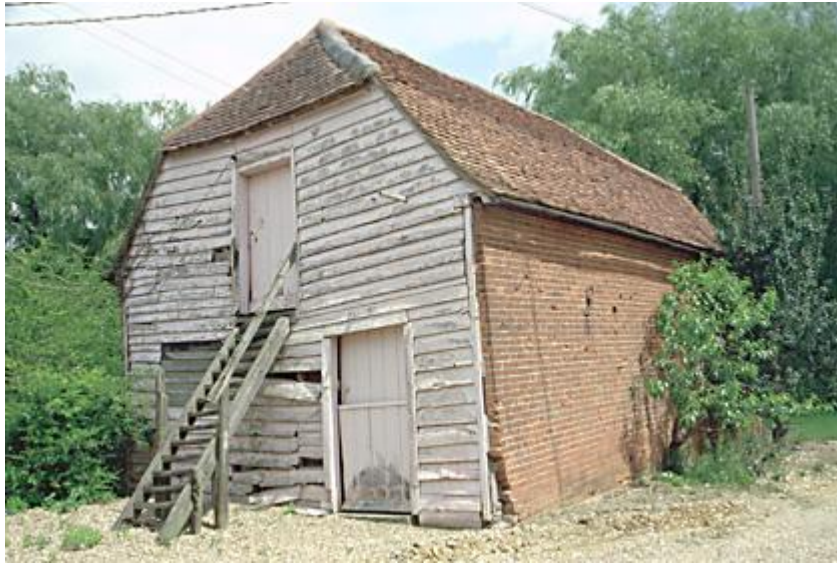
IoE Number:114794

ALPHAMSTONE. TL 83 SE. 4/5 (27/9B) Granary approx. 25 metres east-south-east of Clees Hall GV II. 24.2.82

Granary. Mid C18. N and S walls of red brick in Flemish bond, E and W walls timber framed and weatherboarded, roofed with handmade red clay tiles. Gambrel roof half-hipped at both ends. 2 storeys. External ladder access at W end.

Hanging knees to beams. Lodged side purlin roof with intermediate collars.

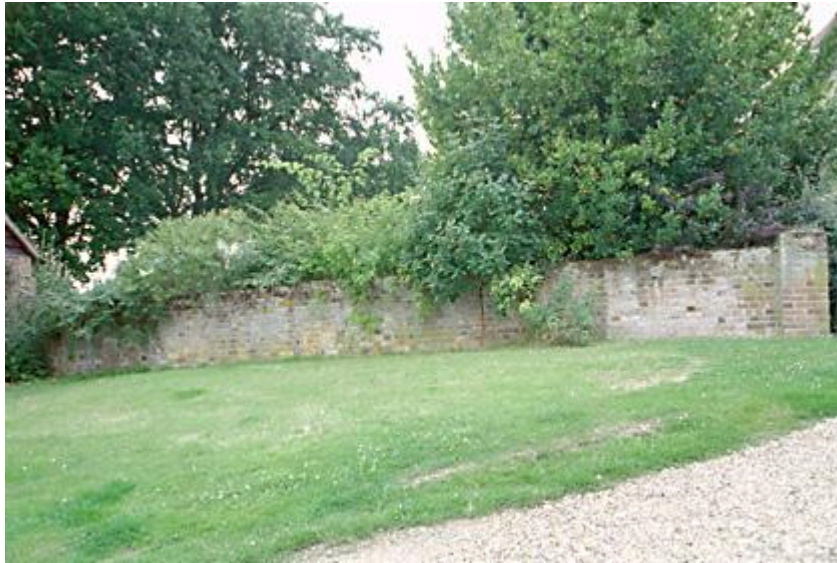
IoE Number:114793

TL 83 SE4/4 (27/9A)Wall approx. 20 metres south-east of Clees Hall.GVII. 24.2.82.

ALPHAMSTONE TL 83 SE 4/4 (27/9A) Wall approx. 20 metres 24.2.82 south-east of Clees Hall. GV II Wall. Early C16. Red brick, lime mortar, mainly of header bond on W side with some courses of stretcher bond. Approx. 5 metres long, 2 metres high, 0.33 metre thick, thicker at base. Now forms the W side of a C20 ancillary building, originally part of or associated with the former Clees Hall. Moated site.

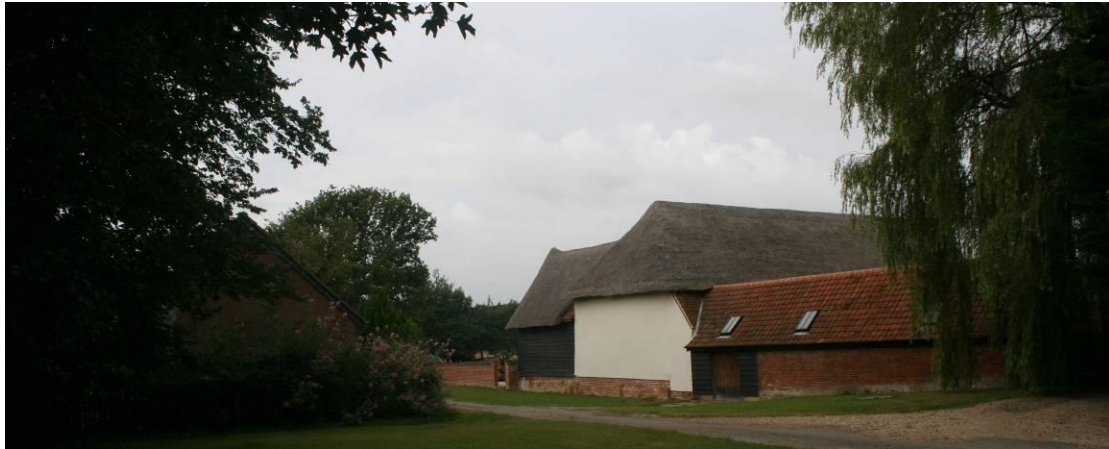
The Bungalow(LHS) in relation to the Listed Barn. Looking S.

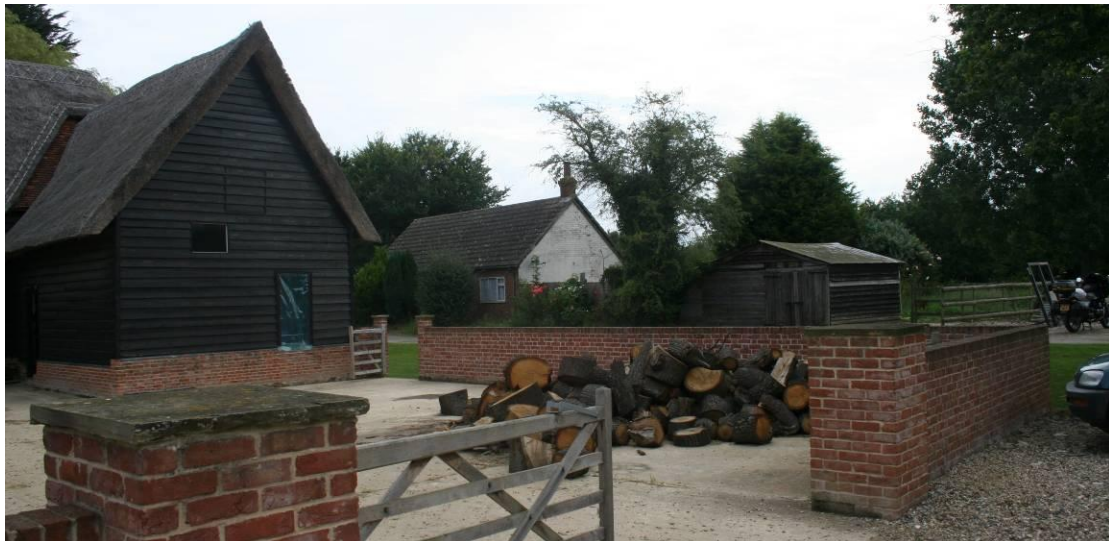
The Bungalow from across the stable yard. Looking NE.

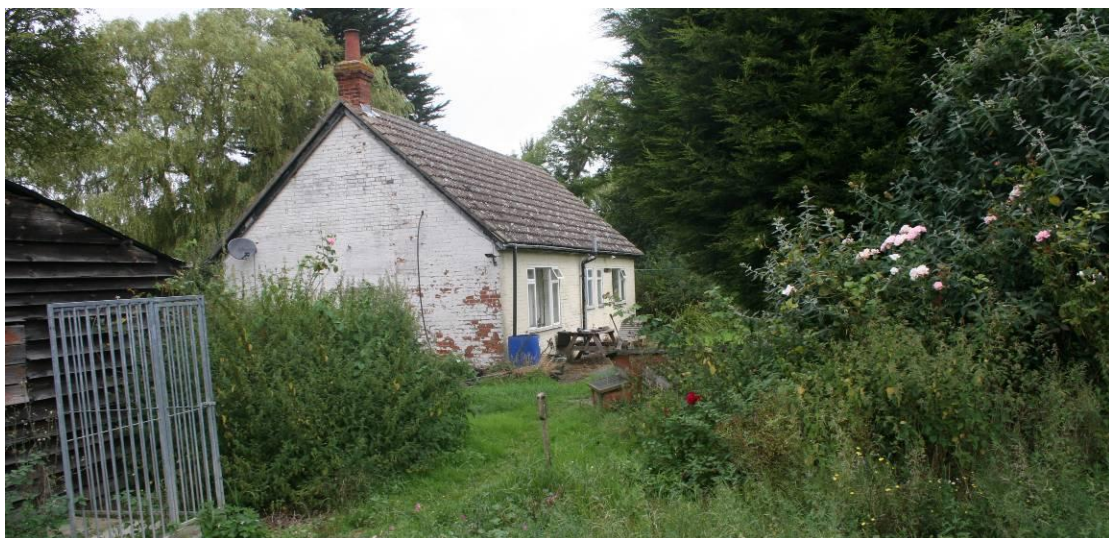
The rear of the Bungalow in its own garden. Garage at left. Looking NW.

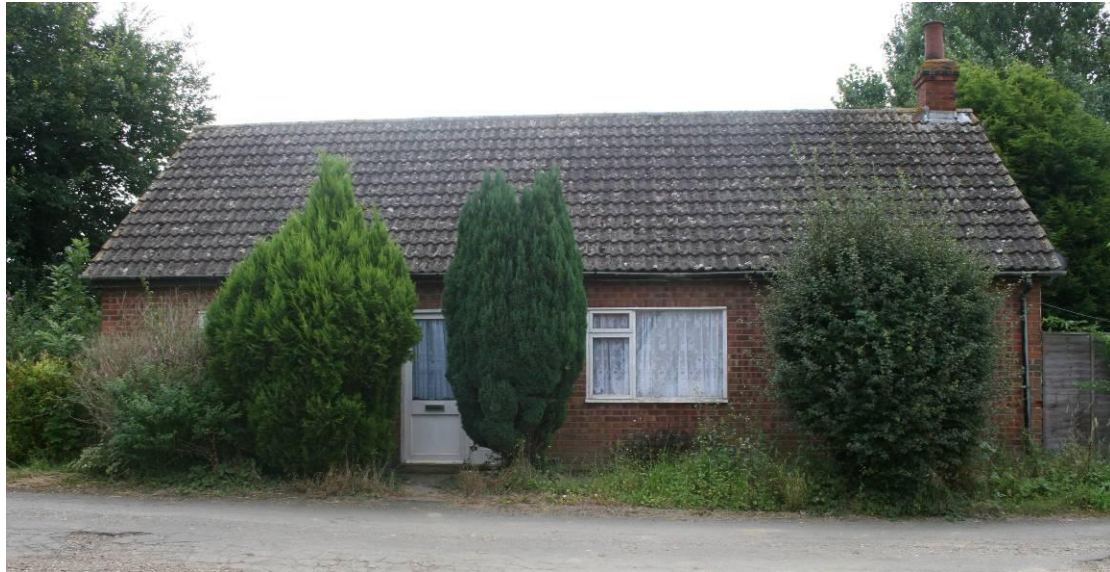
Western Elevation

The western elevation is the front of the house and has the front door and three casement windows. The brickwork is LC20th textured 65x110x210mm Flettons set in grey cement in stretcher bond. The openings are dressed with single header courses. The roof is clad with concrete interlocking double roman tiles with dry verges. The rainwater goods are of painted metal.

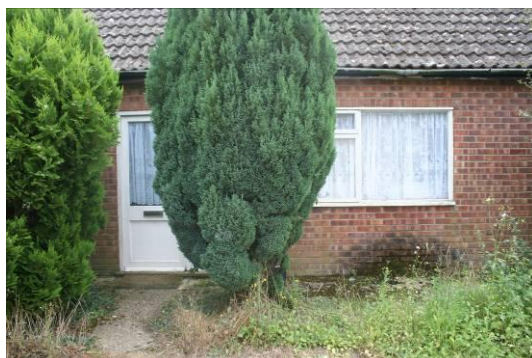
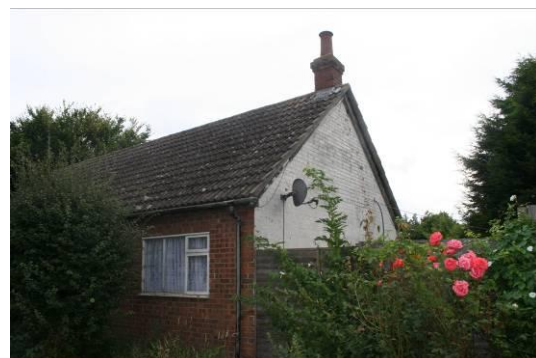
The front door and LC20th casement.

The front door is a LC20th half-glazed unit with a full height side glazed panel hidden from the road by an evergreen tree. The joinery is of the same style as the large fixed pane with opening casements and top-lights common in the 1970's onwards.

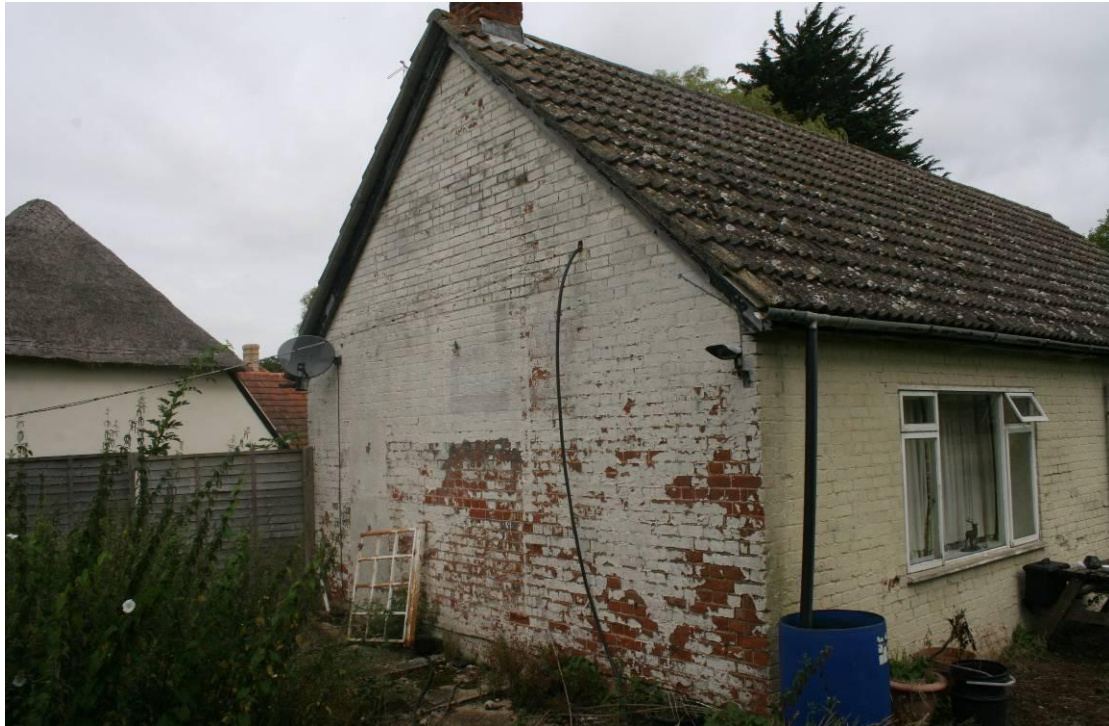
The southern elevation has a blocked doorway to the west.

The southern elevation presents a blank gable with evidence for a blocked doorway to the western side. The brickwork is made of orange 65x100x220mm soft handmade bricks with slightly creased faces, horizontal pressure lines and crisp arrises. They are set in a gritty white mortar. The bricks are laid in English bond up to eaves height and then change to Flemish bond to complete the gable. The quoins are finished with queen closers.

The brickwork has been lime washed and shows damage from plant and frost action. Lines indicate a removed structure. The blocked doorway has been hard rendered. The northern elevation is a reflection of the south but has no doorway. The bricks are more purple in colour due to patination.

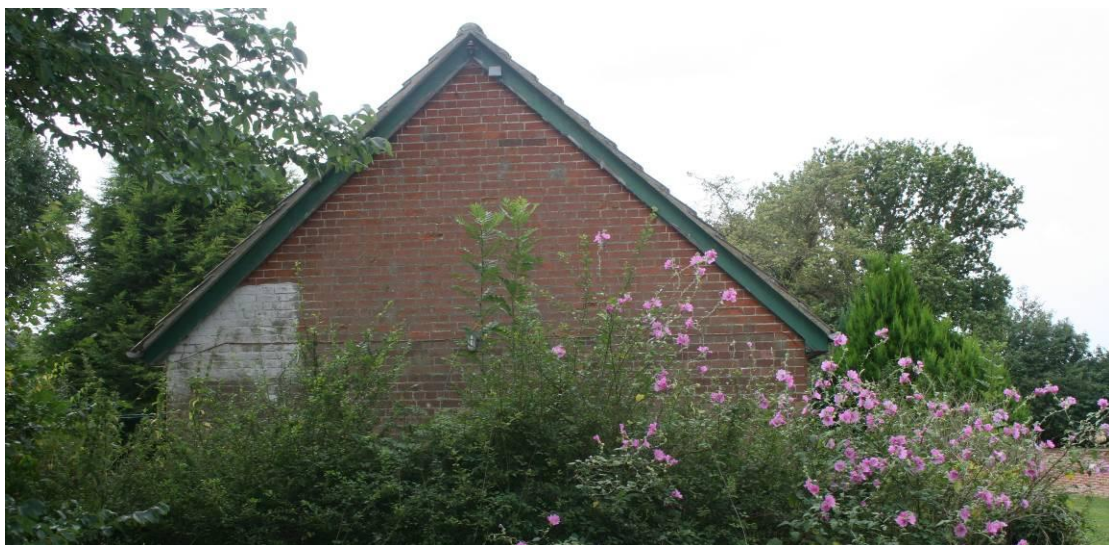
The southern elevation is a reflection of the northern one.

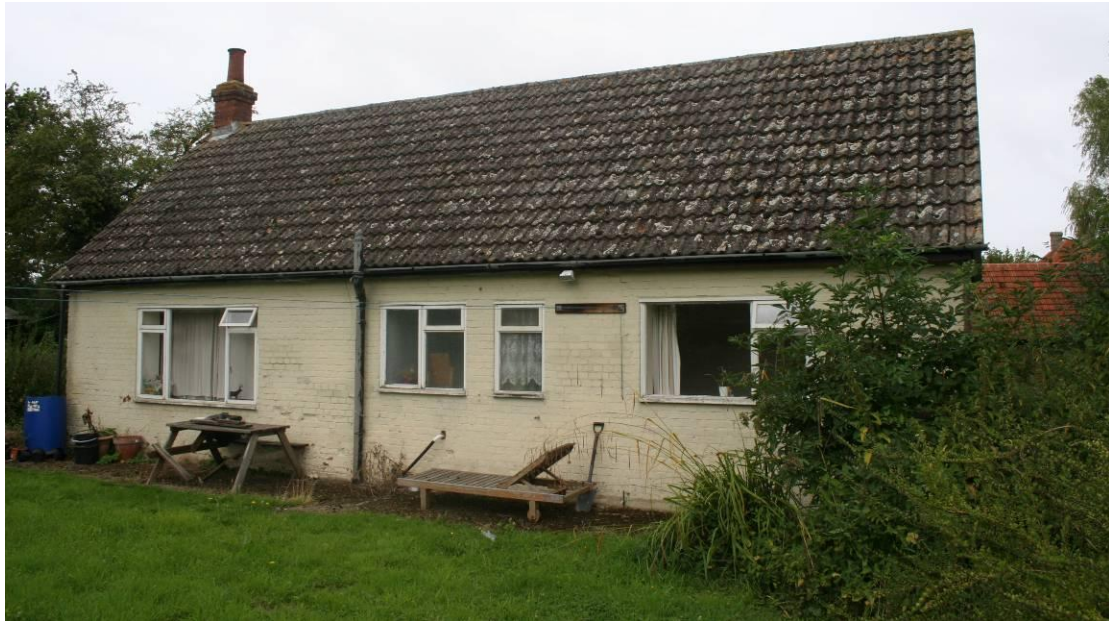
The eastern elevation looking SW.

The eastern elevation is composed of the same bricks as the gable ends and must have been the carcase of an earlier building open to the west with timber gables above the eaves. The C20th casement windows are all inserted and of the same pattern. The openings have no queen closers. Surprisingly there is no back door so the blocked doorway in the southern wall must have served this purpose.

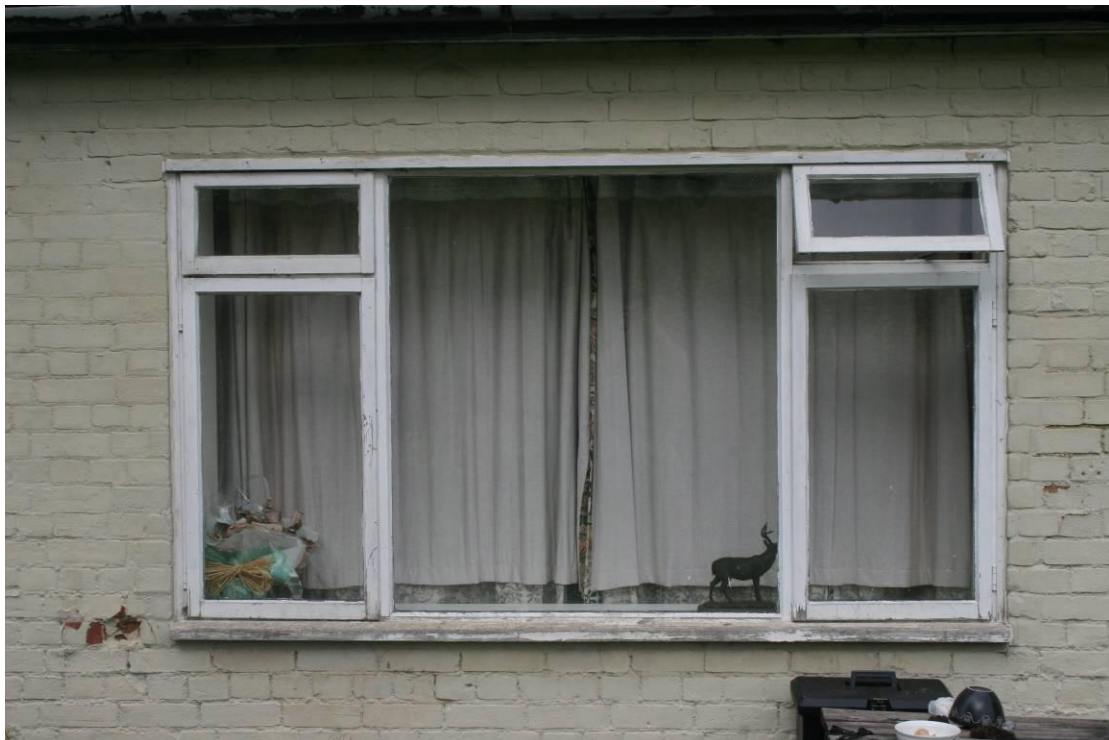
Detail of the rear Living Room casement.

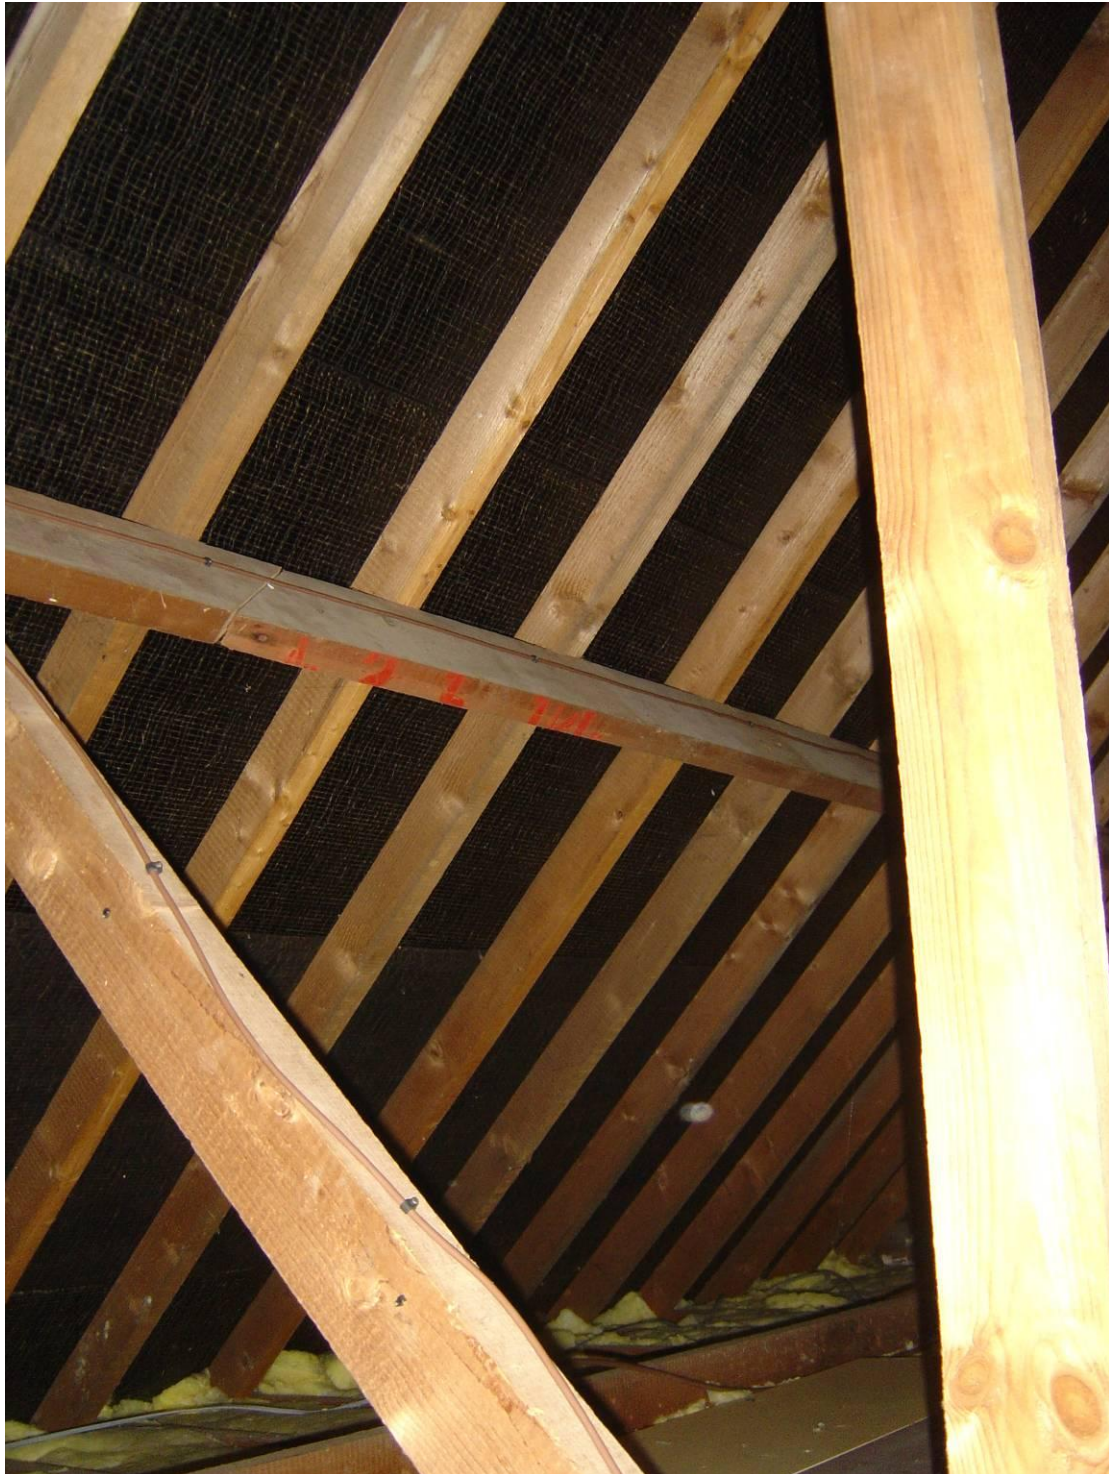
Detail of the roof void. Supplied by David Snaith, architect.

The roof is entirely LC20th, hand cut from machine sawn 2x4in softwood and laid with a hessian backed asphalt membrane. The timber is fixed with French nails and marked up with bright red merchant's marks. The design is of a simple side purlin, held with raking struts and housed in the brickwork.

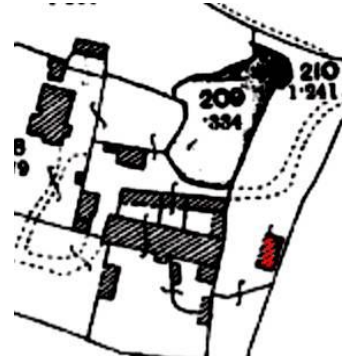
Phase 1. 1876 to 1897.

Notwithstanding the map evidence which clearly shows there was no building on the site of the Bungalow until after the 1876 Ordnance Survey map was made, the type of bricks, their bond and the form of the building indicate a building of this period.

Built as an open sided building with eaves height brickwork laid in English bond the building probably had timber framed gables and an open side to the west supported on posts. Its position on the site suggests an implement or cart shed easily reached from the metalled lane. Its position, on the blind side of the Listed Barn, isolates it from the activities of the farm yard.

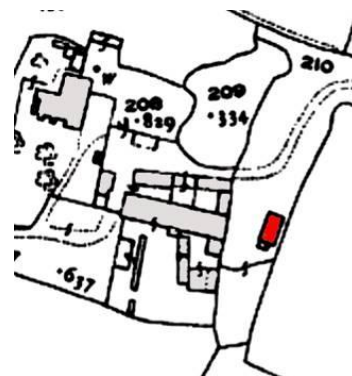
1923 OS Map.

Phase 2. 1923 to 1956

It is known by the farm workers that the Bungalow was converted in the early part of the C20th and was later burned down and rebuilt. The 1923 Ordnance Survey shows the building with a small extension to the south. The shadow of this can be seen in the limewash on the brickwork. It is likely the only remnant of this period is the triangular section of the gabled ends which are built in similar red bricks but laid in Flemish bond. The chimney is built of similar bricks.

It is also likely that the original windows were put in at this time and a doorway cut through to access the extension. The current front facade does not date from this time as the brickwork and details are more common to the 1970's than the 1920's. The 1923 OS map shows no access lane or garden so the work was later than then and prior to 1955.
