Queens Head, 31 High St, Pinner, HA5 5PJ.  
Recording and analysis of the Public House. Surveyed 11 04 2017.

## **Scope of this Report**

This report describes and analyses the fabric of the Queens Head, Pinner with a view to mitigating changes to the upper rooms which were inserted in the MC20th.

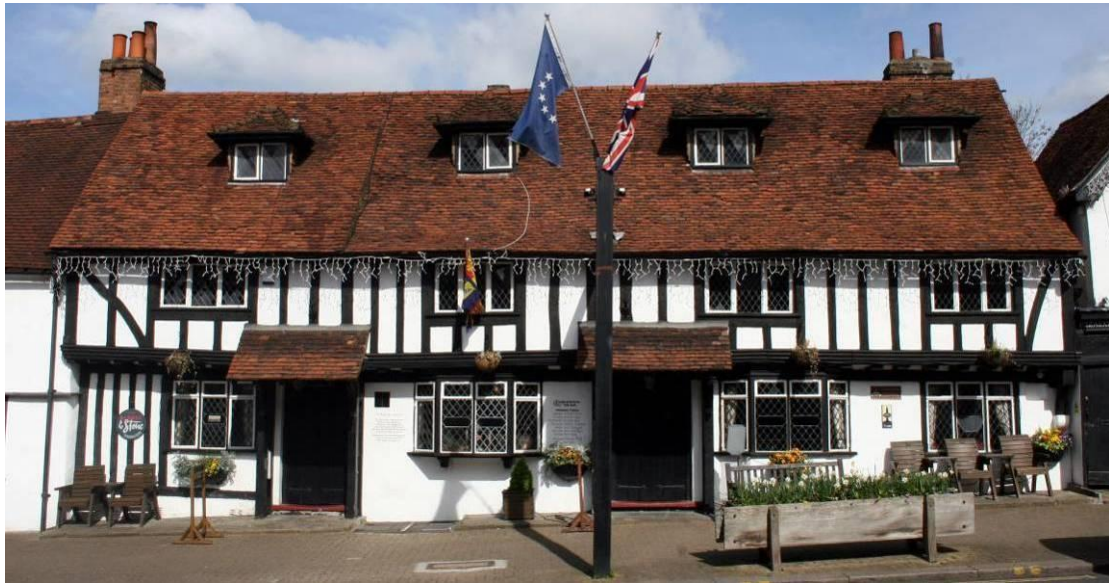
The southern elevation of the Queens Head.

The southern elevation retains a 'modern facade' as recorded in the very brief Listing description and it can be seen that all the studwork and the bressummer is made of machined timbers. The fenestration is of 1930's style leaded lights retaining a LC19th canted bay. The porches and bay window are C20th additions not shown on old photographs. Long walled jetty buildings were very popular in the C16th reaching their peak in the 1550's.

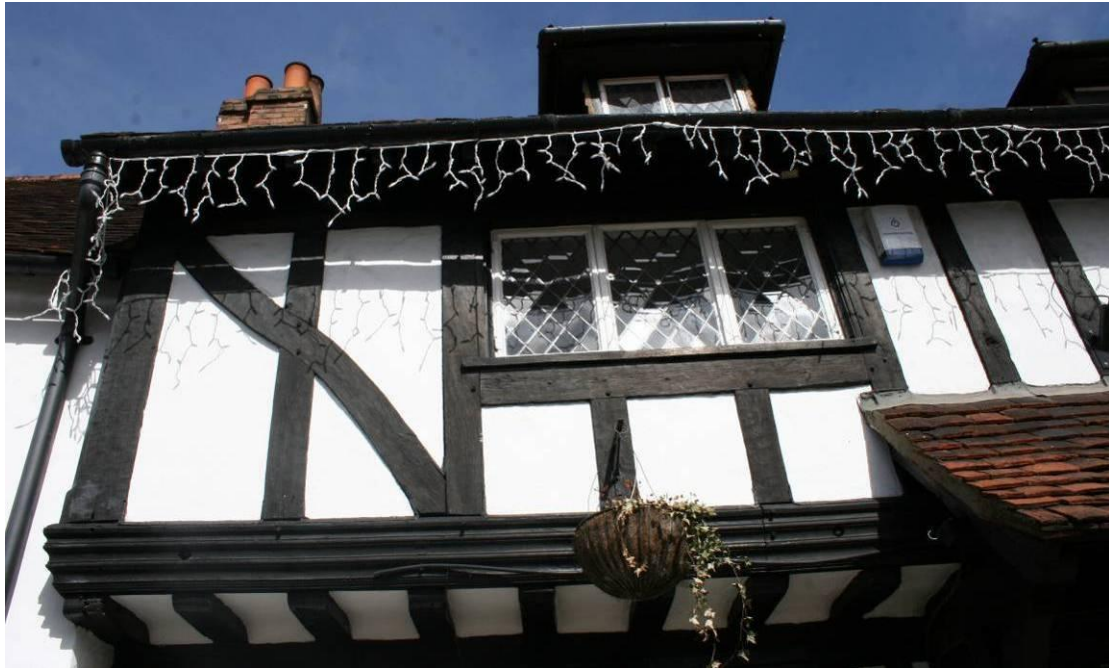
Detail of the jetty. The joists are original but have undergone rebuilding.

The joists forming the jetty are original and carry through the building. They are however of two different forms. The bays at either end have flat, heavy and waney joists while the middle section is of much more regular and square section joists. This may suggest a carriage arch was filled in or there was a serious event that damaged the middle of the building requiring repairs in the LC17/EC18th. For many years a date of 1705 was on the front of the building as this may signify a comprehensive refurbishment at that time.

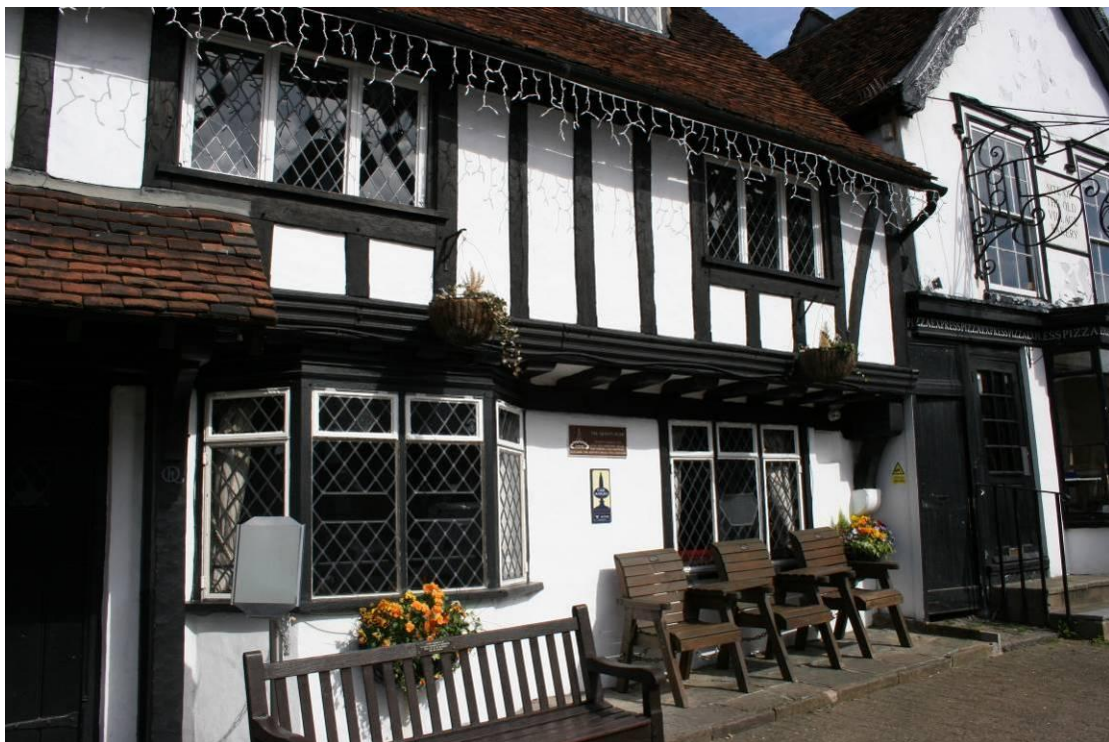
Detail of the canted bay window.

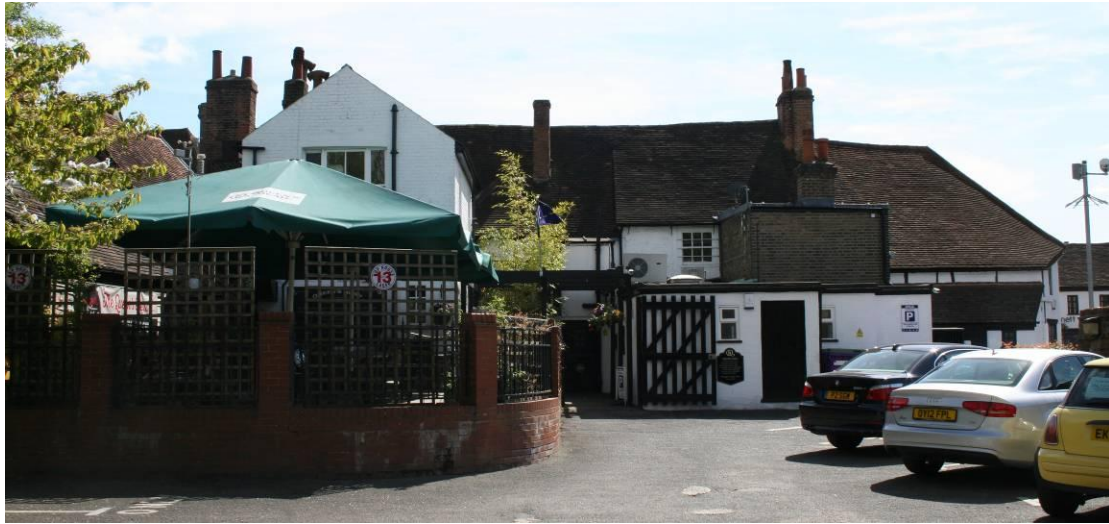
The northern elevation from the car park.

The Northern Elevation is screened by a number of incremental modern extensions which partially overlap with the building to the west. The rear of the original frame has been extended with a narrow tower that contains the staircase and the rear entrance lobby. The roof steps out over the frame of the westernmost bedroom. Adjacent to the west is a two storey rear extension to the neighbouring house made of London Stock bricks and has a chimney with two flues. To the east is an independently built brick two storey rear range under a grey slate roof which does not meet the earlier plain clay tile roof.

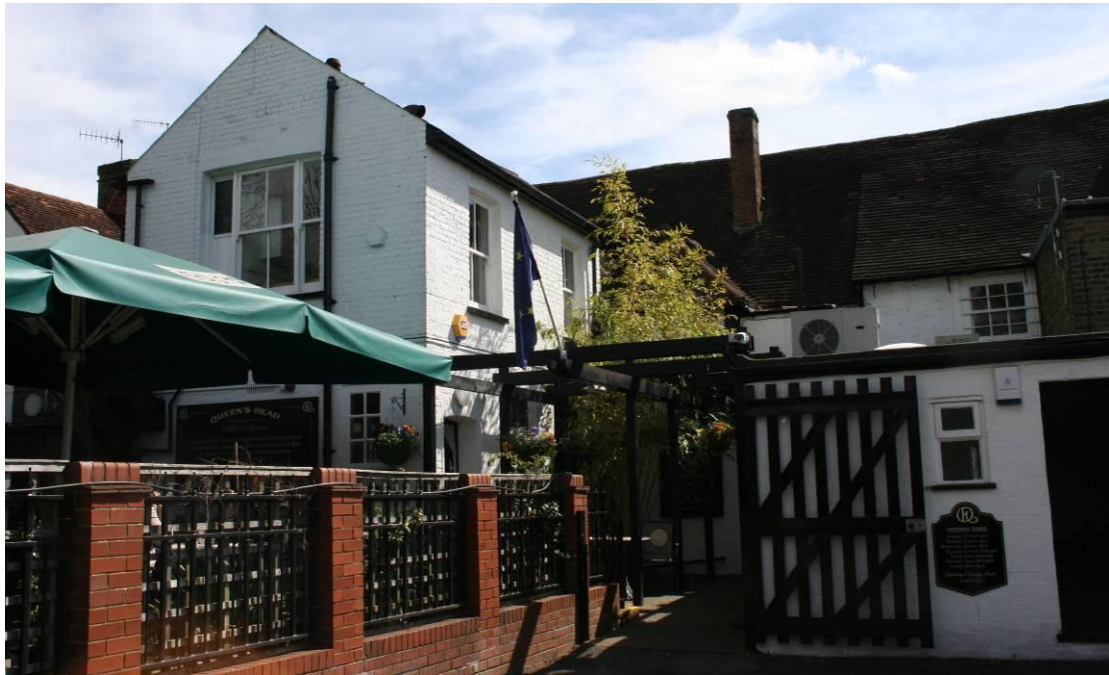
The northern elevation of the main house and the western elevation of the rear range.

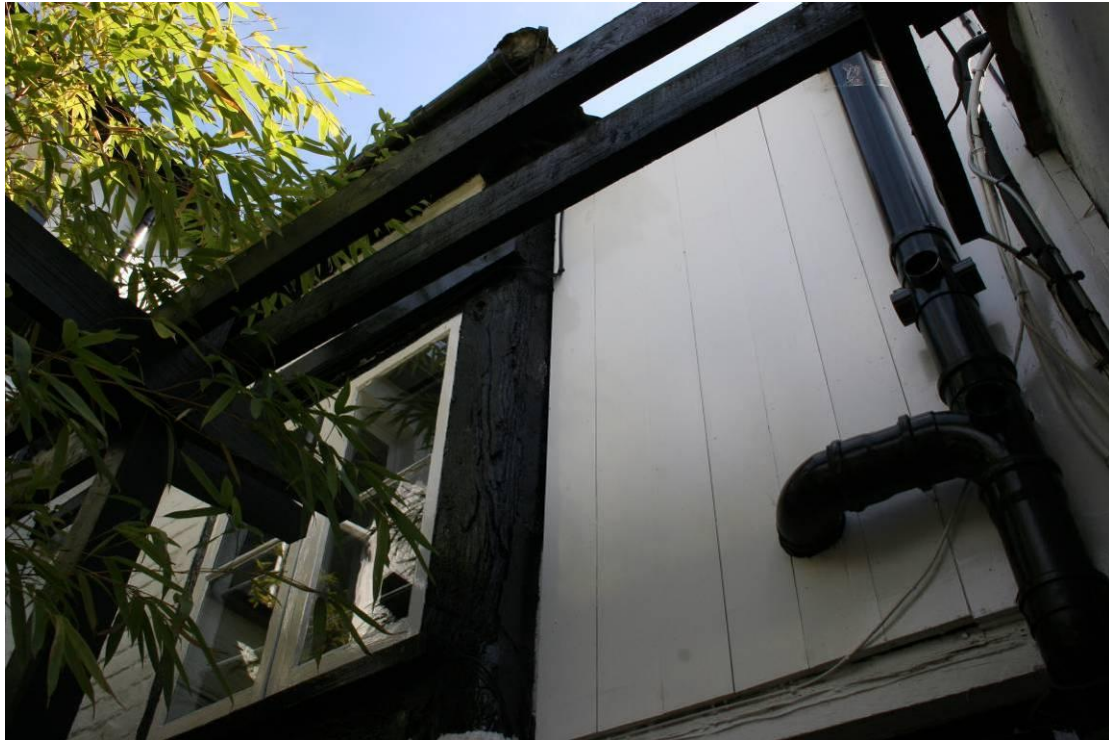
The upper storey of the rear stair tower and the C20th boarding of the WC.

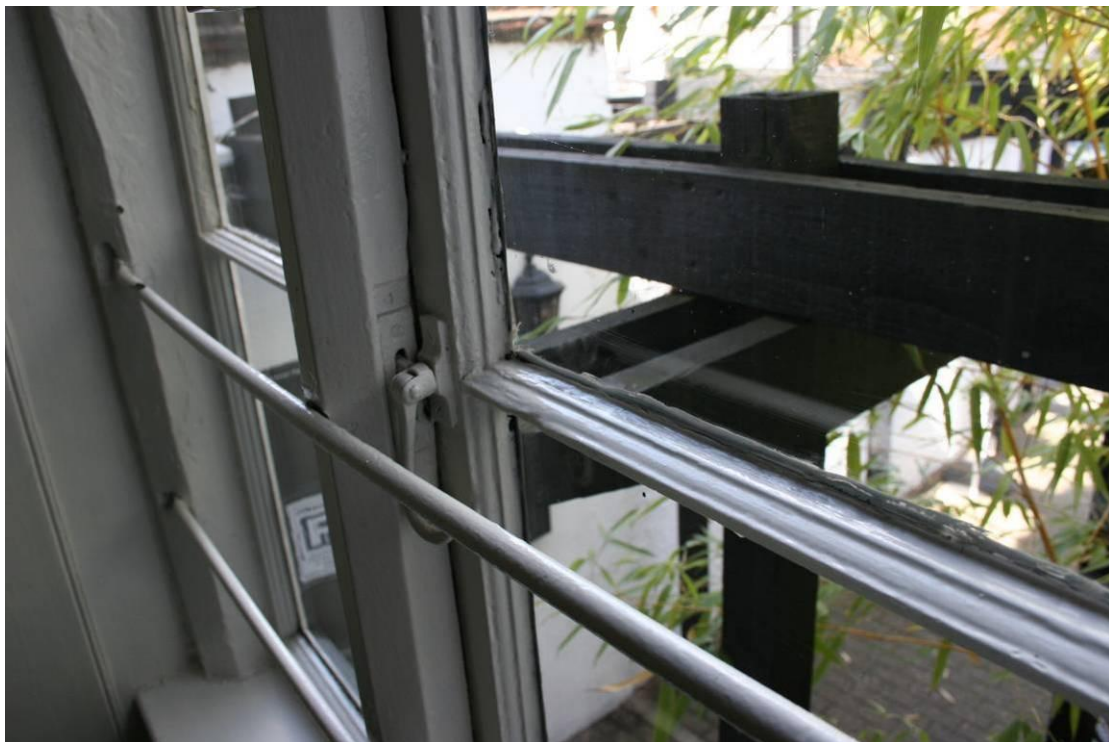
Looking out of the stair tower window.

The stair tower has a LC19th or EC20th casement window with two lights and C20th furniture. This window has been identified for replacement with a door. The frames are quite finely detailed but are machined components. The mullion is quite heavy and put in with security in mind given the MC20th iron rods fixed in place.

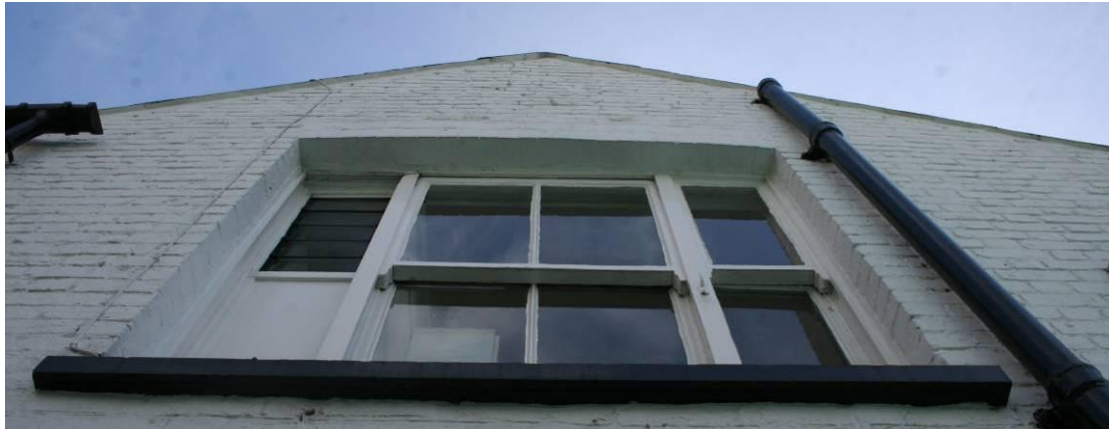
MC19th horned sash windows in the Brick Range.

The Brick Range has large pane 2/2 horned sash windows under segmental brick arches. The northern elevation has a large 2/2 horned sash window with 1/1 side sashes. One side has been removed to install a louvre to ventilate the Kitchen in the room. Close examination shows many of the panes have MC19th milled glass typified by rows of long bubbles in the glass. The painted bricks are 65x110x225mm, the standard Victorian size.

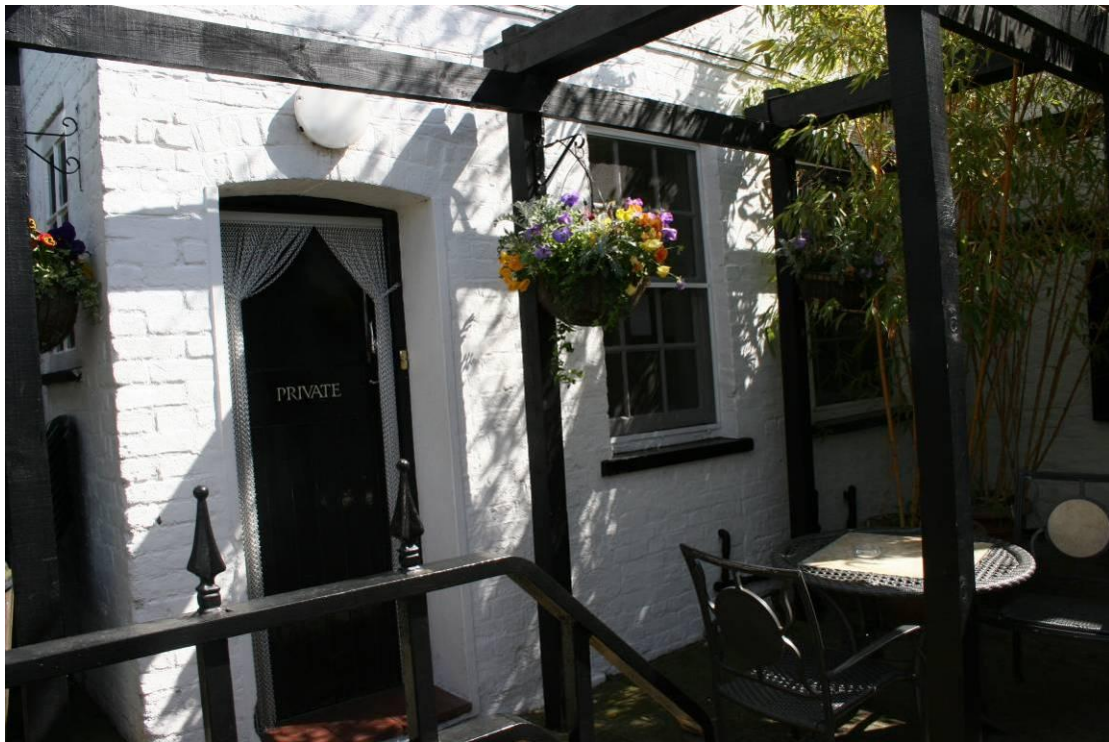
The entrance door and ground floor windows.

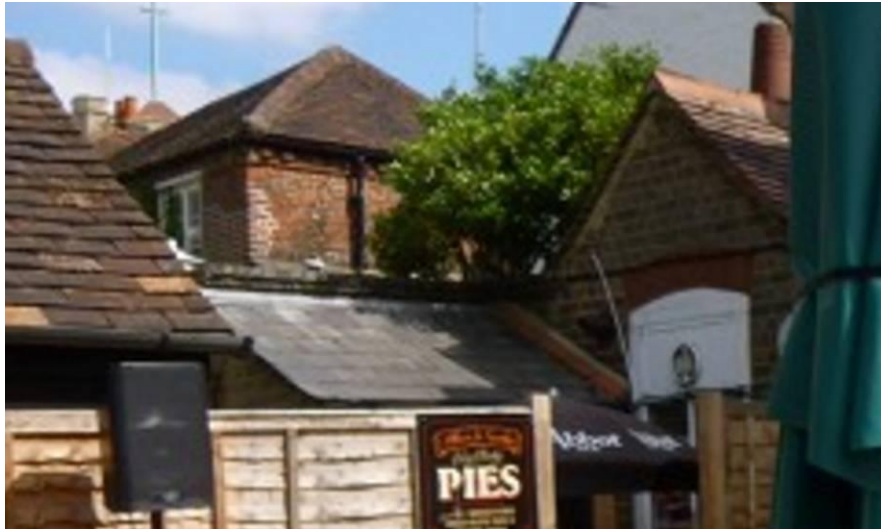
2016. The parallel range from the Queens Head website.

There is a parallel single storey machined timber range with milled steel roof lights which could not be photographed as it was obscured by umbrellas and fencing. This contains the offices and stores. It is built of London Stock bricks with a red rubbed and gauged lintel over the doorway which has a LC19th four panel Victorian style door.

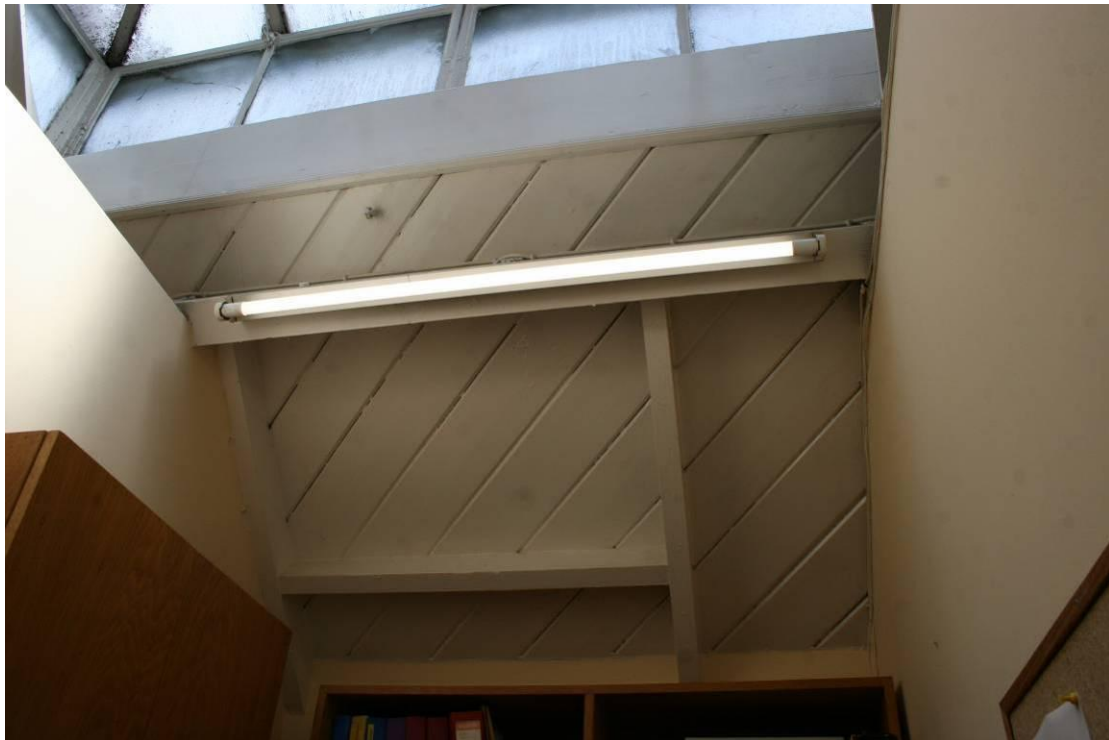
Detail of the boarded roof and skylight.

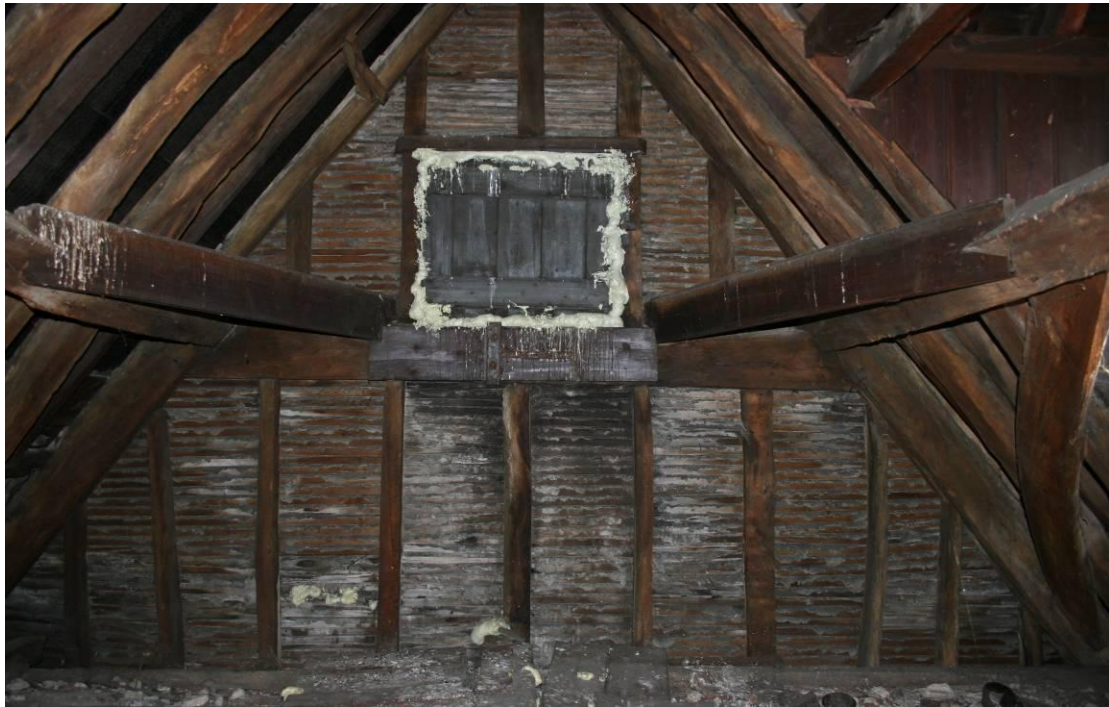
Looking E in the easternmost attic room.

The attics have been divided up into four rooms. The easternmost has not been decorated for habitation so was probably used for storage. The C16th clasped side purlin roof structure is clearly visible. The 6-8in wide rafter pairs are laid on the flat. The principal rafters are waisted (reduced in section) above the collars - a feature often seen in C16th jettied buildings. The partitions are inserted and the collars have been removed to form the rooms.

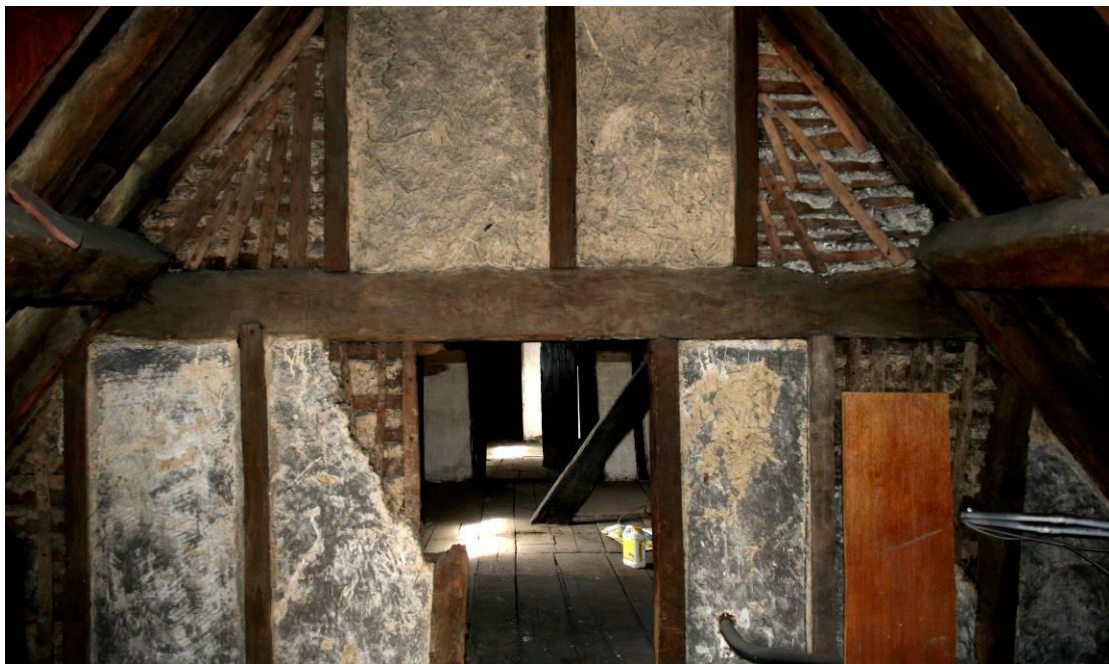
Looking W in the easternmost Attic Room 1.

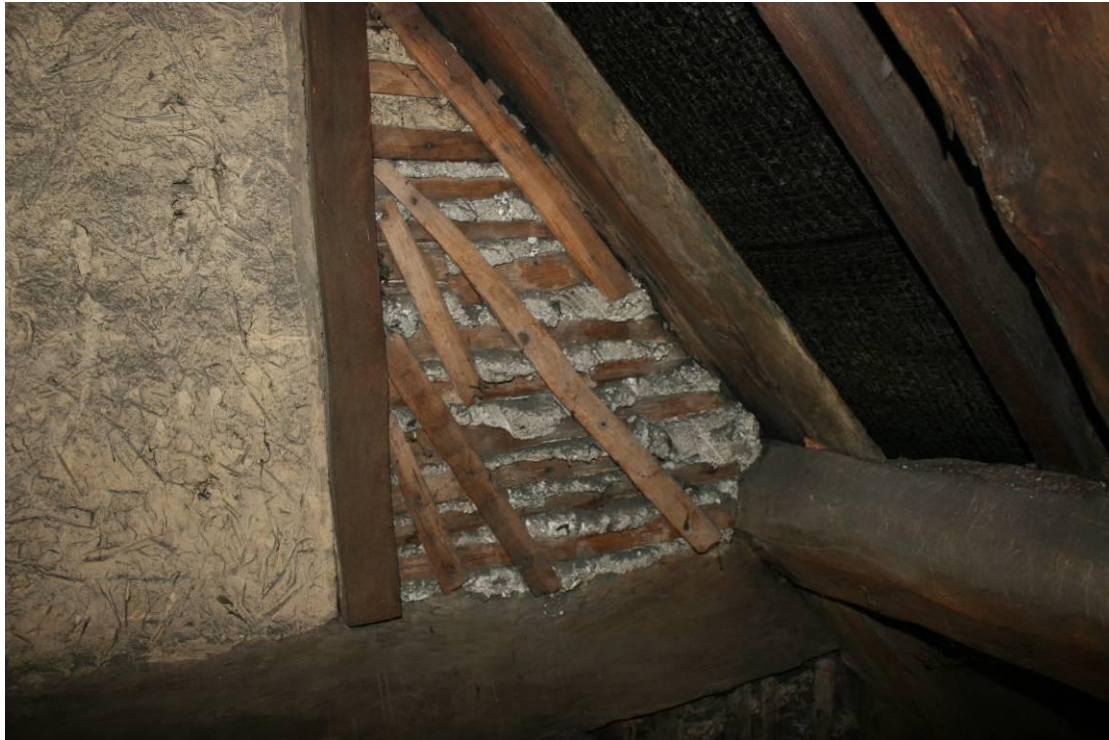
Detail of the lath and daub partitions.

The partitions have side nailed scantling stud work with diagonally applied and nailed together laths finished with heavily strawed daub with a thin lime plaster skim coat. The purlins have been sawn through to insert the four dormers and the collars reused as vertical or raked struts. The work is very poor and is likely EC18th.

The walls and ceilings in the Attic Rooms have been lath and daubed and the fabric and design of the diagonally placed laths that are nailed together is one emerging at the end of the C18th – c.1800. The easternmost room has not been used for habitation as it is not lath and rendered and may have been a store room.

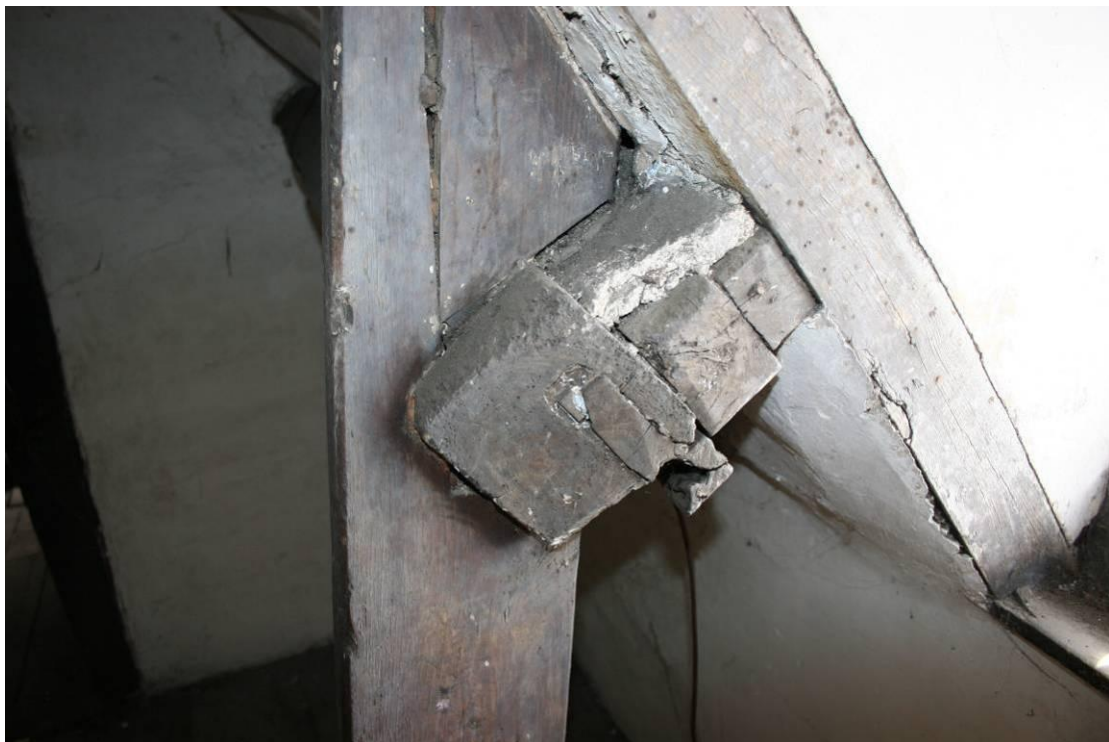
Detail of the sawn through side purlin. The vertical plate was the collar.

The Attic Rooms have been installed by rather brutally cutting through the side purlin to install four dormers. The quality of the work is poor and unusual configurations of reused collars have been used to stiffen the frame. The doors to the Attic Rooms and those on the first floor are atypical of this period. It is evident they are old, having hand wrought furniture, many keyholes and signs of reuse by being extended. It stands to reason that the Attic stairs were also installed at this time.

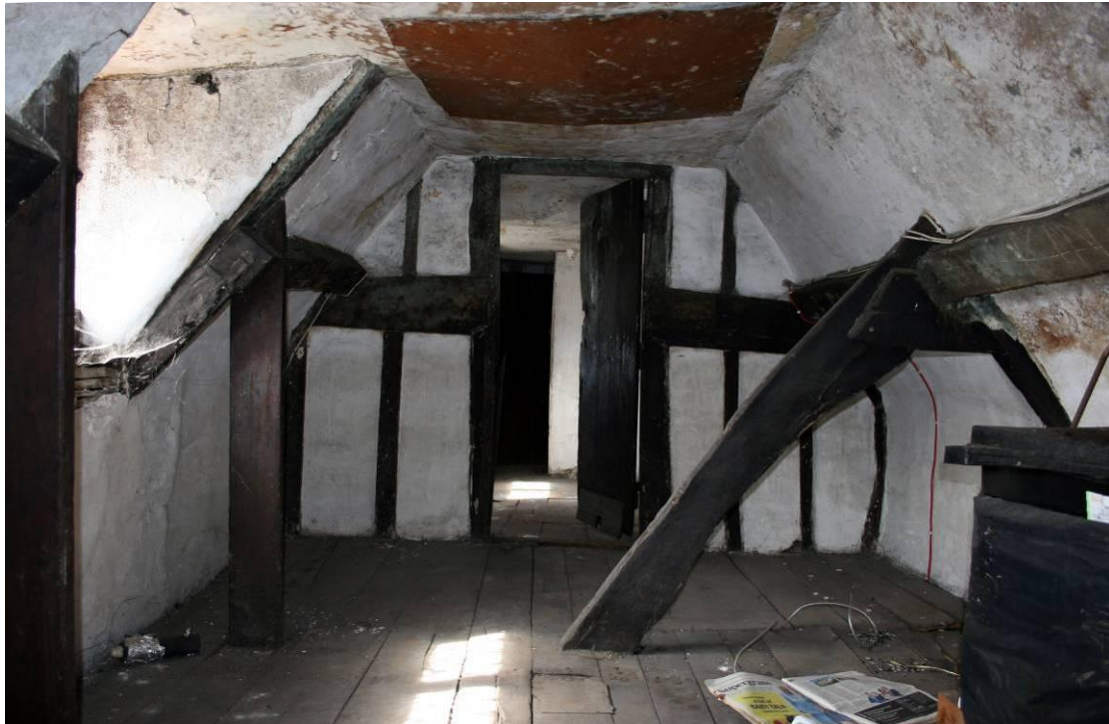
Looking W in Attic Room 2. The collar has been dropped and reused.

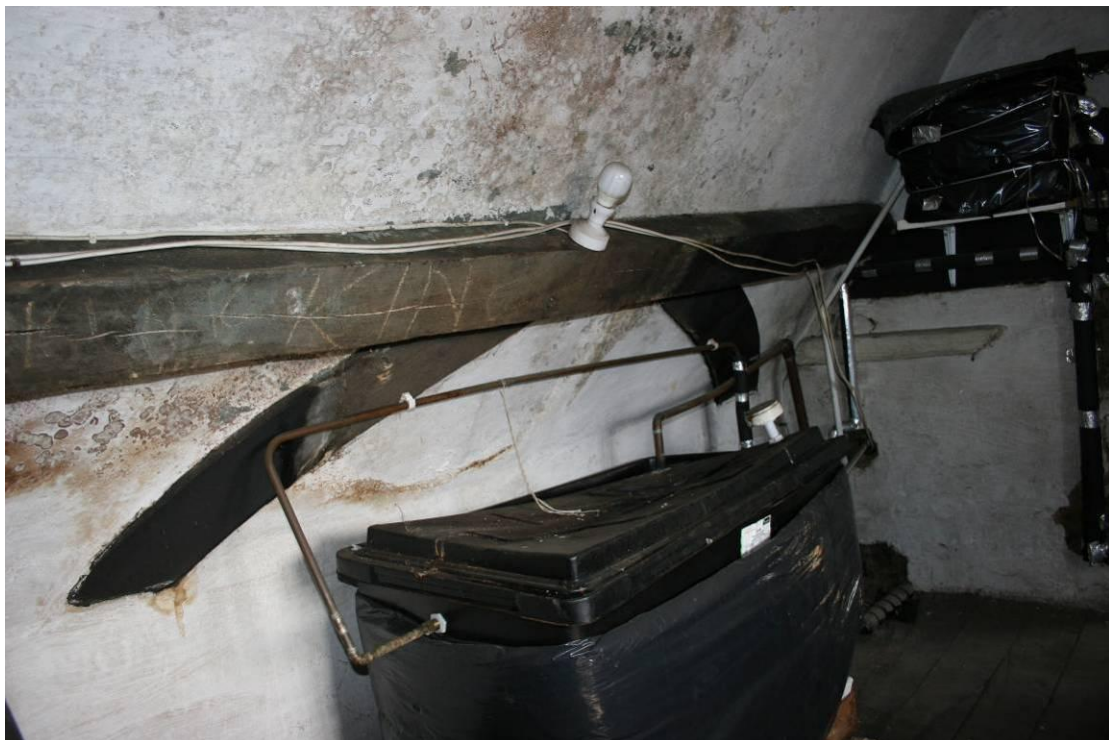
Curved windbraces on the northern side of the frame.

Not only have the collars and purlins been cut through but the curved windbraces connecting the purlins to the principal rafters have been removed on the northern side. It can be assumed the dormer frames act as braces to prevent racking. However the ceilings have slumped.

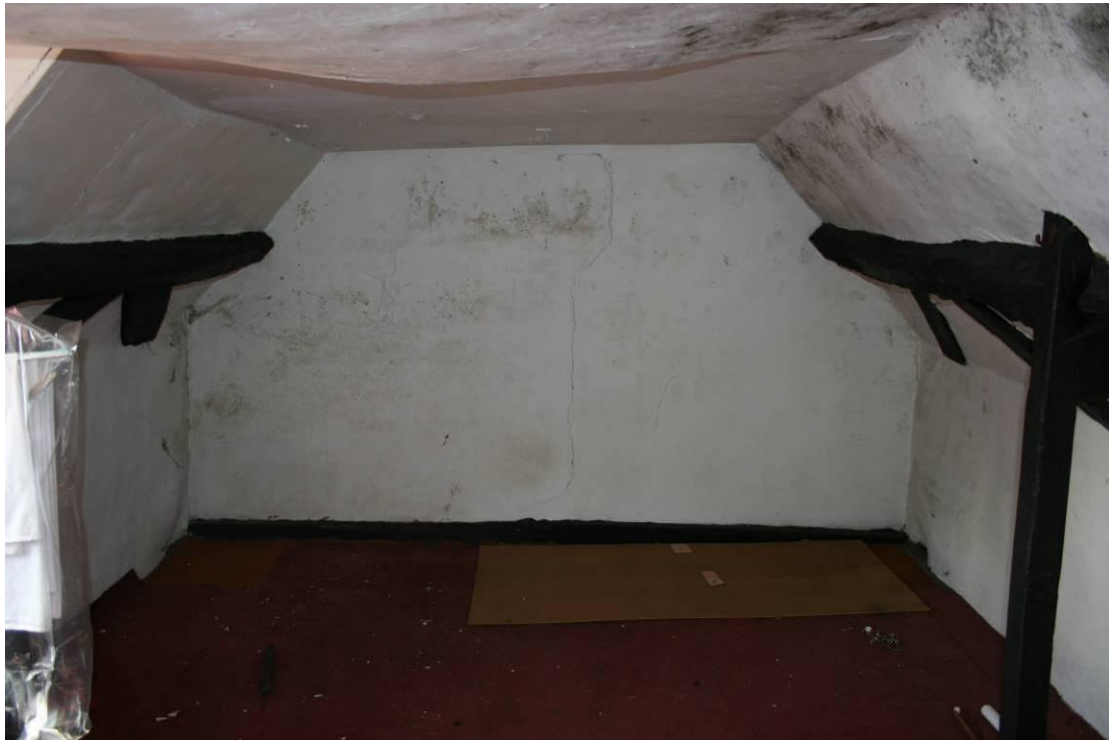
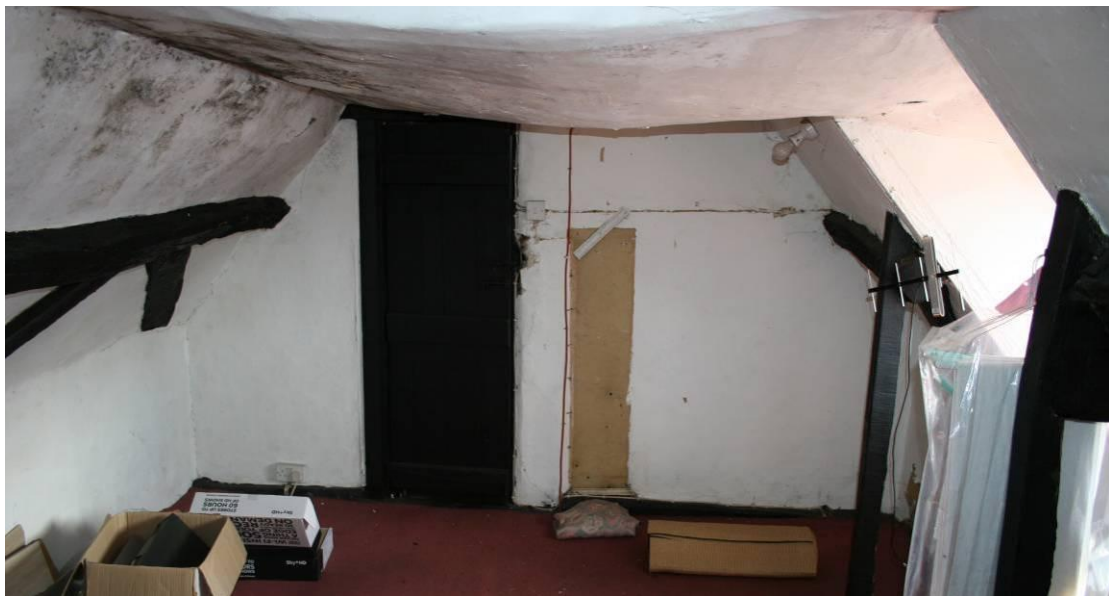
Looking W in Attic Room 4.

Looking E in Attic Room 4

At the western end is separate room with its own door which is a EC20th replacement with mild steel furniture that has been reversed to hang the door the other way round. The roof structure is similar but has been turned through 90 degrees to form a straight roof from a cross-wing roof. This accounts for the change of levels in the rooms. The single dormer is formed in the same way by cutting through the purlin. This higher status room may have been for the house keeper while the dormitory style rooms were for the maids or children.

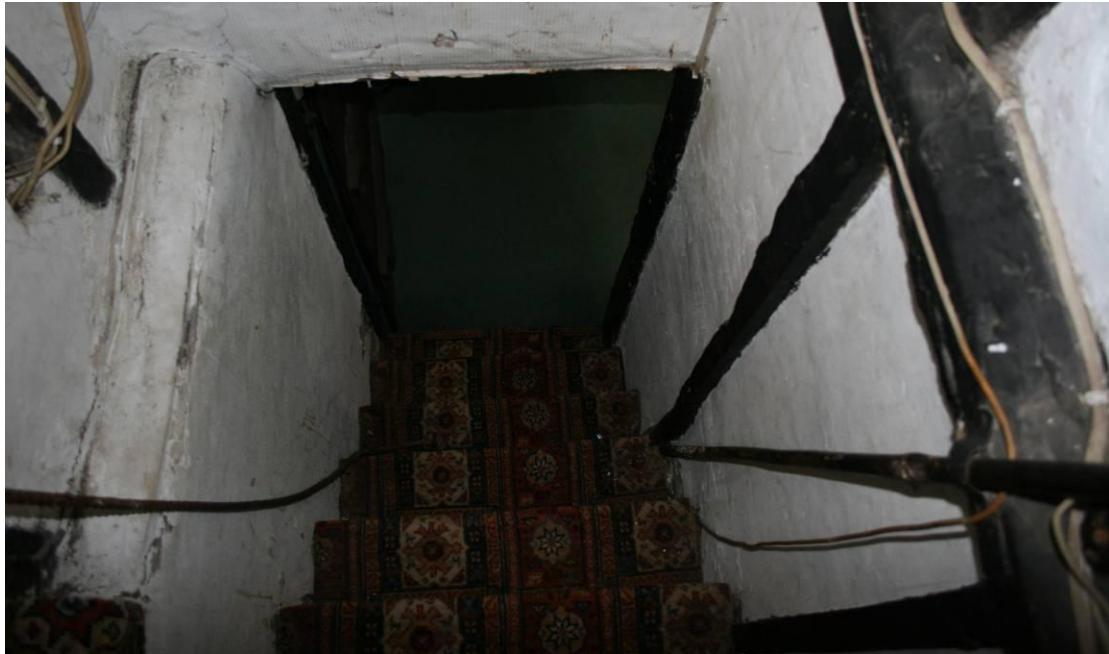
Looking down the steep attic stairs.

The Attic stairs are very steep. At the bottom is a C17th or EC18th style vertically boarded, pit sawn, three plank door with nailed and clenched hand finished ledgers. There is an early Suffolk latch and a staple for an iron bar. The door is hung on hand wrought iron pintle hinges and has been altered long ago to fit the frame by nailing extension pieces to the top.

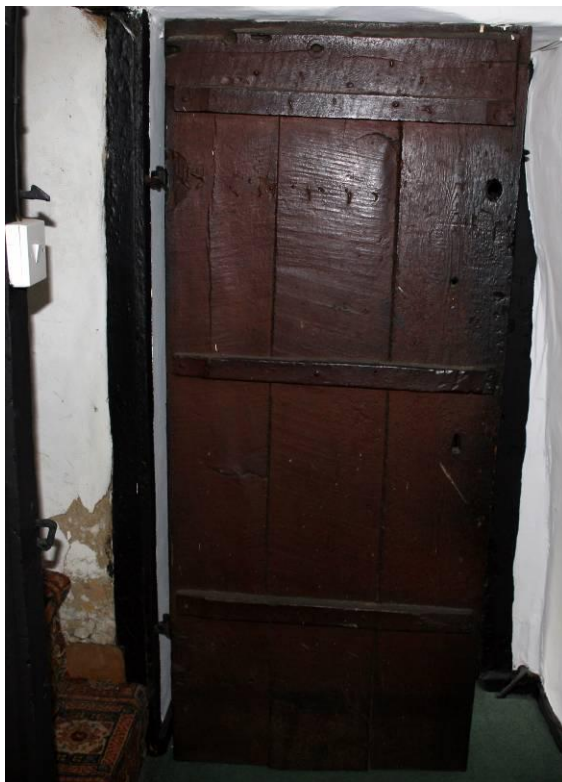
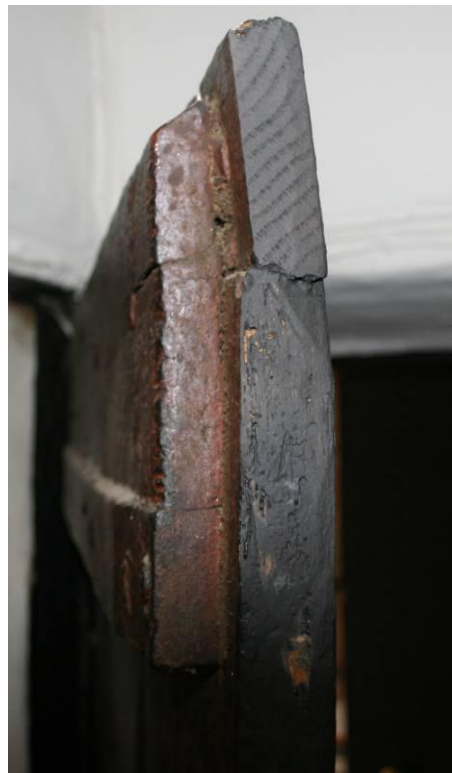
The door to the Attic Stairs.

Extension pieces nailed to the door.

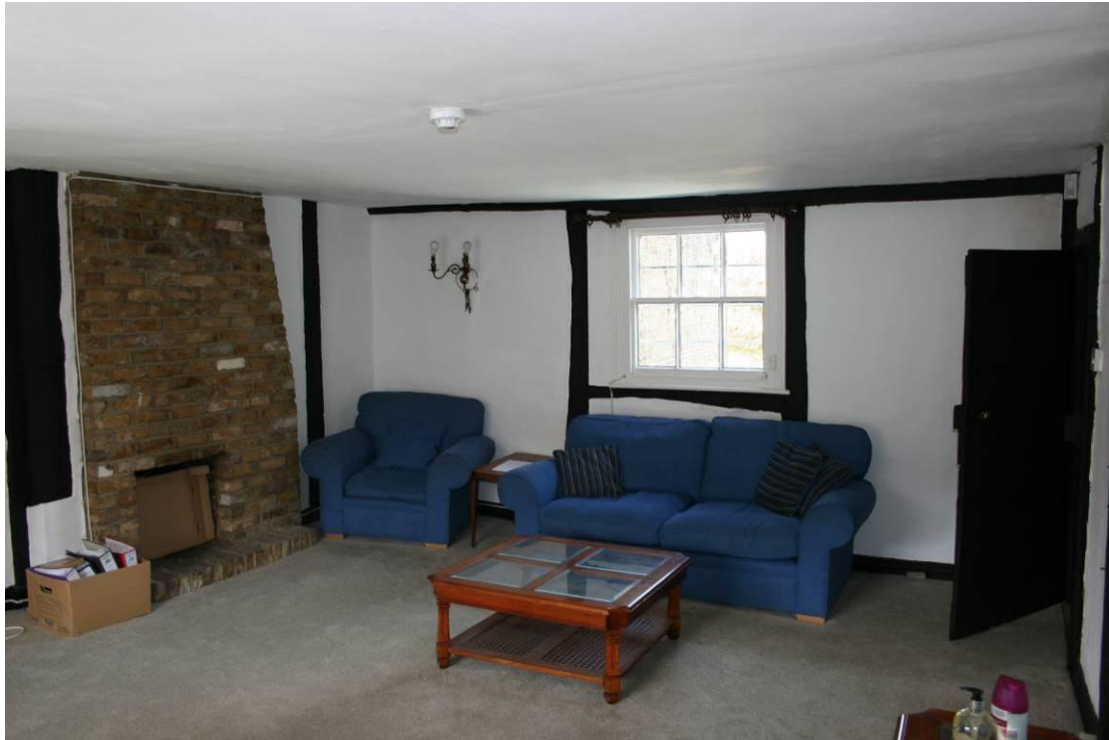
The Living Room looking NW.

Some elements of the timber frame are on display in the Living Room. Of interest is the 1970's style brick chimney piece made of reused bricks bonded with grey cement. It is proposed to remove the brickwork which should reveal the original red brick structure seen in the fireplace in the room below.

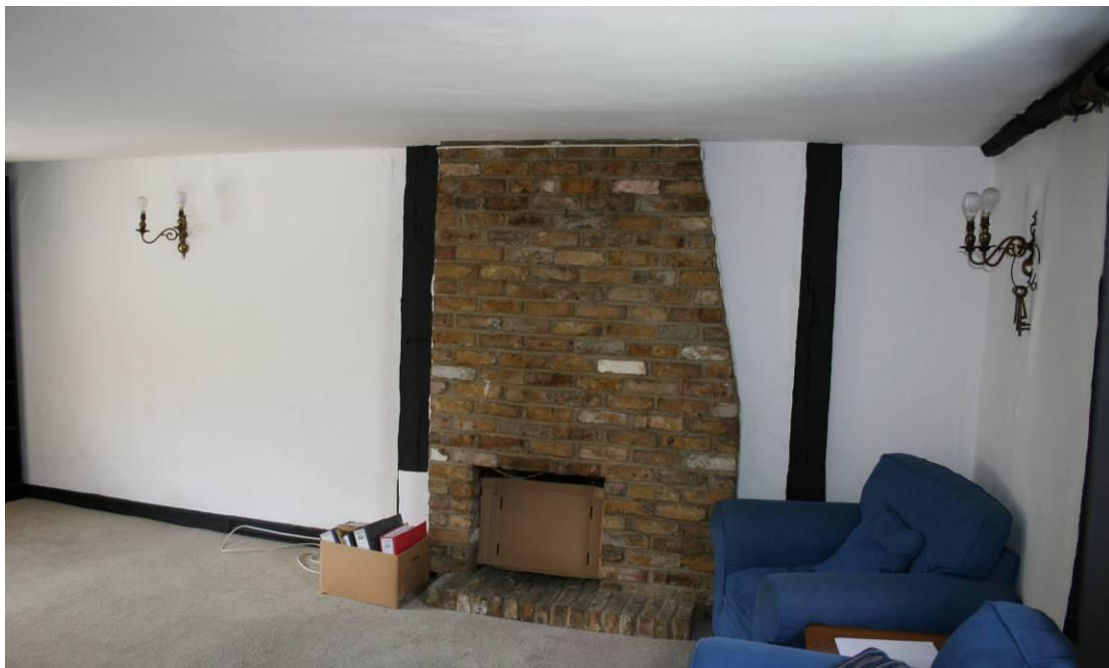
The Living Room looking W.

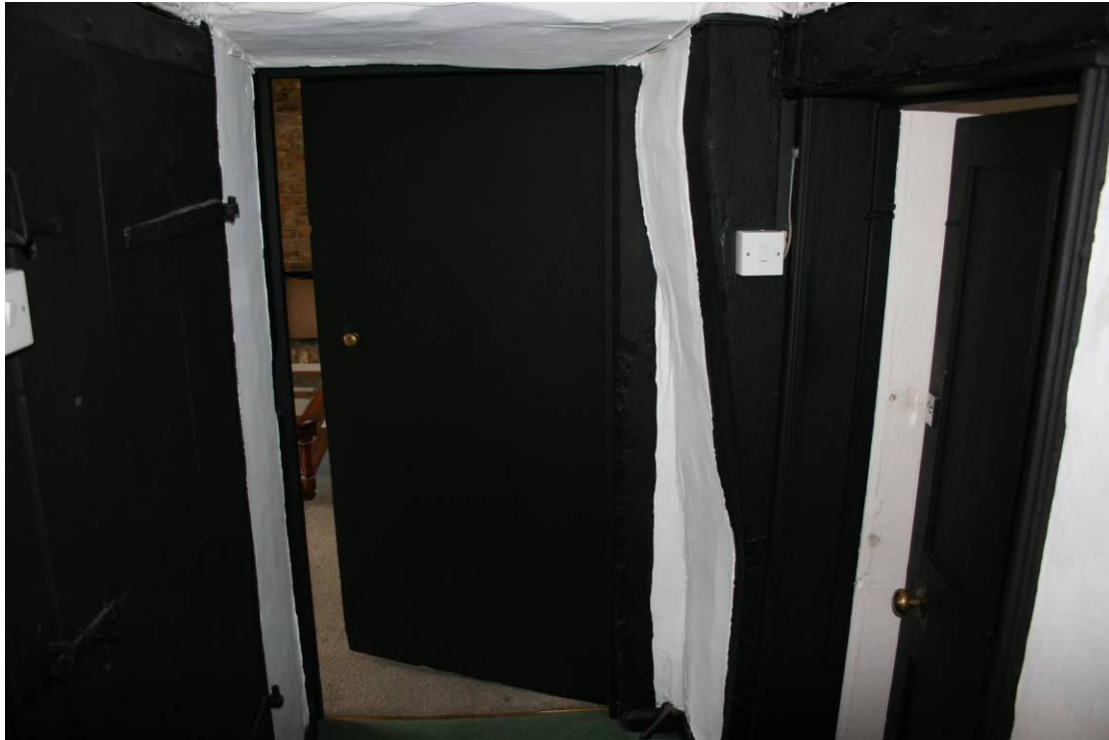
The door to the Living Room has been boarded over. The WC door is to the RHS

The door in to the Living Room has been boarded over on both sides, presumably for sound insulation. It is hung on hand wrought pintles nailed to the boards. There is a late Victorian/Edwardian pressed steel lock box with brass knob. It is likely the door is of the same period as the Attic door.

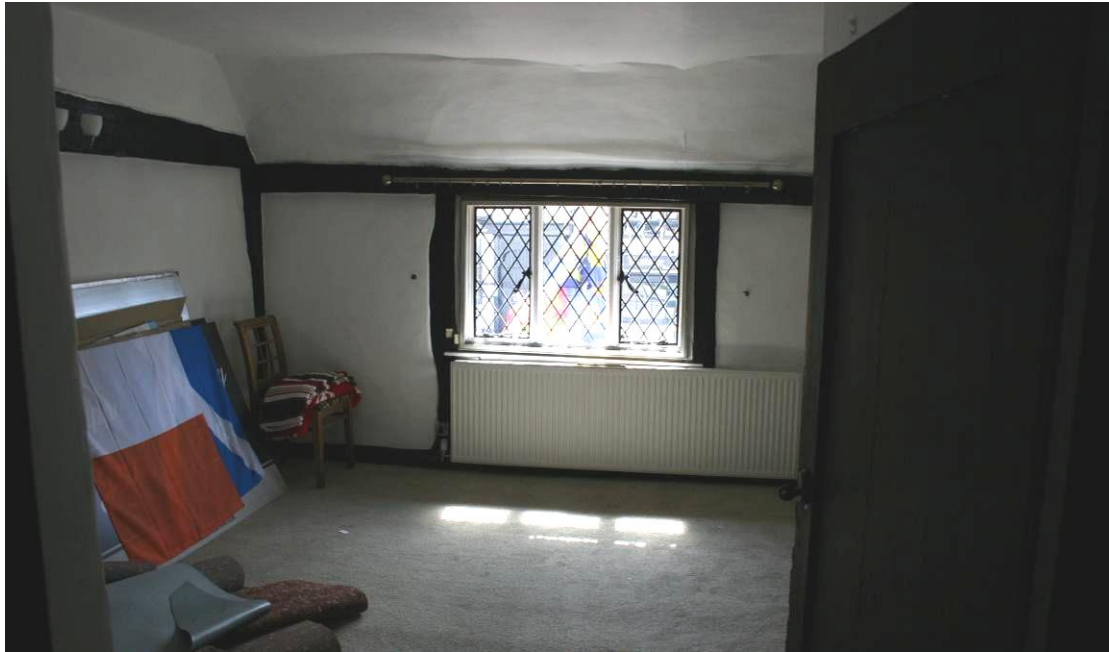
Looking S into Bedroom A.

Bedroom A exhibits the top plate and the cambered tie-beam of the timber-frame. Two studs framing the window and the storey posts are also visible. Of interest is the two panel Georgian door which is the only one in the building. Prior to about 1800 these were for the servant's rooms and closets and used to denote the hierarchy of the rooms. For a brief period of about 30 years the hierarchy was altered such that two panel doors became used for the occupants. This fashion faded in favour of four panel Victorian style doors.

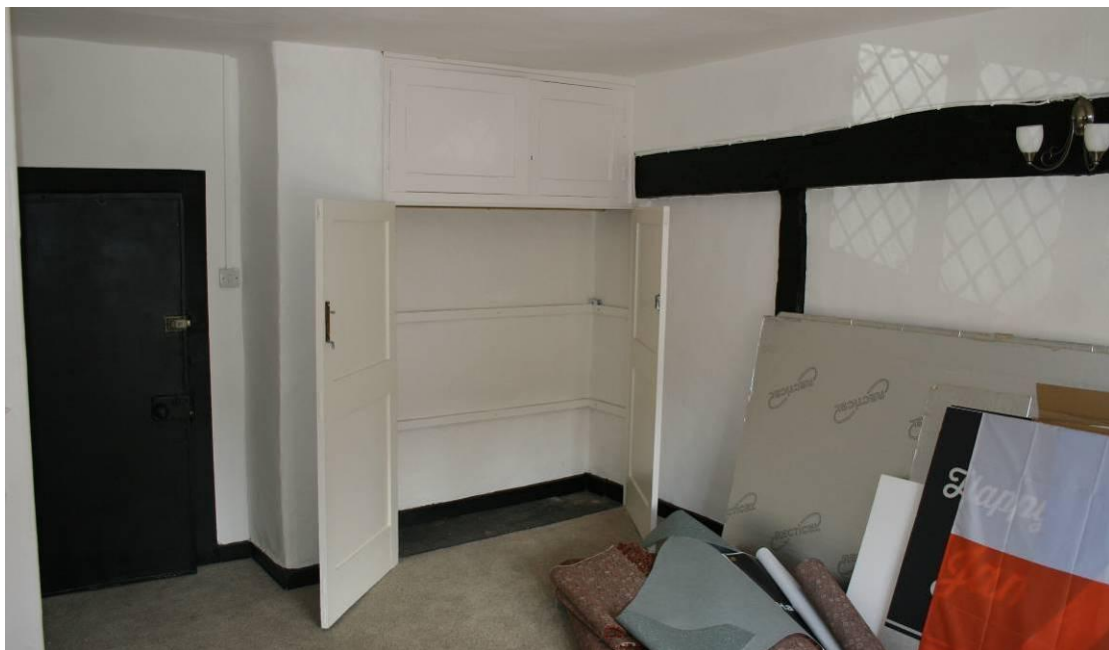
Looking NE in Bedroom A.

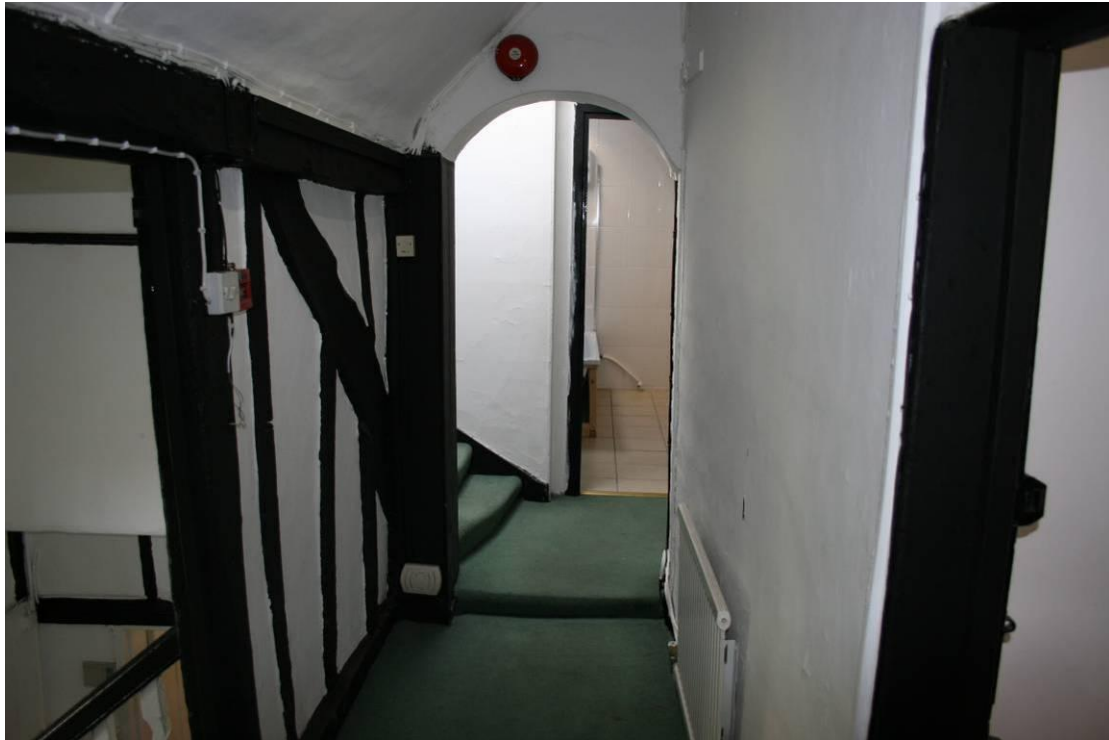
Looking E along the landing. Note the arched doorway and interrupted studwork in the wall.
