Queens Head, 31 High St, Pinner, HA5 5PJ.  
Recording and analysis of the Public House. Surveyed 11 04 2017.

## **Scope of this Report**

This report describes and analyses the fabric of the Queens Head, Pinner with a view to mitigating changes to the upper rooms which were inserted in the MC20th.

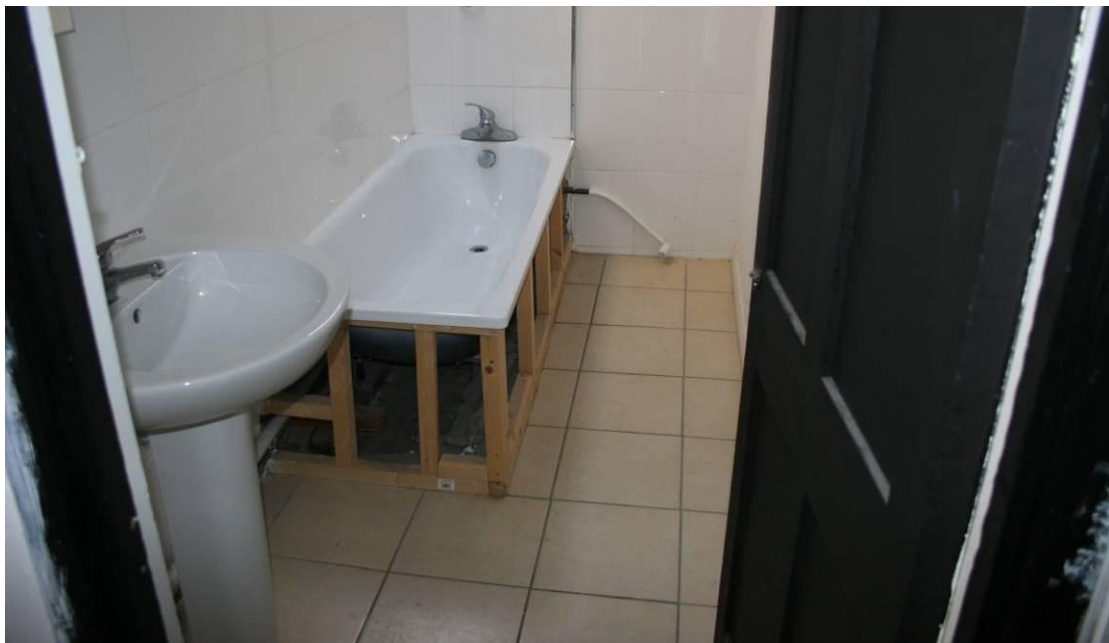
The Bathroom at the end of the Landing. Looking E.

The Bathroom has been inserted in the MC20th and the walls are made of various reclaimed panels and a reused casement window laid on its side. The door is another 1950's cheap Victorian style four panel matching that in the WC. These low cost inserted rooms were commonly installed during WW2 to increase accommodation and then the type of construction continued into the 1950's when materials were scarce and expensive.

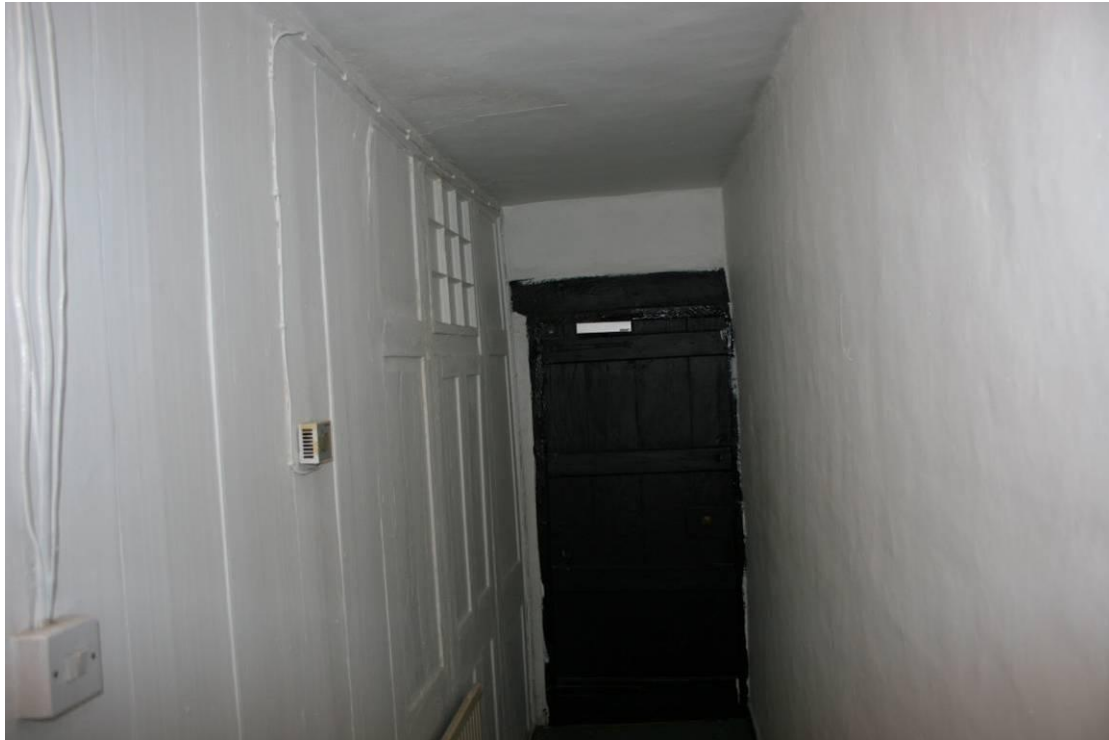
The panelled wall forming the Bathroom. The door leads to Bedroom C.

Beneath the casement window is a reused panelled door which is too low for comfortable use and is fixed shut. The panelling has no special features, joints or mouldings and is probably deal and plywood.

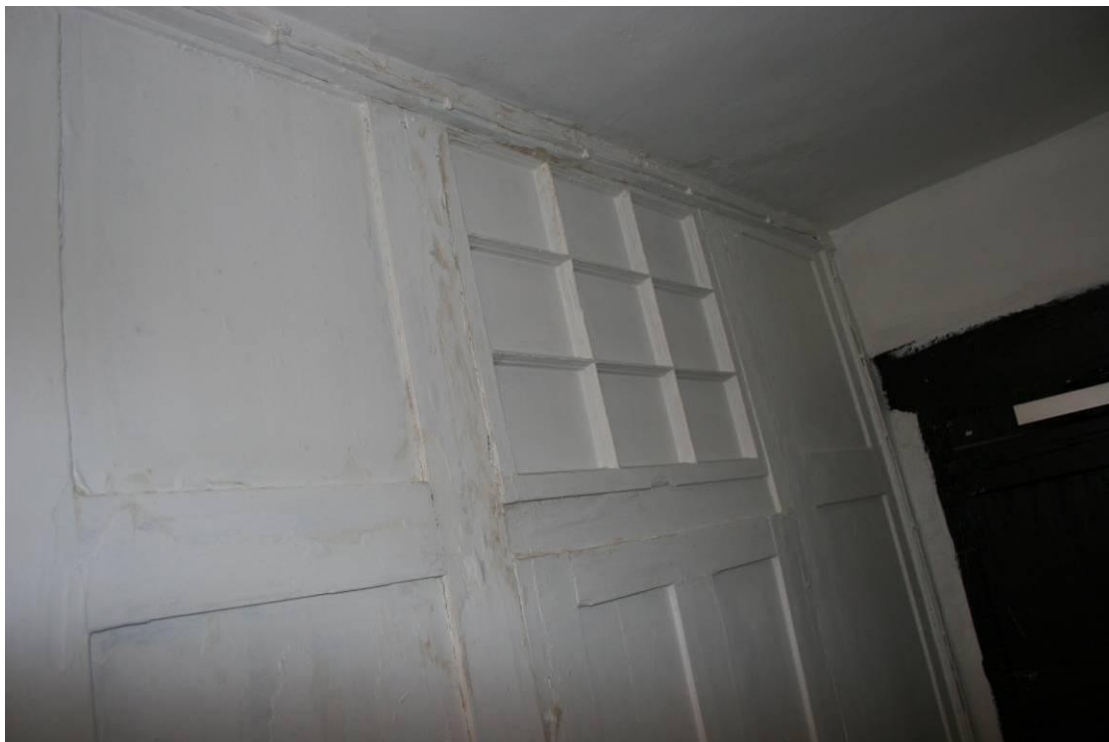
Detail of the reused casement window used to borrow light for the corridor.

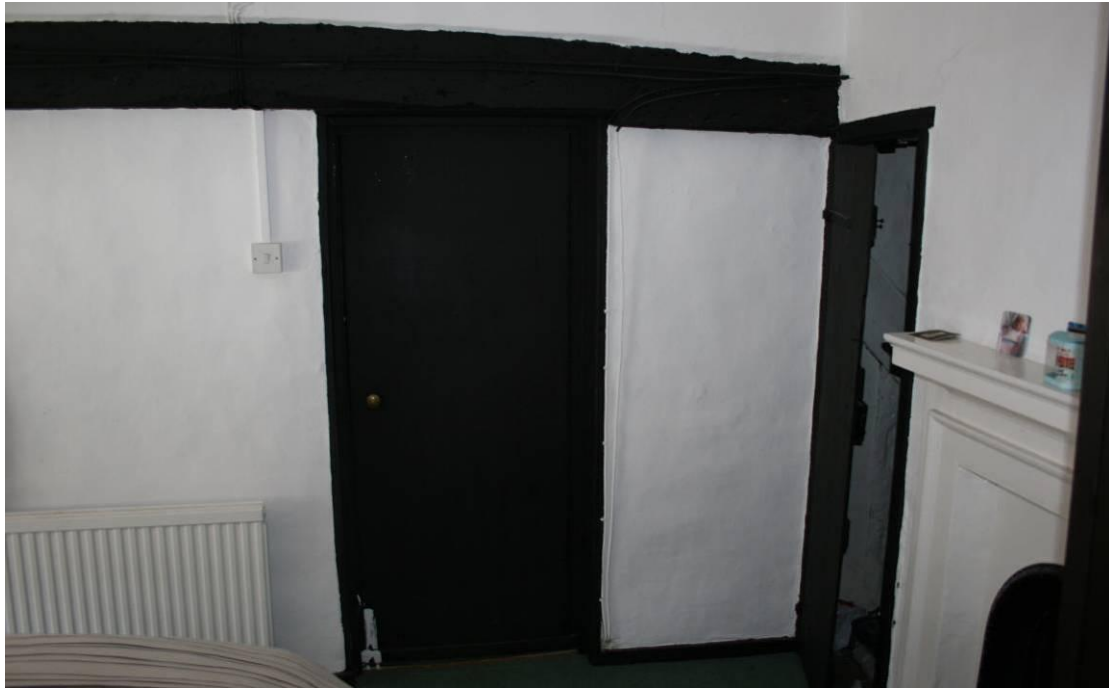
The entrance door, closet door and C19th fireplace. Looking W.

Bedroom B contains no special features. Bedroom C has handsome C19th timber fire surround with mantel shelf and a cast iron hooded register grate decorated with a shell motif. The register plate is decorated like a Bronze Age mirror. This design was common from the 1850's onwards.

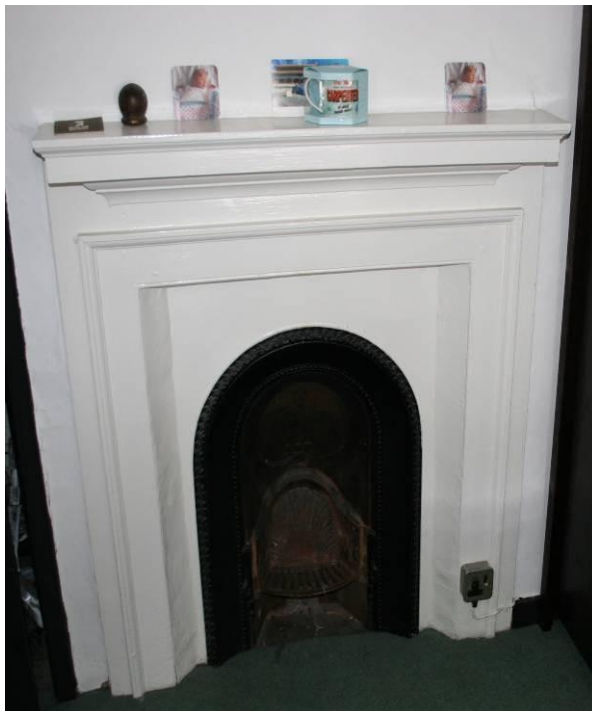
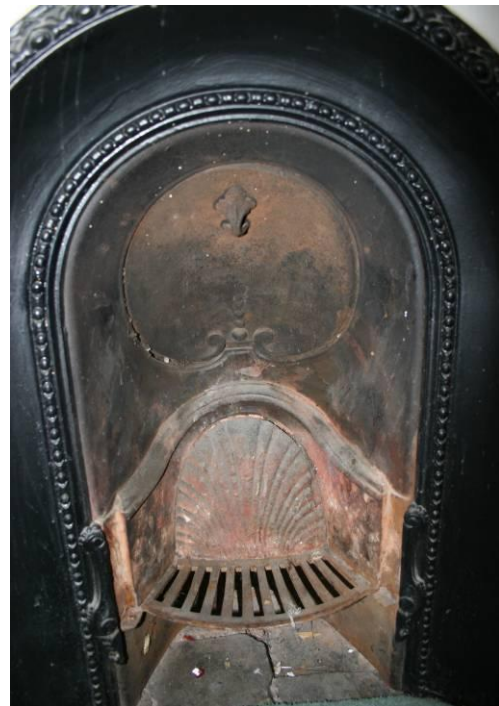
The timber fire surround and detail of the register grate.

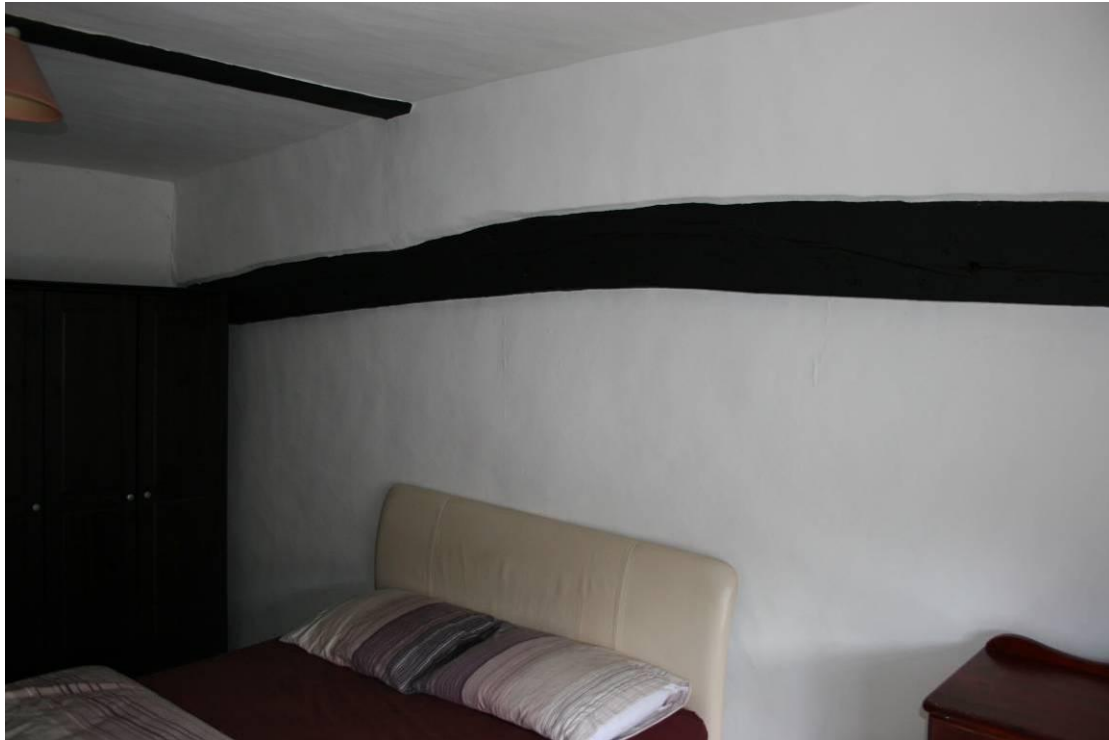
The tie-beam in the eastern wall.

The tie-beam can be seen in the end wall and the details of the junction with the top-plate and the corner post show a heavy jowl with a single peg for the teasel tenon. The single peg in the top of the tie-beam corresponds with the truss seen in the end wall of Attic Room 1.

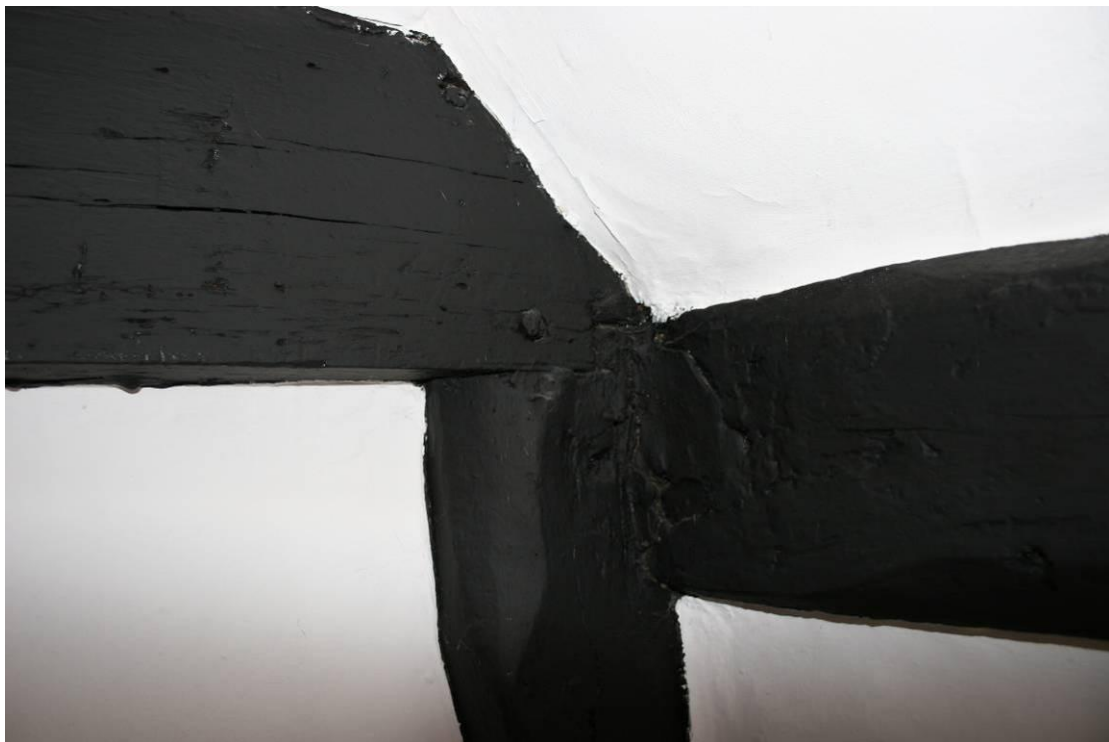
Detail of the jowled corner post.

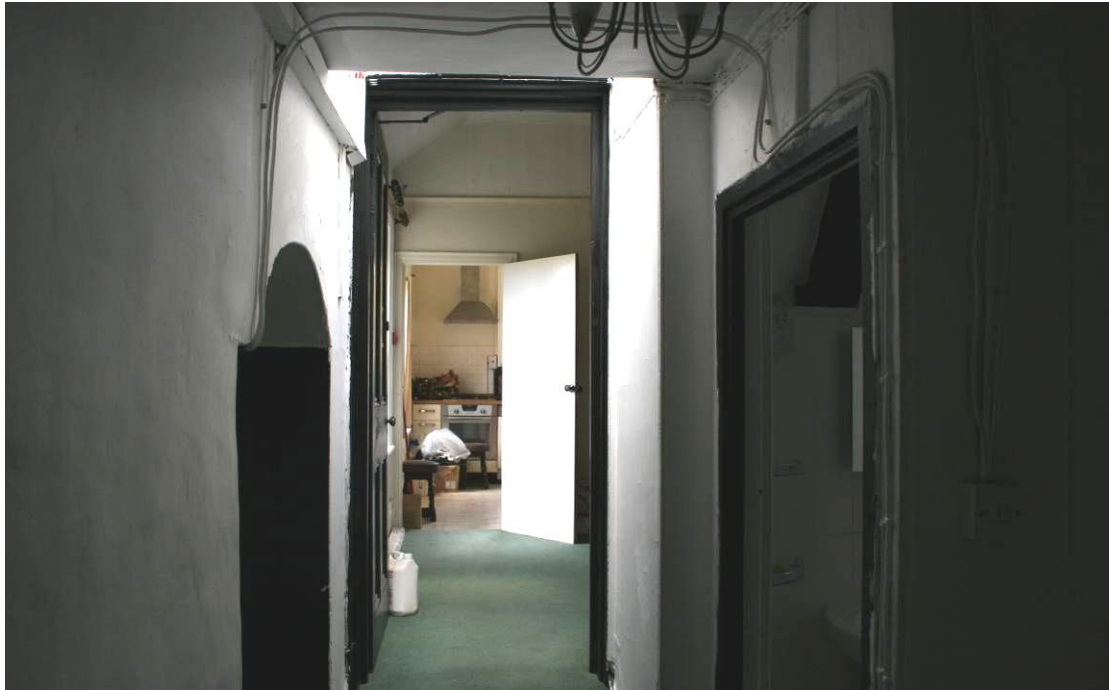
Looking N from the older frame into the Dining Room of the Brick Range.

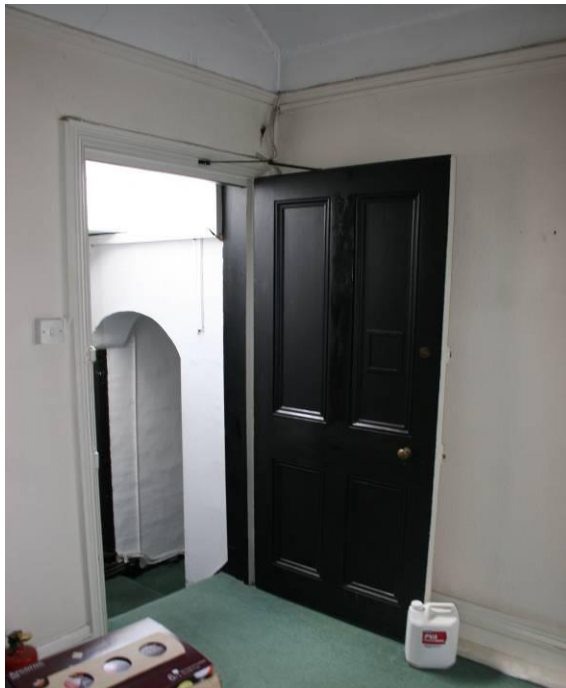
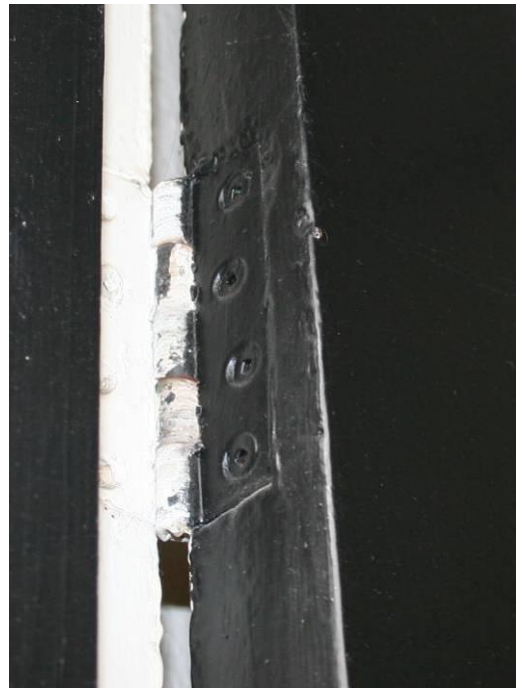
The Victorian door into the Dining Room. The hinges have Robertson screws.

The Dining Room is within the Brick Range. The impressive panelled door has applied mouldings and pressed steel box lock. The hinges have been secured with Robertson screws which is highly unusual. Robertson screws were not invented until 1907 and became popular with furniture makers. The other screws are slot-headed. It is likely the door has been rehung. The pressed steel lock is Edwardian in design.

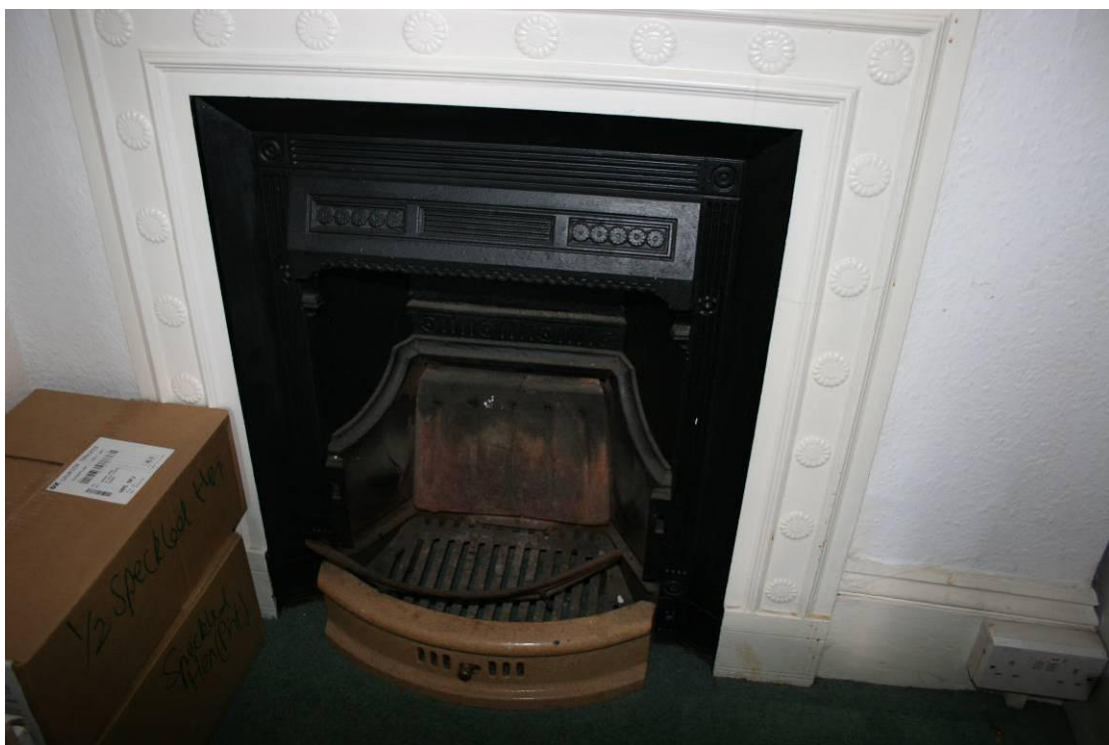
Detail of the Edwardian fireplace.

The ceiling of the Dining Room has been taken up into the rafters to increase the height. Stuck unnaturally in the corner is an Edwardian styled cast iron register grate with machined rilling and a guilloched sunflower design. The simple timber surround has a small mantel shelf and applied sunflower motifs being the symbol of the Arts and Crafts movement.

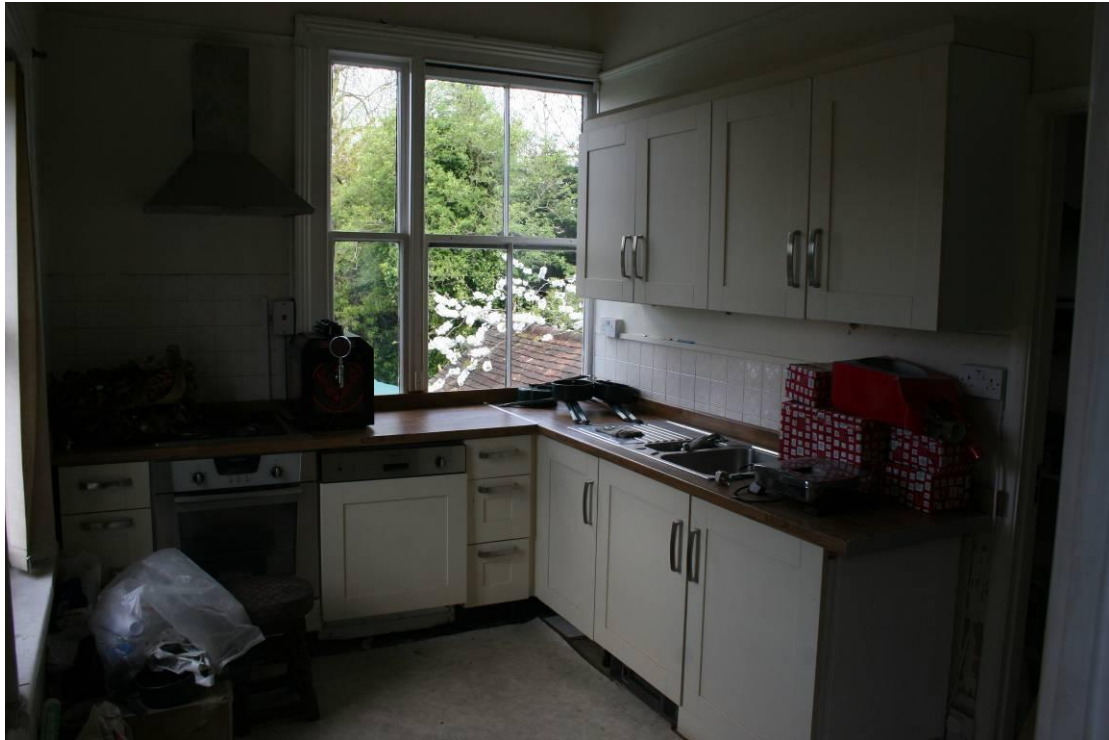
Looking N in the Upstairs Kitchen.

The Upstairs Kitchen reveals no historic features other than the windows. The two doors are LC20th hollow core poor quality items. The large sash window in the north wall has been divided by the insertion of the larder wall and it seems highly likely the Kitchen and larder were inserted in the MC20th when these odd insertions were common and the floor was originally one large function room.

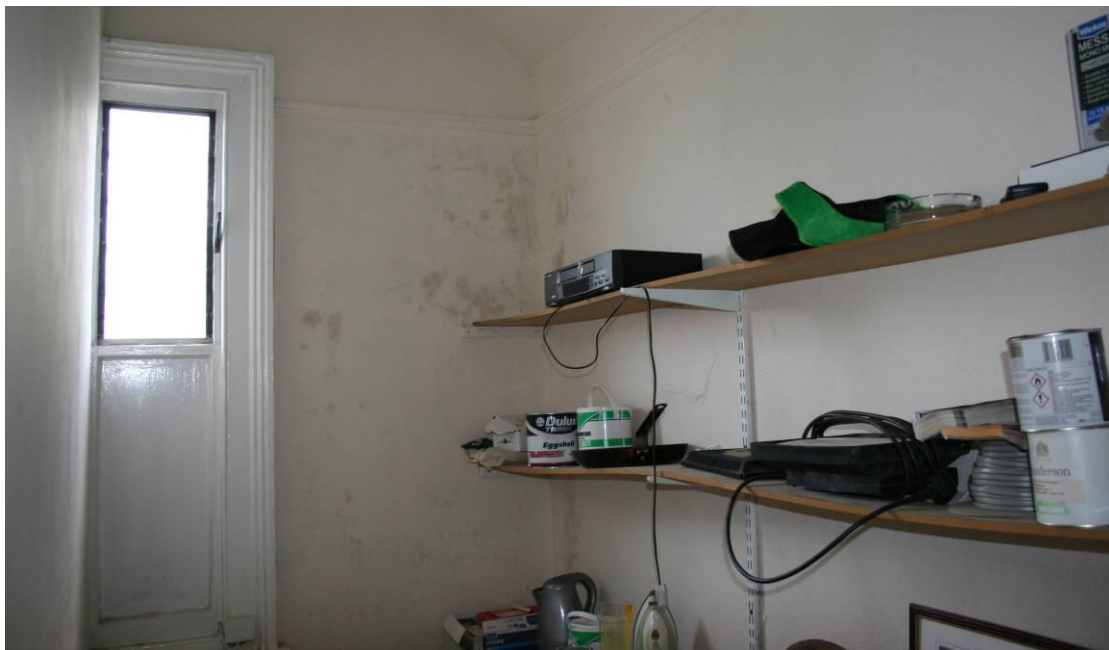
Looking N in the larder. Note the interrupted window frame.

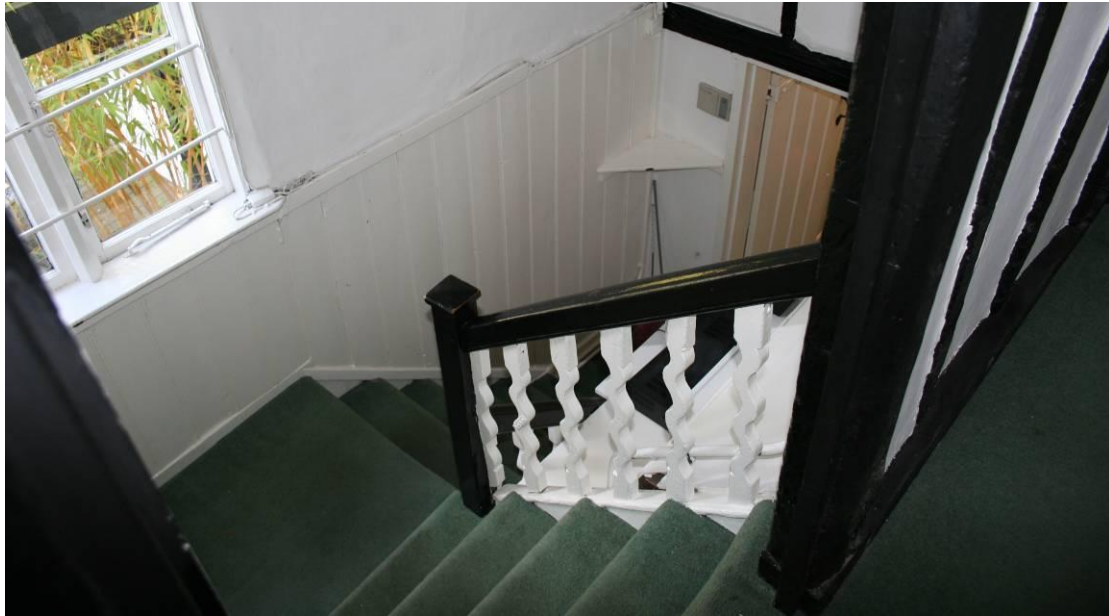
Looking down the staircase.

The Listing mentions a C16th staircase and the 1923 RCHME records a C17th staircase but this is no longer in the building. The rear staircase has wavy splat balusters of a C17th design but they are too thick and machine cut. The plain newel posts and banister rail are not authentic. The scantling frame of the stair tower is visible and would concur with a C17th date but it appears highly rebuilt to insert the upstairs WC and the whole staircase has been moved since the RCHME 1923 plan was made.

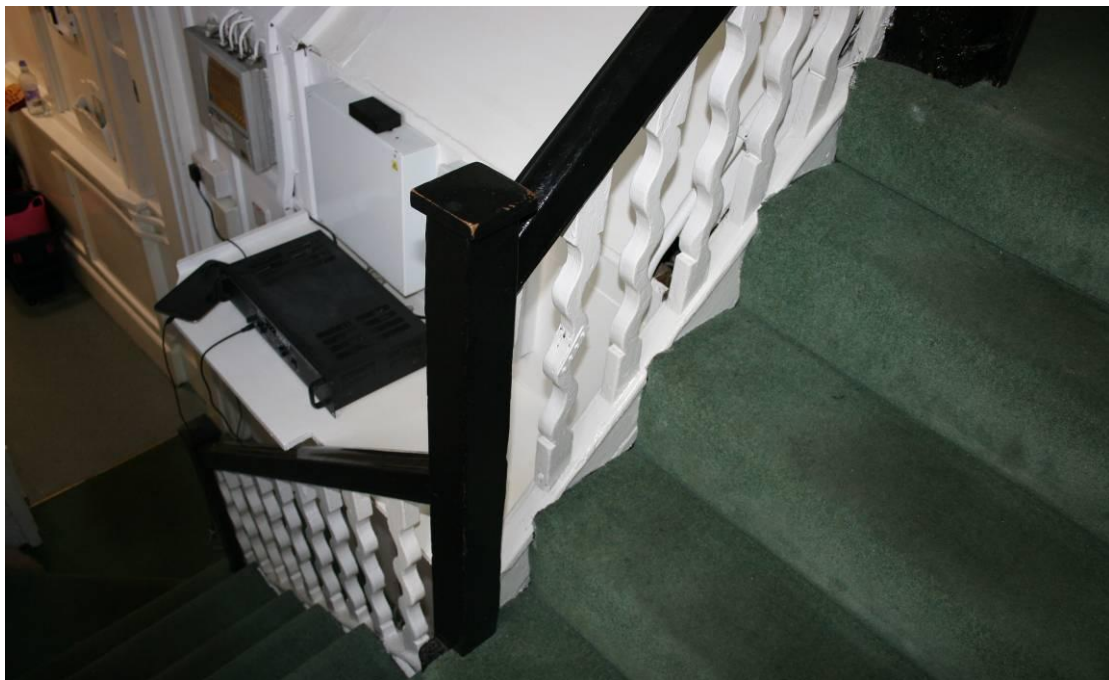
Detail of the splat balusters.

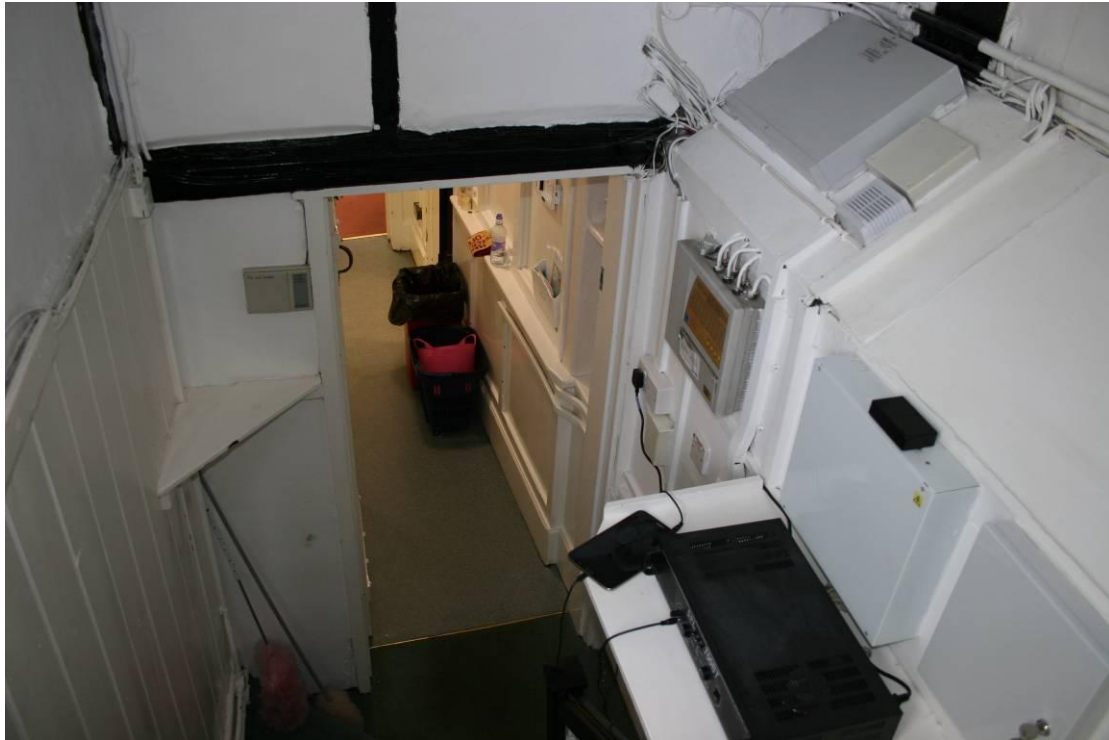
The wall has been brought out to accommodate the bar backfitting.

The wall has been moved out into the stair-tower to accommodate the bar back fitting and it can be imaged the earlier staircase was removed sometime after 1968 (if the earlier staircase was correctly identified).

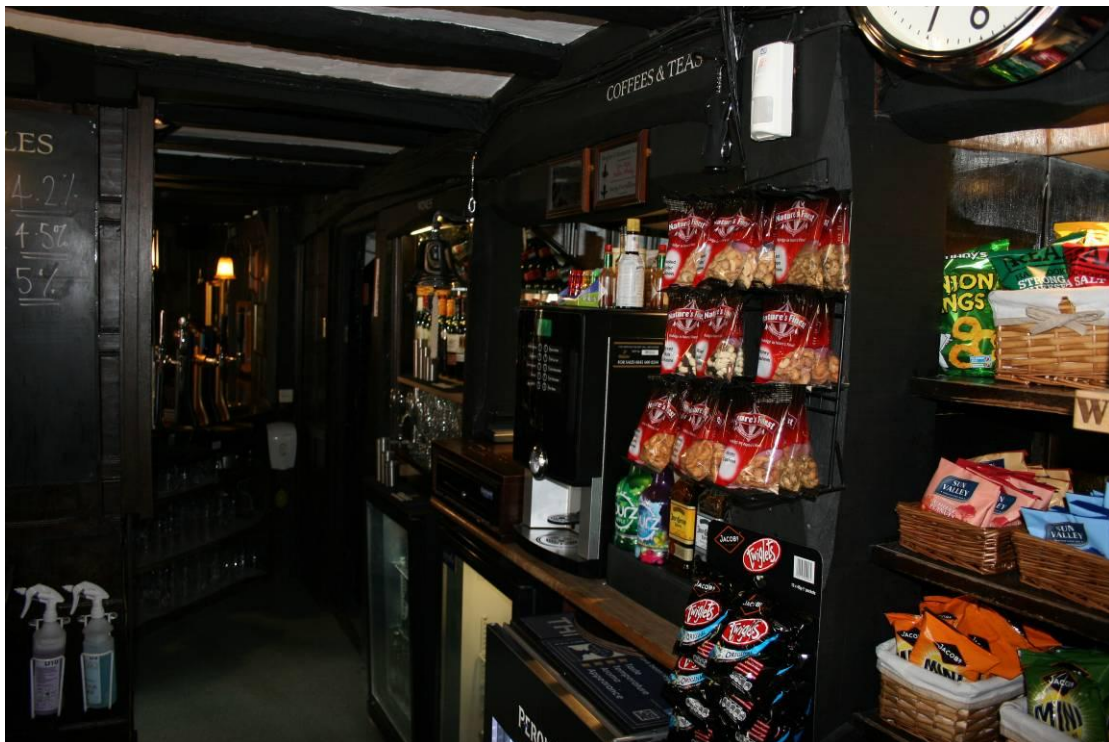
The bar back fitting extends out under the original frame.

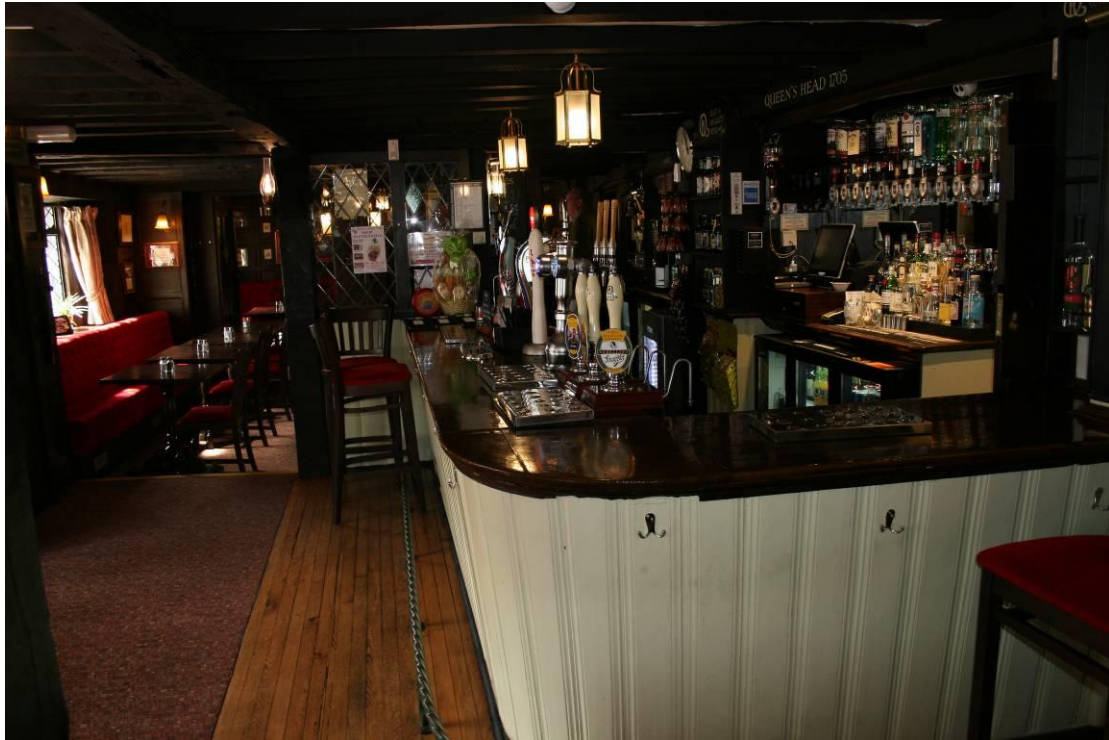
Looking W along the bar counter.

The Bar Counter and Backfitting is typical of the LC20th and most likely of the 1970's. Made of cheap plywood carcasses and veneered it is screwed together with slot headed screws. Frequent alterations have been made to accommodate new pipes and equipment and variety of cheap chip or fibre boards used to create shelves and divisions.

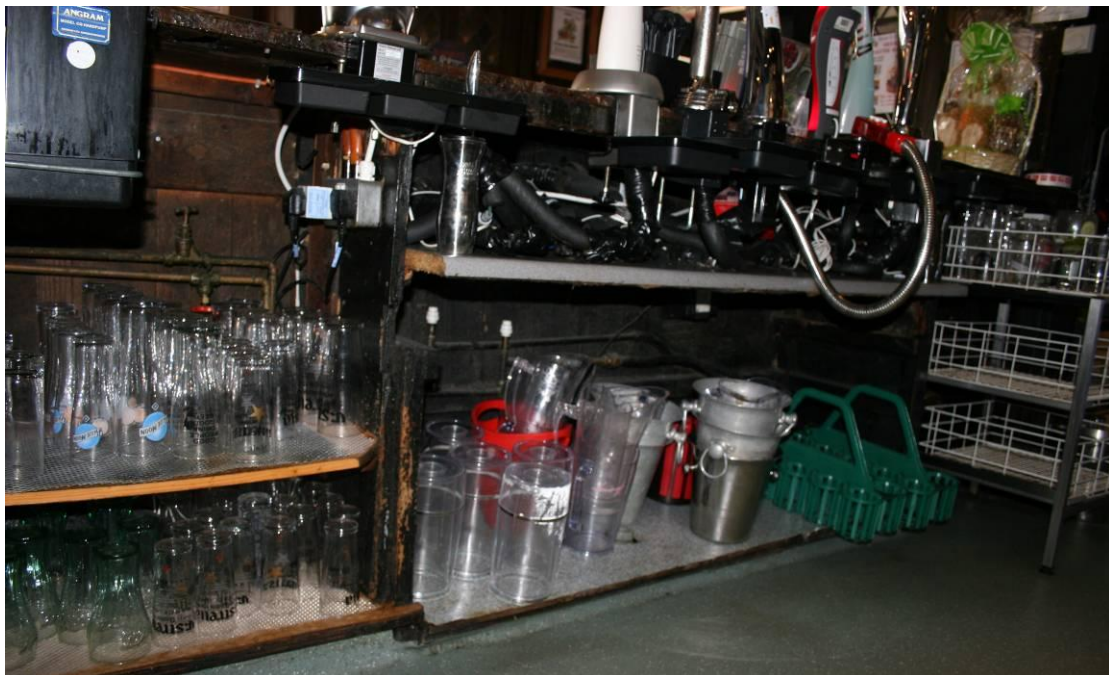
The rear of the bar counter.

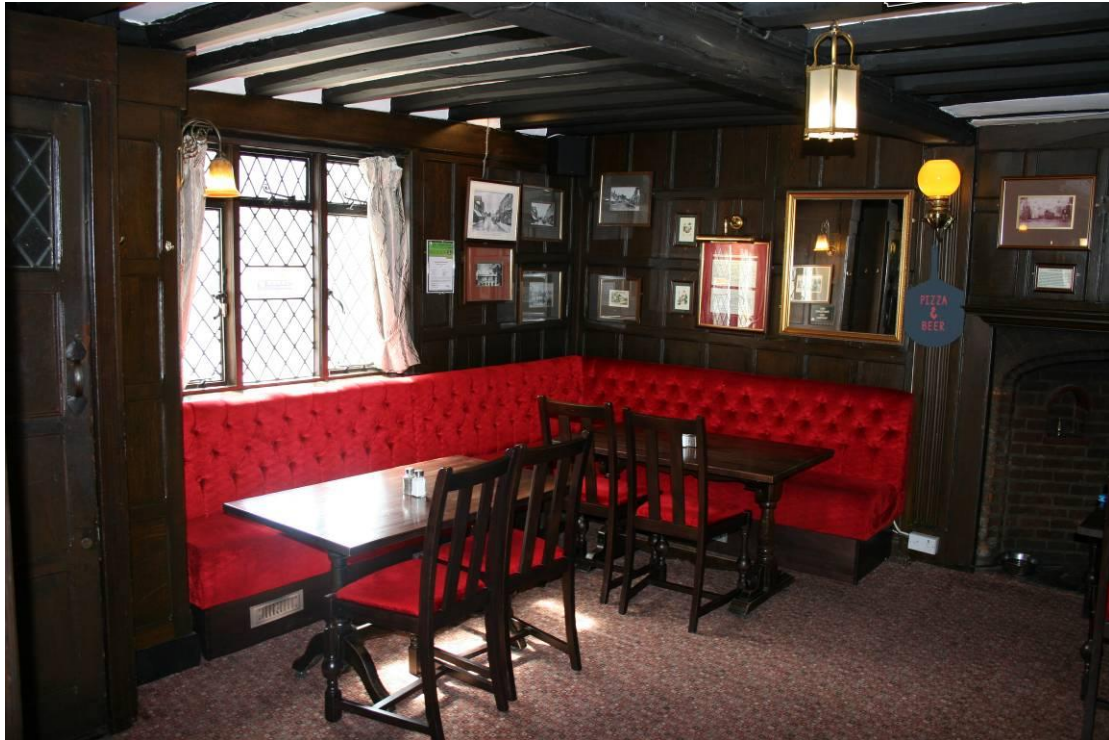
Looking S in the West Bar.

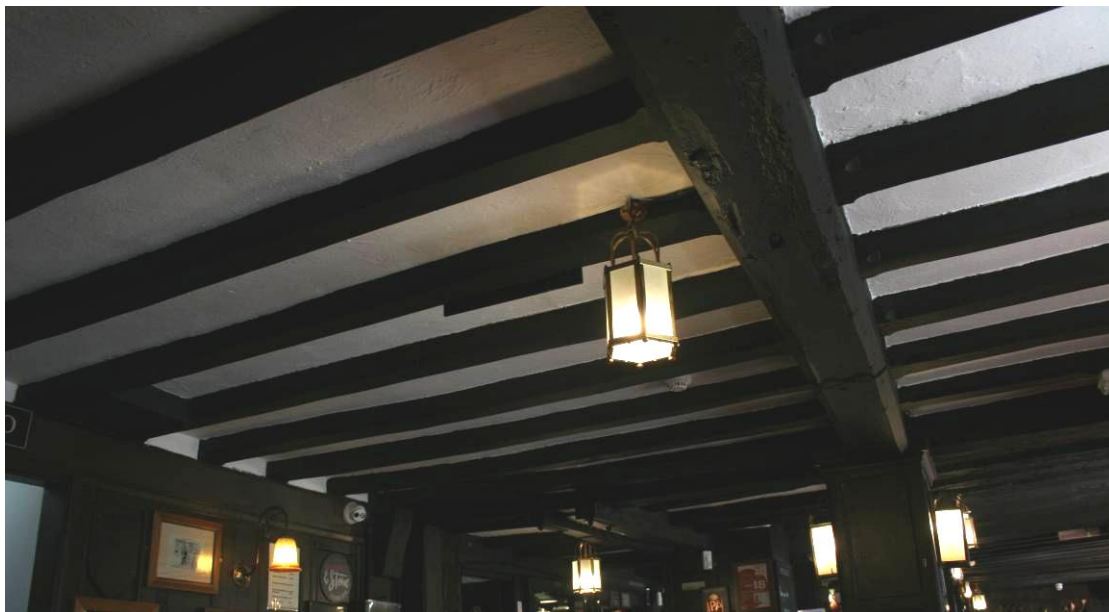
The framing over the West Bar.

The Bars can be divided up by the design of the frames each bay as defined by the transverse wall plates. Bay 1 has a chamfered and cyma stopped heavy axial joist with regular, straight, chamfered and cyma stopped 6in wide common joists. The decoration of the timbers represents the more prestigious end of the building. The dividing walls have been removed and the empty mortices plated over with timber slips.

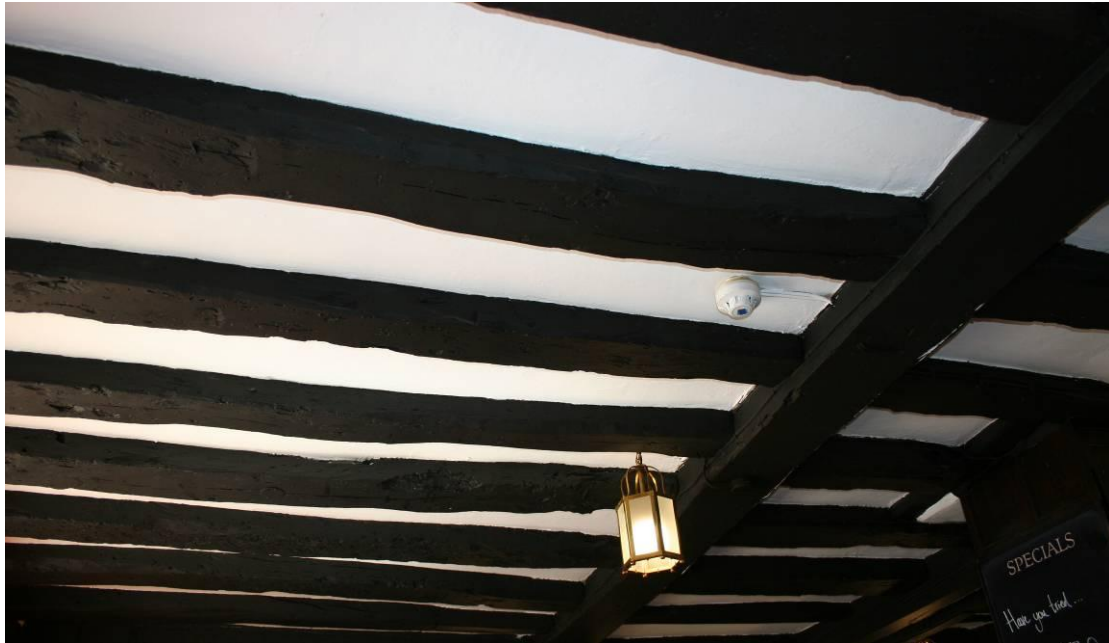
The framing over Bay 2.

Bay 2 has a heavy plain axial main joist with 6-8in wide, flat waney plain joists most typical of C15th and C16th service rooms. The framing over Bay 2 is the same design as over Bay 4.

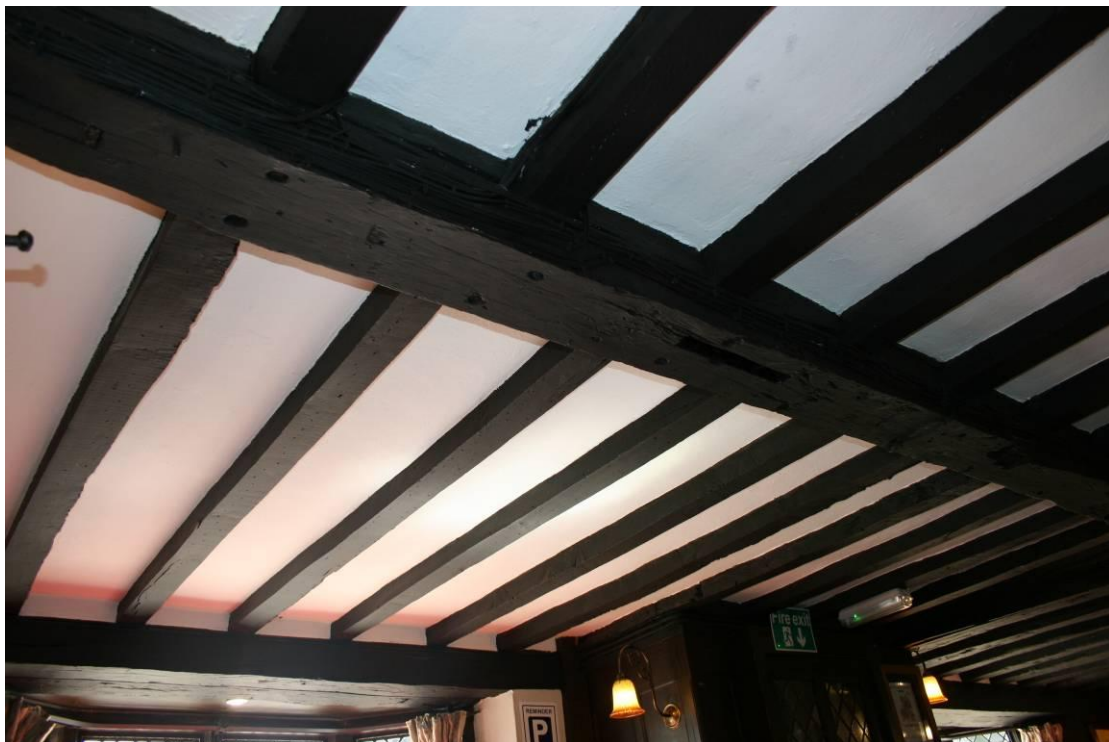
The framing over Bay 3.

The framing over Bay 3 is marked different. The main joist has redundant mortices from spandrels and is definitely reused. The pitsawn common joists are square in section and only 4in across and the mortices are oversized. It would appear this section of the frame has been rebuilt in the LC16th/EC17th.

On the ground floor the ceiling joists in Bay 3 have been replaced with near square 4in pitsawn joists set in a reused main axial joist. It is speculated that the building originally had a carriage arch, a very common feature for an inn, which was infilled to improve the accommodation.

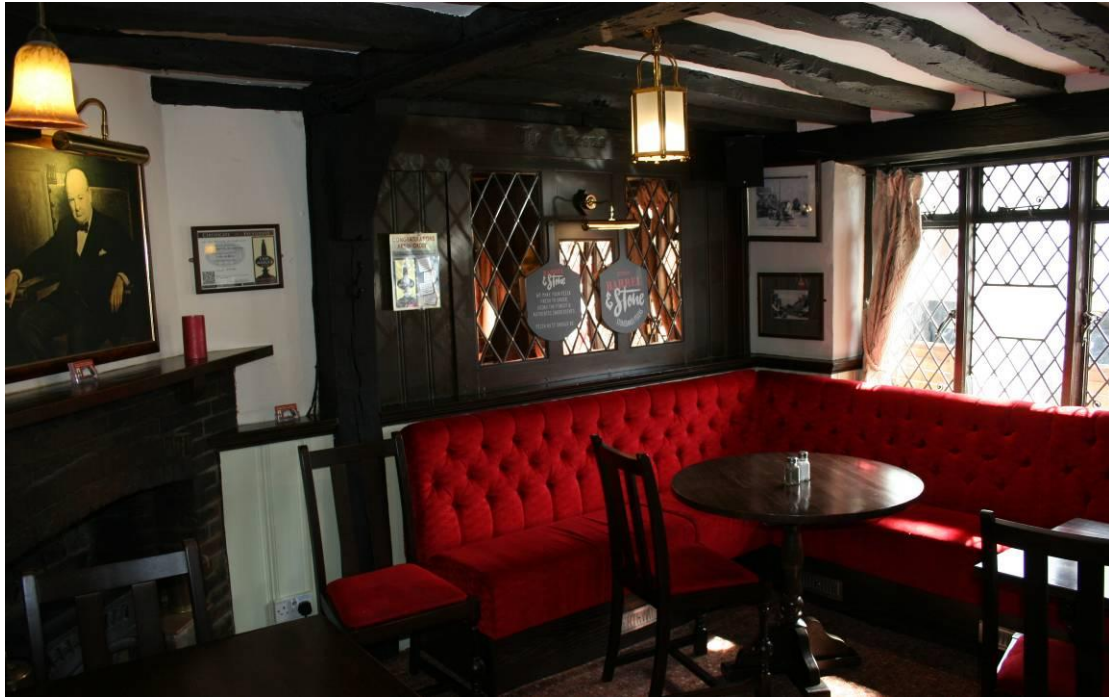
Looking SE in Bay 4

The wane joists are most noticeably in Bay 4. All the joist were examined for carpenter's assembly marks but none were found. With the exception of Bay 3 all the visible timbers are axe finished and it is most likely they are oak. No gaps in the paintwork could be found to confirm this however.

The Queens Head has a four bay timber-frame forming a long walled jetty house. Two of the bays (2 and 4 reading W to E) have flat waney 6-8in wide, axe finished common joists that denote service rooms of an early design in the C16th. Bay 1 has chamfered and cyma stopped joists denoting a reception room of higher status set in a cross-wing with its own frame. Bay 3 has had the main and axial joists replaced; most likely c.1700 and this may indicate there was a carriage way through the building or that there was some calamity that required an extensive repair.

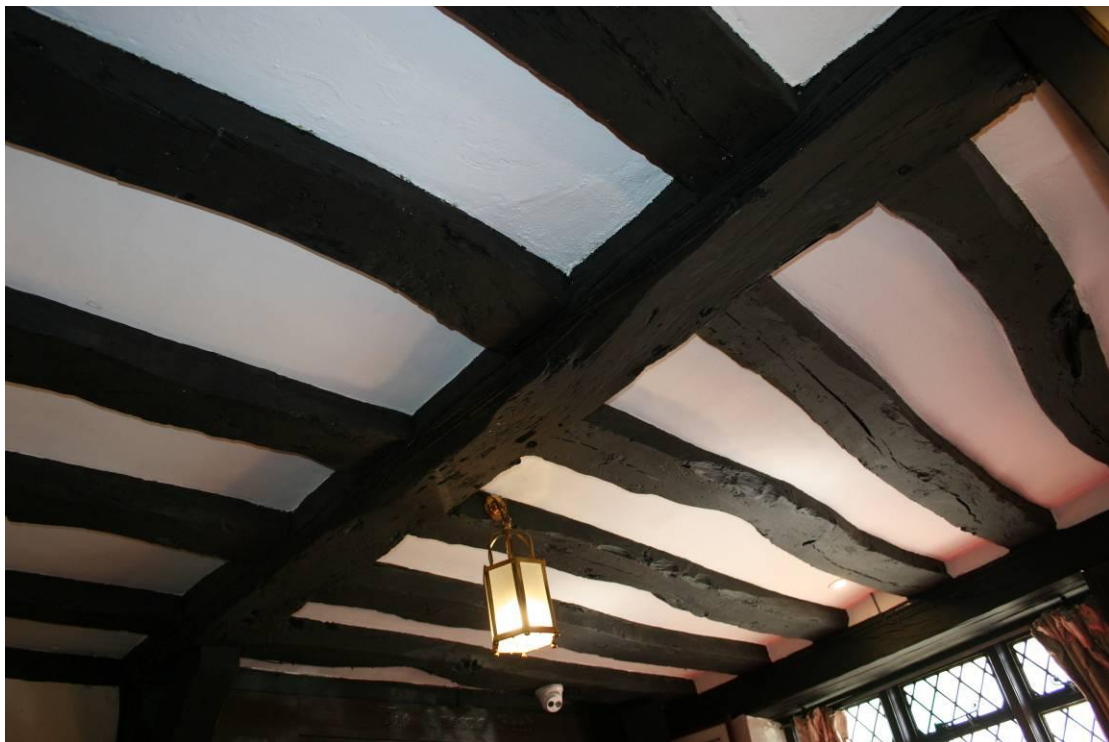
Detail of the wane flat joists in the Bay 4.

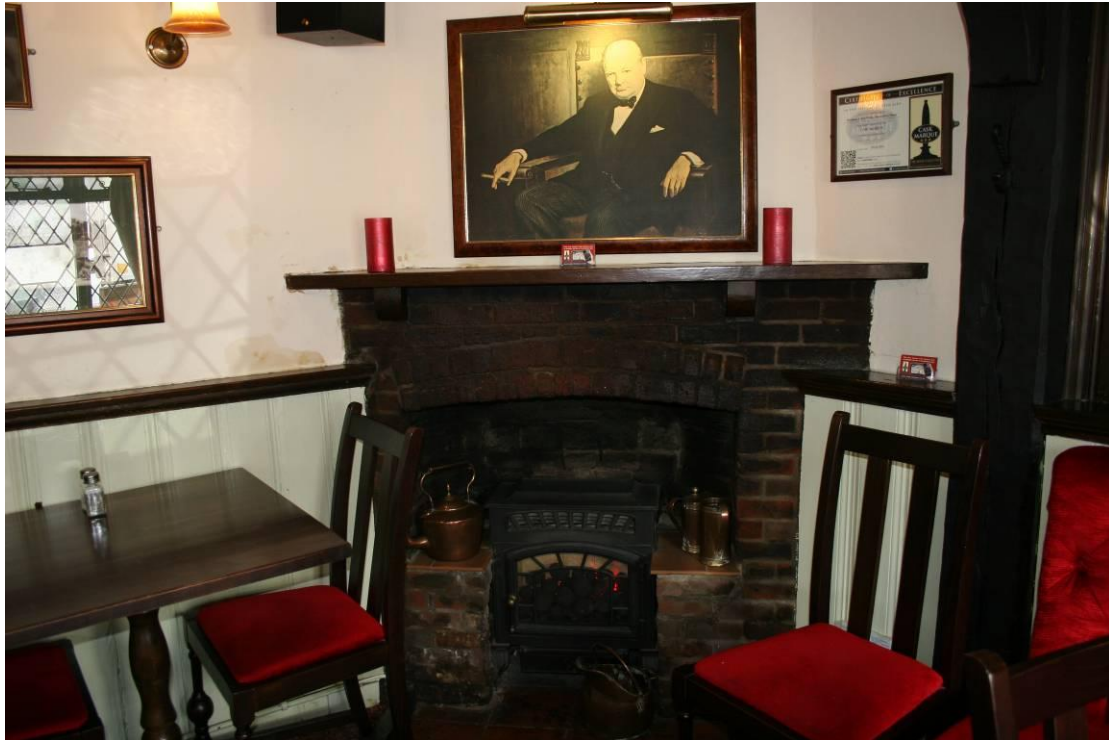
LC20th reconstruction of a hob grate fireplace.

There are two fireplaces in the Bar Areas. That in Bay 4 is a LC20th interpretation of a hob grate fireplace set into a Victorian corner flue. The fireplace in the westernmost wall has convincing moulded segmental Georgian arched bressummer but is pointed in grey cement. The brick cheeks are C20th but are likely to be from the 1930's to 1950's when brick fireplaces became popular and could be bought from catalogues.

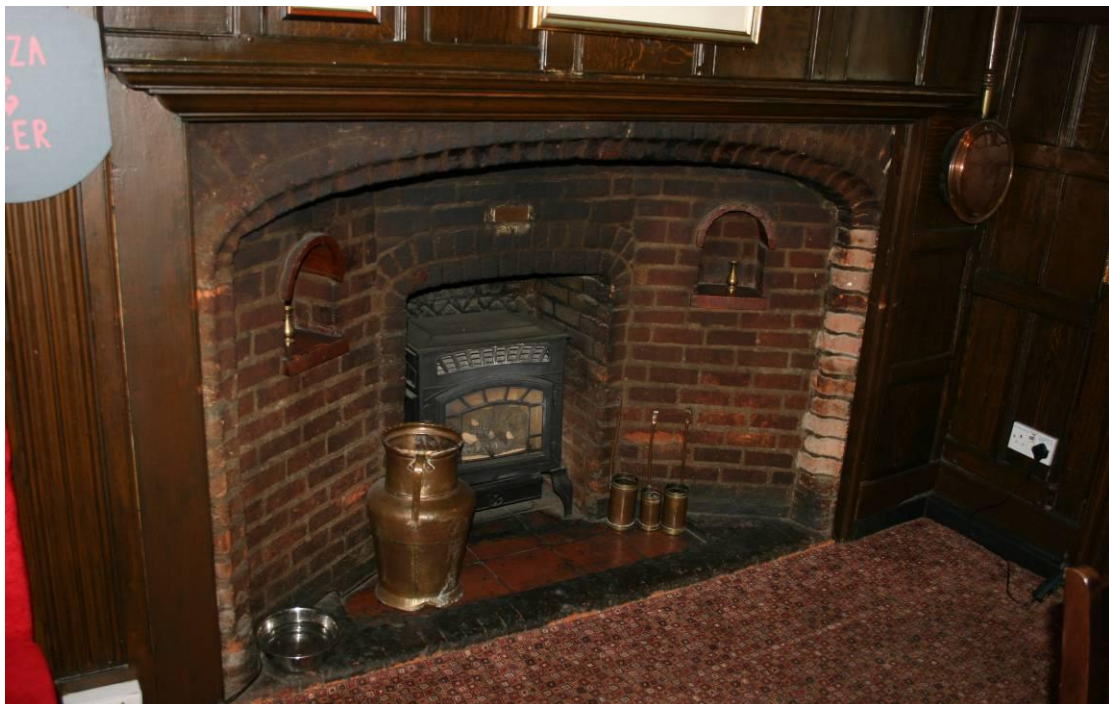
C18th fireplace with LC20th inserted brickwork.
