Queens Head, 31 High St, Pinner, HA5 5PJ.  
Recording and analysis of the Public House. Surveyed 11 04 2017.

## **Scope of this Report**

This report describes and analyses the fabric of the Queens Head, Pinner with a view to mitigating changes to the upper rooms which were inserted in the MC20th.

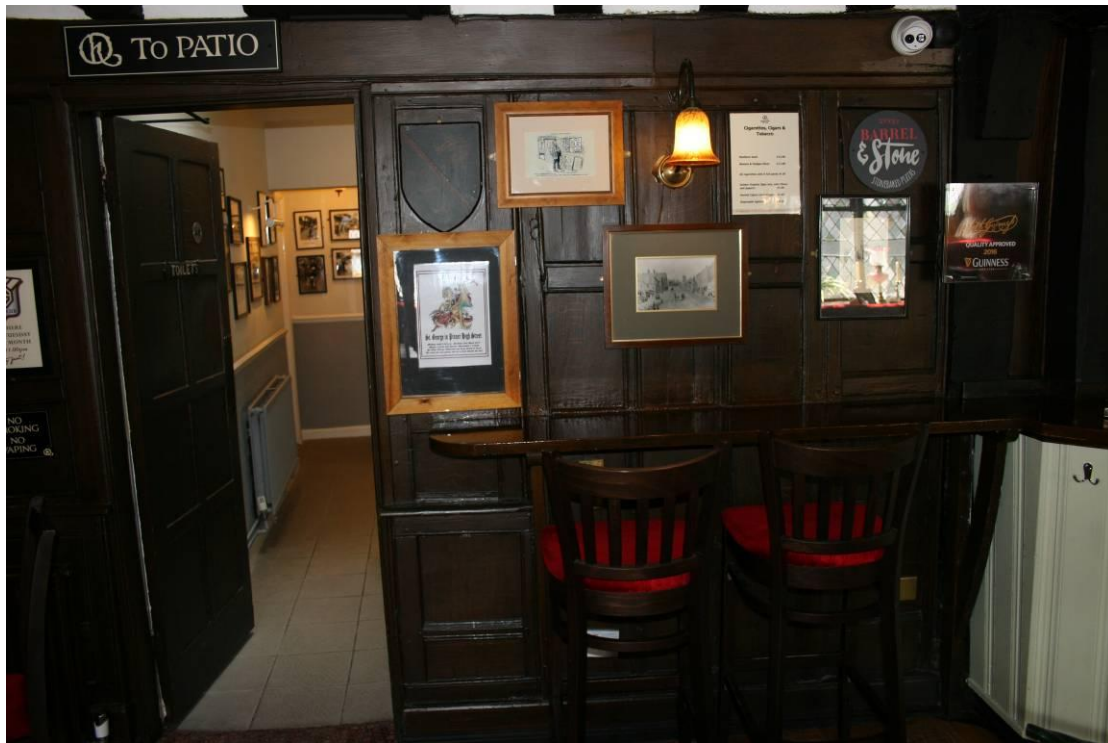
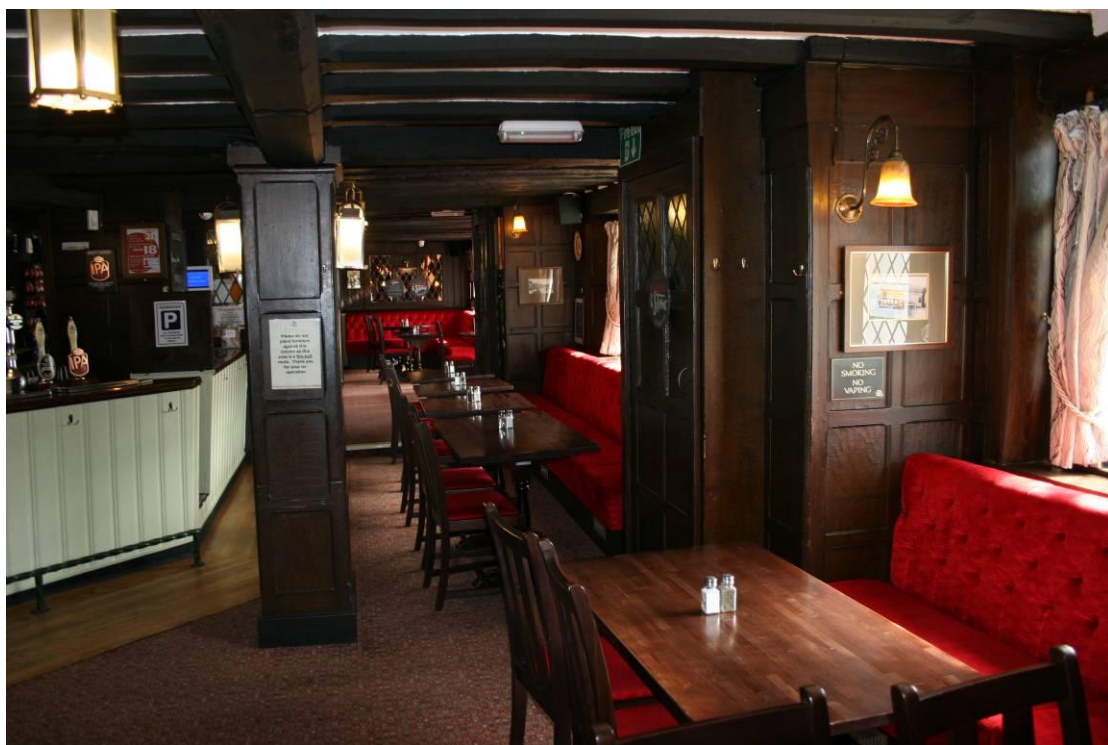
Wall panelling in Bay 1 looking N.

Wall panelling in Bay 1 looking E.

The brief Listing mentions C16th wall panelling and there is some authentic panelling on the walls in Bay 1. However it has all been repositioned as part of the LC20th remodelling of the Bar Areas.

Bay 1 retains some genuine C16th/C17th panelling but it has all been repositioned – i.e cut down to fit and its origin is undetermined.

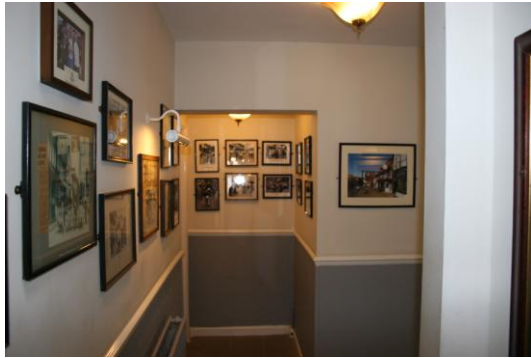
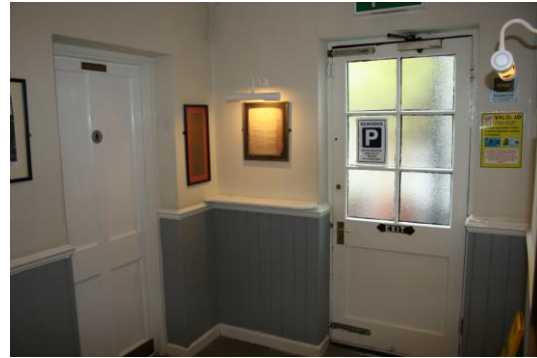
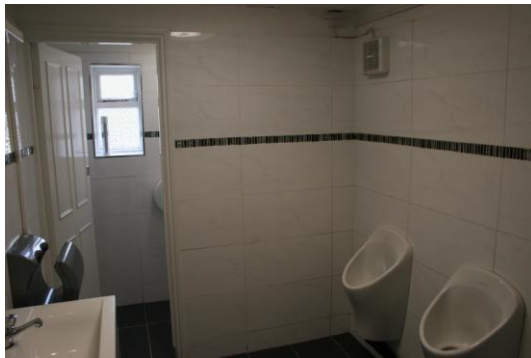
Looking N into the WC block.

The lobby looking E.

Sample interiors of the WC's.

The Toilet Block is entered from Bay 1 of the Bar Area and can be accessed from the rear of the building. All visible fixtures and fittings are LC20th. The sanitary ware is all very recent.

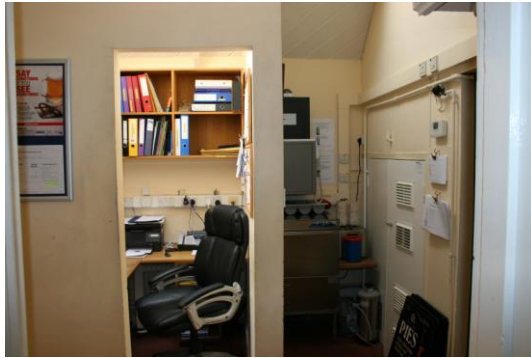
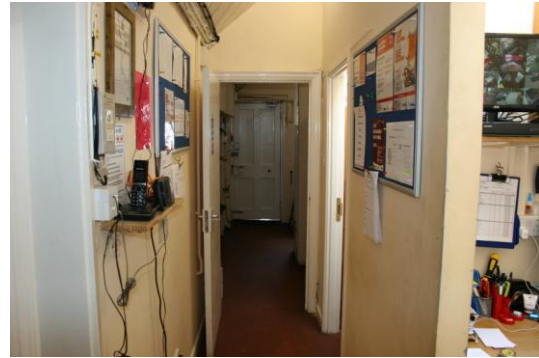
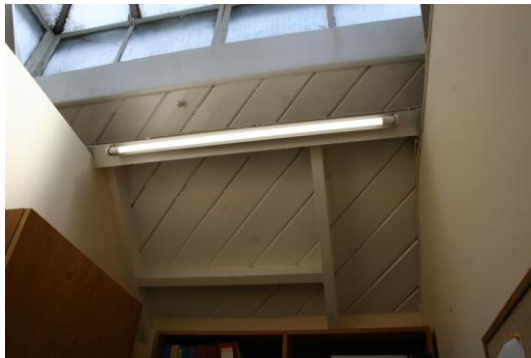
The Office looking E.

Office corridor looking N.

Details of the roof structure over the Offices.

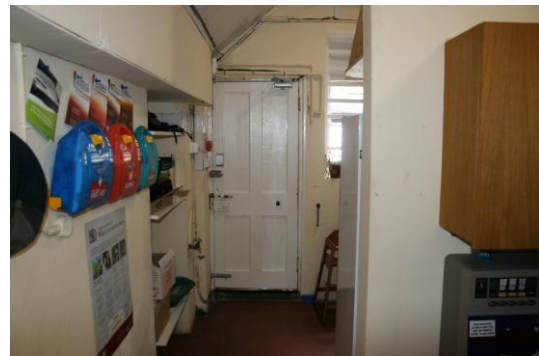
The back door to the garden.

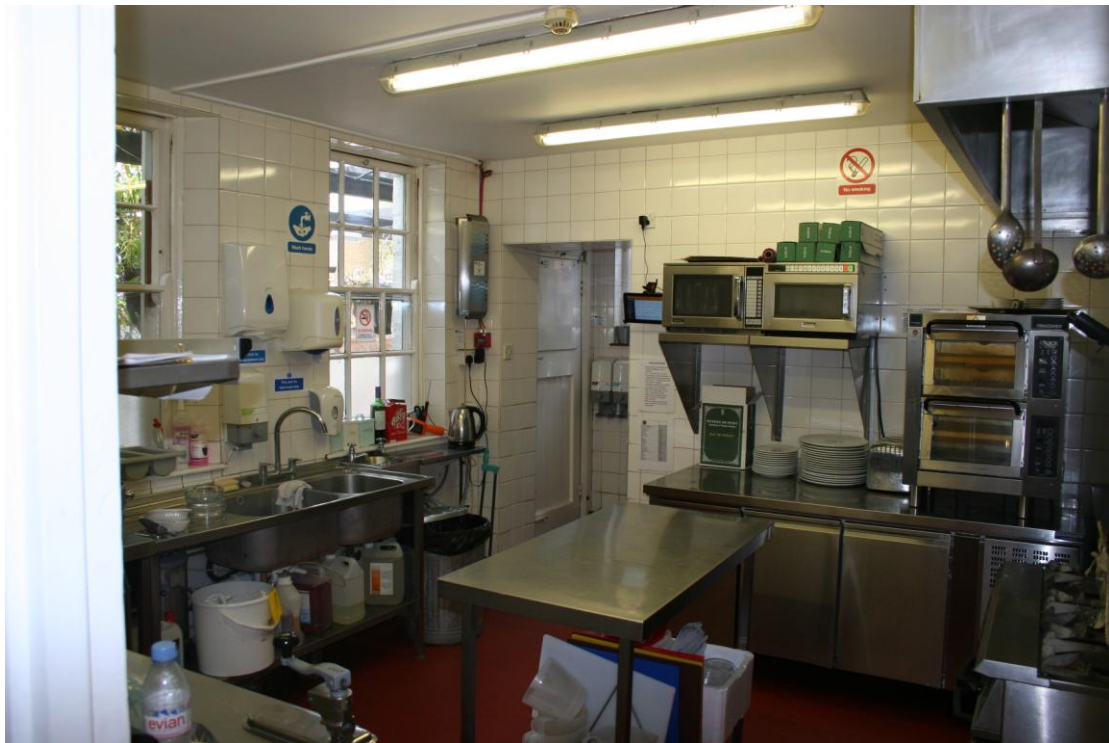
Looking NW in the Kitchen.

The Kitchen is equipped to C21st standards and no historic fabric is visible at all.

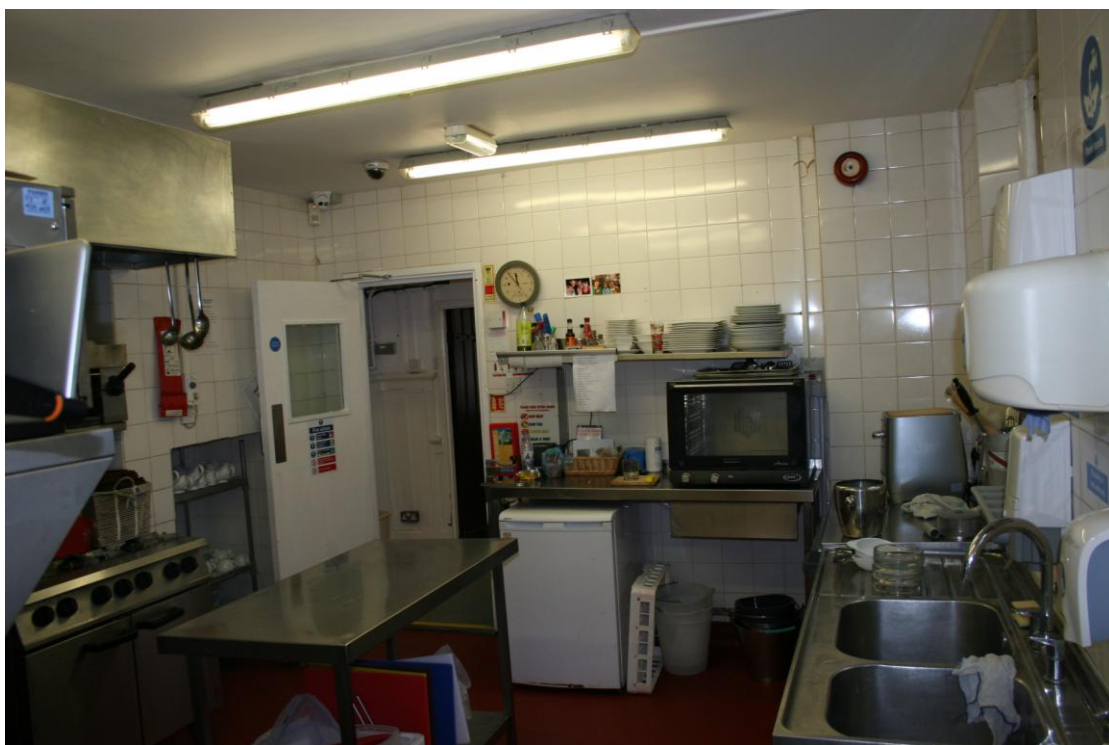
Looking SE in the Kitchen.

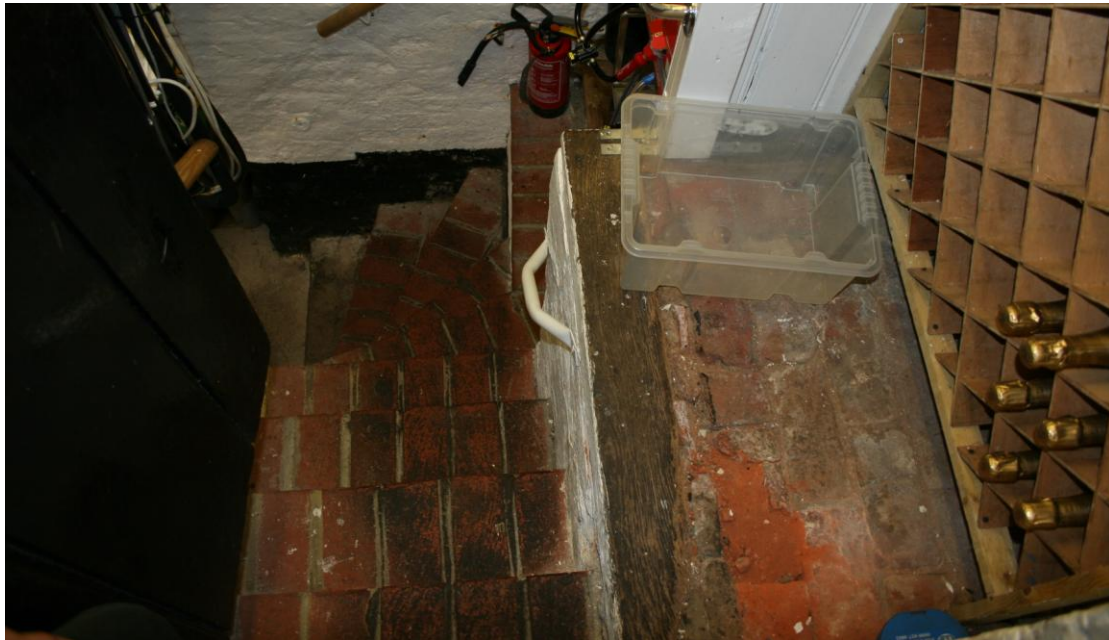
C20th brick steps down to the Cellar.

The Cellar is reputed to date to 1207. However the interior is insulated with C21st thermal boards and none of the original walls are visible. The brickwork is either C19th forming the barrel drop or C20th forming the retreaded stairs. The Cellar door has C19th box locks and T-strap hinges fixed with slot headed screws.

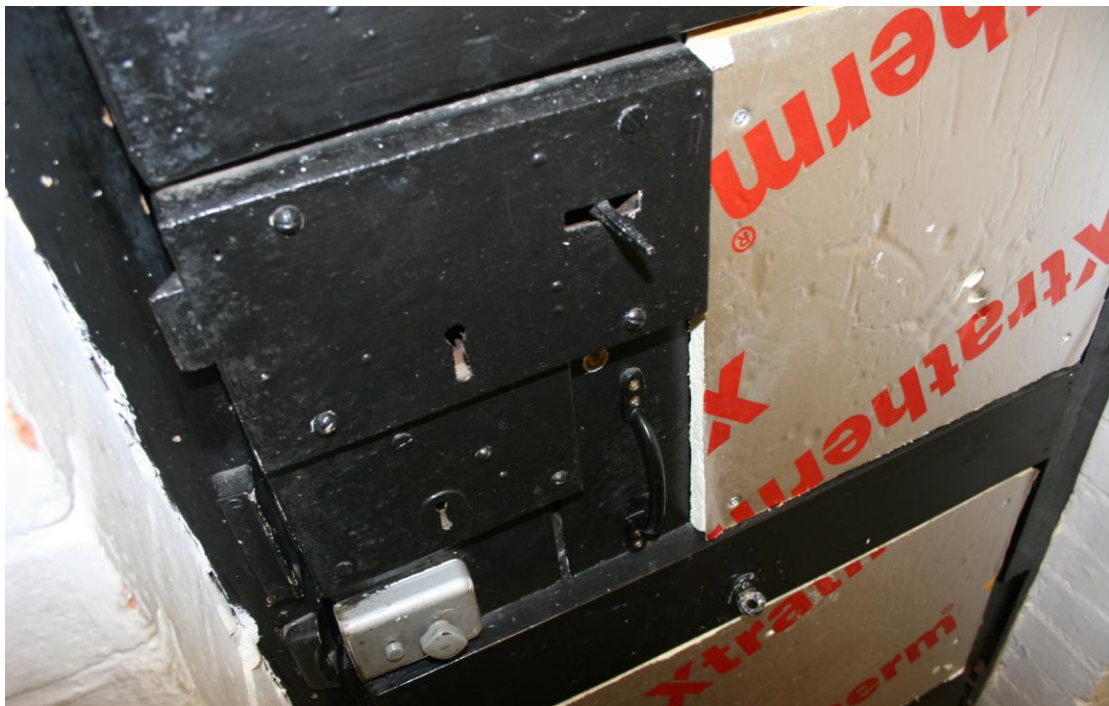
C19th lock boxes on the Cellar door.

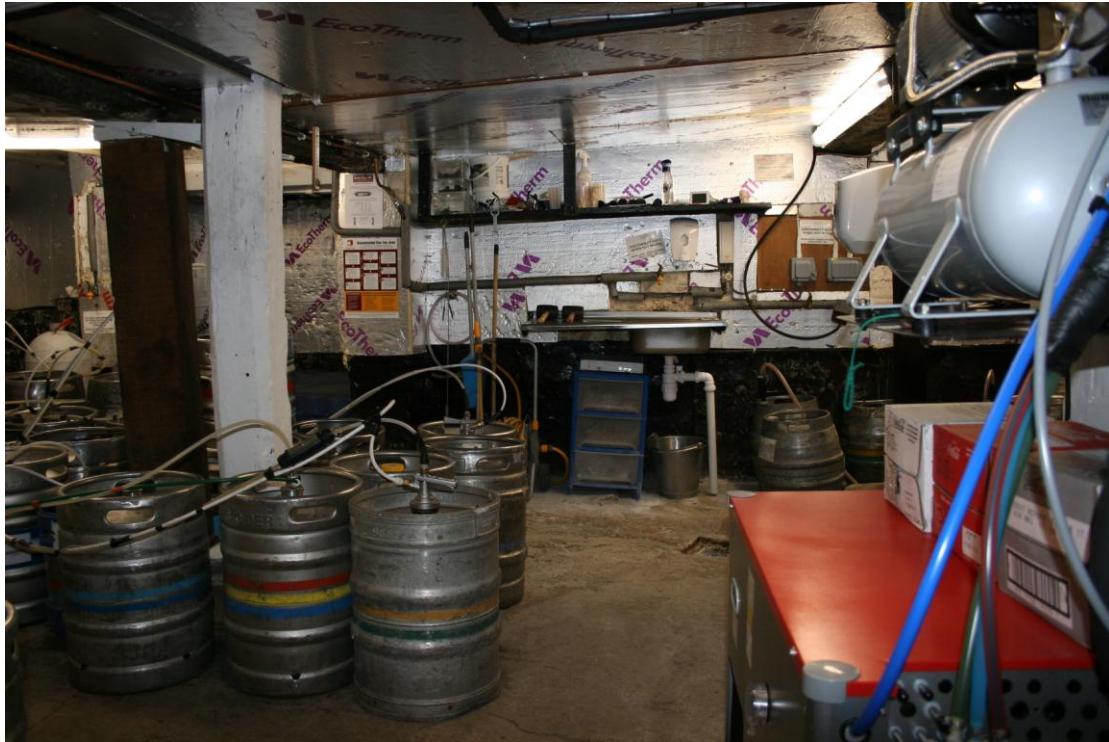
Looking S in the Cellar from the stairs.

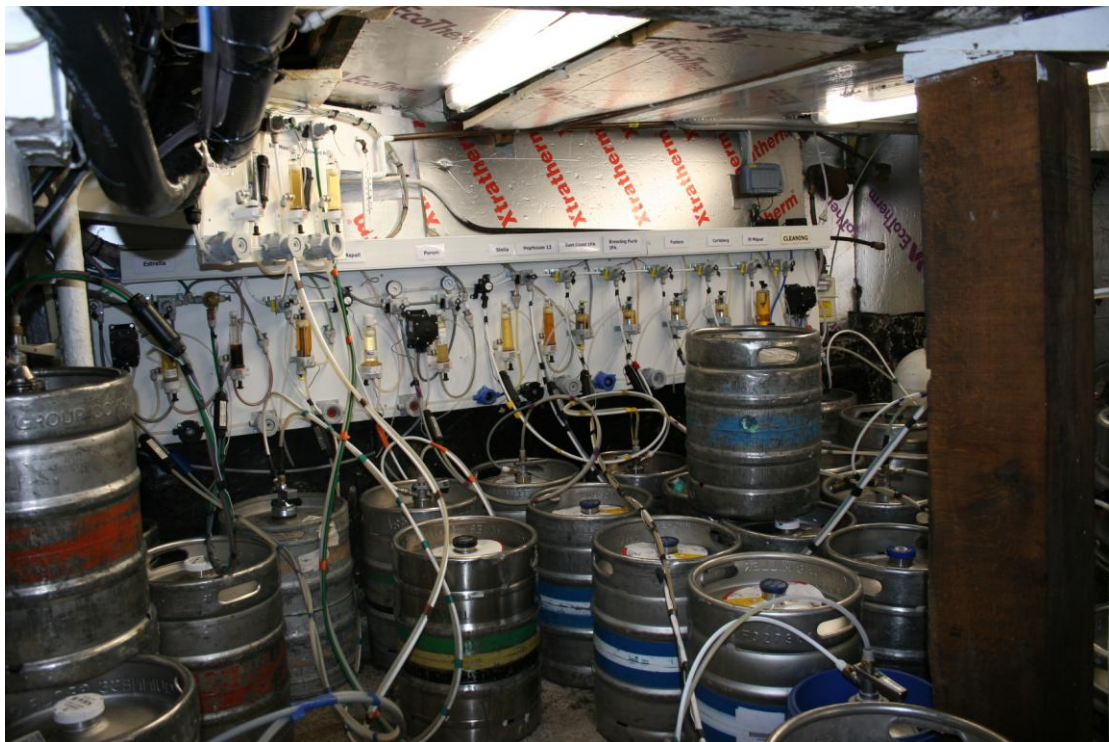
Looking E in the Cellar.

As is to be expected the Cellar is full of recently installed equipment for supplying the pumps above.

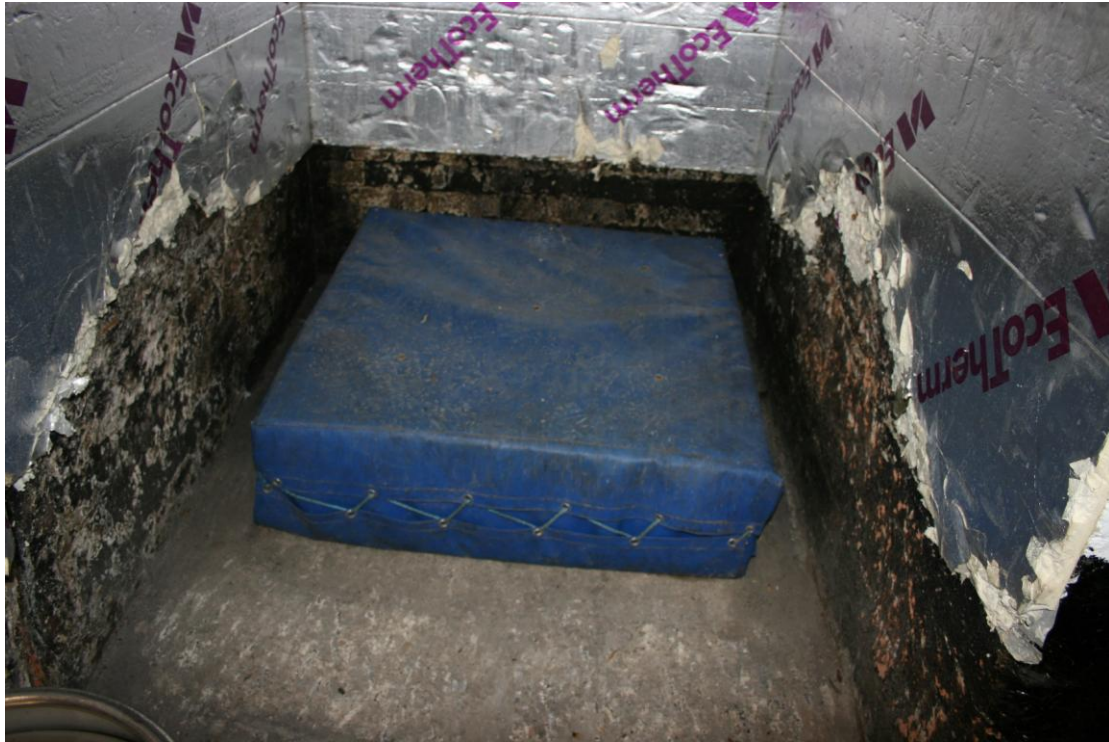
Scuffed brickwork in the barrel drop.

The main joist over the Cellar is evidently old and has chamfers softened by time. A rebate in the centre shows where an earlier prop was used to arrest the sag of the floor. Scuffed bricks are visible in the barrel drop and these appear to be C19th.

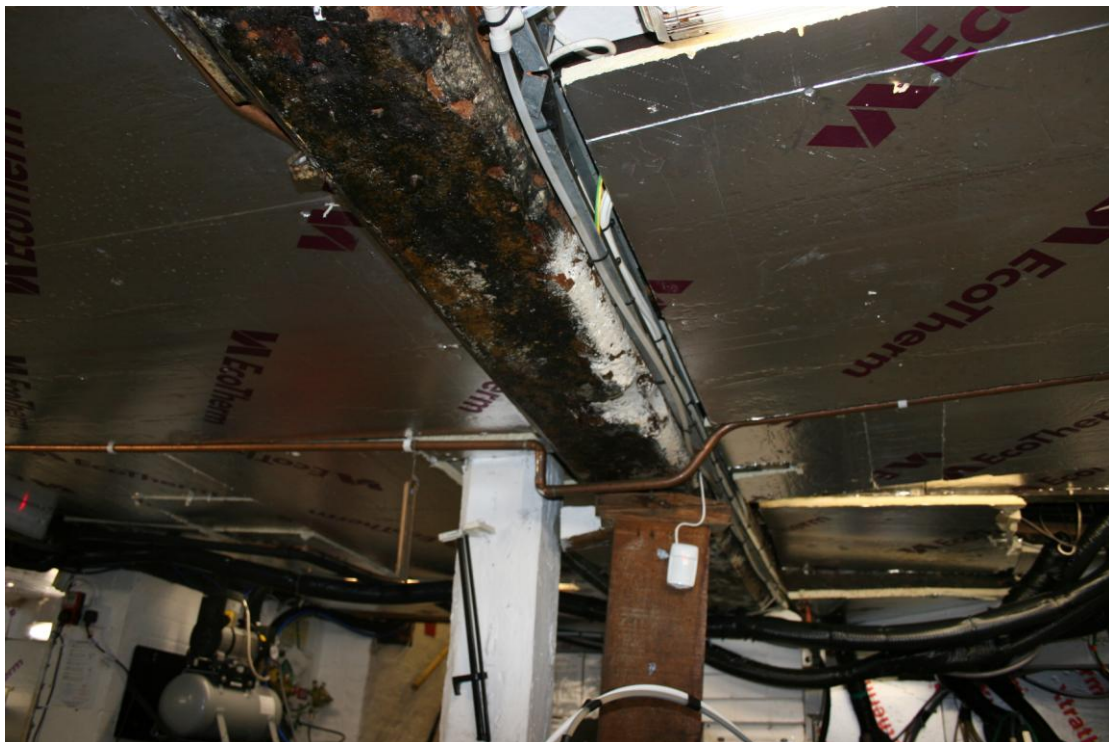
Main floor joist across the building.

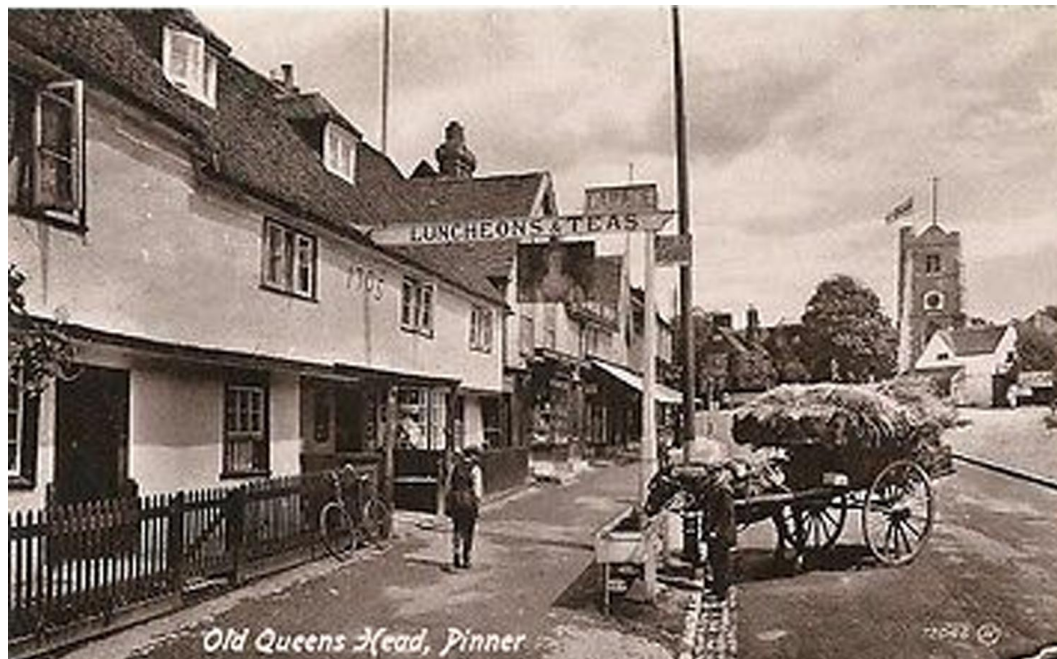
c.1900. Old Queens Head, Pinner.

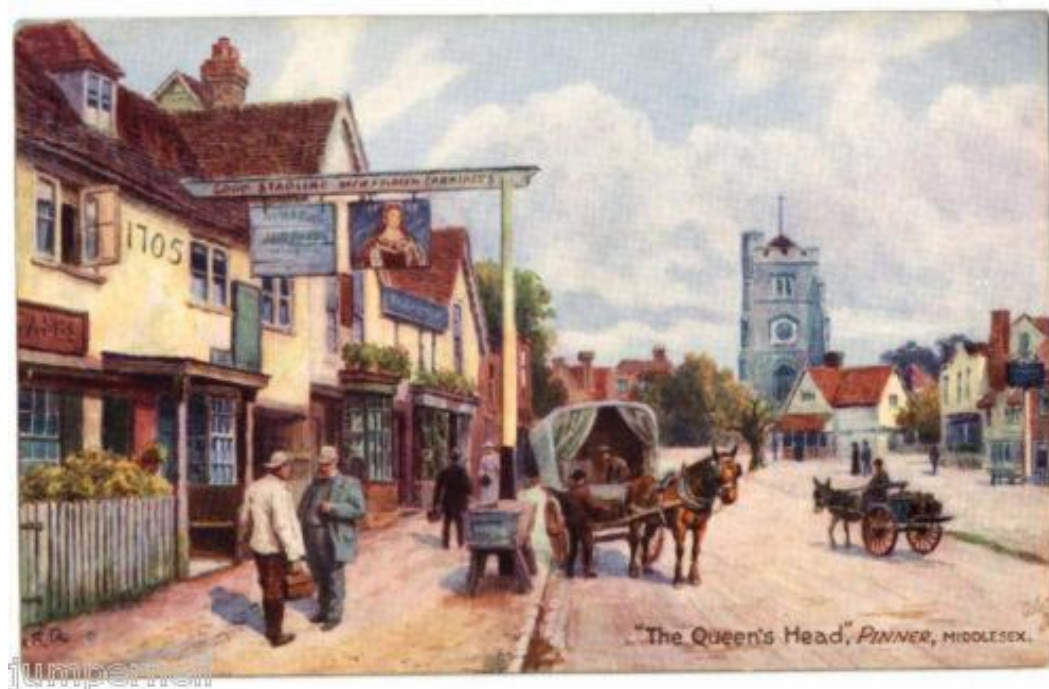
Post Card of Queens Head, Pinner with the 1705 date on the building. Undated.

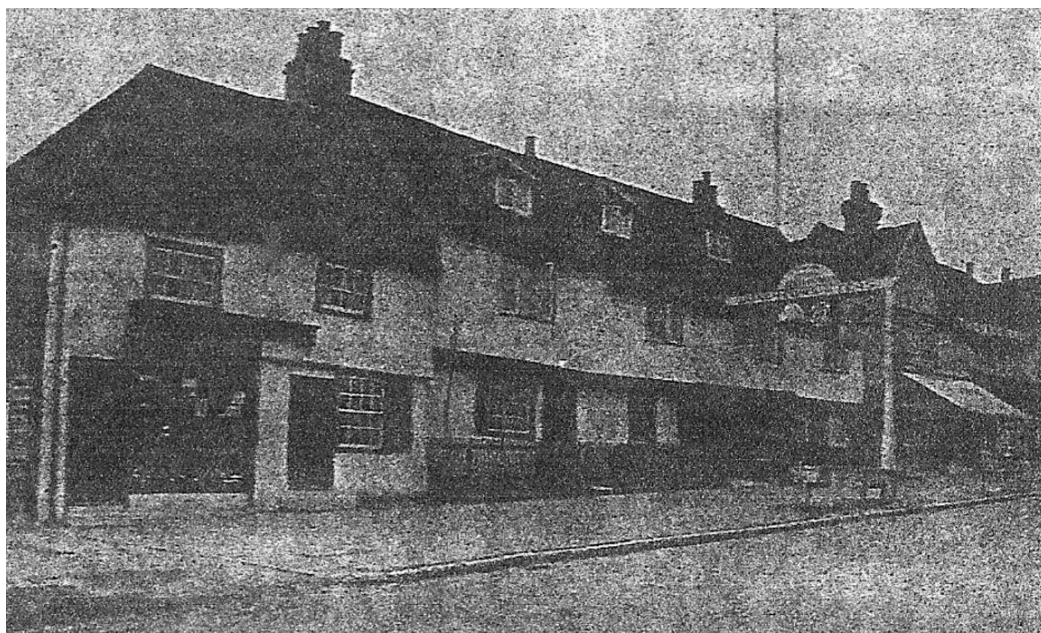
1923 RCHME Record Car photograph.

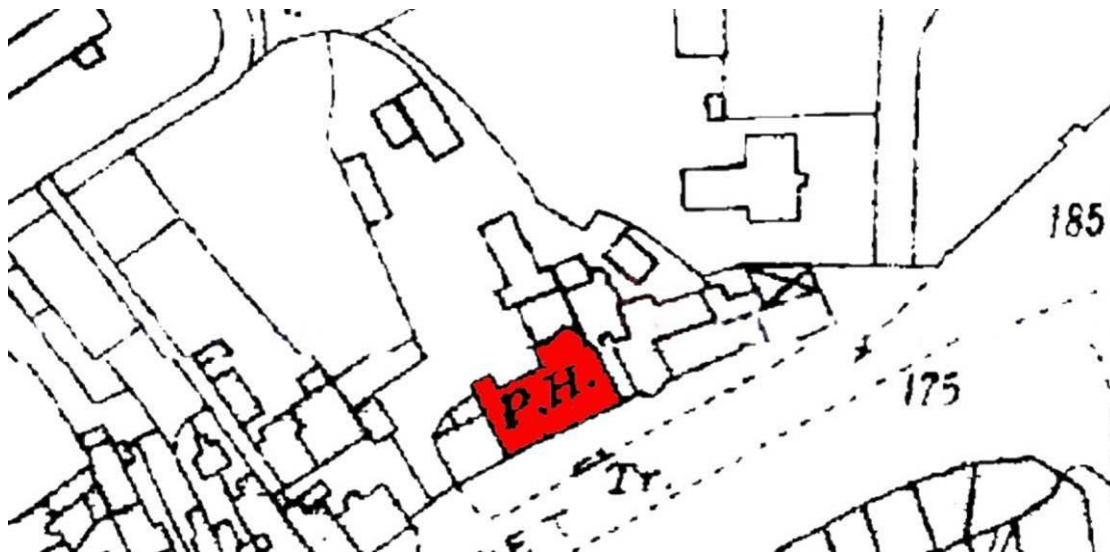
1935 Ordnance Survey.

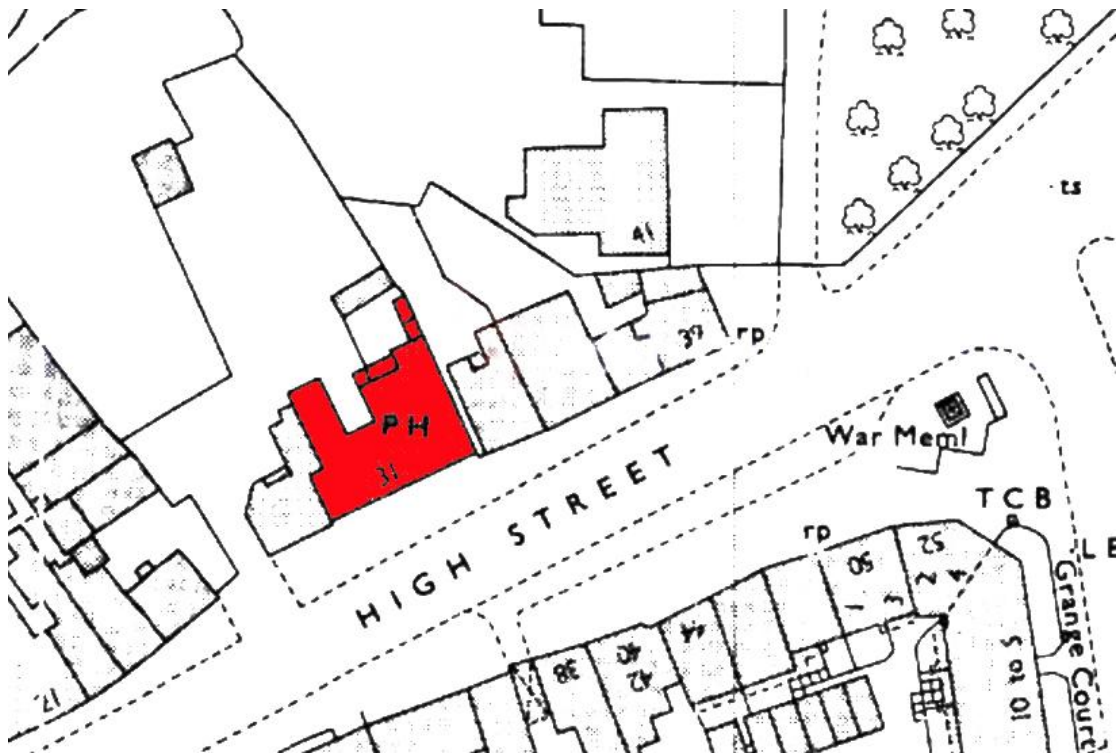
1972 Ordnance Survey

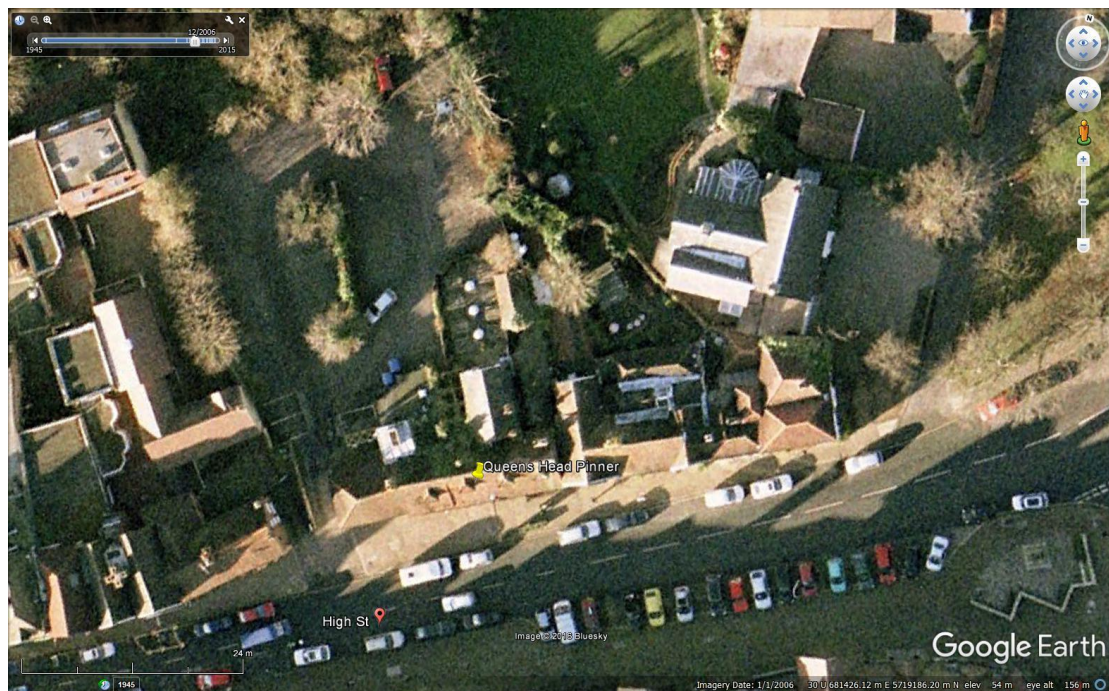
2006 Google earth.

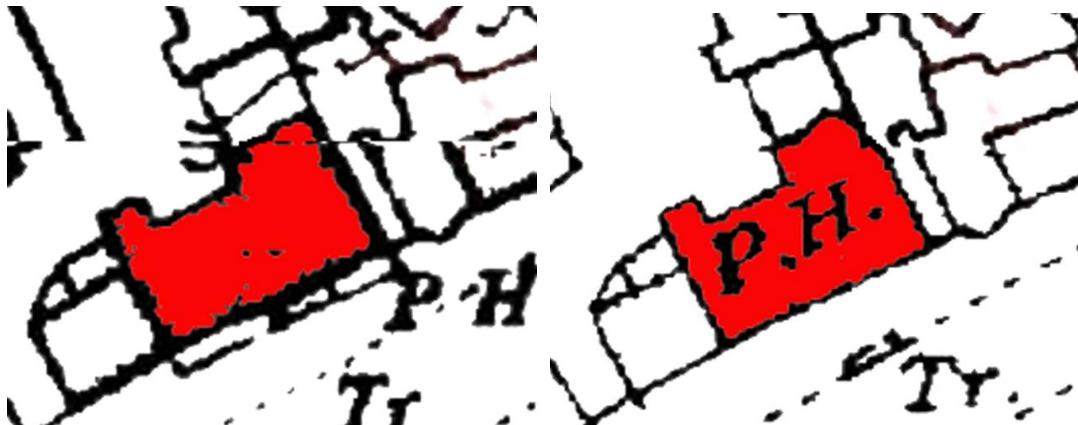
The first three editions of the Ordnance Survey maps have the building divided between two sheets. The meeting has not been exact and some detail is lost. The Brick Range is not shown on the first three maps.

1913 OS Map.

1935 OS Map. On the edge of two sheets.
