Excavations for foundations of an external lift tower at Loughton Hall, Loughton, Essex. June 2009.

The current works for which the excavations were recorded were positioned against the SW elevation and required the demolition of part of the southernmost C20th flat-roofed extension to build a two storey tower to house a lift.

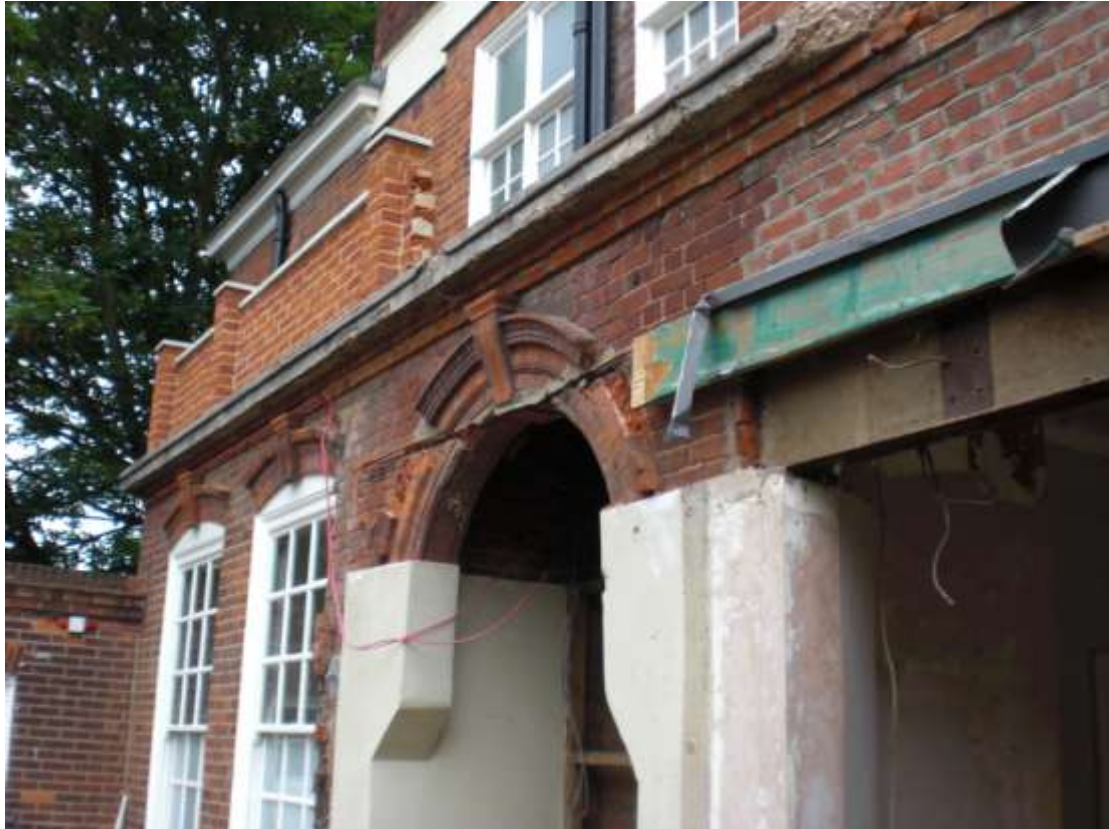
The SW elevation showing the original entrance and windows and the inserted 1970's steelwork.

The lower part of the elevation originally consisted of a centrally placed recessed doorway with a gauged decorative brick roman arch flanked by two pairs of deep Georgian style 9/9 horned sash windows with gauged arched lintels with central moulded brick keystones with the date 1878 and the letter M.

Sometime in the 1970's (in an act of architectural vandalism) the southern pair of windows was removed and a pair of steel lintels placed in the opening to provide entrance into a single storey contemporary flat-roofed extension.

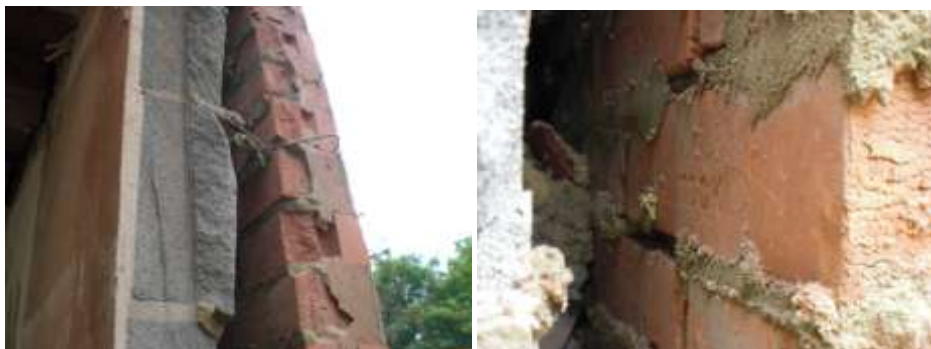
Detail of the cavity wall of the 1970's extension and close up of lbstock bricks.

This was constructed on concrete foundations deep in the ground with a fletton brick sub-structure below ground and a Celcon block and Ibstock brick faced cavity wall. The skins being tied together with butterfly ties of galvanised wire. At the same time a large brick and concrete drain chamber was built in the floor plan to serve the toilets.

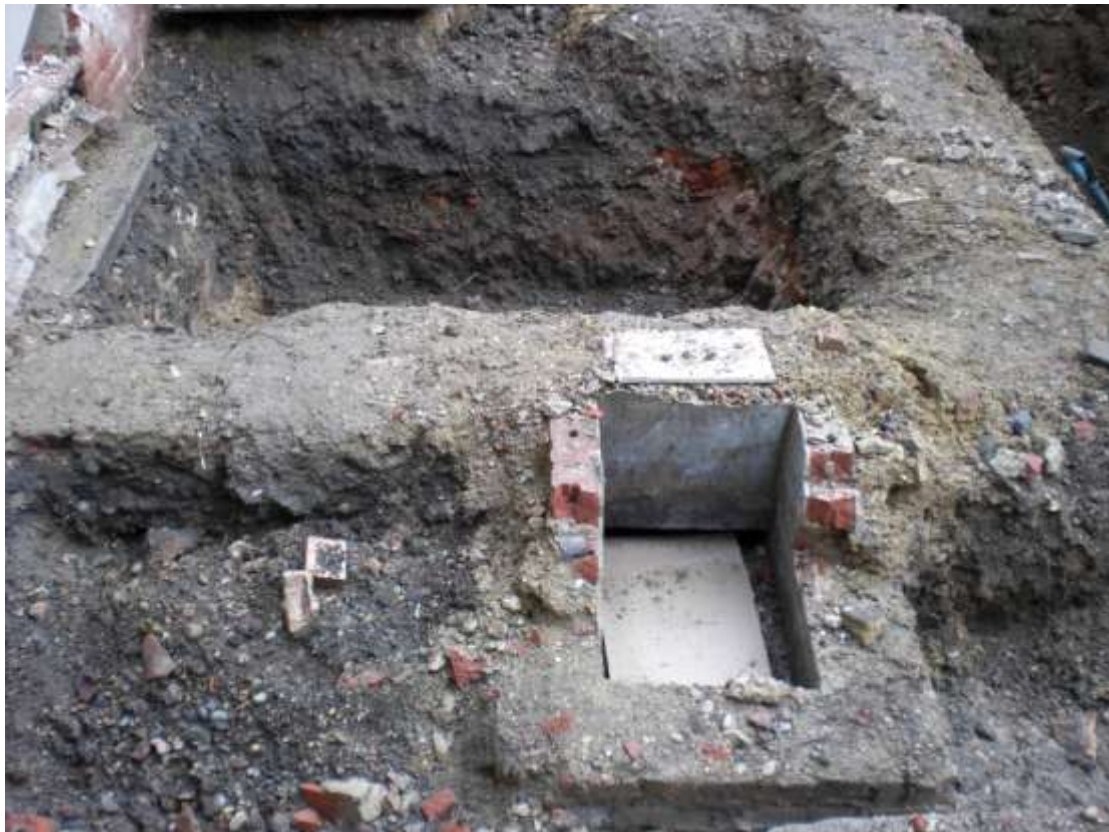
Brick and concrete foul water inspection chamber shown partly demolished.

The concrete inspection chamber was removed using a Kango hammer. The fletton substructure was broken through with sledge hammers where it crossed the line of the new foundation trench.

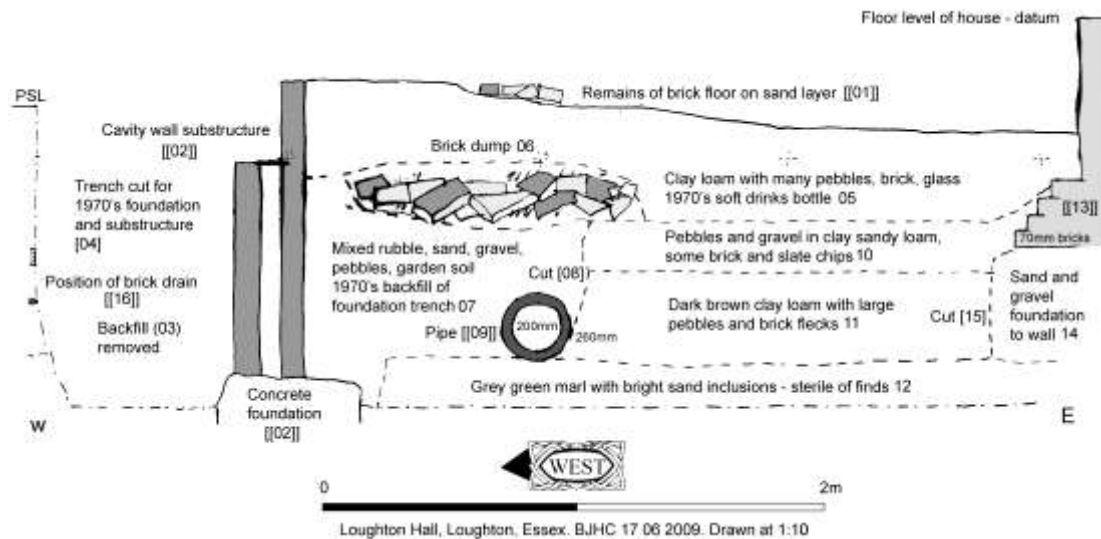
Section through the excavations at Loughton Hall.

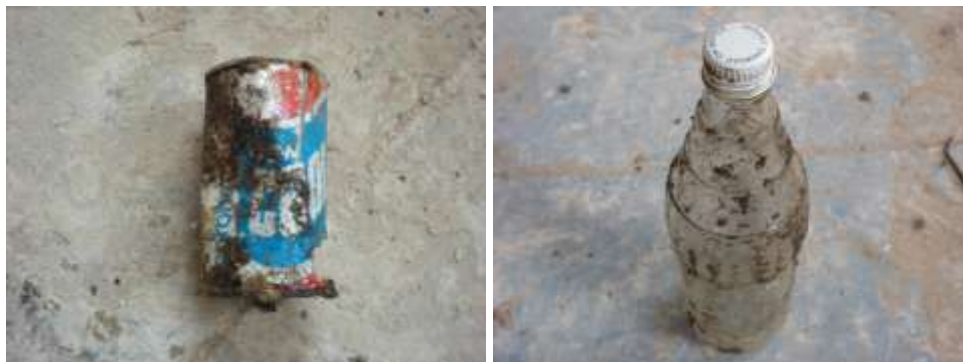
The 1970's extension was demolished down to ground level and the concrete floor [[01]] removed. This appeared to consist of flettons laid on a building sand raft and then covered with poured concrete. Within the confines of the extension there was then a thick layer of redeposited mixed soils, gravel, sand and building rubble 05 including bricks obviously removed from the main house when breaking through. Contained in the soil was a corroded can of Corona Cola and a perfectly preserved 1970's glass pop bottle with a screw top bearing the legend 'Deposit charged on bottle'. There was also much window glass presumably from the demolition of the two Victorian windows.

Tinned metal Corona can and glass bottle from the 1970's.

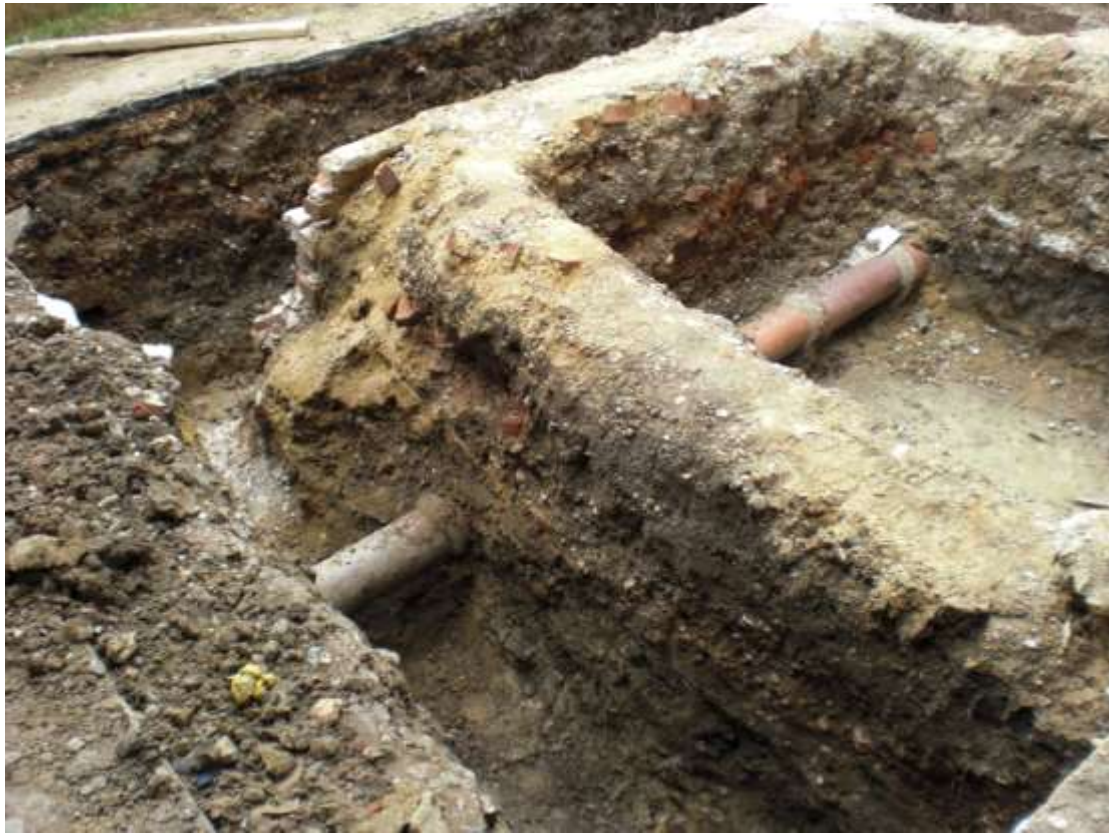
Foundation trenches revealed disturbed drainage trench with ceramic pipe.

However the trench cut the backfill for an earlier service trench containing a 200mm ID ceramic rainwater pipe [[09]] running parallel to the main building and 2.2m from it. To the north, a downpipe from a small extension built in the 1920's showed the source of the rainwater. At the point where the section was drawn all the original backfill of the drain trench had been removed for the 1970's work. The ceramic pipe passed under and was not connected to the concrete inspection chamber which was part of the 1970's floor structure [[01]].

The cut for the drain trench passed through three distinct layers. The upper one 10, sealed by the 1970's overburden was 200mm deep, resembled garden soil and contained pebbles and gravel in a sandy clay loam mix. There were also brick and slate fragments. Below this was a more dense 350mm deep layer 11 of dark brown clay loam subsoil containing large pebbles and some fine brick flecks brought down by plant action. This lay on a layer of clay marl 12 with some bright sand inclusions which was sterile of finds and was the level at which the 1970's foundations had been cut from.

A substantial trench was dug at least 600mm deep to house a 200mm inside diameter ceramic sectional pipe to run rainwater from a small extension built on the side of Loughton Hall in the 1920's. The trench was re-excavated in the 1970's removing most of the backfill.

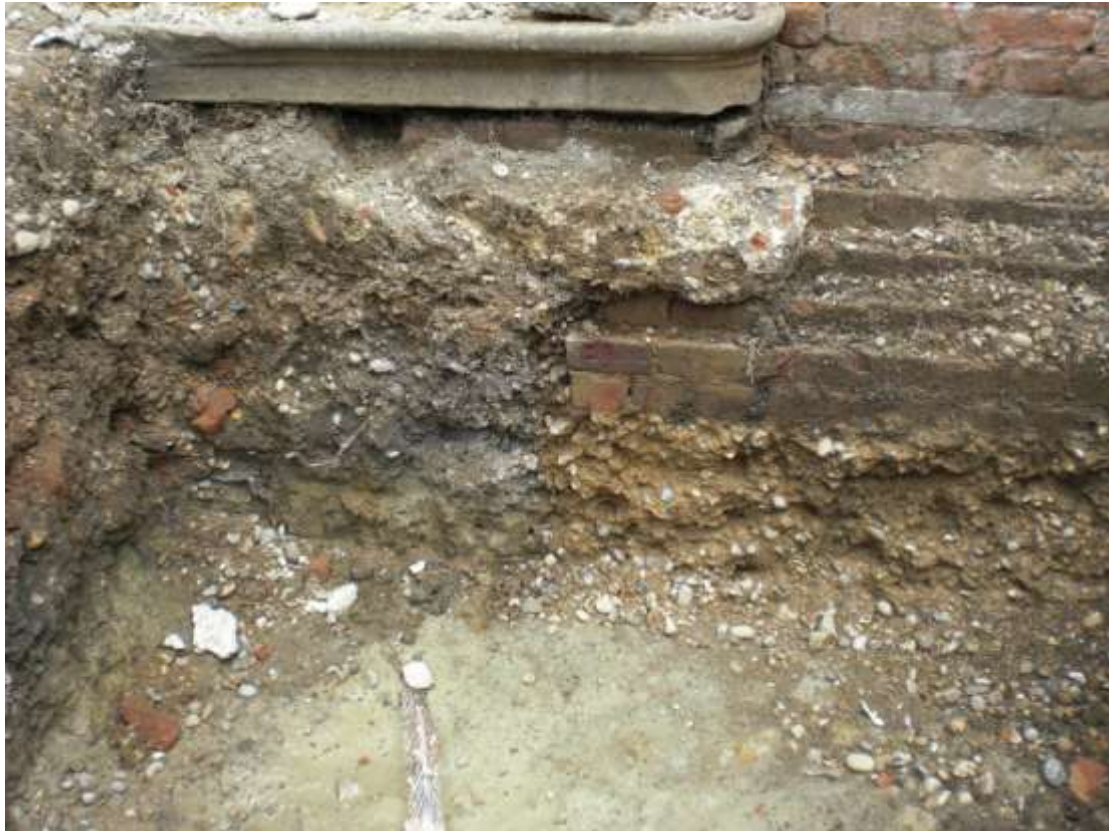
Section beneath the porch step showing the foundation trench cutting the earlier layers. Bricks are 70mm thick for scale.

Beneath the house itself the foundations consisted of a dense layer of sand and gravel (14) 450mm deep set in a trench [15] cut from within the layer of subsoil and resting on top of the clay marl. The brickwork [[13]] was laid to form a stepped pressure base to spread the load. The variously fired bricks were of the same size, 70 x 110 x 220mm as the facing bricks but of a poorer rough finish. There was no foundation beneath the porch so the section there also illustrated the stratigraphic sequence. The stone step [[17]] was laid on a bed of crushed brick bonded with lime mortar 18 up to 400mm deep.

This phase is represented by the sand and gravel foundation (14), [15] that was cut into the subsoil 11 and down onto the solid clay 12. Only 450mm deep it was considered sufficient to support the great bulk of the house above it. The brick base of the wall was stepped out over four courses to provide a pressure base to spread the load. Topsoil was later placed against the brickwork, no doubt to provide flower beds either side of the garden porch.

No foundation was dug beneath the porch and a rubble and mortar mix 18 was poured in to support the stone rear step [[17]].

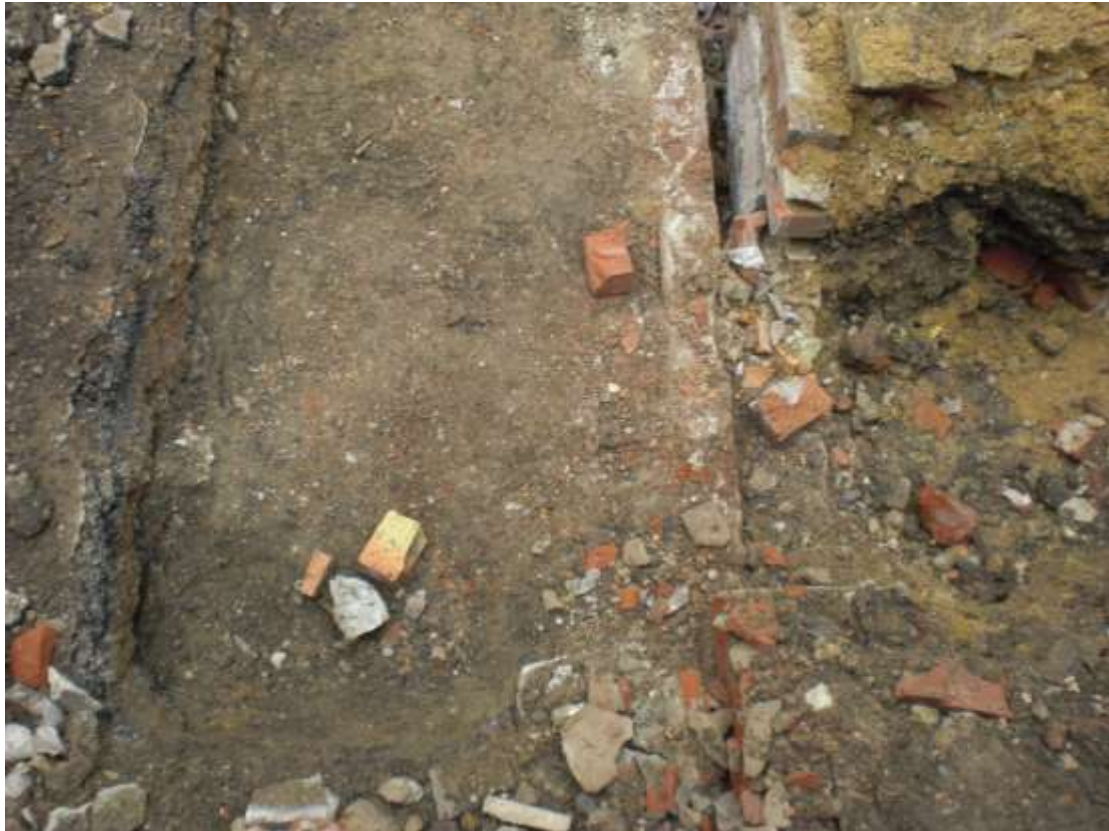
Densely packed modern trench backfill prior to removal in the NW corner of the site. Looking N.

External to the 1970's extension was a broad foundation trench [04] evidently opened to allow the brickwork for the fletton substructure [[02]] to be put in place. This was filled with a compacted mixture (03) of redeposited soils, brick rubble, sand, gravel and building waste. There were also some more soft drinks bottles and metal ring pull cans. From within the matrix was recovered a 1961 threepenny bit. One of the monogrammed window keystones was also recovered from here.

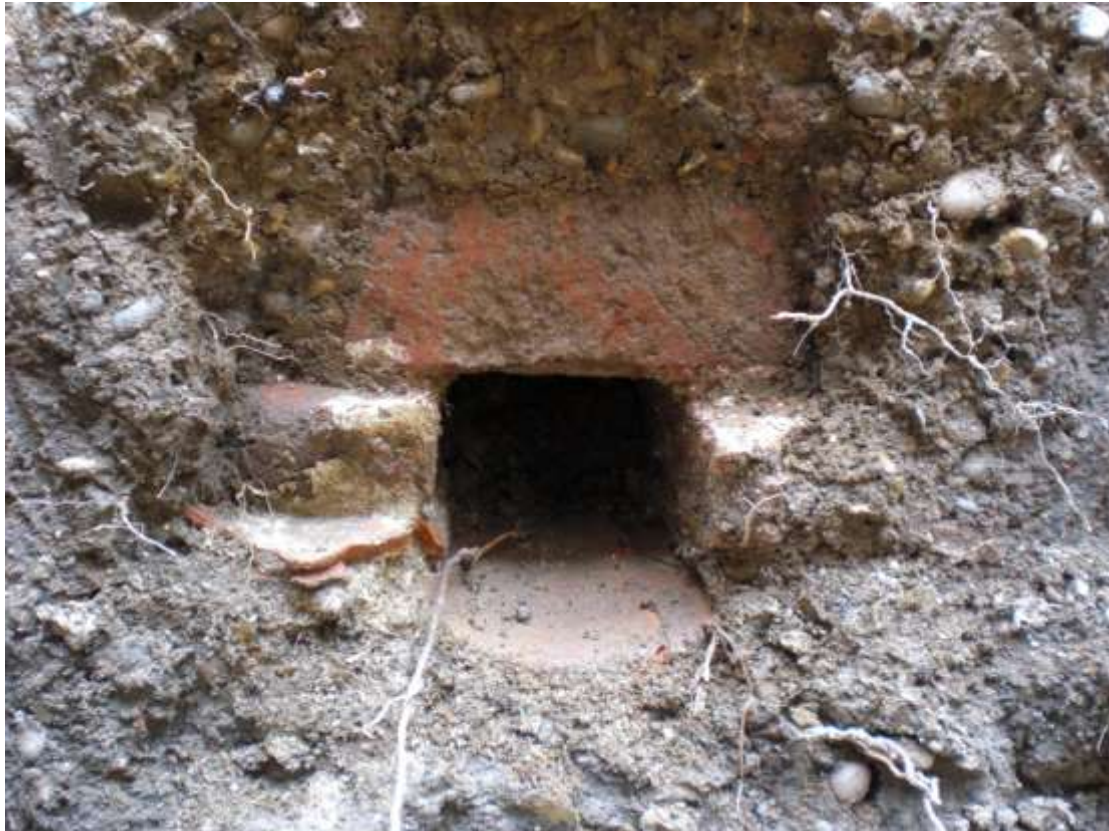
Victorian brick drain discovered in the western section of the excavation.

The section that was created to the west side was completely uniform being the redeposited mix of soils for the backfilled trench but there remained part of a brick built rainwater drain which must have previously served the Victorian drain system from the side of the house. The bricks were the type used in the foundations and the base was lined with peg tile.

A brick rainwater drain [[16]] was dug into the top of the subsoil 11 and buried in the garden soil 10. It must have served a down pipe running between the two windows that were subsequently removed as part of the 1970's works.
