Bushby House Greystoke

Historic Building Record

JB Heritage Consultancy was commissioned by Carrock Design Build Ltd to carry out a Level 3 Historic Building Record of Bushby House, Greystoke, Cumbria on 10 February 2012 prior to development work being carried out. The inspection of the property was carried out by Mr John Bargh MSc IHBC on 30 February and 9 March 2012. The report was written by John Bargh. Plans and Elevations are provided by Carrock Design Build Ltd.

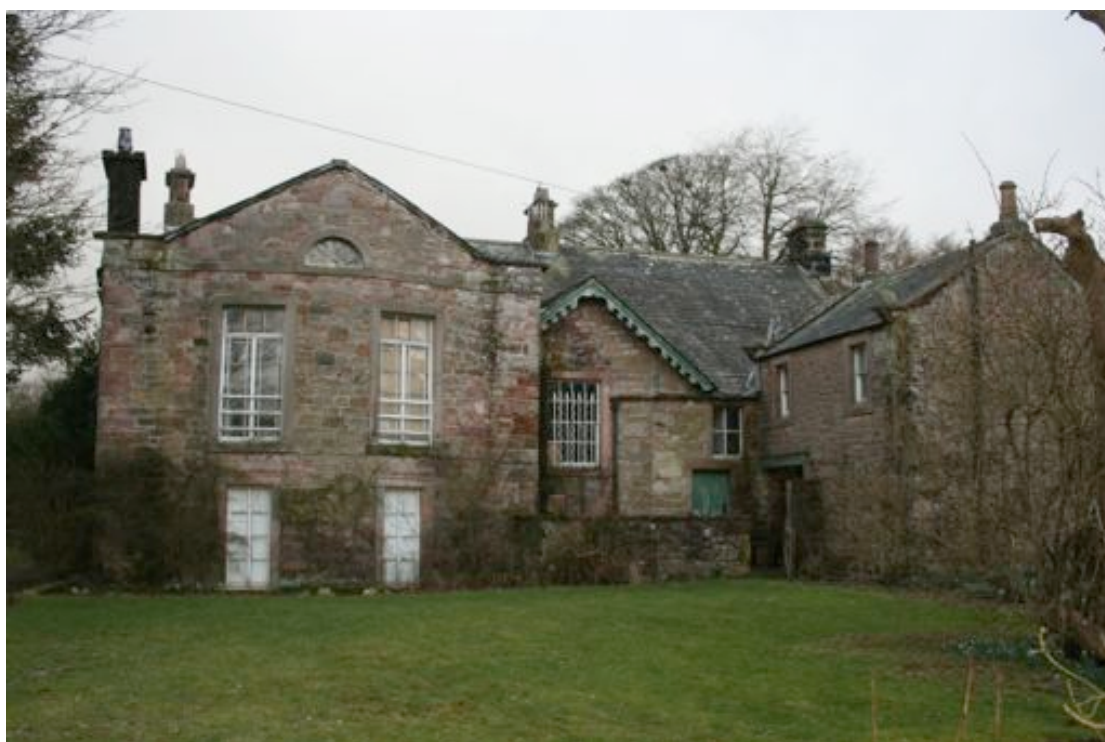
Plate 1. Rear (East) Elevation

balanced as a full height bay occupies a large part of one wall. Bushby House has solid stone external walls, a pitched roof covered with slates and further pitched slated roofs at the rear set perpendicular to the main house. The internal walls are mainly solid and the floors are mostly timber suspended with some solid. Windows are timber vertical sliding sash and side hung casement and the internal doors are timber panel type. The Coach House is detached and has solid stone external walls. The roof is pitched and covered with slates. The windows and doors are timber. The ground floor is stone and cobbles and the first floor is timber suspended. The Barn is composed of three single storey buildings built in solid stone with a pitched state roof. Doors are of timber and the floors are generally cobbles. The small detached outbuilding on the edge of the garden at the rear of the main house is built of solid stone, with a pitched roof covered with slates.

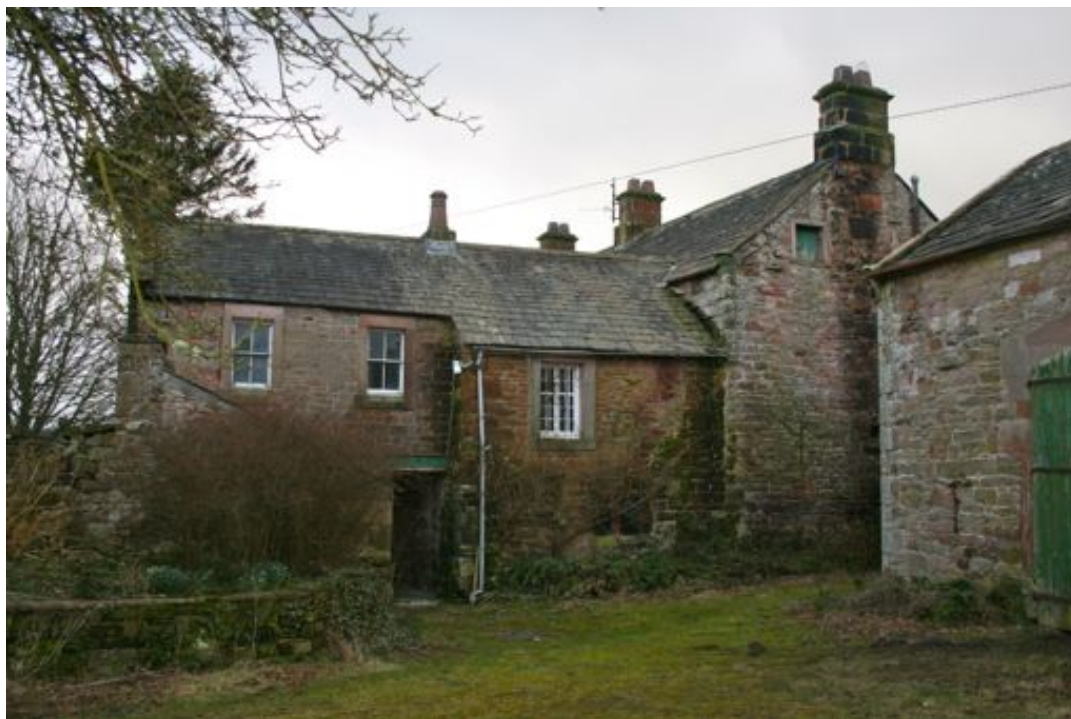
Plate 2. North Elevation Servants' Quarters. The end of the barn is visible on the right.

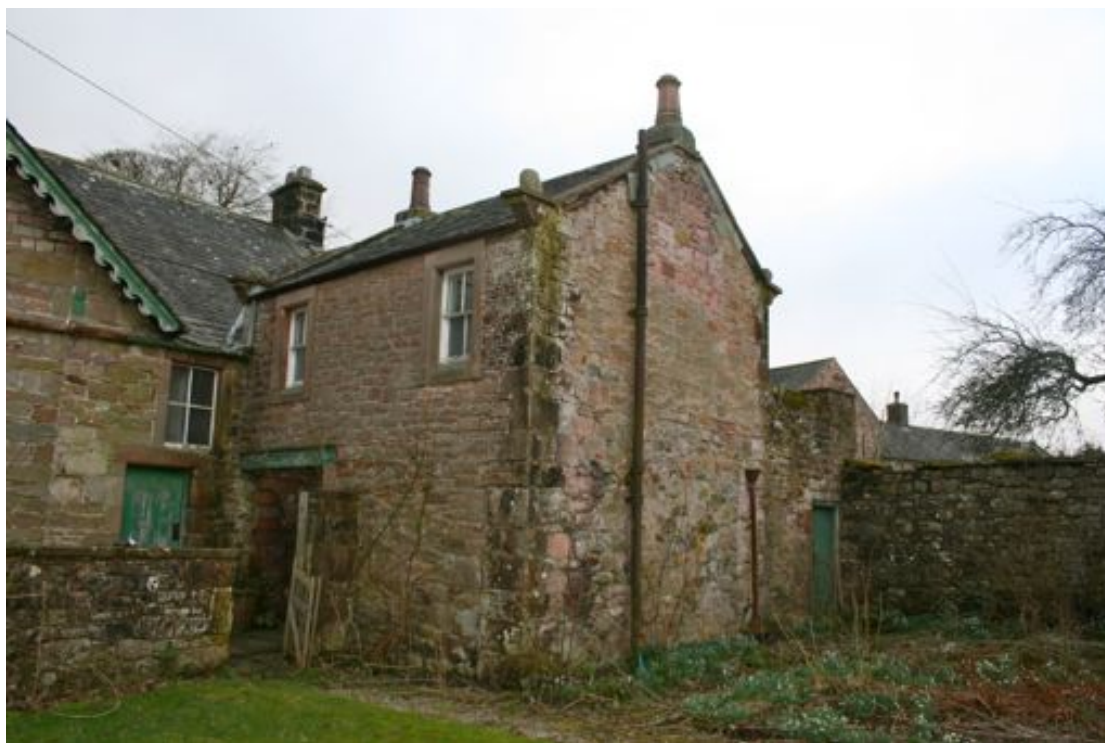
Plate 3. First Floor Extension

The roof is pitched and covered with random diminished Lakeland slate with a stone ridge. The gables are capped with stone tabling supported by a stone kneeler at eaves level. Access did not permit an inspection of the main roof space but it is likely that the roof construction consists of large section oak trusses, purlins and rafters. This opinion is supported by an inspection of the roof space above the servant's bedroom where an oak tie beam and collar truss supports oak purlins and oak rafters, all timbers being roughly cut. The underside of the slates in this roof space is torched with lime mortar. Interestingly, the roof space above the later extension which adjoins this room has more modern machine cut timber purlins and rafters which supports the view that this roof is of a later date. The chimneys to the main house are constructed from stone ashlar with a plinth, stone moulded cap and mostly square pots. The chimney to the Sitting Rooms is tall with a dentil capping. The chimneys to the later extension are short stone stacks with tall pots. One gable at the rear has scalloped timber bargeboards and the kneelers to another gable at the rear have crude stone finial details (Plate 3).

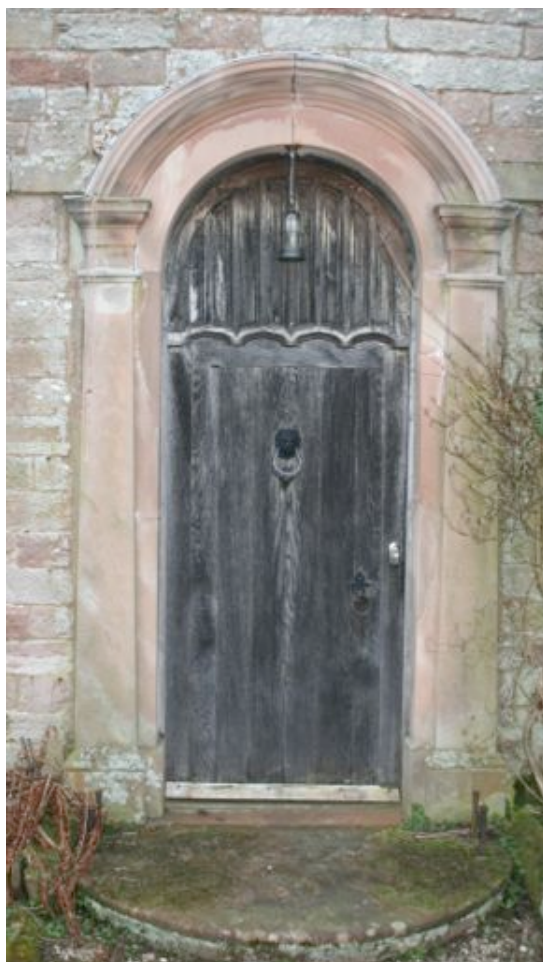
Plate 4. Front Door Surround

This house has approximately 600mm thick solid stone external walls of squared rubble to the front and random rubble to the remaining walls. The front (west) elevation has chamfered stone quoins and plain stone surrounds around windows. There is a chamfered stone plinth at ground level; at mid height of the wall there is a string course and at the top there is a projecting cavetto moulded eaves course. The front door has square stone pilasters with capitals and plinth to each side supporting a semi circular stone moulded head (Plate 4). At ground level there is a stone semi circular step and the two iron foot scrapers are a typical Georgian and Regency feature.⁵³ Moving to the rear of the house the walls are random rubble, there are some rough squared stone quoins and all the windows have plain stone surrounds, except those to the lower segmental bay wall which have an additional moulding. The segmental bay has a shallow projection and extends the full height of the wall. This feature was popular in the Regency period.⁵⁴ In the bay there is a stone string course at eaves level with an interesting glazed fanlight, a popular feature from the mid eighteenth century,⁵⁵ with stone surround in the gable. On the north facing part of the external wall of the Lower Sitting Room there is a stone surround to a former opening, possibly a recessed feature, which is now blocked up with stone. There is a small stone figure set into the wall above the back door, size 180mm w x 380mm h (Plate 5). This may, in some way, relate to the Howards as this part of the wall appears to be included in the first floor extension possibly built at the time the Howards were the owners.

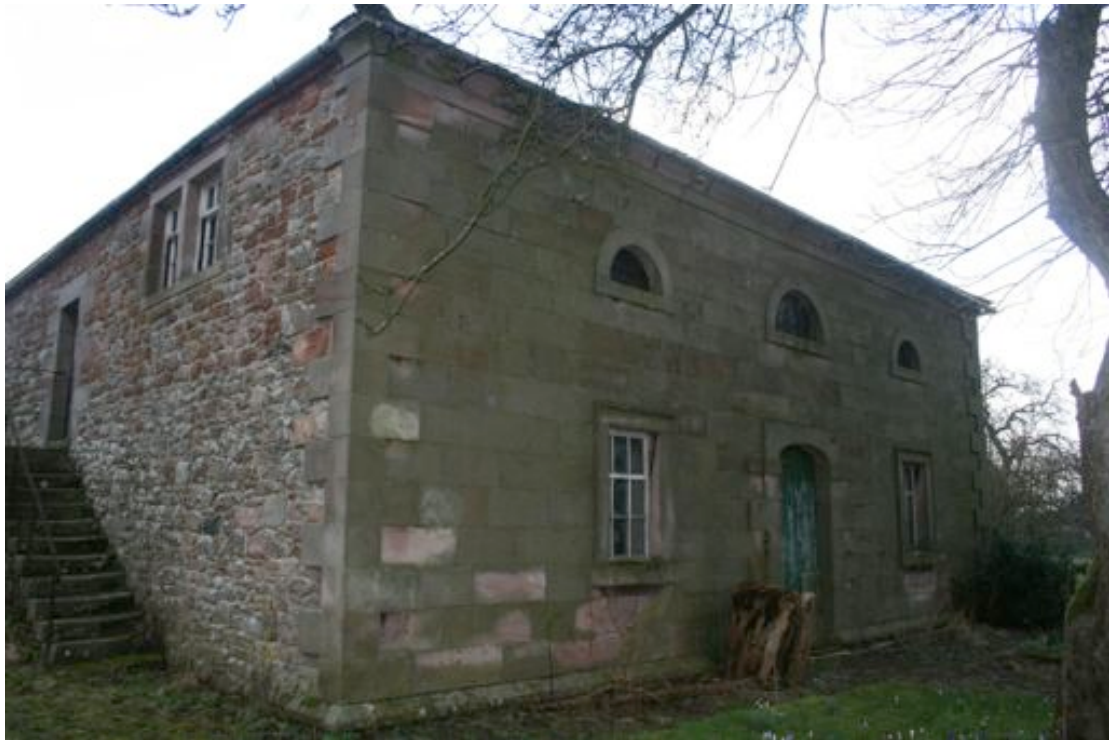
Plate 6. Coach House South-West Elevation

The Coach House is a detached building with stone random rubble to all the external walls except the south wall where stone ashlar has been used. This wall has some fine detailing. At the base there is a stone plinth and at the top of the wall is a stone eaves detail running the full length of the wall. On the first floor there are three semi circular glazed window openings with stone surrounds; a wrought iron grill is fitted on the centre window and metal bars built into the other windows. On the ground floor the door is positioned in the centre of the wall with stone dressings around the opening. This door is a timber split leaf and is vertical boarded externally and has horizontal boards internally. The two timber windows either side of the door are finished with a moulded stone surround.

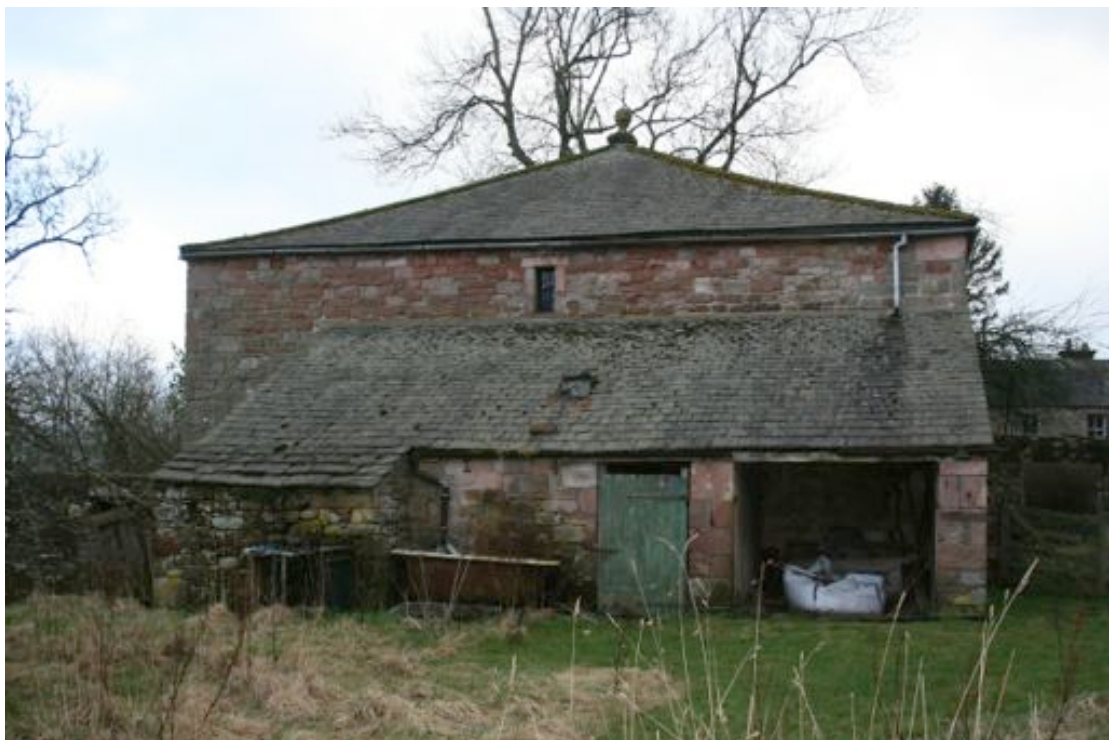
Plate 7. Coach House North Elevation

On the north wall there is a small stone dressed window at high level with a metal bar. Below, concealed by the lean-to attached outbuilding, are several ventilation slits in the wall. The lean-to outbuilding has several rooms (Plate 7). At the west end there is an open compartment with plastered walls. This compartment originally had large doors to the opening and a ceiling and it was possibly used as a store for farm implements. In the centre another compartment has lime washed walls and a cobbled floor and was possibly used for housing poultry. The last pair of compartments on the east side of the lean-to outbuilding follows a design usually seen in a pigsty.⁵⁸ The two compartments each have low ceilings and low doorways and each have a separate small external exercise area separated by a stone wall. Above the ceilings may have been a poultry loft.⁵⁹ These exercise areas each have stone troughs let into an aperture in the wall and an entrance opening with hooks on which to hang doors (Plate 8). The reveals to the stone trough openings have an inclined recess cut into the masonry, possibly to locate a timber board.

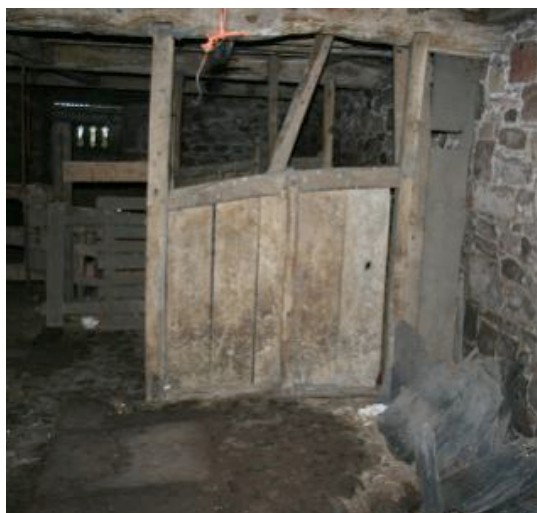
Plate 9. Cow House Stall

The ground floor is divided into two main compartments by a stone wall running west to east. The northern compartment has a stone cobbled floor with a narrow dish and kerb formed from west to east. There are two timber stalls positioned down one side of the compartment (Photo 9). These appear very old and are framed with the uprights fixed to the ground and into the first floor beams. The uppermost horizontal member is curved and the whole frame is panelled with timber. In the compartment these stalls, or 'scale boards', separated probably a pair of cows tethered so that they backed onto the combined feeding, manure and drain passage all accommodated under a low ceiling with no windows and ventilation only from the doors. This compartment resembles a typical cow house as described by Brunskill.^{61, 62}

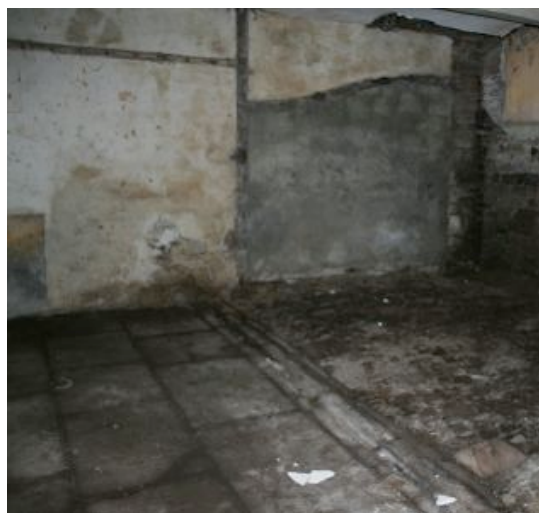
Plate 10. Stable

The southern compartment is divided into two, a large room and a small room. The ceilings to both rooms are plastered and there is some plaster to the walls. The floor to both rooms is raised towards the rear and finished with cobbles to the larger room and timber boarding and concrete to the smaller room. The front part of the floor to both rooms is covered with stone flags and a stone drain runs across the floor from west to east. There is evidence that the walls to both rooms may have been timber boarded stalls to about two thirds the room height. Set into the floor of the large room there are three pieces of sandstone possibly indicating that this area was divided into four (Photo 10 shows the larger room and the sandstone pieces in the floor). In the smaller room, one piece of sandstone suggests this room was divided into two. The doorway between the two rooms is dressed with ashlar and the door is a timber ledged door. On the inside of the south wall there is a high level cupboard, rows of timber hooks and timber window boxes below each window with top hinged lid. This accommodation is taller and cleaner than the cow house and has attributes similar to those of a stable for possibly up to five horses.^{63, 64}

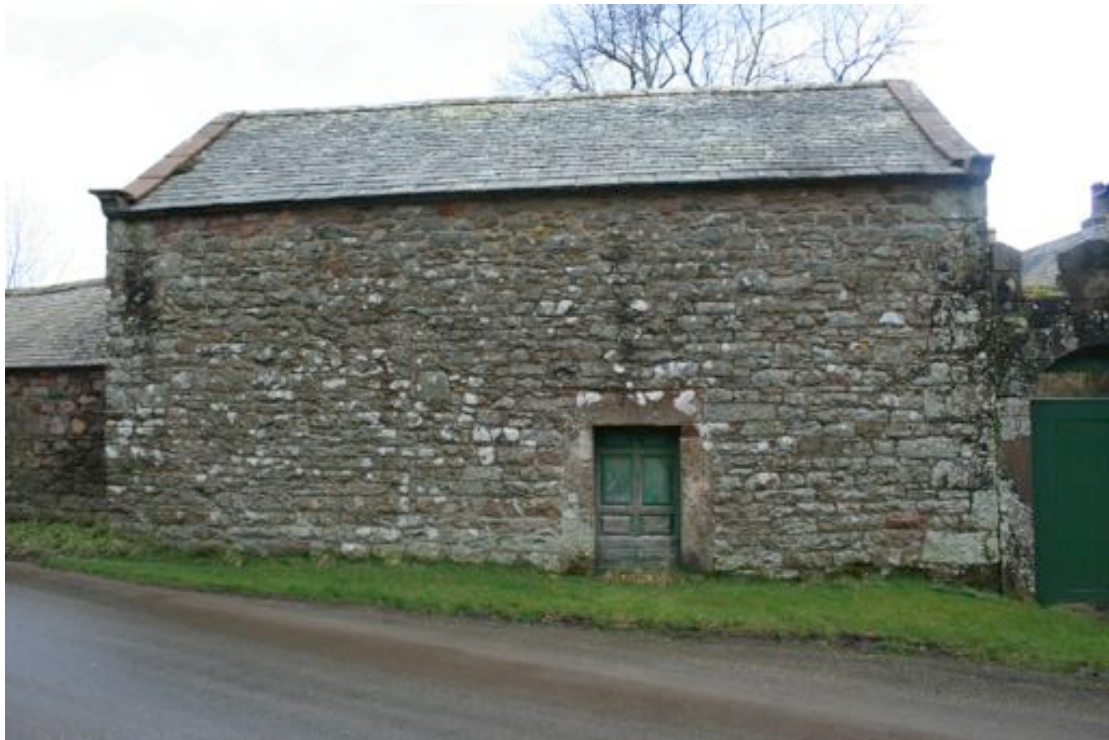
Plate 11. West Elevation Tall Barn

The Barn comprises three single storey buildings, the tall barn, lower barn and store, all connected into one complex. The barn is connected to the main house with a squared rubble stone wall with crenelated top. This wall has two openings that appear original: one has a semi circular arch formed with stone voussoirs over a modern door; the other has chamfered stone dressings to the jambs and a stone lintel with keystone detail over the opening. This latter door has been blocked up with stone.

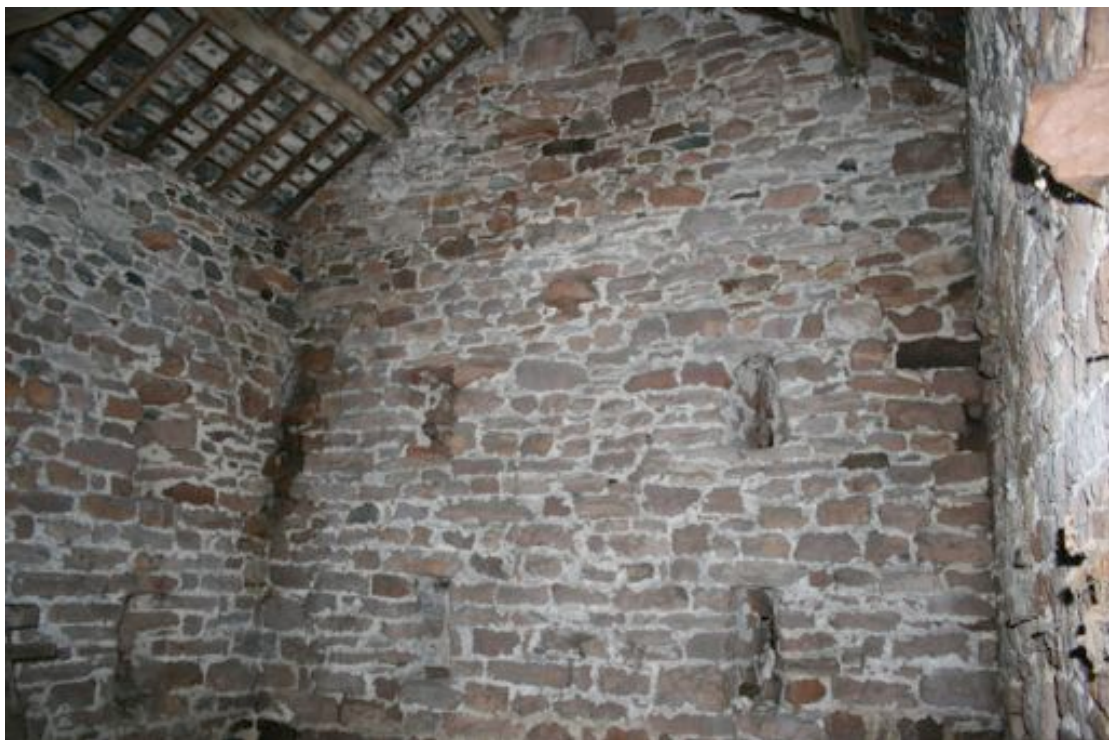
Plate 12. Interior of Tall Barn

The tall barn has a large internal open space and was probably used for storage and animals (Plate 12). It could also have been used for hand threshing. The roof is pitched and covered with random diminished Lakeland slates with a stone ridge. The underside of the slates is torched with lime mortar. There is stone tabling up the verge and moulded kneelers at the eaves. The roof construction is oak tie beam trusses (one of which has a collar) supporting purlins. The rafters appear of later date. The last rafter on the gable is protected from the weather by slates nailed vertically. The external walls are stone random rubble with ventilation slits, those on the west side built up with stone. On the gables are sealed up owl holes at high level. Inside on the south wall is a horizontal pole across the barn at 1000mm height possibly to tether animals. On the west elevation there is a panel door with eight raised and fielded panels (Plate 11) and on the east side there are a pair of tall timber doors hung on strap hinges. The arch over this door is segmental with two stone springers at the side and only two arch stones, or voussoirs, over the opening. The floors are a mixture of cobbles and stone flags.

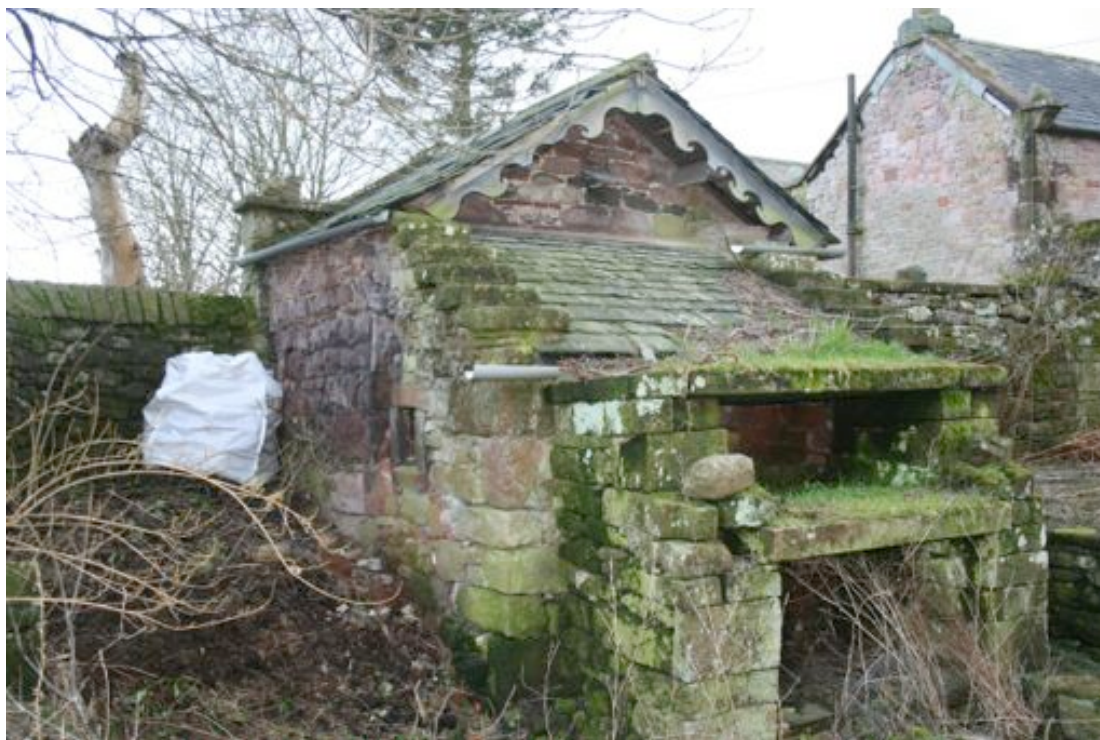
Plate 13. Small Detached Outbuilding North Elevation

This detached single storey building is in two parts (Plate 13). The main building is constructed from random rubble stone with dressed stone around the doorway. The roof is pitched and covered with welsh slates and the roof timbers are recent. The south gable is capped with a coping and rough stone finials at each end. The north gable has a scalloped timber bargeboard. The door is timber. The remaining part of this building is to the north. Its walls are random stone rubble and it has a mono pitched roof covered with random diminished Lakeland slates and recent roof timbers. The side gable verges are stepped with stone and there is a timber door. Inside the floor is stone flagged and there is a thin piece of stone set vertically across the floor. On the north wall of this part of the building is a curious structure of walls supporting large stone slabs. The southern part of this building may have been a store for the garden. It is not known what purpose the northern part served.

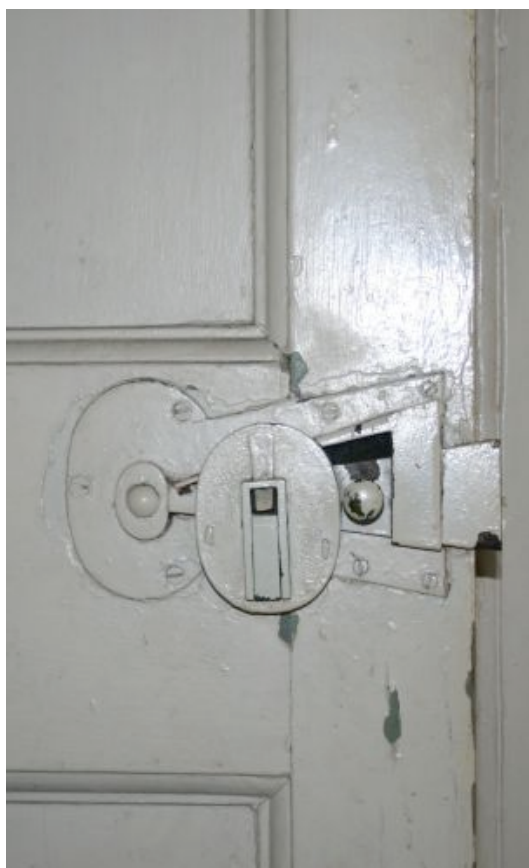
Plate 14. Lock to Dressing Room Door

cast iron fireplace with hob grate has a plain stone surround and timber mantle (size to outside of surround: 1250mm w x 1200mm h). The six-panel door has an original latch with intricate key that fits into a round hole in the lock (Plates 14 and 15). On the side facing into the master bedroom the panels to the door are flush with the frame and the deep skirting to the walls continues along the face of the door. There is also no architrave giving the effect that this doorway was intended to be inconspicuous (Plate 16).

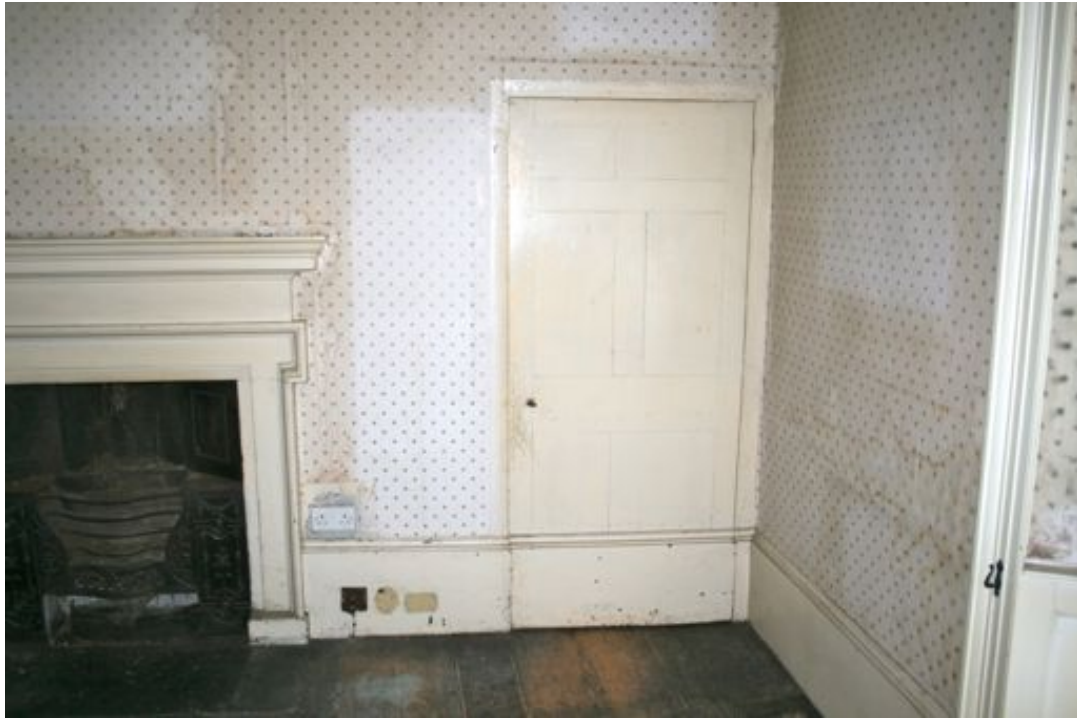
Plate 16. Dressing Room Door Showing Flush Arrangement and Skirting

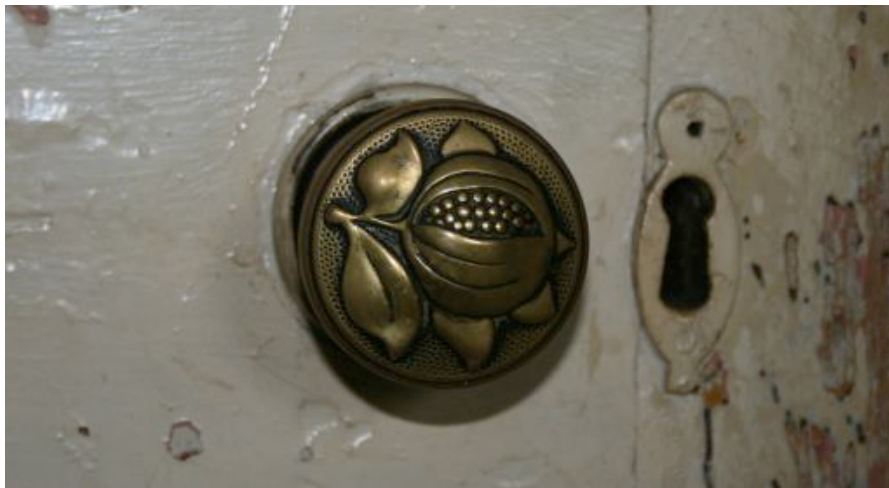
Plate 17. Knob Furniture Master Bedroom

The ceiling is finished with fibrous plaster foliage moulding (Plates 18, 19 and 20). There is a timber picture rail. The vertical sliding sash window frame appears not to be original and is fitted with shutters. The cast iron fireplace with hob grate has a plain stone surround and stone mantle (size to outside of surround: 1300mm w x 1400mm h). There is an alcove formed within the internal wall with plaster finish, probably a wardrobe. The door to this wardrobe is a six-panelled door with raised and fielded panels. To the left of this door is the door leading to the landing of the same design but has interesting knob furniture (Plate 17). Between the two doors there is a narrow timber vertical fluted pilaster.

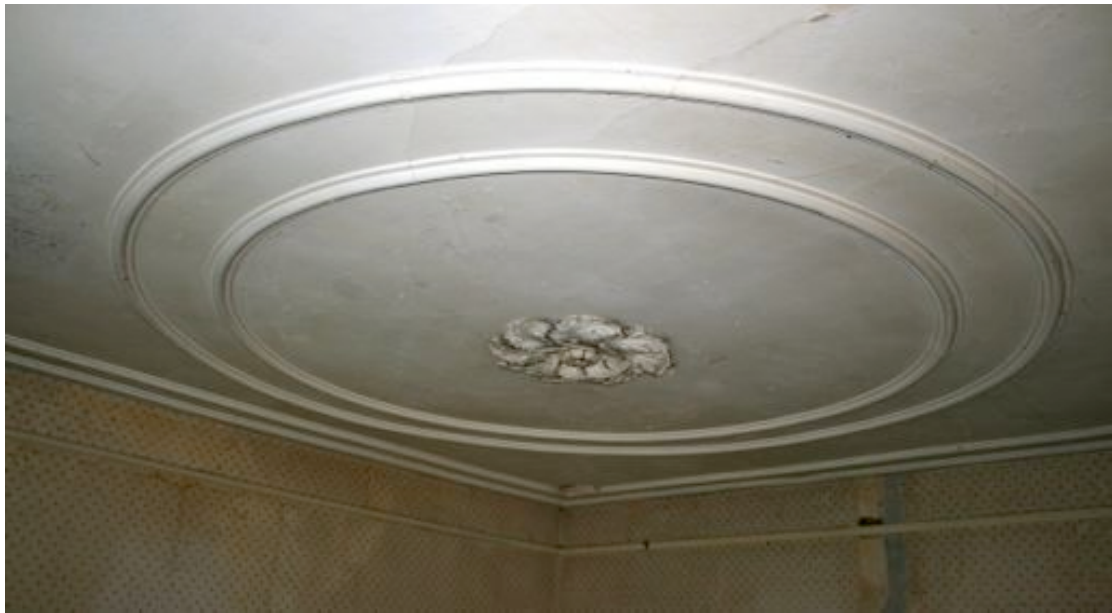
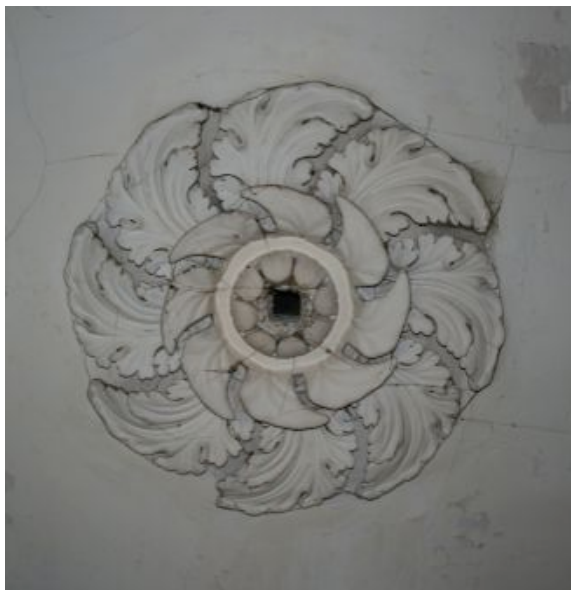
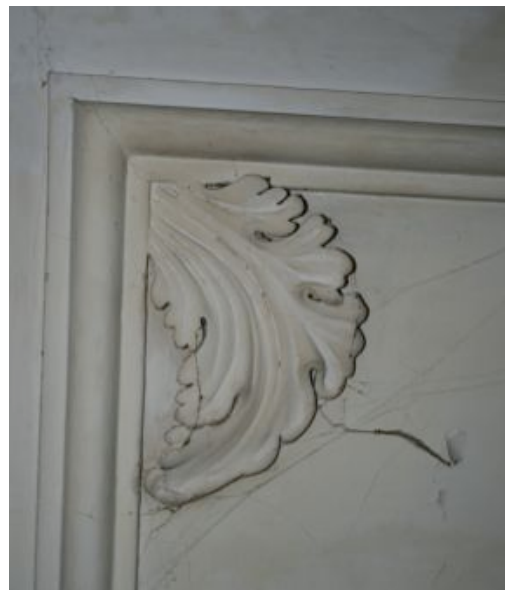
Plate 18. Plaster Ceiling Master Bedroom

Plate 19. Ceiling Rose Master Bedroom

Plate 20. Leaf Detail Master Bedroom Ceiling

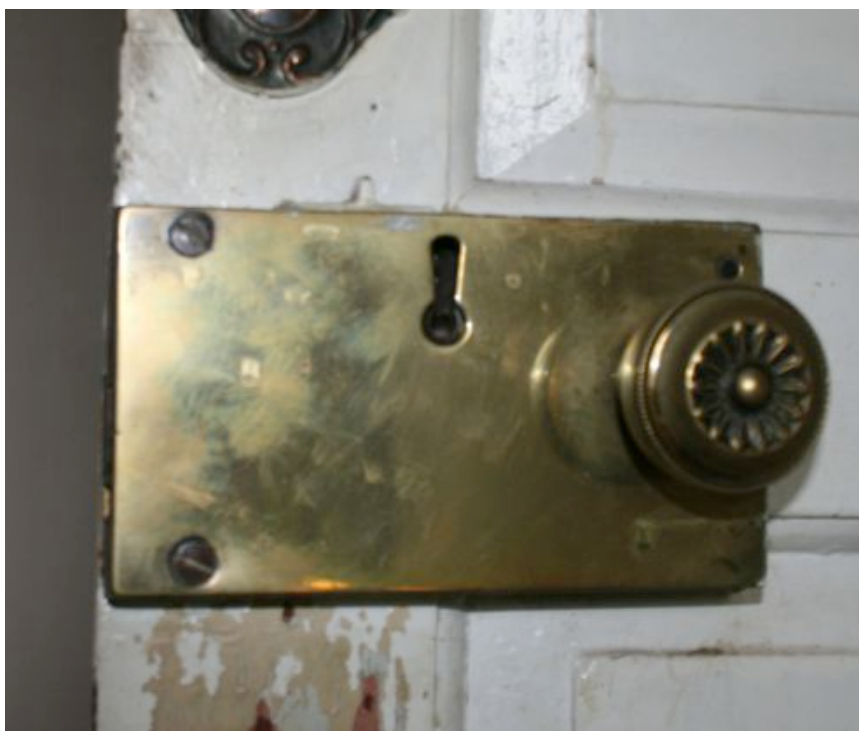
The vertical sliding sash window frame that appears not to be original is fitted with shutters. The cast iron fireplace with hob grate has a plain stone surround with timber trim and timber mantle (size to outside of surround: 1100mm w x 1300mm h). The eight-panel door with raised and fielded panels has an early brass lock (Plate 21). At ceiling level there is part of the servants call bell system mechanism that extends through to the landing.

Plate 21. Brass Lock Bedroom 2.

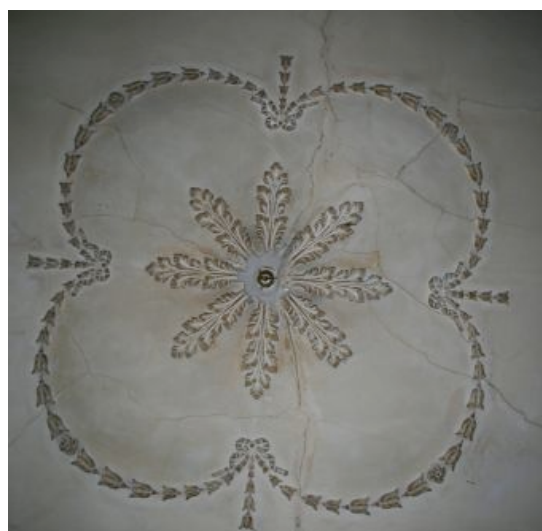
Plate 23. Ceiling Feature Upper Sitting Room

From the half space landing on the staircase there are three timber steps up to this large room overlooking the garden. This is one of the more imposing rooms of the house. The plaster ceiling has a central feature formed in fibrous plaster (Plate 23) and a wide cornice. The walls to this room appear to be lined probably with vertical timber studs and lath and plaster to give improved thermal insulation. There is a timber picture rail and timber dado rail. The cast iron fireplace has a stone surround and timber mantle (size to outside of surround: 1700mm w x 1350mm h). The main feature on the walls is the segmental bay that contains two window openings fitted with side hung windows with fixed and opening light above all with small panes of apparent older date (Plate 27). The windows are fitted with shutters with flat panels and planted thin mouldings. There is a six panel door with flat panels with planted thin moulding and a brass knob. The skirting has quite intricate moulding.

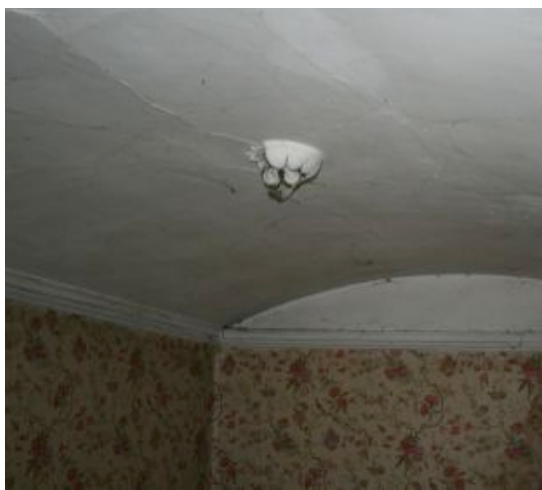
The plaster ceiling over this space is segmental with a plaster cornice (Plate 25). In the centre of the ceiling is an ornate rose for a light fitting. The window is a vertical sliding sash of apparent older date set into an opening with splayed reveals but no shutters. Externally in front of this window is an ornate wrought iron window guard, these typically dating from the late eighteenth century.⁶⁵ The dog-leg staircase construction comprises substantial stone units which form the tread and also its riser supported partly on the walls below and partly by an oak carriage (Plate 26). The balustrade is formed with slender square section timber balusters, indicative of the late eighteenth century,⁶⁶ set into the top of the steps and into a hardwood handrail with turned newel post. Under the ground floor stairs is a store area.

Plate 25. Ceiling and Light Fitting Main Stairs

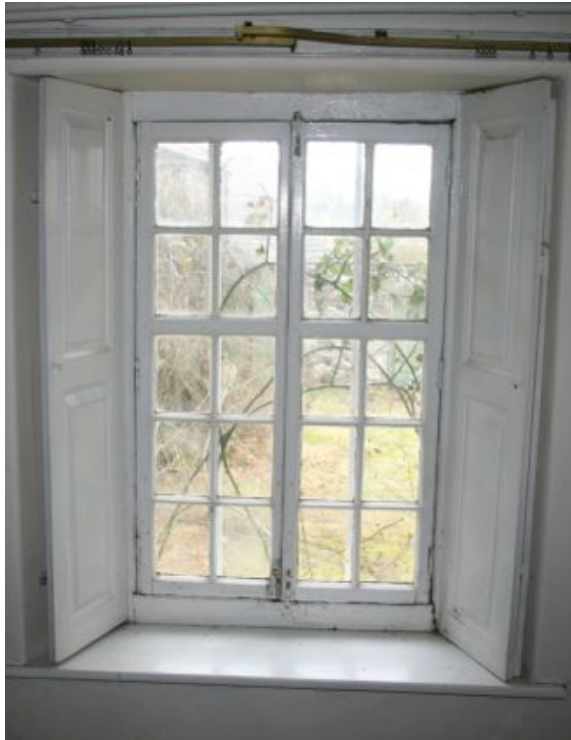
The plastered ceiling has a plastered beam across the room. There is a small cast iron fireplace with a stone surround (size to outside of surround: 1150mm w x 1150mm h). The side hung timber casement window has small panes and shutters with raised and fielded panels (Plate 28). The door to this room has four plain panels.

Plate 28. Early Side Hung Casement Window

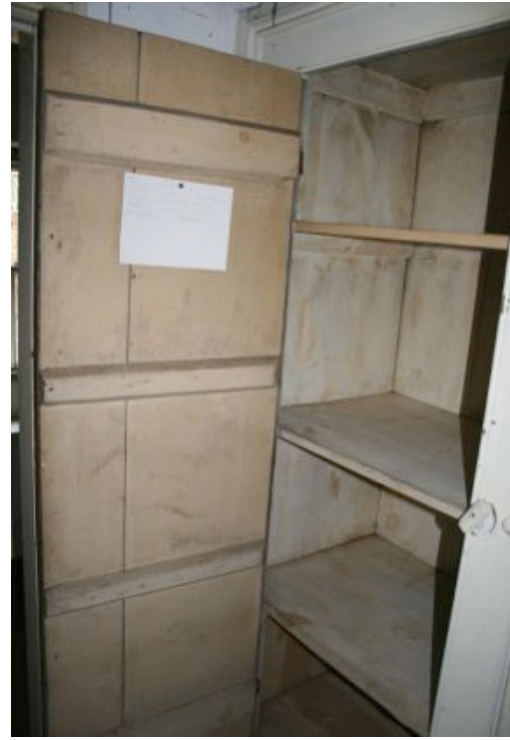
Plate 29. Linen Cupboard

The vertical sliding sash window would probably date from the extension and the external stone dressings match those on the south elevation of the Dressing Room. The door has four plain panels. The large linen cupboard appears to be of some age. It has ledged doors with timber turn button fasteners (Plate 29). Inside there is a paper notice referring to equestrian activities and bearing the name 'Mrs Howard.'

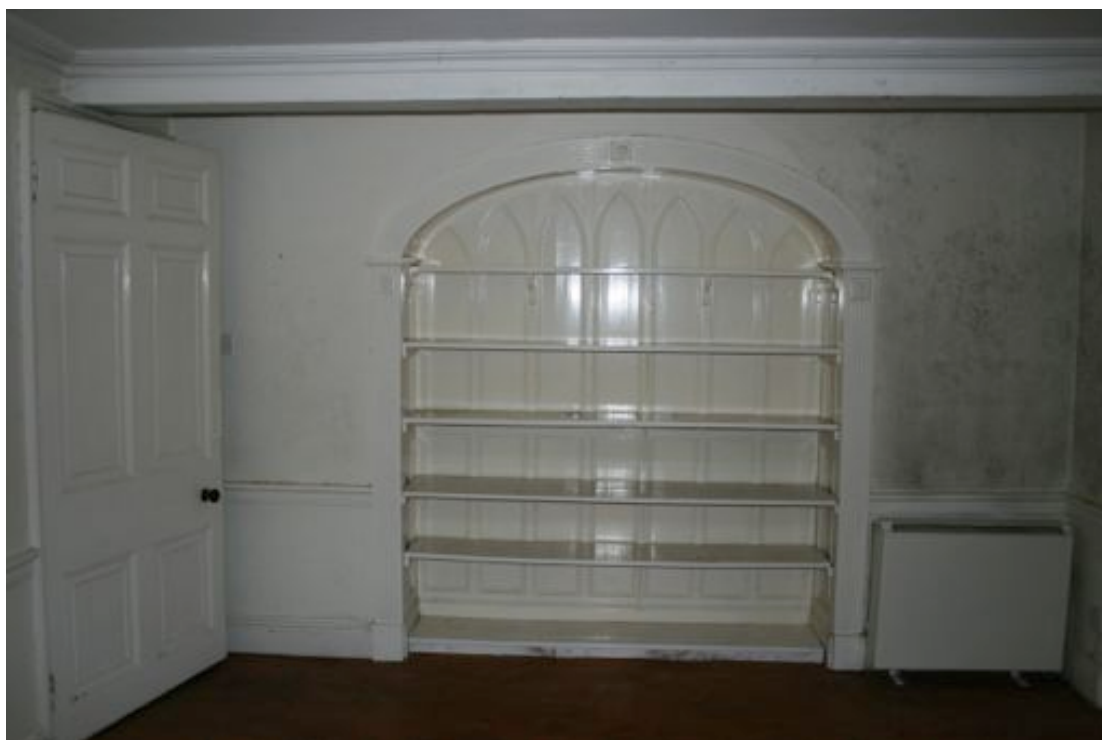
There is an alcove fitted with modern shelving (Plate 30). This has a plaster moulded architrave to the elliptical head and the sides of the alcove are finished with a timber moulded architrave. The back of the alcove is finished with timber Gothick moulding. The cheeks of the alcove are timber framed with plain panels and planted thin mouldings.

Plate 30. Alcove in Lower Sitting Room

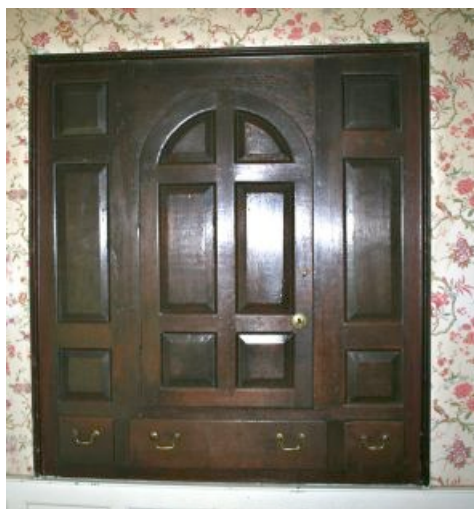
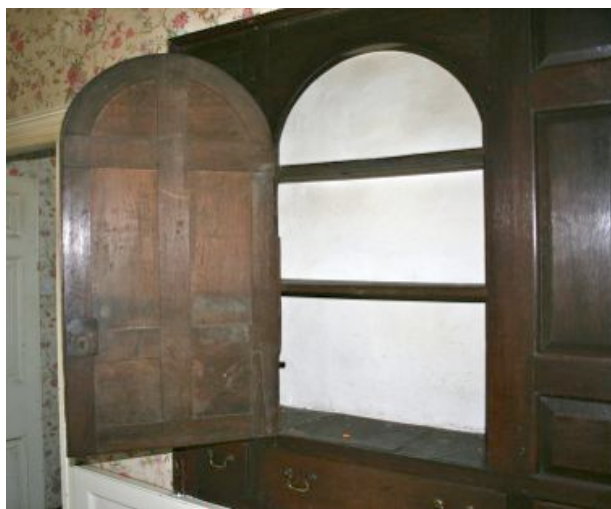
Plate 31. Wall Cupboard

Plate 32. Wall Cupboard Interior

The plaster ceiling has plaster cornices and plaster applied to the first floor beams. There is panelled dado boarding at low level on the wall. The cast iron fireplace with hob grate has a stone surround, stone mantle and stone hearth (size to outside of surround: 1200mm w x 1250mm h). The vertical sliding sash window frame of apparent older date is fitted with shutters. There are two sets of double doors; one, leading to the Lower Sitting Room door, is fixed permanently open in order to support handrails and the other leads to the main staircase. The panels are flat with planted thin moulding. On the wall opposite the main entrance door there is a very attractive oak inset wall cupboard (size: 1200mm w x 1300mm h). This comprises one central side hung opening door with a semi-circular head revealing oak shelves within and three drawers below it. The drawers are all oak and formed with dovetail joints and the front is finished with French polish. The furniture is mostly brass (Plates 31 and 32).

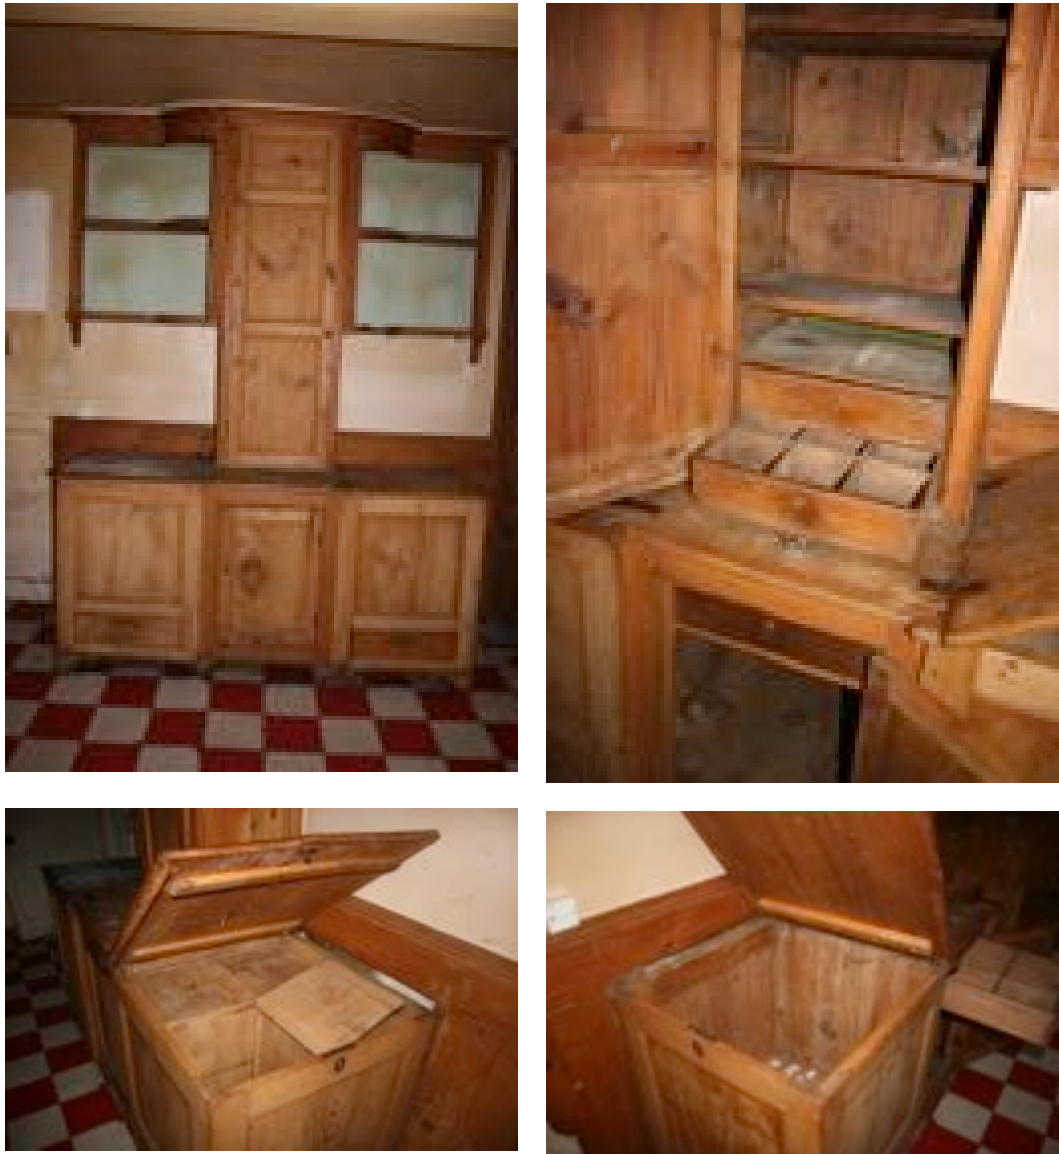
Plate 33. Pitch Pine Kitchen Cupboard

A large full height cupboard unit made from pitch pine, size: 1850mm w x 930mm to worktop x 2600mm total height (Plate 33). The lower part of this has a central cupboard with drawer. To each side are two square compartments with hinged top opening doors; the right hand one contains four separate compartments with lids. The upper part of the unit has a central cupboard with shelves and racks with holes and two drawers, one of which has compartments. To each side of this cupboard are open shelves with curved cornice.

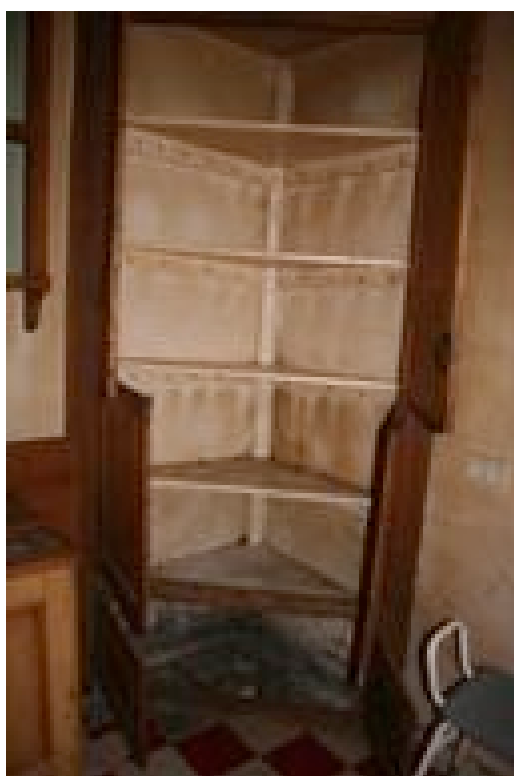
There is a full height pitch pine corner cupboard with doors and shelves of width 1300mm (Plate 34).

Plate 34. Corner Cupboard

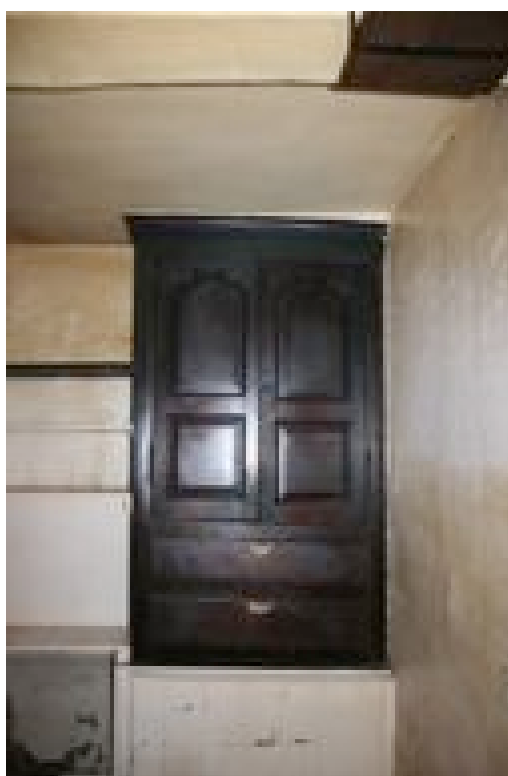
There is an oak wall cupboard (size: 970mm w x 1680mm h) at higher level with dentil cornice and a pair of cupboard doors framed with raised and fielded panels and shaped top rail. Below the doors are two drawers, one with three compartments. This cupboard has brass drawer handles and is finished with French polish (Plate 35).

Plate 35. Oak Wall Cupboard

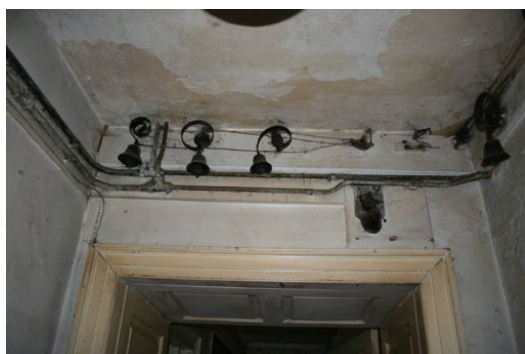
Plate 36. Servants' Bells

This is a lobby and of interest here is the servants' bells at high level. There are six bells (but seven positions) fixed to springs and cables that in the past would have served the main habitable rooms of the house (Plate 36). In the Regency period servants were summoned by bells connected to the various rooms by a system of fine wires ⁶⁷ sometimes passing through the roof and at high level near the ceiling.

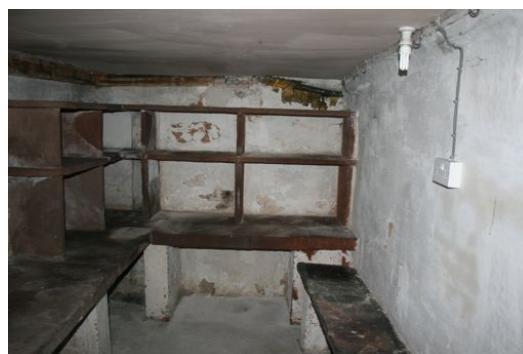
Plate 37. Dairy

The walls are plaster and lime wash and the floor is concrete. This room has a number of hooks at high level probably used for hanging meat. The small stone dressed window on the north side is covered with perforated zinc. Along the long external wall is a range of sandstone shelves and sandstone work surface supported on piers (Plate 37). There is a lobby to this room that contains a vertical cupboard. To keep the dairy cool it was often positioned on the north or east side of the house.⁶⁸
